# Summary of Results

## Walk the WBID Exercise for Turkey Creek (WBID 1578B)

*Florida Department of Environmental Protection  
Division of Environmental Assessment and Restoration  
Bureau of Watershed Restoration  
Tallahassee, FL 32399*

August 2012

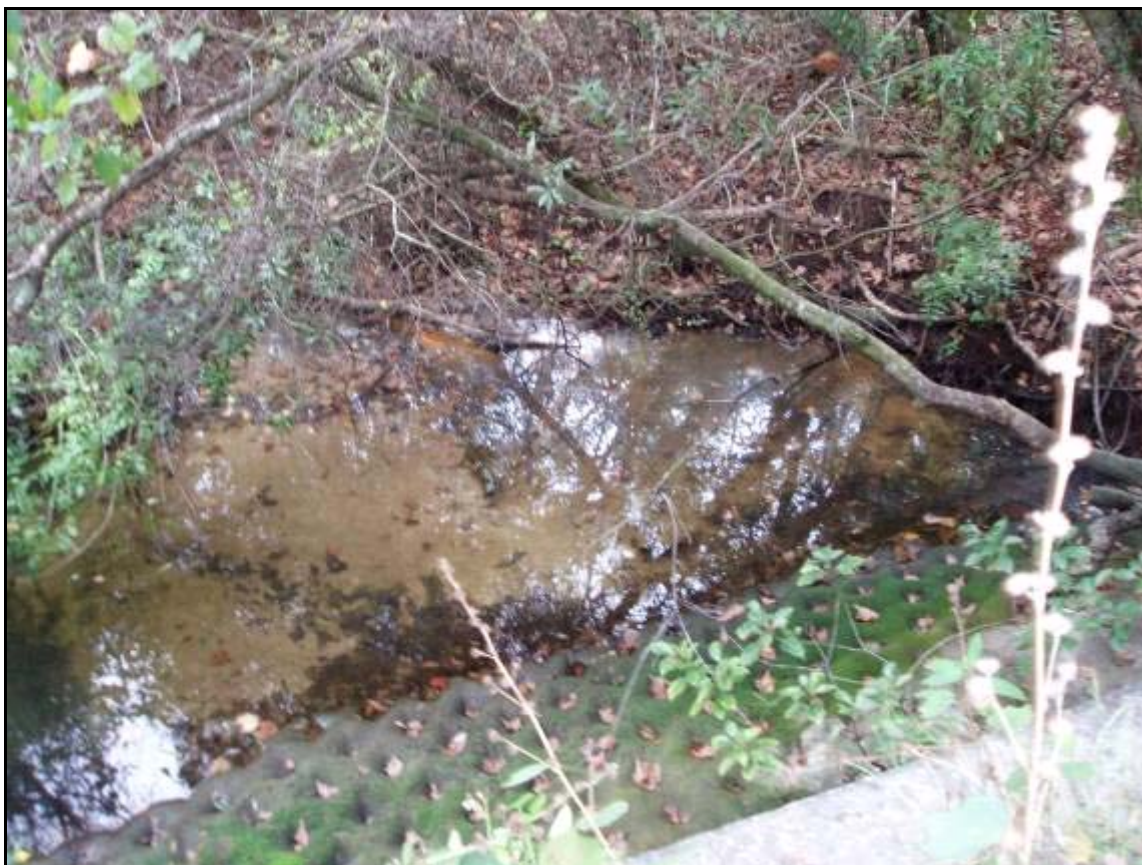
***Figure 6. Valrico AWT Facility outfall located behind Keith Waller Park. Discharge was minimal at the time of the visit. However, a slight oily sheen was visible on the surface, along with areas of orange discoloration associated with iron oxidizing bacteria.***

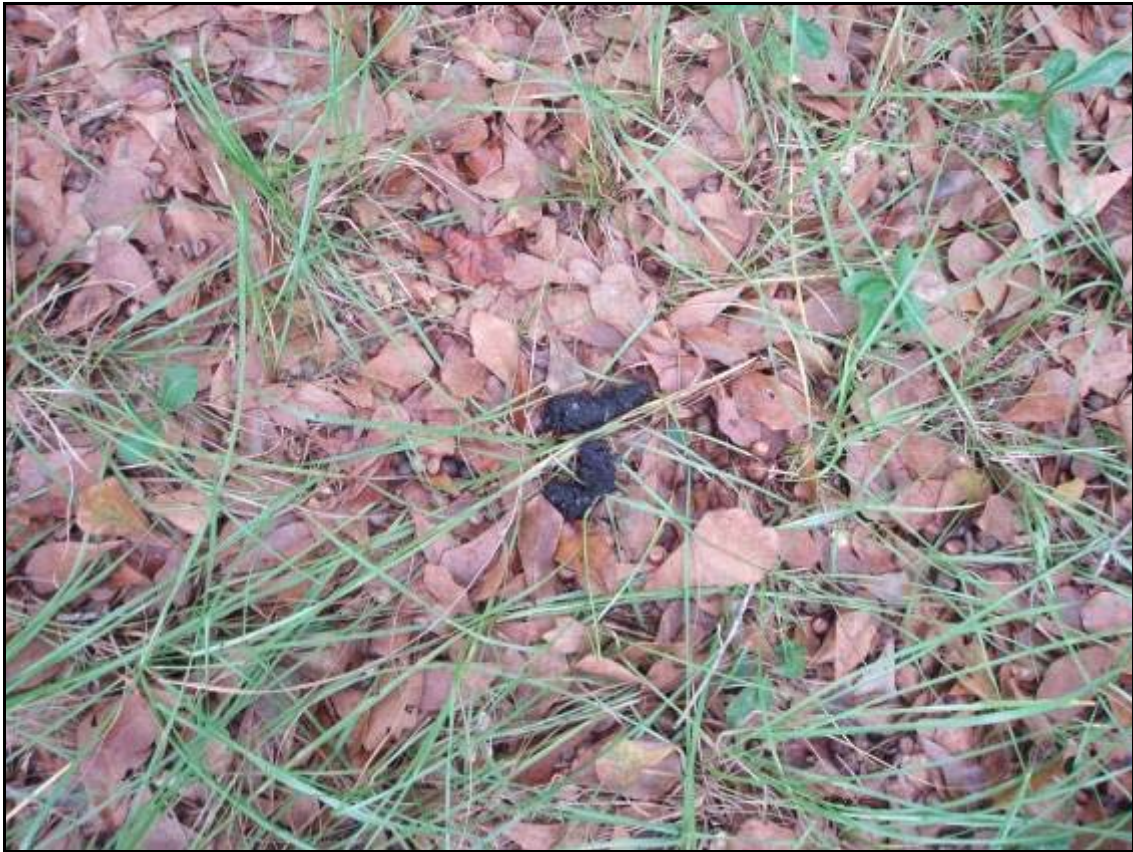
*Figure 7. Evidence of wildlife was found adjacent to the Valrico AWWTF outfall.*

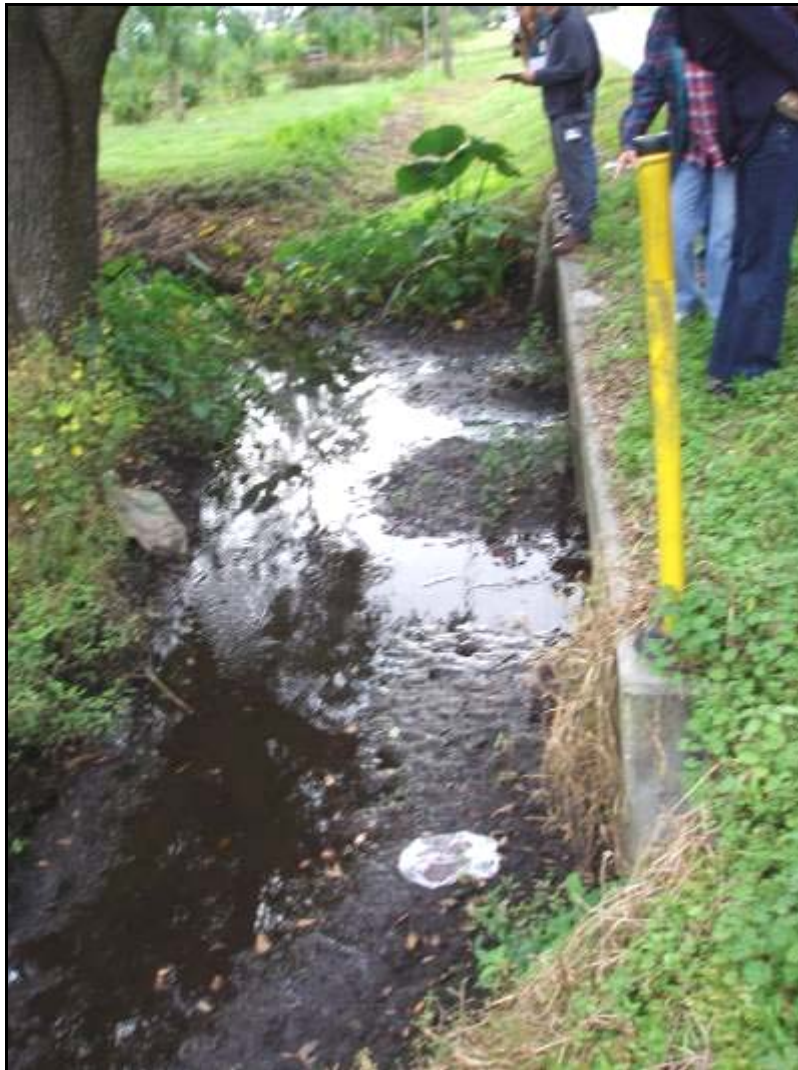
***Figure 8. Convergence of several ditches and a cross drain running under Sydney Dover Rd south of Walden Sheffield Rd. Oily sheen, wildlife tracks, and litter visible in the creek. Spoke with adjacent landowner, George Williamson Farm, regarding hydrology and water quality. George Williamson Farm participates in the FDACS BMP enrollment program.***

- Bacterial re-growth is probable in ditches and natural watercourses given the subtropical climate and natural sediments observed. See Figures 8, 9, 19, 29, and 56.

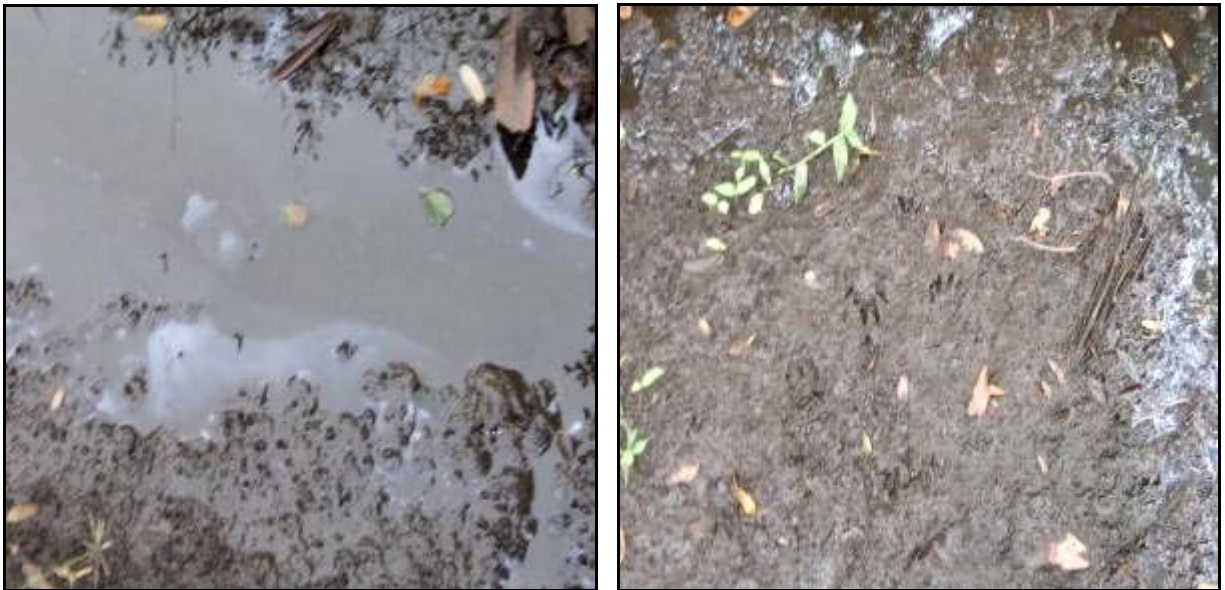
*Figure 9. Close up of oily sheen and raccoon tracks at cross drain shown in Figure 8. Oily sheen appeared to be a natural condition attributed to sediment characteristics.*

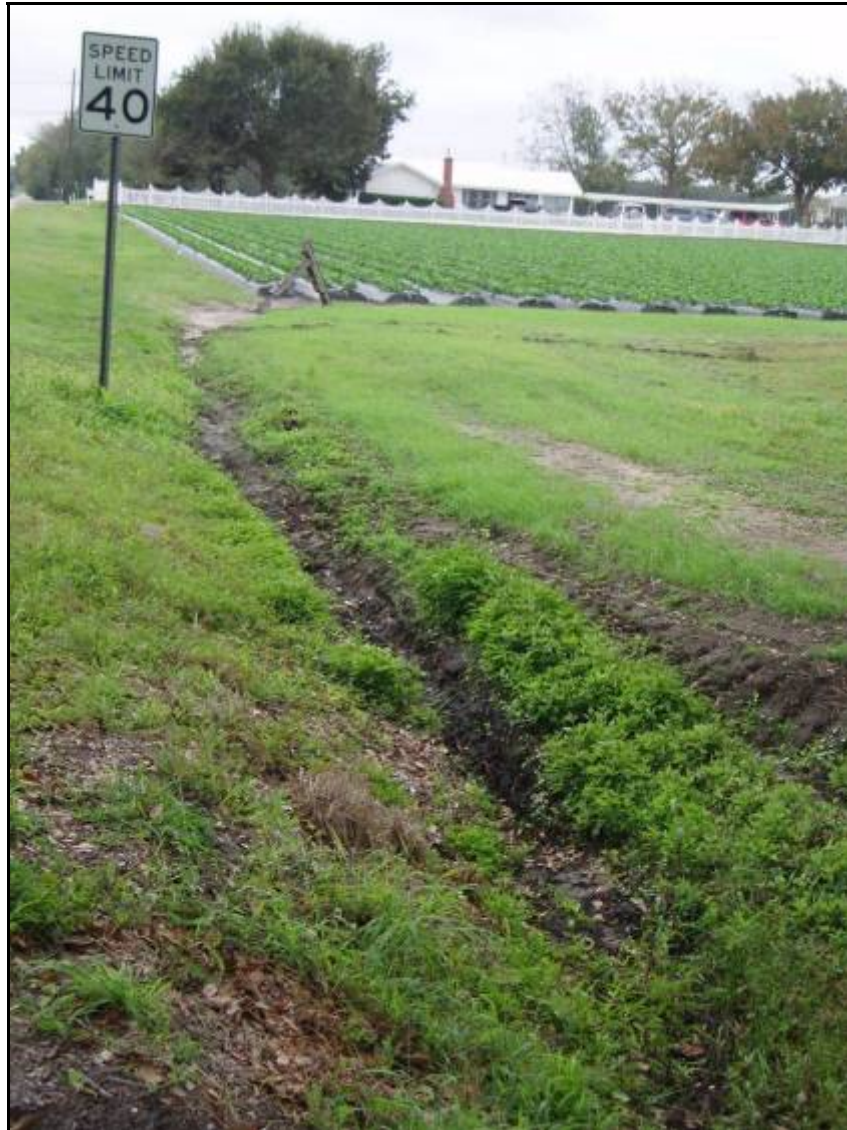
*Figure 10. Erosion from a strawberry field toward the cross drain in Figure 8. While the photo depicts a discrete instance, erosion from agricultural lands was commonly observed during the Walk. Erosion causes sedimentation in ditches and creeks, which may create favorable conditions for fecal coliform bacteria.*

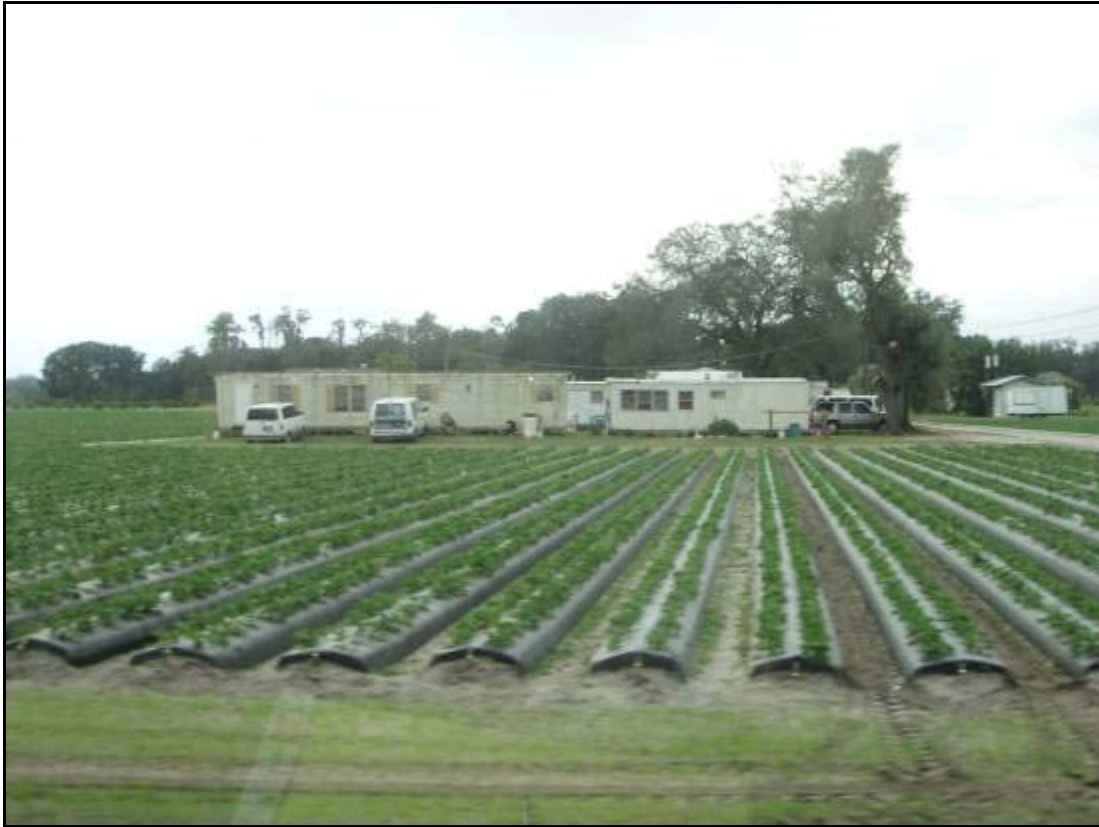
***Figure 11. Migrant farm worker housing located off of Sydney Dover Rd south of Downing St. Closer inspection was not possible due to limited access; however, this example is typical of lower quality migrant housing. Similar migrant housing conditions were observed throughout the Walk.***

*Post Field Note: DOH Farm Worker Housing Program inspects all migrant housing twice quarterly during occupancy.*

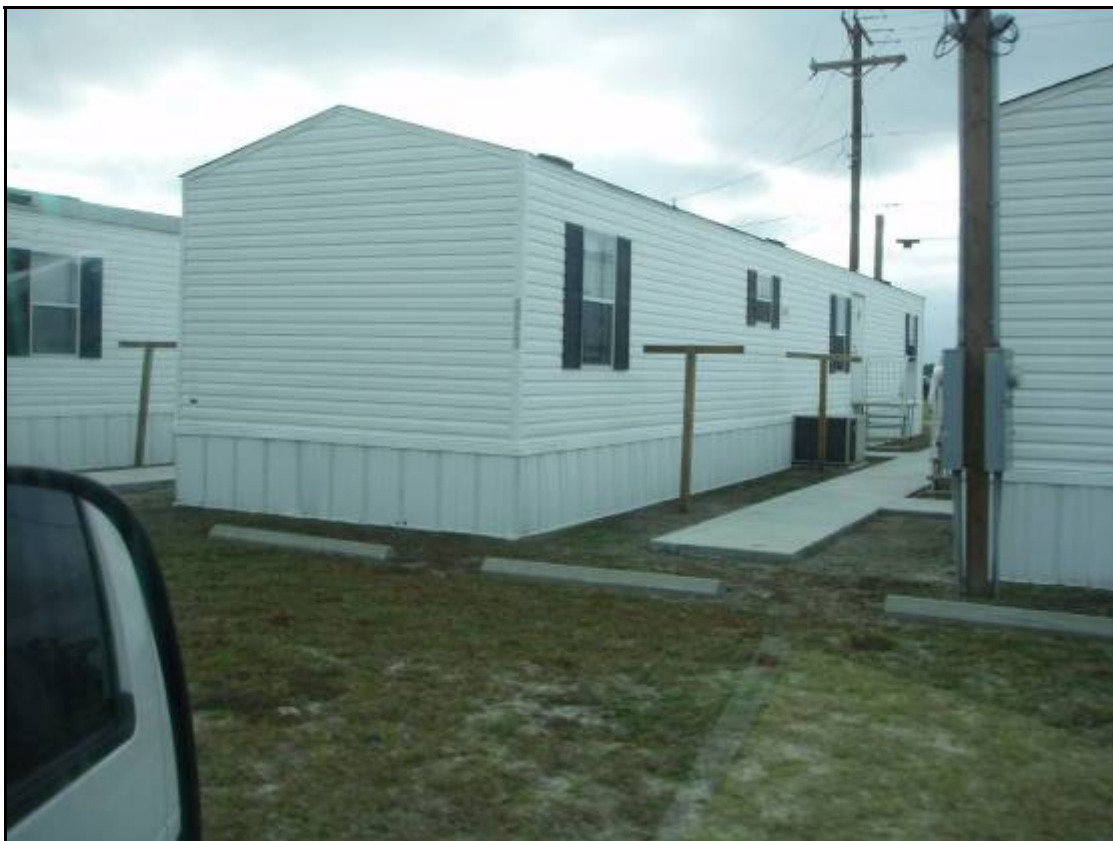
***Figure 12. High quality migrant farm worker housing located at G & F farm [Sydney Dover Rd]. Property manager allowed access for inspection of migrant housing, OSTDS drain field, and on-site BMPs. No potential sources were observed here. This is an example of the requirements for new migrant housing.***

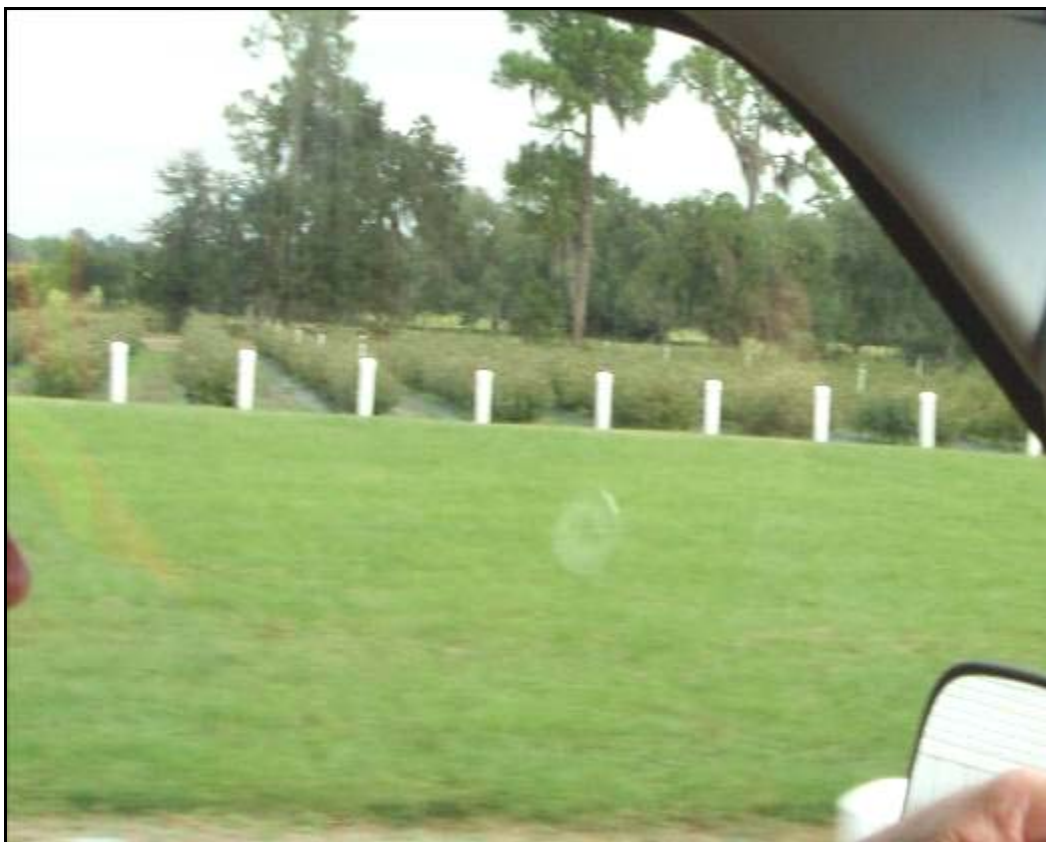
*Figure 13. Septic system drain field serving migrant housing on Higgins Farm. The drain field is cordoned off and appears well functioning.*

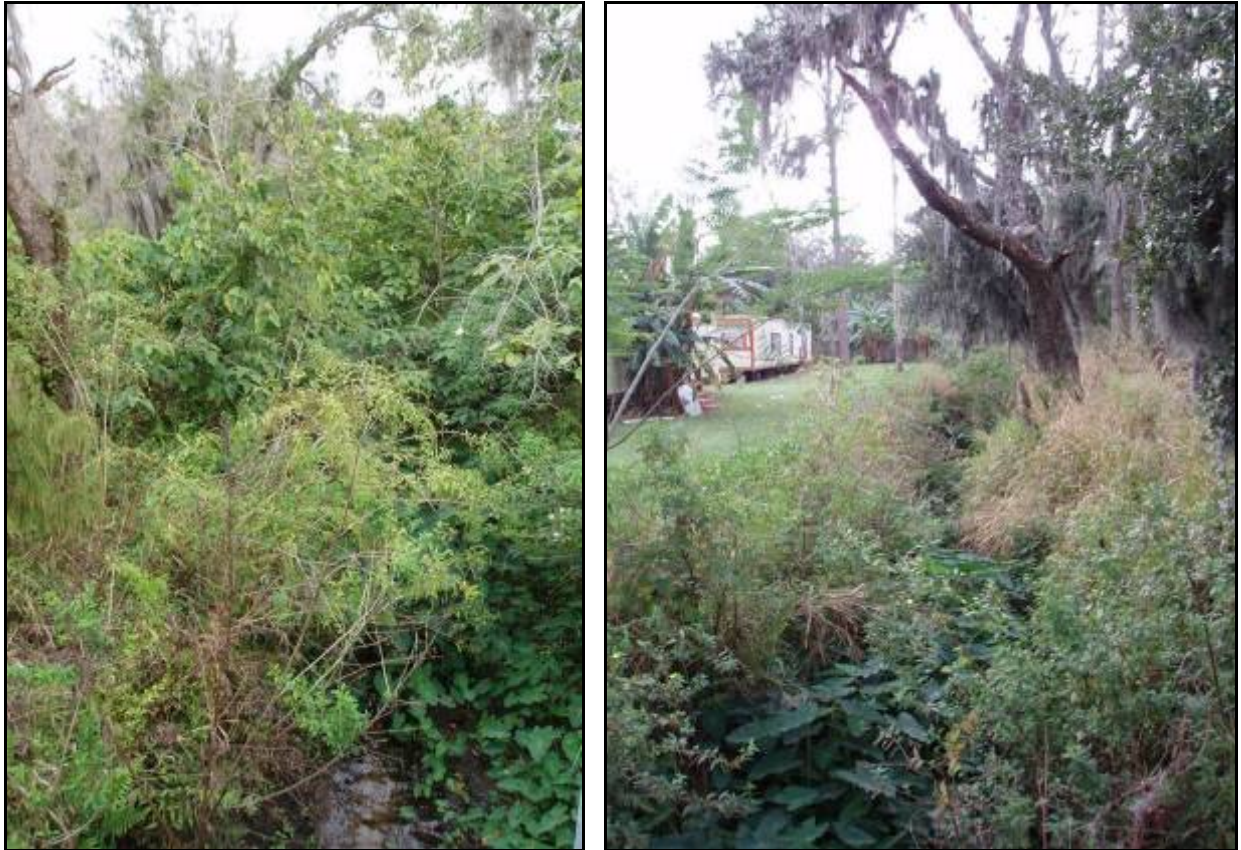
***Figure 14. Turkey Creek at Downing St. Preliminary sampling at this location [Figure 4: Site 9S] indicated coliform contamination [2420 CFU/100mL]. Creek is considerably overgrown with invasive vegetation. Migrant farm worker housing can be seen along the bank. Migrant housing at this location has a history of poor sanitation and deficient OSTDS. However, improvements to the OSTDS have recently been made according to EPC and DOH.***

*Post Field Note: Super-saturation and ponding of the septic drainfield was observed during a post Walk inspection of migrant housing at this location by EPC [12/14/2011]. The owner was notified of the violation and recommended actions were detailed by EPC. EPC will increase inspection frequency to ensure proper functionality.*

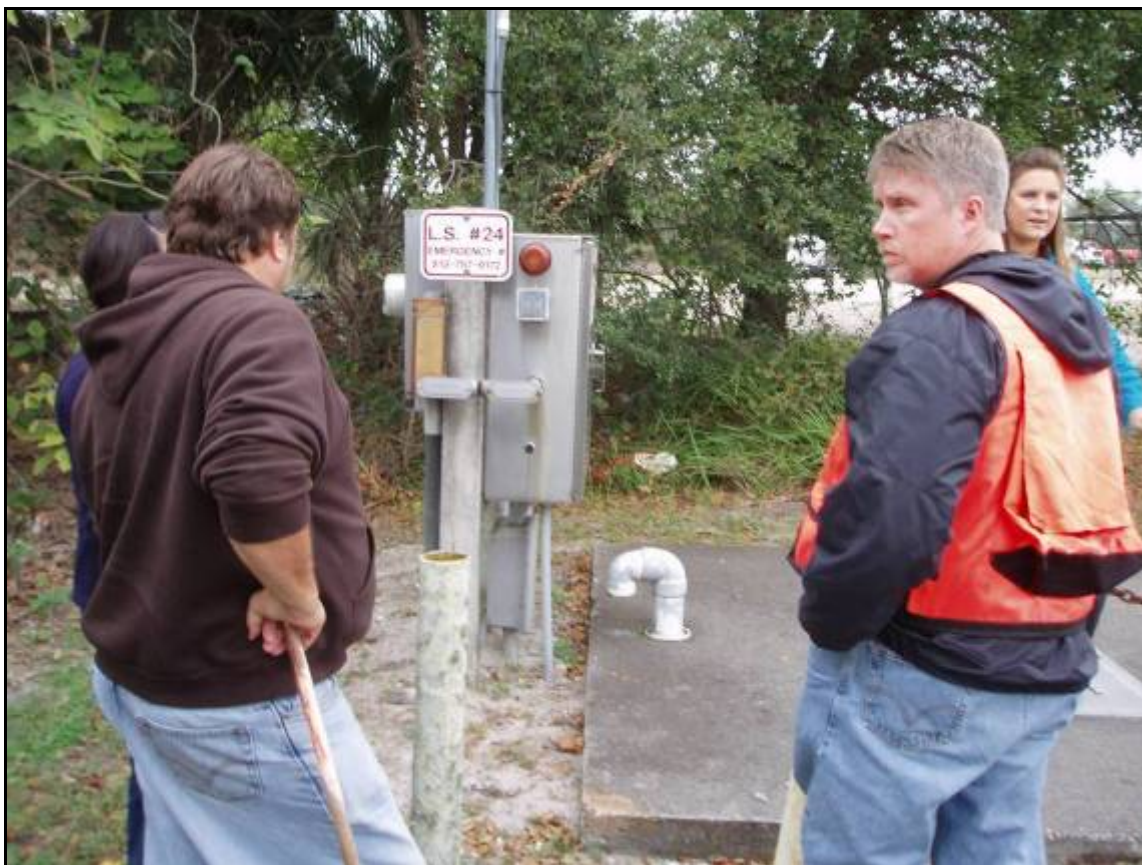
***Figure 15. Lift station 24 operated by the City of Plant City. No history of discharge and appears to be functioning appropriately. Emergency number is posted, and notification light appears operational. Additionally, all lift stations in the Turkey Creek watershed are inspected weekly and equipped with telemetry notification.***

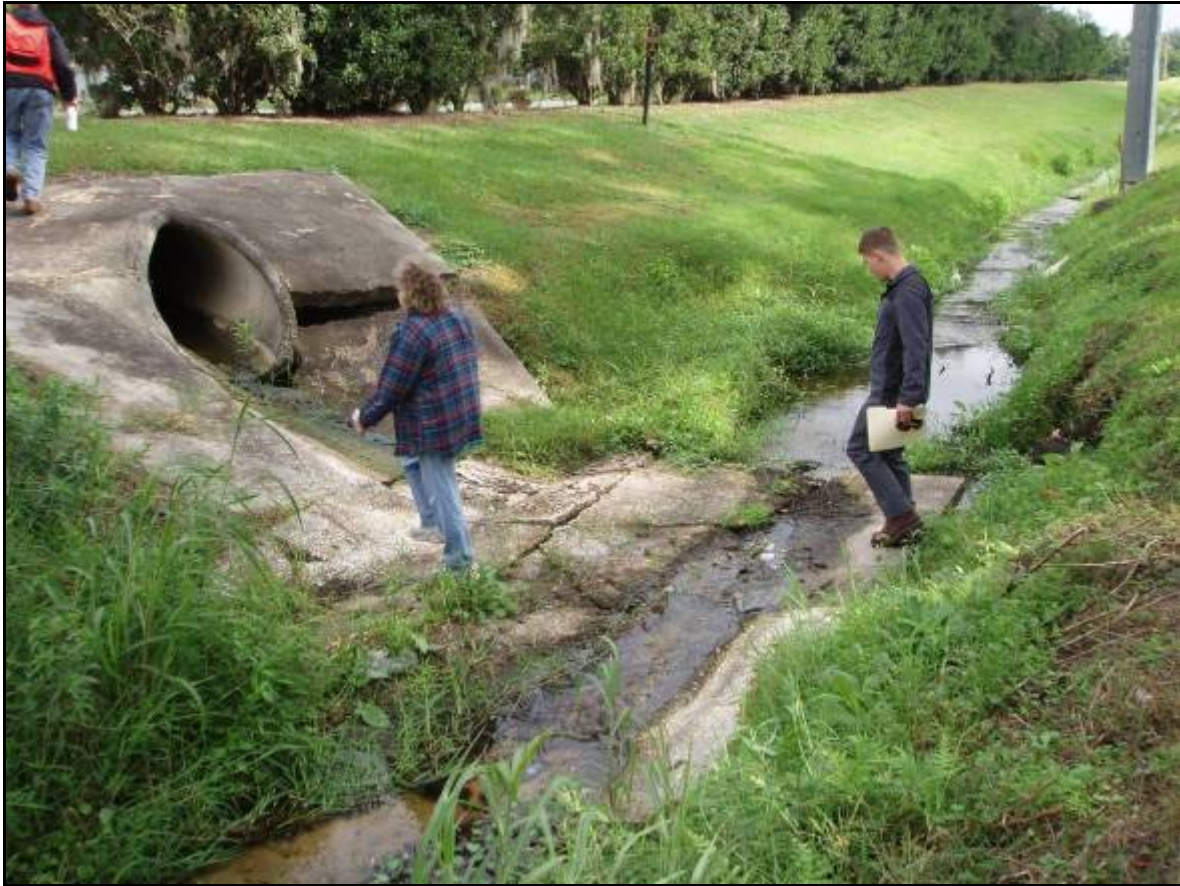
***Figure 16. Outfall from Walden Lakes community located on Trapnell Rd west of Timberlane Dr. The outfall drains the southern half of Walden Lakes subdivision. Significant erosion was present.***

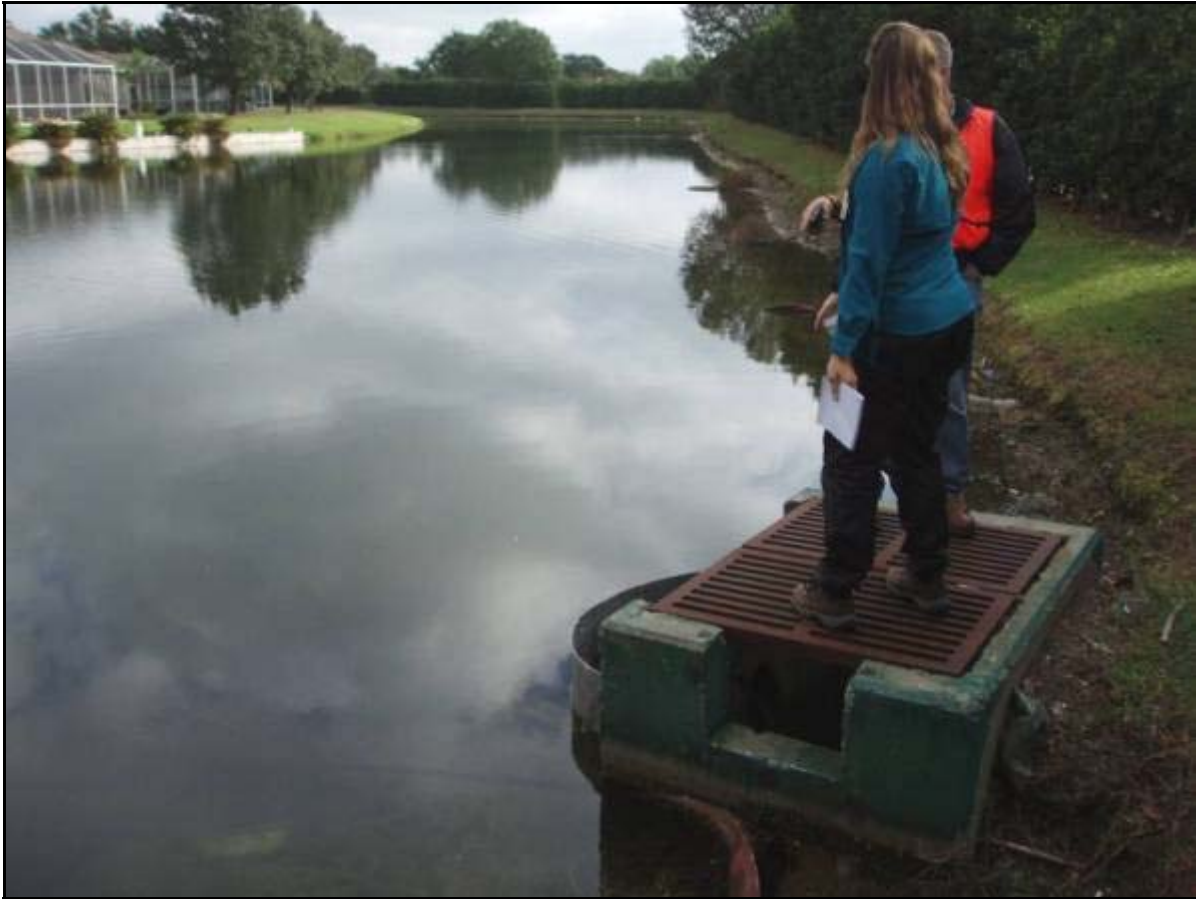
*Figure 17. Wet detention pond in Walden Lakes subdivision. Control structure discharges directly to the outfall pictured in Figure 16.*

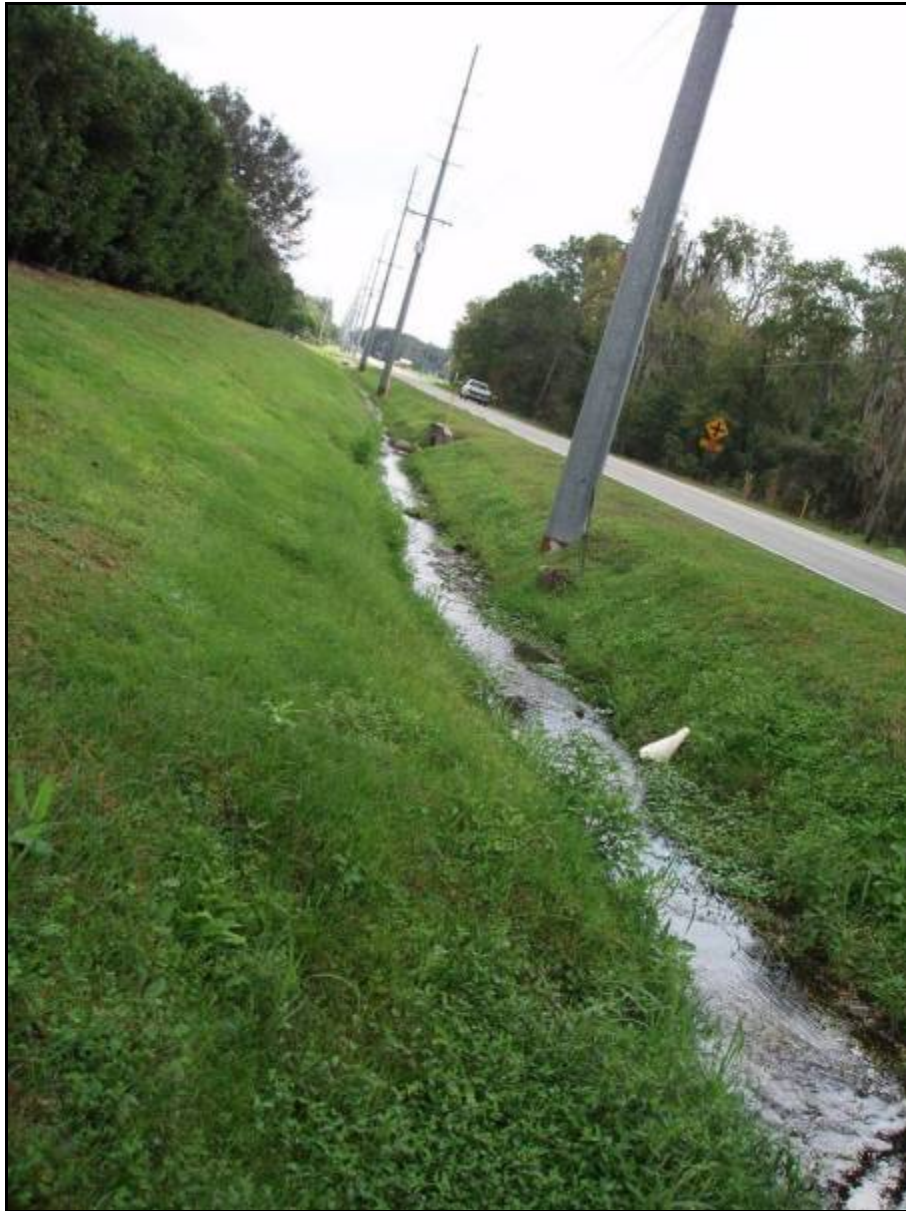
***Figure 18. Ditch downstream of Walden Lakes outfall [east on Trapnell]. Water flows to the cross drain where it joins the easternmost tributary of Turkey Creek.***

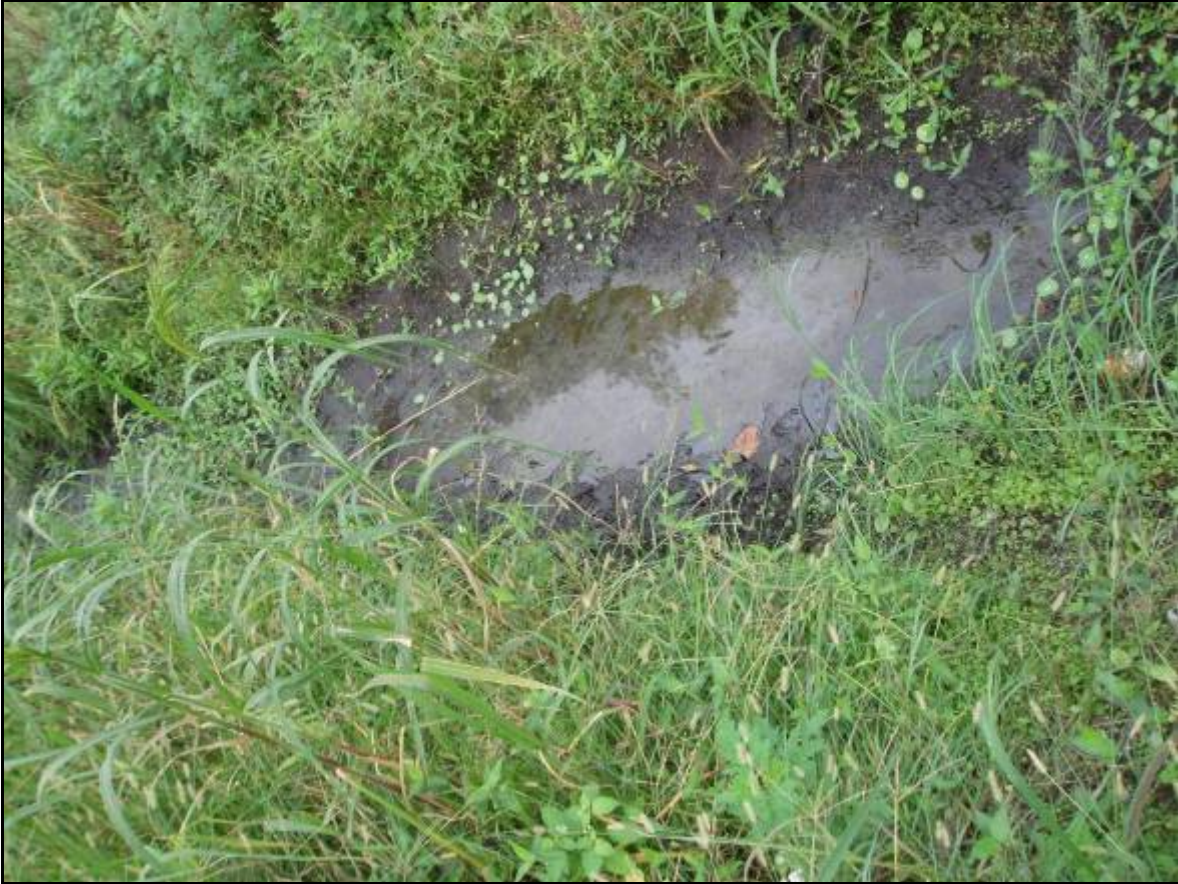
***Figure 19. Ditch along Trapnell Rd upstream of Walden Lakes outfall. Low flow in the ditch; however, water is cloudy and gray. Small trailer park adjacent; however, no obvious signs of influence.***

| Location | Suggested Action | Responsible Entity | Date Completed | Results |
|---|---|---|---|---|
| Figure 19 | Follow up inspection to verify problem persists and identify potential sources. | HCPW | 01/24/2012 | Follow up inspection showed improved conditions. Runoff appears to be entirely from a strawberry field and anthropogenic sources of coliforms are unlikely. |

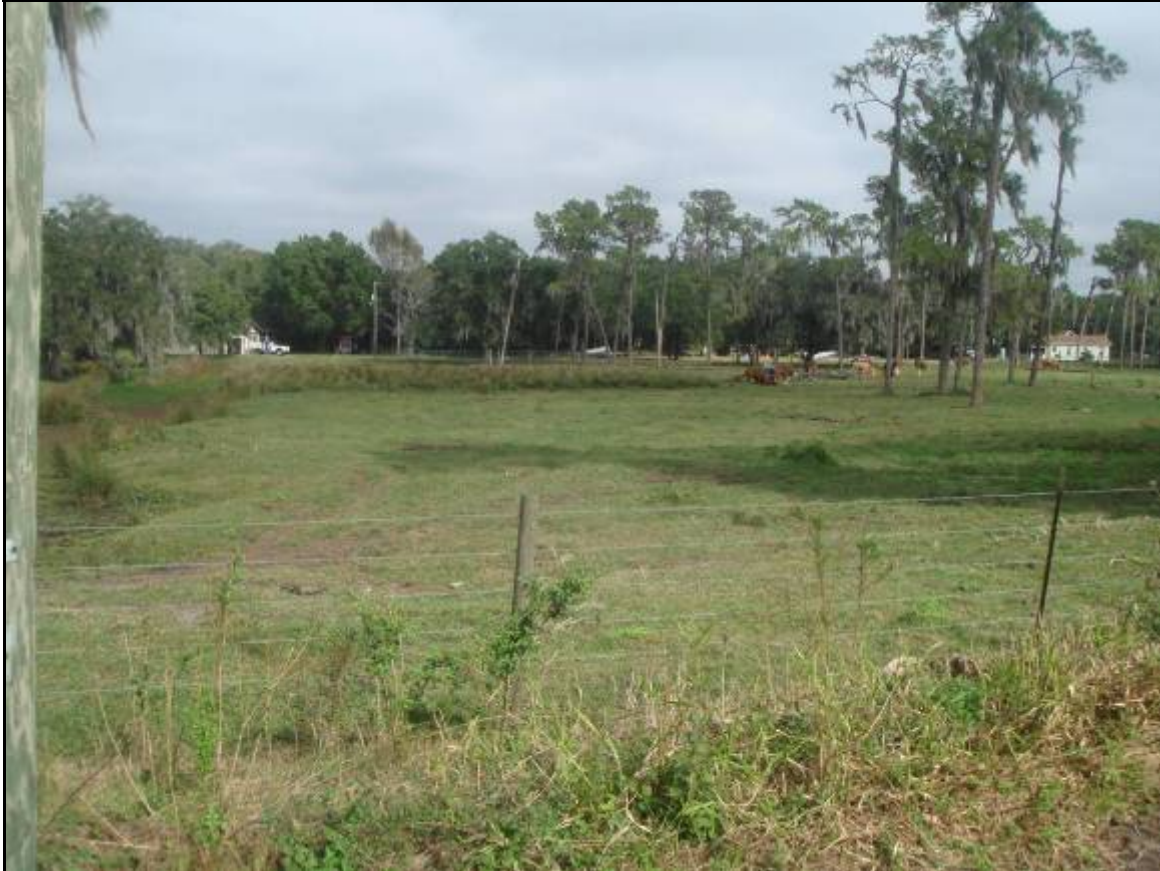
***Figure 20. Cattle grazing in a wetland at the intersection of Trapnell Rd and Turkey Creek Rd. Discharge from the wetland area is observed to the ditch along Trapnell Rd, which flows a short distance to a major tributary. Preliminary water sample taken just downstream [Figure 4: Site 12P] showed moderate fecal contamination [560 CFU/100mL]. FDACS and/or IFAS to contact landowner.***

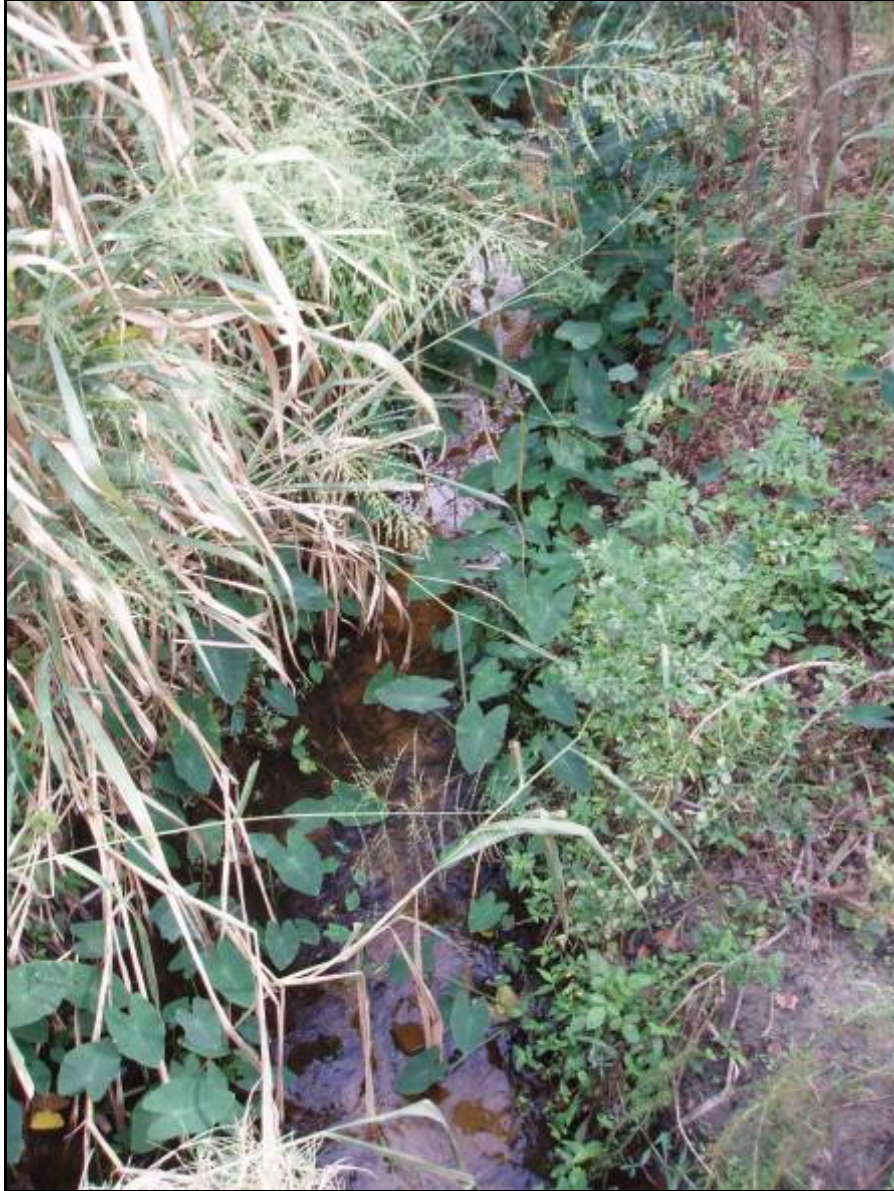
***Figure 21. Tributary at Forbes Rd just north of Trapnell. Segment of creek walked. Somewhat overgrown. Preliminary sampling at this location [Figure 4: Site 7S] showed considerable coliform contamination [2880 CFU/100mL].***

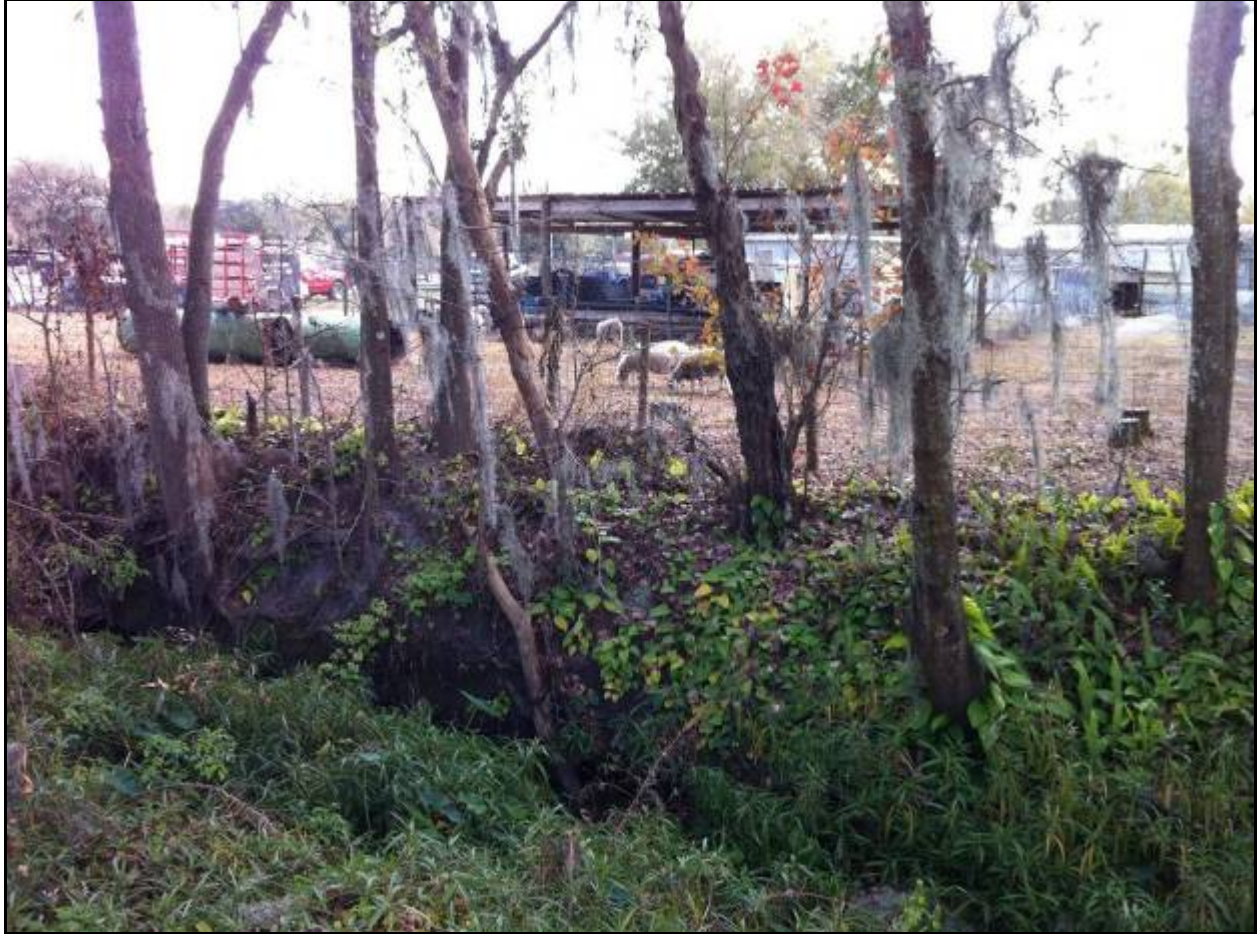
***Figure 22. Follow up inspection on 01/24/12 found sheep farm just upstream from Figure 21 and adjacent to the creek. IFAS will contact landowner to distribute educational brochure.***

*Post Field Note: [01/24/12] During follow up inspection, nearby resident indicated septic system located on adjacent parcel [3428 S Forbes Rd] may have unpermitted modifications and chronic failures.*

| Location | Suggested Action | Responsible Entity | Date Completed | Results |
|---|---|---|---|---|
| Figure 22 | Investigate resident complaint of potential chronic septic failures. | DOH | 02/14/2012 | DOH complaint inspection showed no evidence of sanitary nuisance. |

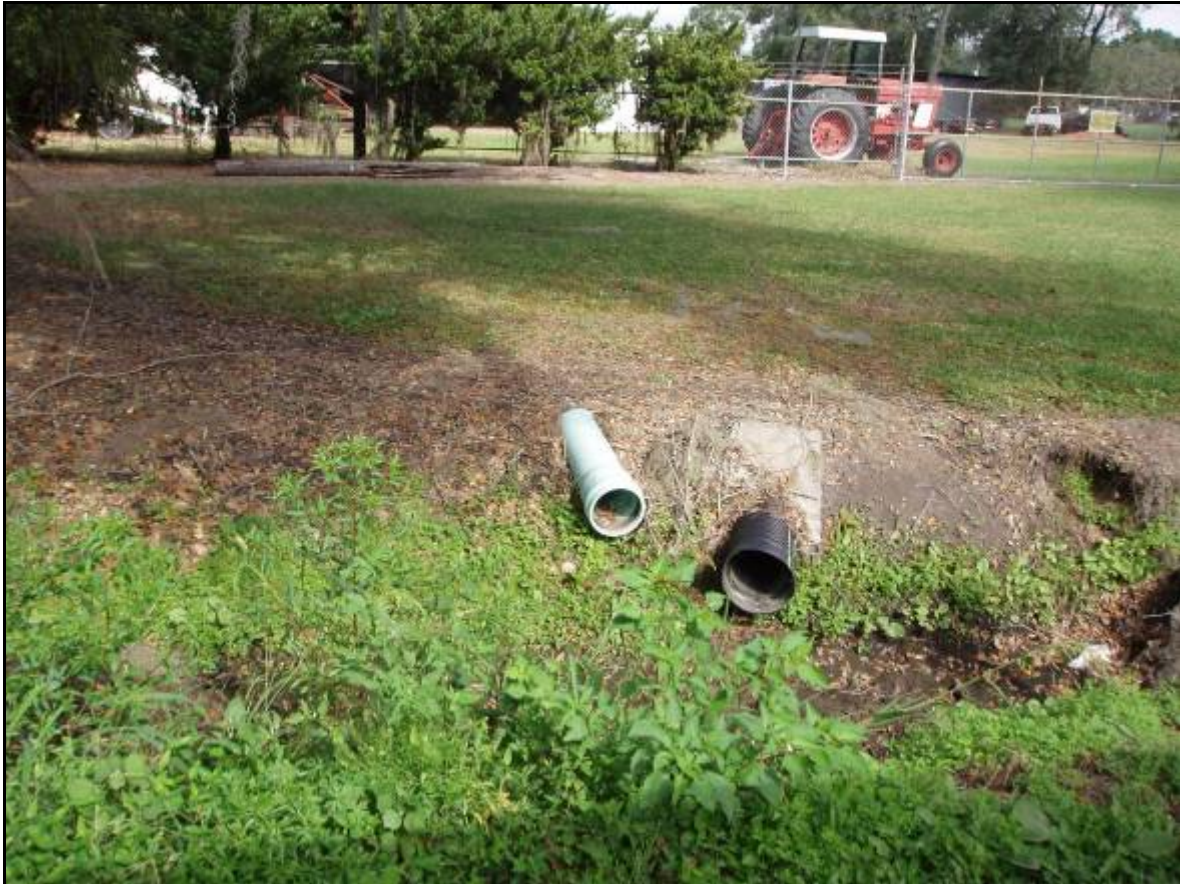
***Figure 23. Potential illicit connections on Caruthers Ave. near Sydney Rd. Pipes protrude from the parcel into the roadside ditch. Referred to EPC for enforcement.***

| Location | Suggested Action | Responsible Entity | Date Completed | Results |
|---|---|---|---|---|
| Figures 23 | Investigate unknown pipes for potential illicit connections. | EPC | | EPC investigation found discharge is composed entirely of stormwater and, therefore, a legal connection. |

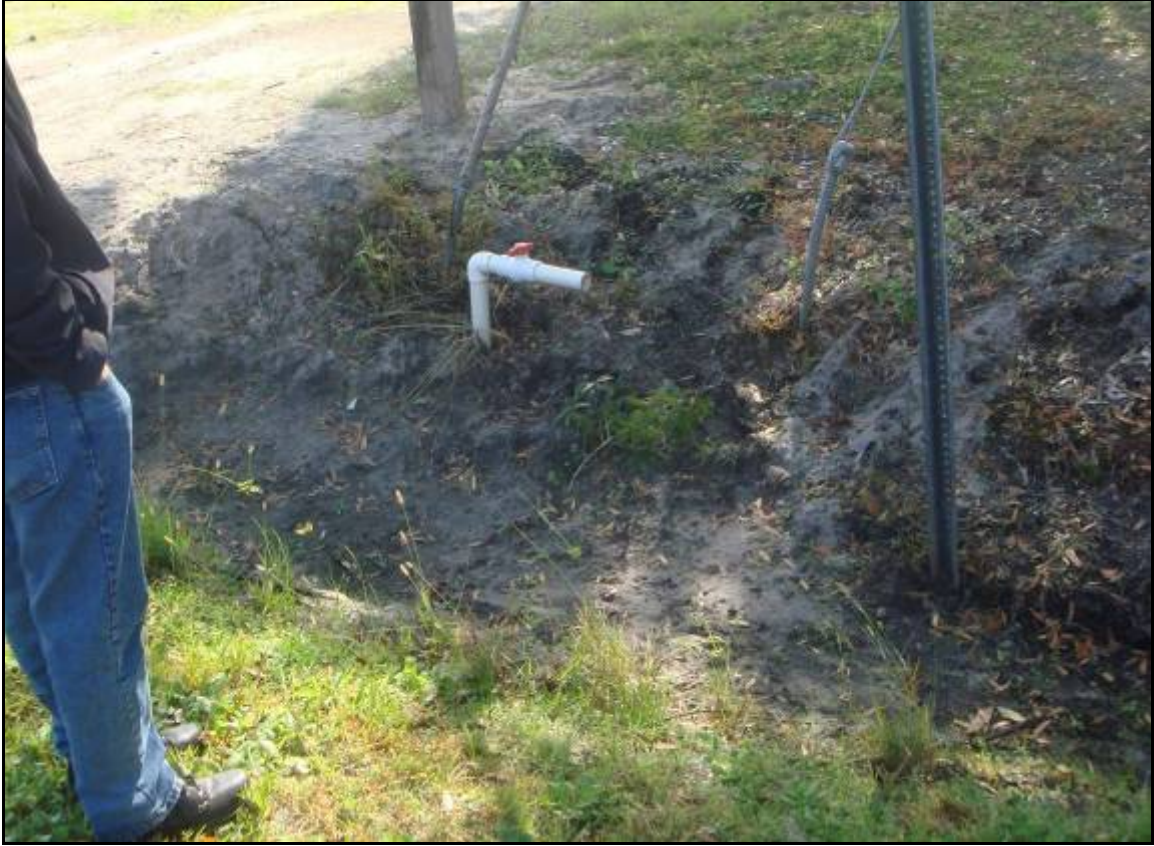
***Figure 24. Potential illicit connection on Caruthers Ave near Turkey Creek crossing. Pipe is adjacent to a strawberry field and enters the roadside ditch.***

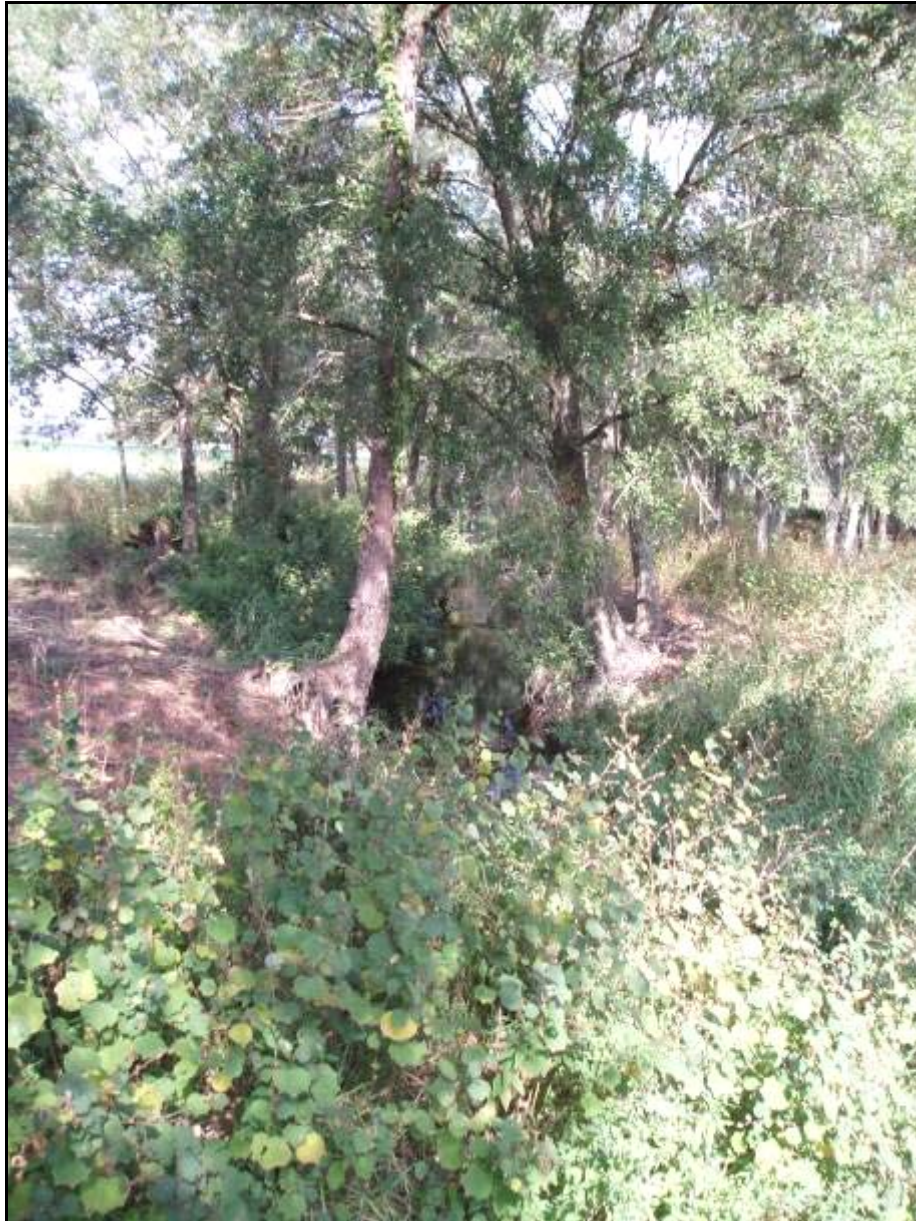
*Figure 25. Turkey Creek at Caruthers Ave. Some overgrowth of invasive vegetation.*

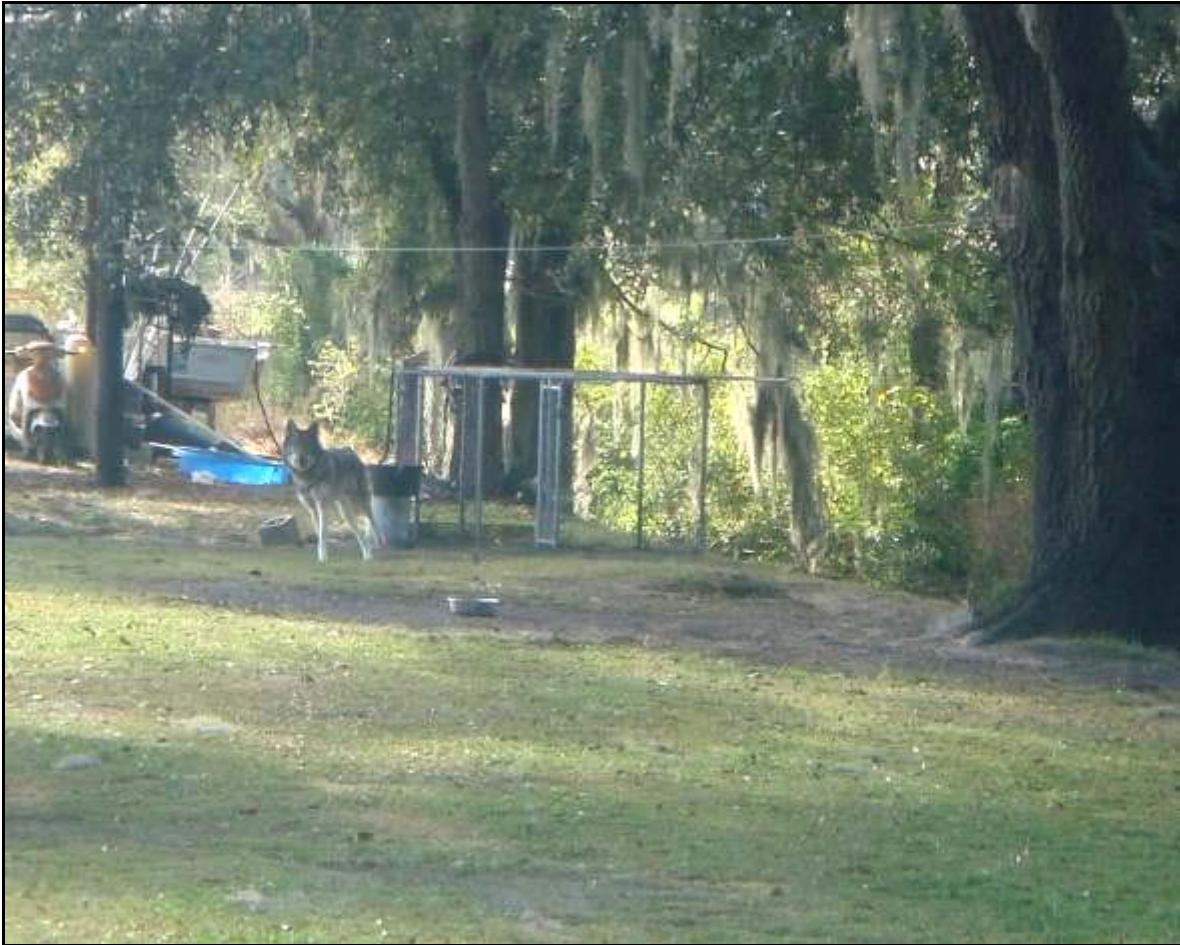
***Figure 26. Dog tethered adjacent to Turkey Creek at Caruthers Road.***
