# Summary of Results

## Walk the WBID Exercise for Turkey Creek (WBID 1578B)

*Florida Department of Environmental Protection  
Division of Environmental Assessment and Restoration  
Bureau of Watershed Restoration  
Tallahassee, FL 32399*

August 2012

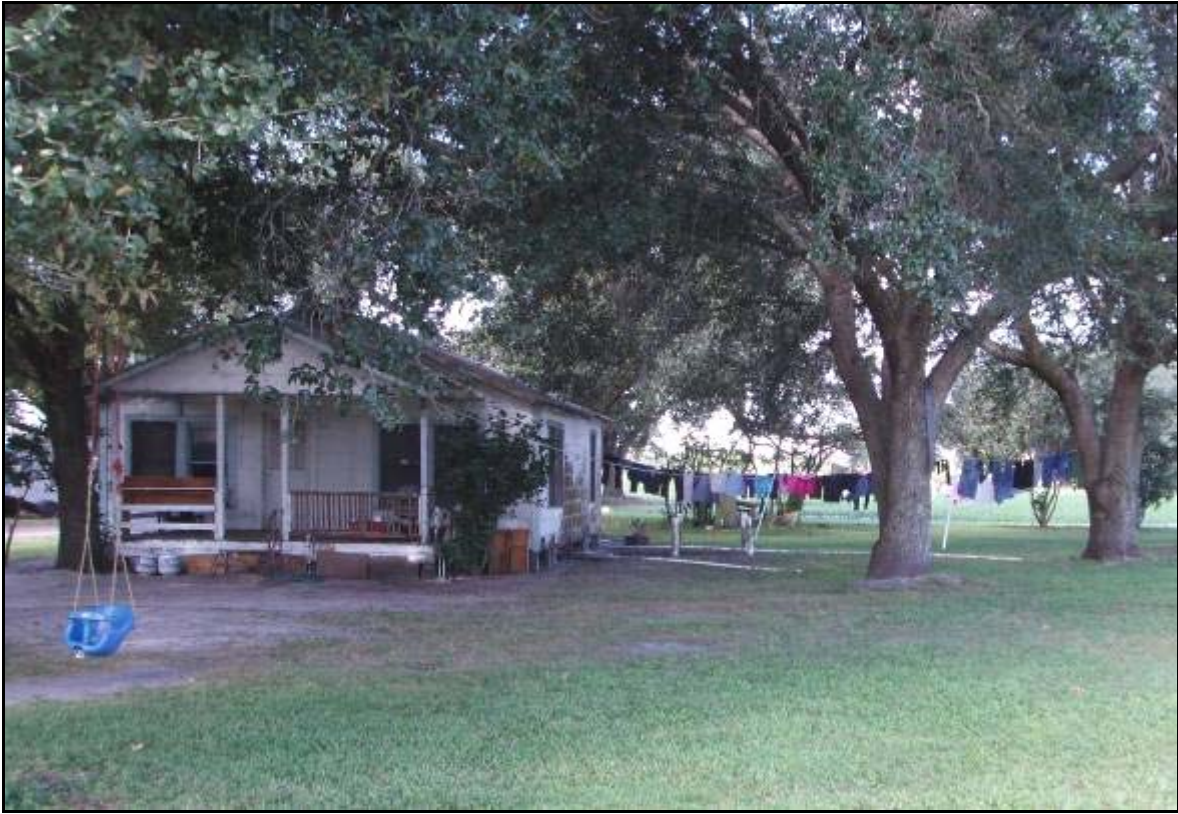
***Figure 27. Small housing area, possibly migrant workers, located on Sydney west of Caruthers Ave. Several PVC pipes are protruding from the house, which appears consistent with the discharge of washing machine grey water. DOH spoke with the land manager during the Walk and will return to inspect the pipes.***

Post Field Note: Subsequent DOH inspection revealed pipes had been removed and no sanitary nuisance observed.

| Location | Suggested Action | Responsible Entity | Date Completed | Results |
|---|---|---|---|---|
| Figure 27 | Inspect unknown pipes observed during the Walk. | DOH | 12/21/2012 | Contact with landowner was made during the Walk. Subsequent DOH inspection states pipes had been removed and no sanitary nuisance exists. |

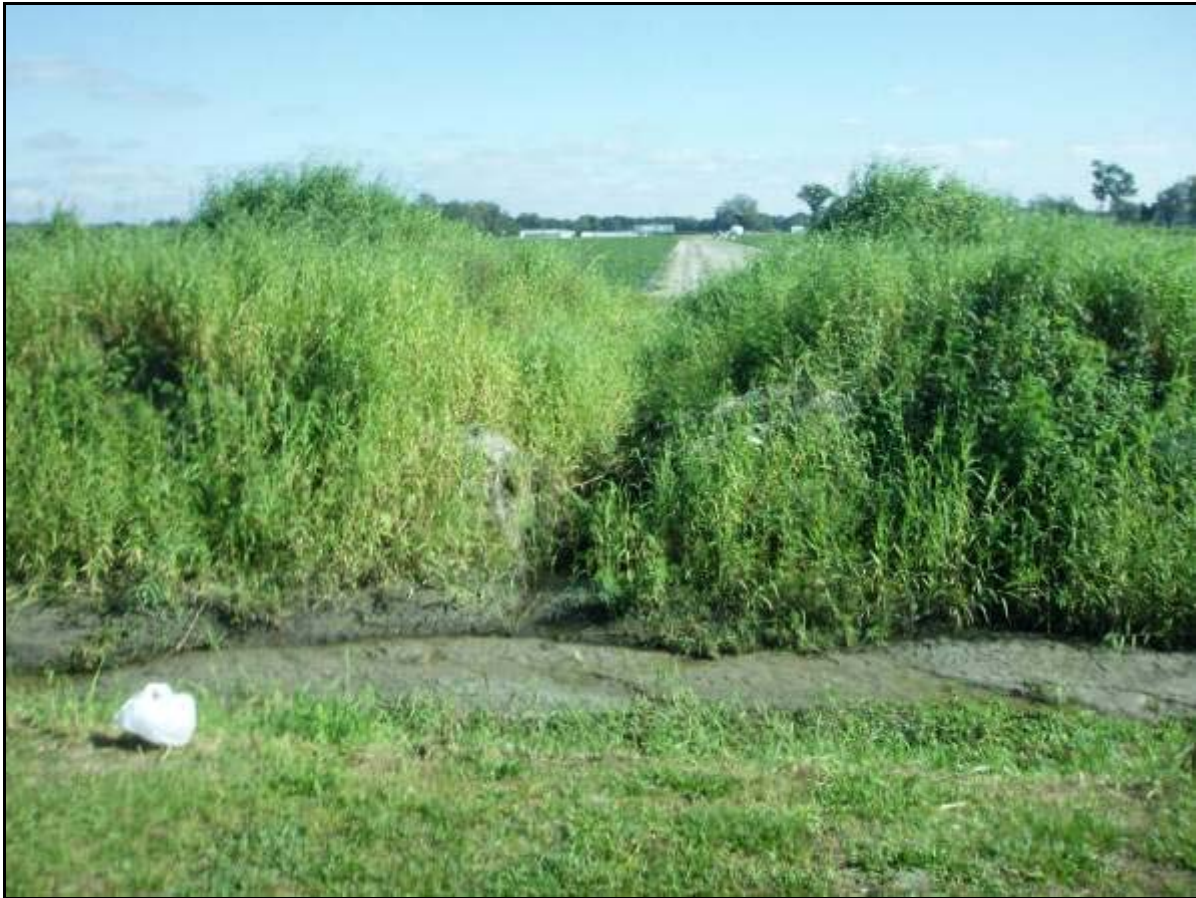
***Figure 28. Sediment eroding from strawberry field adjacent to Starlite Mobile Home Park. Sedimentation was evident throughout the ditch system and small tributary here, which flows a short distance to Turkey Creek.***

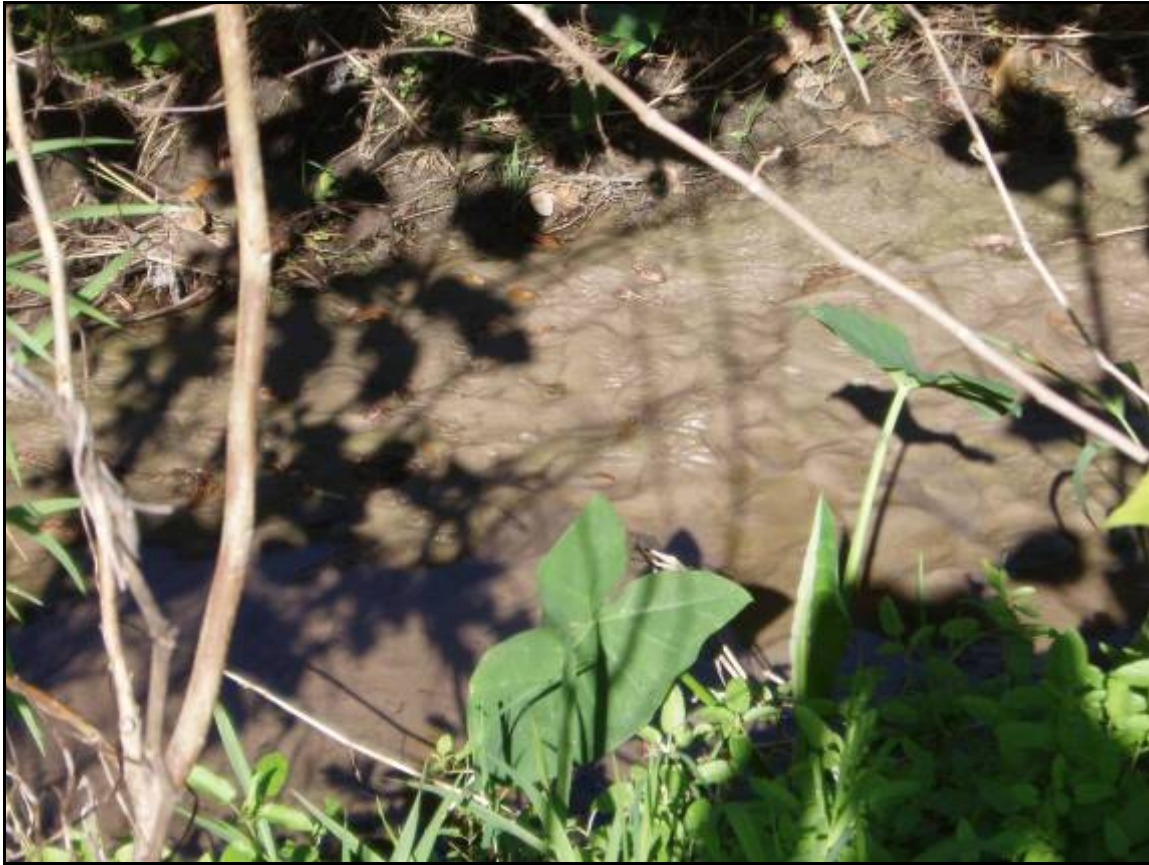
*Figure 29. Evidence of sedimentation downstream of Figure 28. Additionally, numerous wildlife tracks are evident in the mud.*

- Bacterial re-growth is probable in ditches and natural watercourses given the subtropical climate and natural sediments observed. See Figures 8, 9, 19, 29, and 56.

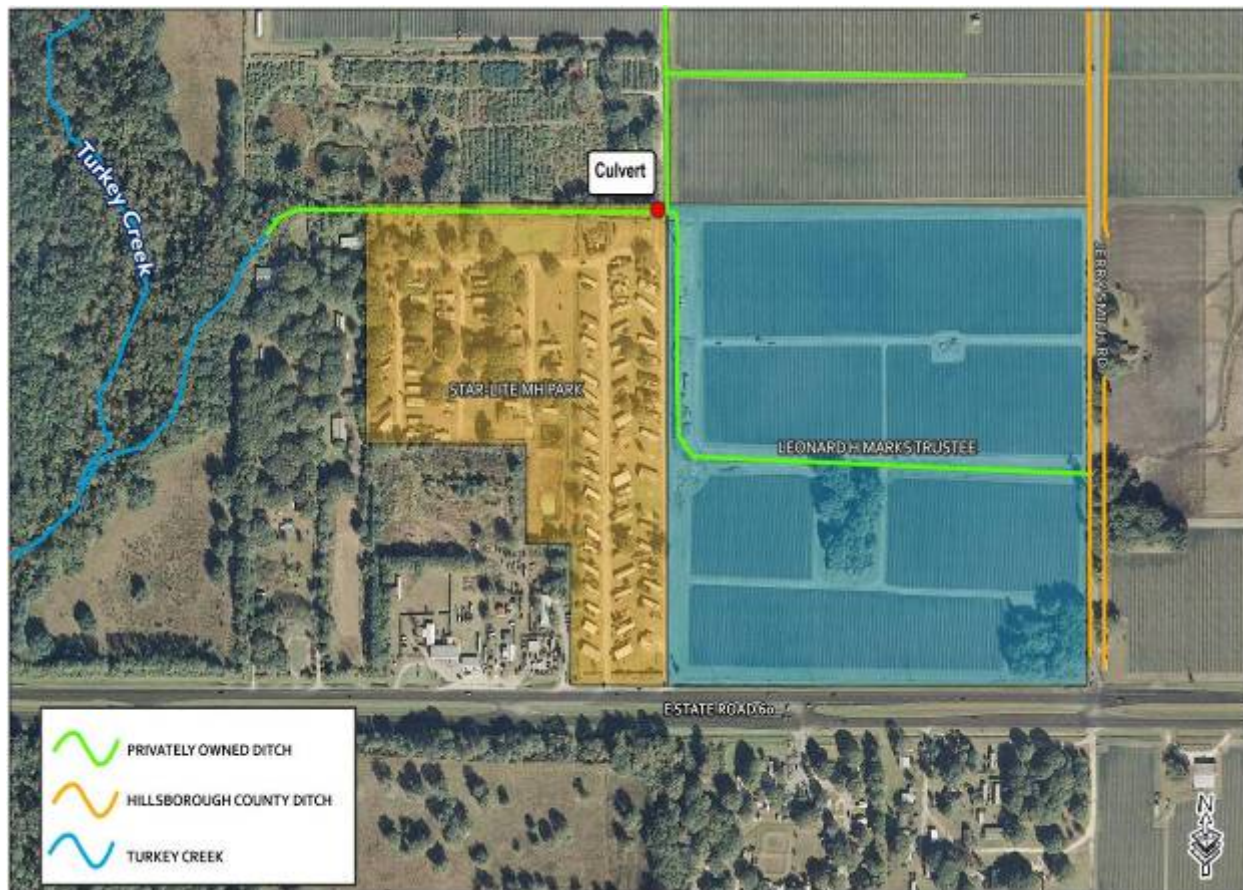
*Figure 30. System of conveyances near Jerry Smith Rd and SR 60. The farmers here attribute erosion and sedimentation illustrated in Figures 28 and 29 to the privately owned culvert shown here. Further research is necessary to resolve all concerns and develop an appropriate solution. IFAS and FDACS are in regular contact with the farmers.*

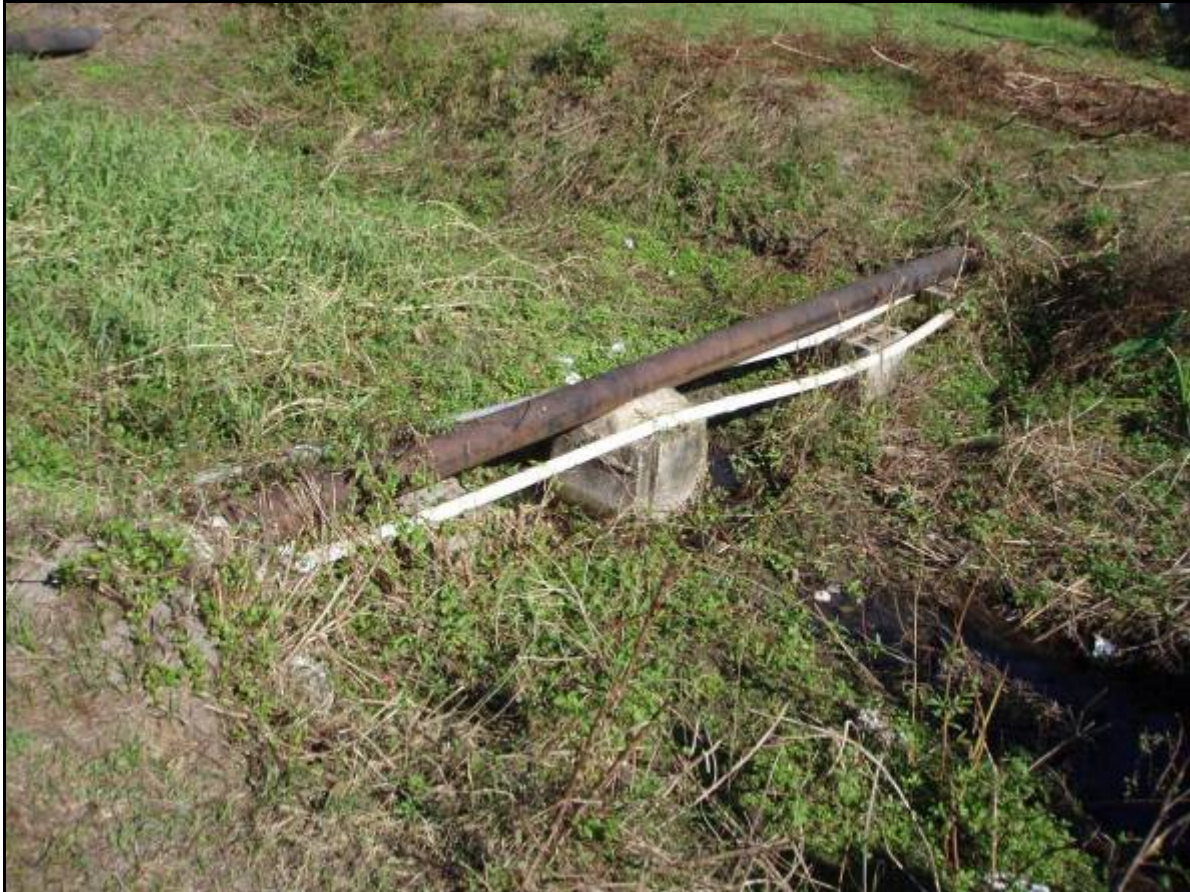
***Figure 31. Pipes crossing a ditch in Starlite MHP. These pipes appear to be a part of the onsite wastewater treatment facility. No leaks were witnessed. However, the mobile home park is largely abandoned, in disrepair, and has a history of deficient wastewater treatment plant.***

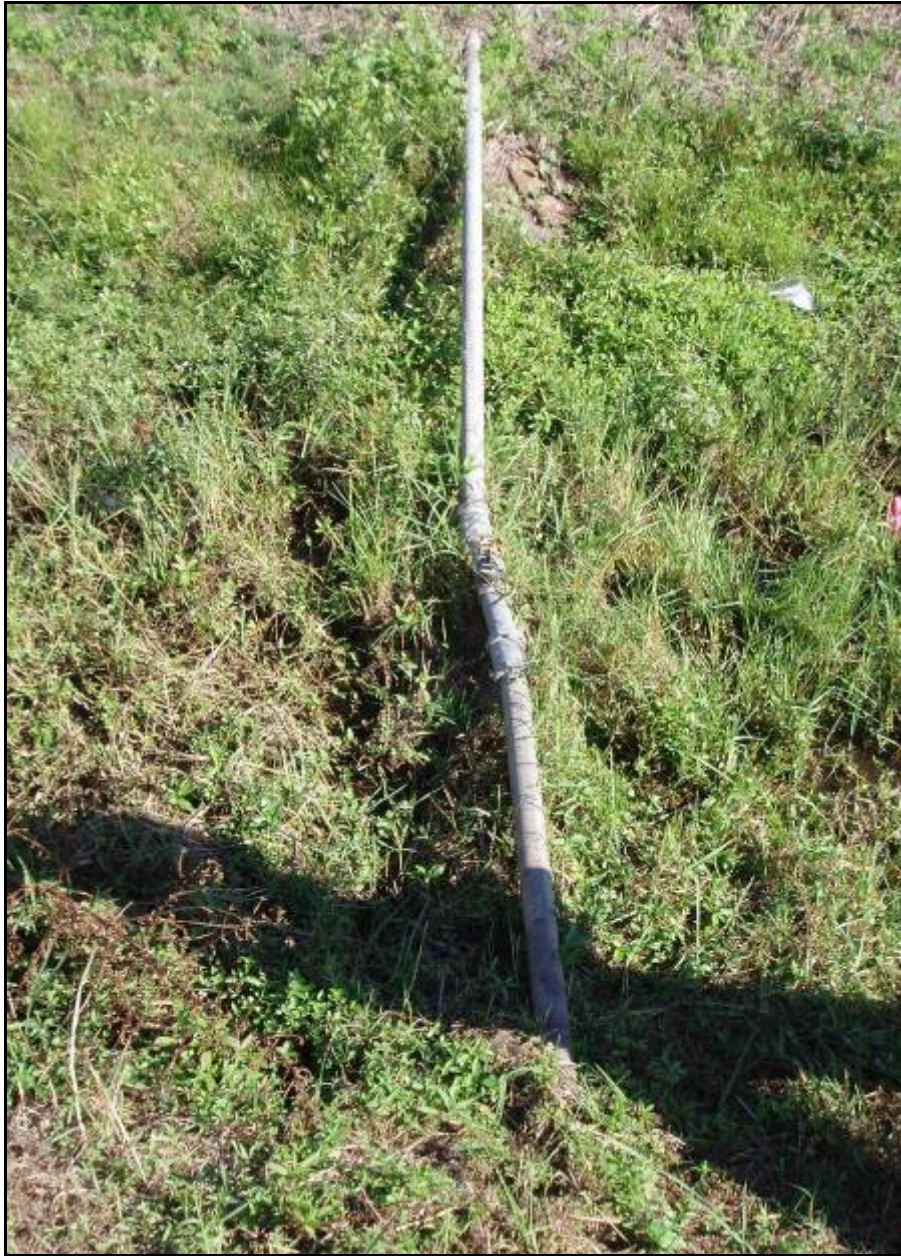
*Figure 32. Another unknown pipe crossing a ditch in Starlite MHP. This pipe is not connected properly with a high likelihood of leaking should effluent or other liquids be transported. No leaks witnessed while onsite.*

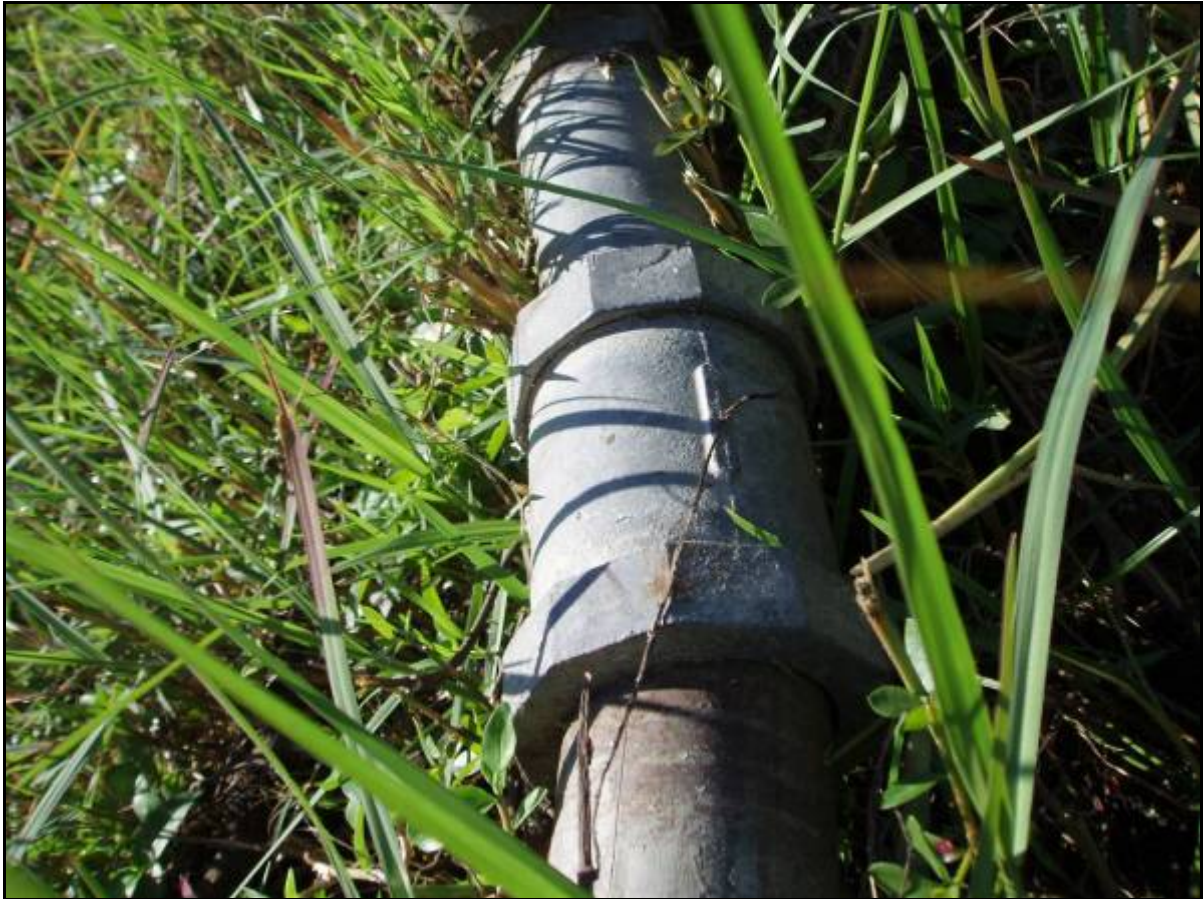
*Figure 33. Close up of pipe in Figure 32, which shows the disconnection at the pipefitting.*

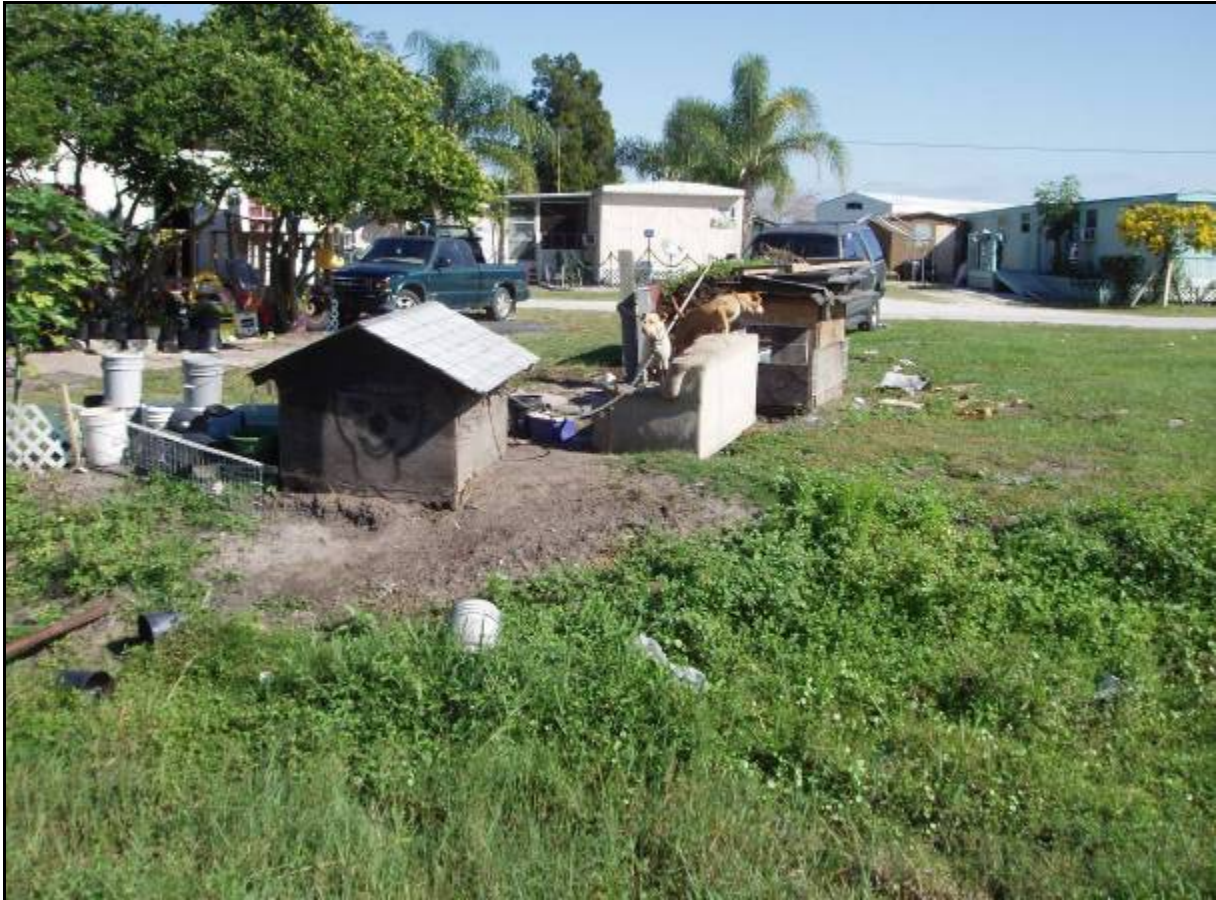
***Figure 34. Several dogs tethered adjacent to the ditch in Starlite MHP. Numerous other dogs seen in similar conditions during the visit to Starlite.***

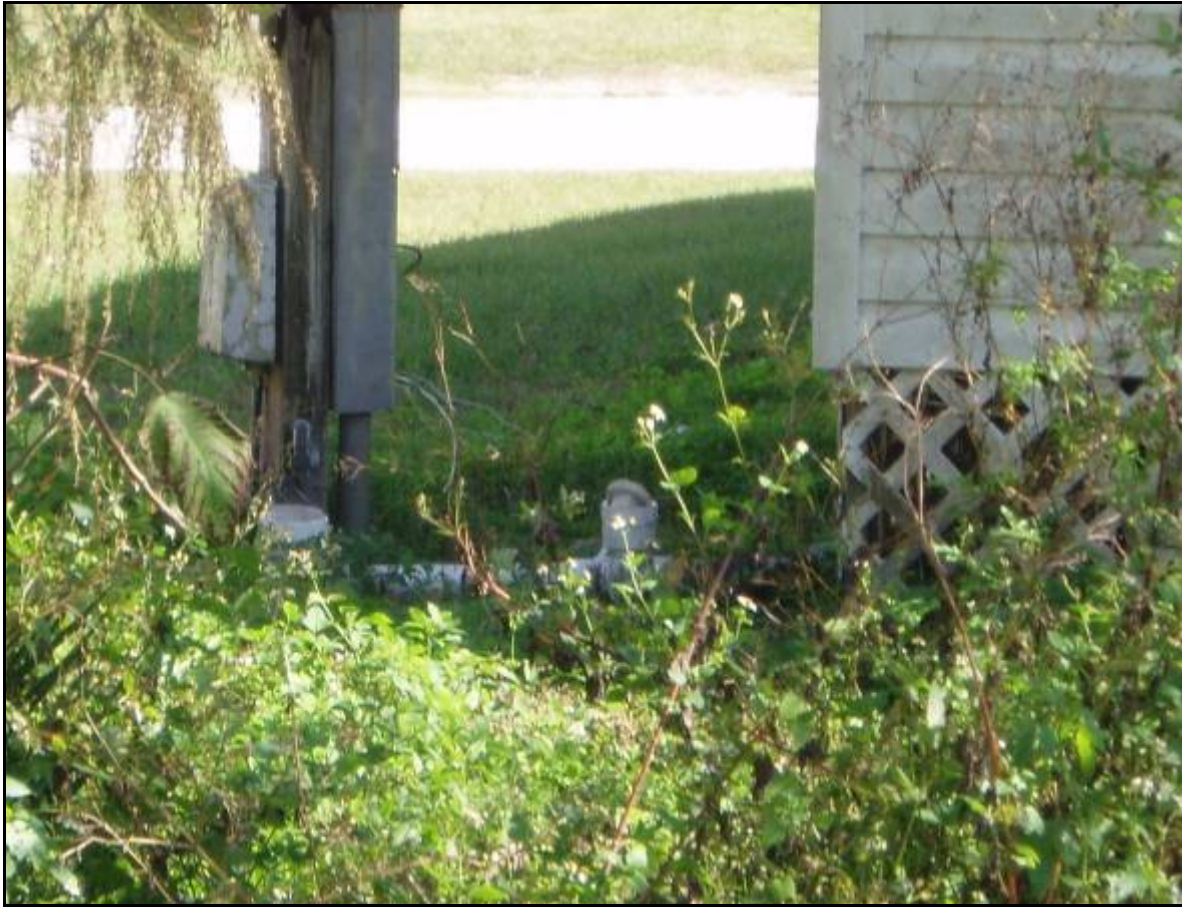
***Figure 35. Several wastewater cleanouts were uncapped throughout Starlite MHP. While many of the homes appeared abandoned, i.e. system not in use, there is potential for illegal inhabitation, and cleanouts are often in close proximity to stormwater conveyances.***

*EPC conducts twice yearly inspection. Hillsborough County will conduct monthly inspections until hazardous conditions appear to be resolved.*

| Location | Suggested Action | Responsible Entity | Date Completed | Results |
|---|---|---|---|---|
| Figure 35 | Direct owner of Starlite MHP to properly secure lids to wastewater clean outs. | EPC | | EPC inspection indicated cleanouts were uncapped as a result of malfunctioning wastewater treatment plant. Wastewater cleanouts have since been properly capped per their request. EPC conducts twice yearly inspection. Hillsborough County will conduct monthly inspections until hazardous conditions are resolved. |

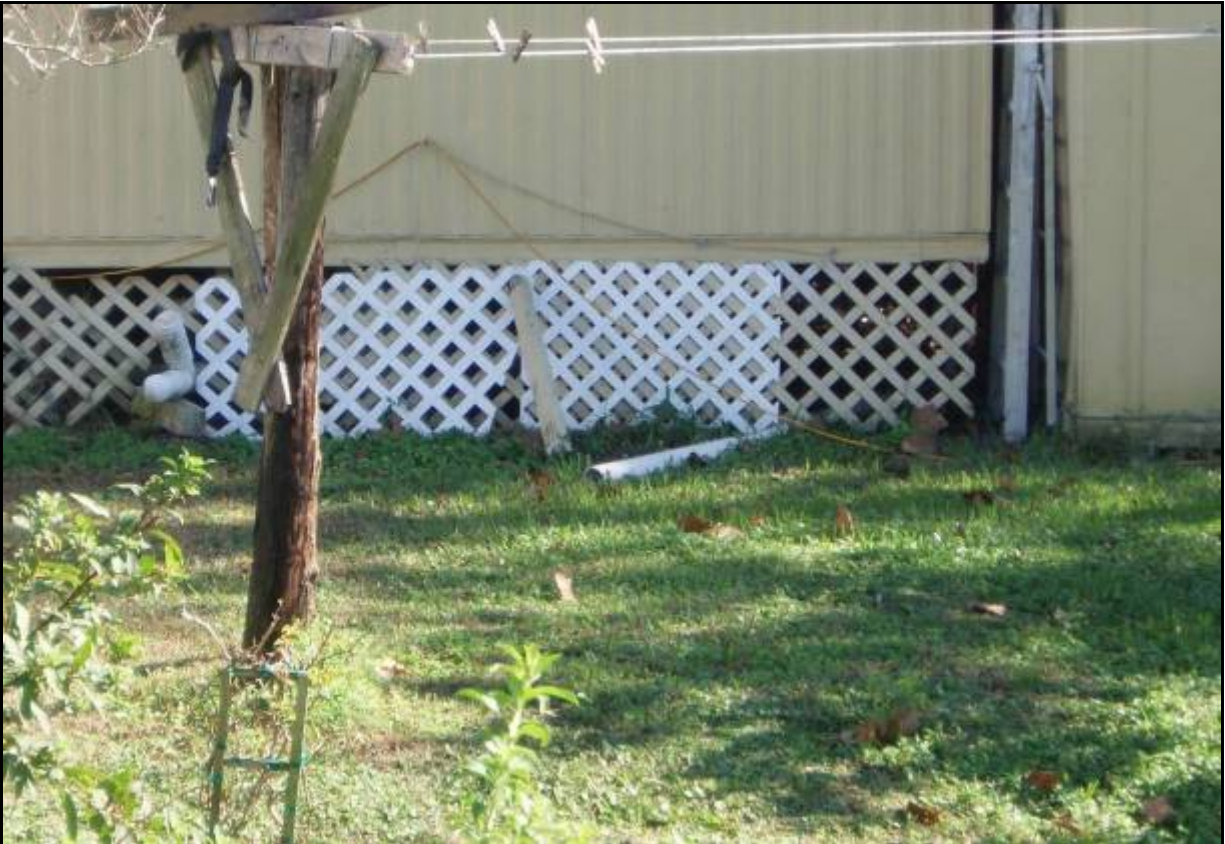
*Figure 36. Unknown pipe extending from underneath a mobile home at Starlite MHP. Appearance is consistent with the discharge of washing machine grey water.*

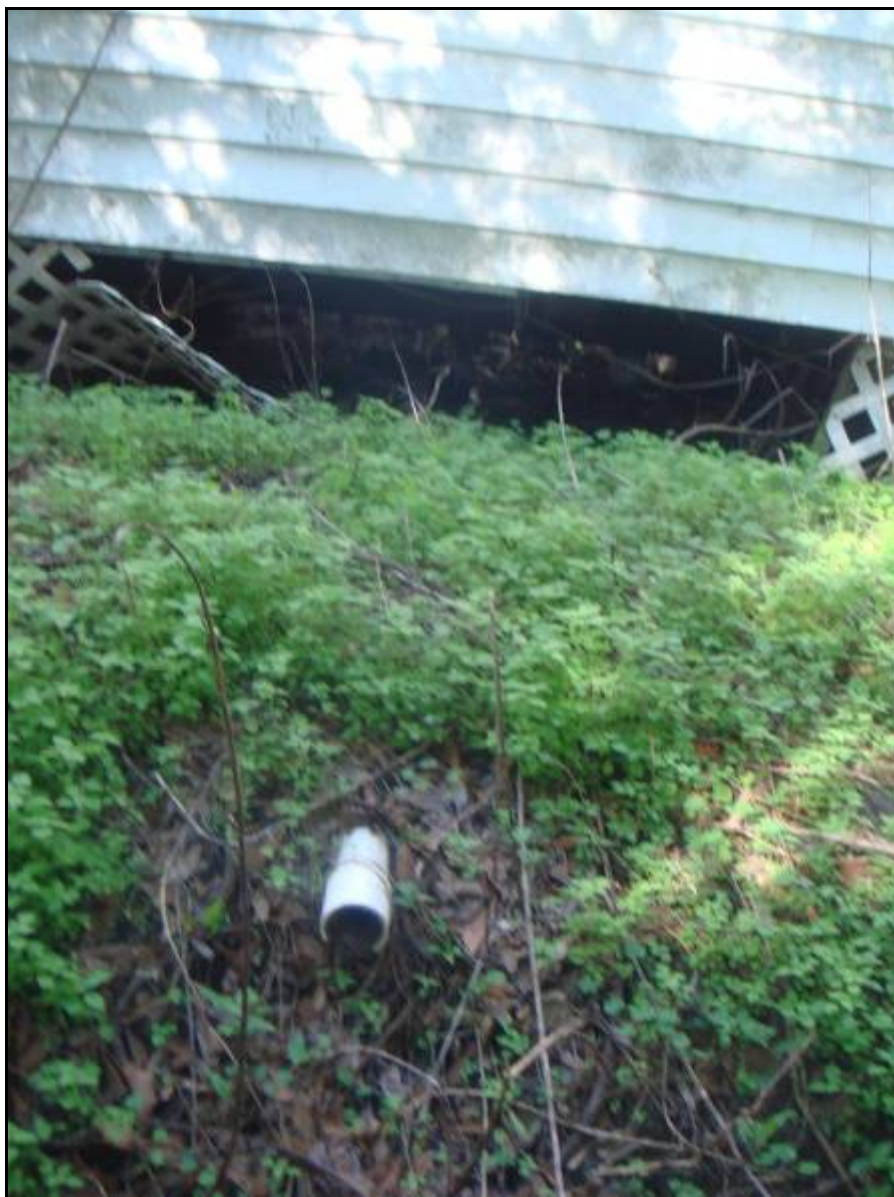
*Figure 37. Another unknown pipe extending from underneath a mobile home at Starlite MHP into a stormwater conveyance.*

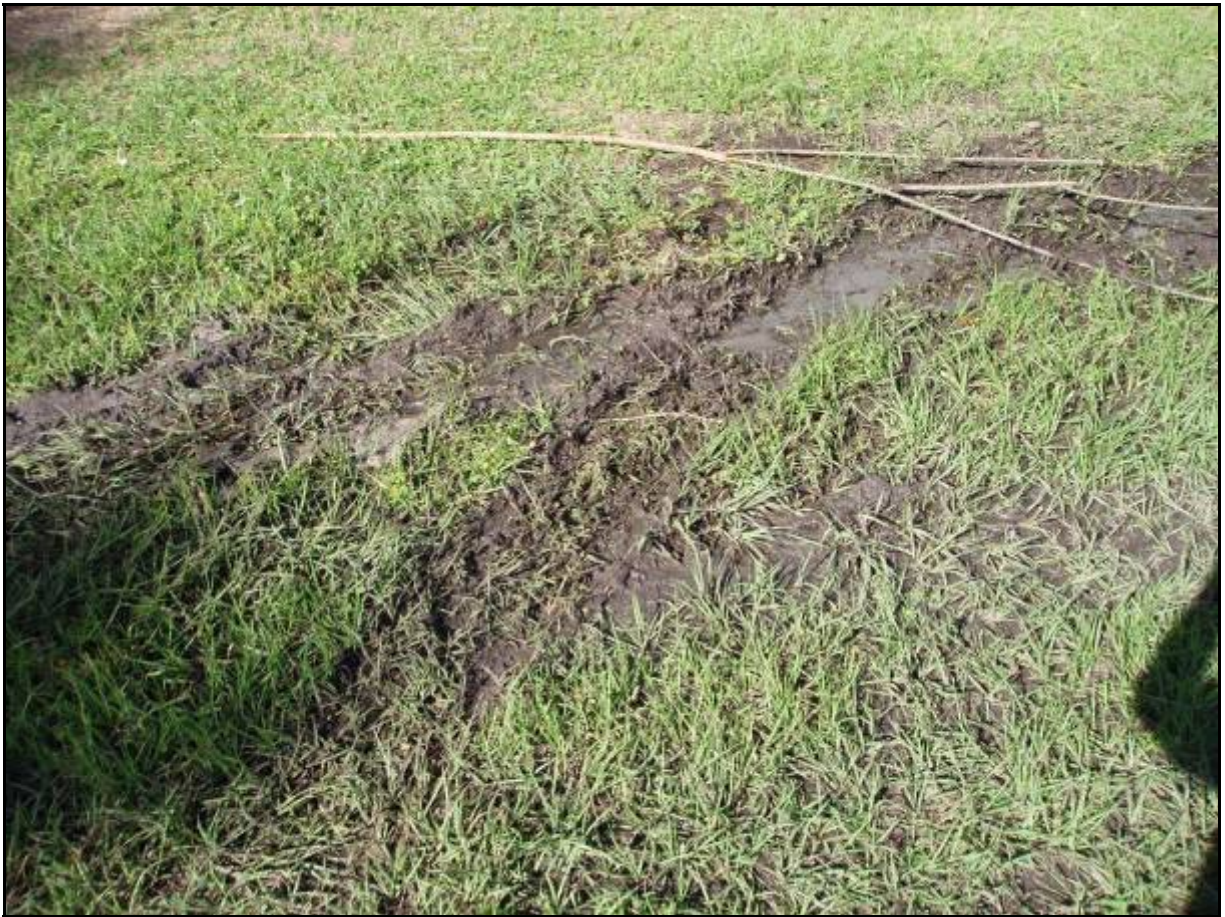
*Figure 38. Saturated soil adjacent to a mobile home in Starlite MHP. The location could be indicative of an underground leak or spill; however, the puddle had no detectable odor.*

| Location | Suggested Action | Responsible Entity | Date Completed | Results |
|---|---|---|---|---|
| Figures 38 & 39 | Follow up visits to investigate source of saturation at Starlite MHP. | HCPW<br>EPC | 01/25/2012 | EPC investigation determined saturation was the result of an underground potable water leak. Owner was notified. Subsequent inspection showed no evidence of saturation. |

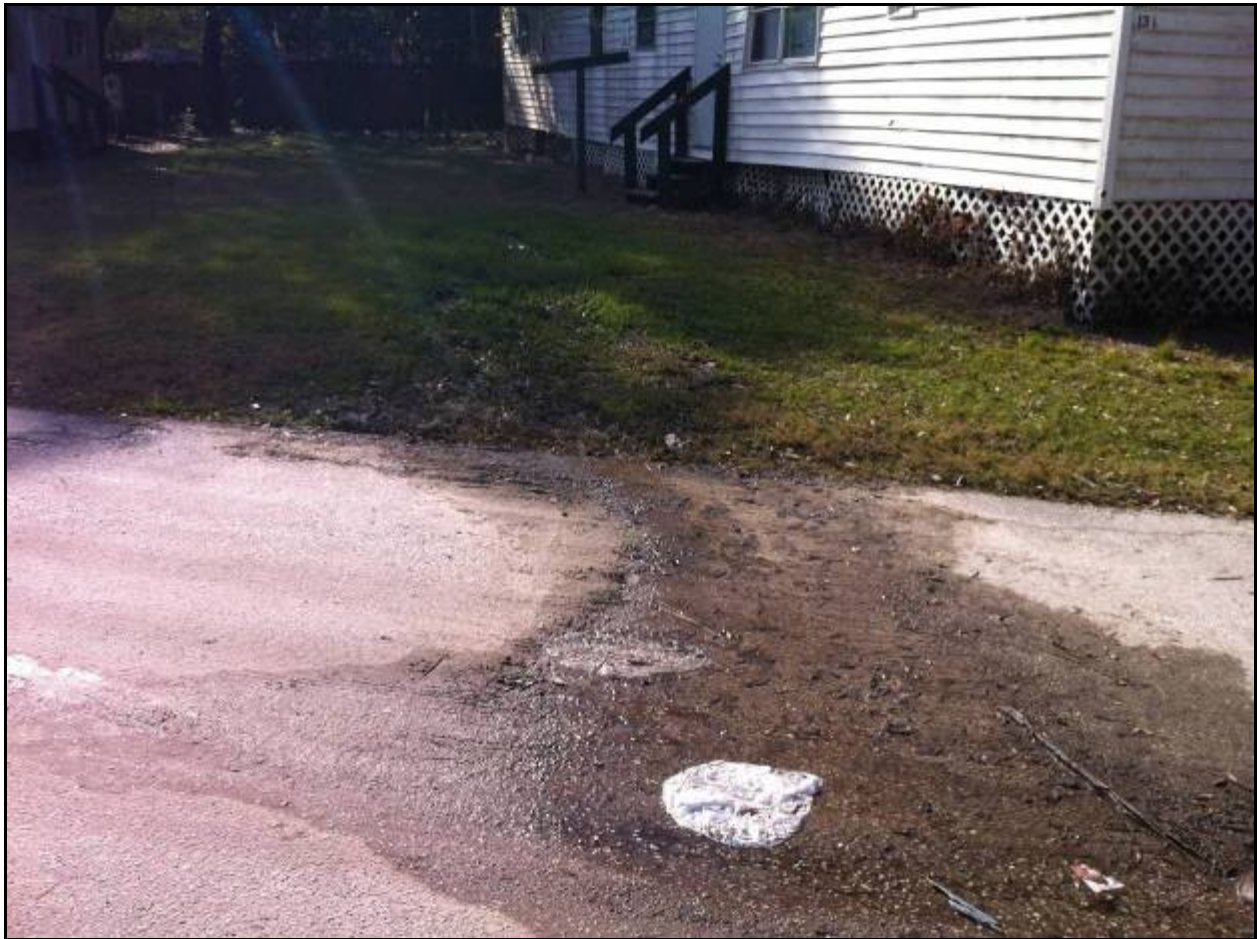
***Figure 39. Follow up inspection on 01/24/12 showed saturation in Figure 38 persists and has increased considerably. Standing water present and continues down the street. The water contained no detectable odor or discoloration. Referred to EPC for investigation.***

*Post Field Note: EPC inspection on 01/25/12 determined the saturation was a result of an underground potable water leak. The property owner was informed of the problem. Subsequent inspection [04/09/12] indicates no visible saturation. EPC indicates owner has addressed potable water leak.*

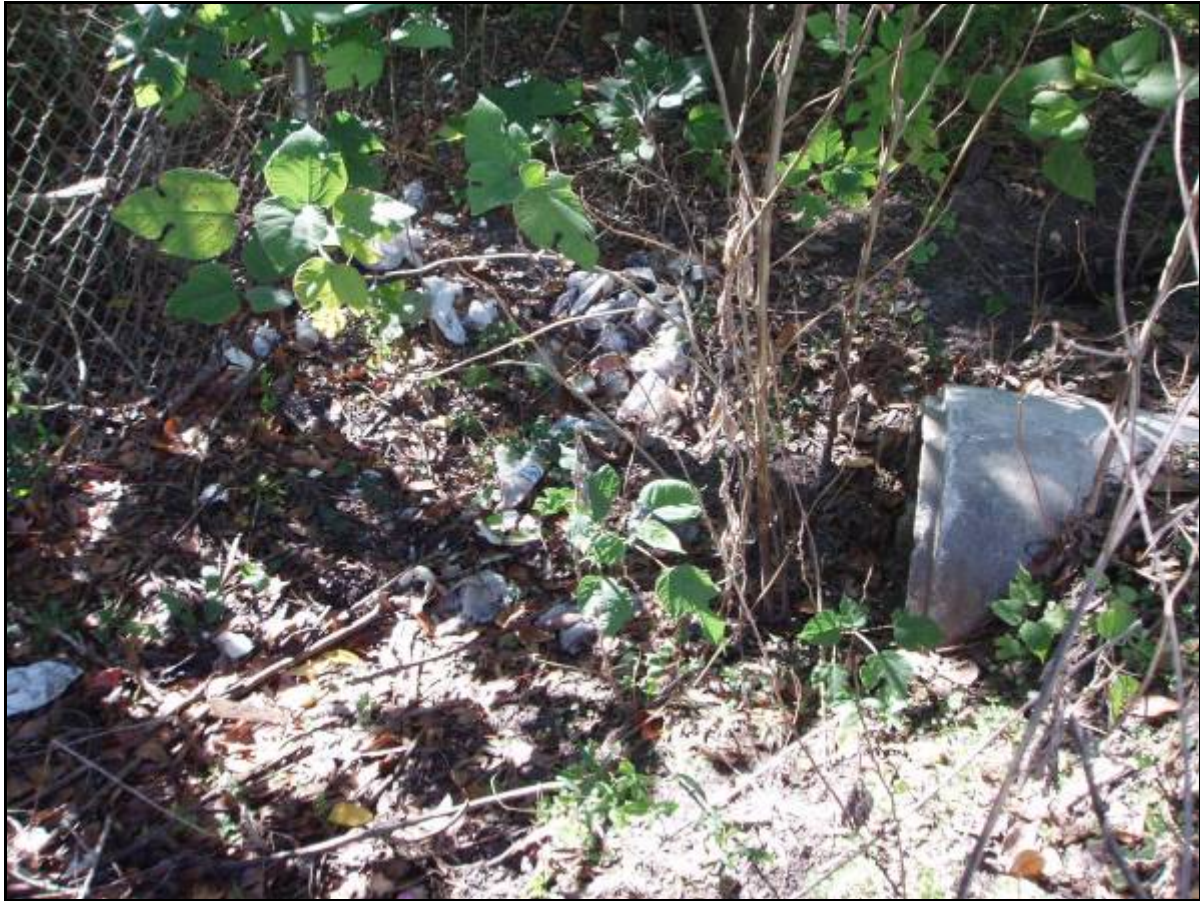
*Figure 40. Trash accumulation at a discharge point in Starlite MHP. Overall, the park was poorly maintained and trash strewn throughout, including inside stormwater conveyances.*

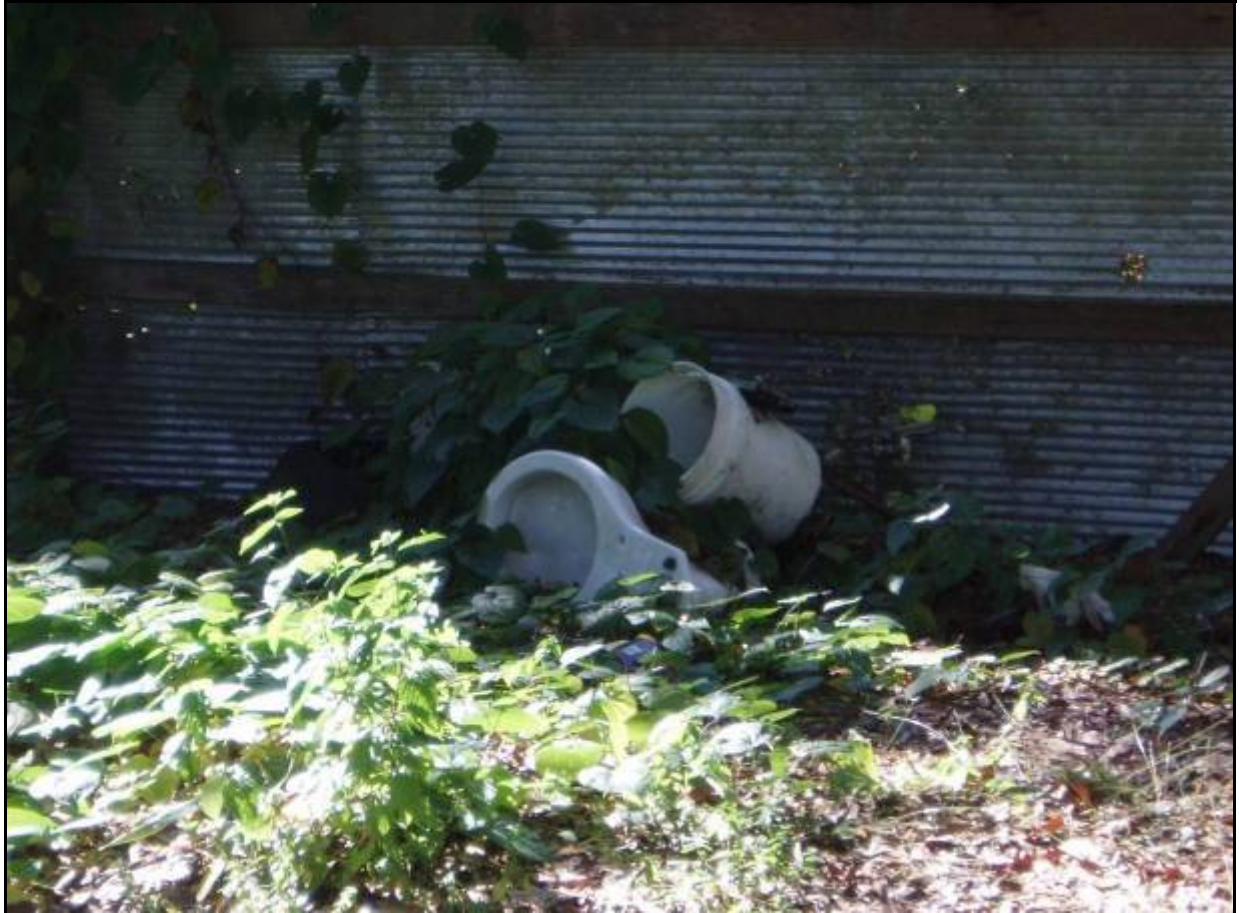
*Figure 41. Discarded toilets were among the trash dumped in Starlite MHP.*

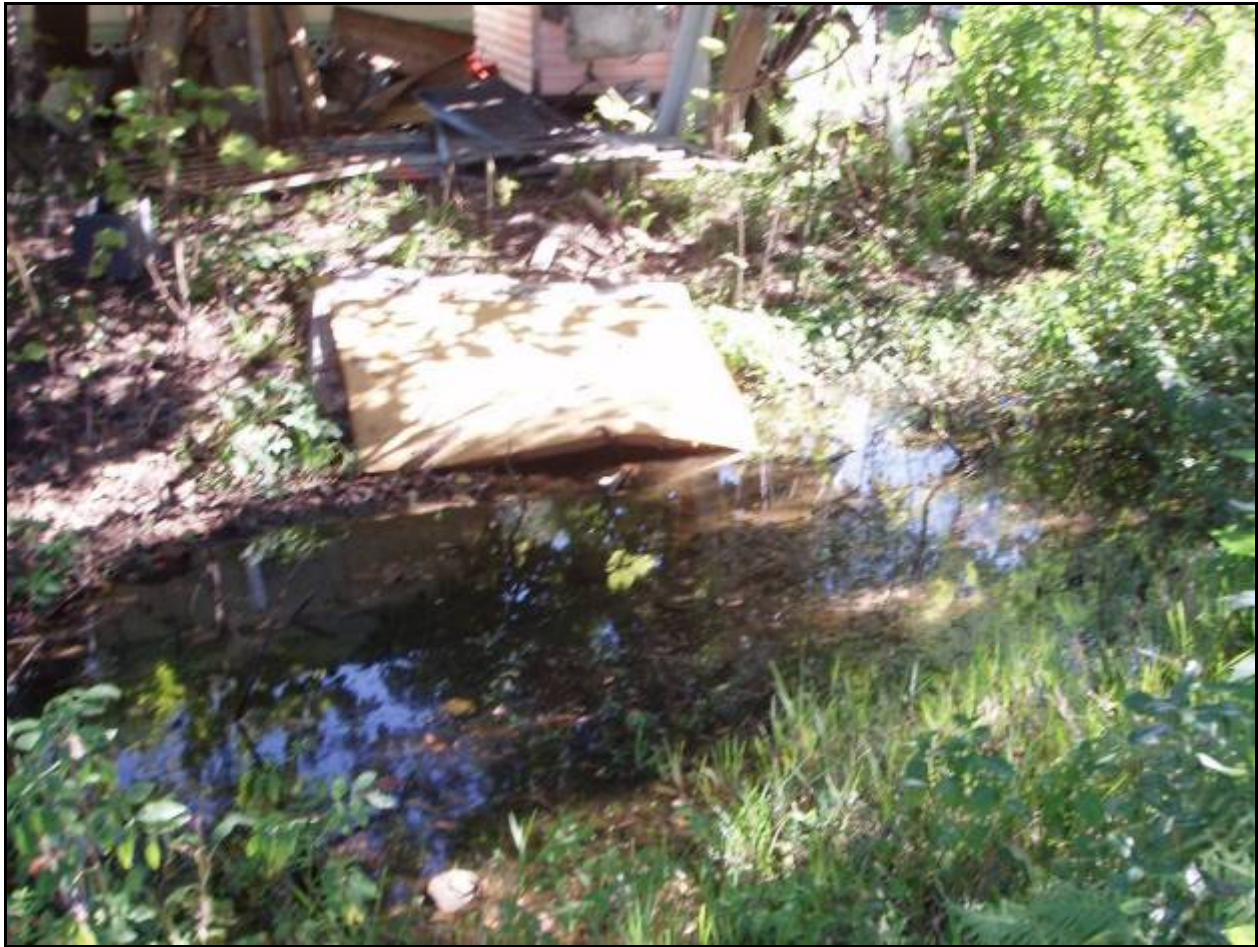
*Figure 42. Mattress found in the ditch at Starlite MHP. The ditch is part of a system of conveyances which drain the park toward Turkey Creek.*

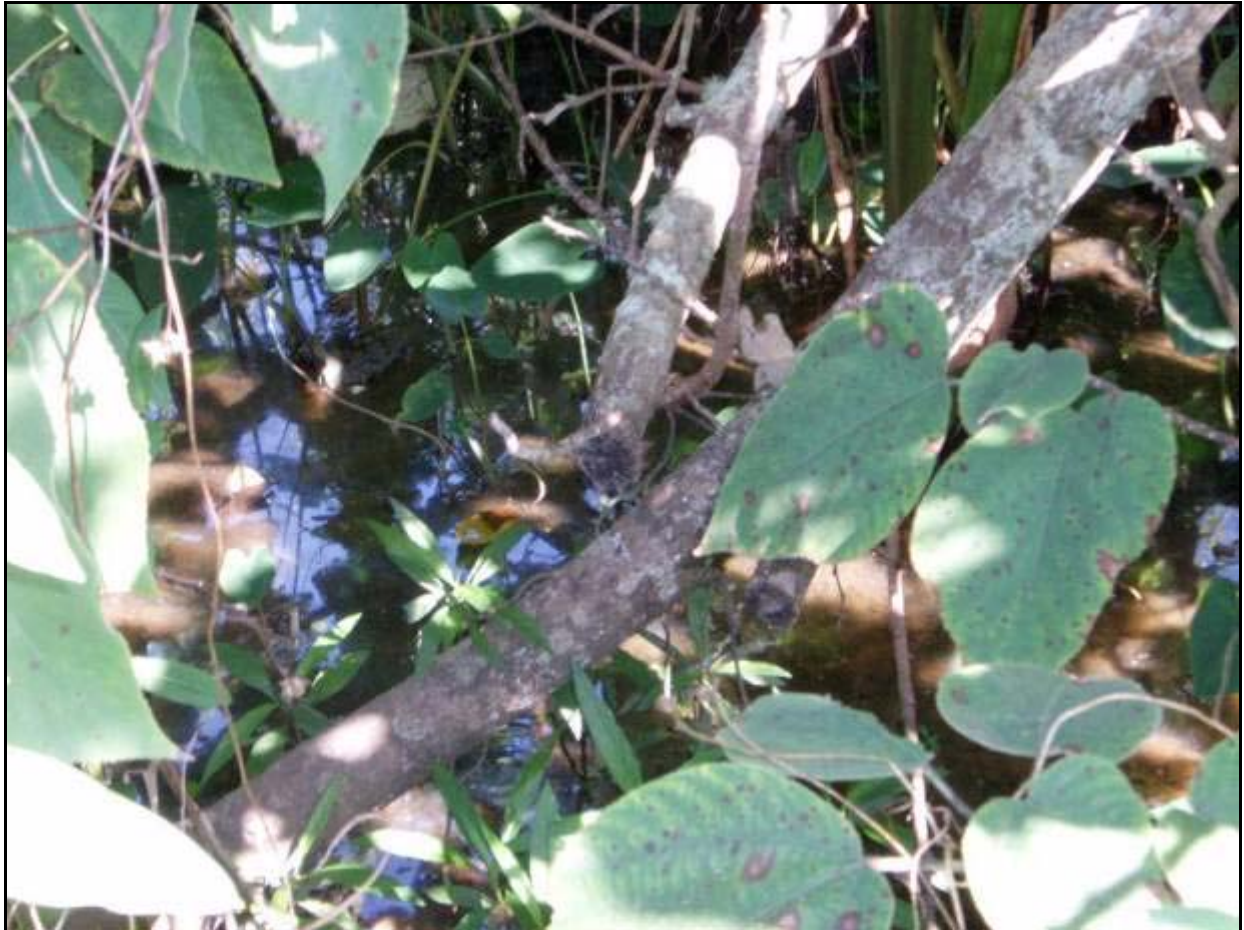
***Figure 43. Close up of ditch in Starlite MHP. The ditch is considerably overgrown, and water is murky and discolored.***

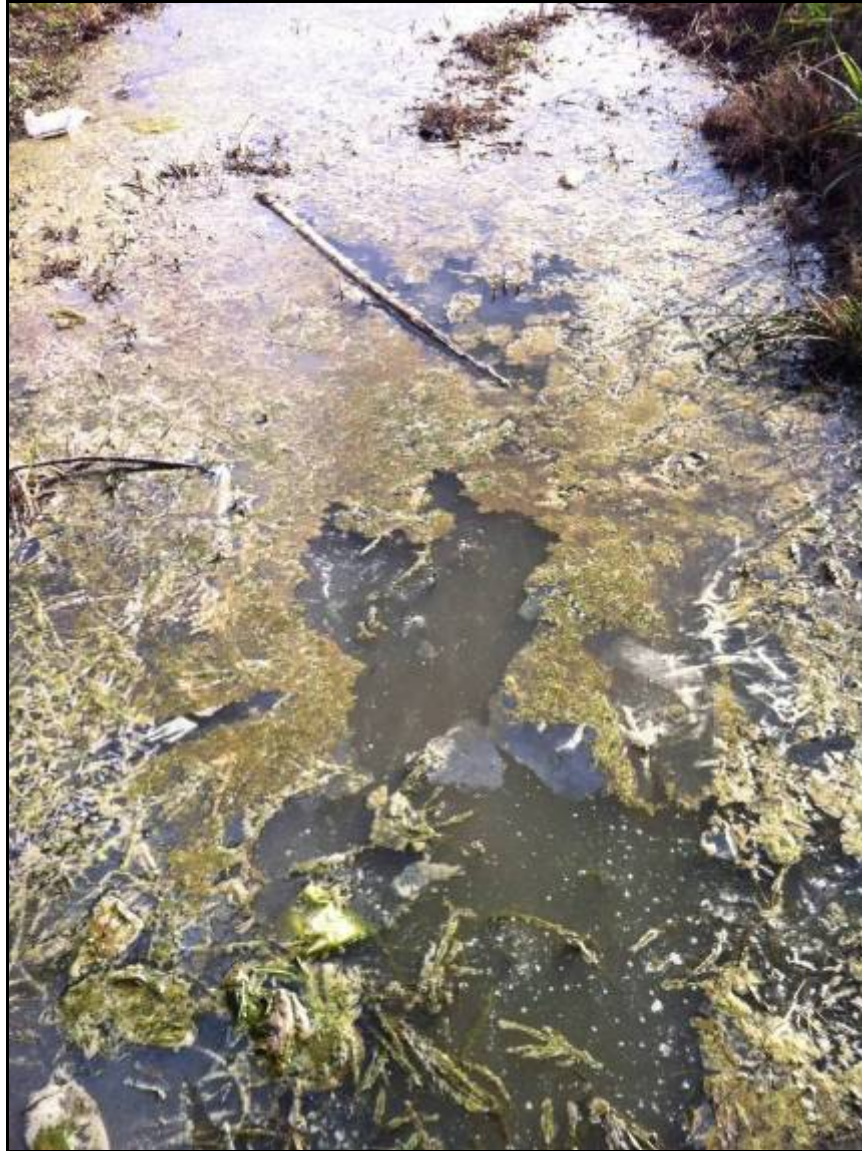
***Figure 44. Follow up inspection was conducted on 01/24/12 to resolve observations made in Figure 38. Re-inspection also revealed deteriorating conditions in the ditch shown in Figure 43. Water was cloudy/murky with a strong sewage odor and algal mats. Referred to EPC for immediate investigation.***

*Post Field Note: EPC inspection on 01/25/12 verified the observation. Water sampling confirmed the coliform hazard [ $>200,000$  CFU/100mL]. EPC report identified sewage discharges to the ditch to originate from the uncapped wastewater cleanouts [Figure 35]. Landowner was notified, and the condition no longer exists. Further investigation will be conducted to confirm continued compliance.*

| Location | Suggested Action | Responsible Entity | Date Completed | Results |
|---|---|---|---|---|
| <b>Figures 44 &amp; 45</b> | <b>Investigate source and magnitude of potential coliform contamination to resolve hazard.</b> | EPC | | <b>Water sampling conducted on 01/25/12 revealed significant coliform contamination [&gt;200,000. CFU/100mL]. Owner was immediately notified. Subsequent inspection showed no evidence of sanitary nuisance.</b> |

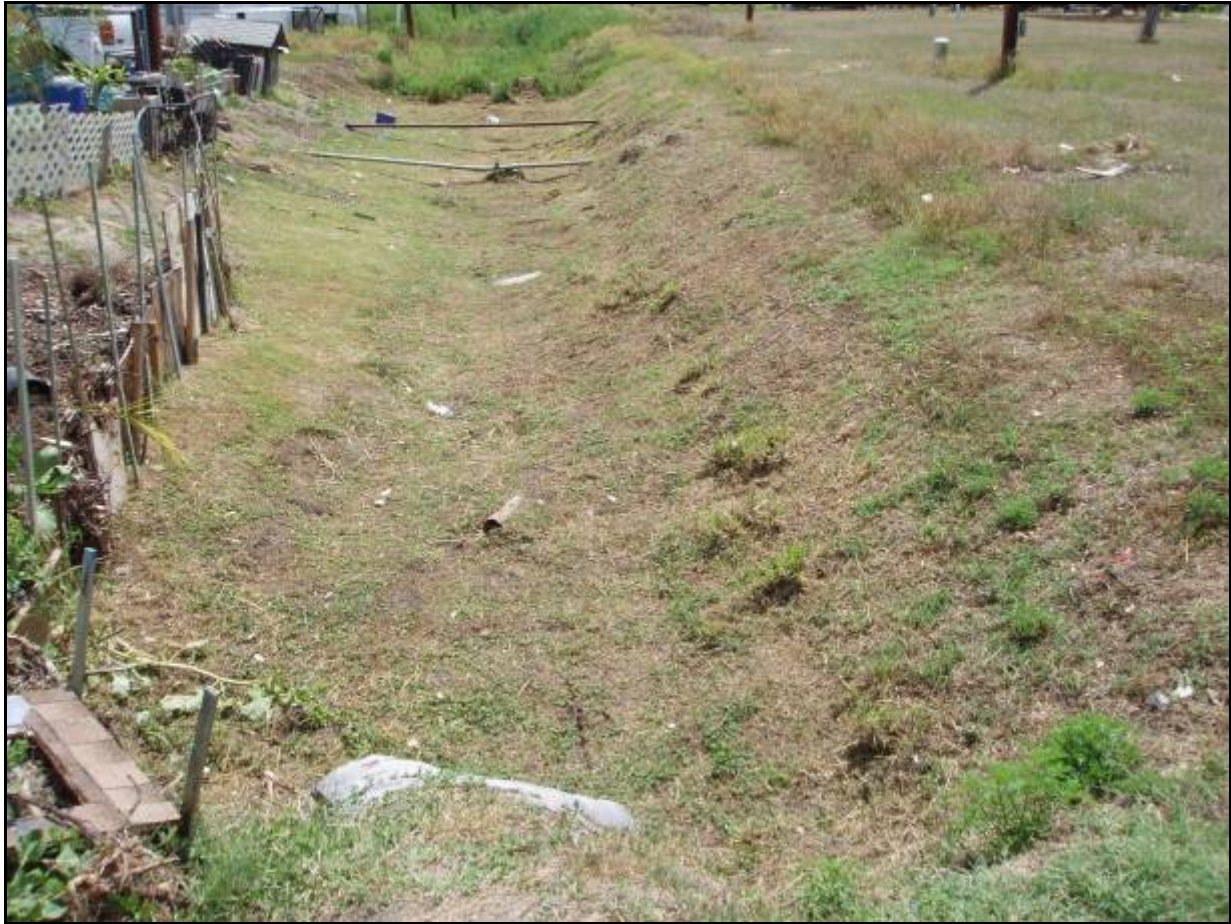
*Figure 45. Follow up inspection [04/09/12] found sanitary nuisance illustrated in Figure 44 has been resolved.*
