# Summary of Results

## Walk the WBID Exercise for Turkey Creek (WBID 1578B)

*Florida Department of Environmental Protection  
Division of Environmental Assessment and Restoration  
Bureau of Watershed Restoration  
Tallahassee, FL 32399*

August 2012

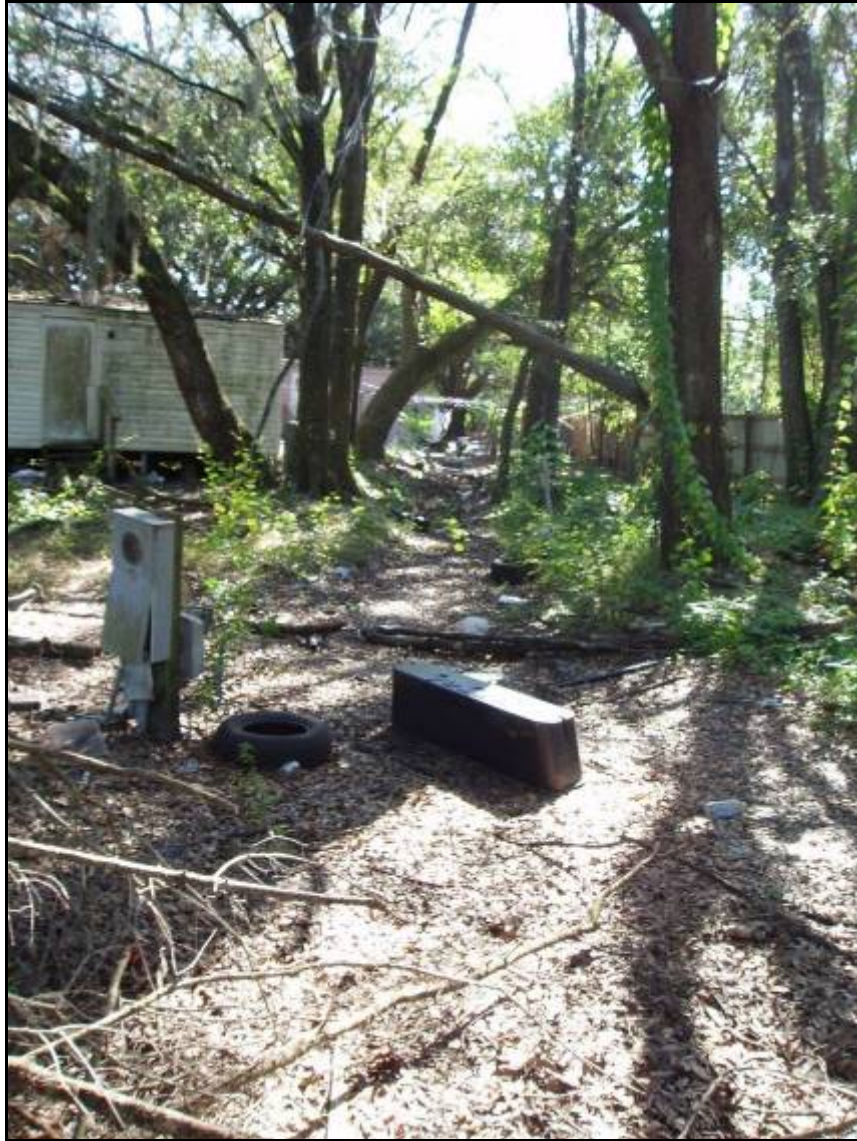
**Figure 46. Conveyance in Starlite MHP containing considerable amounts of trash.**

*Post Field Note: EPC investigation [02/27/12] confirmed routine garbage collection has ceased at Starlite MHP. Some residents are burning refuse. Potential trash accumulation and transport to Turkey Creek is accelerated as a result.*

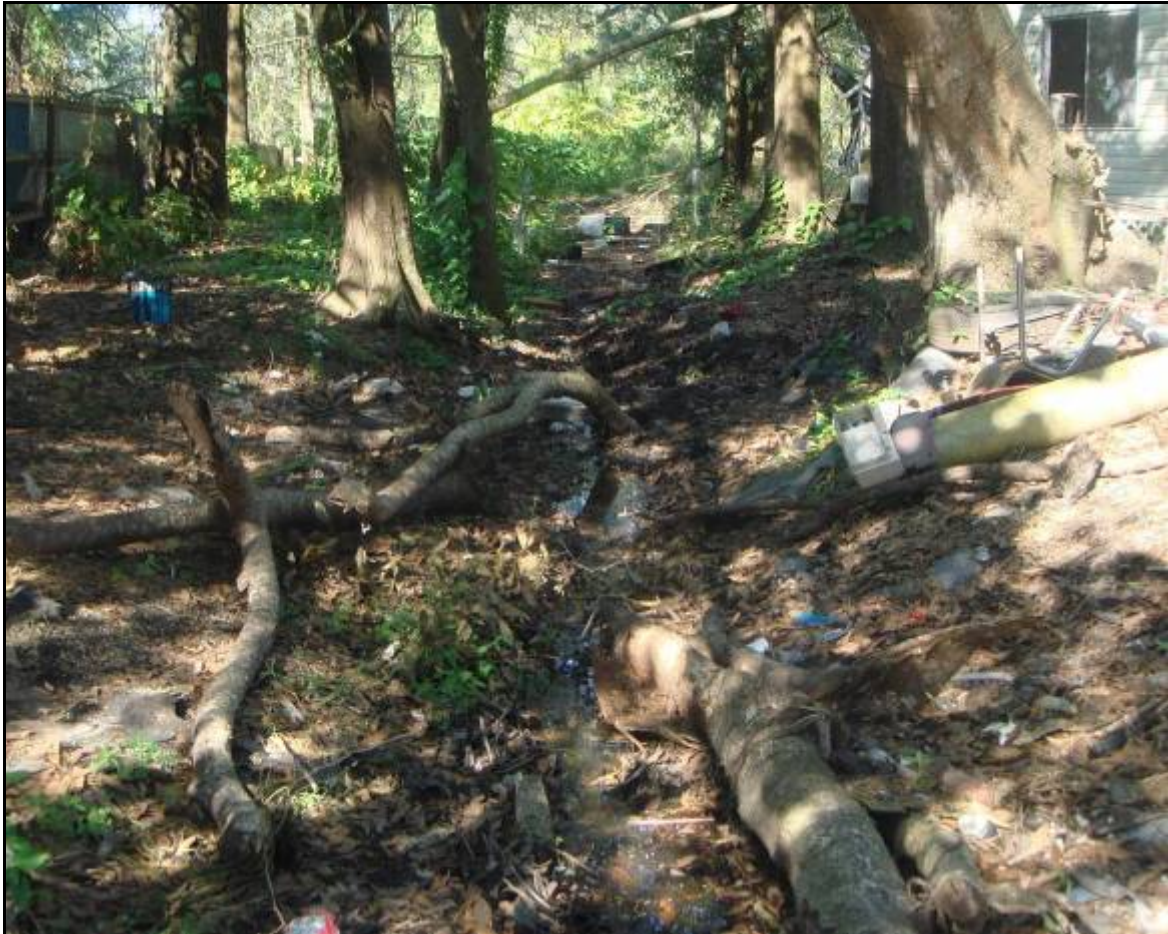
*Figure 47. Another conveyance in Starlite MHP containing considerable amounts of trash.*

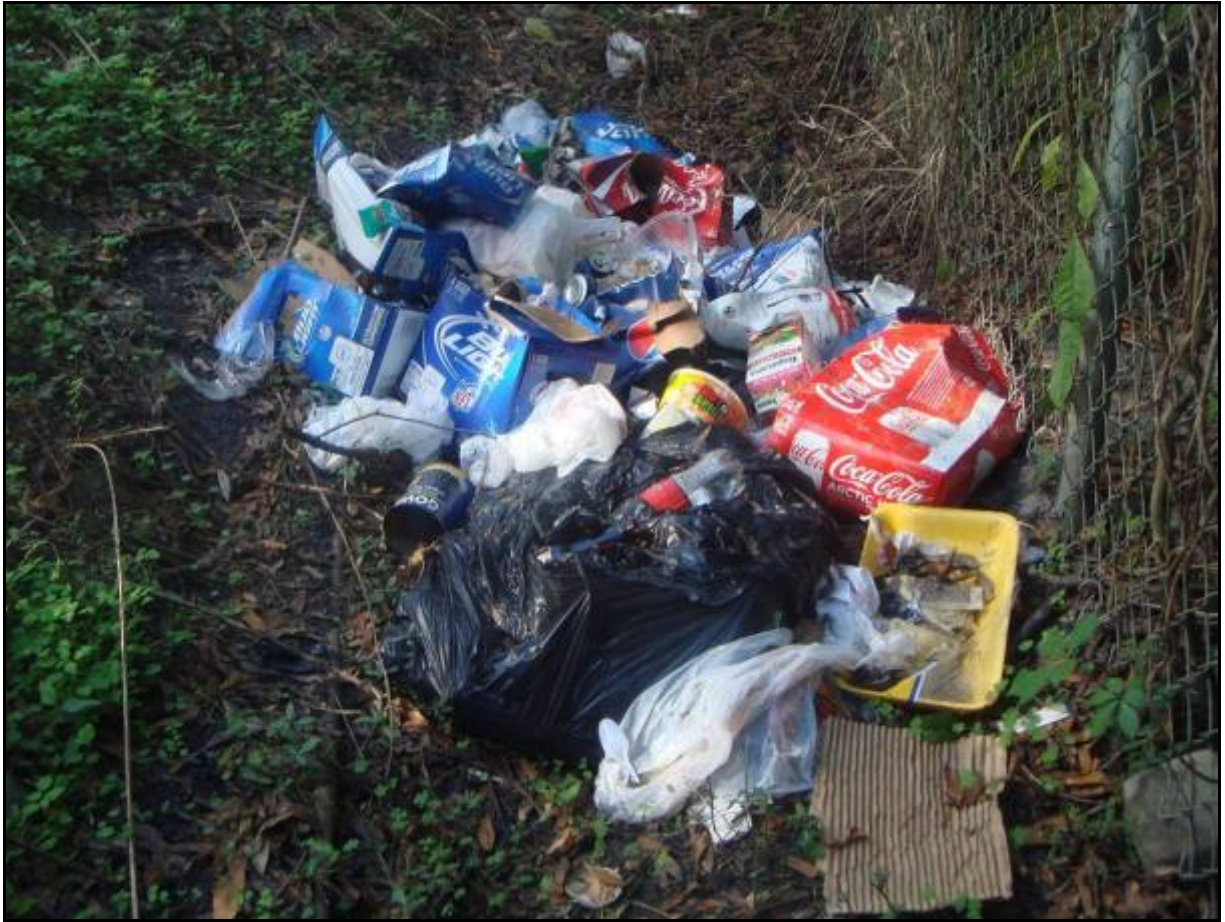
*Figure 48. Trash dumped in a stormwater conveyance within Starlite MHP.*

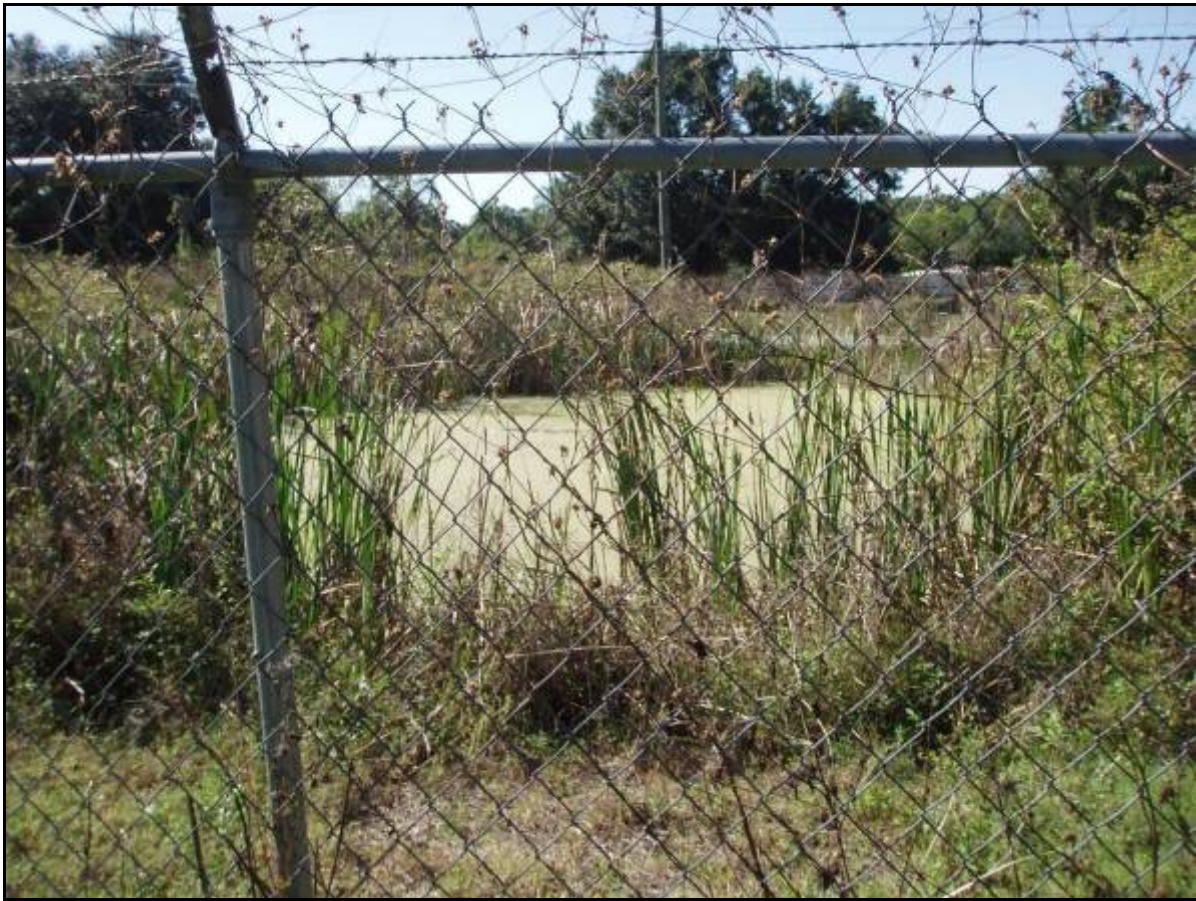
***Figure 49. Treated effluent from Starlite MHP's OSTDS is discharged to this pond. Overall, the pond and conveyance systems are overgrown and contain considerable amounts of trash and sediment, possibly contributing to bacterial growth.***

Post Field Note: Starlite MHP is in receivership as of the date of the Walk; however, continued efforts will be made to resolve hazards observed. Currently, most actions are pending resolution of numerous code violations and existing lawsuits; however, several code violations have been resolved with individual homeowners located within Starlite MHP.

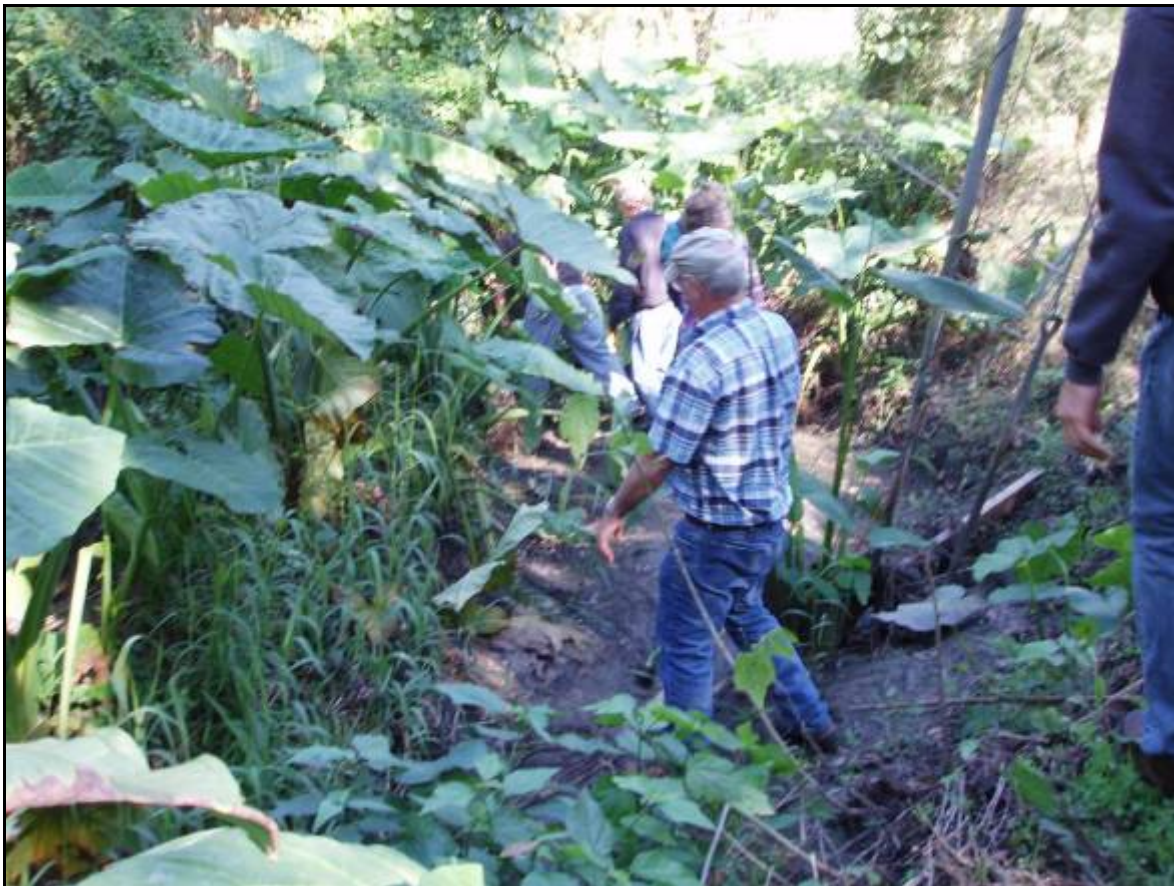
*Figure 50. Likewise, the ditch/tributary, which runs behind Starlite MHP to Turkey Creek, is similarly overgrown and harboring trash and excess sediment.*

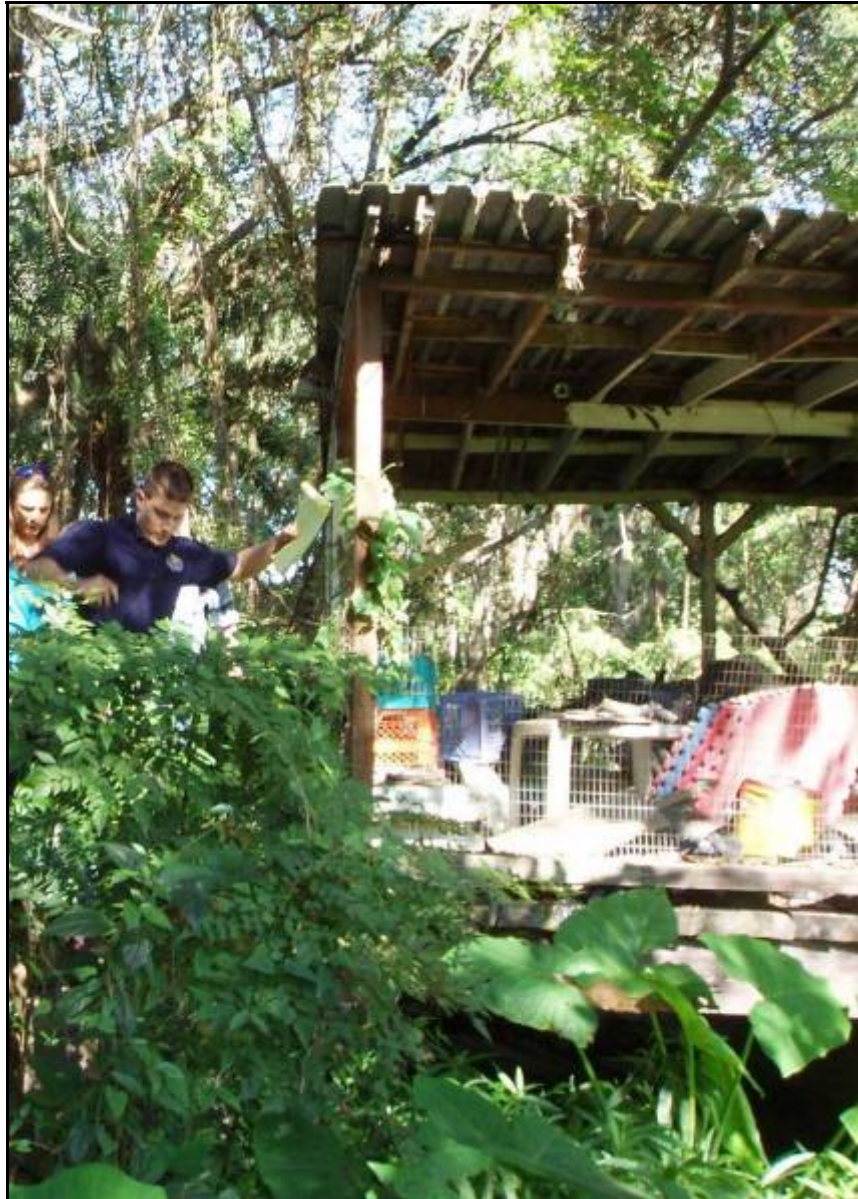
*Figure 52. Makeshift building constructed over the ditch/tributary along the northern edge of Starlite MHP. The tributary runs underneath the elevated building. The building appears to be primarily for storage and is located approximately 500 meters from Turkey Creek's main branch near the northern terminus of Marge Owens Rd.*

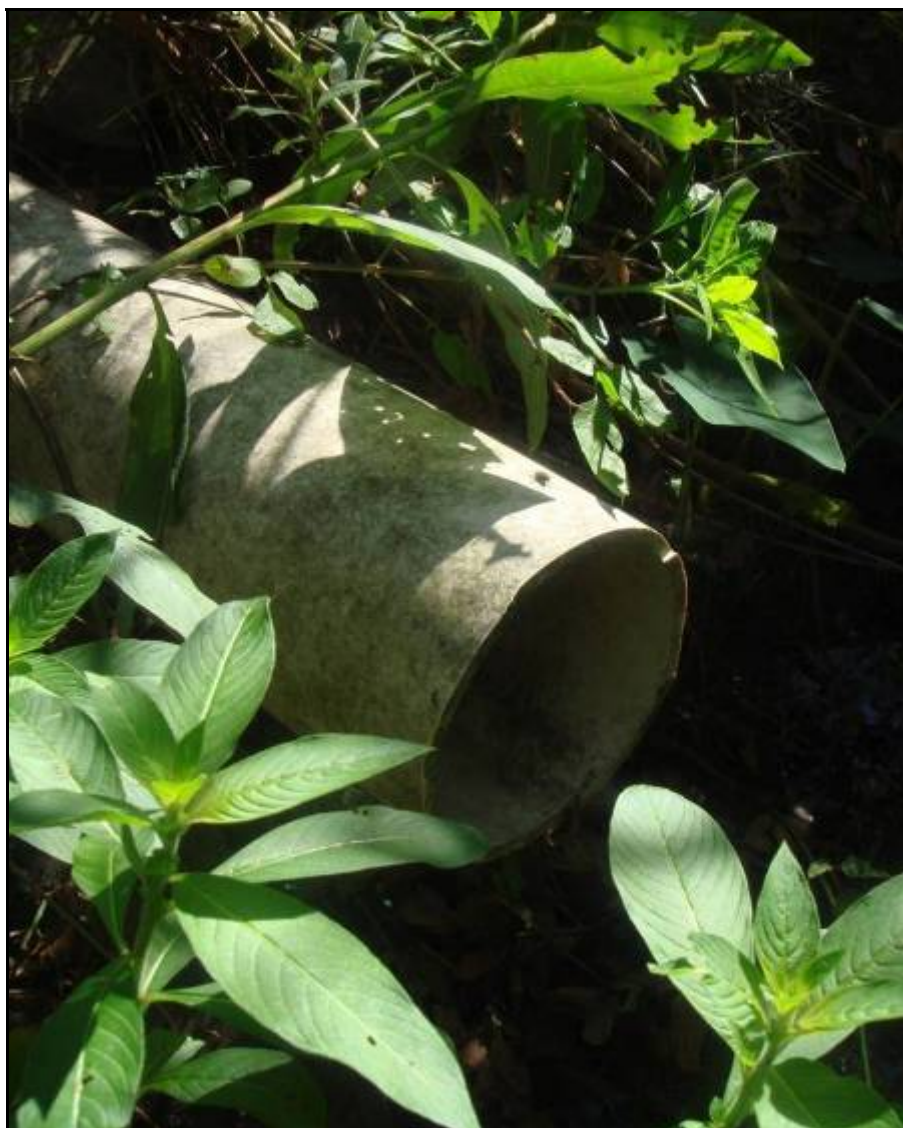
***Figure 53. Potential illicit connection into tributary at Jerry Smith Rd between Trapnell & Sydney. The trajectory of the pipe appears to lead to a mounded septic system. No discharge witnessed while onsite. Referred to DOH for nuisance complaint investigation.***

Post Field Notes: EPC notified residents of the potential hazard. Pipe has subsequently been removed [07/31/12]. Upon removal, residents indicate pipe was only a seven foot section and not connected to the OSTDS.

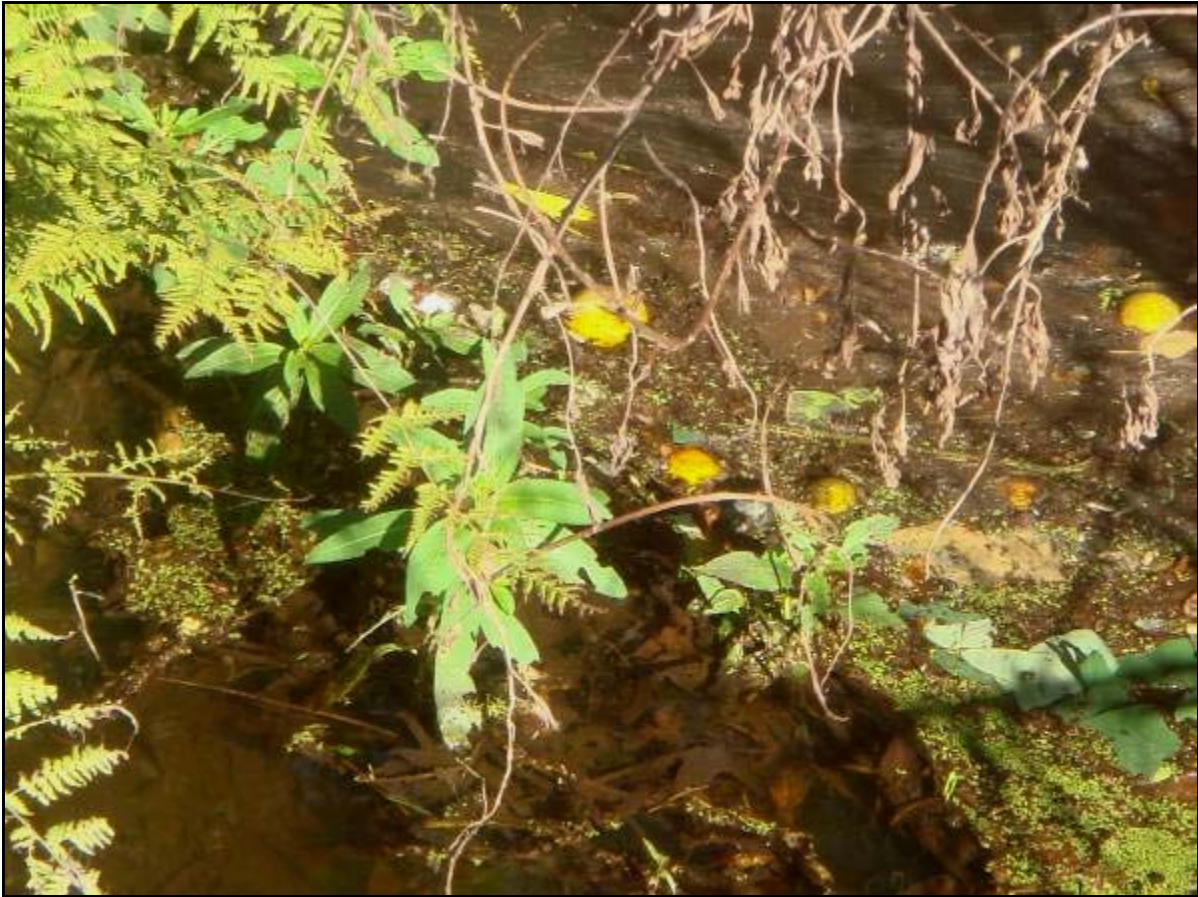
***Figure 54. Citrus in Turkey Creek tributary at Jerry Smith Rd between Trapnell & Sydney. Citrobacter is known to cause Type I errors in fecal coliform testing.***

- *Citrobacter* grows on rotting fruit and can cause Type I errors in fecal coliform tests. Citrus grows wild and in residential yards throughout the watershed. See Figure 54.

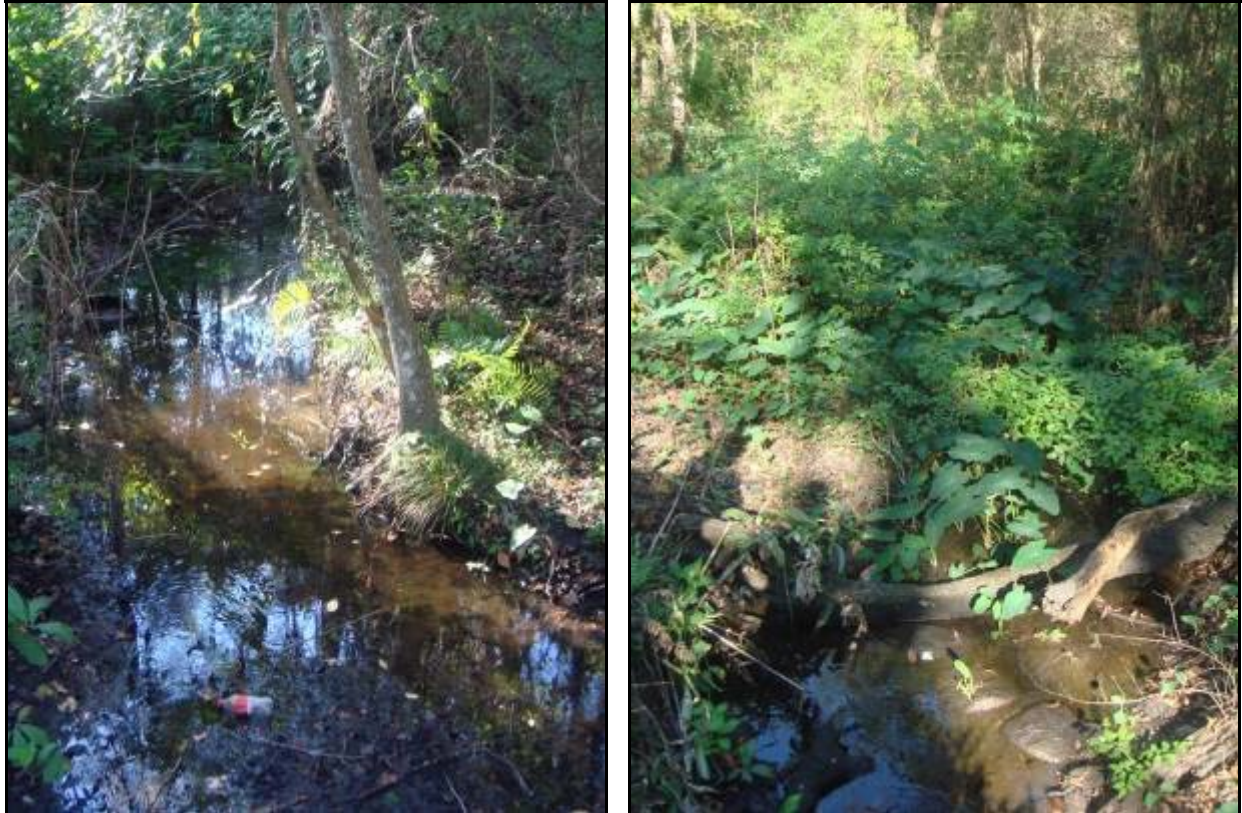
***Figure 55. Tributary at Jerry Smith Rd near Touchstone Rd. Dense vegetation and litter present, including a discarded tire. Preliminary sampling at this location [Figure 4: Site 6S] showed considerable coliform contamination [2820 CFU/100mL].***

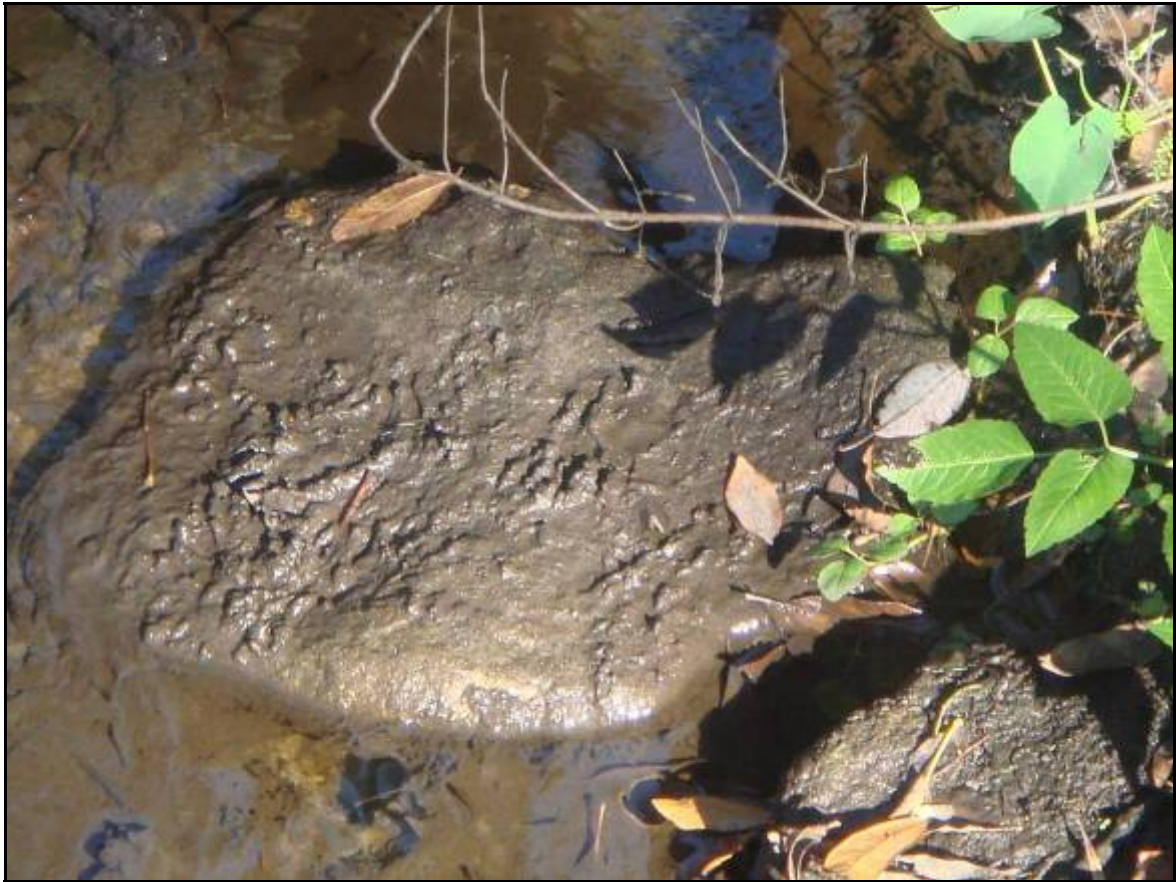
*Figure 56. In addition, animal tracks observed in the mud at Figure 55.*

- Bacterial re-growth is probable in ditches and natural watercourses given the subtropical climate and natural sediments observed. See Figures 8, 9, 19, 29, and 56.

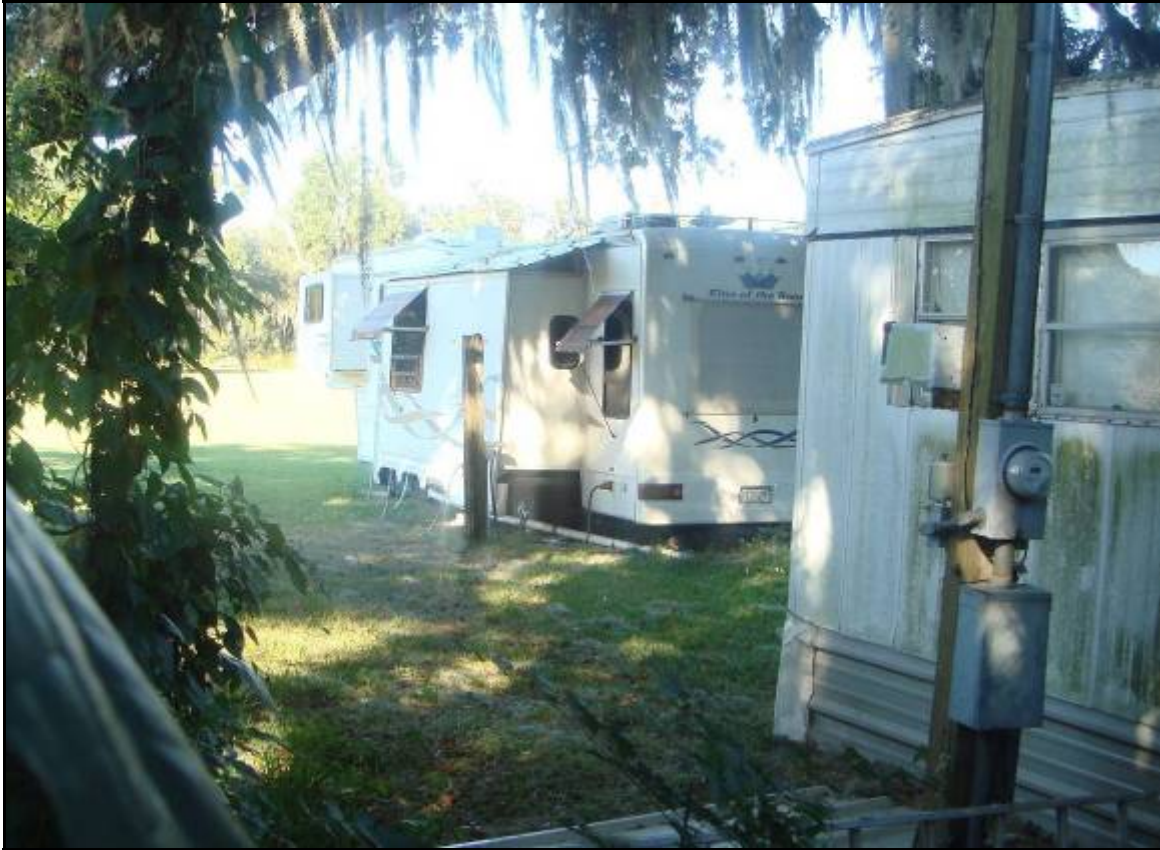
***Figure 57. White PVC pipe extends from camper/RV into the ground adjacent to tributary at Connell Rd. Referred to DOH for nuisance complaint investigation.***

Post Field Note: DOH inspection revealed no compliance violations and no sanitary nuisance.

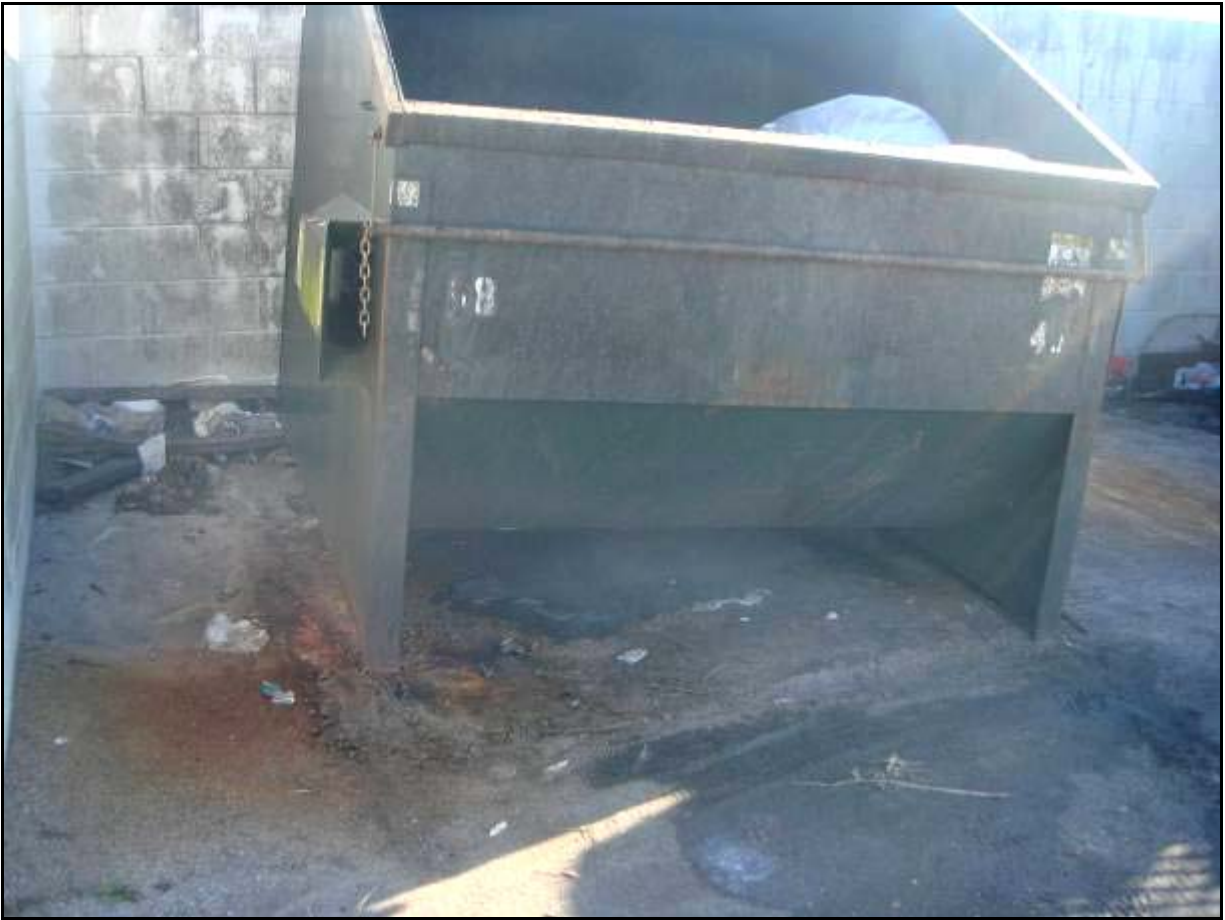
***Figure 58. Open dumpster in parking lot of J.S. Robinson Elementary. Stormwater has the potential to transport pollutants from open dumpsters to surface waterbodies.***

| Location | Suggested Action | Responsible Entity | Date Completed | Results |
|---|---|---|---|---|
| <b>Figure 58</b> | <b>Inform Robinson Elementary of potential water quality hazard and request dumpster lids remain secured.</b> | HCPW | <b>12/14/2011</b> | <b>Informed Principal Wilkerson of the potential water quality hazard and requested the lids remain secured. Subsequent visit found lids secured.</b> |

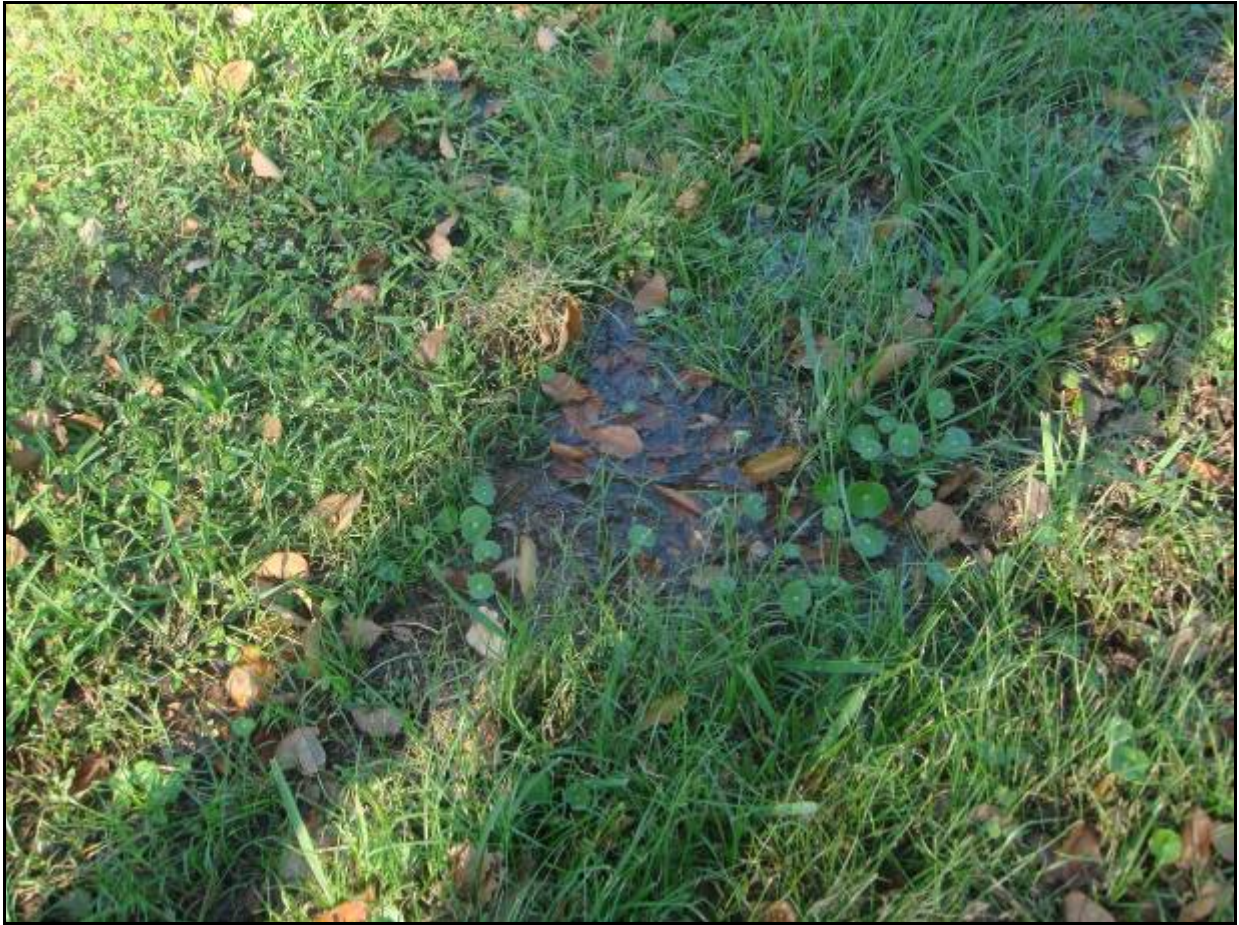
***Figure 59. Septic drain field at Crawford 3B's Mobile Home Park is super-saturated and ponding. The effluent was observed adjacent to the Turkey Creek tributary. EPC notified the owner of the concern during the Walk and directed to resolve the violation. Re-inspection should confirm proper functionality.***

Post Field Note: EPC has re-inspected and found trace deficiencies. Inspection frequency increased and enforcement will be pursued if problems persist.

| Location | Suggested Action | Responsible Entity | Date Completed | Results |
|---|---|---|---|---|
| <b>Figure 59</b> | <b>Re-inspect drain field at Crawford 3B's Mobile Home Park to ensure proper function.</b> | EPC | Ongoing | Owner was notified of the violation during the Walk. EPC has re-inspected and found trace deficiencies. EPC will increase inspection frequency, and enforcement will be pursued if problem persist. |

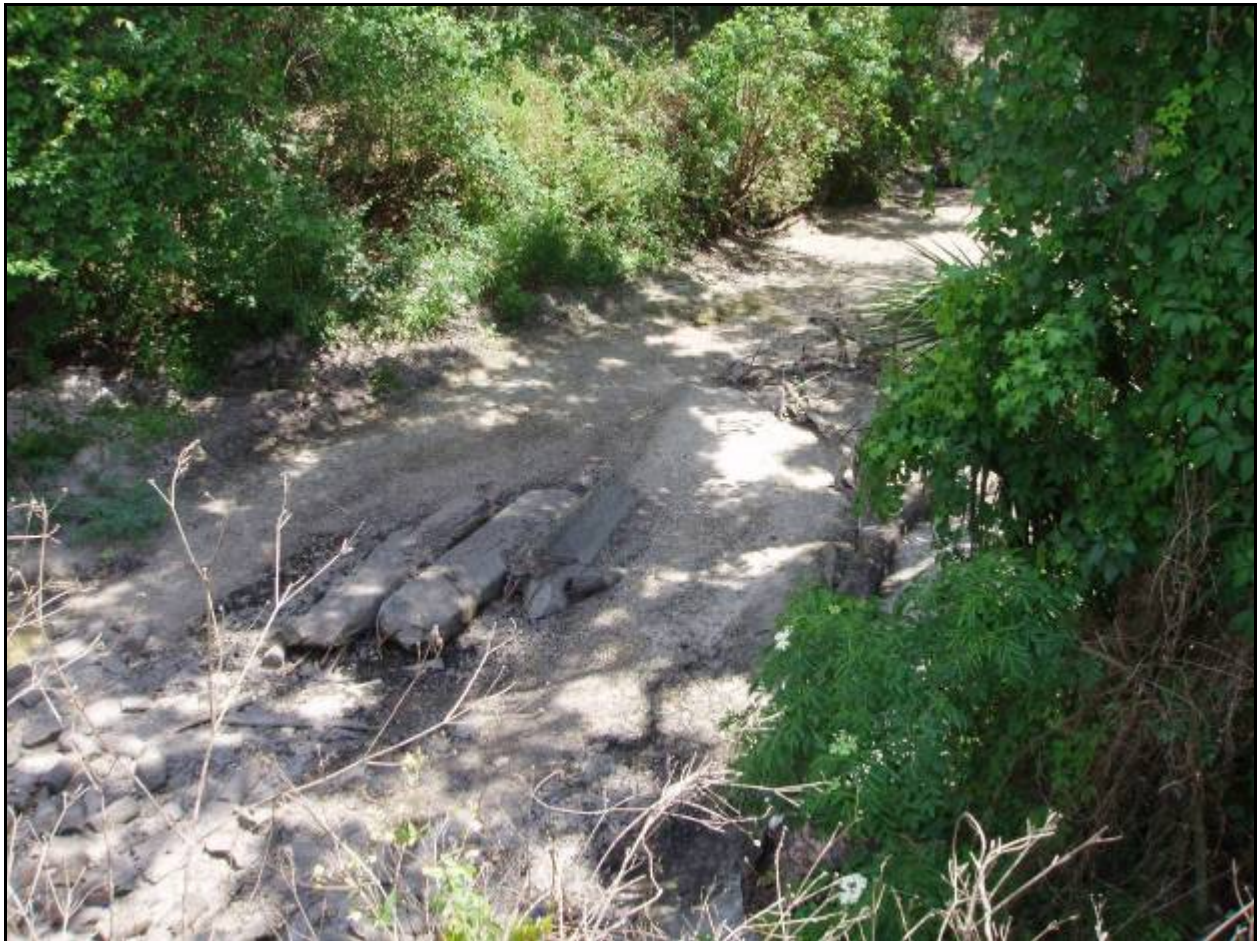
***Figure 64. Main branch of Turkey Creek is completely dry at SR 60 during follow up visit [04/09/12].  
All upstream portions inspected that day appeared in similar conditions.***
