# **RENOVATION ASBESTOS SURVEY REPORT**

**Apalachicola Research Center  
University of Florida  
261 Frederick Humphries Drive  
Apalachicola, Florida**

**GLE Project No.: 16140-01354**

**April 2016**

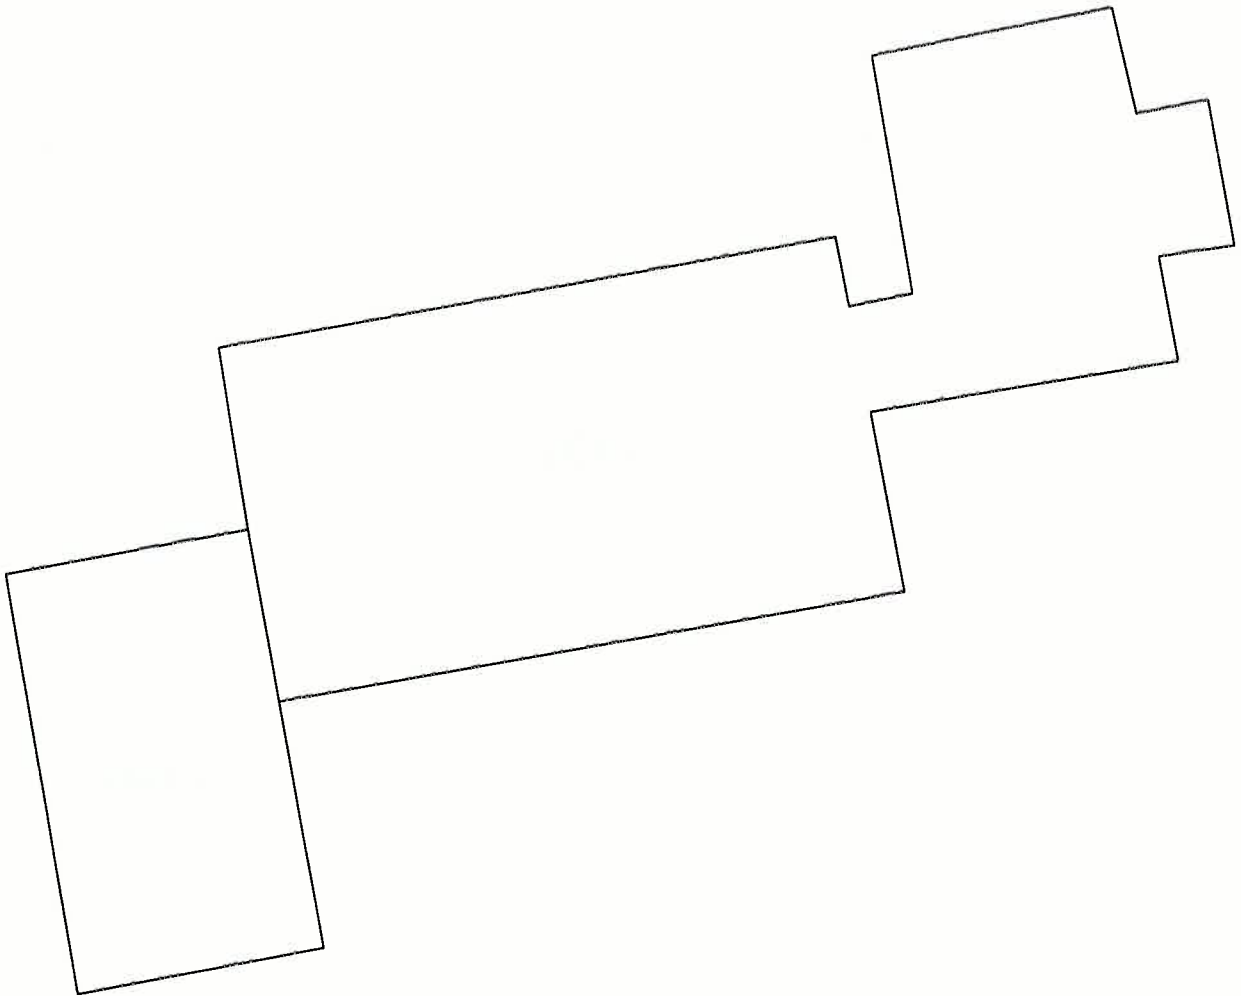
NOTE:  
NO ASBESTOS-CONTAINING MATERIALS OBSERVED.

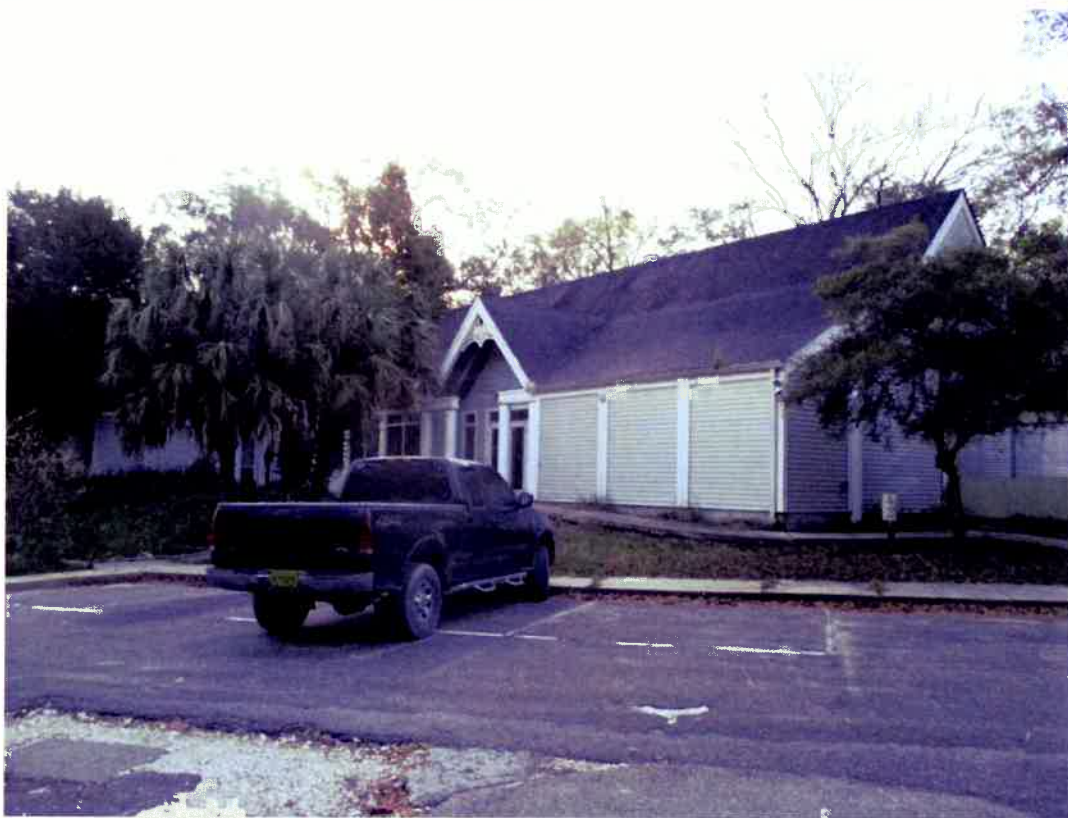
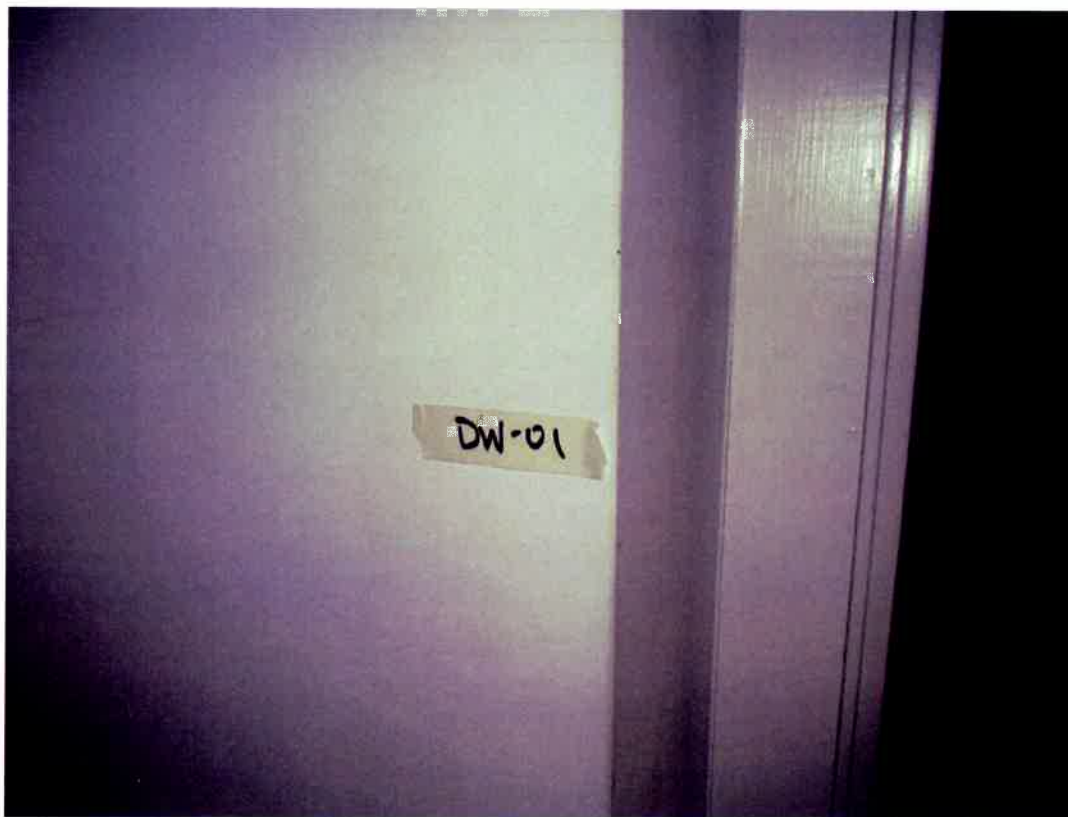
**Photo D-1**

| TABLE 2.2-1: SUMMARY OF HOMOGENEOUS SAMPLING AREAS<br>APALACHICOLA RESEARCH CENTER<br>UNIVERSITY OF FLORIDA – APALACHICOLA, FLORIDA | | | | | | | |
|---|---|---|---|---|---|---|---|
| DW-01 | Drywall with Joint Compound | Throughout | NF | ND | 3 | NIS | NA |

Upper Photo: Apalachicola Research Center  
Lower Photo: DW-01-Drywall with Joint Compound

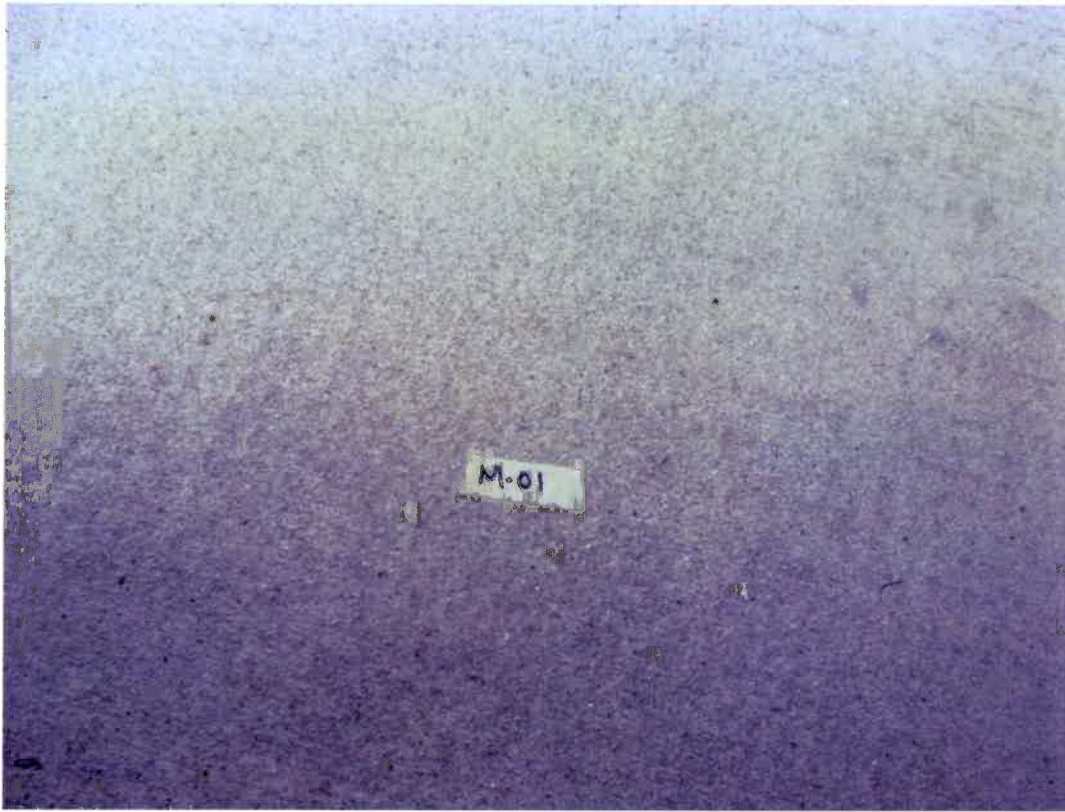
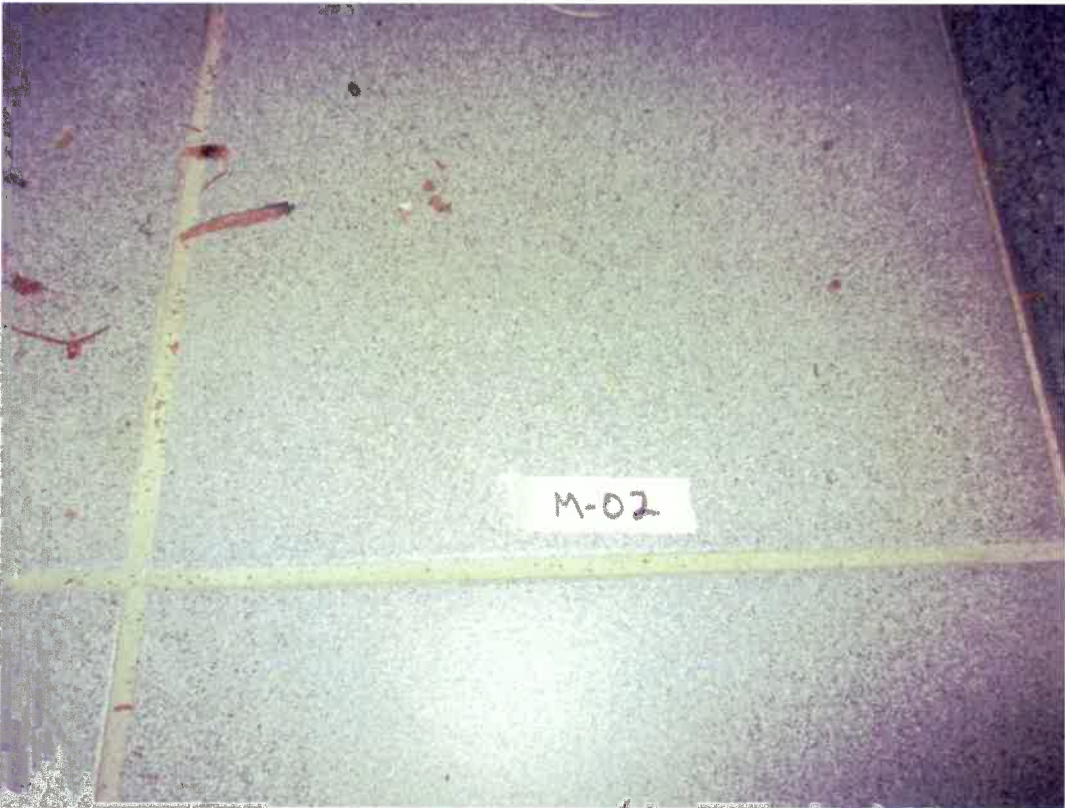
**Photo D-2**

| TABLE 2.2-1: SUMMARY OF HOMOGENEOUS SAMPLING AREAS<br>APALACHICOLA RESEARCH CENTER<br>UNIVERSITY OF FLORIDA – APALACHICOLA, FLORIDA | | | | | | | |
|---|---|---|---|---|---|---|---|
| M-01 | Concrete | Slab | NF | ND | 3 | NIS | NA |

Upper Photo: M-01-Concrete

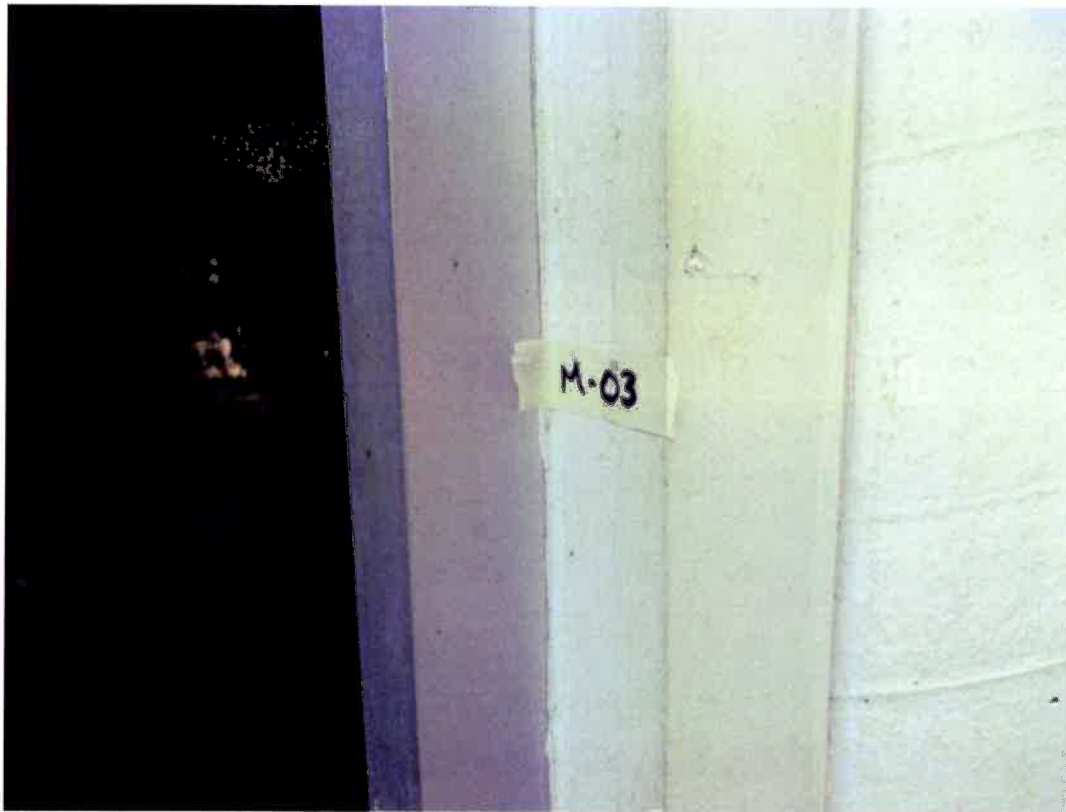
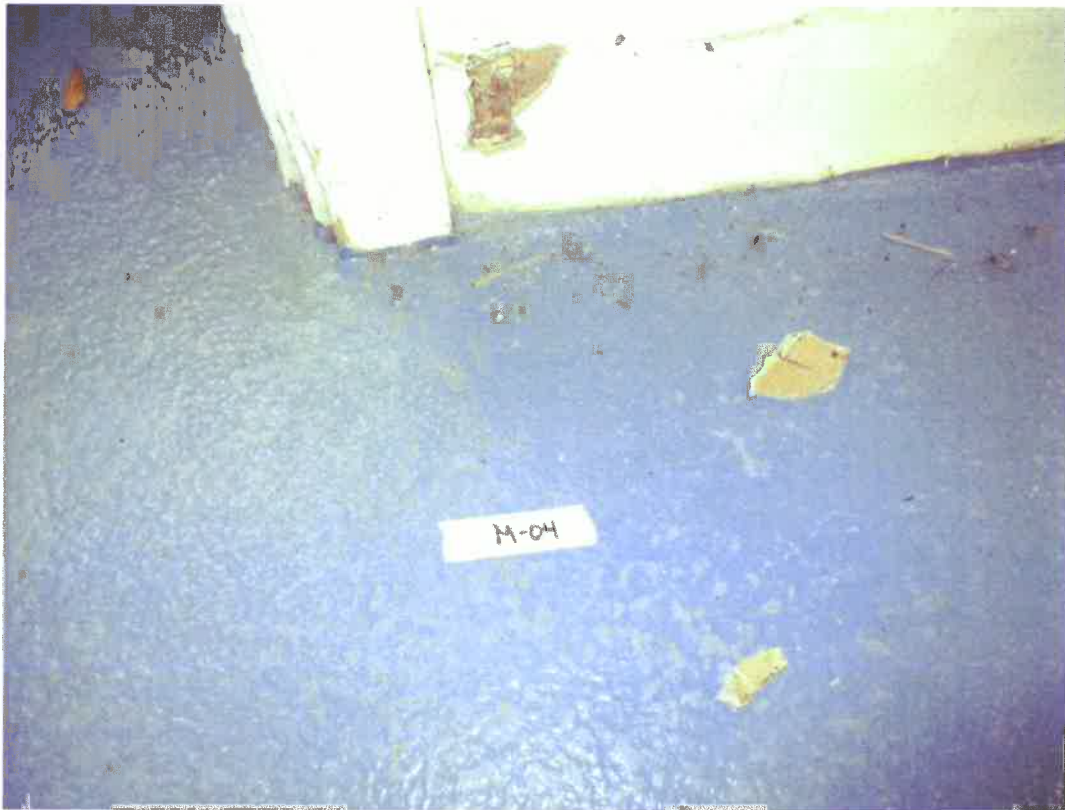
**Photo D-3**

| TABLE 2.2-1: SUMMARY OF HOMOGENEOUS SAMPLING AREAS<br>APALACHICOLA RESEARCH CENTER<br>UNIVERSITY OF FLORIDA – APALACHICOLA, FLORIDA | | | | | | | |
|---|---|---|---|---|---|---|---|
| M-03 | White Caulk | Windows and Exterior Doors | NF | ND | 3 | NIS | NA |
| M-04 | Epoxy Floor Coating | Southwest Rooms | NF | ND | 3 | NIS | NA |

Upper Photo: M-03-White Caulk  
Lower Photo: M-04-Epoxy Floor Coating

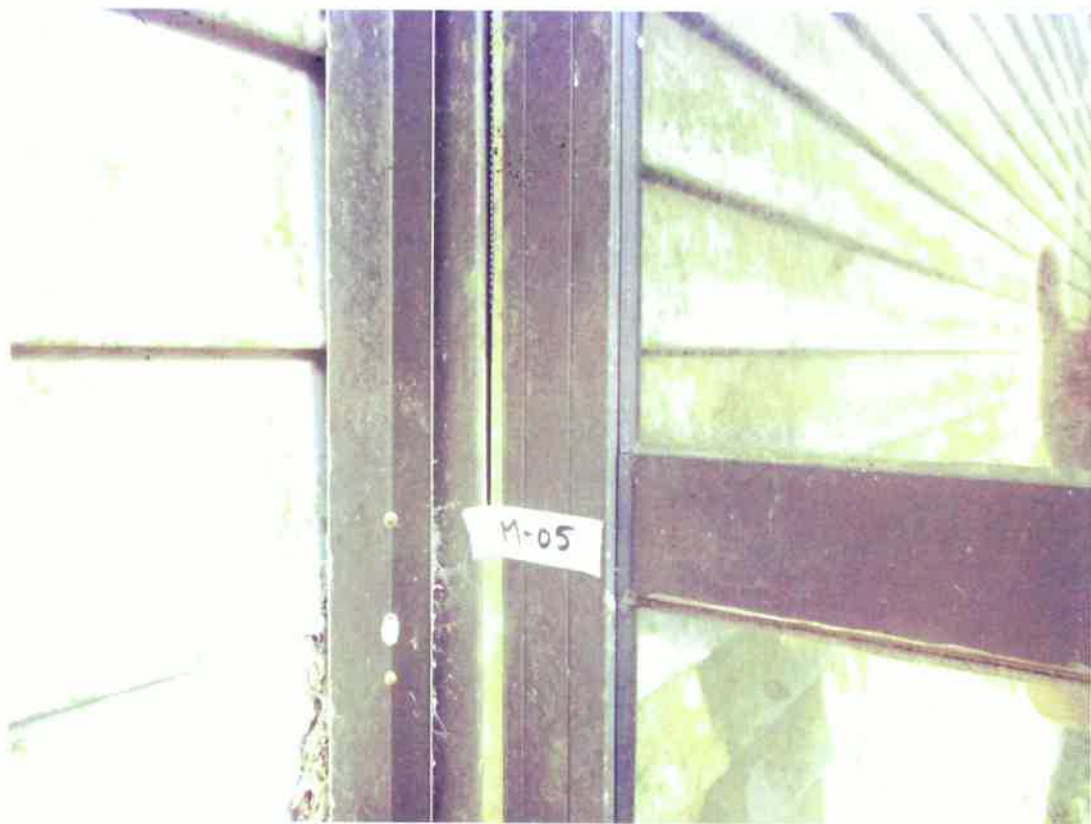
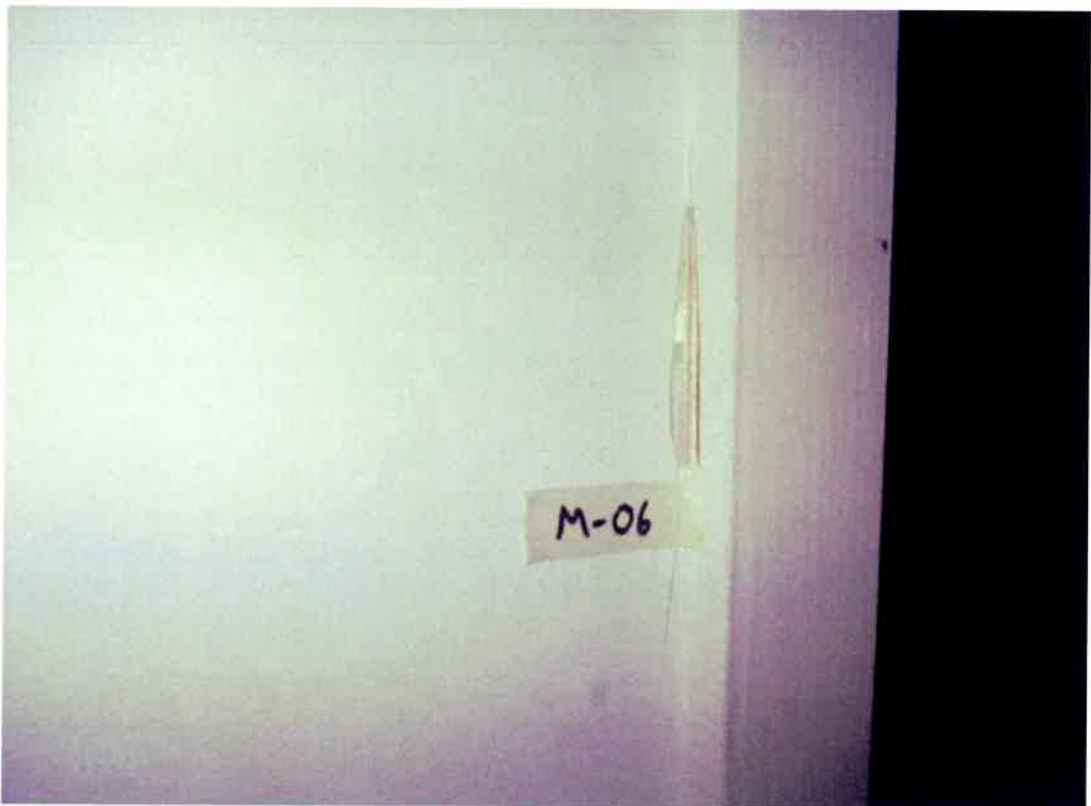
**Photo D-4**

| TABLE 2.2-1: SUMMARY OF HOMOGENEOUS SAMPLING AREAS<br>APALACHICOLA RESEARCH CENTER<br>UNIVERSITY OF FLORIDA – APALACHICOLA, FLORIDA | | | | | | | |
|---|---|---|---|---|---|---|---|
| M-05 | Black Caulk | Glass Canopy Room | NF | ND | 3 | NIS | NA |
| M-06 | White Door Frame Caulk | Interior Doors | NF | ND | 3 | NIS | NA |

Upper Photo: M-05-Black Caulk  
Lower Photo: M-06-White Door Frame Caulk

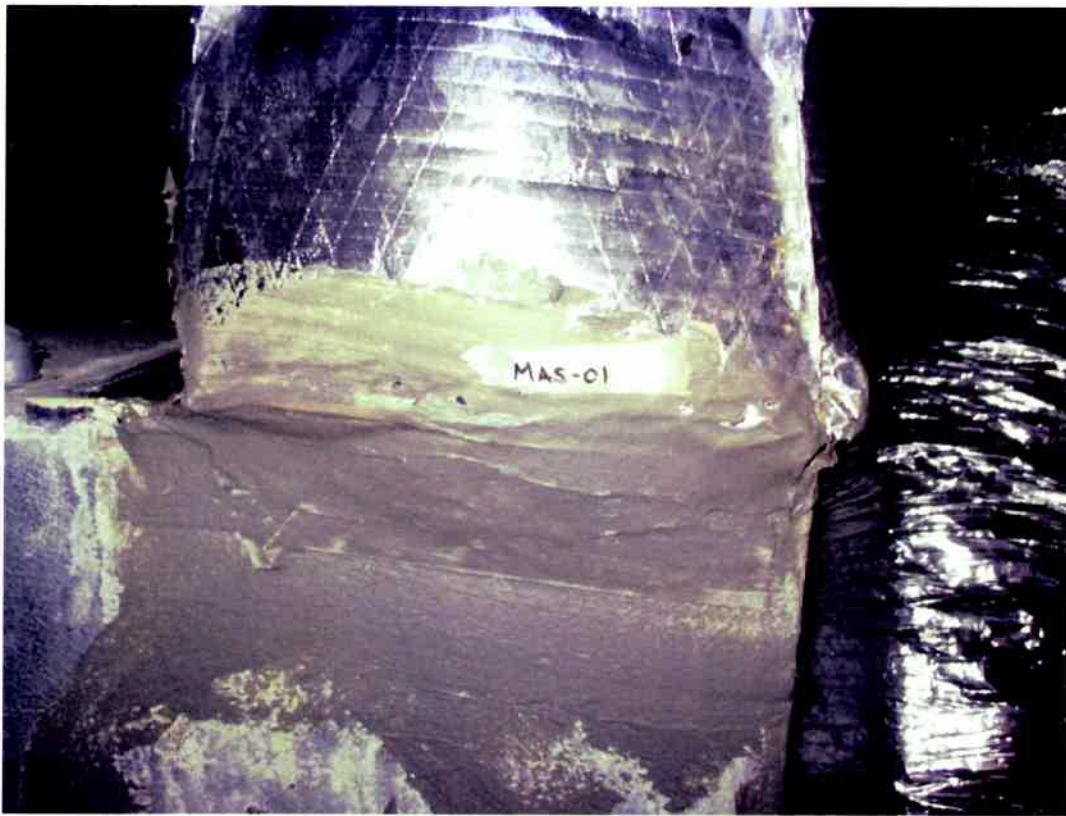
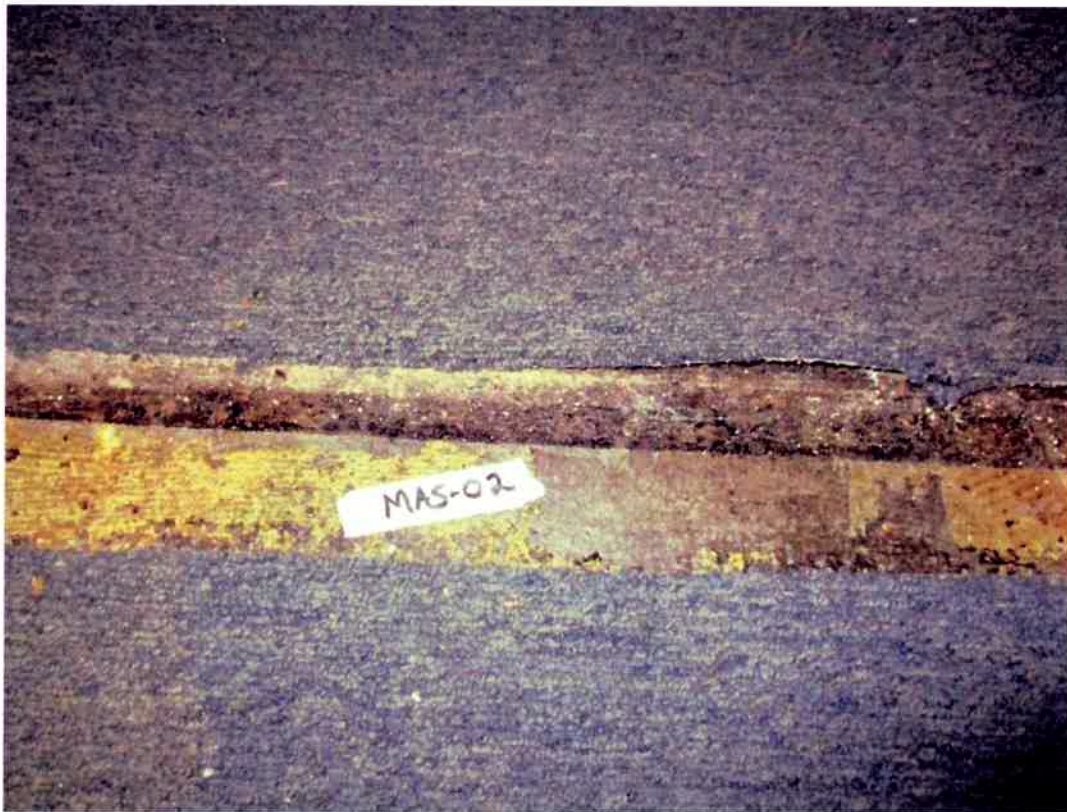
**Photo D-5**

| TABLE 2.2-1: SUMMARY OF HOMOGENEOUS SAMPLING AREAS<br>APALACHICOLA RESEARCH CENTER<br>UNIVERSITY OF FLORIDA – APALACHICOLA, FLORIDA | | | | | | | |
|---|---|---|---|---|---|---|---|
| MAS-01 | Gray HVAC Mastic | Attic, Duct Penetrations | NF | ND | 3 | NIS | NA |
| MAS-02 | Black and Yellow Floor Mastic | Under Carpet, Main Front Area | NF | ND | 3 | NIS | NA |

Upper Photo: MAS-01-Gray HVAC Mastic  
Lower Photo: MAS-02-Black and Yellow  
Floor Mastic

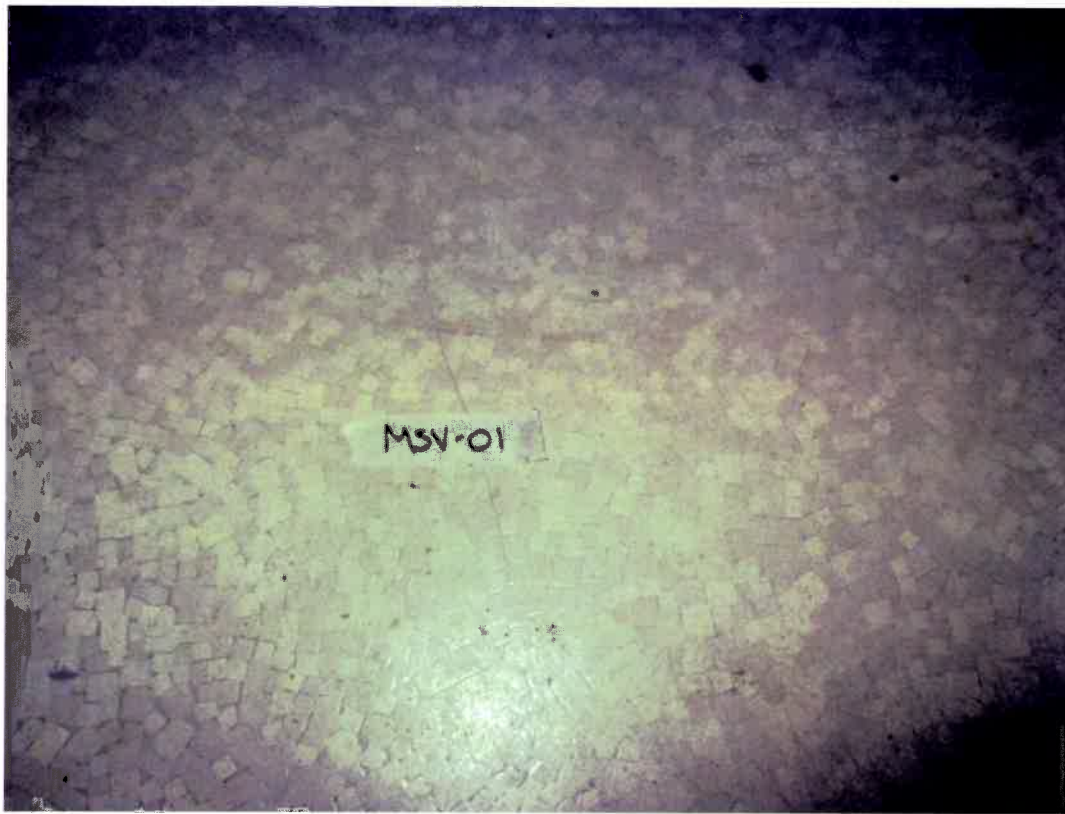
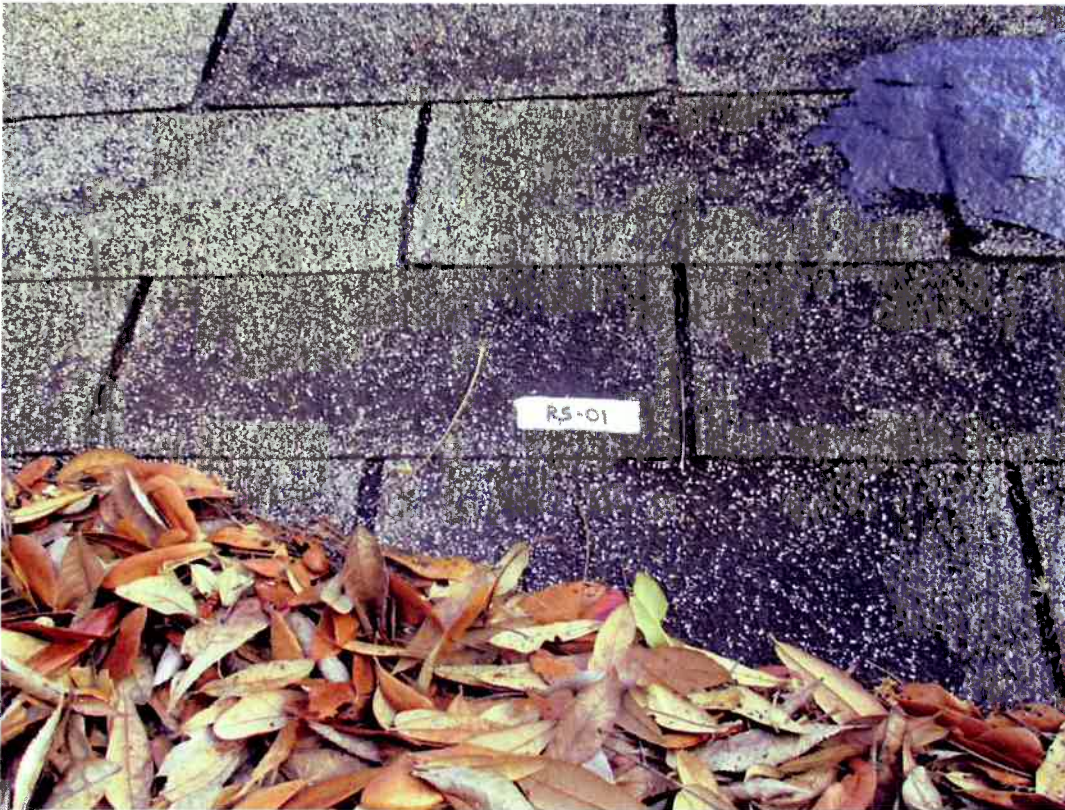
**Photo D-6**

| TABLE 2.2-1: SUMMARY OF HOMOGENEOUS SAMPLING AREAS<br>APALACHICOLA RESEARCH CENTER<br>UNIVERSITY OF FLORIDA – APALACHICOLA, FLORIDA | | | | | | | |
|---|---|---|---|---|---|---|---|
| MSV-01 | Gray Pebble Pattern Sheet Vinyl with Yellow Mastic | Bathrooms, Entry Storage, Southeast Rooms | NF | ND | 3 | NIS | NA |
| RS-01 | Roofing Shingles | Roof | NF | ND | 3 | NIS | NA |

Upper Photo: MSV-01-Gray Pebble pattern  
Sheet Vinyl with Yellow Mastic  
Lower Photo: RS-01-Roofing Shingles

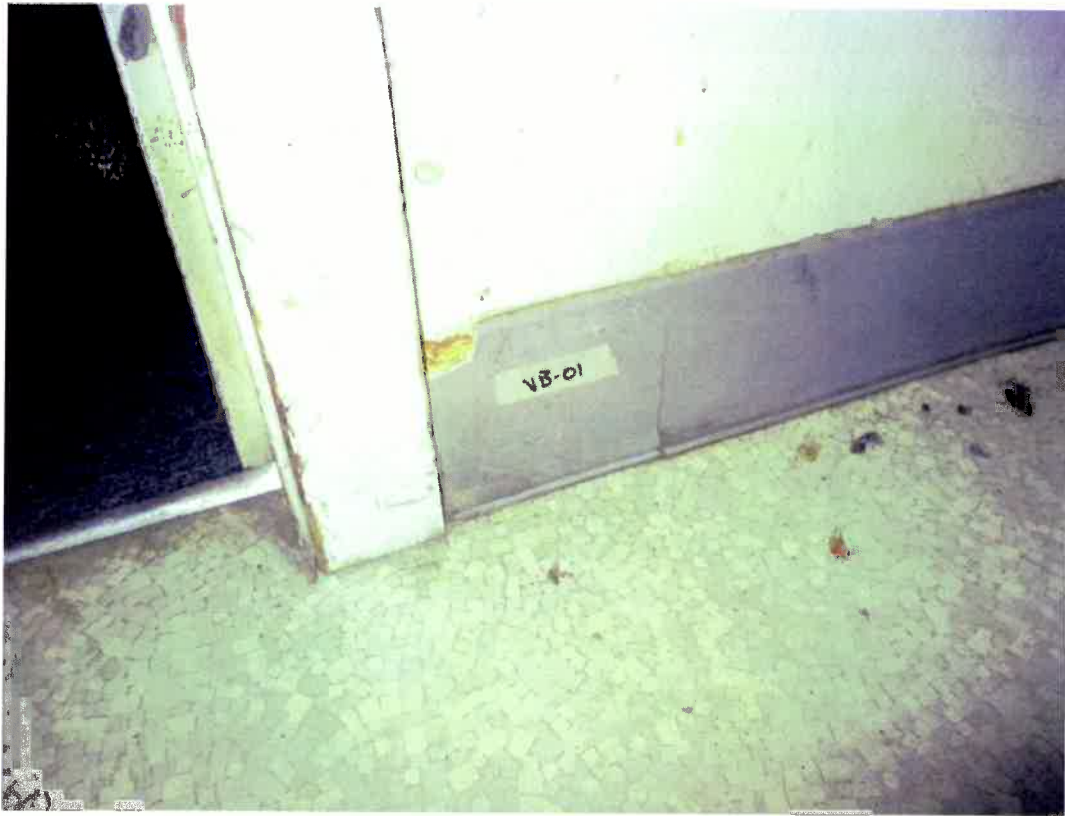
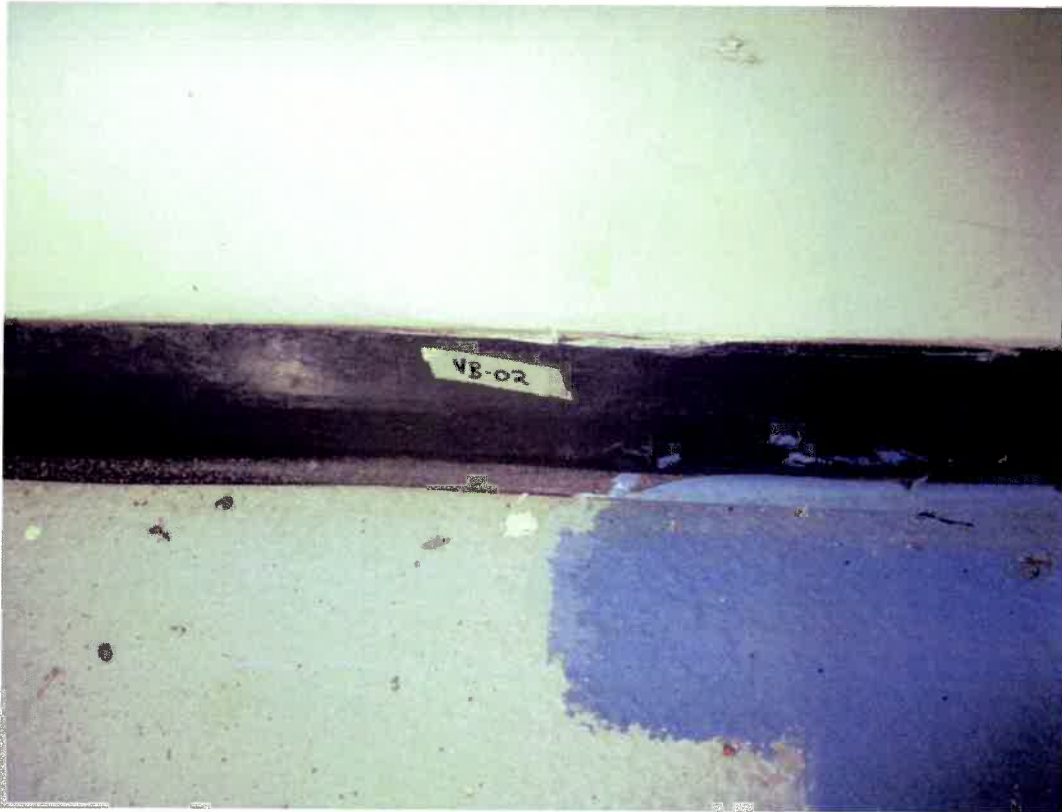
**Photo D-7**

| TABLE 2.2-1: SUMMARY OF HOMOGENEOUS SAMPLING AREAS<br>APALACHICOLA RESEARCH CENTER<br>UNIVERSITY OF FLORIDA – APALACHICOLA, FLORIDA | | | | | | | |
|---|---|---|---|---|---|---|---|
| VB-01 | 4" Gray Cove Base with Tan Mastic | Associated with MSV-01, and in South Center Office | NF | ND | 3 | NIS | NA |

Upper Photo: VB-01-4" Gray Cove Base with Tan Mastic
