**SUMMARY REPORT OF A ROADWAY SOIL SURVEY  
AND PAVEMENT EVALUATION**

**DEVIL'S MILLHOPPER STATE PRESERVE  
ALACHUA COUNTY, FLORIDA**

**GSE PROJECT No. 15981**

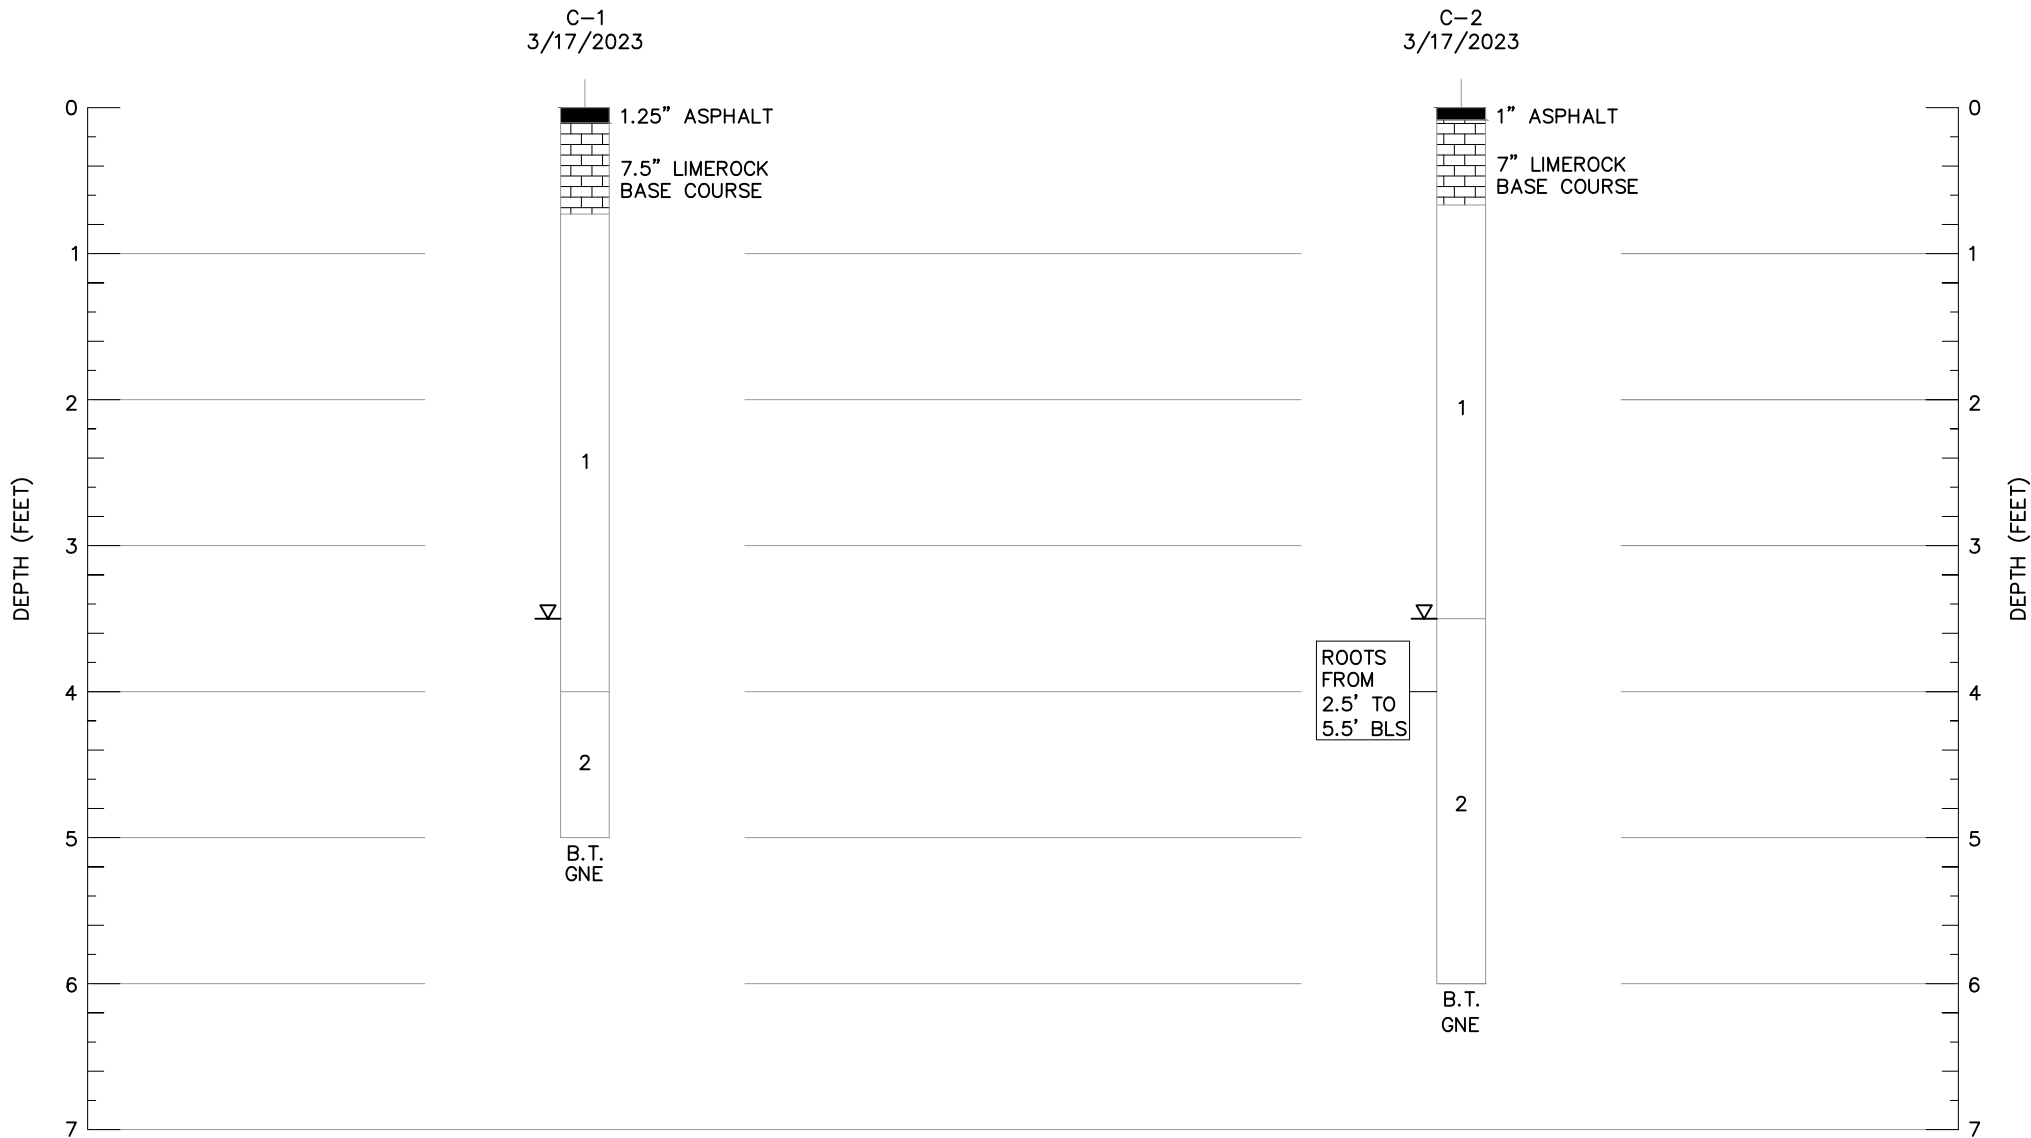
| DATE | DESCRIPTION | DATE | DESCRIPTION | JASON E. GOWLAND P.E. 66467<br>GSE ENGINEERING & CONSULTING, INC.<br>5590 SW 64TH STREET, SUITE B<br>GAINESVILLE, FLORIDA 32608 | GEORGE F. YOUNG, INC. | | | AUGER BORING PROFILES | SHEET<br>NO. |

The auger borings performed in the coring locations indicate the soils across these areas are relatively consistent. The auger borings initially penetrated 3.5 to 4 feet of a near-surface sandy stratum consisting of sand with silt and sand with silt and roots (A-3). This was underlain by silty sand and silty sand with roots (A-2-4) to the explored depths of 5 to 6 feet bls. Auger boring C-2 encountered the roots from 2.5 to 5.5 feet bls.

Roots were encountered at auger boring C-2 at depths of approximately 2.5 to 5.5 feet bls. The roots were abundant in the samples obtained from the augers and could be contributing to the pavement performance at this boring location. GSE did not evaluate the lateral extent of the roots.

5. THE ROOTS AND ORGANIC MATTER ENCOUNTERED SHALL BE REMOVED IN ACCORDANCE WITH INDEX 120-001.

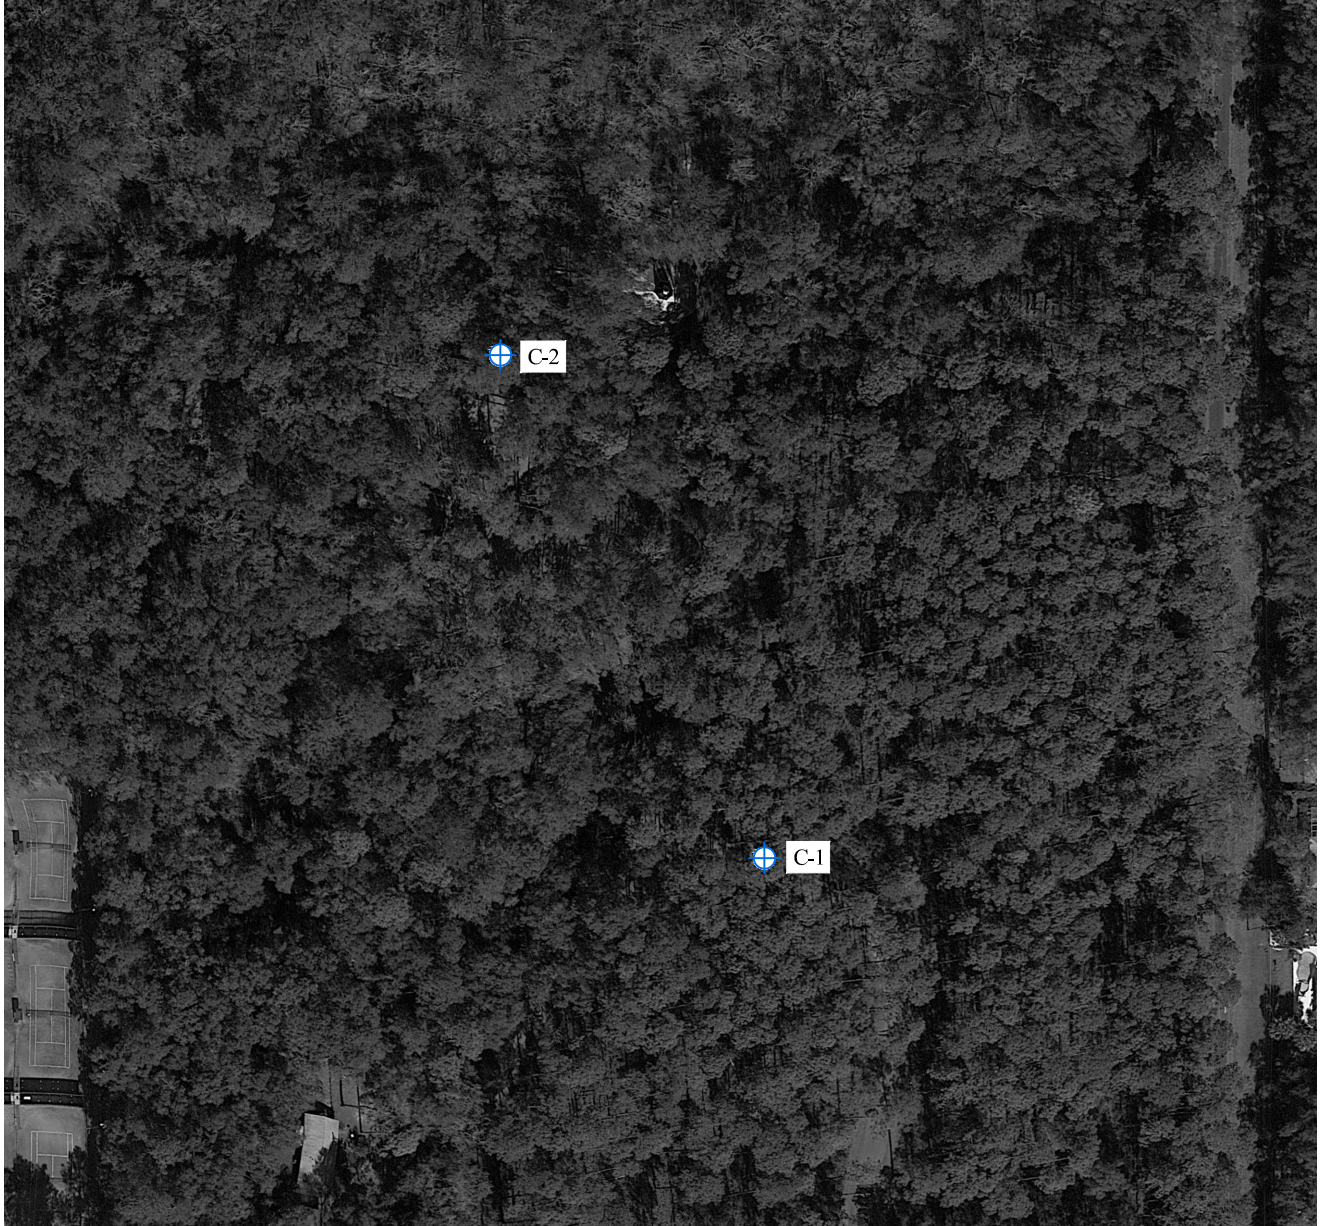
AERIAL PHOTOGRAPH SHOWING APPROXIMATE  
LOCATIONS OF FIELD TESTS

The locations of the asphalt cores and hand auger borings are illustrated on Figure 2. The asphalt cores performed indicate approximately 1 to 1.25 inches of asphalt overlies approximately 7 to 7.5 inches of limerock base course at the time and location of our exploration. The results of the asphalt cores are included in the Table below.
