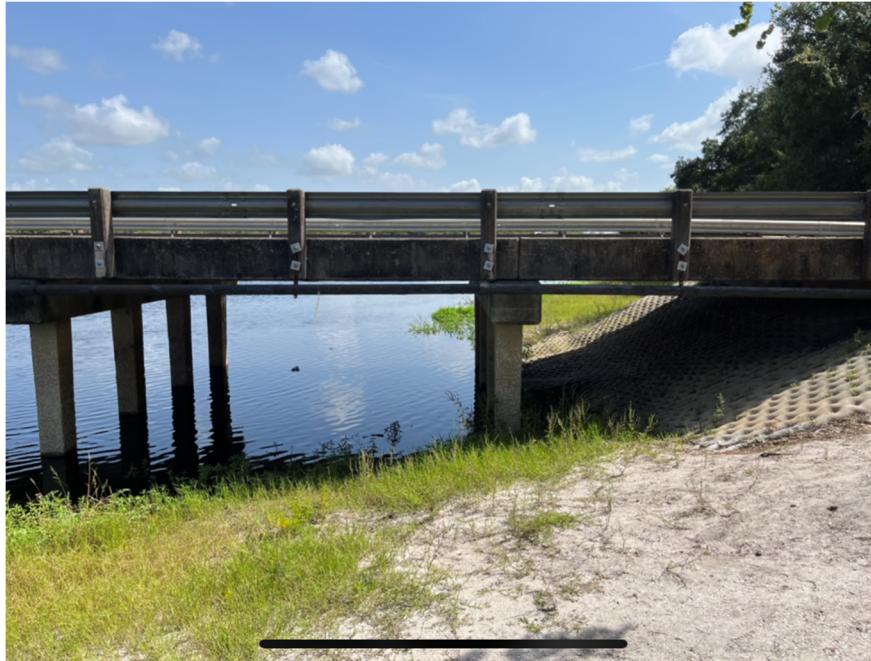
*Figure 1 – Upstream section of abutment of the Myakka State Park bridge at East End Bent..*

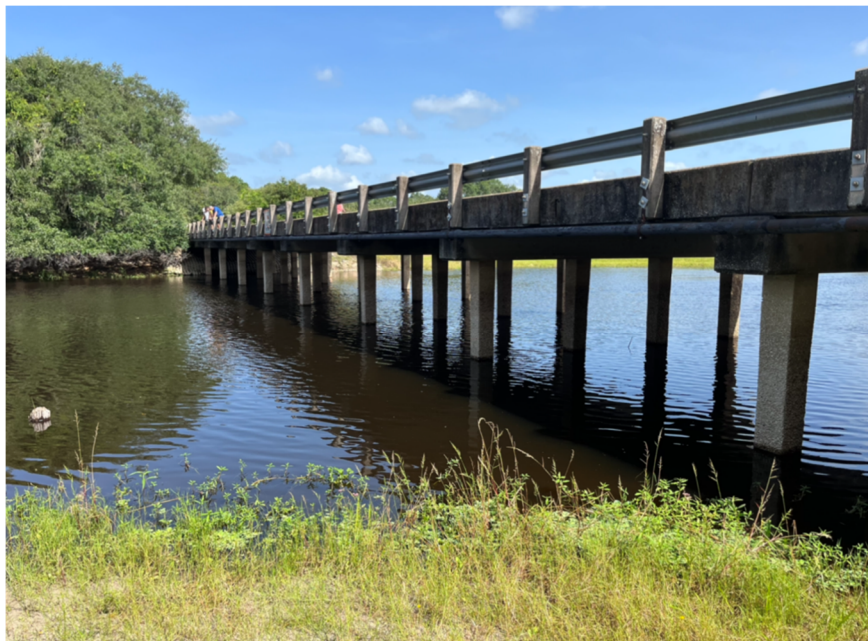
*Figure 2 – View of the upstream section of the Myakka State Park bridge at East End Bent..*

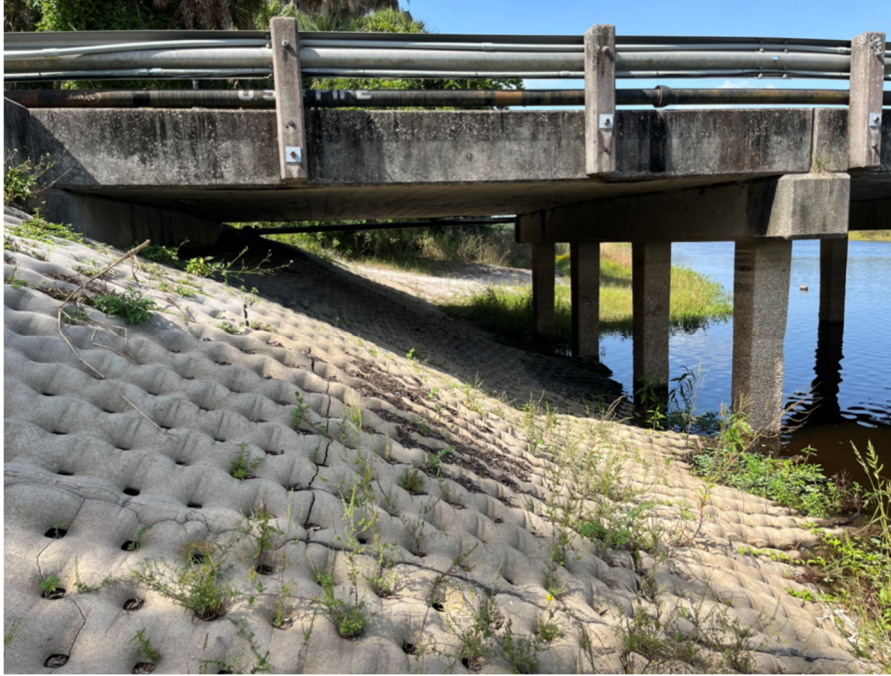
*Figure 3 - Downstream section of East End Bent.*

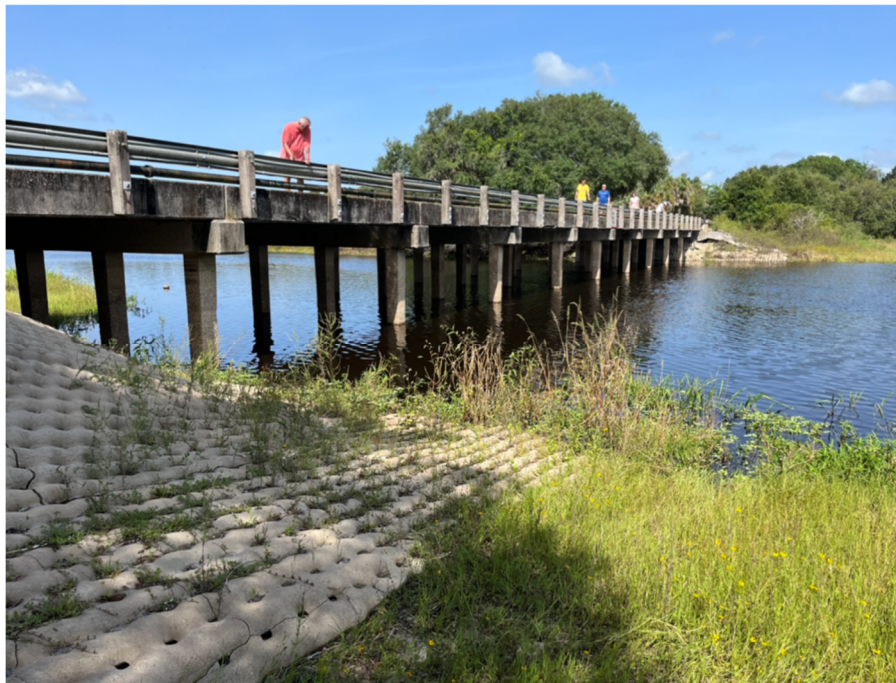
*Figure 4 - View of the downstream section of the Myakka State Park bridge. East end bent in foreground*

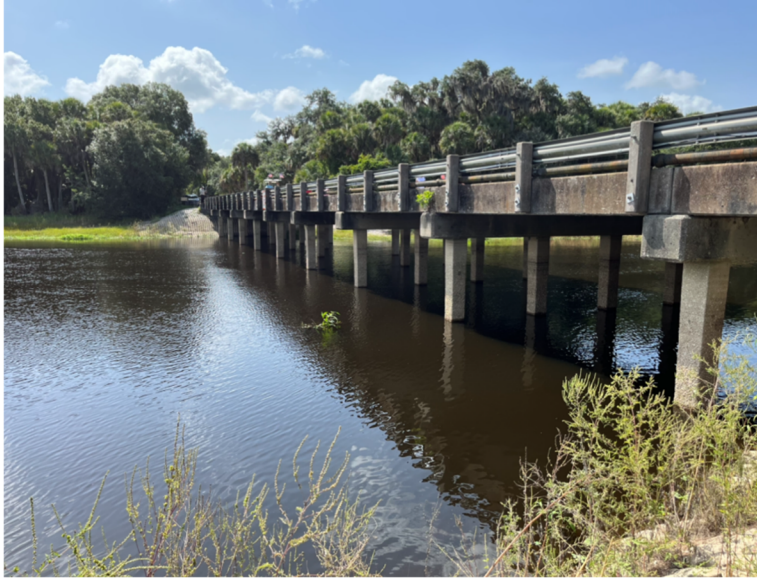
*Figure 5 – Upstream view. West end bent in foreground.*

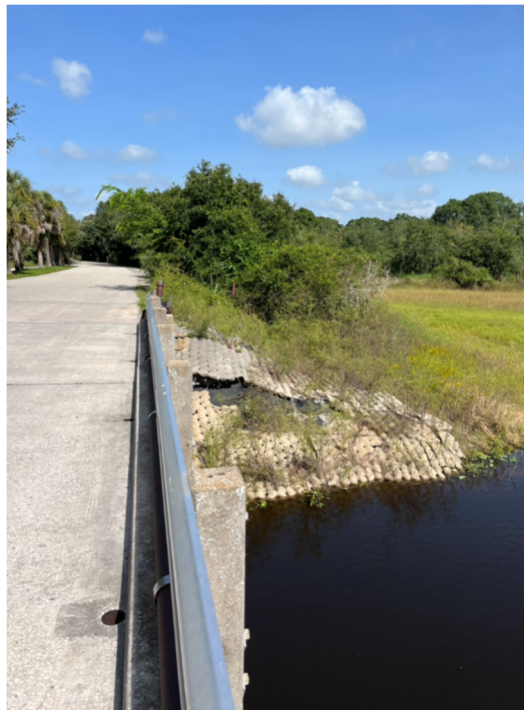
*Figure 6 – Top of rail and bridge slab. Damaged Riprap at West End Bent*

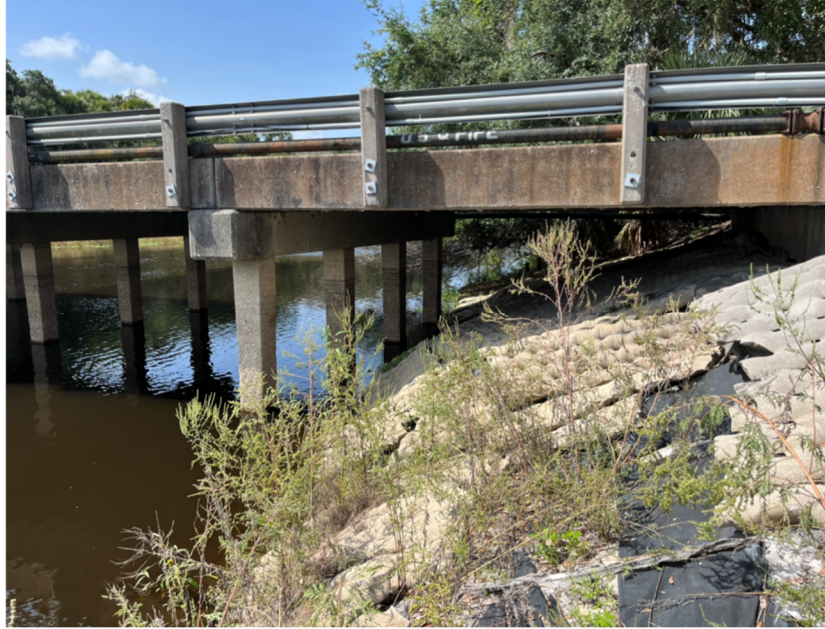
*Figure 7 – Damaged Sand Cement riprap at West End Bent*

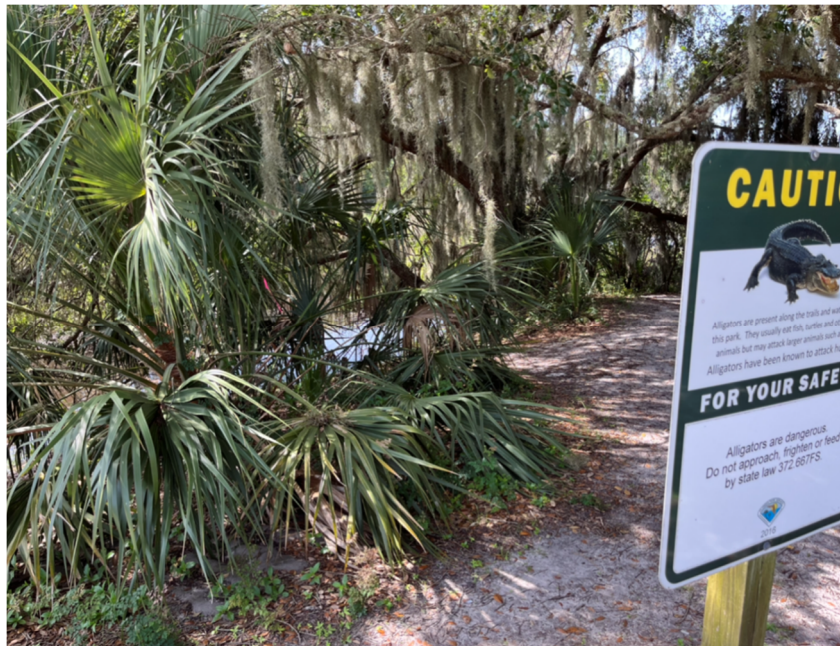
*Figure 8 – Bridge surroundings*

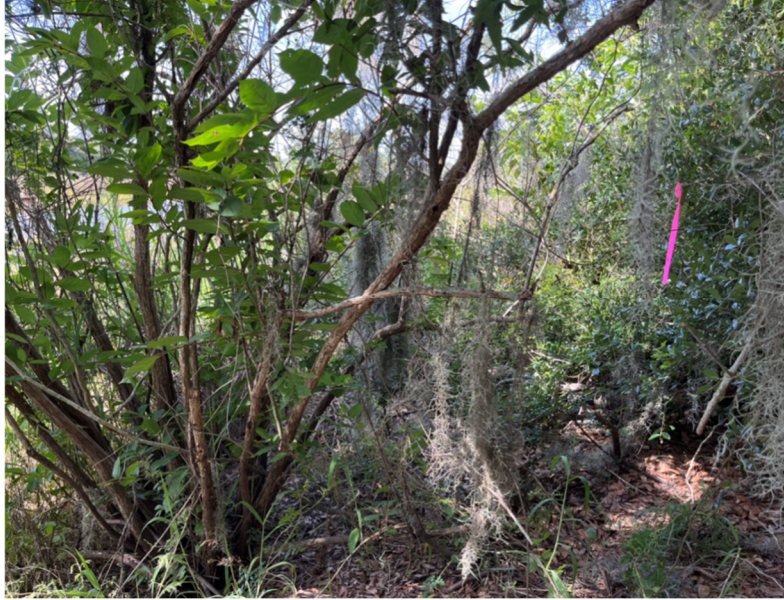
*Figure 9 – Forested overbank area west of the bridge*

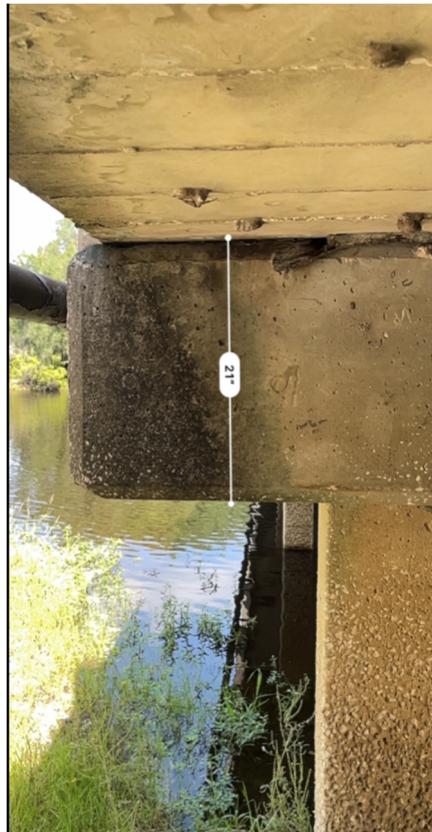
*Figure 10 – Bent dimensions*

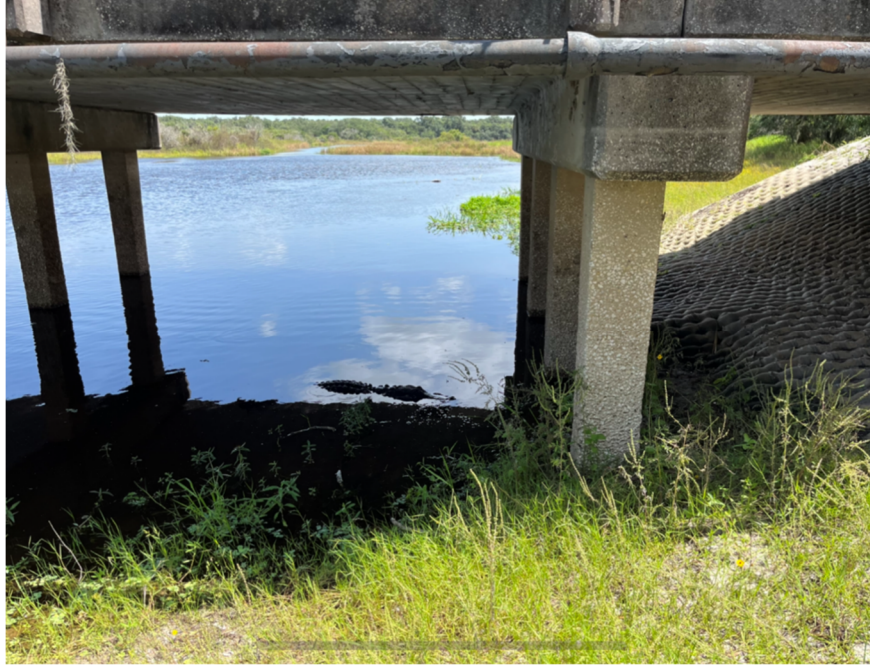
*Figure 11 – View of the bridge's bent and piles.*

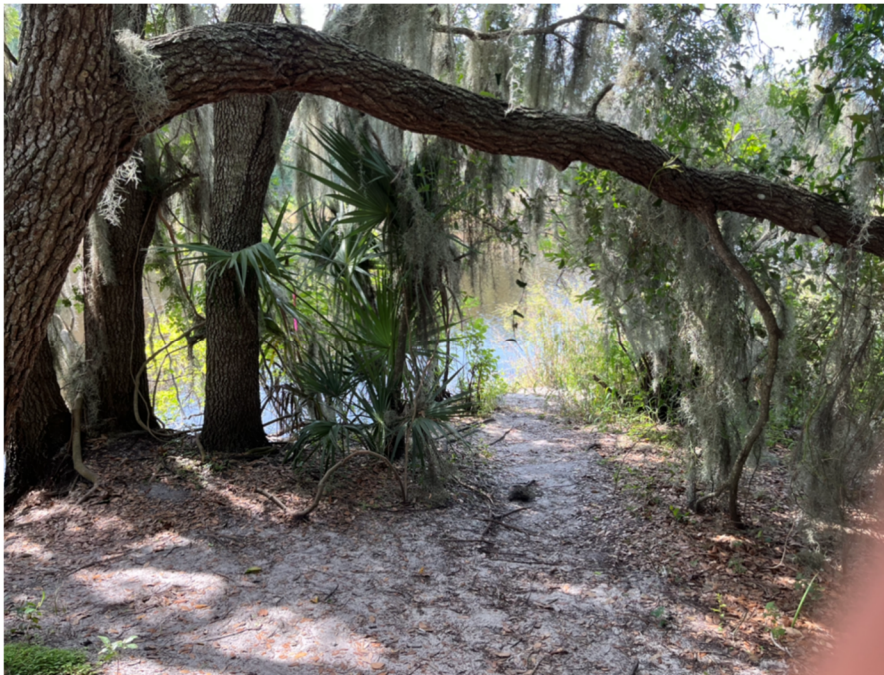
*Figure 12 – Bridge overbank area.*
