# FINAL Preliminary Assessment Report Dade City Readiness Center Dade City, Florida

Perfluorooctanesulfonic Acid (PFOS) and Perfluorooctanoic  
Acid (PFOA) Impacted Sites  
ARNG Installations, Nationwide

August 2020

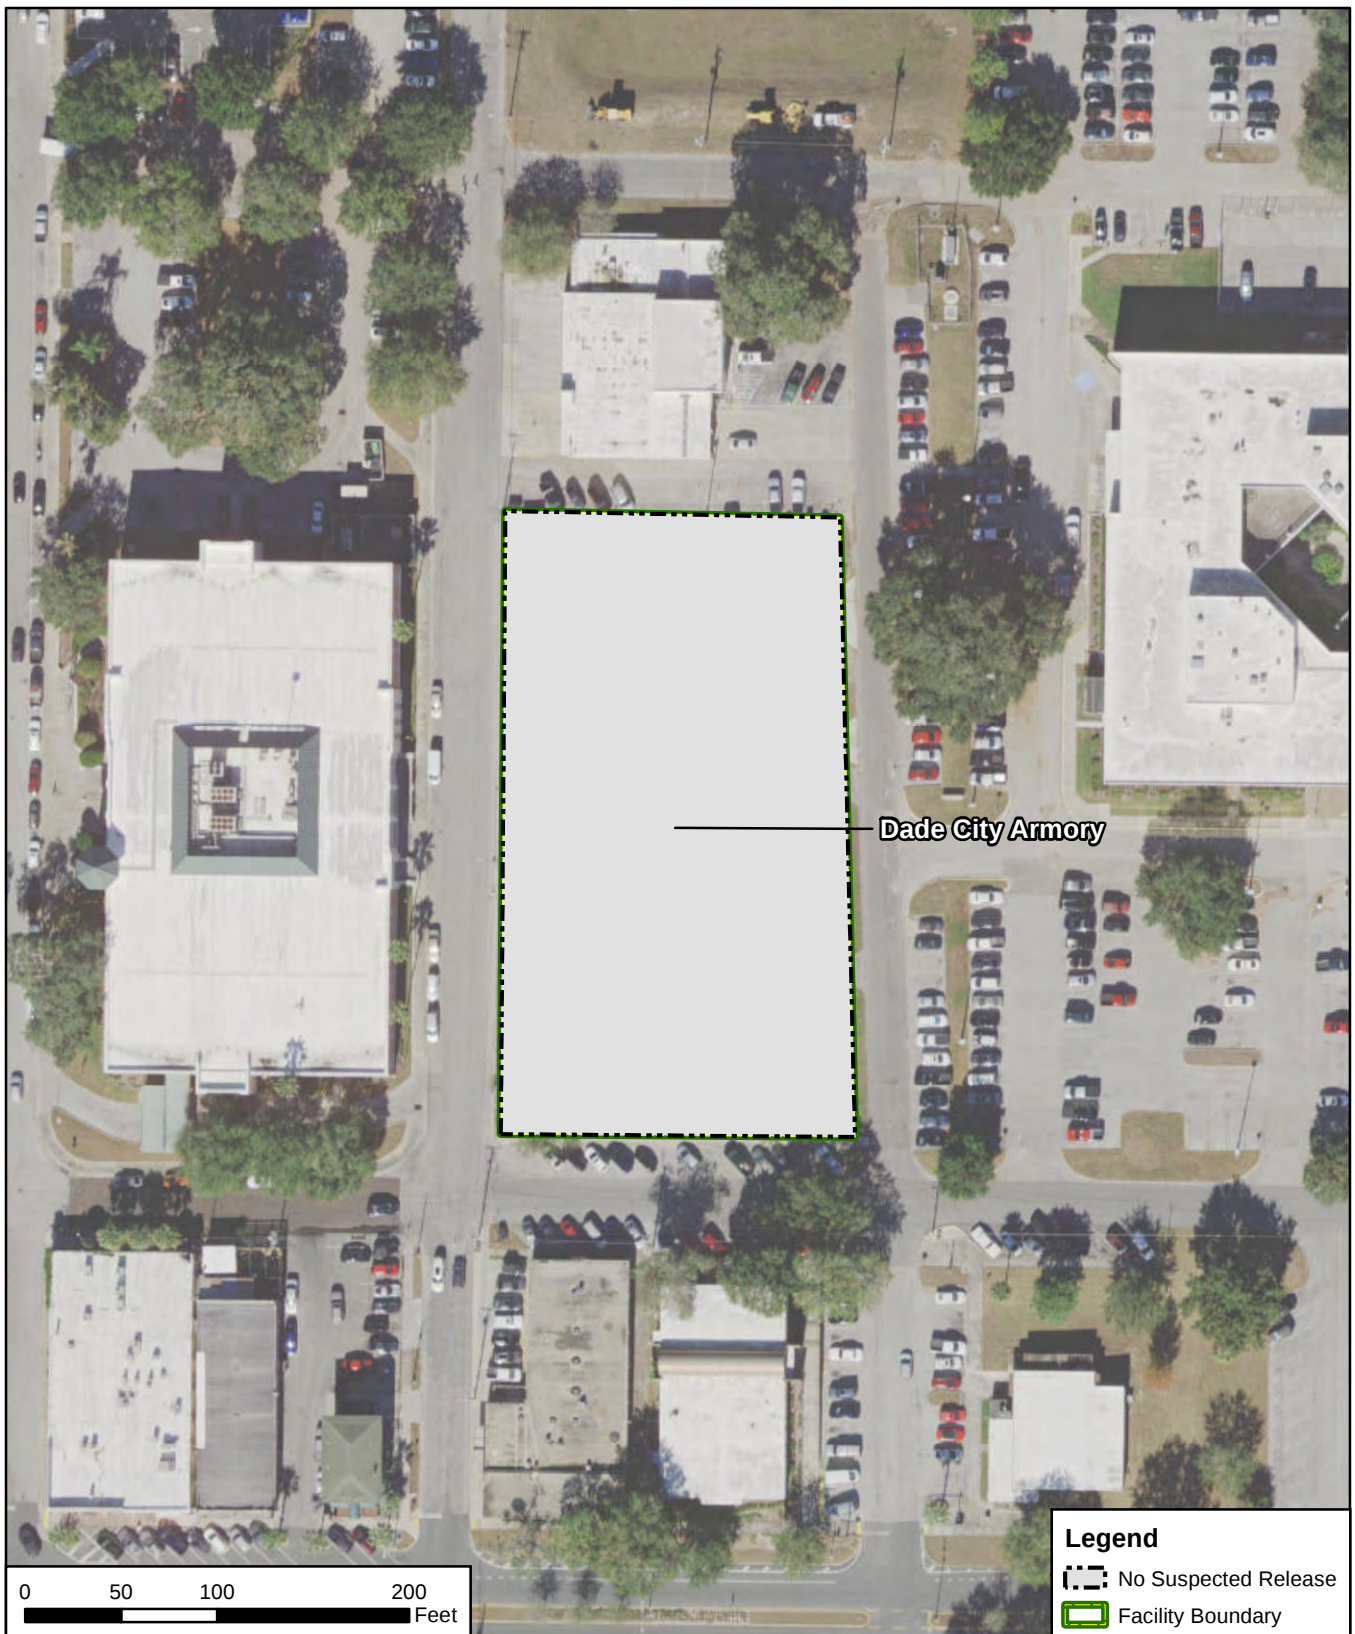
| NOTES Preliminary Assessment for PFAS at Dade City Readiness Center, FL | | | | | <br>12420 Milestone Center Drive<br>Germantown, MD 20876 | Figure ES-1 |

One area, Dade City RC Armory, has been identified as No Suspected Release (**Figure ES-1**). Based on the documented absence (1955-present) of the use or release of PFAS-containing materials at Dade City RC, no areas of interest (AOIs) were identified during the PA. Evidence does not indicate that current or former ARNG activities contributed PFAS contamination to soil, groundwater, surface water, or sediment at the facility or adjacent areas. Dade City RC will not move forward in the Comprehensive Environmental Response, Compensation, and Liability Act (CERCLA) process.

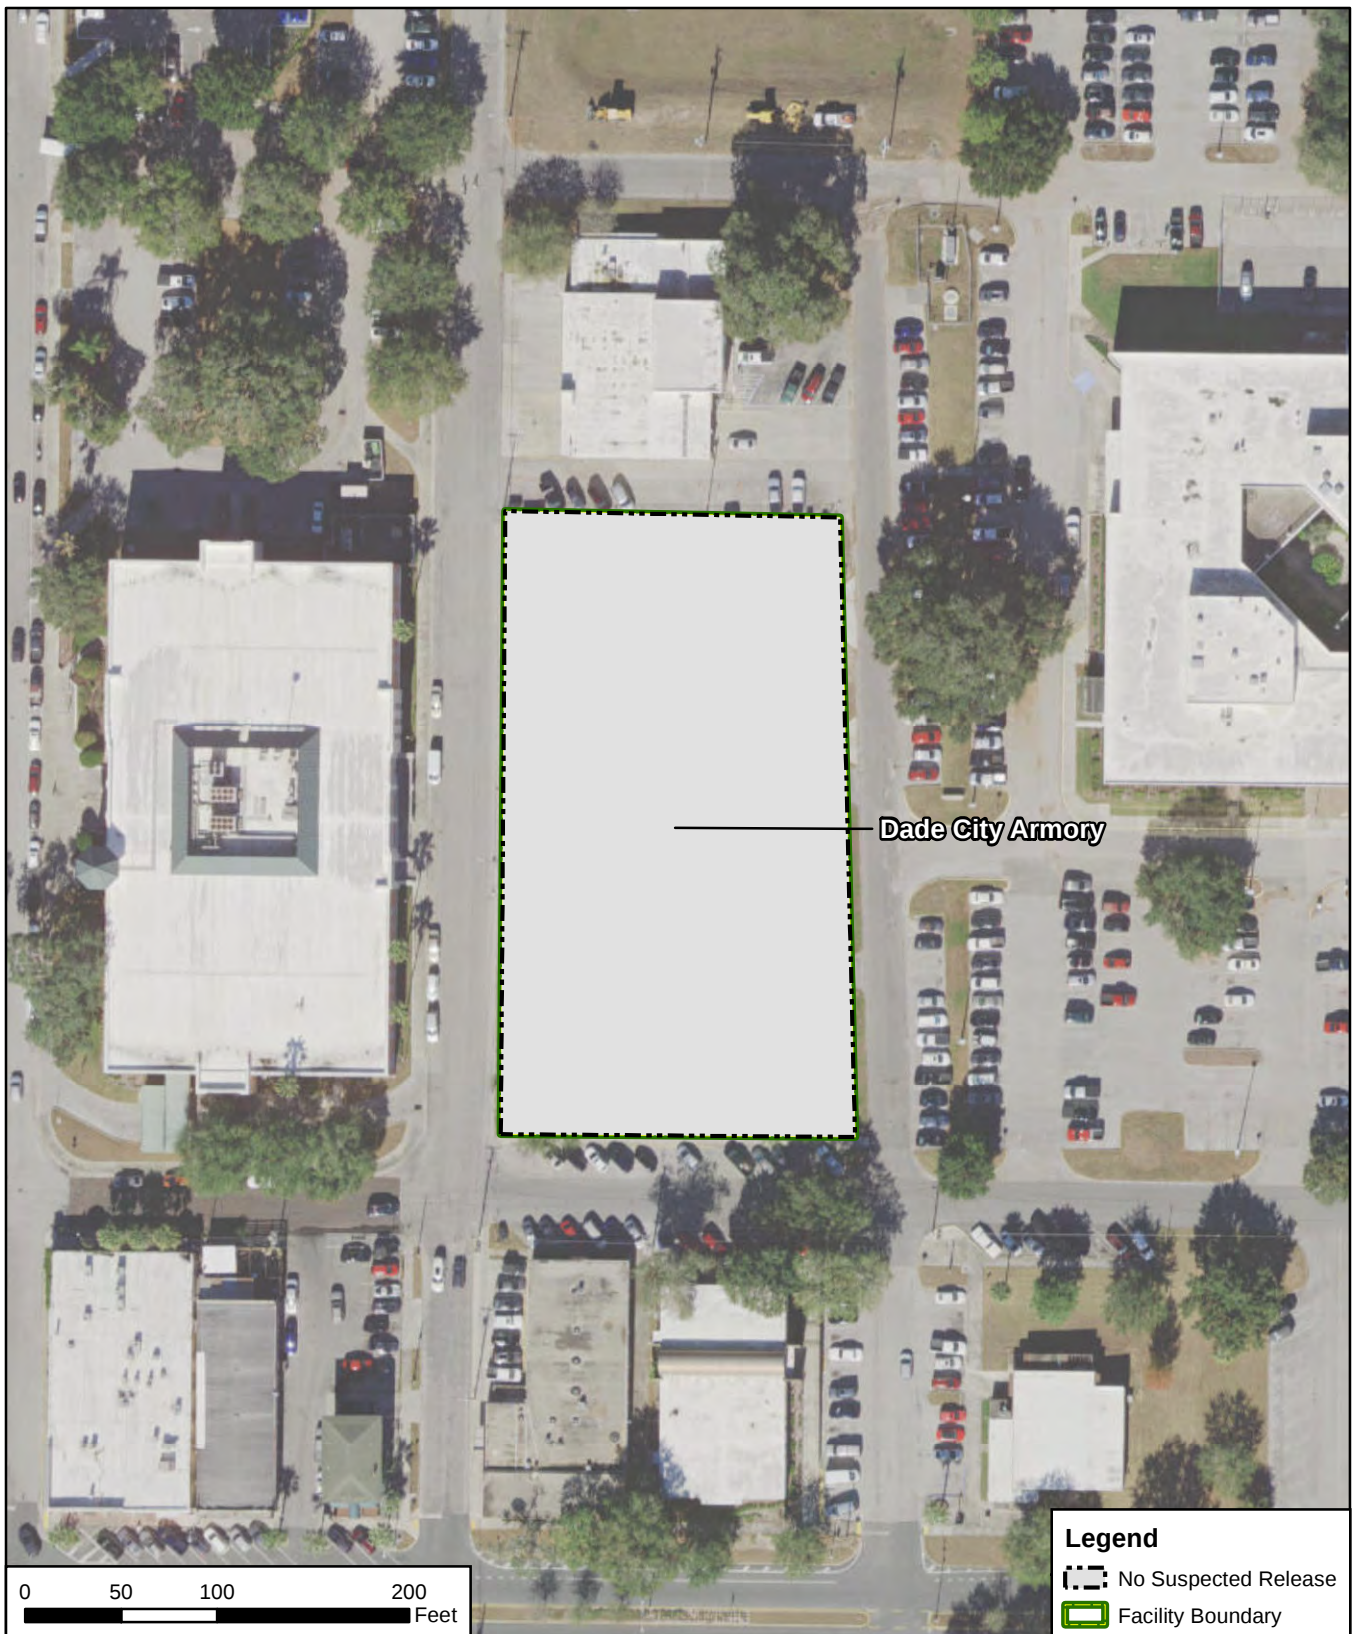
The Armory is located in the center of the facility property (**Figure 3-1**). The geographic coordinates are 28°21'56.59"N; 82°11'13.82"W. The armory is used for drills and is not outfitted with a fire suppression system. During the site visit, ABC Dry chemical extinguishers were found throughout the facility. The kitchen portion of the armory is outfitted with a fire suppression system. At the time of the visit and to interviewee knowledge dating back to 2008, the fire suppression system contained potassium carbonate solution. A potential PFAS release to the environment at the armory is not suspected.

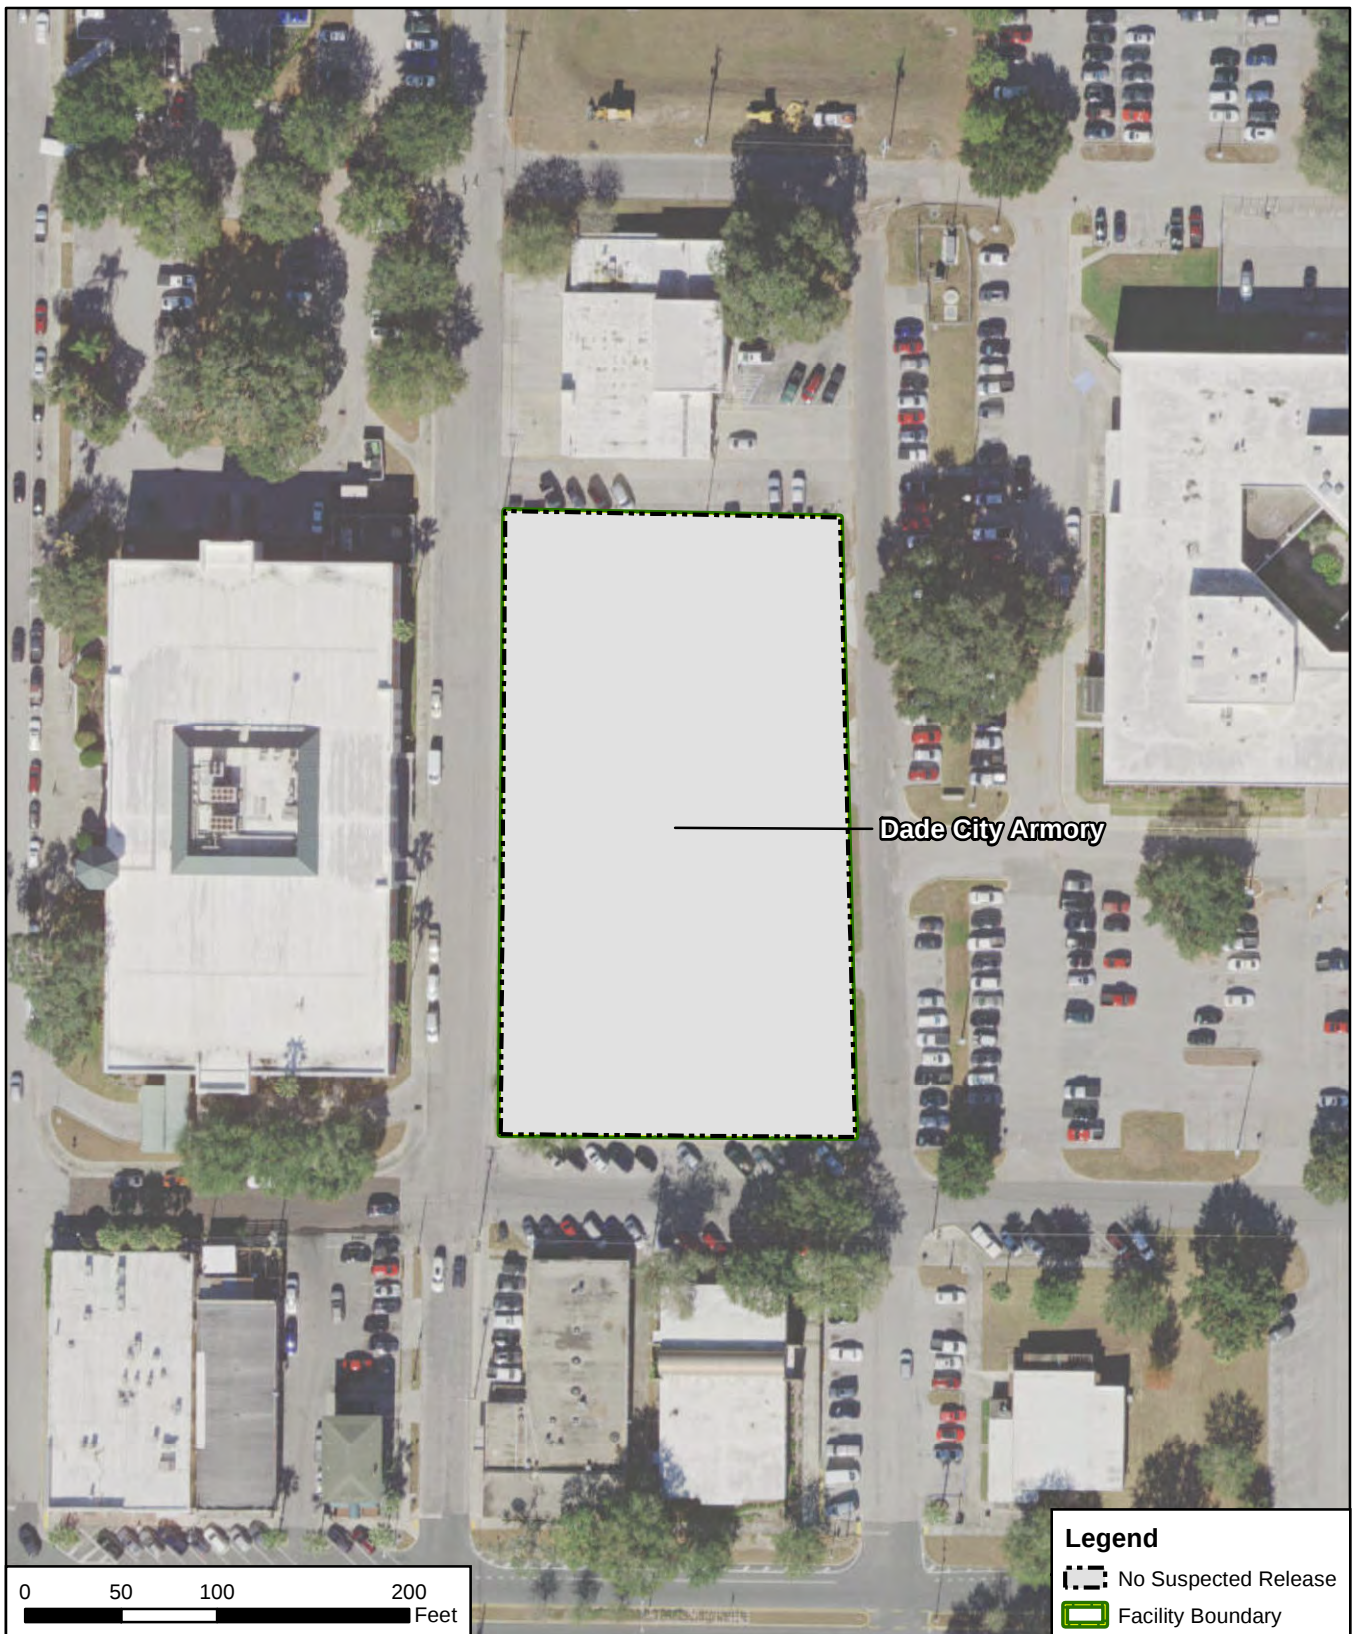
**Figure 7-1**

No PFAS releases relating to current or historical activities at Dade City RC were identified during this PA. The following areas discussed in **Section 3 (Figure 7-1)**, and presented in **Table 7-1** below, were determined to have no suspected release:

| No Suspected Release Area | Used by | Rationale for No Suspected Release Determination |
|---|---|---|
| Armory | FLARNG | Interviewees indicated the fire extinguishers located around the facility have been ABC dry chemical. Fire suppression system installed in the facility kitchen contains potassium carbonate. |

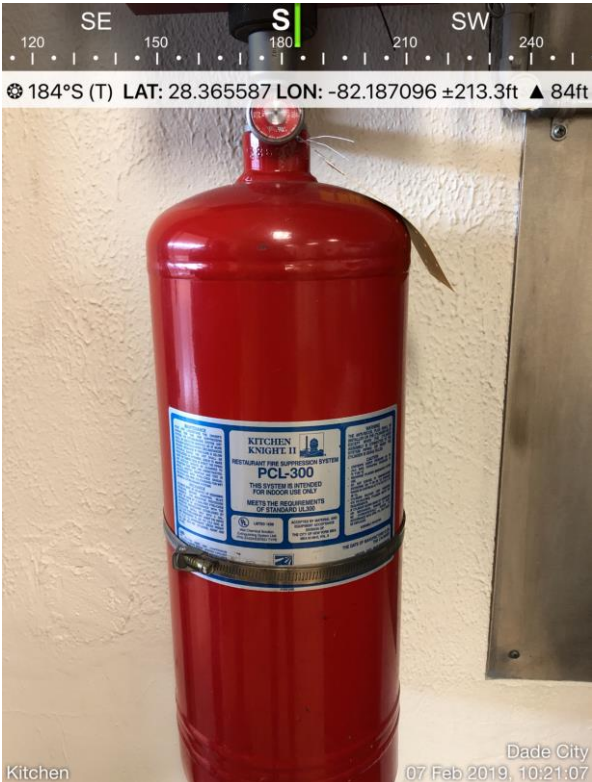
| Army National Guard, Preliminary Assessment for PFAS | Dade City Readiness Center | Dade City, Florida |
|---|---|---|
| <p><b>Photograph No. 1</b></p> <p><b>Date</b> 2/7/2019<br/> <b>Time</b> 10:21</p> <p><b>Description:</b><br/> Facility Kitchen fire suppression system chemical, potassium carbonate solution.</p> <p><b>Orientation:</b><br/> South</p> | <p>SE 120 150 180 S SW 210 240</p> <p>184°S (T) LAT: 28.365587 LON: -82.187096 ±213.3ft ▲ 84ft</p> <p>Kitchen</p> <p>Dade City<br/>07 Feb 2019, 10:21:07</p> | |

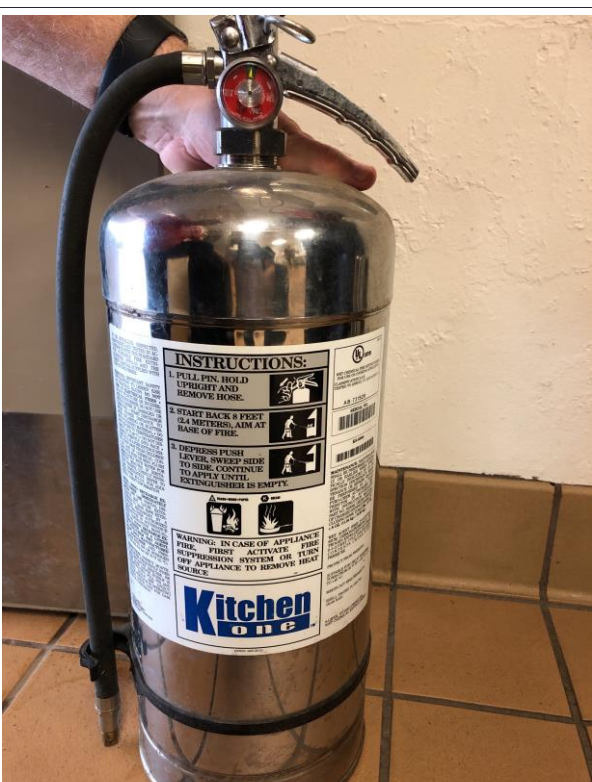
| Army National Guard, Preliminary Assessment for PFAS | Dade City Readiness Center | Dade City, Florida |
|---|---|---|
| <p><b>Photograph No. 2</b></p> <p><b>Date</b> 2/7/2019<br/> <b>Time</b> 10:22</p> <p><b>Description:</b><br/> Facility Kitchen Fire suppression, Potassium carbonate.</p> <p><b>Orientation:</b><br/> South</p> | <p>INSTRUCTIONS:</p> <ol style="list-style-type: none"> <li>1. PULL PIN, HOLD UPRIGHT AND REMOVE HOSE.</li> <li>2. START BACK 8 FEET (2.4 METERS), AIM AT BASE OF FIRE.</li> <li>3. DEPRESS PUSH LEVER, SWEEP SIDE TO SIDE, CONTINUE TO APPLY UNTIL EXTINGUISHER IS EMPTY.</li> </ol> <p>WARNING: IN CASE OF APPLIANCE FIRE, FIRST ACTIVATE FIRE SUPPRESSION SYSTEM OR TURN OFF APPLIANCE TO REMOVE HEAT SOURCE</p> <p>Kitchen</p> | |
