**GROUNDWATER CONTAMINATION AND SINKHOLE COLLAPSE  
INDUCED BY LEAKY IMPOUNDMENTS  
IN SOLUBLE ROCK TERRAIN**

By Thomas J. Aley  
James H. Williams  
James W. Massello

**MISSOURI GEOLOGICAL SURVEY AND WATER RESOURCES**

*Aley, Thomas J., James H. Williams and James W. Massello, 1972, Groundwater contamination and sinkhole collapse induced by leaky impoundments in soluble rock terrain: Mo. Geol. Survey and Water Resources, Engineering Geology Series No. 5, 40 p., 10 figs., 1 tbl.*

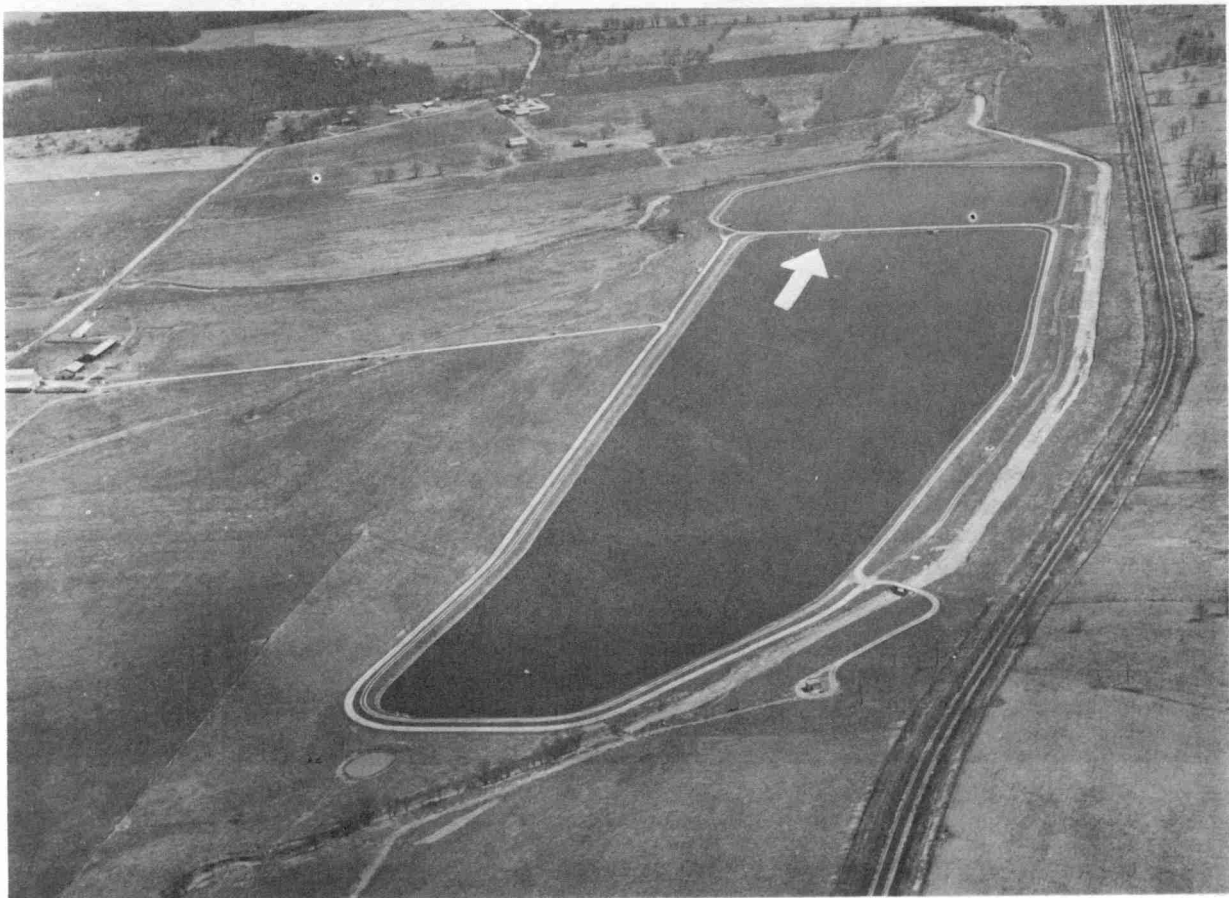
Figure 2

Collapse within sewage lagoons has also occurred at West Plains, Howell County, Missouri (fig. 2). The

Aerial view of the West Plains sewage lagoon as it appeared in 1971. The area which collapsed in 1966 is shown by the arrow. Photo by Jerry D. Vineyard.

The 1966 collapse at the West Plains lagoon was about 34 feet in diameter, and probably 10 to 20 feet deep. This hole was filled with clay and bentonite to the level of the dike wall and the lagoon was returned to use. Mr. Renfrow, formerly Assistant City Engineer of West Plains, reported that he walked about 4 miles of the Howell Creek channel below the lagoon collapse, but found no evidence of lagoon water. There were no reports of well contamination

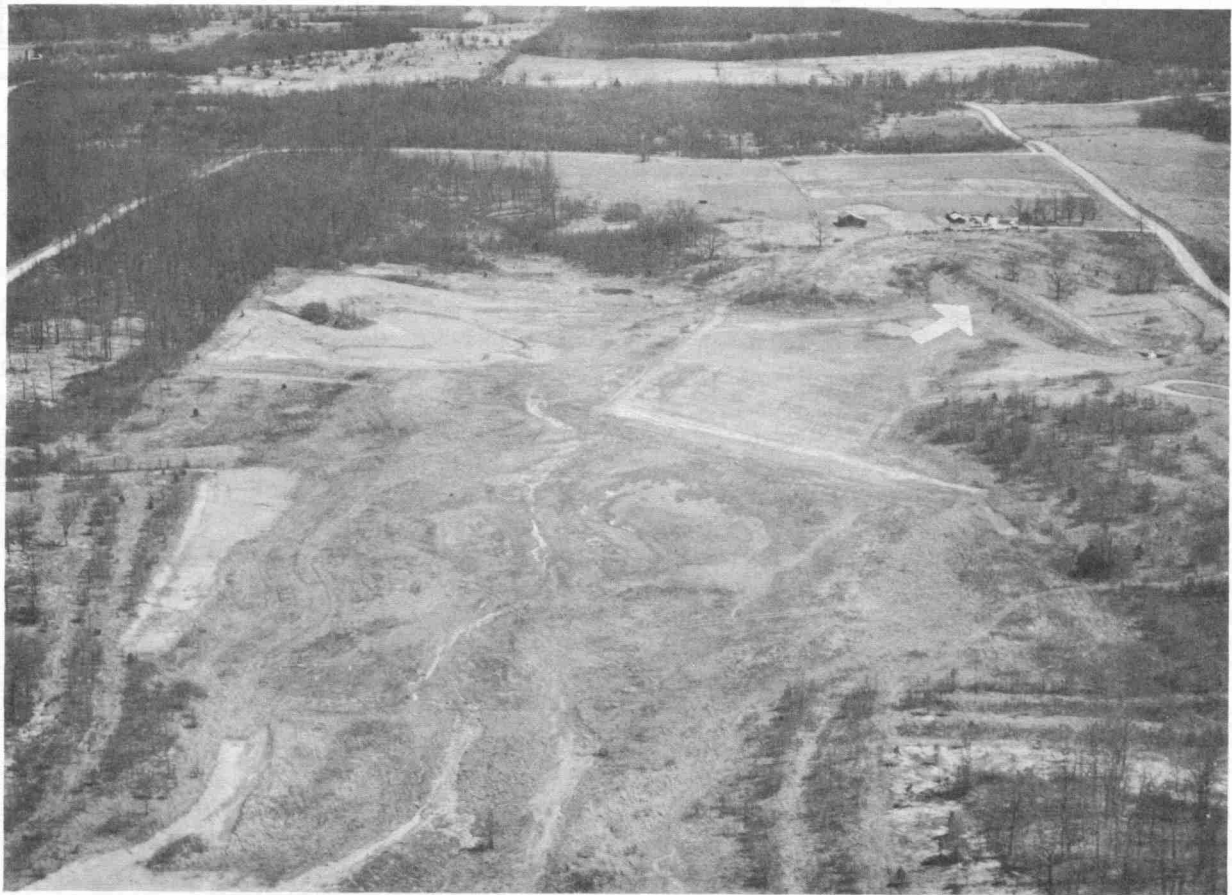
Figure 4

impoundment held a substantial volume of water. Unfortunately, a sinkhole suddenly formed in the floor of the impoundment and drained all the water from the reservoir. Substantial efforts were made to stop the leakage, but they have failed. Personnel of the Missouri Geological Survey report seeing flows of 10 cubic feet per second disappearing underground within the impoundment area.

Aerial view of a portion of the planned impoundment area of the Dean W. Davis Reservoir near Pomona. The arrow indicates the dam. A catastrophic sink formed within 75 yards of the dam and totally drained the impoundment overnight. Extensive attempts to seal the impoundment were unsuccessful. Photo by Jerry D. Vineyard.

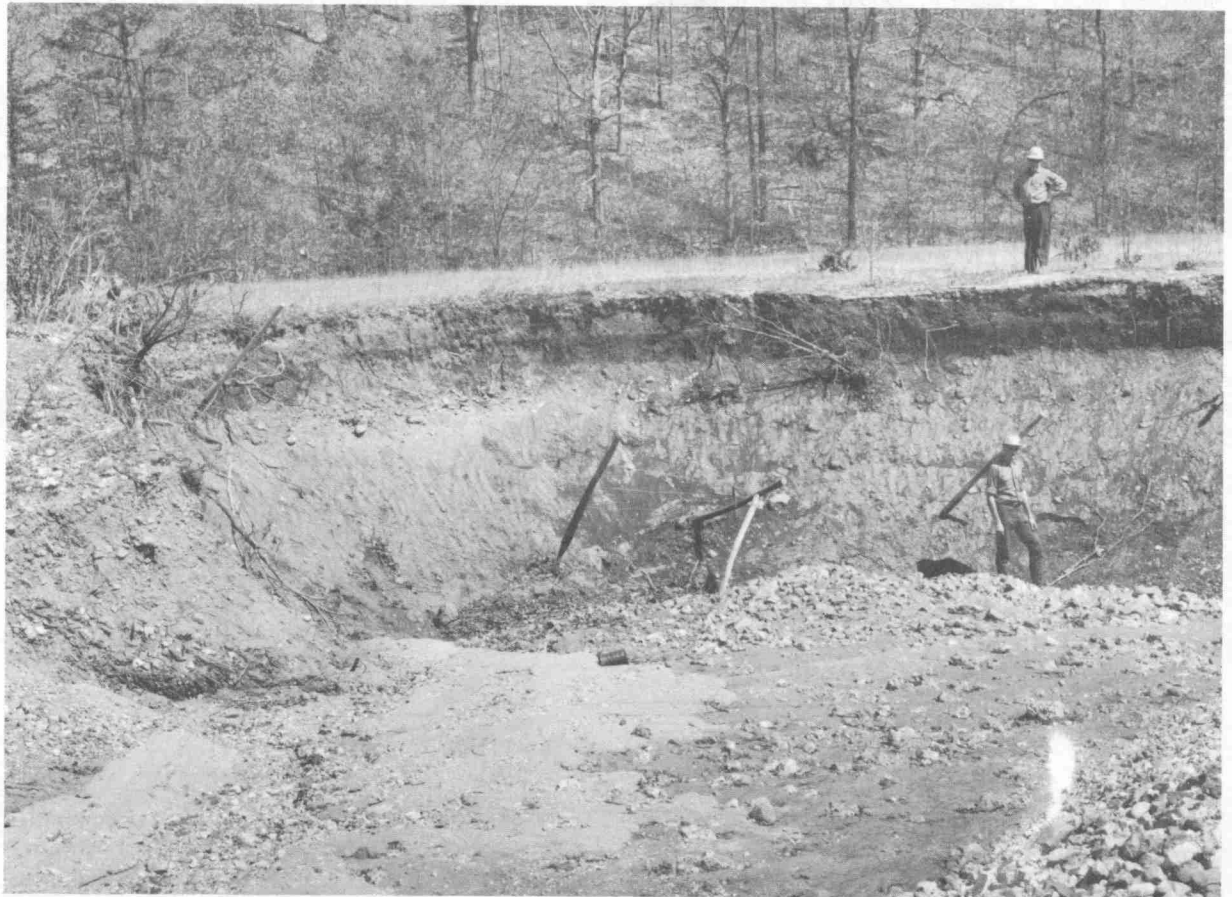
**Figure 8**

The sink was visited about two weeks after it formed, and at that time it was about 25 feet in diameter, 60 feet deep, and nearly cylindrical in shape. By 1968 (fig. 8) stream gravels had nearly filled the sink; in a few years most, if not all, of the topographic expression of the sink will have disappeared.

Sycamore Creek Sink two years after its formation. The sinkhole has been nearly filled with sand and gravel transported by Sycamore Creek. Photo by James W. Massello.
