**Merritts Mill Pond Arsenic Study  
Marianna, Jackson County, Florida  
Preliminary Contamination Assessment Report**

**SIS Report Number 2005-03  
Issued June 2005**

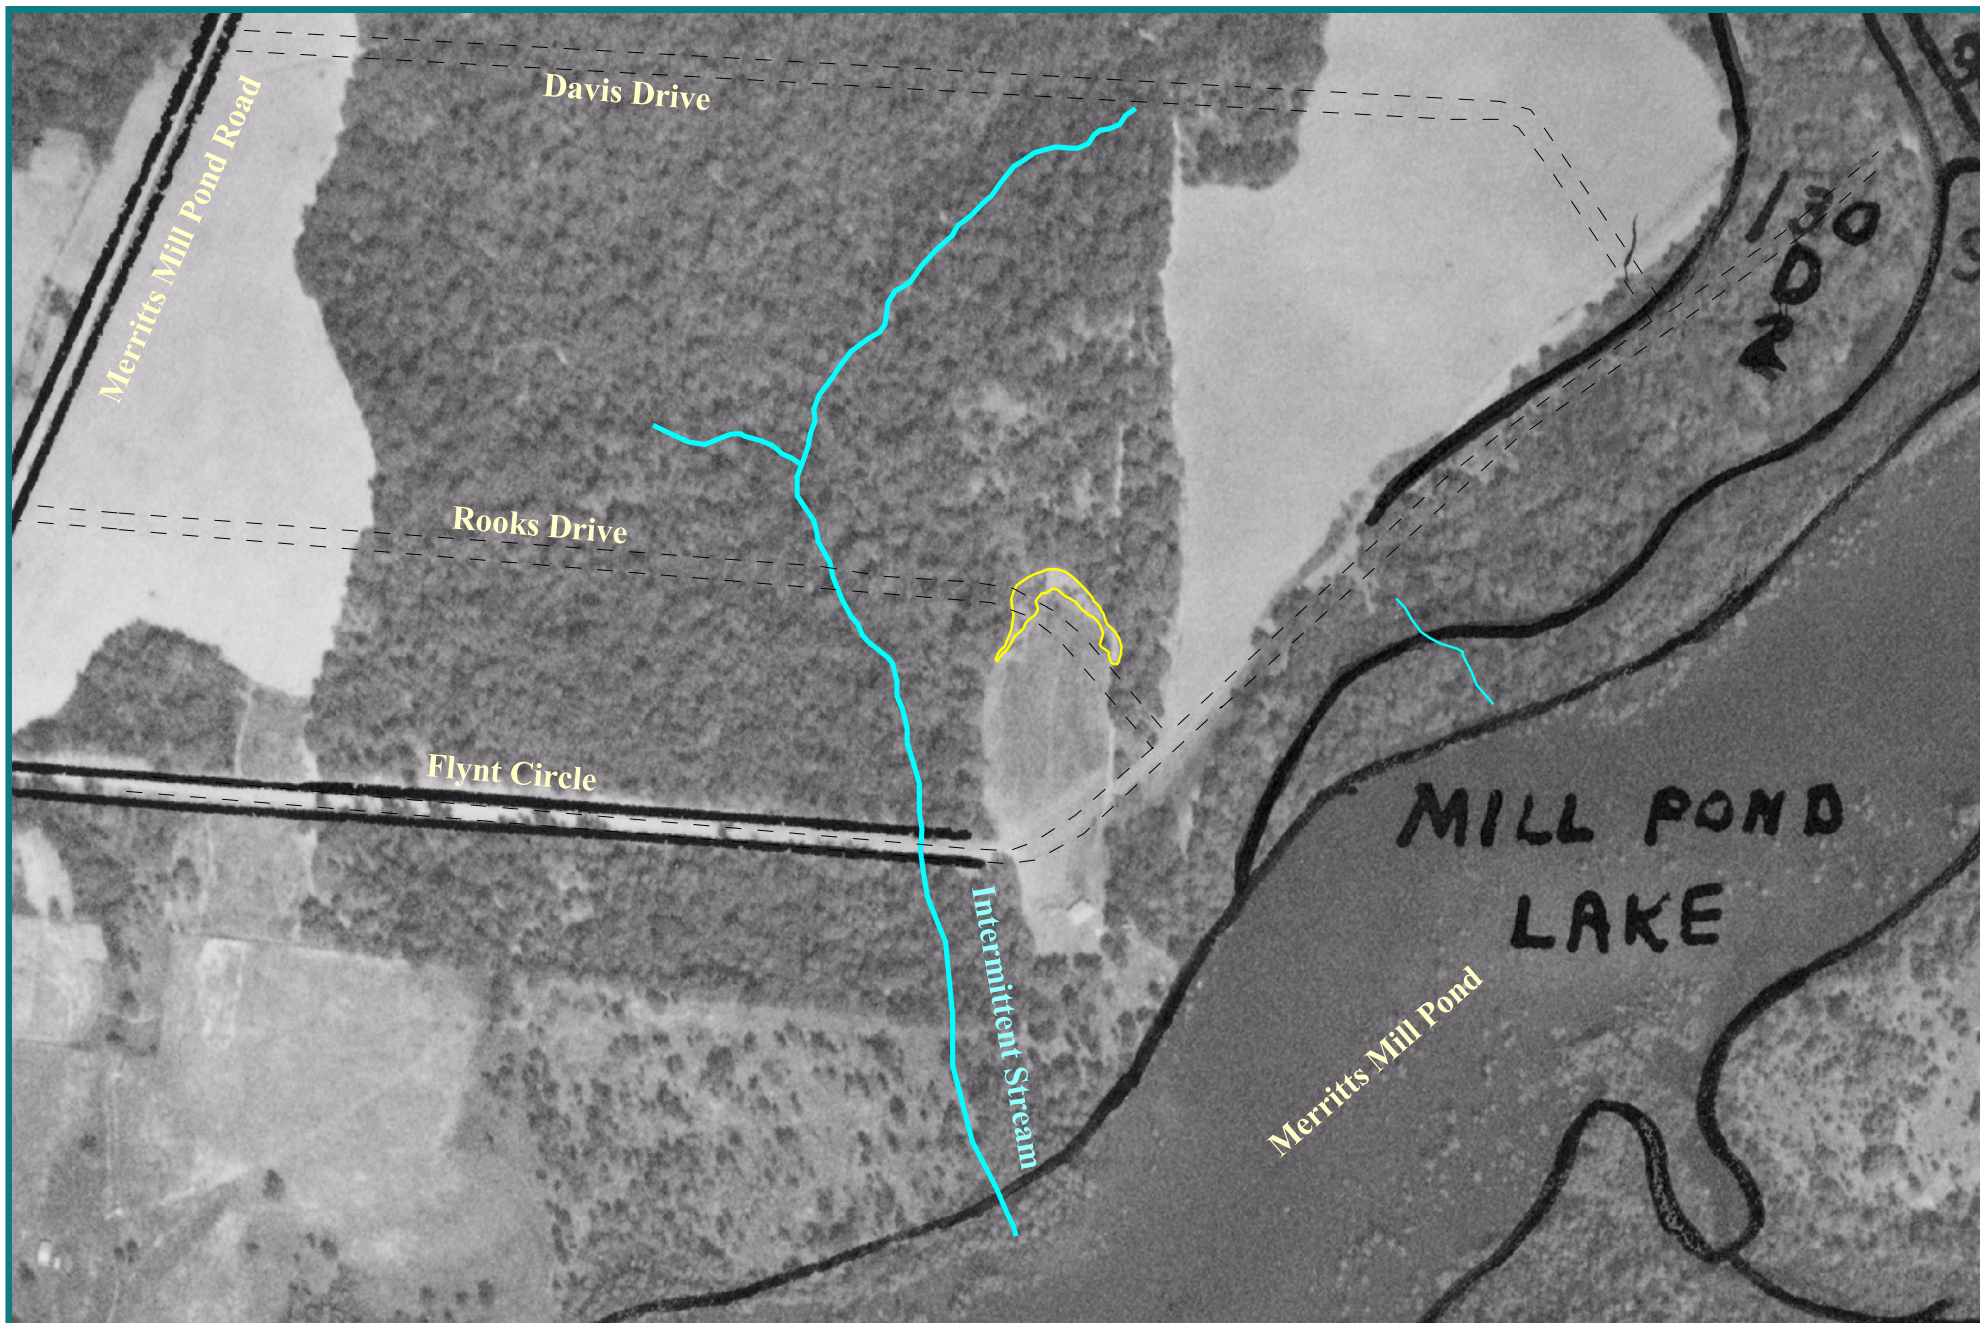
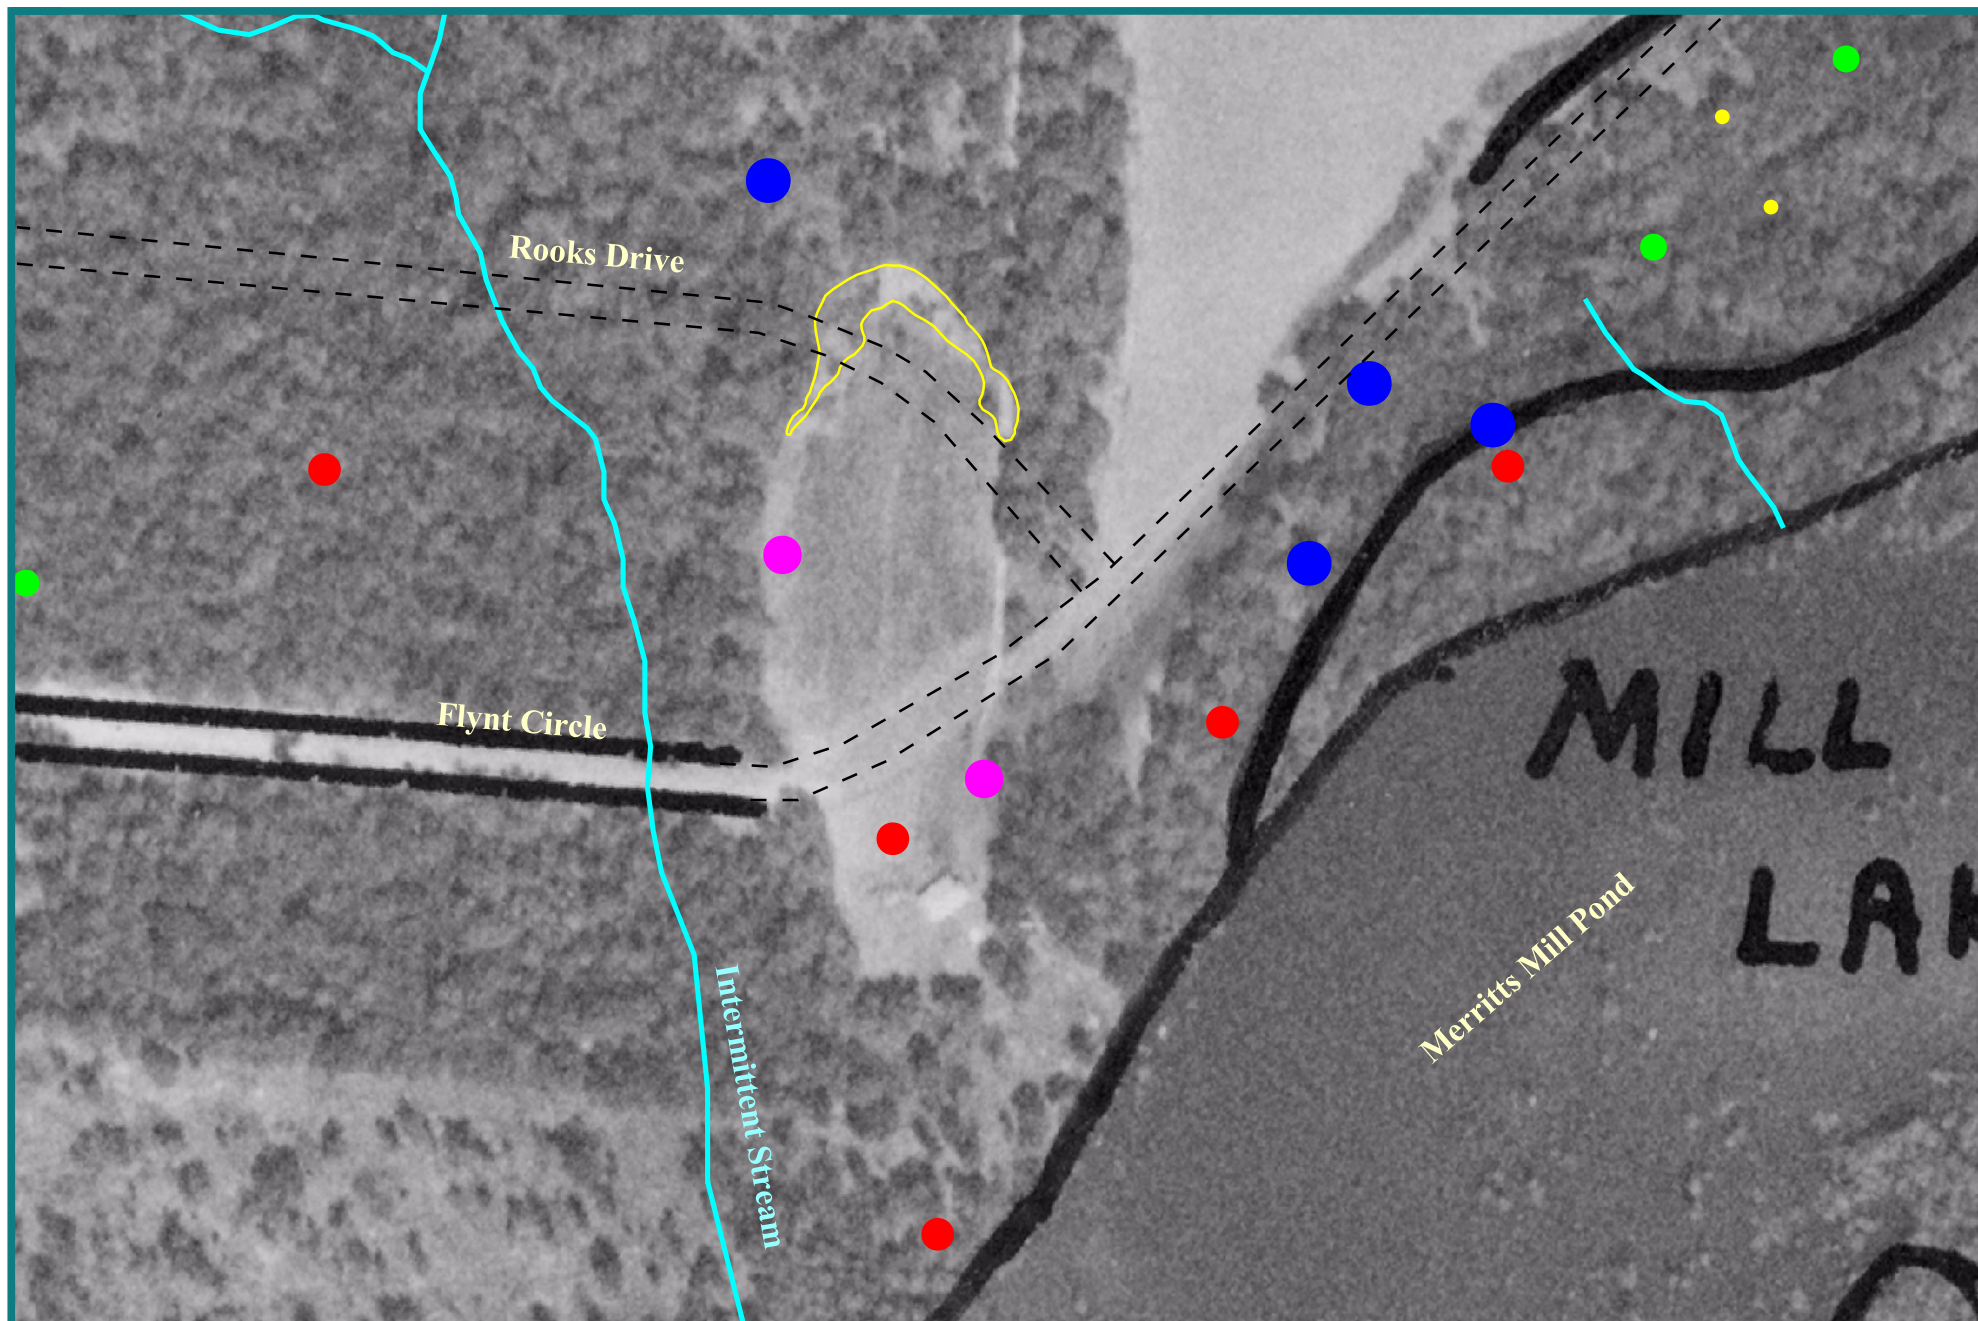
**Figure 8**  
**Location of 1955 Fill Area**  
**Merritts Mill Pond Arsenic Study**  
**Marianna, Jackson County, Florida**

Soil sample locations Soil 44 through 65 were collected within an area identified from a 1955 United States Soil Conservation Service aerial photograph (Figures 8 and 9) as a potential fill area. This area of concern is centrally located between the four supply wells reported to have the highest levels of arsenic. The soil sample locations were positioned on a grid with twenty-foot centers as best allowed for by site conditions (Figure 10 and Table 3). Several trees were located within the grid and a septic drain field was located along its northern periphery. The samples were collected from a four-foot long core barrel that was driven six feet into the substrate by the SIS direct push rig. The core itself was collected within a PVC liner positioned within the core barrel. Once the core was brought to the surface, the liner was removed from the barrel and then sliced open to reveal the sample matrix. Samples were stored on ice and delivered under chain-of-custody to the FDEP Central Laboratory for EPA Method 6020 (arsenic and lead) analyses. EPA Method 200.8 (arsenic and lead) was utilized for equipment rinsate blank sample analyses.

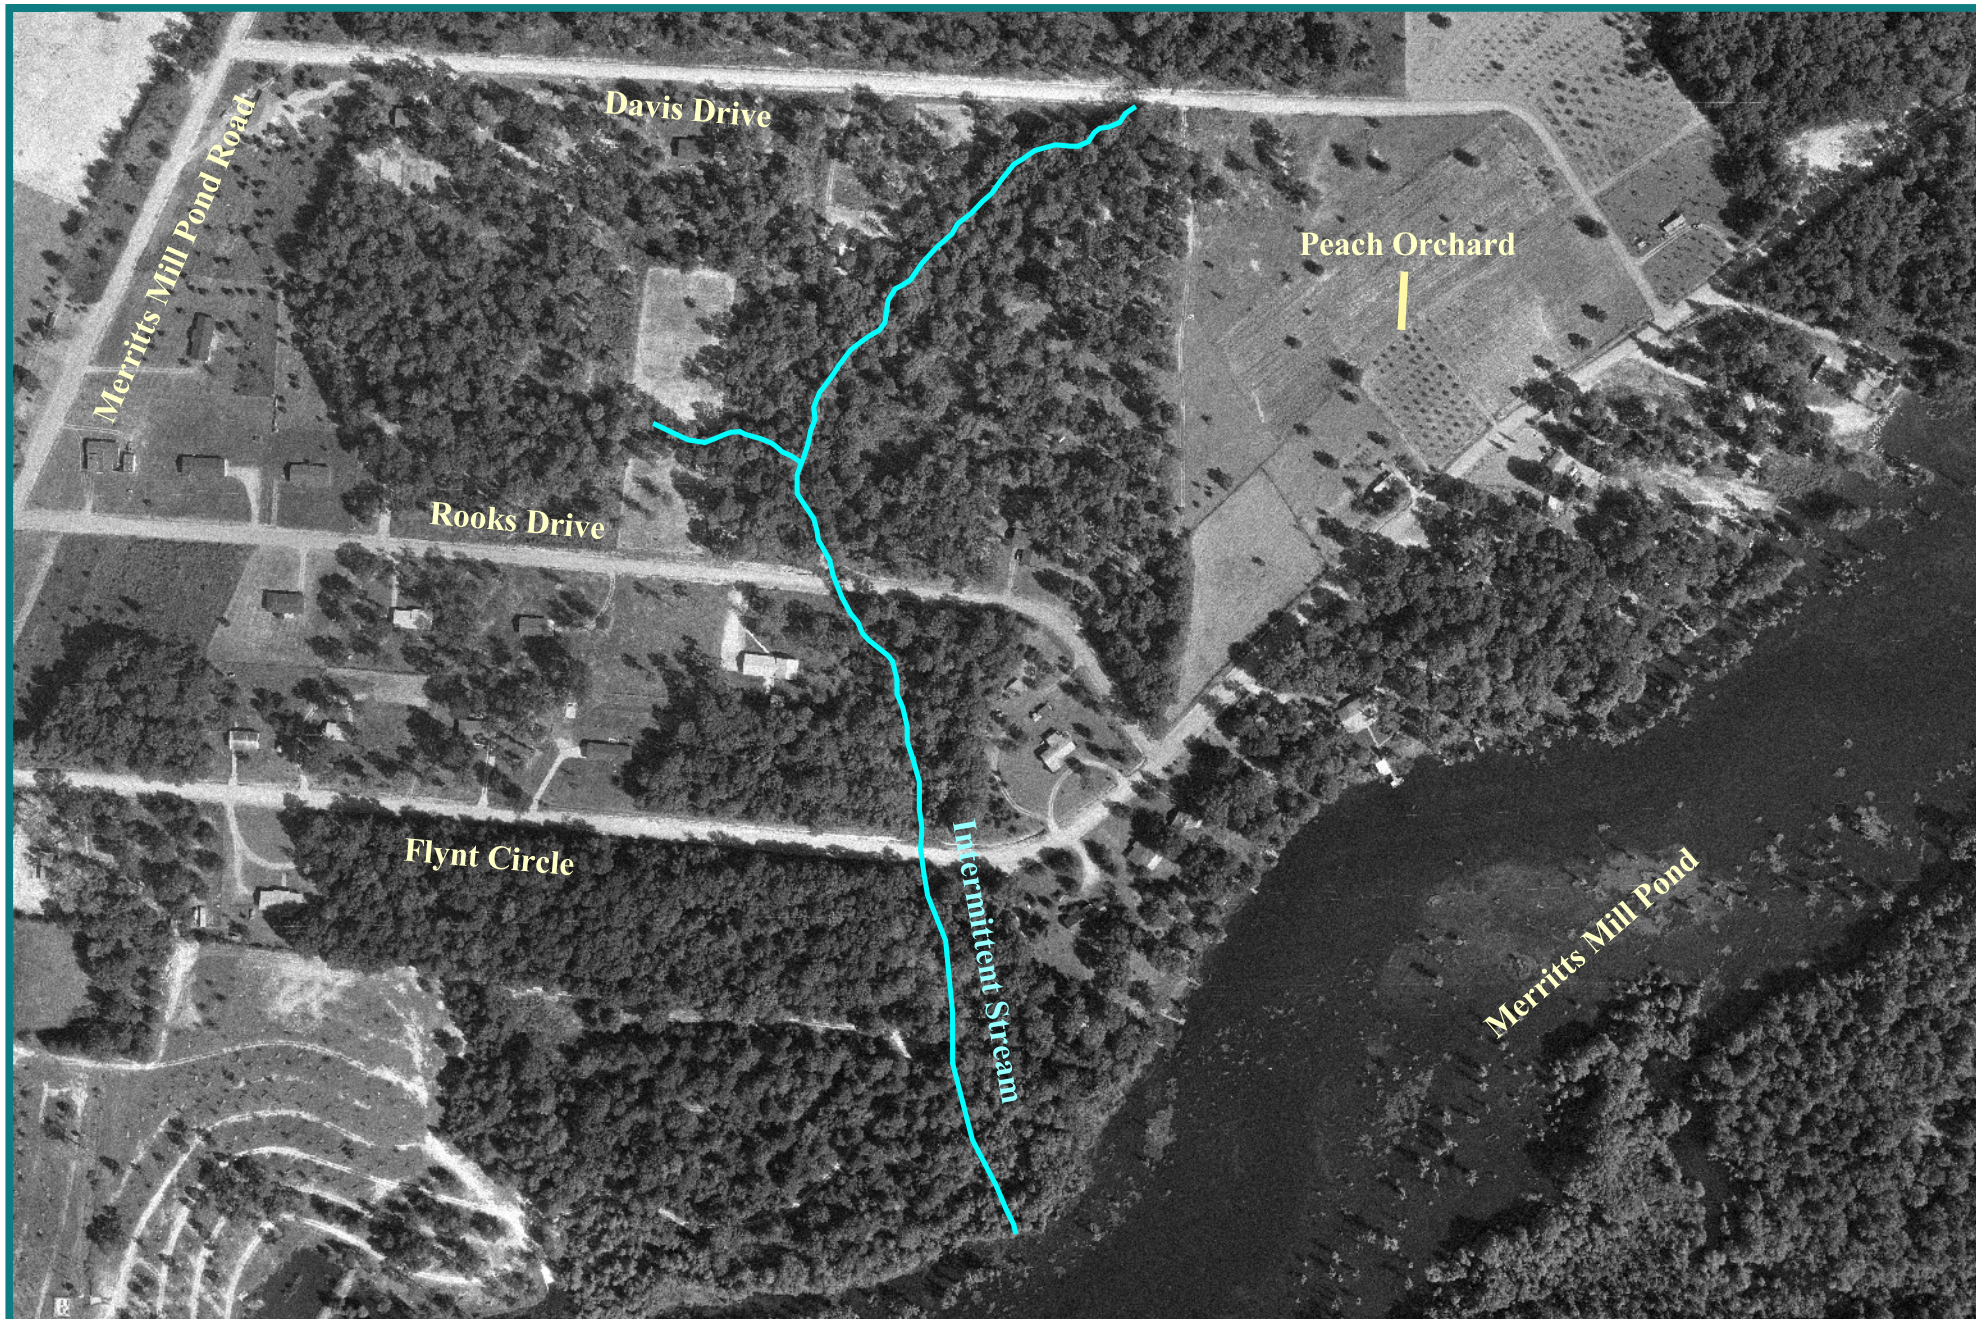
**Figure 11**  
**1970 Site Map**  
**Merritts Mill Pond Arsenic Study**  
**Marianna, Jackson County, Florida**

A 1970 Florida Department of Transportation aerial photograph indicated the presence of a tree farm adjacent to Flynt Circle, just north of the elevated arsenic cluster ([Figure 11](#)). Discussions with long-term residents confirmed that the property's owner had attempted to establish a peach orchard. After several failed attempts, he allowed the tract to go fallow. Fruit orchards are notorious receptors of arsenic based insecticides and herbicides (Washington Department of Agriculture, 2003).

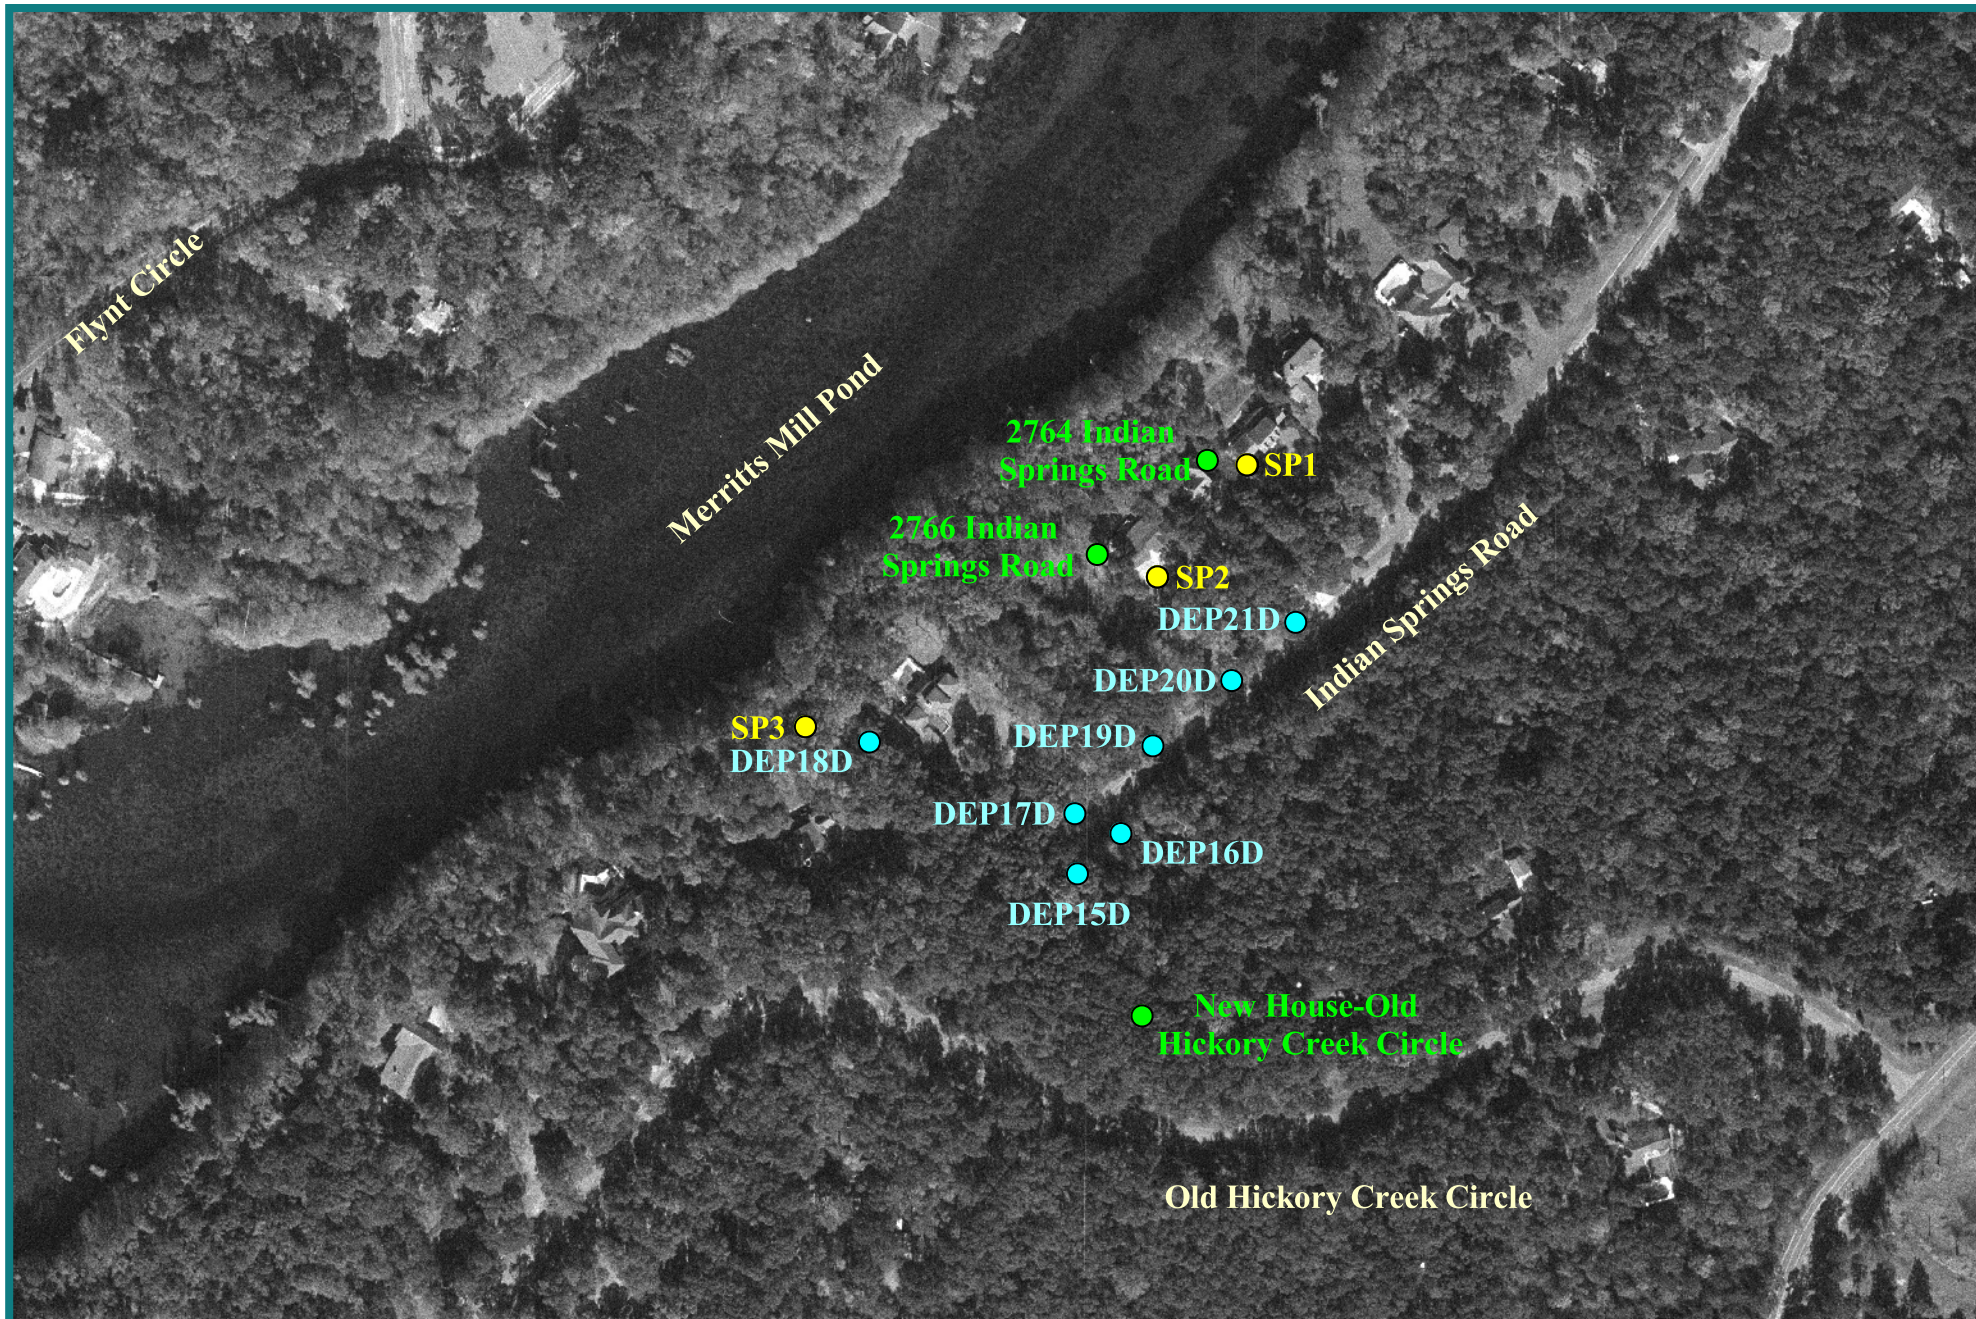
**Figure 18**  
**SIS Eastern Study Area Microwell Locations**  
**Merritts Mill Pond Arsenic Study**  
**Marianna, Jackson County, Florida**

Later in December 2004, deep screen point samples were collected in the vicinity of the 2766 and 2764 Indian Springs Drive supply wells (SP1 and SP2)(Table 4, Figure 18). This was done to ascertain the extent of arsenic in relation to depth in hopes of determining whether an arsenic source area was in proximity to this area. A screen point sample was also collected near the confluence of the linear karstic feature and the spring run lineament (SP3). It was conjectured by SIS that fractures within the limestone units housing the Floridan aquifer may be providing preferential flow pathways for ground water. The presence of these fractures may account for the unusual distribution of arsenic on both sides of the pond. The direct push was able to drive the SP3 sampler to 70 feet BLS. Direct push refusal was encountered only 10 feet BLS at two locations just 100 feet away from the SP3 location. This testifies to how thin fractures may be that are present within the underlying limestone.

On the eastern side of the pond, supply well samples collected from the 2766 and 2764 Indian Springs Road addresses indicated the elevated presence of arsenic at levels of 78.3 and 200 ug/L. The screen point sample (SP1) collected adjacent to the 2764 Indian Springs Road well contained arsenic at a level of 18.8 ug/L. The difference in depth between the well and the screen point's sampled interval is 43 feet. The SP2 sample, collected in the vicinity of the 2766 Indian Springs Road well contained arsenic at a concentration of 5.6 ug/L. The SP3 sample, collected within the fracture zone associated with the karstic feature was reported to contain arsenic at a concentration of 116 ug/L. This is the highest level of arsenic observed in a shallow interval sample (collected from an interval less than 70 feet BLS). The network of microwells installed upgradient of these impacted supply wells and near the karst feature showed no significant impact by arsenic ([Table 9](#)).

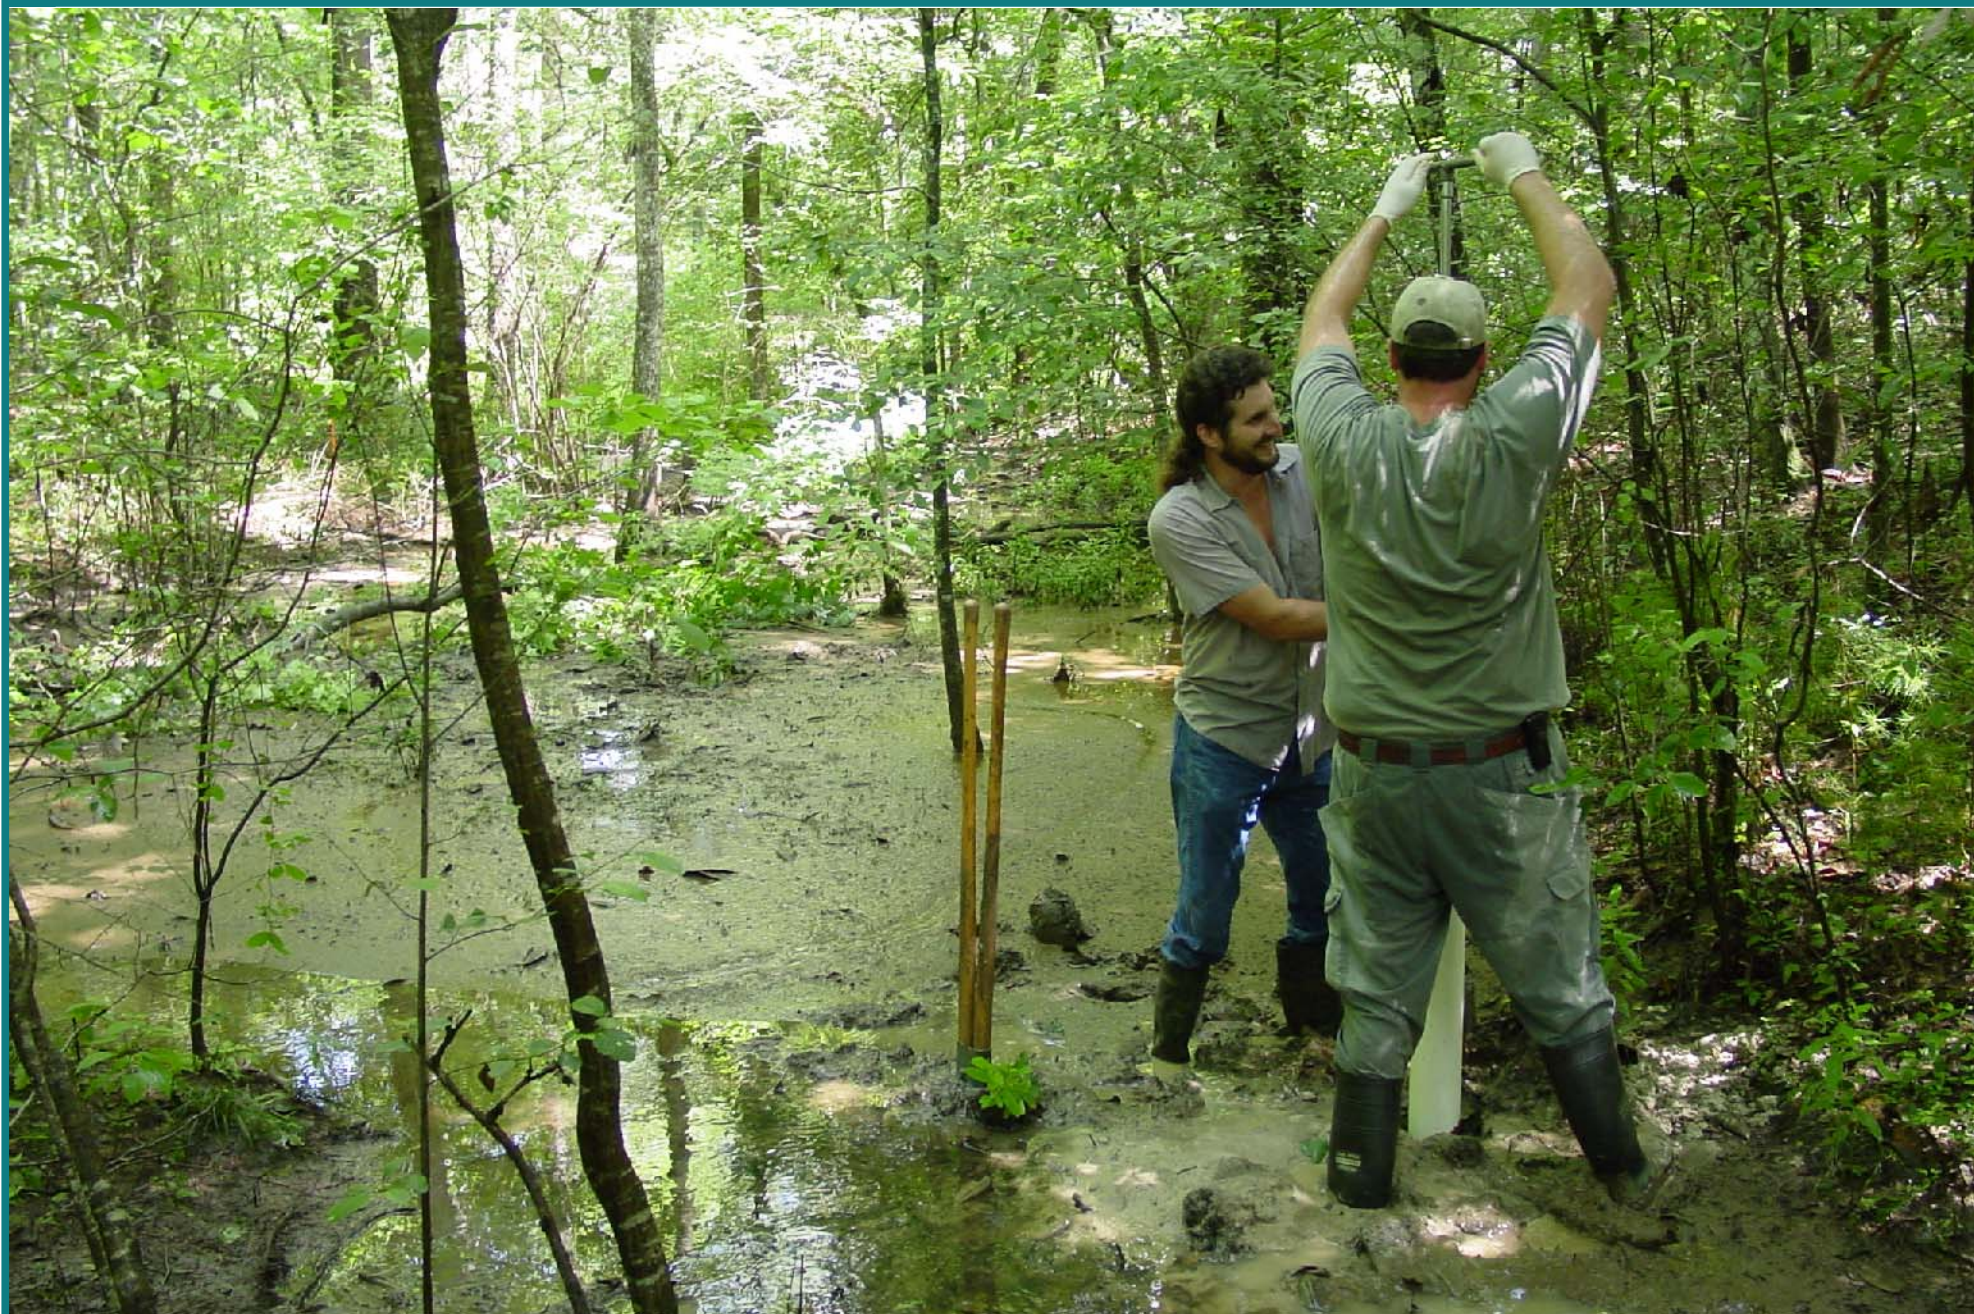
**Photograph 3**  
**First Ravine Sediment Sampling**  
**Merritts Mill Pond Arsenic Study**  
**Marianna, Jackson County, Florida**

All of the samples were collected utilizing hand driven stainless steel bucket augers. The dense foliage and large trees within the ravine precluded the use of power equipment. The lithology encountered was primarily medium to coarse grain, unconsolidated quartz sands underlain by silts and clays. In order to collect the deeper interval samples, four-inch PVC surface casing was employed to prevent running sands from backfilling into the borehole (Photograph 3).

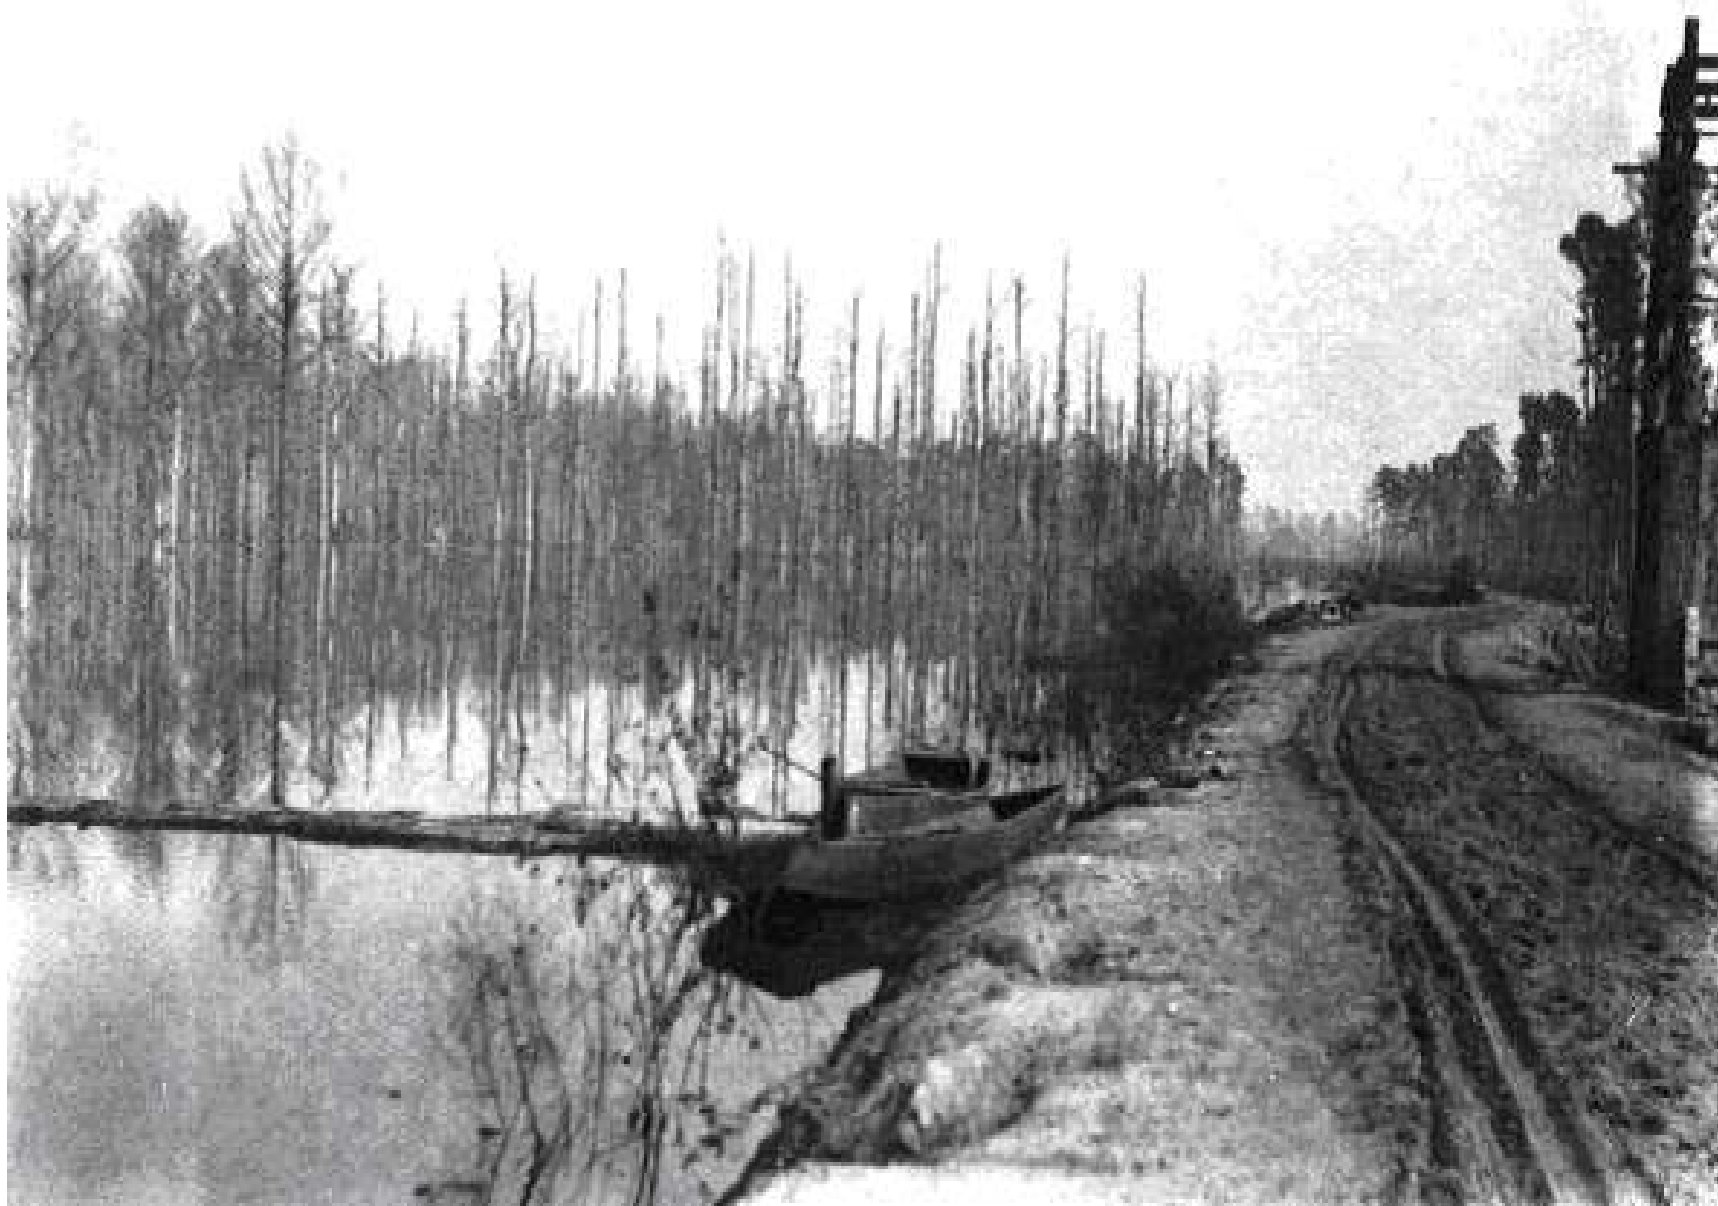
**Photograph 6**  
**Merritt's Mill Pond Dam (1922)**  
**Merritt's Mill Pond Arsenic Study**  
**Marianna, Jackson County, Florida**

Given the fact that some of the highest concentrations of arsenic reported were in supply wells on parcels located immediately next to the pond, consideration was given to the possibility that the source of the contamination is within the pond itself. The pond's waterfront has changed over the years in response to climatic events and modifications associated with the dam, including its replacement ([Appendix B](#)). A dam has been at this location since the 1870's (for grist) (Pratt, 2003). During much of the past, the dam has been a simple earthen berm set at a lower height than its current elevation ([Photograph 6](#)). Presently the dam is a concrete structure with a fixed gate.

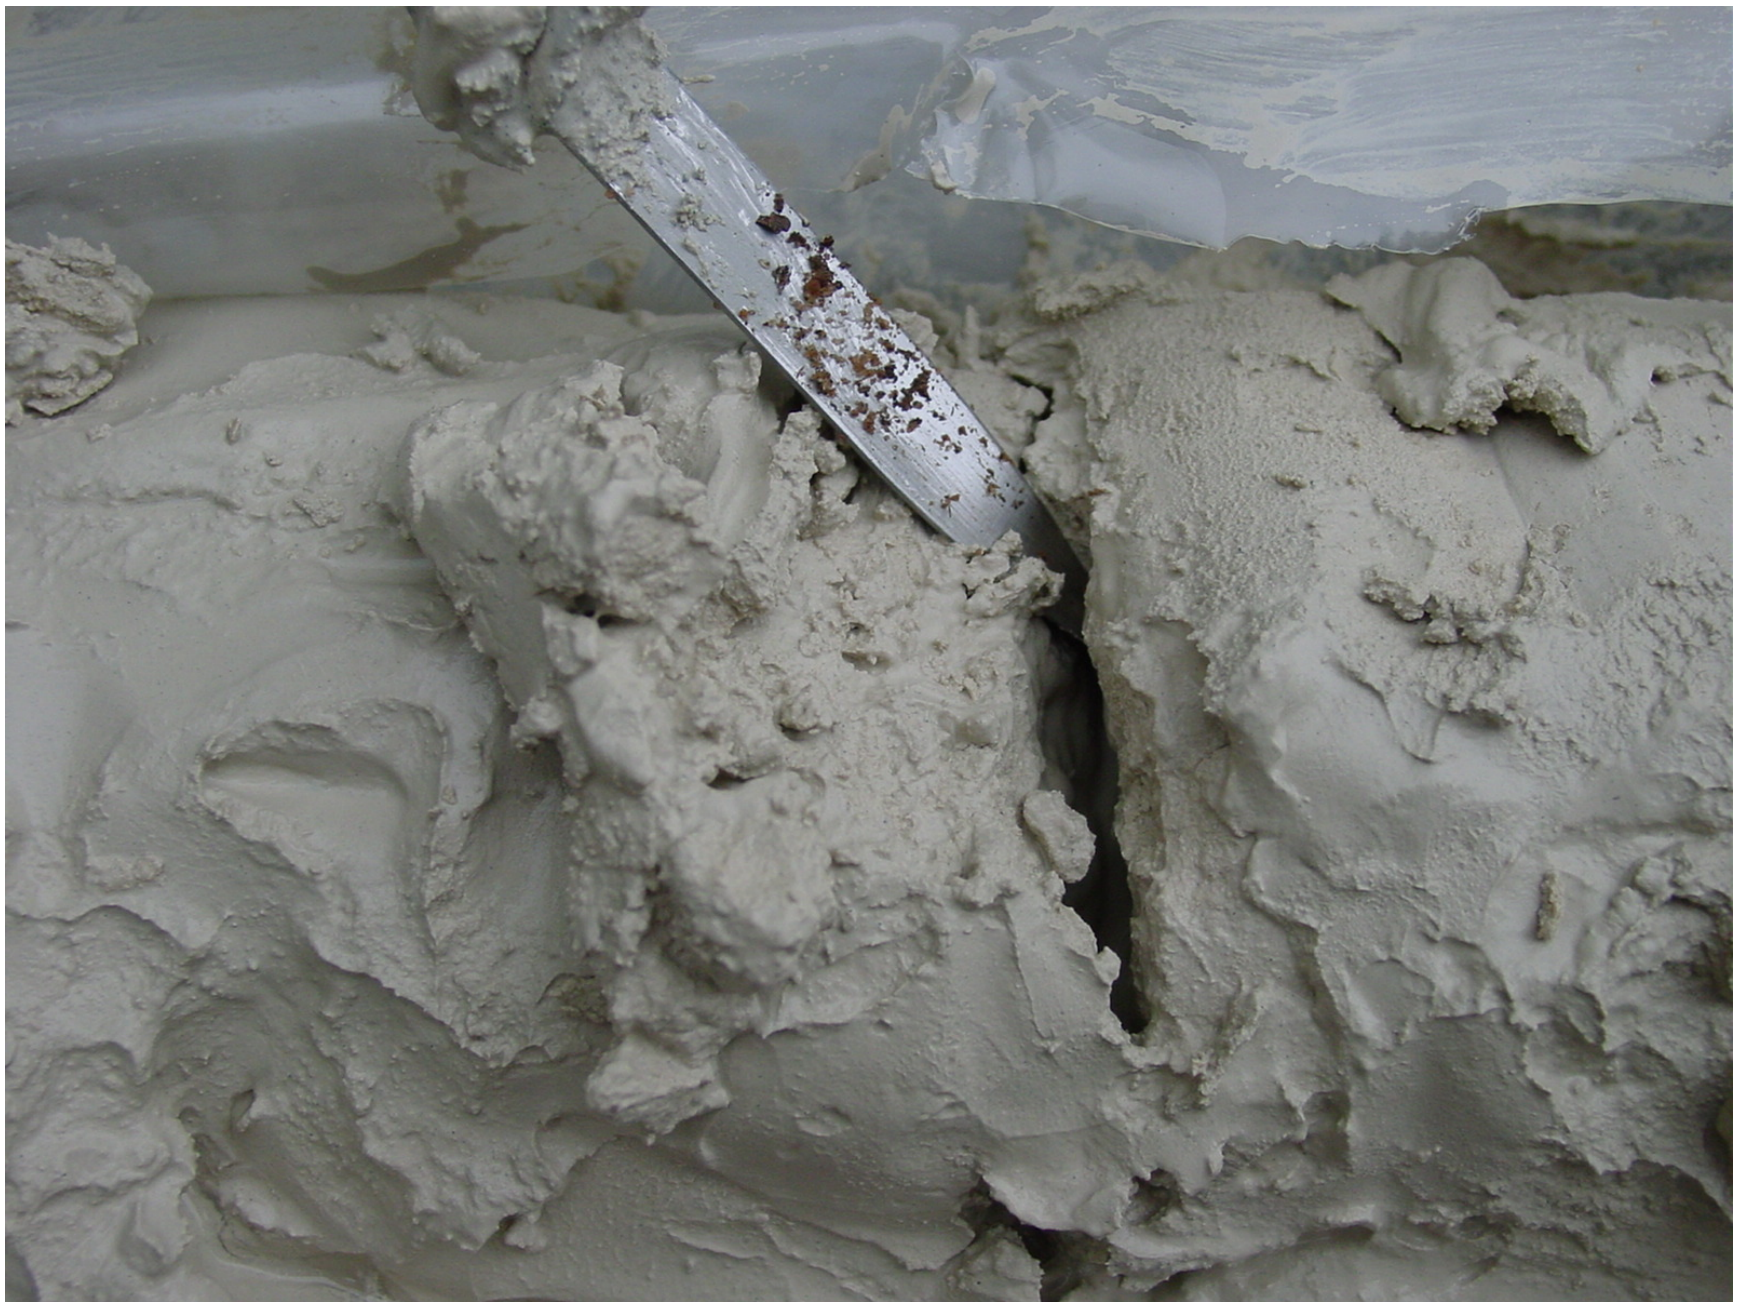
**Depth: 45-50' BLS.**

| DEPTH | SPL | SAMPLE DESCRIPTION | COMMENTS |
|---|---|---|---|
| 45 – 50' | | Limestone: chalky, buff tan to gray, beds are approximately 1 – 2" thick, interbedded with marly clay (fat and lean), entire section is damp to moist, foraminifera present. | |
