**Merritts Mill Pond Arsenic Study  
Marianna, Jackson County, Florida  
Preliminary Contamination Assessment Report**

**SIS Report Number 2005-03  
Issued June 2005**

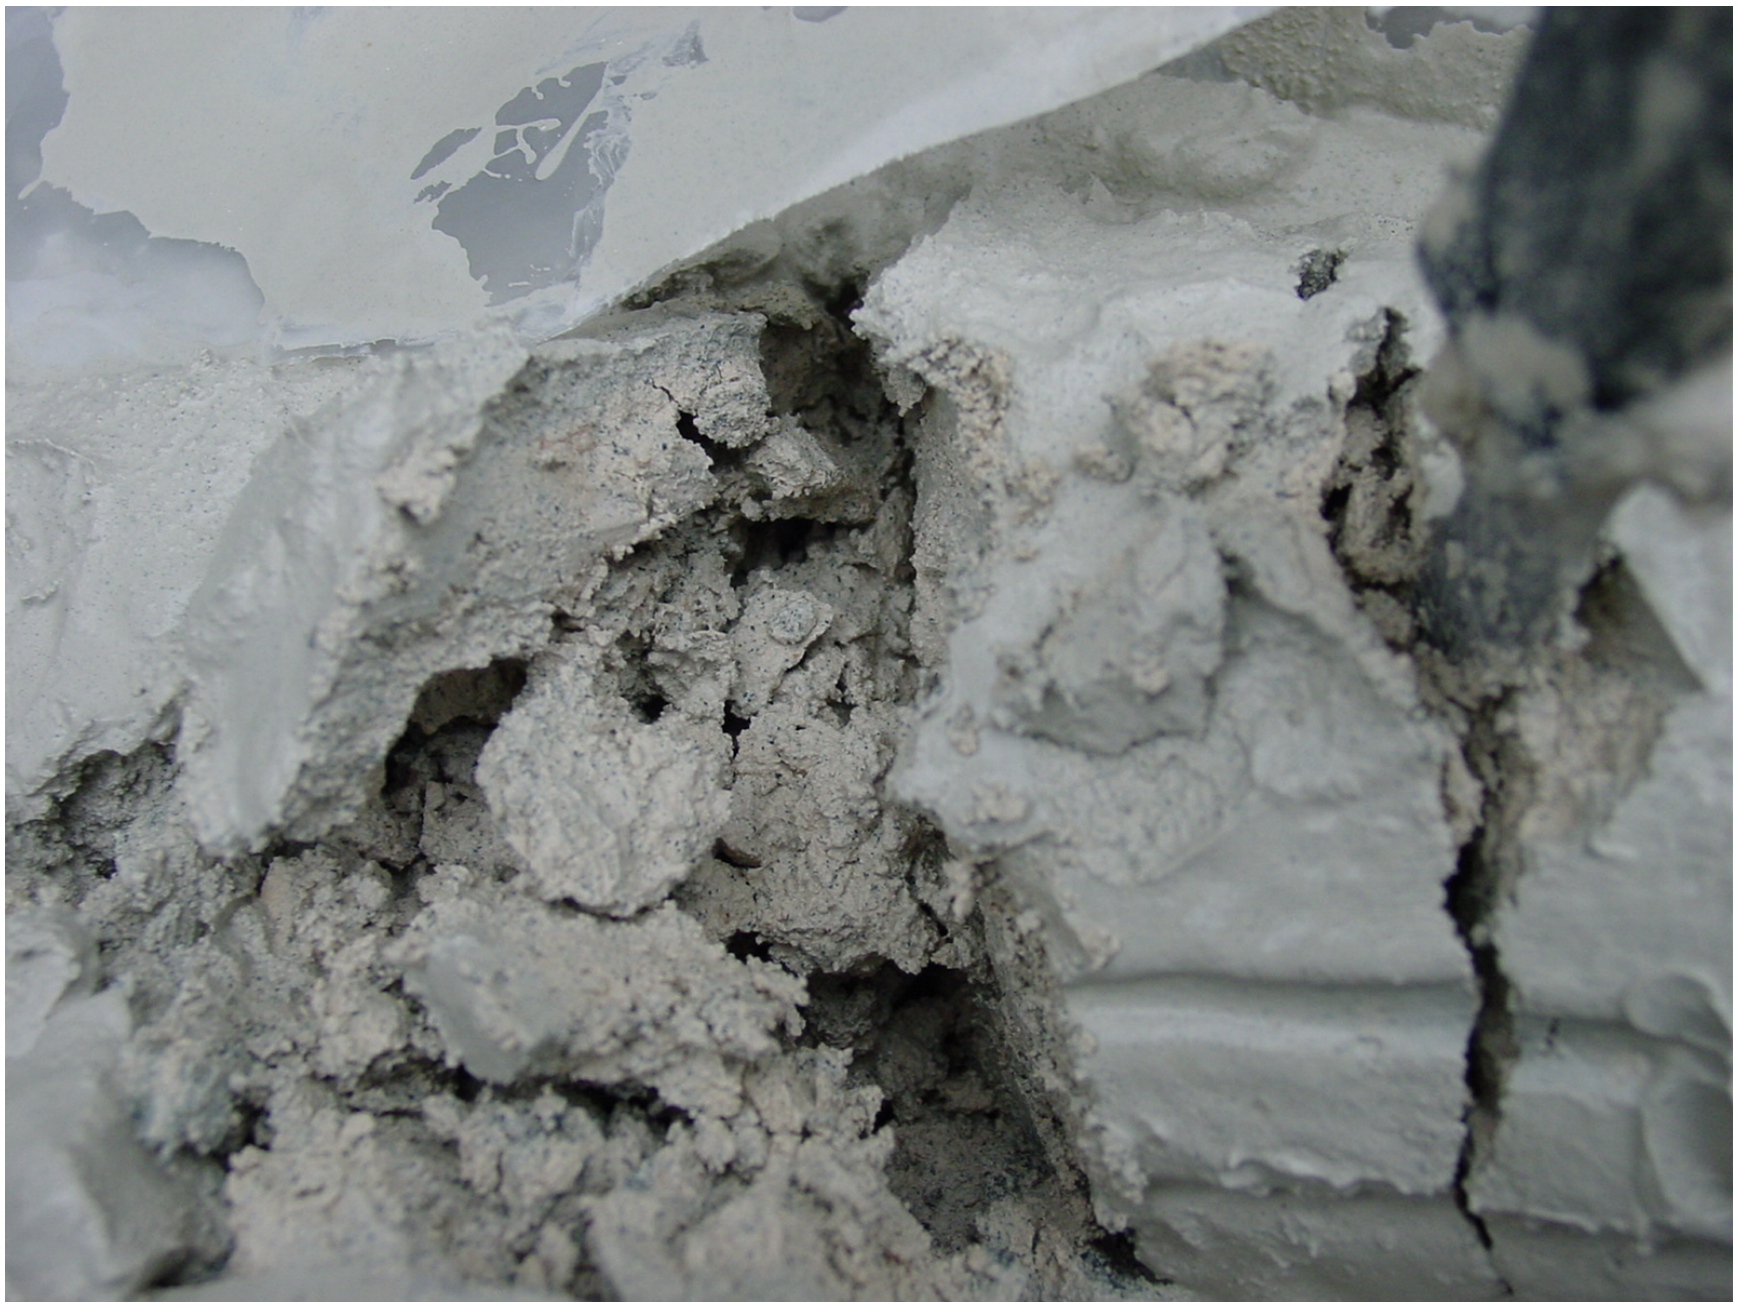
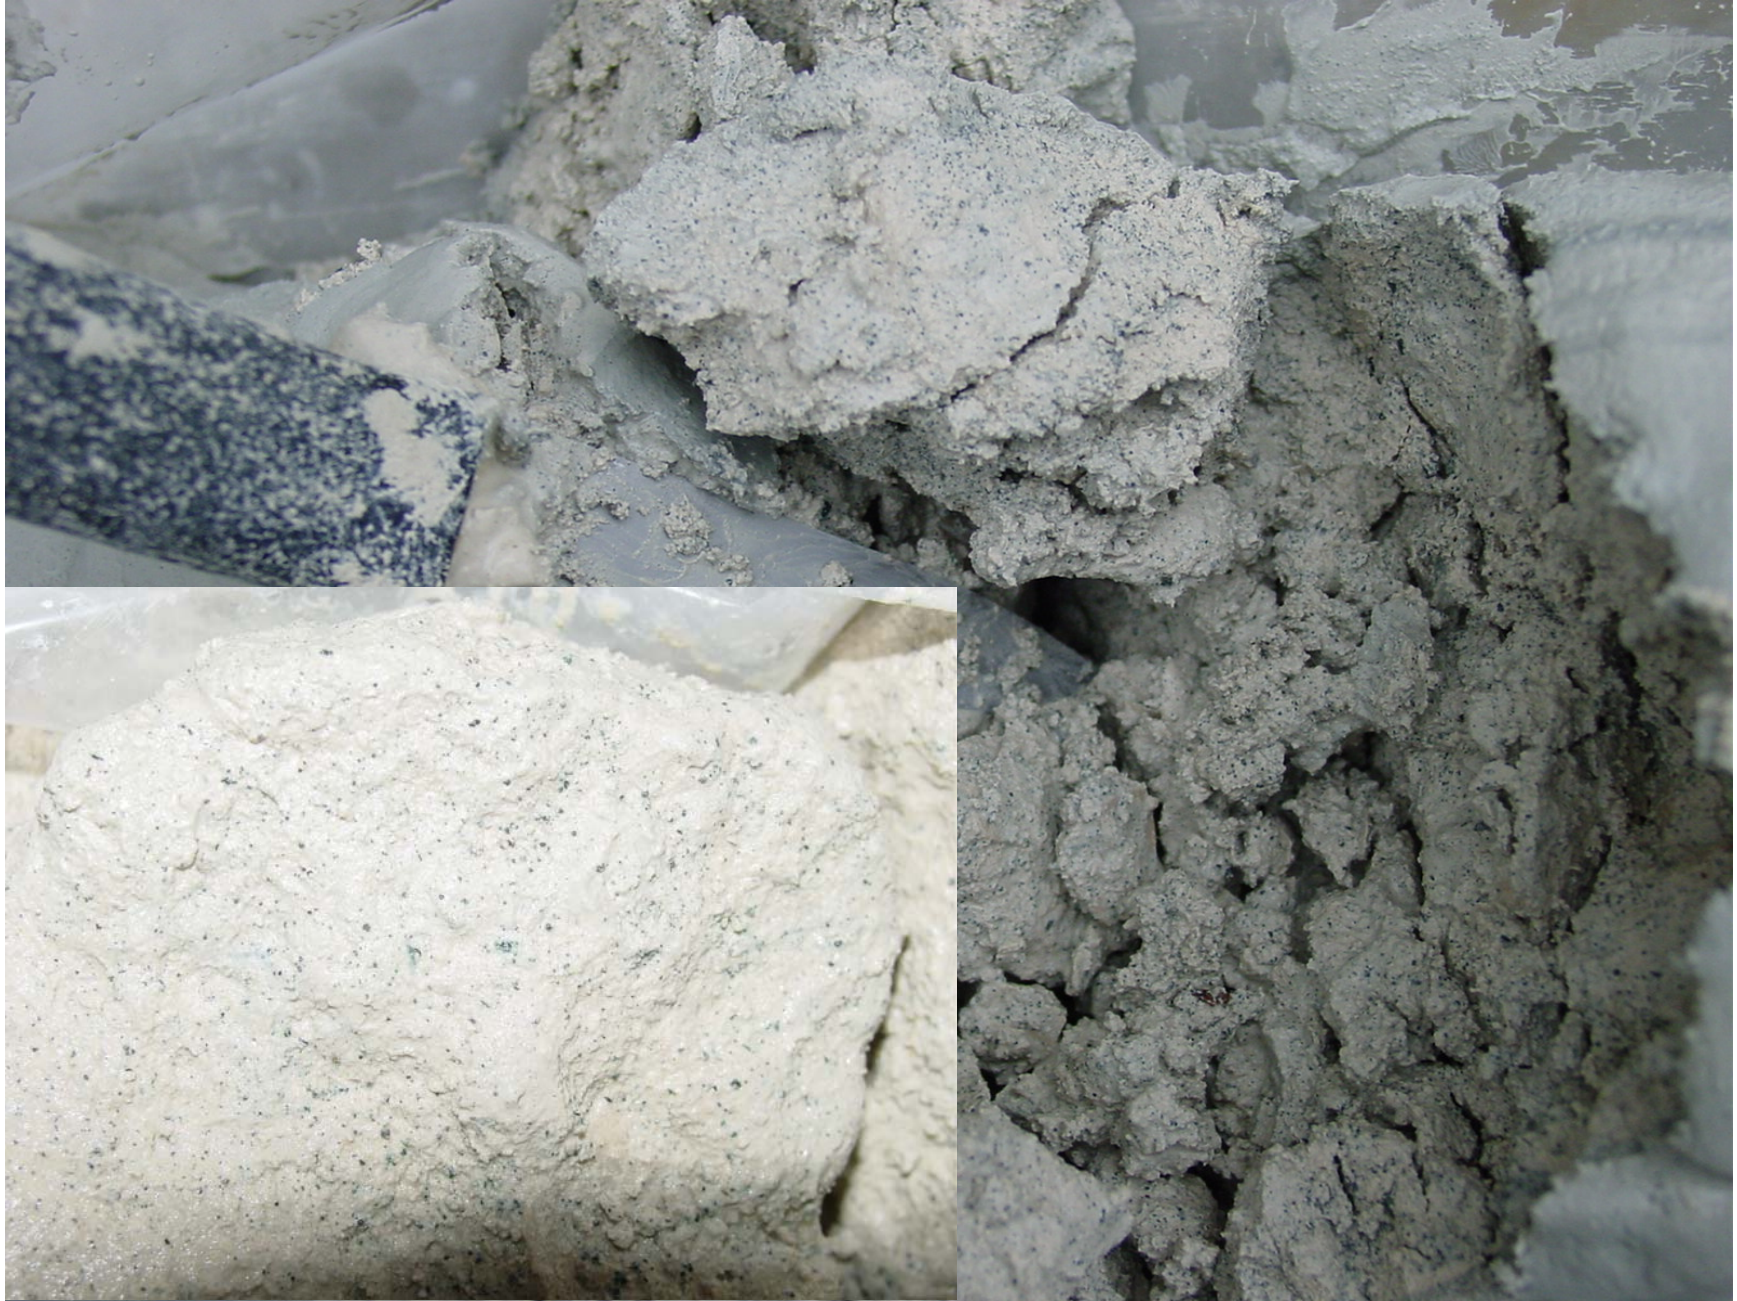
Depth: 50-67' BLS.

| DEPTH | SPL | SAMPLE DESCRIPTION | COMMENTS |
|---|---|---|---|
| 50 – 67' | | Limestone: off white to light gray, very friable, fossiliferous (foraminifera) with abundant glauconite, trace silt, moist to slightly wet. Blue/green glauconite nodules encountered in FL-2 deep core. | |

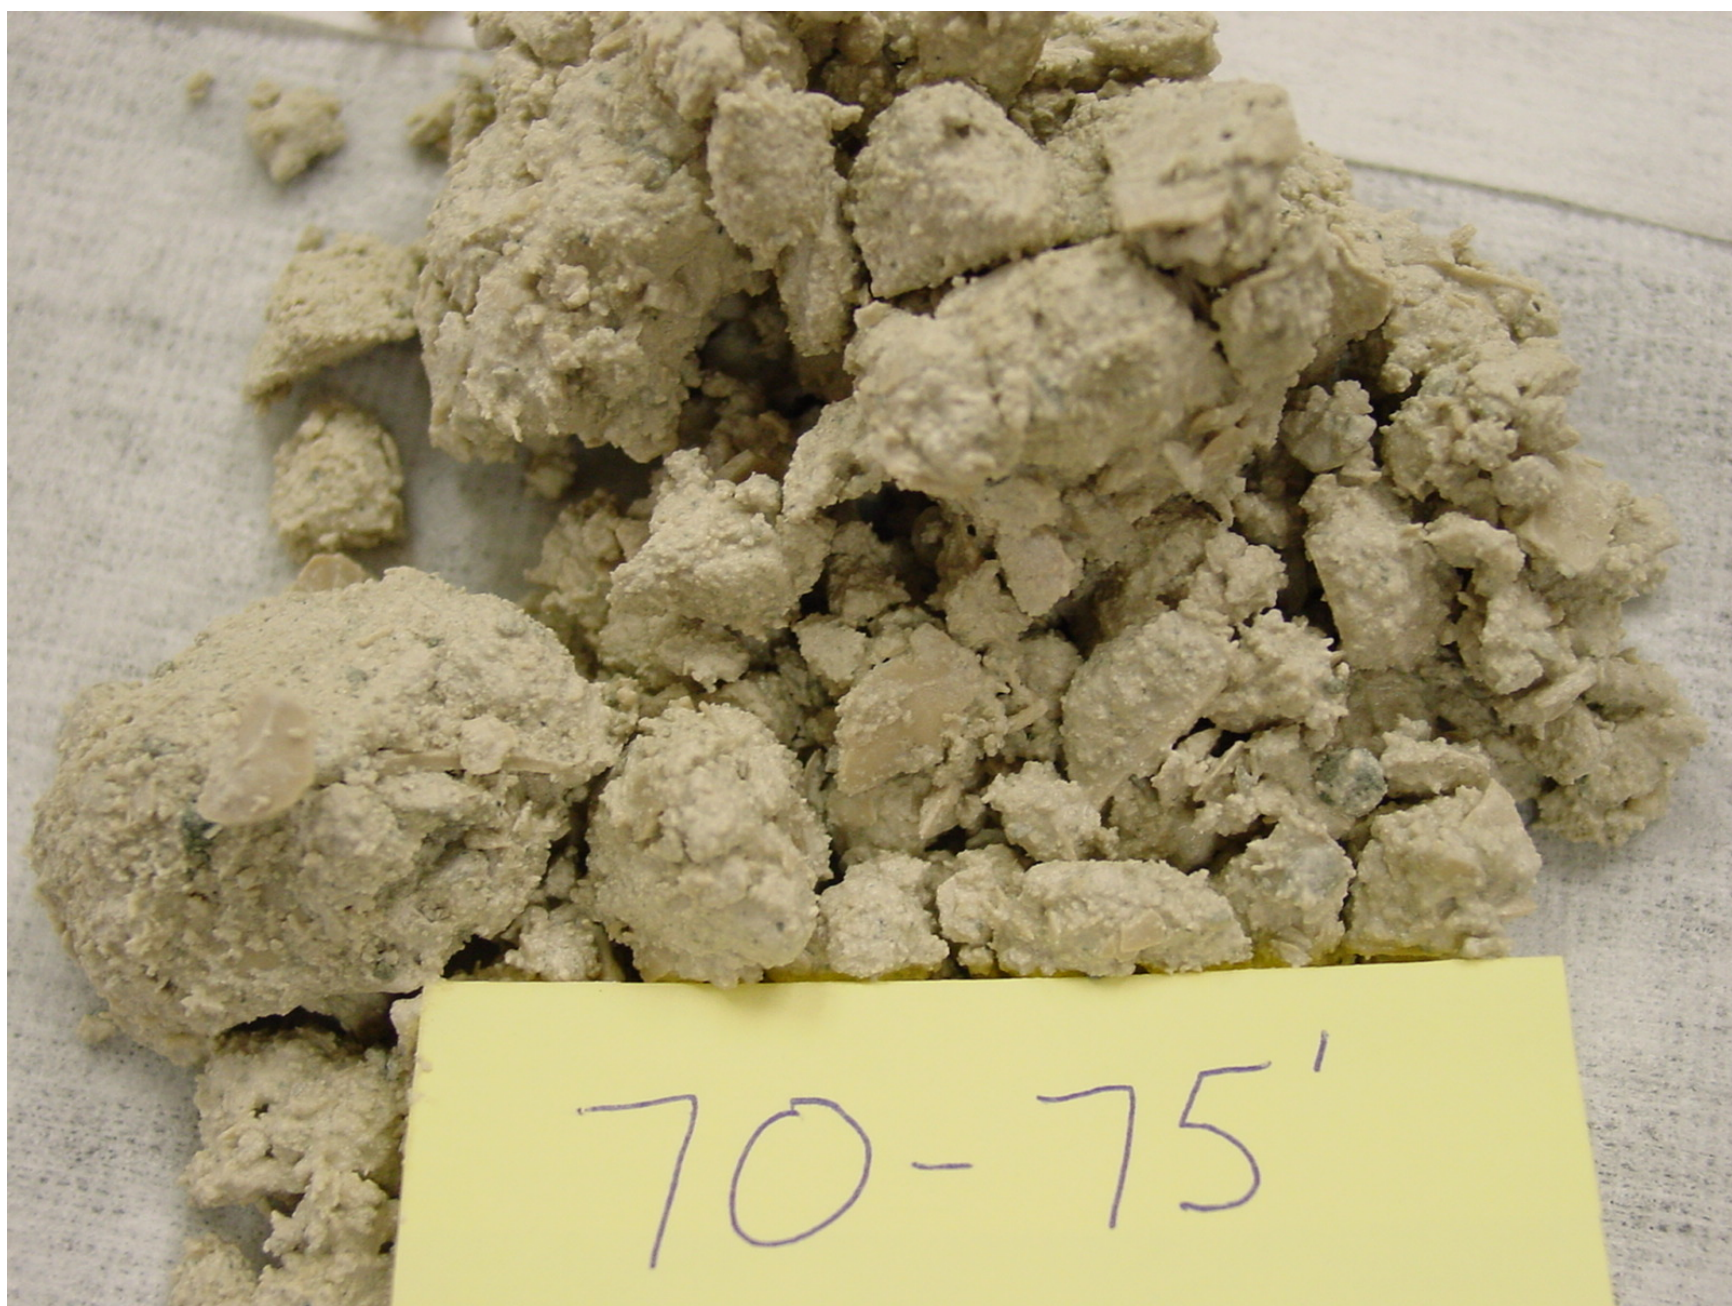
Depth: 70-78' BLS.

| DEPTH | SPL | SAMPLE DESCRIPTION | COMMENTS |
|---|---|---|---|
| 70 – 78' | | Limestone: off white to pale orange, friable, fossiliferous (abundant foraminifera) trace silt, moist. | |

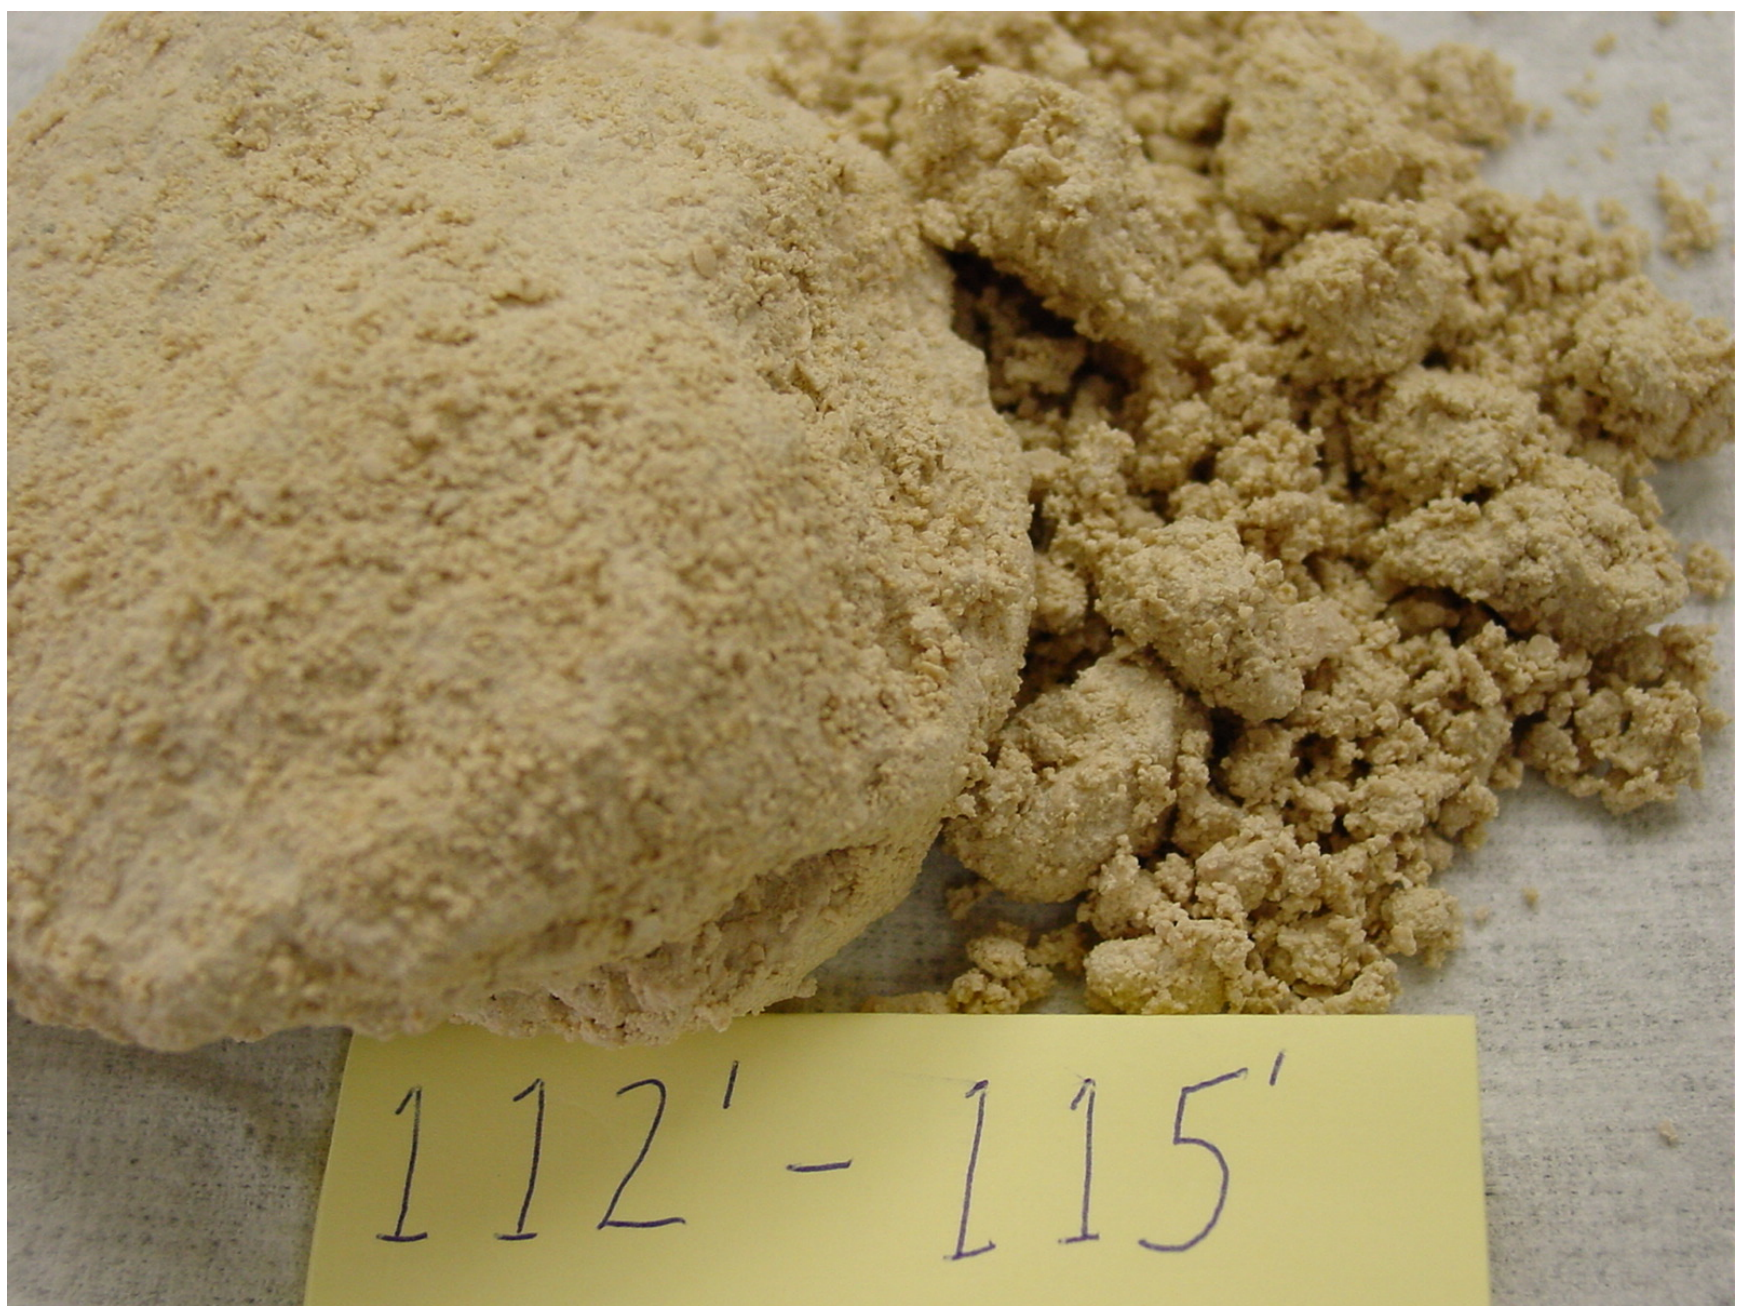
**Depth: 112-119' BLS.**

| DEPTH | SPL | SAMPLE DESCRIPTION | COMMENTS |
|---|---|---|---|
| 112 – 119' | | Limestone: pale orange, very damp, friable with thin intervals exhibiting cementation, rust colored specks in samples. | |

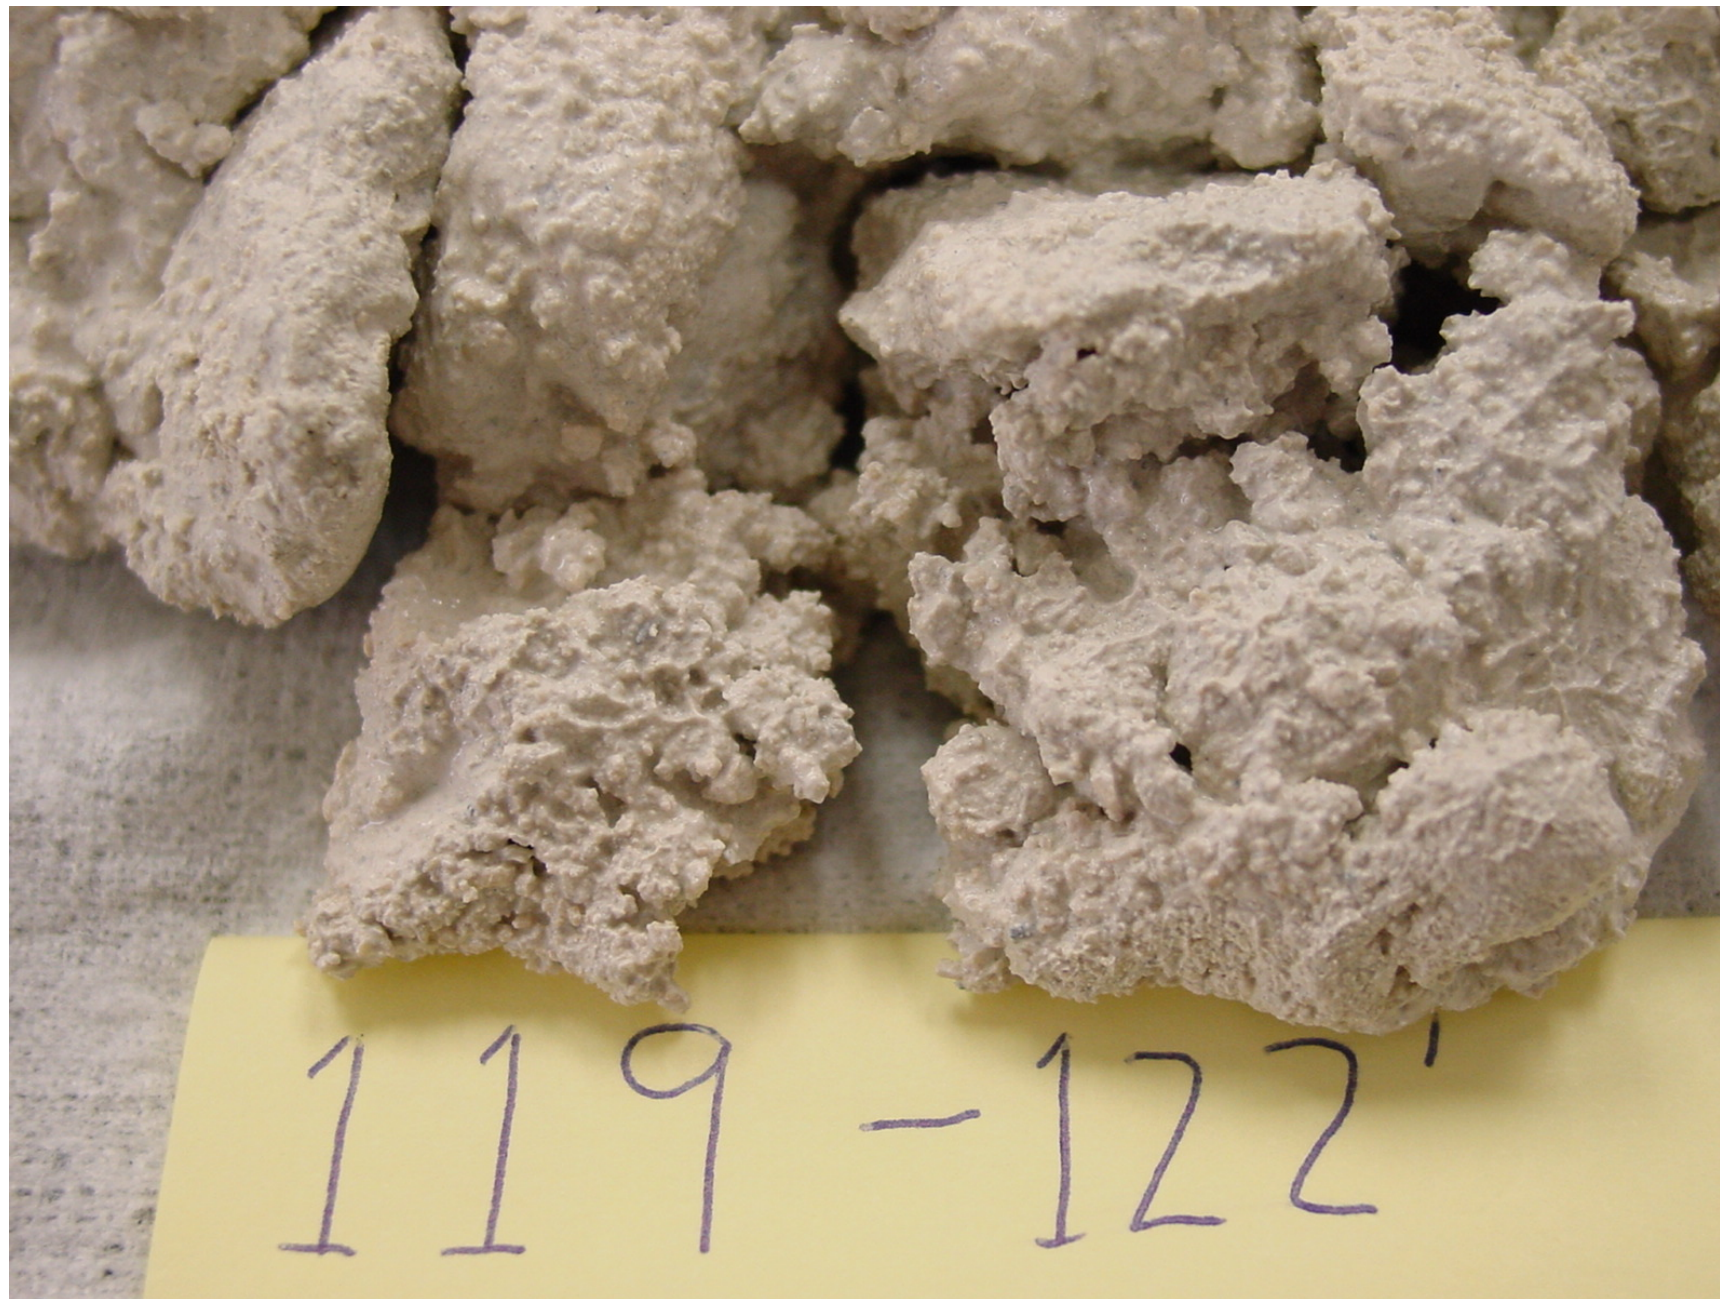
Depth: 119-122' BLS.

| DEPTH | SPL | SAMPLE DESCRIPTION | COMMENTS |
|---|---|---|---|
| 119 – 122' | | Clay: calcareous, dry, slightly plastic, off white to light gray with thin intervals of chalky limestone, intervals of limestone less than 1 inch thick. | |

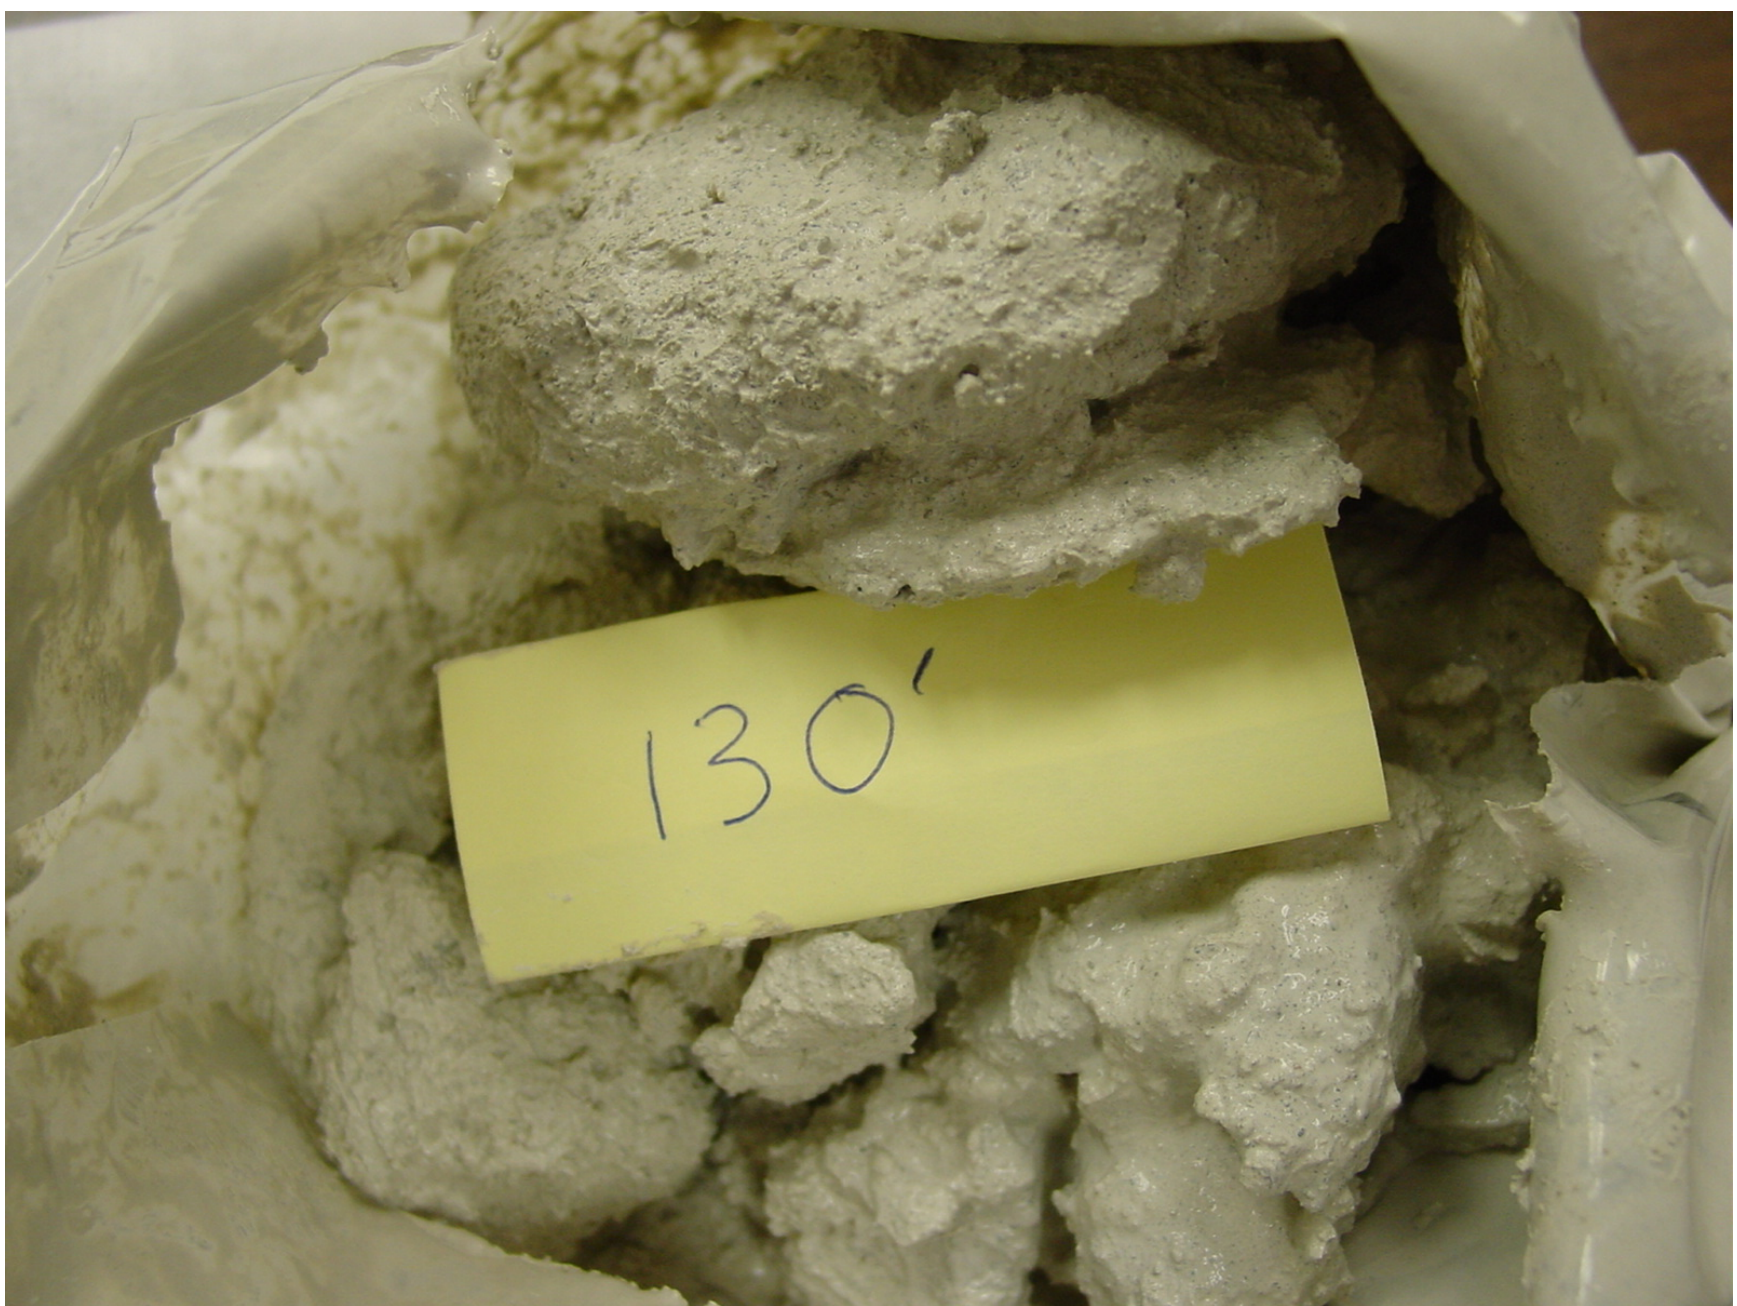
**Depth: 122-130' BLS.**

| DEPTH | SPL | SAMPLE DESCRIPTION | COMMENTS |
|---|---|---|---|
| 122 – 130' | | Limestone: light orange to pale gray, indurated, fossiliferous (foraminifera and brachiopods), trace of secondary porosity evident, some silica cementation evident. | |
