**SANITARY SEWER EVALUATION SURVEY**  
**PLAN "B"**

**SMOKE TEST OBSERVATION AND RESULTS**

| Facility Name | VA Hospital |
| Time | June 2nd, 2011 at 11:00 A.M. |

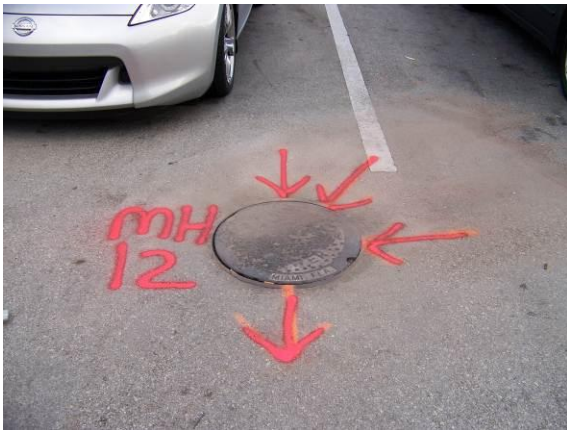
**Point of Injection:** Manhole # 12

**Testing Includes:** M.H # 12, M.H. 13, M.H. 16, M.H 17, M.H. 19, Pump Station A and P.S. B and all associated piping of this section of the SSCY

**Location:** On concrete

**Result:** The smoke reached all part of the sanitary sewer collection system of the section being tested and their corresponding vents

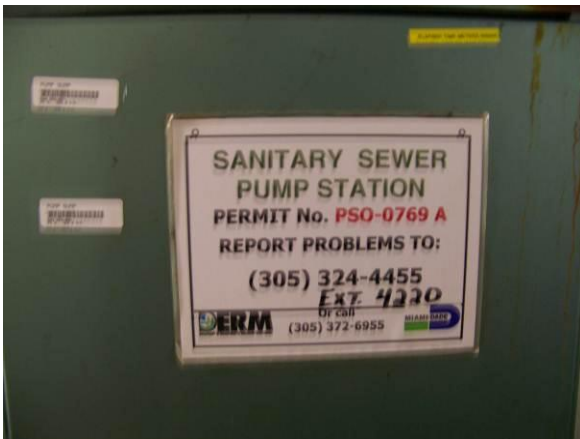
**Pump Station A:** In compliance

**Address:** On the North West side within; main building. This ejector collects the waste water below the 1<sup>st</sup> floor and discharges it into M.H. # 19

**Size and Material:** 40 Ø x 10ö concrete precast structure

**Inflow Potential:** None

**Defect Rating:** None

- No work required

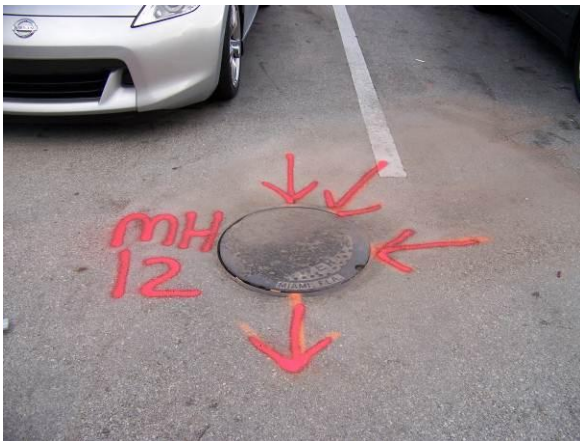
**Manhole # 12:** Not In compliance  
 Solids blocking flow of one channel  
**Address:** South of the building on asphalt driveway

**Inflow Potential:** Moderate

**Defect Rating:** Moderate  
**Task to be performed:**

- Install inflow dish
- Clean inflow lines

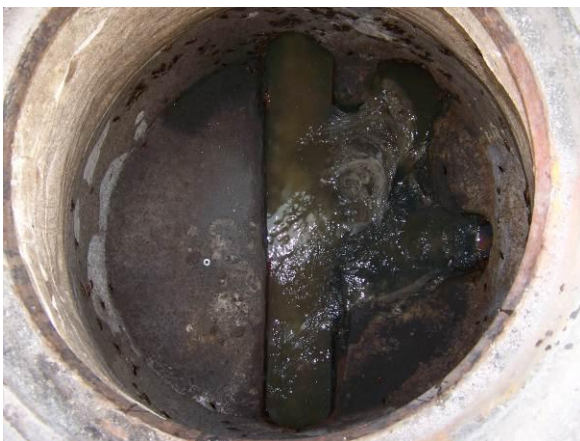
**Manhole # 12:** Not In compliance

**Inflow Potential:** Moderate

**Defect Rating:** Moderate  
**Task to be performed:**

- Install inflow dish
- Clean inflow lines

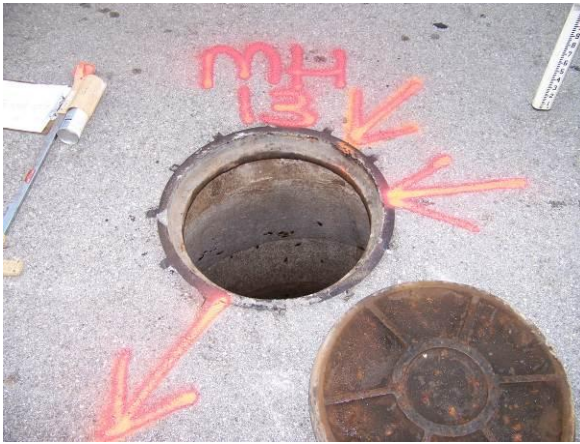
**Manhole # 13:** Not in compliance  
 Solids blocking flow of one channel  
**Address:** South of the building on asphalt driveway

**Inflow Potential:** Moderate

**Defect Rating:** Moderate

- Install inflow dish
- Clean inflow and outflow lines

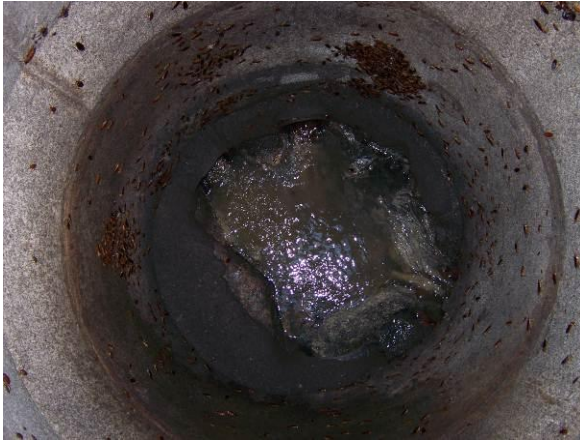
**Manhole # 13:** Not in compliance

**Inflow Potential:** Moderate

**Defect Rating:** Moderate

- Install inflow dish
- Clean inflow and outflow lines

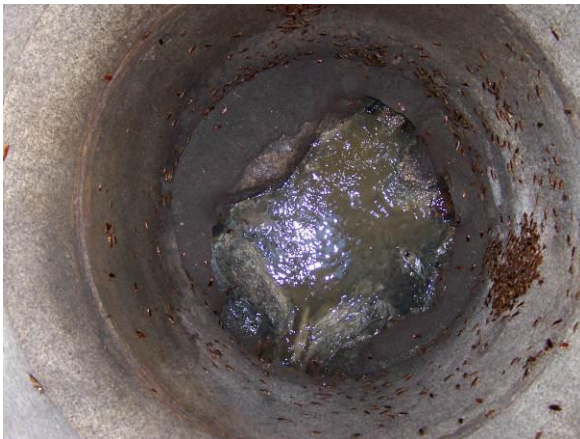
**Manhole # 13:** Not in compliance

**Inflow Potential:** Moderate

**Defect Rating:** Moderate

- Install inflow dish
- Clean inflow and outflow lines

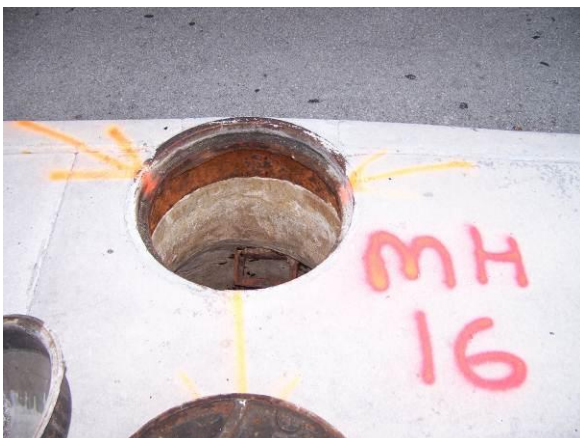
**Manhole # 16:** Not in compliance

**Inflow Potential:** Moderate

**Defect Rating:** Moderate

- Install inflow dish

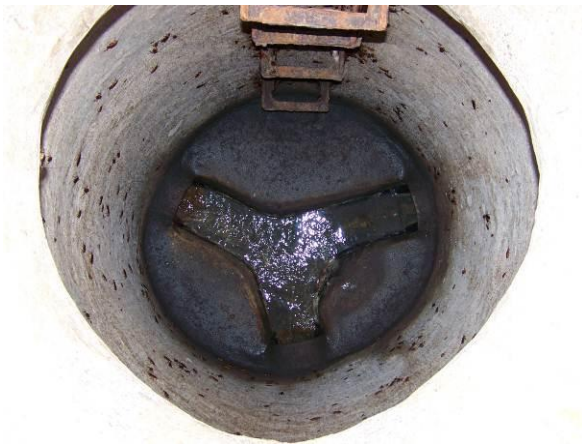
**Manhole # 16:** Not in compliance

**Inflow Potential:** Moderate

**Defect Rating:** Moderate

- Install inflow dish

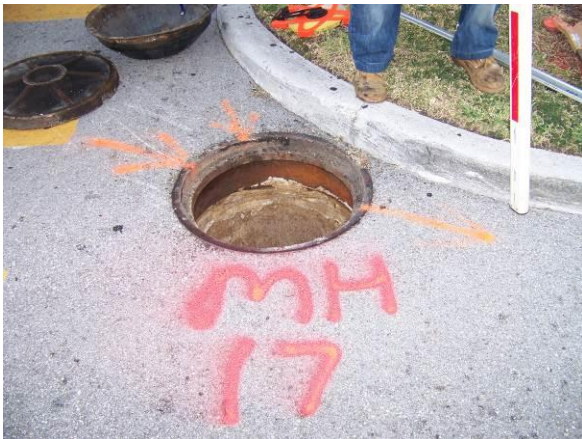
**Manhole # 17:** No in compliance

**Inflow Potential:** Moderate

**Defect Rating:** Moderate

- Install inflow dish

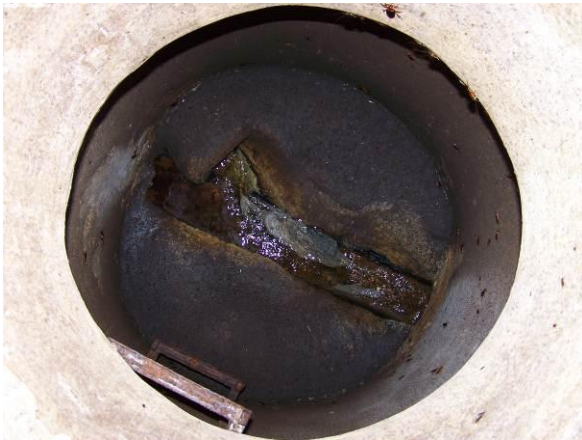
**Manhole # 17:** Not in compliance

**Inflow Potential:** Moderate

**Defect Rating:** Moderate

- Install inflow dish

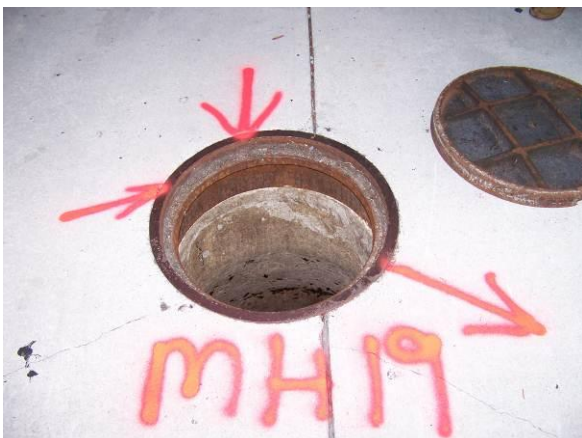
**Manhole # 19:** Not in compliance

**Inflow Potential:** Moderate

**Defect Rating:** Moderate

- Install inflow dish

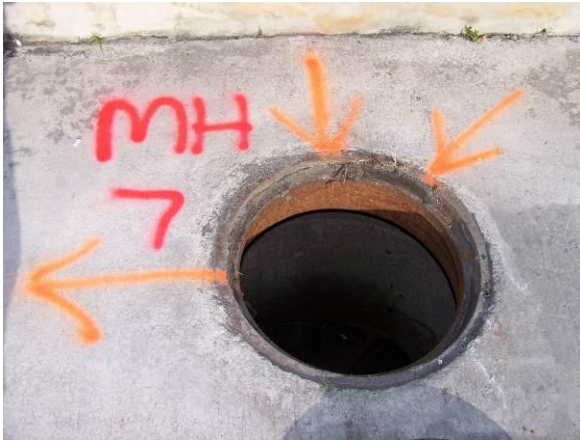
**Manhole # 7:** Not in compliance

**Inflow Potential:** Moderate

**Defect Rating:** Moderate

- Install inflow dish

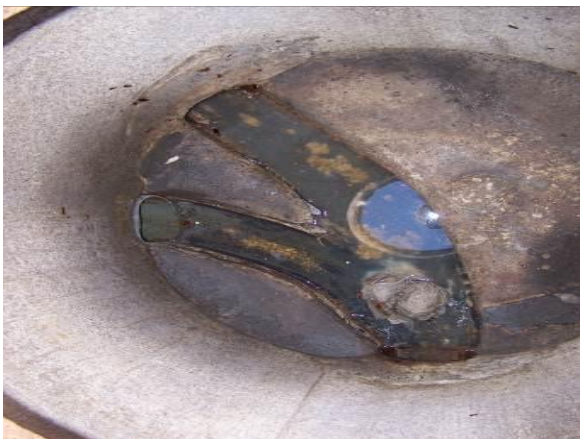
**Manhole # 7:** Not in compliance

**Inflow Potential:** Moderate

**Defect Rating:** Moderate

- Install inflow dish

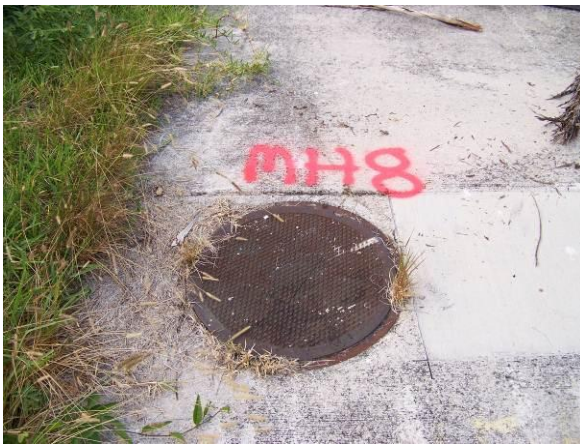
**Manhole # 8:** Not in compliance

**Inflow Potential:** Moderate

**Defect Rating:** Moderate

- Install inflow dish

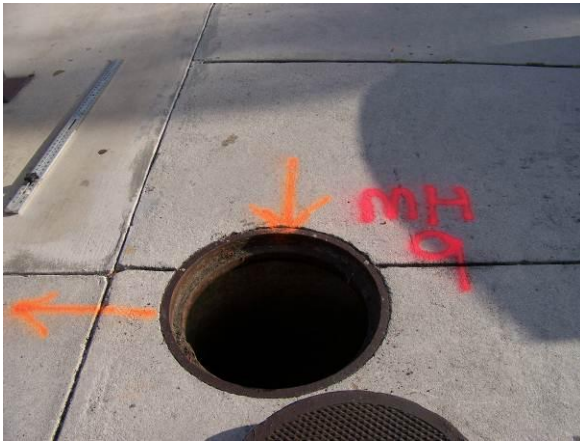
**Manhole # 9:** Not in compliance

**Inflow Potential:** Moderate

**Defect Rating:** Moderate

- Install inflow dish

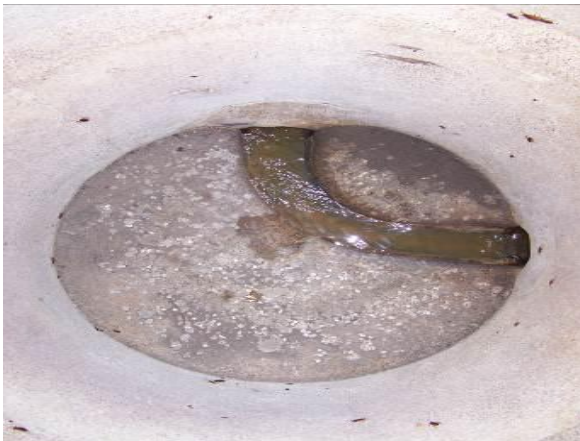
**Manhole # 9:** Not in compliance

**Inflow Potential:** Moderate

**Defect Rating:** Moderate

- Install inflow dish

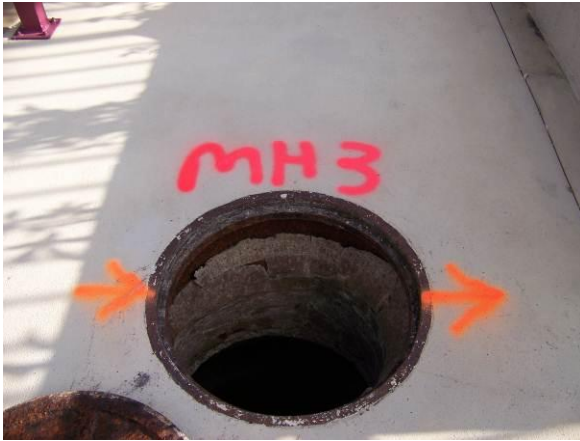
**Manhole # 3:** Not in compliance

**Inflow Potential:** Moderate

**Defect Rating:** Moderate

- Install inflow dish

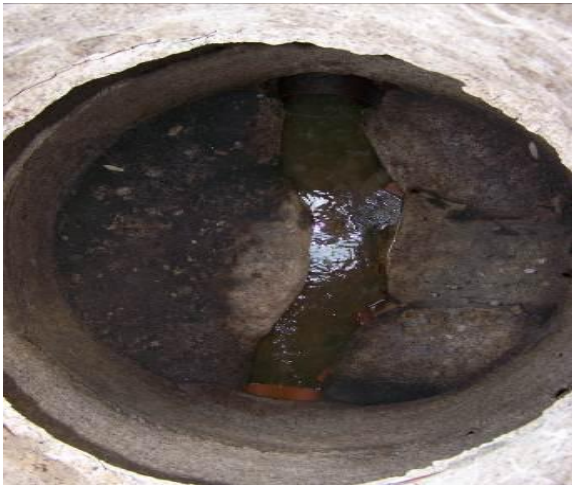
**Manhole # 3:** Not in compliance

**Inflow Potential:** Moderate

**Defect Rating:** Moderate

- Install inflow dish

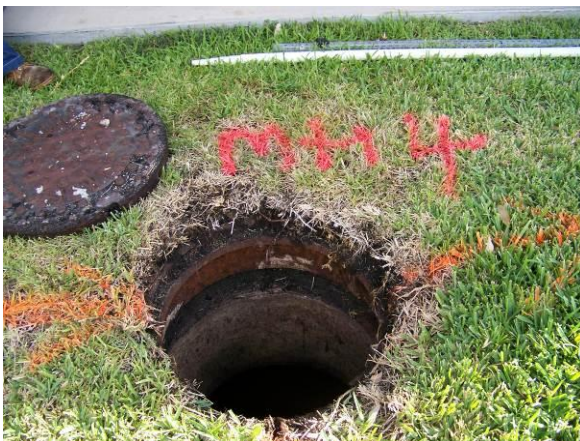
**Manhole # 4:** Not in compliance

The manhole rim is misaligned with the structure

**Inflow Potential:** Moderate

**Defect Rating:** Moderate

- Install inflow dish
- Line need cleaning
- Remove and re-set manhole rim

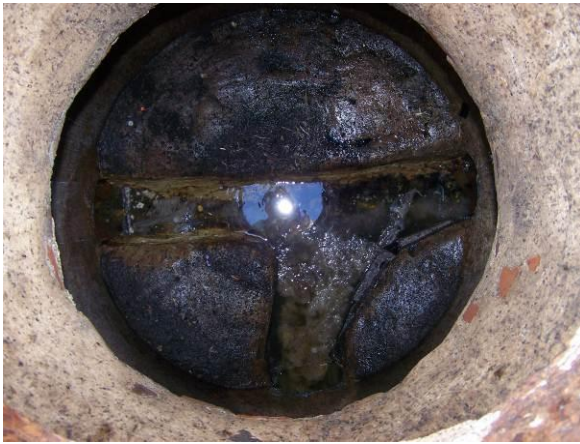
**Manhole # 4:** Not in compliance

**Inflow Potential:** Moderate

**Defect Rating:** Moderate

- Install inflow dish
- Line need cleaning

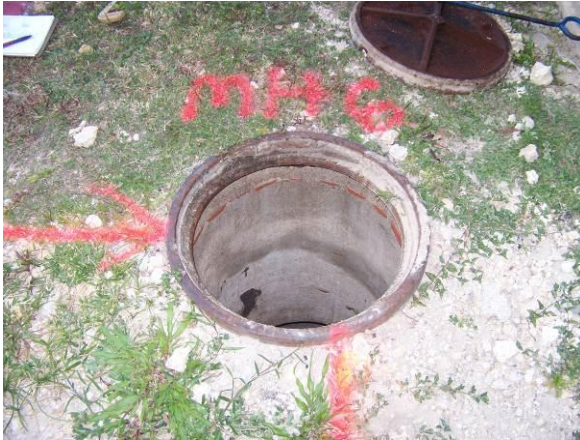
**Manhole # 6:** Not in compliance

**Inflow Potential:** Moderate

**Defect Rating:** Moderate

- Install inflow dish

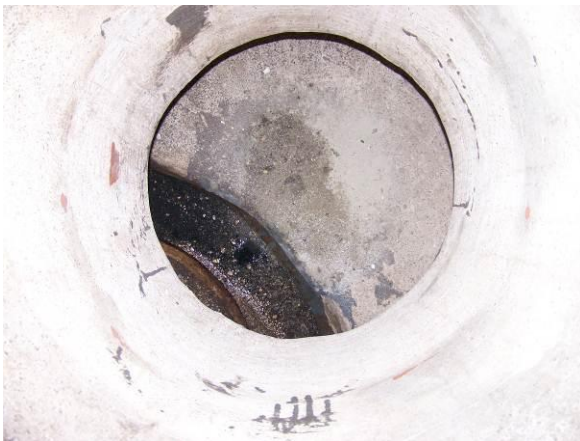
**Manhole # 6:** Not in compliance

**Inflow Potential:** Moderate

**Defect Rating:** Moderate

- Install inflow dish

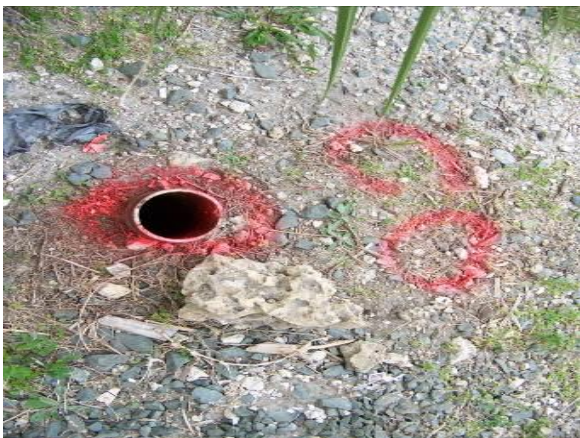
**C.O. # 1:** Not in compliance

This 46 cast iron clean out is missing the  
clean out ferrule and the plug

**Inflow Potential:** Severe

**Defect Rating:** Severe

- Excavate to remove damage portion  
of pipe
- Install new clean out

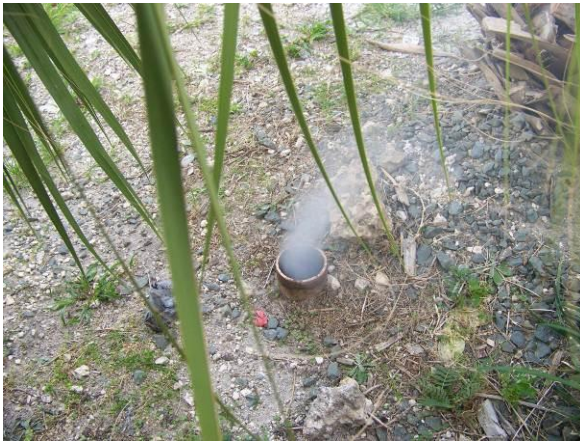
**C.O. # 1:** Not in compliance

This 4" cast iron clean out is missing the clean out ferrule and the plug

**Inflow Potential:** Severe

**Defect Rating:** Severe

- Excavate to remove damage portion of pipe
- Install new clean out

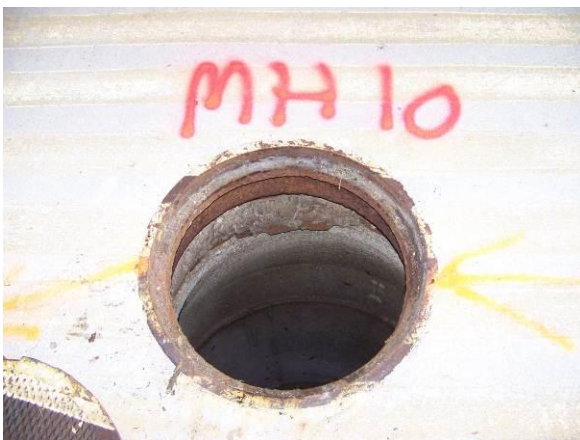
**Manhole # 10:** Not in compliance

- Install inflow dish
- Jet clean line partially obstructed

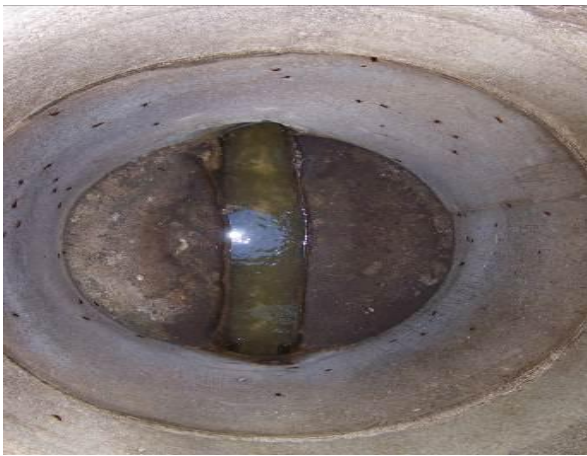
**Manhole # 10:** Not in compliance

- Install inflow dish
- Jet clean line partially obstructed

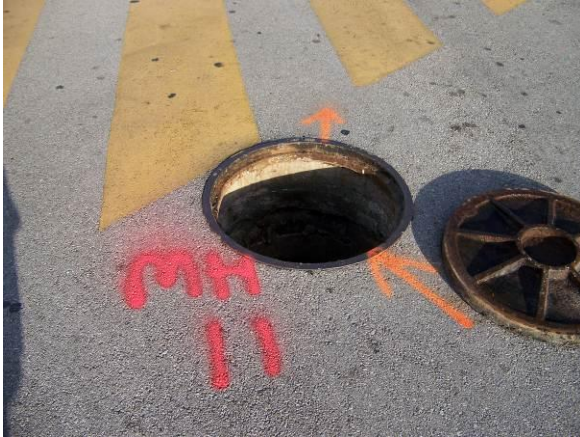
**Manhole # 11:** Not in compliance

- Install inflow dish
- Jet clean line partially obstructed

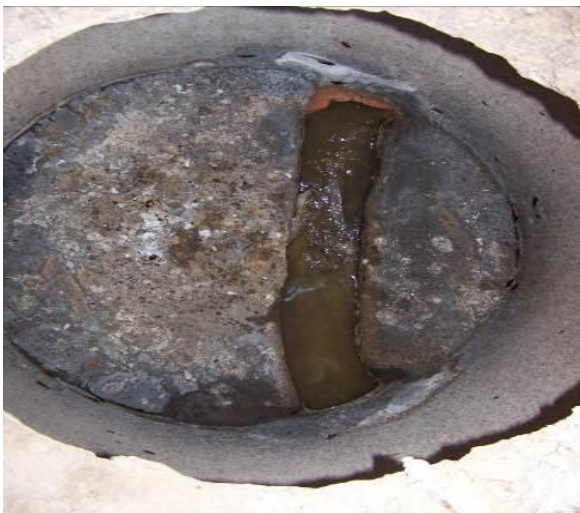
**Manhole # 11:** Not in compliance

- Install inflow dish
- Jet clean line partially obstructed

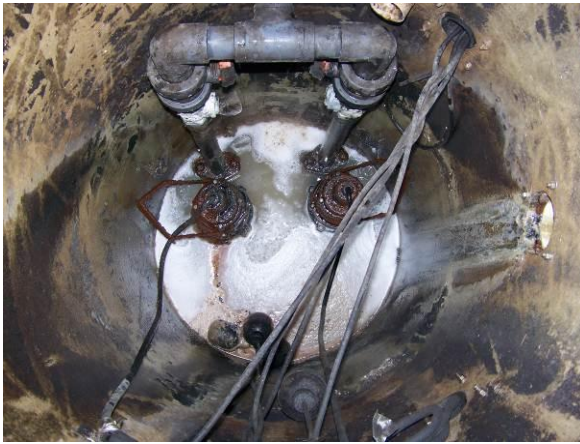
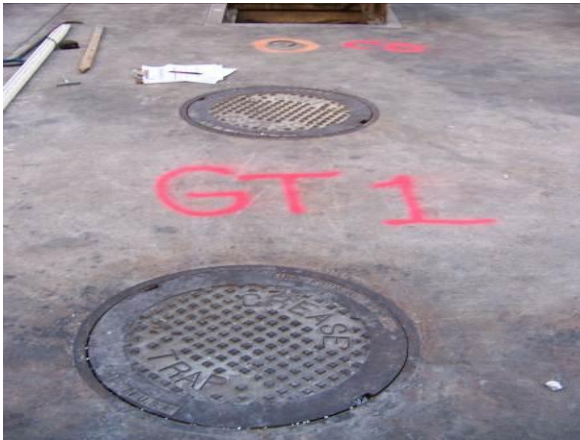
**Grease Trap # 1:** In compliance  
**Address:** North Side of Main building on concrete driveway  
**Size and Material:** 5öx 8ö concrete precast

**Inflow Potential:** Moderate

**Defect Rating:** Moderate

- Install inflow dish

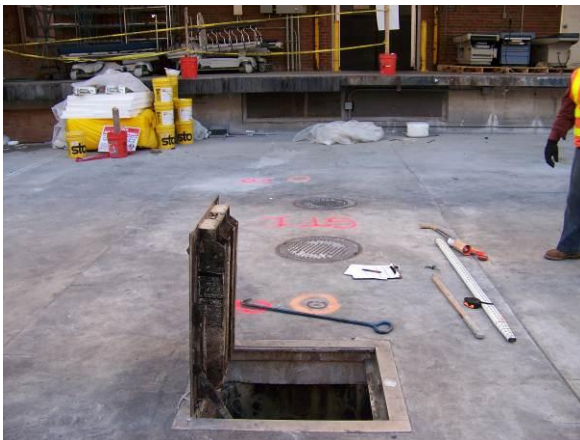
**Grease Trap # 1:** In compliance  
**Address:** North Side of Main building on concrete driveway  
**Size and Material:** 5öx 8ö concrete precast

**Inflow Potential:** Moderate

**Defect Rating:** Moderate

- Install inflow dish
