# Florida Department of Environmental Protection

## WINDSHIELD SURVEY REPORT

| Hurricane Name: 2017 Pre-Season | | Survey Date: 5/22/17 & 5/24/17 | | | | | Survey Tide Stage (if known): | | | | | | | |

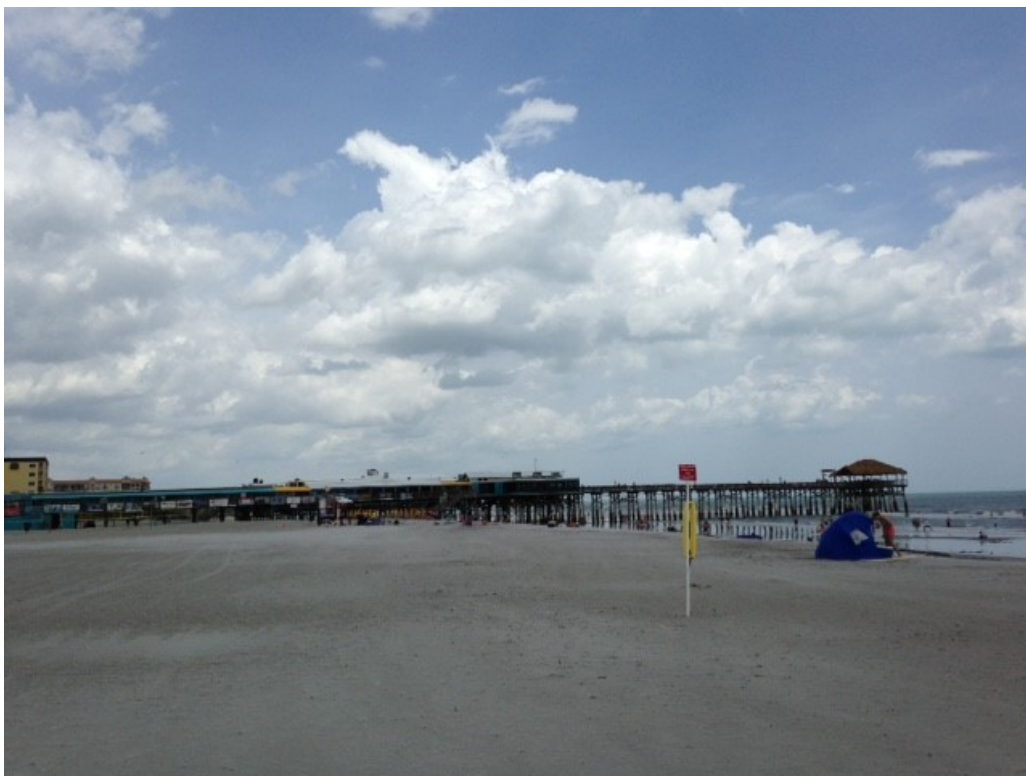
1. View looking north from ~R-17 toward the Cocoa Beach Pier. This beach is very wide, flat and stable. No areas of concern were observed.

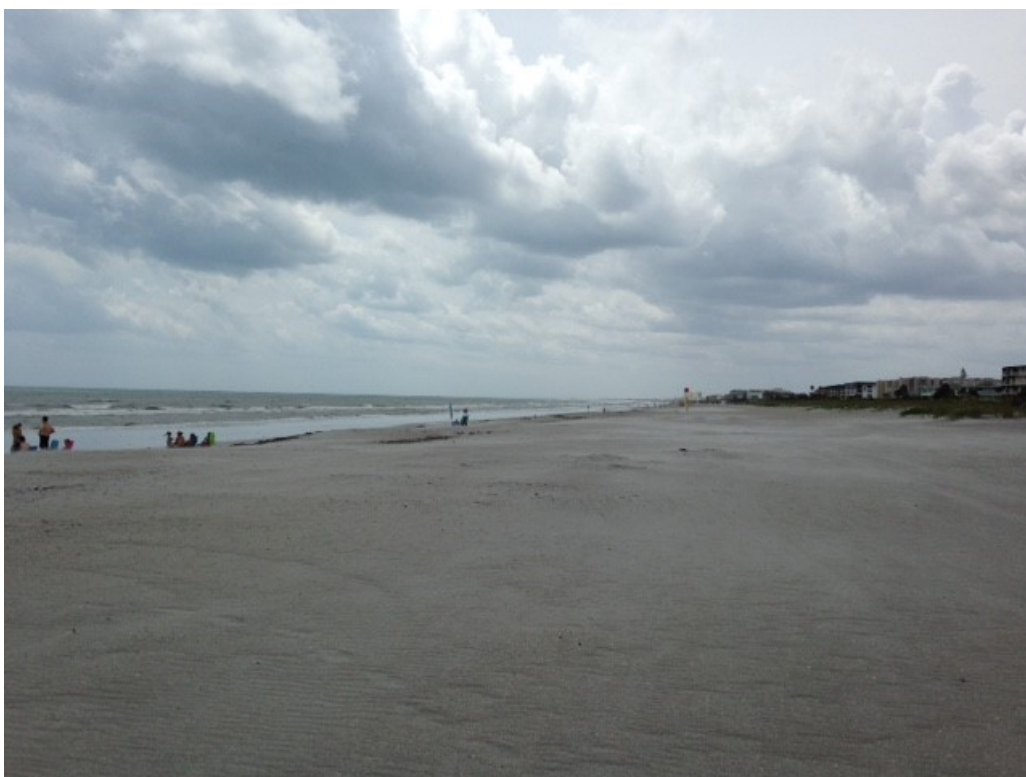
2. View looking south from ~R-17 just south of the Cocoa Beach Pier. This beach is very wide, flat and stable. No areas of concern were observed

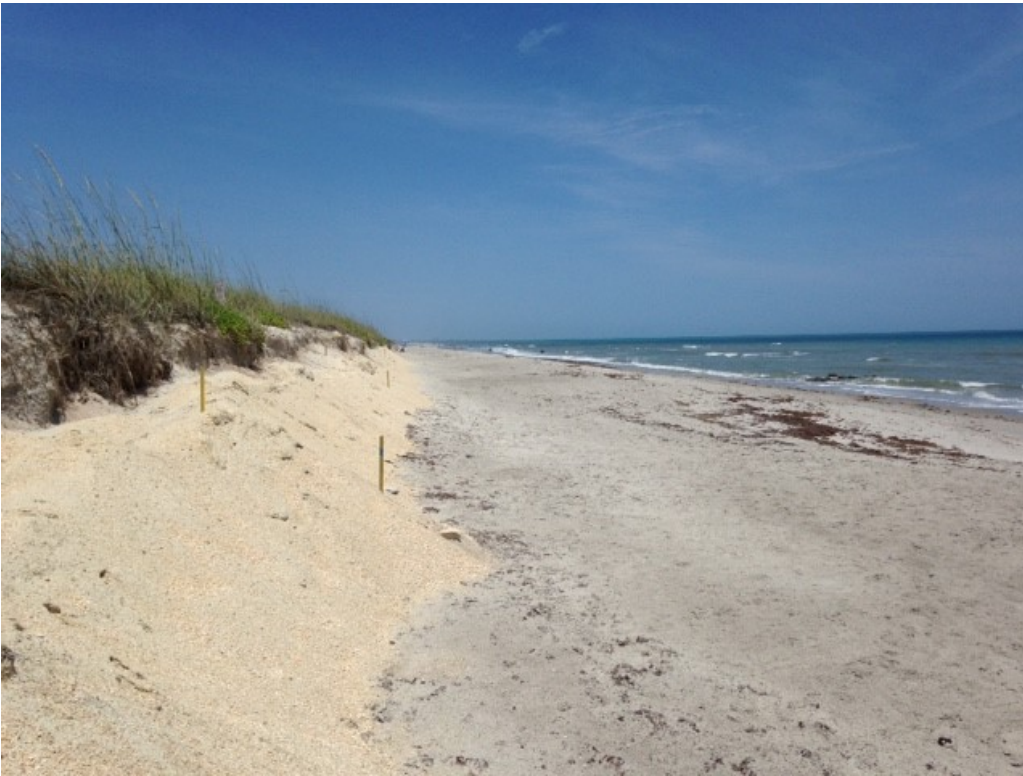
3. View looking north seaward of the Pineda Ocean Club. This fill was recently placed and is usually added annually (prior to nesting season) to ensure that the existing tube structure is adequately covered. Also visible is the older 3-4' scarp behind the fill.

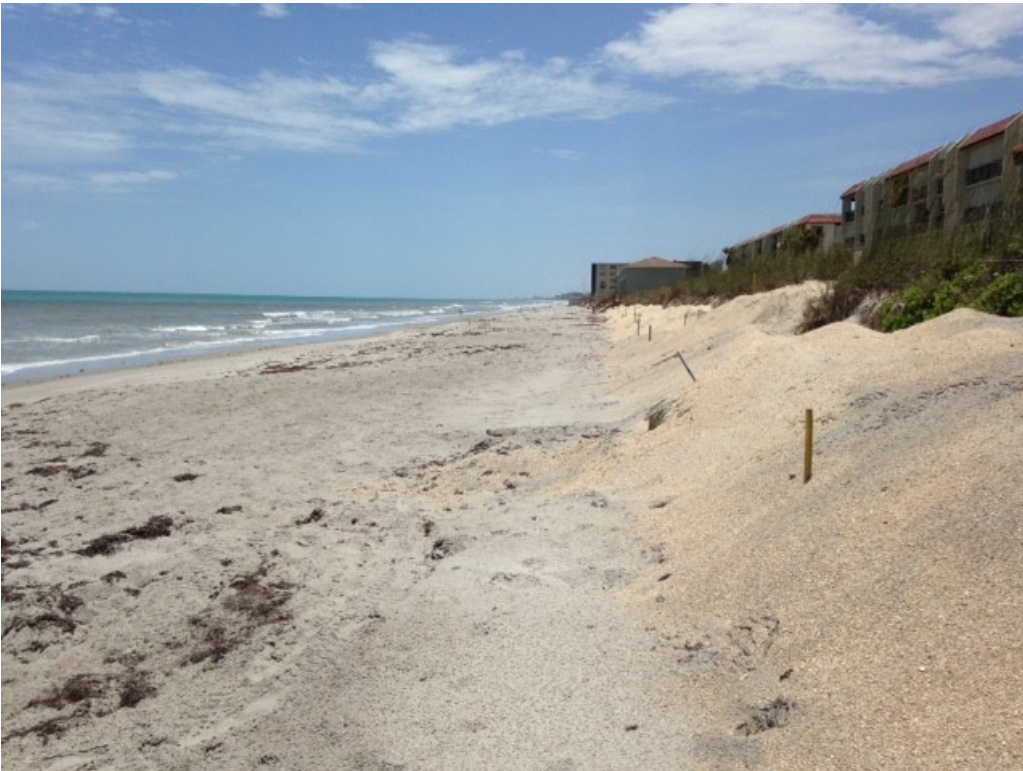
4. View looking south seaward of the Pineda Ocean Club. This fill was recently placed and is usually added annually (prior to nesting season) to ensure that the existing tube structure is adequately covered.

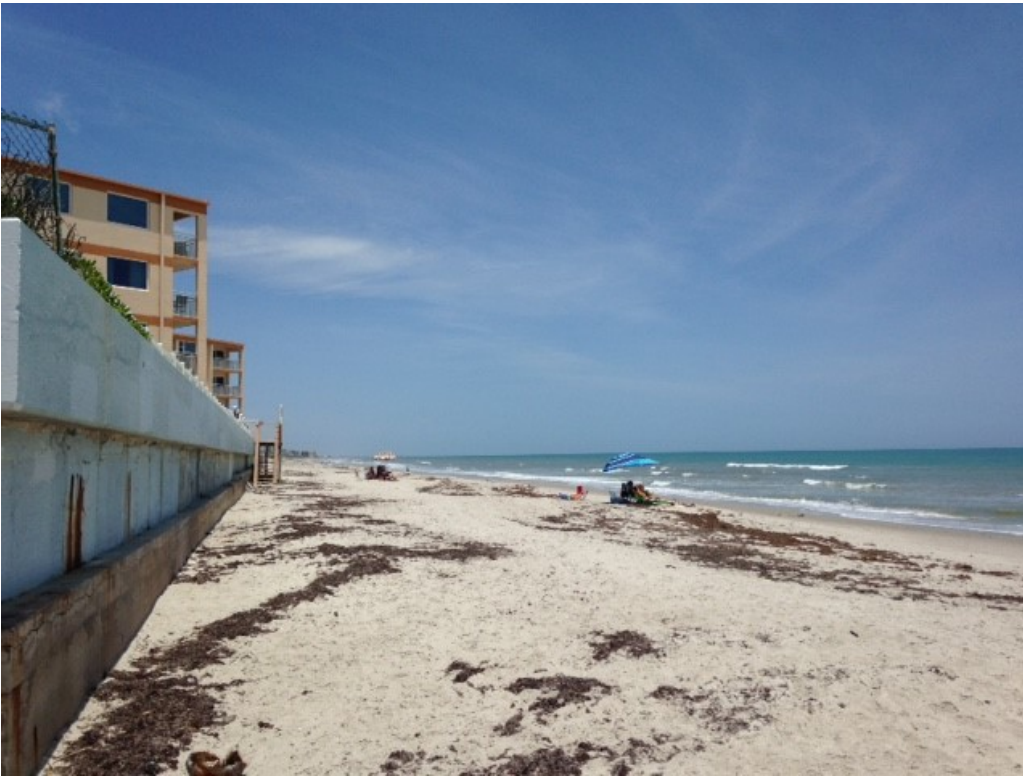
5. View looking north along the seawall at Paradise Beach Club just south of R-85. In this area it is typical for water to come up to the seawall as evident with the wrack zone. In this location the beach is generally flat with no dune system or native vegetation.

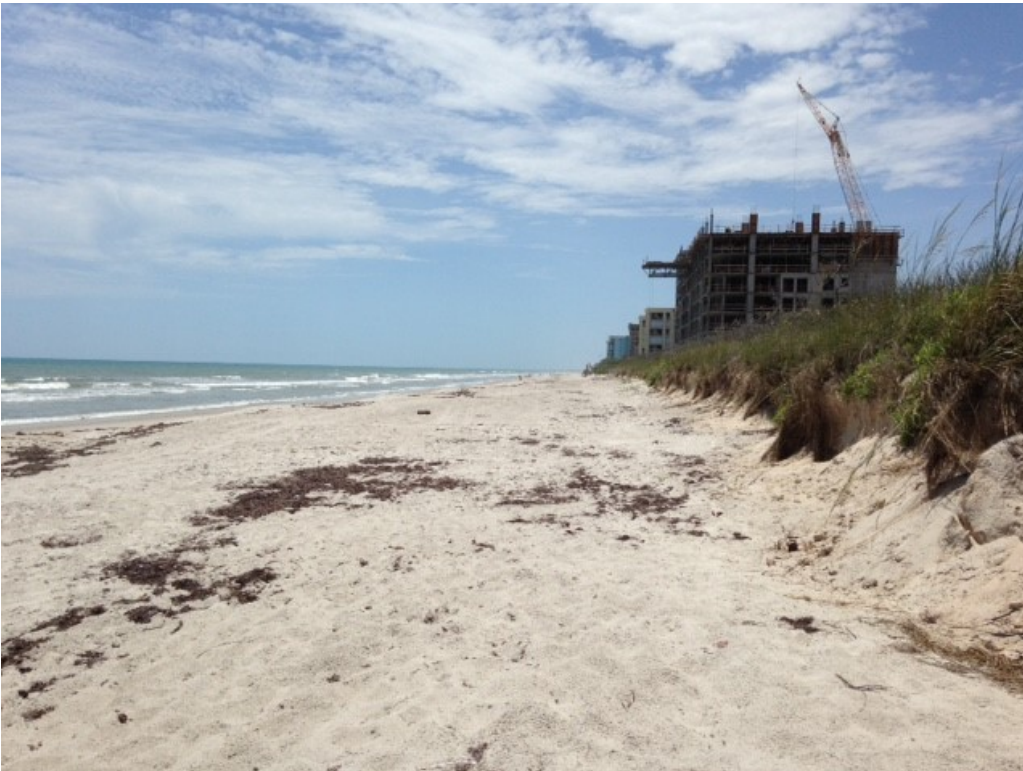
6. View looking south and a 180 degree pan from Photo #5. This section of beach is not armored and currently has a 4-6' landward scarp which is typical for this location. During periods of high waves/tides it is typical to see water up to the scarp as this beach is flat. BE-1346 construction is also pictured here in the distance.

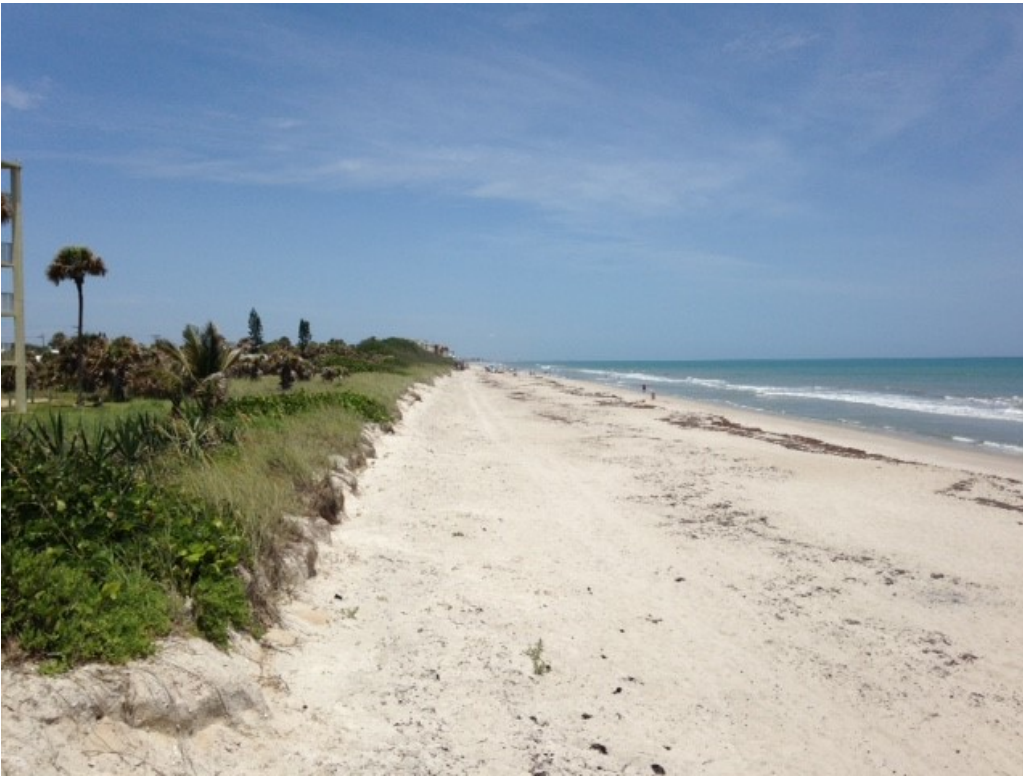
7. View looking north at R-95.5, just seaward of the Desoto access and Ocean St. Pictured here is a 2-4' landward scarp.

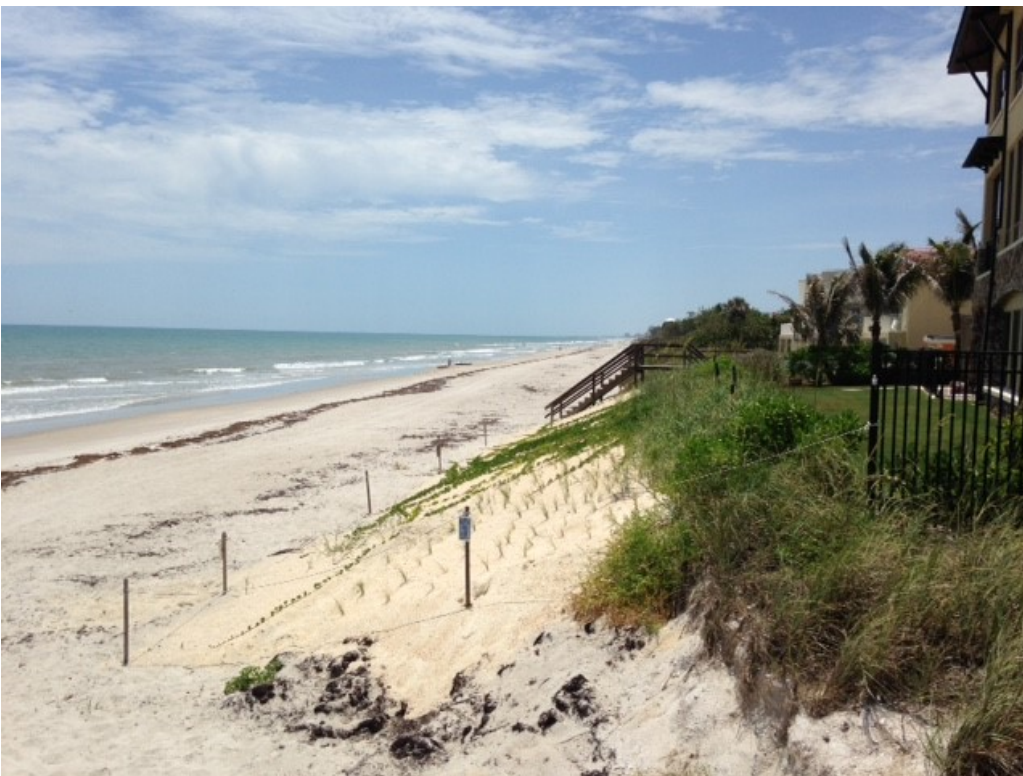
8. View looking south at R-95.5, just seaward of the Desoto access and Ocean St. Pictured here is the north property on Ocean Street where fill was recently placed under the Hurricane Matthew Emergency Order.

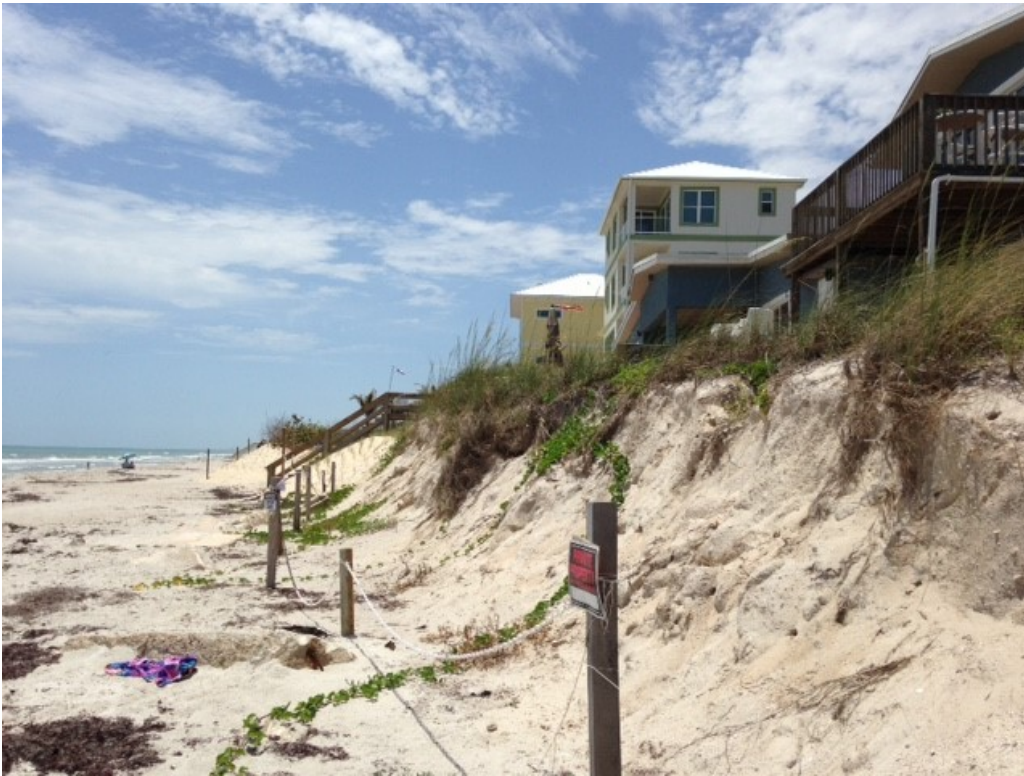
9. View looking south along the length of Shell Street. Currently there is a 4-6' landward scarp across the majority of the area. Just to the north of the photo there is some old debris/rock that was exposed on the beach. Some of the properties just south of this photo placed sand under the Hurricane Matthew Emergency Order and can be seen in the photo.

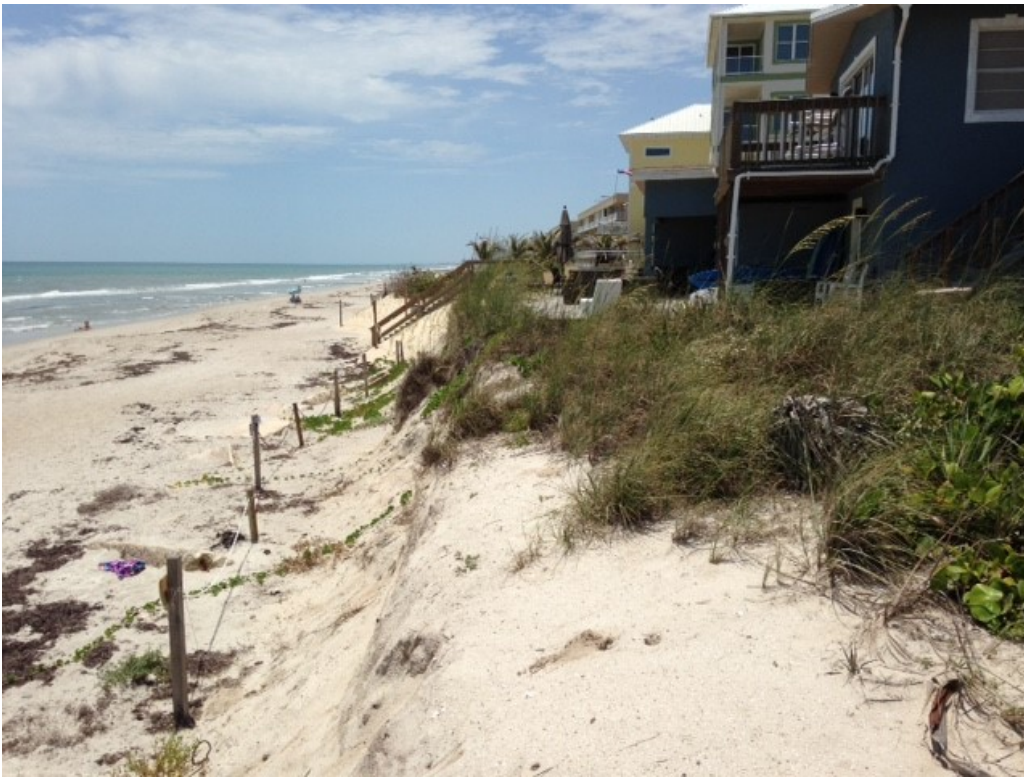
10. Same location as Photo #9 just taken from the elevated public dune walkover to get a better vantage point and to illustrate the proximity of scarp to major structures. This area is typically impacted during heavy storm/wave events. In addition, some of the debris can now be seen on the sandy beach.

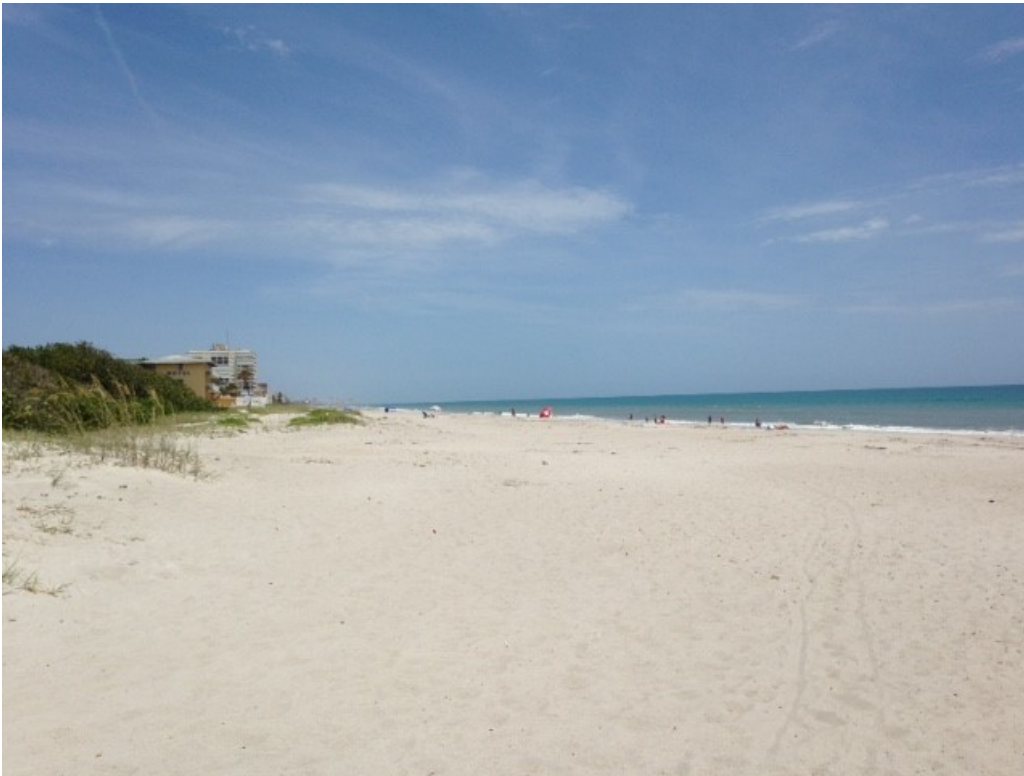
11. View looking north along the beach at R-123 just seaward of the Indialantic Boardwalk. Currently, the beach is wide with a accreting foredune.

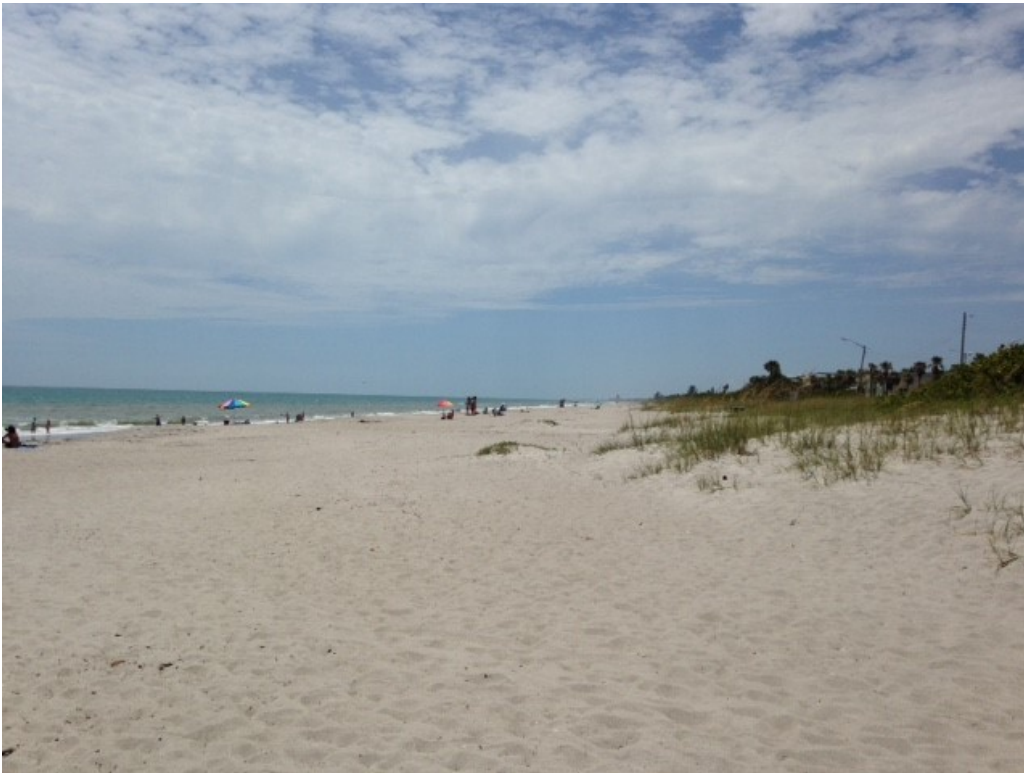
12. View looking south along the beach at R-123 just seaward of the Indialantic Boardwalk. Currently, the beach is wide with a accreting foredune. There were no areas of concern noted throughout this area.

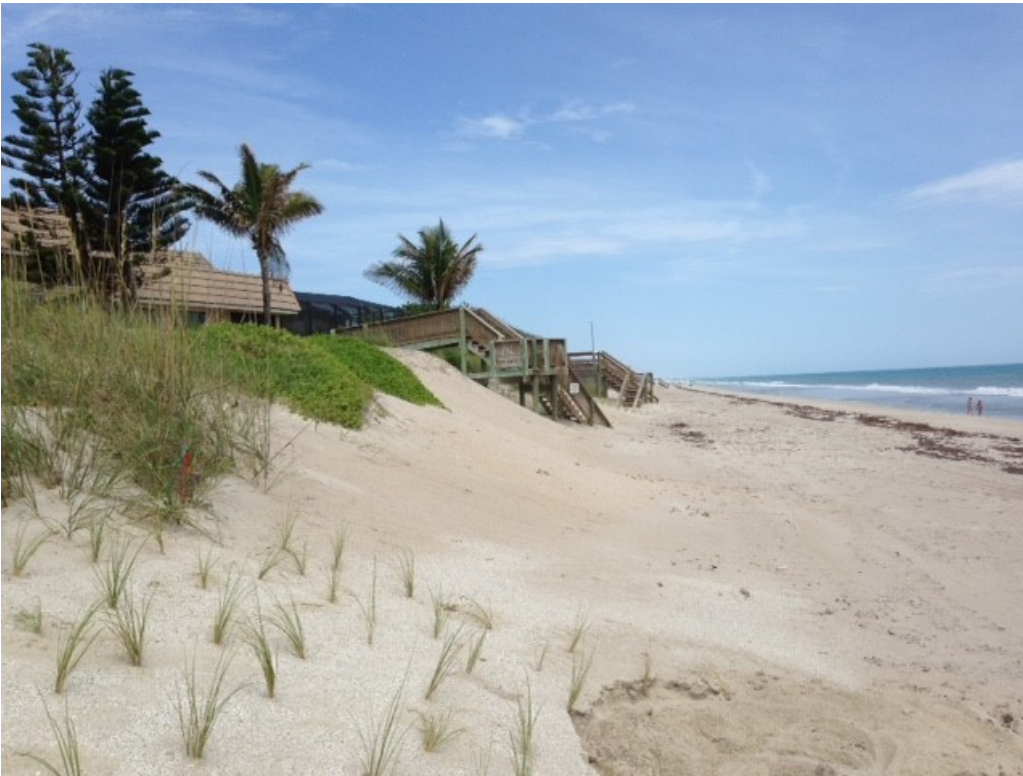
13. View looking north along the beach at ~R-153 toward the 3125 A1A, Melbourne Beach address. There is an existing tube structure at this residence.

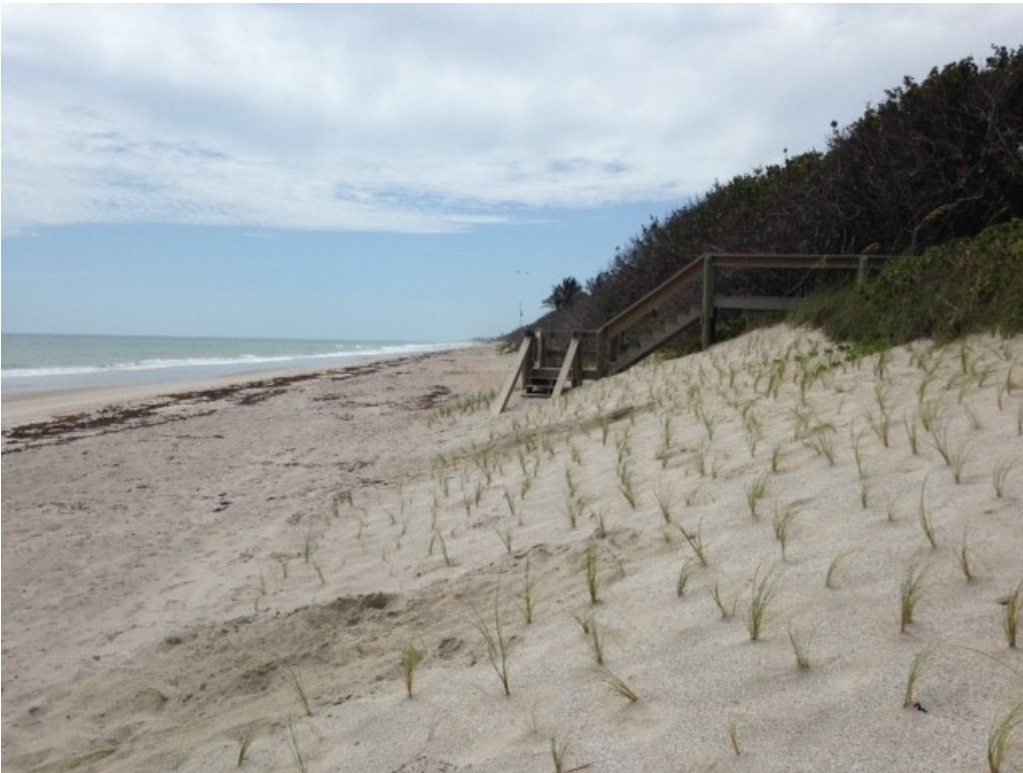
14. A 180 degree pan from Photo #13 at R-153. Sand was placed at this residence after Hurrican Matthew under the Emergency order.

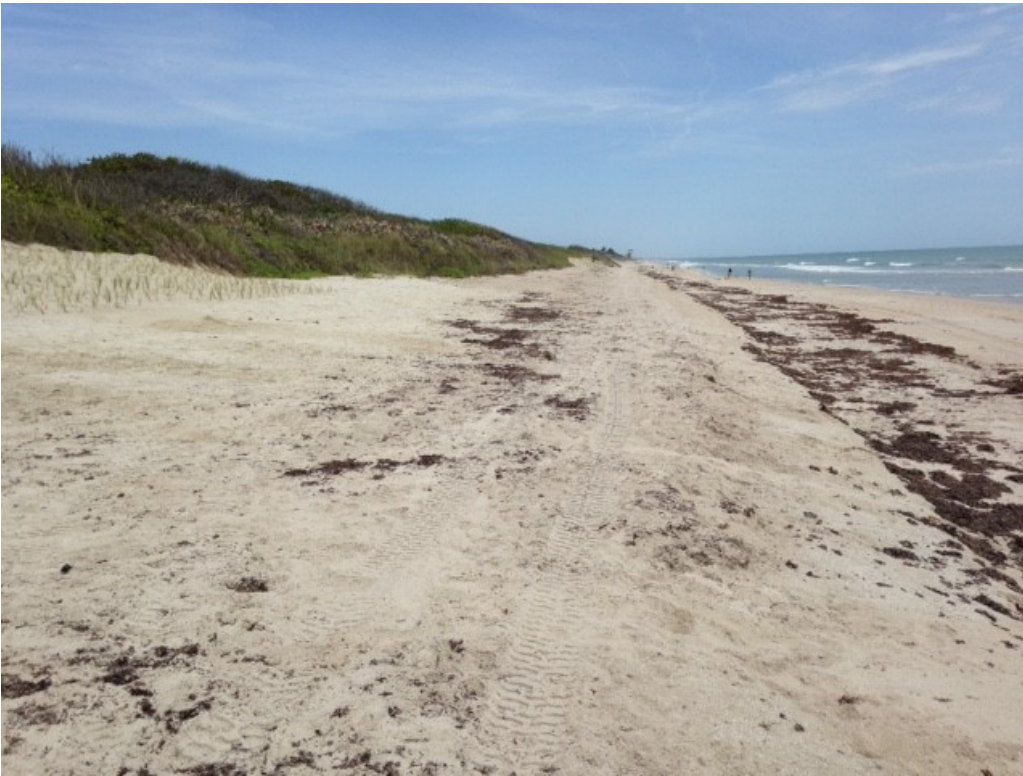
15. View looking north along the beach at ~R-159. Currently, there is a 2-4' low angle scarp located at mid-beach. As observed in the photo beach compatible fill and supplemental dune plantings were placed here by the county following Hurricane Matthew.

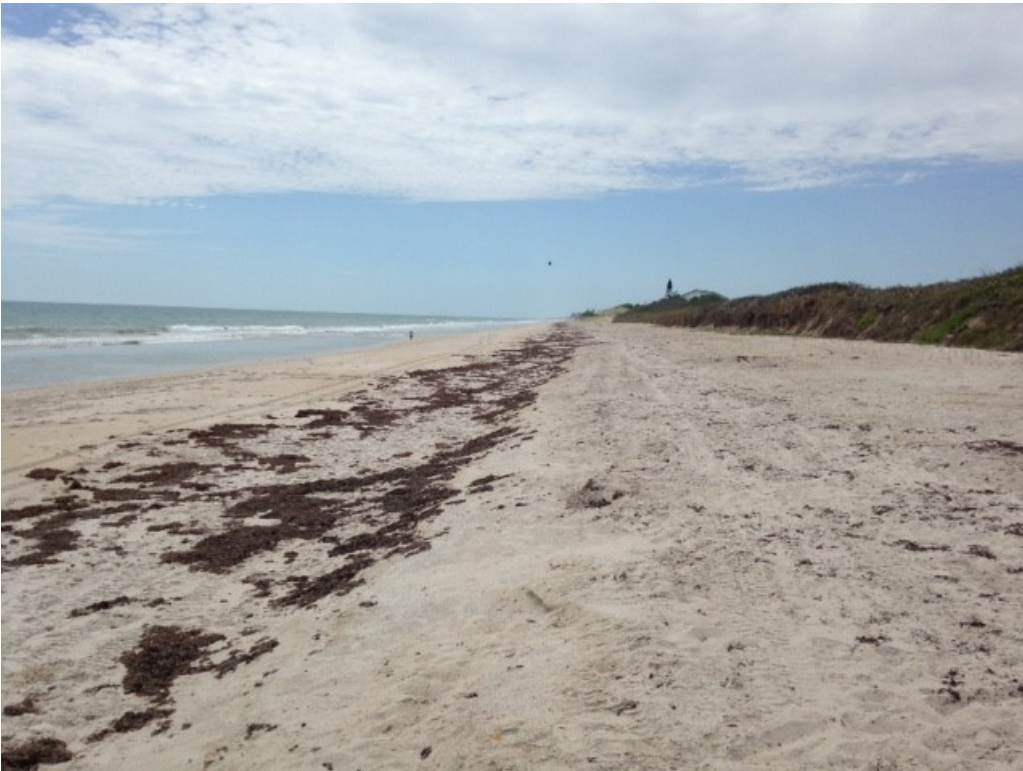
16. View looking south along the beach at ~R-159. Currently, there is a 1-3' low angle scarp located mid-beach at this location. There is a much larger and steeper slope further landward in this direction.

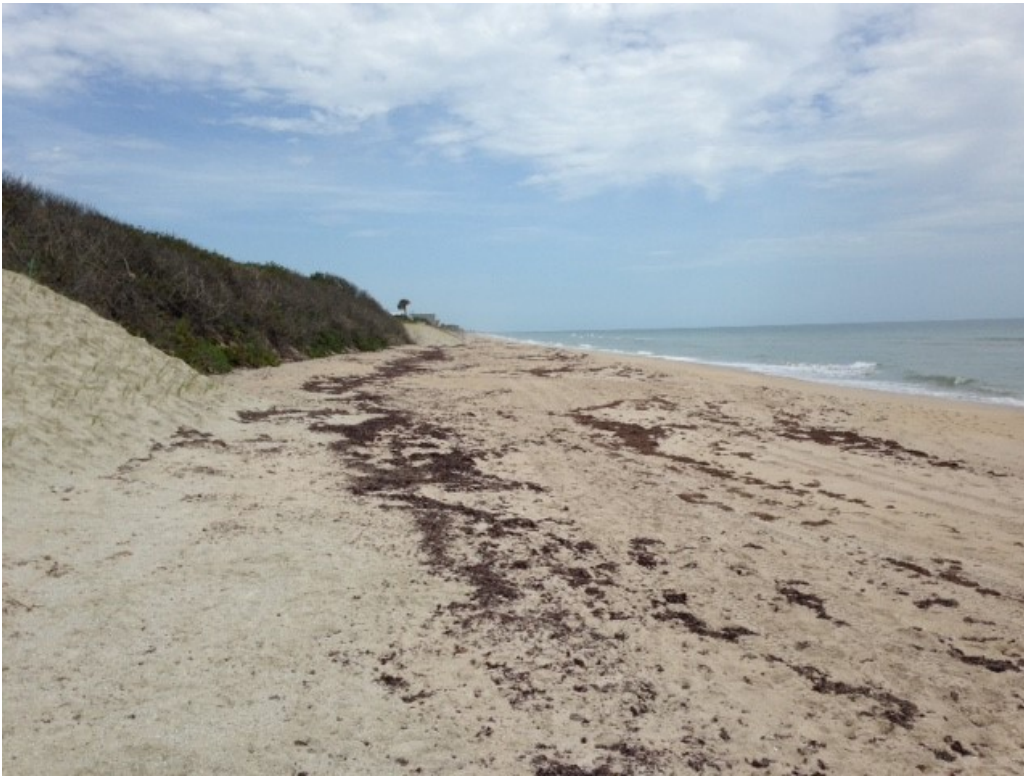
17. View looking north along the beach at ~R-187.5 just north of the Sebastian Beach Inn. As observed in the photo beach compatible fill and supplemental dune plantings were placed here by the county following Hurricane Matthew.

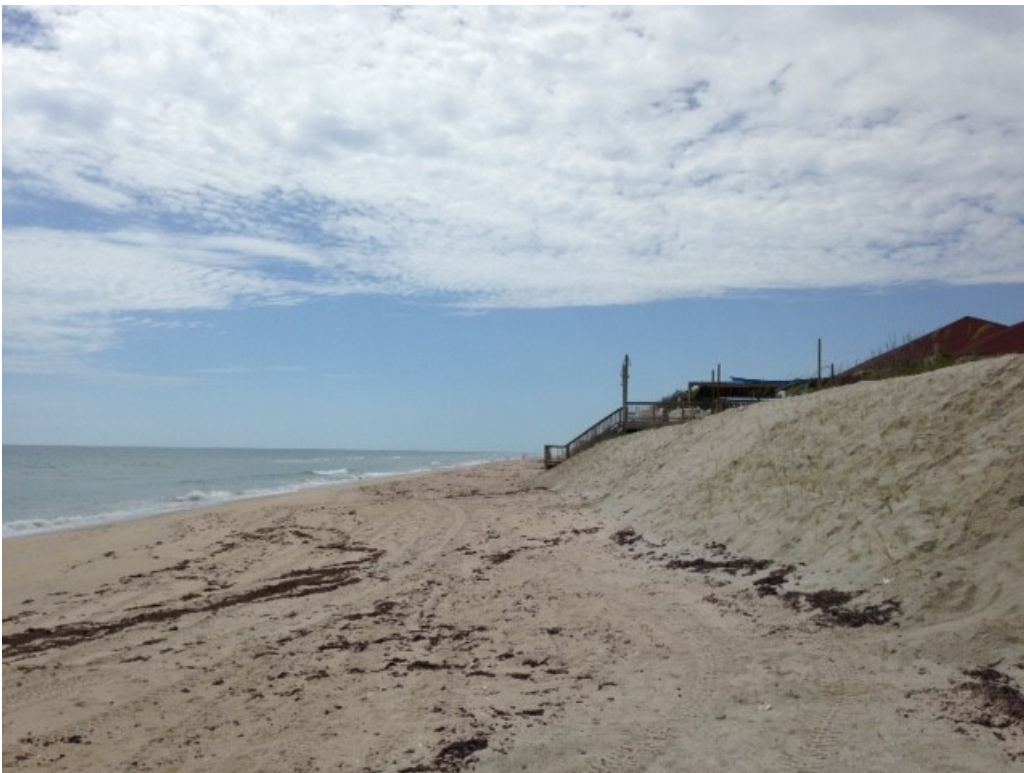
18. View looking south along the beach at ~R-187.5 toward the Sebastian Beach Inn.. Currently, the beach is wide for this area with no seaward scarps being observed. As seen in this photo, sand was placed to the seaward end of the dune walkover. Sand placement under the Emergency Order also included the planting of Sea oats here.

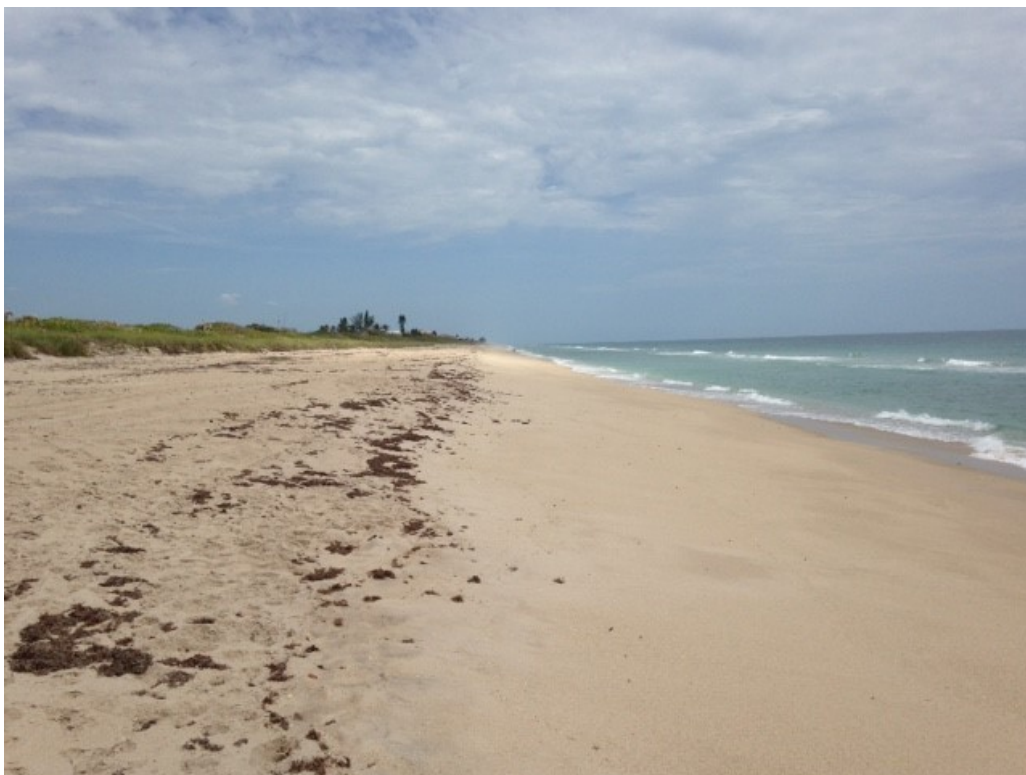
19. View looking north along the beach at ~R-215 just north of the Sebastian Inlet. Currently, there are no areas of concern at this location and the beach slopes moderately to the water.

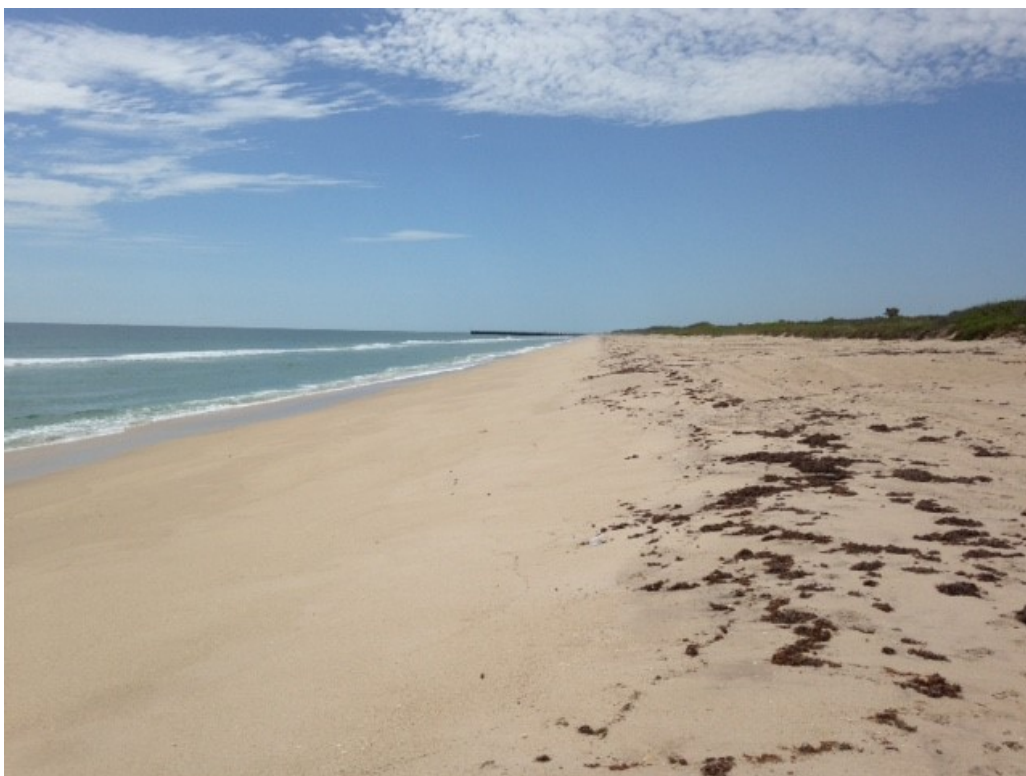
20. View looking south along the beach at ~R-215 just north of the Sebastian Inlet which can be seen in this photo. Currently, there are no areas of concern at this location and the beach slopes moderately to the water.
