# Florida Department of Environmental Protection

## WINDSHIELD SURVEY REPORT

| Hurricane Name: 2017 Pre-Season | | Survey Date: 05/10/17 | | | | | Survey Tide Stage (if known): | | | | | | | | | |

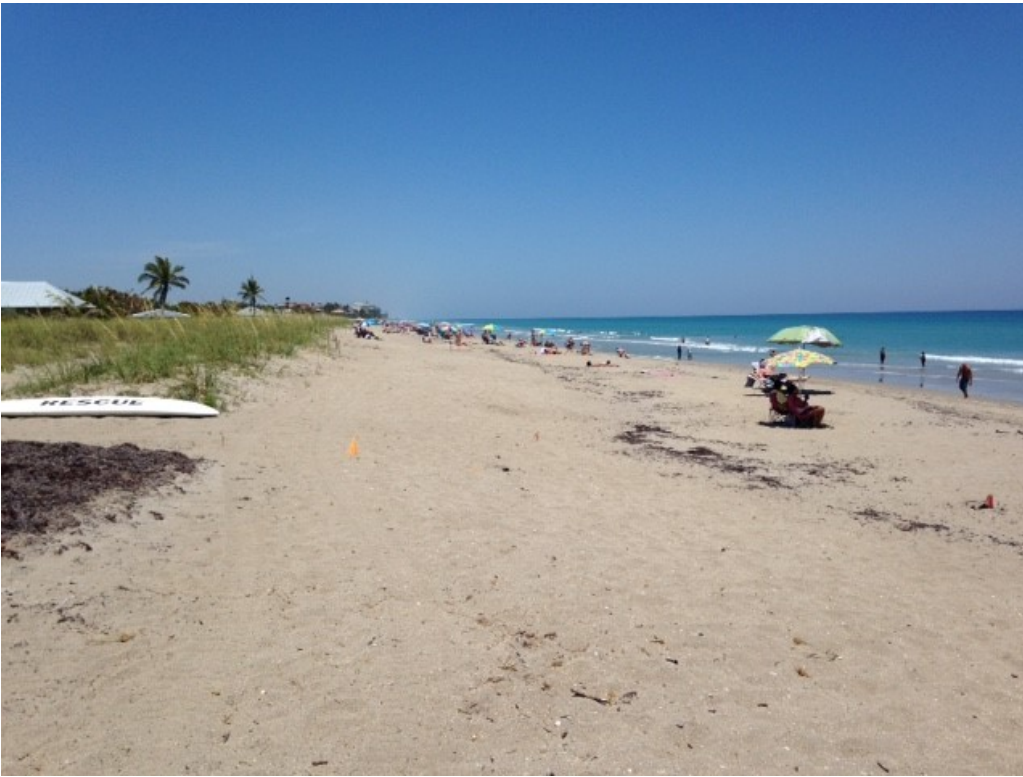
1. View looking north from ~R-5.5 at Jensen Beach Park. Currently the beach is fairly wide, typical and with no problem areas noted.

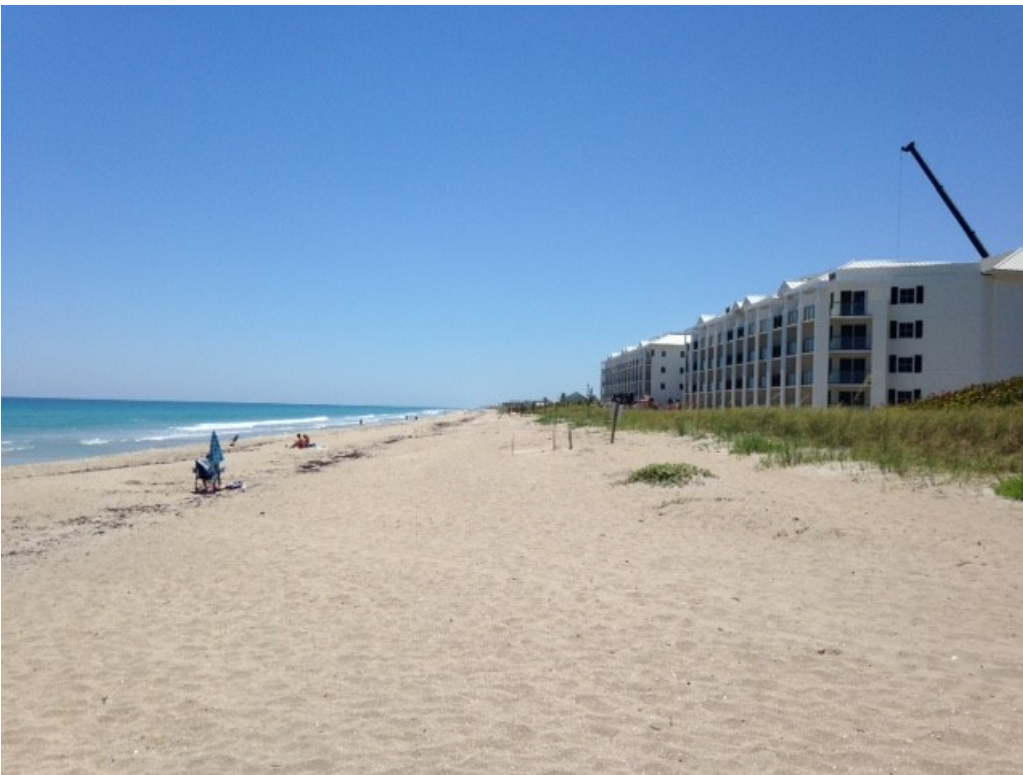
2. View looking south from ~R-5.5 at Jensen Beach Park. Currently the beach is wide with no problem areas noted. As pictured, there are minor amounts of hummocky foredune features trying to establish.

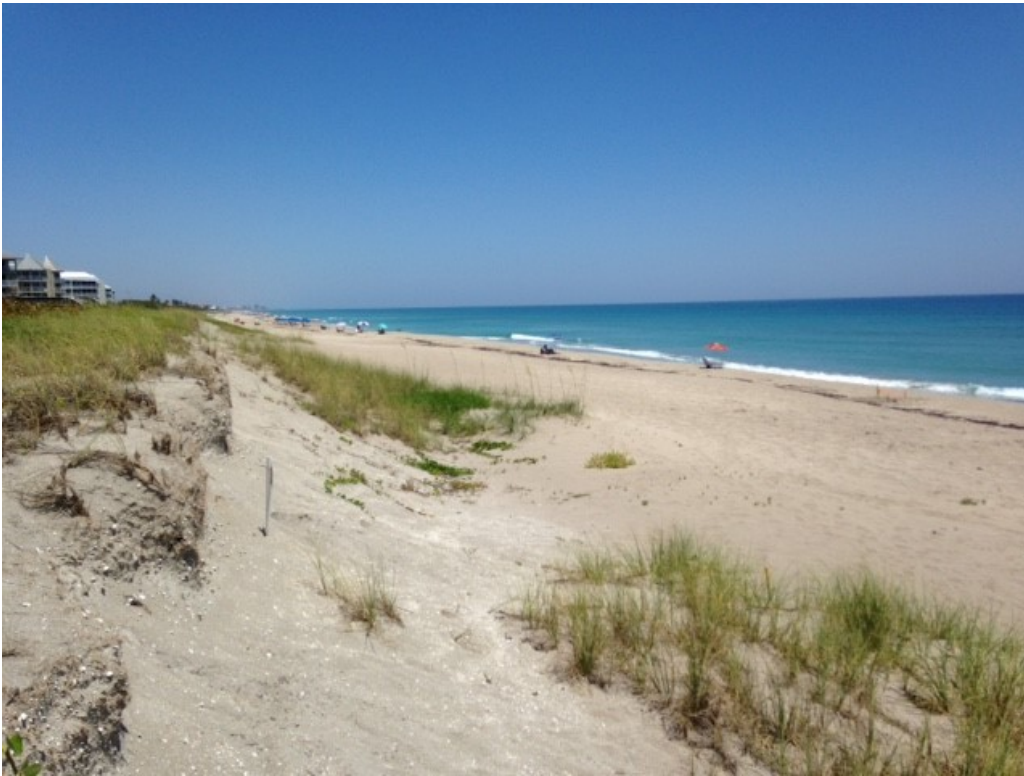
3. View looking north from ~R-25.5 at the Dunes Club Condo. Pictured here is an old scarp (1-3') which is landward of existing pioneer vegetation. Currently the beach is wide, typical and with no problem areas noted.

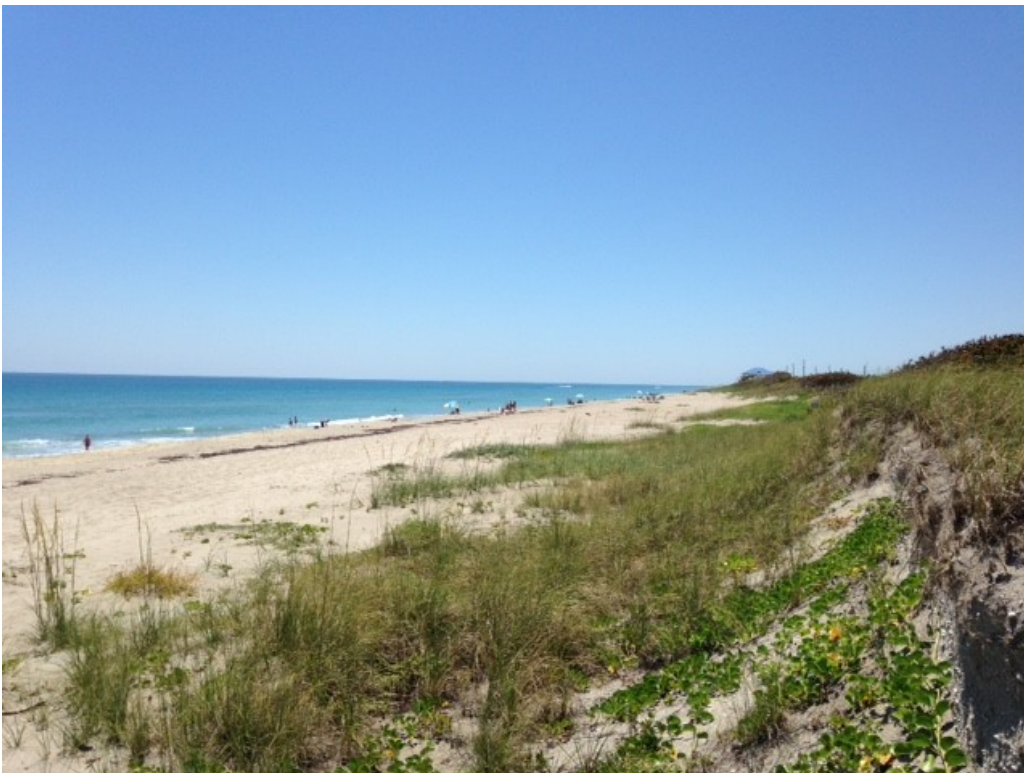
4. View looking south from ~R-25.5 at the Dunes Club Condo. Pictured here is an old scarp (1-3') which is well landward of existing pioneer vegetation. Currently the beach is wide, typical and with no problem areas noted.

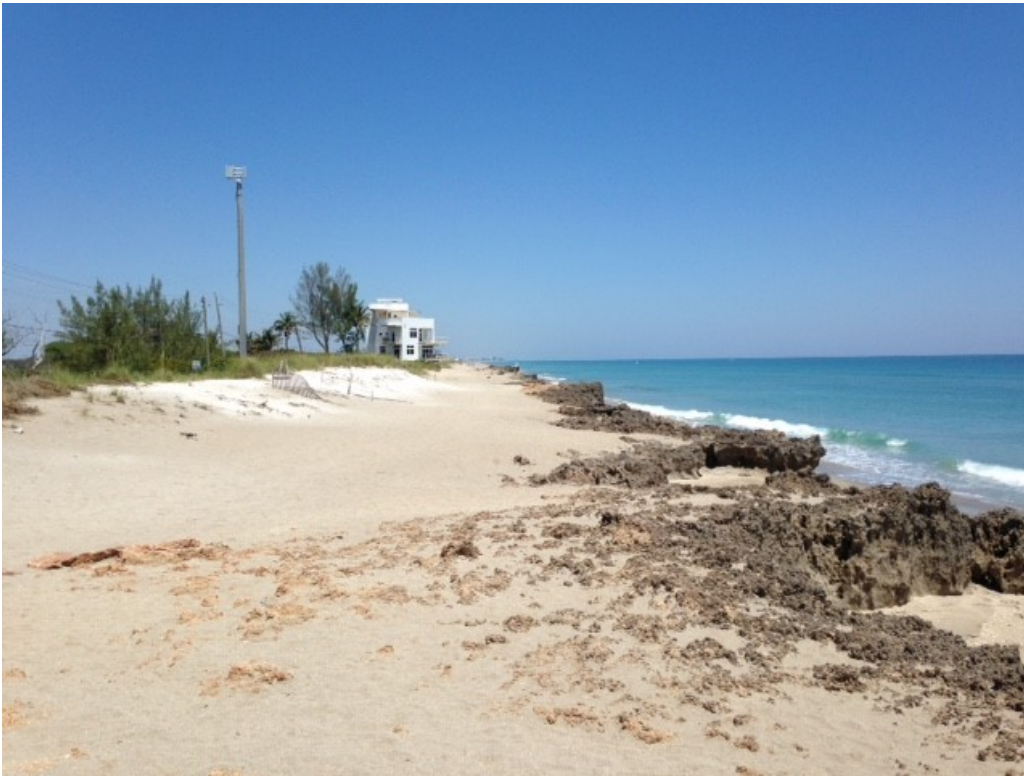
5. View looking north from ~R-29.5 at the House of Refuge showing typical conditions.

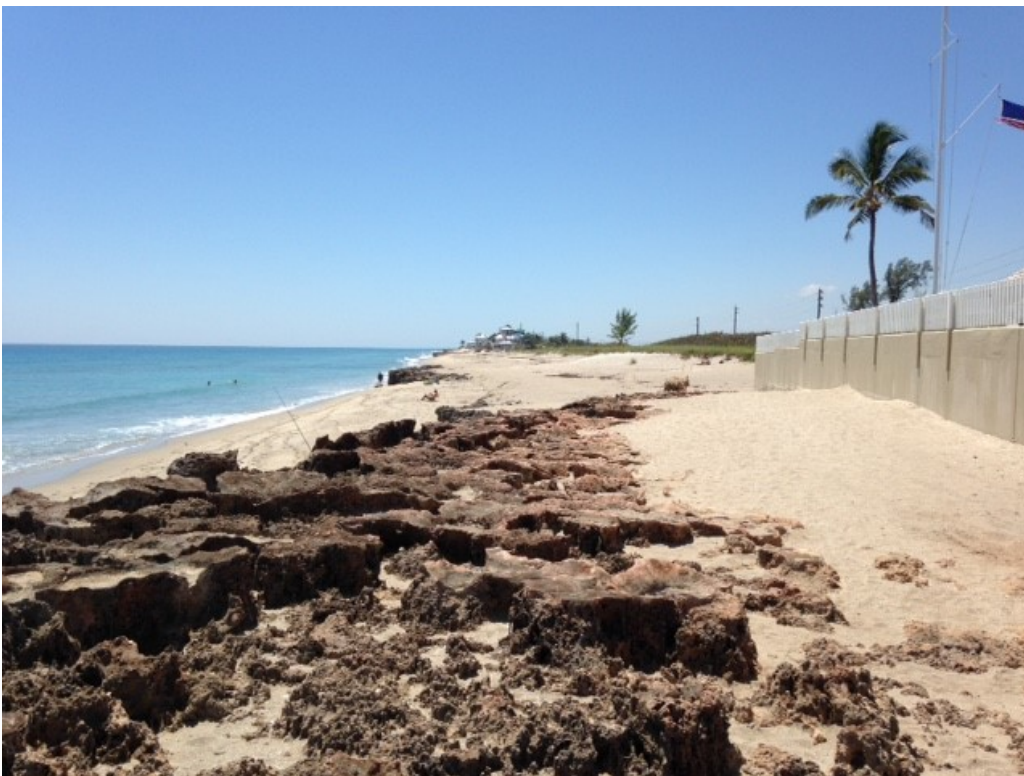
6. View looking south from ~R-29.5 at the House of Refuge. No problem areas were noted.

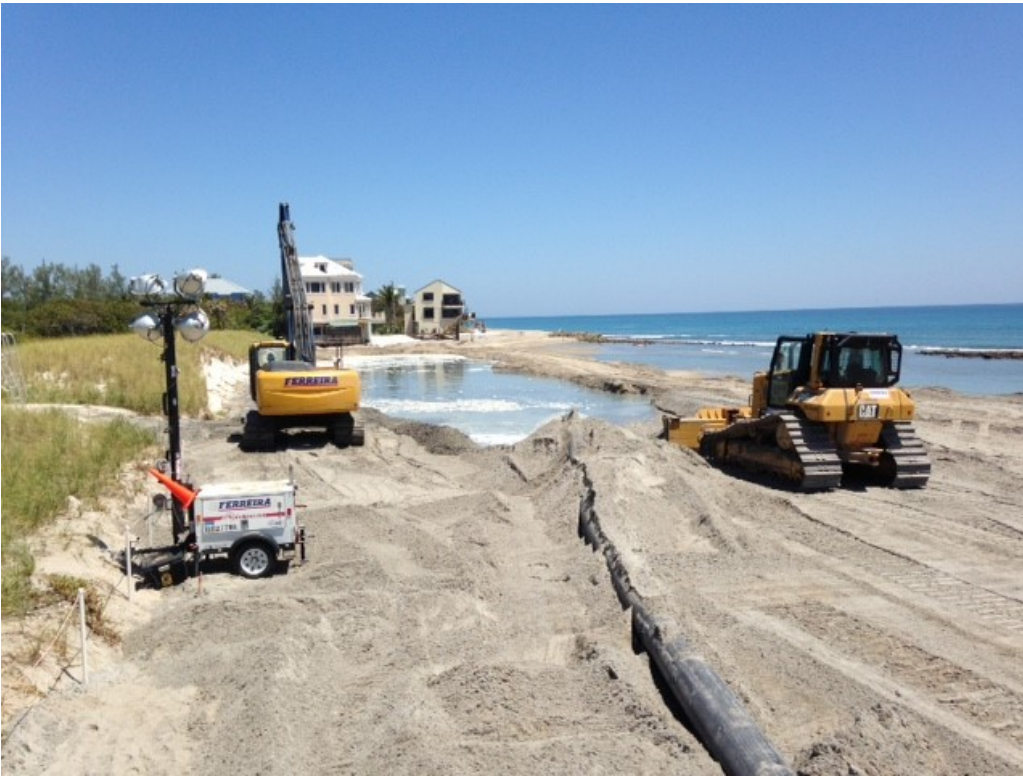
7. View looking north toward the Brown/Taschman property and Bathtub Reef Beach from ~R-35. As pictured, there is currently a JCP sand placement project underway. Due to an extensive sand placement project here last year, the beach was still quite wide despite having a scarp mid-beach prior to this photo. It should be noted that the dune construction and revegetation (left) remains well intact from last year's project. Beyond the equipment, typical low-tide conditions are observed.

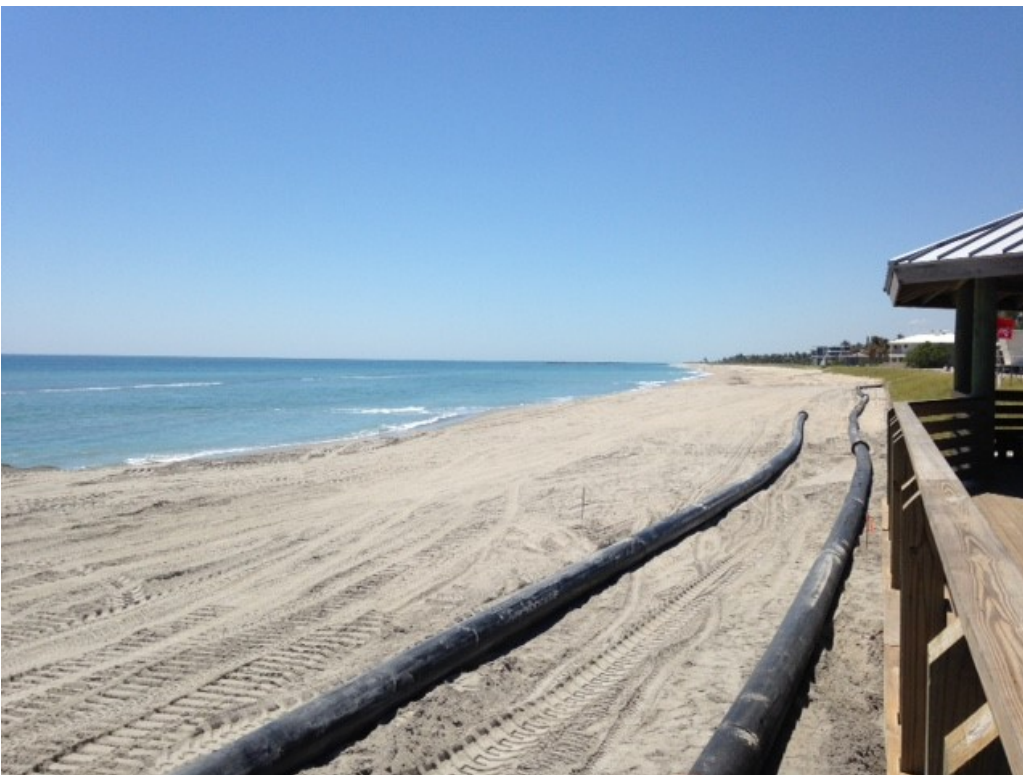
8. View looking south from the Bathtub Reef Beach deck/pavilion from ~R-35. Despite some sand loss during winter 2016/2017, the beach remained wide due to the large JCP sand placement project last year. Prior to this year's JCP project there was a scarp mid-beach but conditions overall were still much wider than in year's past.

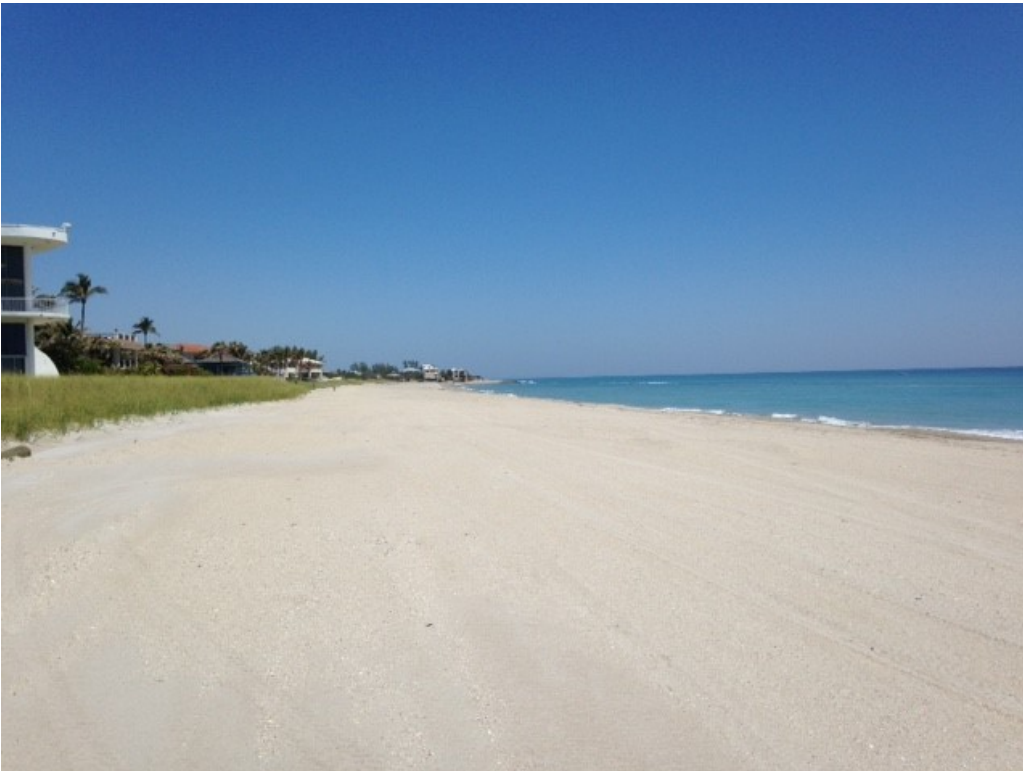
10. View looking north seaward of the 2001 Condominium and un-permitted rock revetment. Currently, the beach is wide due to recent (Spring 2017) sand placement under JCP permit.

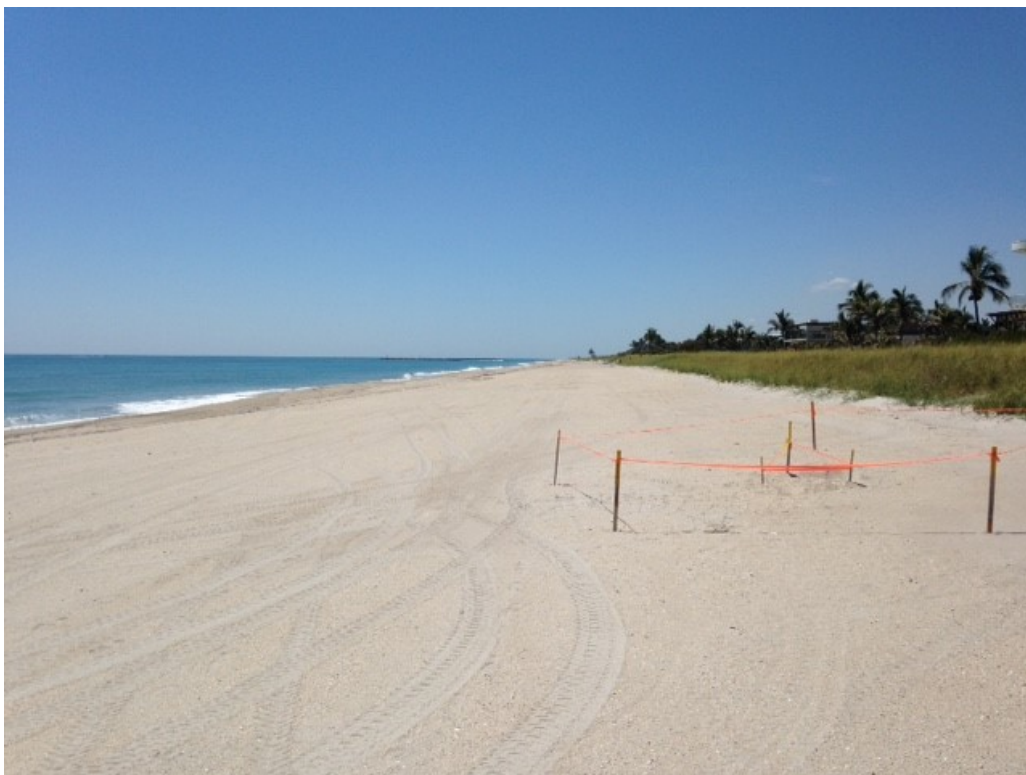
11. A 180-degree pan from Photo #10 looking south seaward of the 2001 Condominium and un-permitted rock revetment. Currently, the beach is wide due to recent (Spring 2017) sand placement under JCP permit.

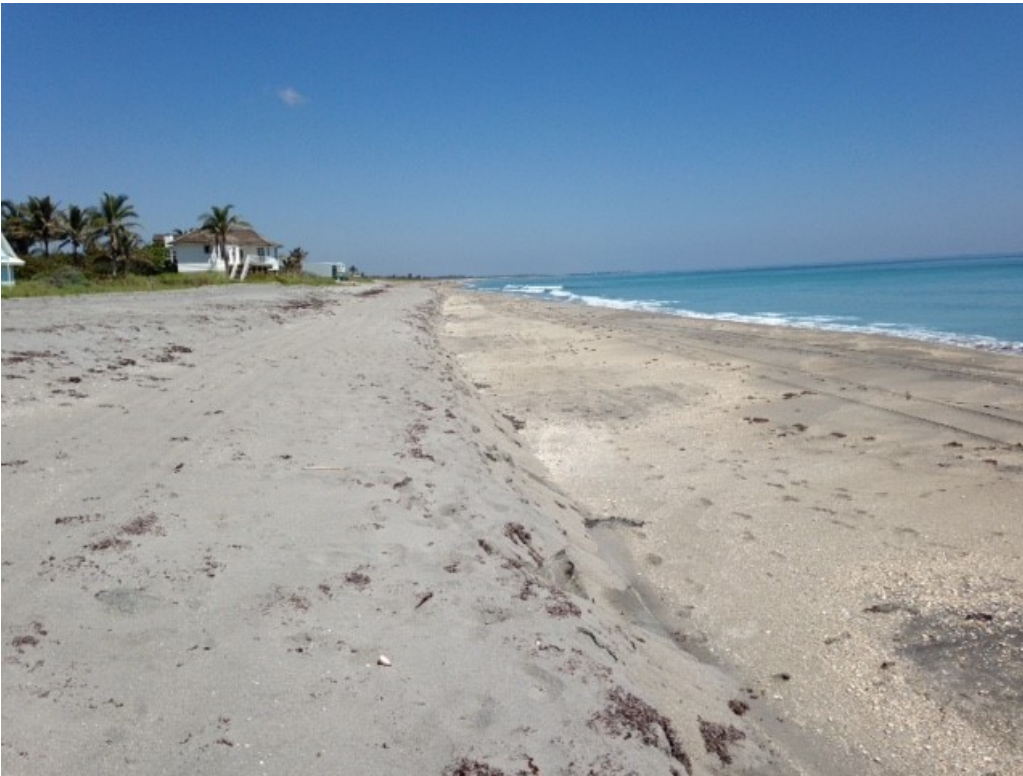
12. View looking north from ~R-78.5 seaward of the 141 N. Beach Rd. area. Prior to 2016, this area was chronically plagued with highwater incursions and steep vertical scarping. However, with the 2016 JCP sand placement project, the beach remains wide. The boundary between the JCP placed sand last year and native beach sand can be seen by the difference in color. This area is currently marked by a 1-3' scarp (pictured). No current problems were noted.

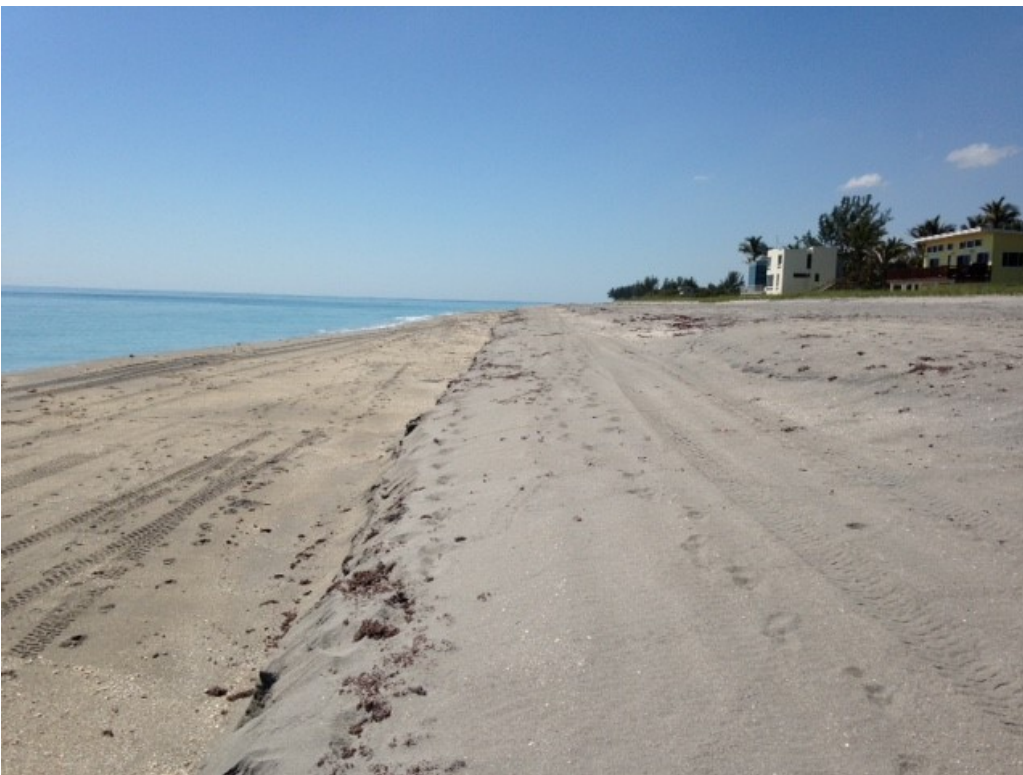
13. View looking south from ~R-78.5 seaward of the 141 N. Beach Rd. area. This area was chronically plagued with highwater incursions and steep vertical scarping. However, a 2016 JCP sand placement project has widened this beach considerably. The boundary between the JCP placed sand last year and native beach sand can be seen by the difference in color. This area is currently marked by a 1-3' scarp (pictured). No current problems were noted.

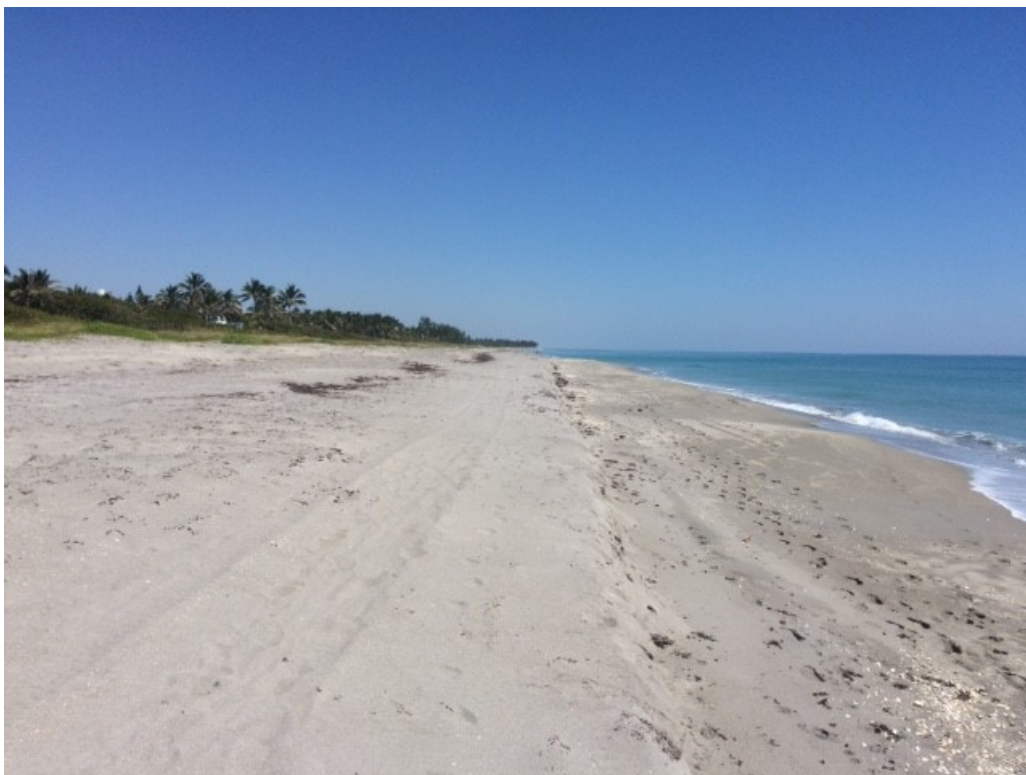
14. View looking north near ~R-82. The 2016 JCP sand placement project has widened this beach considerably. This area is currently marked by a 1-3' seaward scarp (pictured). No current problems were noted.

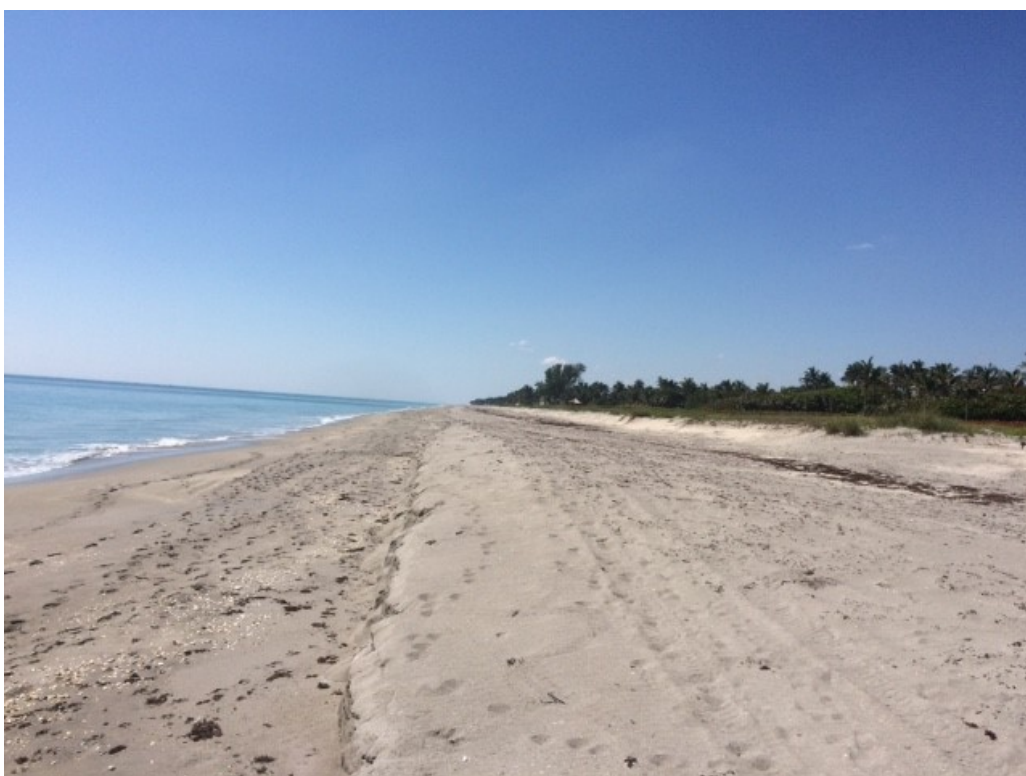
15. View looking south near ~R-82. The 2016 JCP sand placement project has widened this beach considerably. This area is currently marked by a 1-3' seaward scarp (pictured). No current problems were noted.

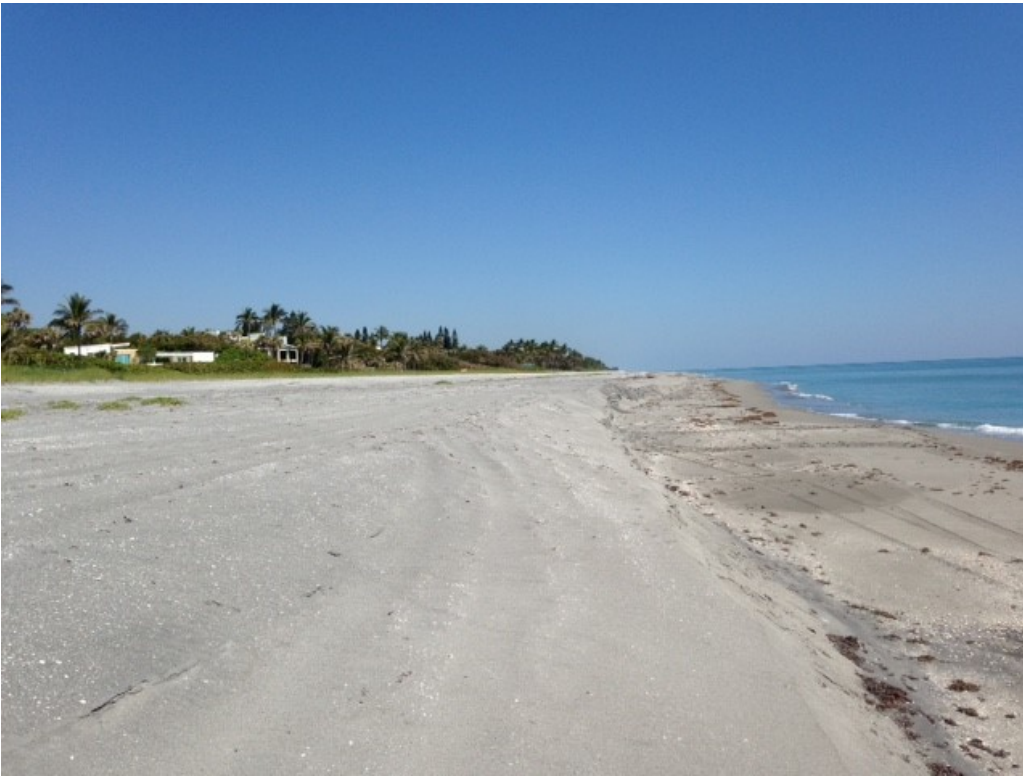
16. View looking north from ~R-104.5 seaward of 285 S. Beach Road, Jupiter Island. A recently concluded JCP sand placement project has widened this beach considerably. Currently there is a low angle 2-4' scarp at mid-beach and further seaward. This area is armored with seawalls and revetments and under prolonged storm/erosional circumstances this beach is usually very narrow. During those periods, it is typical to see the water up to the seawalls (and difficult to traverse the beach) as was observed in 2014/2015 windshield reports.

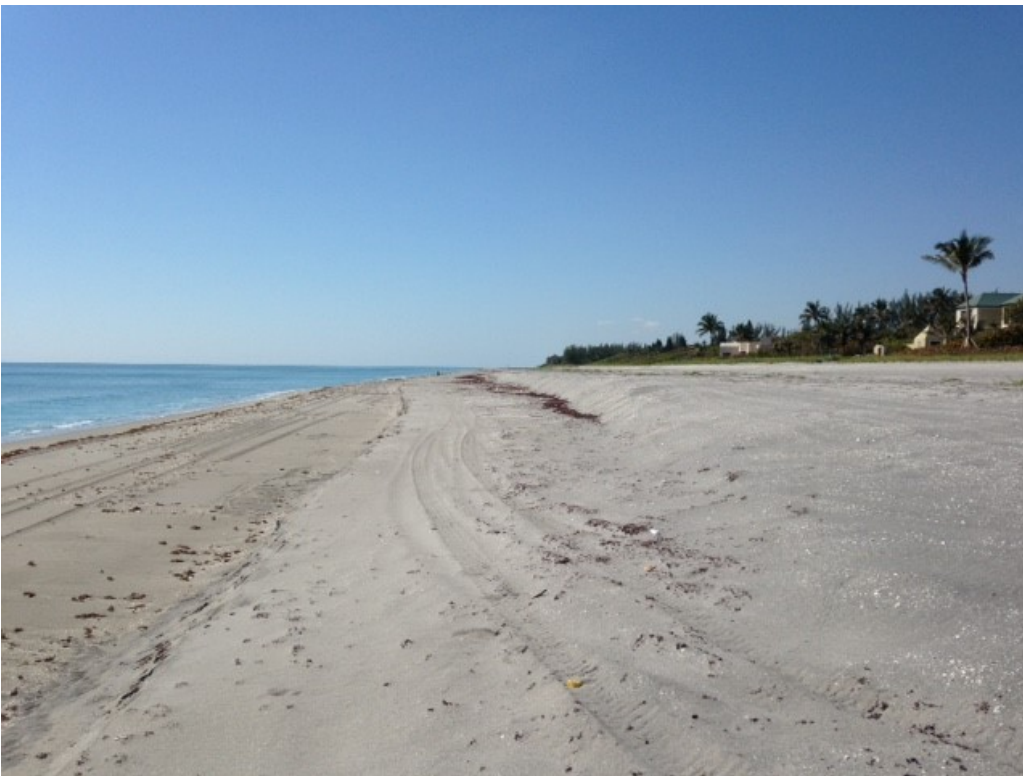
17. View looking south from ~R-104.5 seaward of 285 S. Beach Road, Jupiter Island (180-degree pan from Photo #16). A recently concluded JCP sand placement project has widened this beach considerably. Currently there is a low angle 2-4' scarp at mid-beach and further seaward.

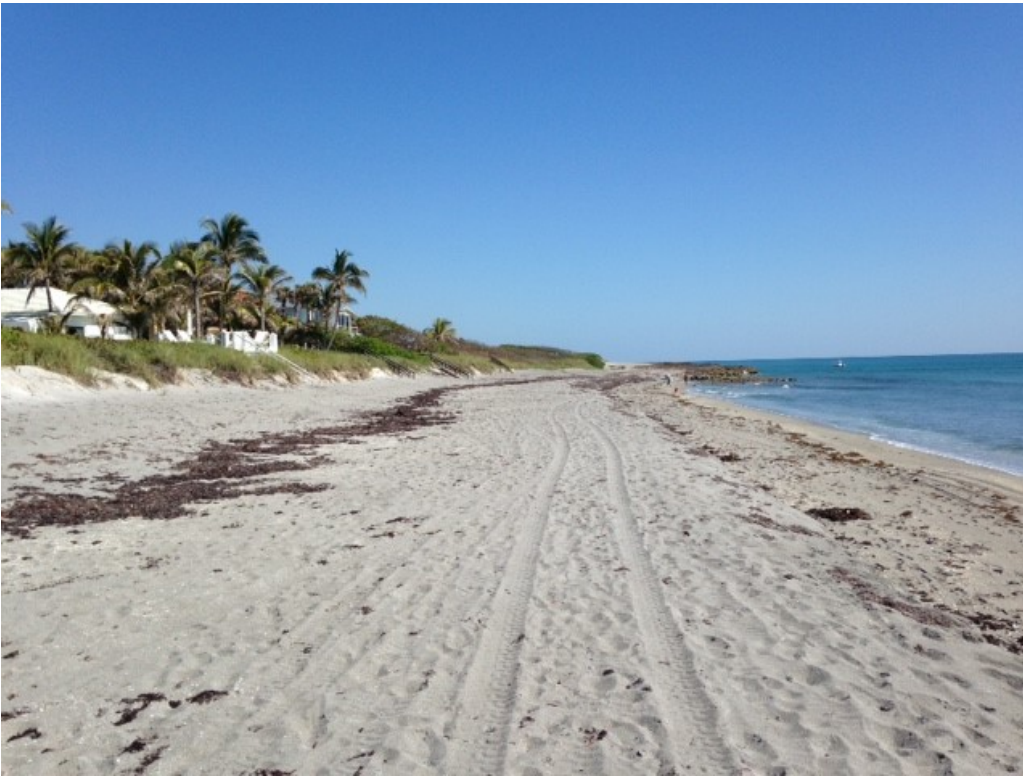
18. View looking north near ~R-127.5 seaward of 615 S. Beach Road, Jupiter Island. Currently in this location there is a 1-3' seaward vertical scarp and a lower angle 2-5' older, landward scarp. No problems were noted.

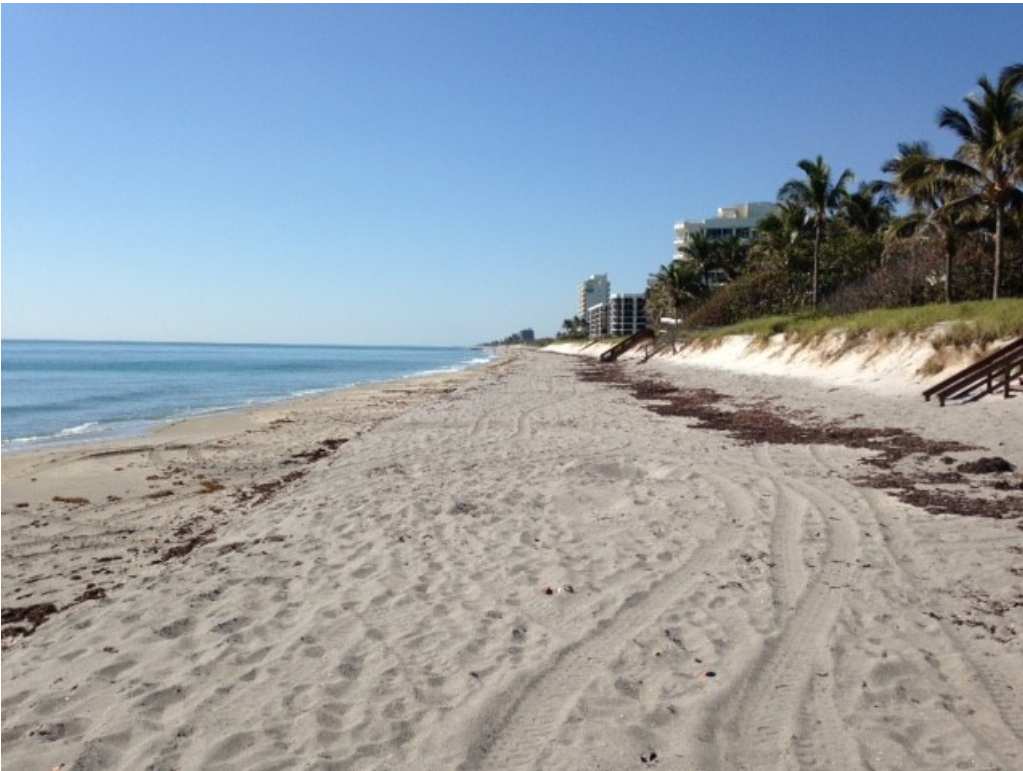
19. View looking south near ~R-127.5 seaward of 615 S. Beach Road, Jupiter Island. Currently in this location there is a 1-3' seaward vertical scarp and a lower angle 2-5' older, landward scarp. No problems were noted.
