# Appendix A

## Gottfried Creek Shoreline Inspection

December 16, 2011 and July 2, 2012

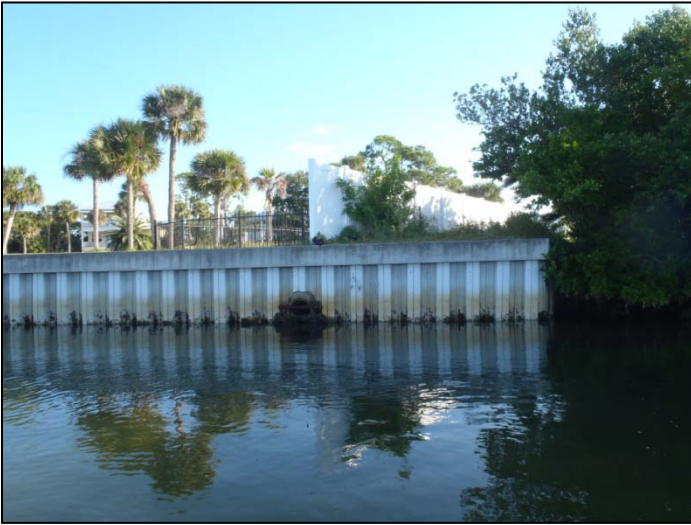
**Figure A.1.**

GC-1: 18" Concrete Stormwater Pipe  
26.93582/-82.34287

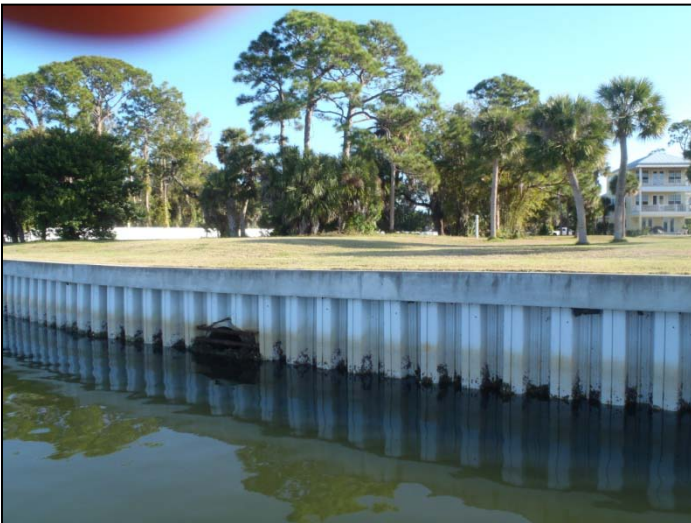
**Figure A.2.**

GC 2: 30" Concrete Stormwater Pipe  
26.93642/-82.34315

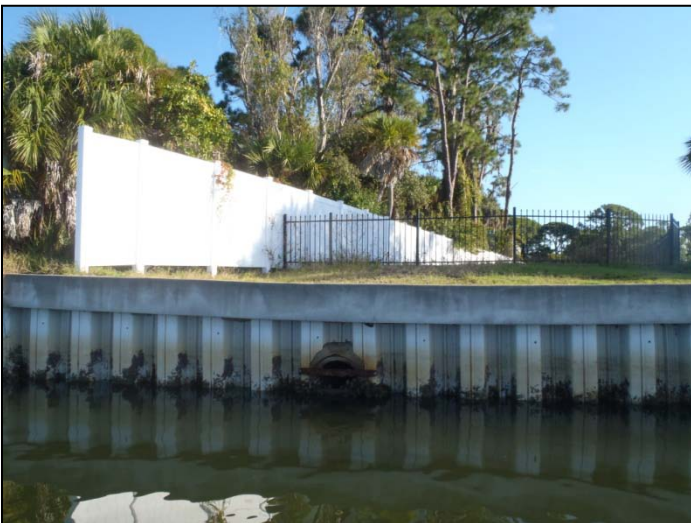
**Figure A.3.**

GC-3: 18" Concrete Stormwater Pipe  
26.93681/-82.34322

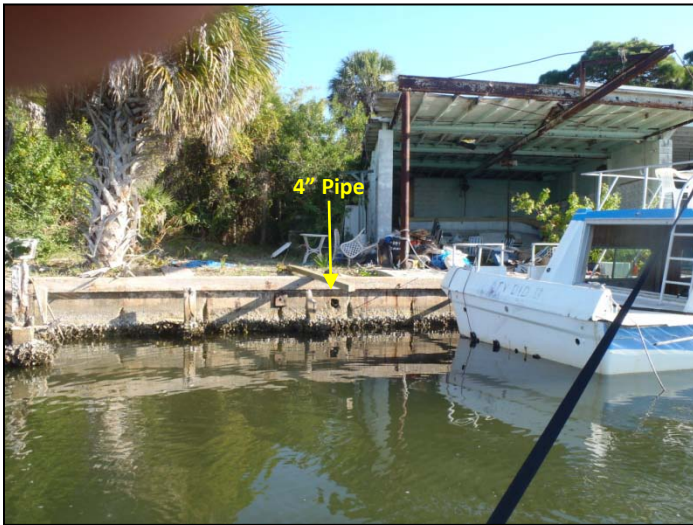
**Figure A.4.**

GC-4: 4" PVC Pipe in Bulkhead  
26.93706/-82.34344

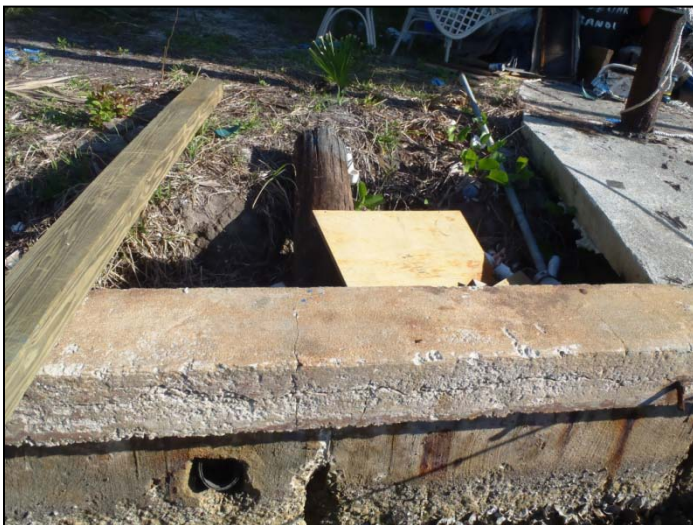
**Figure A.5.**

GC-4: 4" PVC Pipe crushed on inside of  
bulkhead; No connection to anything.

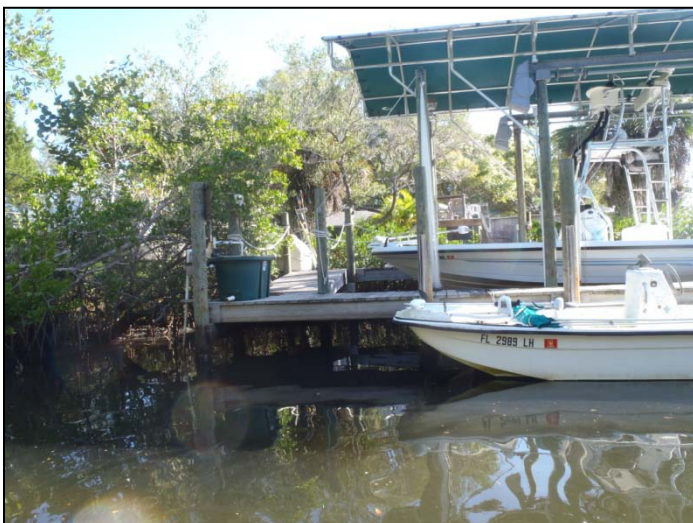
**Figure A.6.**

GC-5: 1" PVC pipes; Green box; Above-  
ground swimming pool on property. 300 Bay  
Heights Ave., Englewood, FL  
26.94417/-82.34788

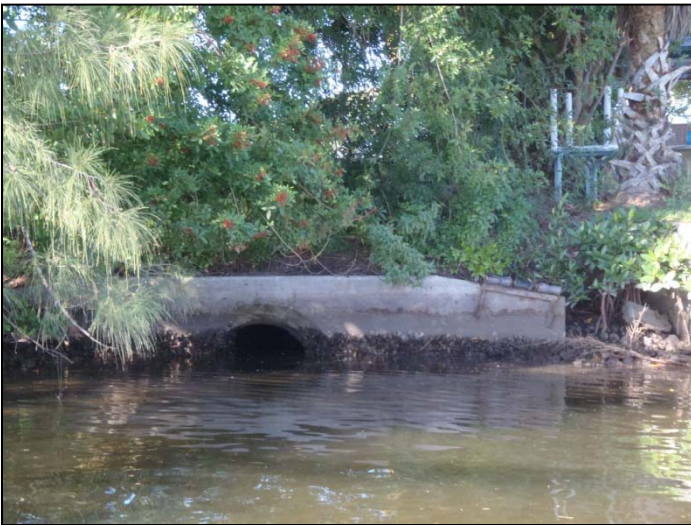
**Figure A.8.**

GC 7: 30" Concrete Culvert Pipe; Discharge  
has surface scum and stale odor; Collected  
GOT-1 grab sample for fecal coliform;  
26.94497/-82.34716  
Sample Results 120 col/100mL

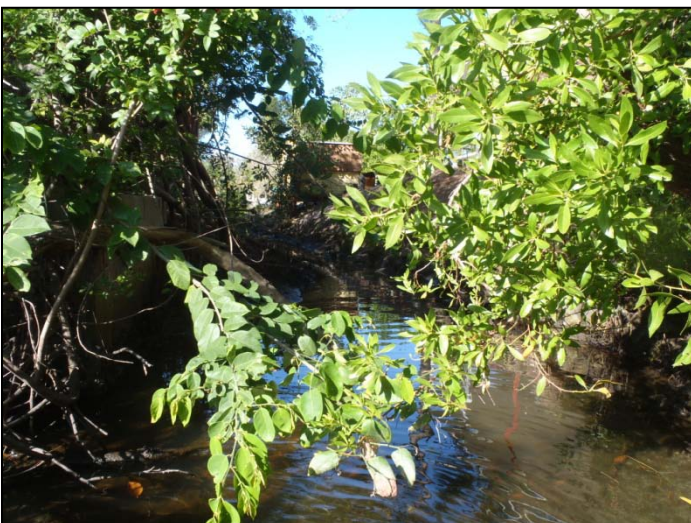
**Figure A.9.**

GC-8: Open Stormwater Ditch; White/Gray  
Slime at Outfall; Collected GOT-2 grab  
samples for fecal coliform.  
26.94584/-82.34699  
Sample Results 550 col/100mL

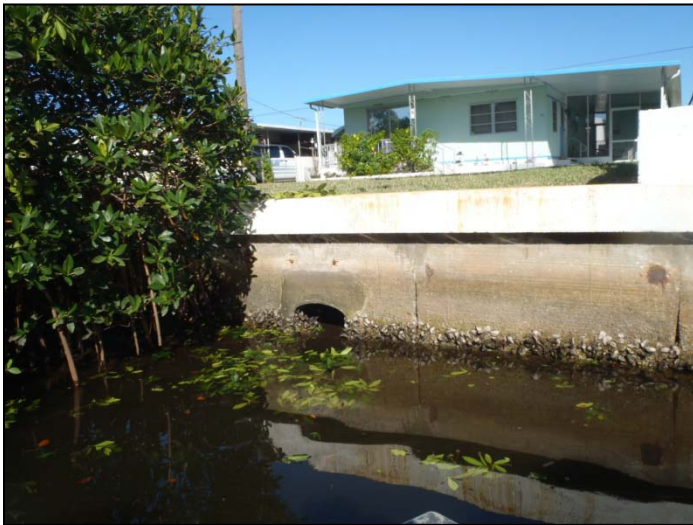
**Figure A.10.**

GC-9: 30" Concrete Stormwater Pipe  
26.94641/-82.34728

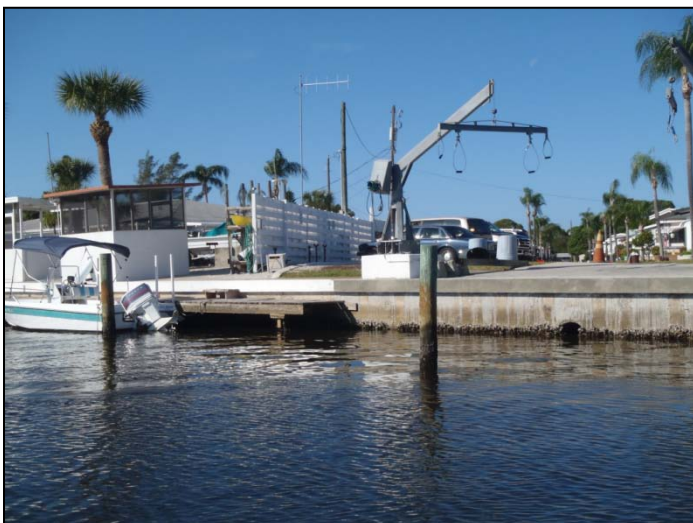
**Figure A.12.**

GC-11: 18" Concrete Pipe; Deer Creek MHP  
26.94672/-82.34560

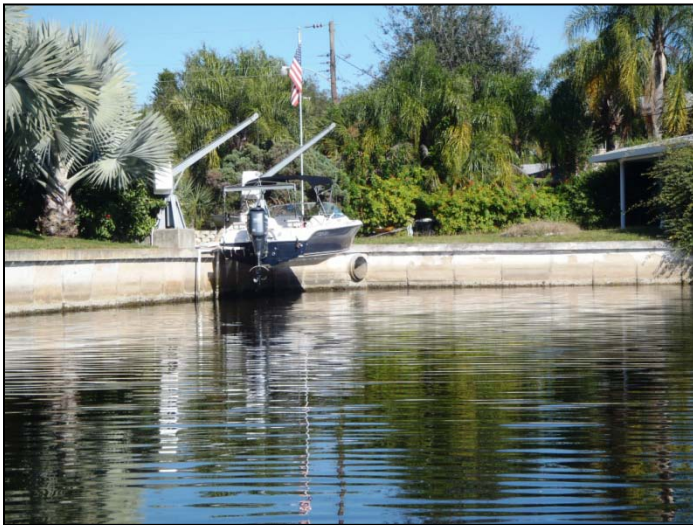
**Figure A.13.**

GC-12: 30" Concrete Stormwater Pipe  
26.96346/-82.34303

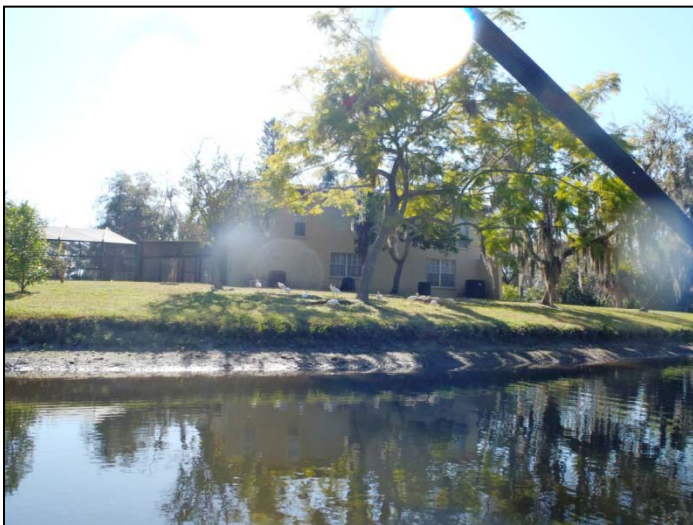
**Figure A.14.**

GC-13 & GC-14: Wildlife – Flock of White  
Ibis; Creek Narrow & Shallow; Not  
Navigable; 26.96523/-82.34736

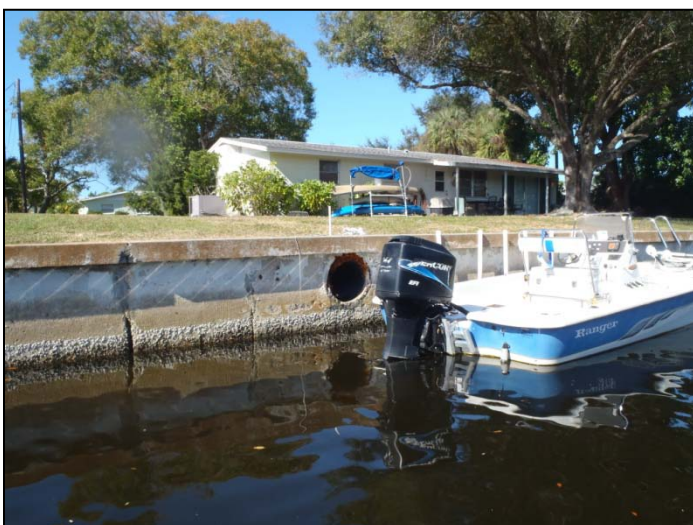
**Figure A.15.**

GC-15: 30" Concrete Stormwater Pipe  
26.96305/-82.34315

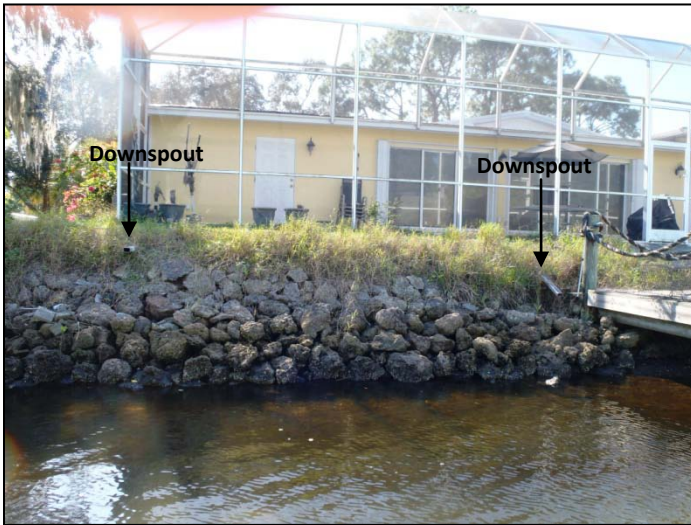
**Figure A.16.**

GC-16: Roof Downspouts Flow to Canal  
26.96151/-82.34081

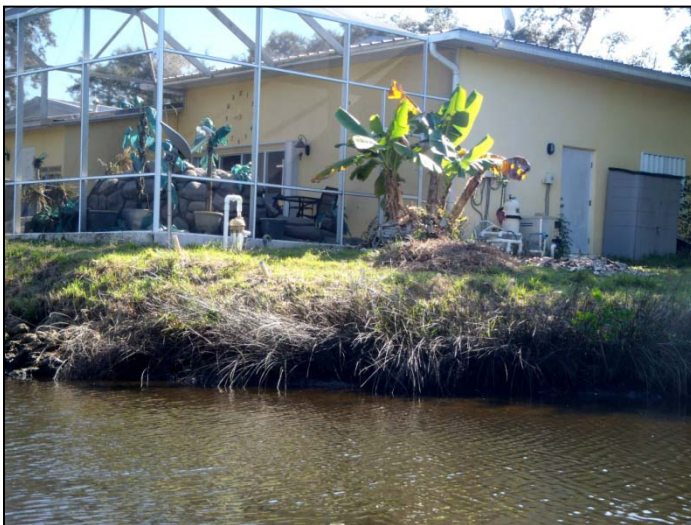
**Figure `A.17.**

GC-16: 5-2" PVC Pipes Stuck in Ground;  
26.96151/-82.34081

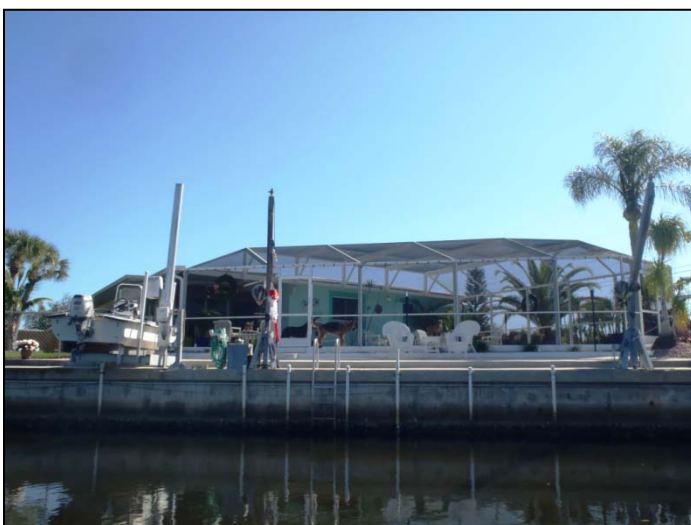
**Figure A.18.**

GC-17: 12" Concrete Pipe in Seawall;  
4 Large Dogs  
26.95395/-82.34314

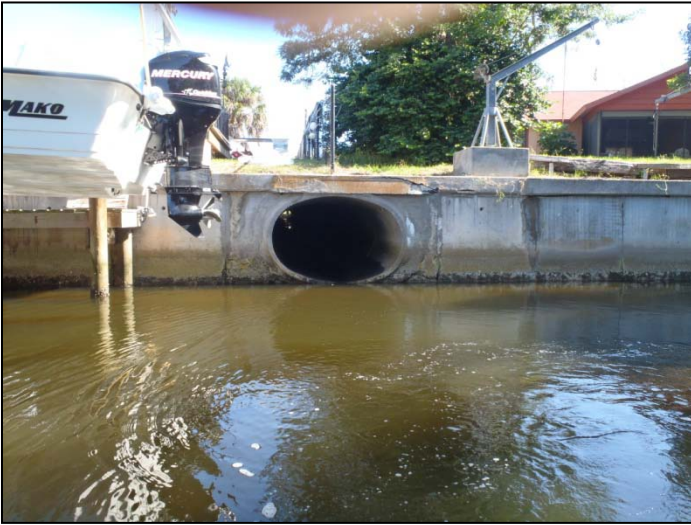
**Figure A.19.**

GC-18: 4'-5' Culvert Pipe Connects  
Large Open Stormwater Ditch to Canal  
26.95320/-82.34142

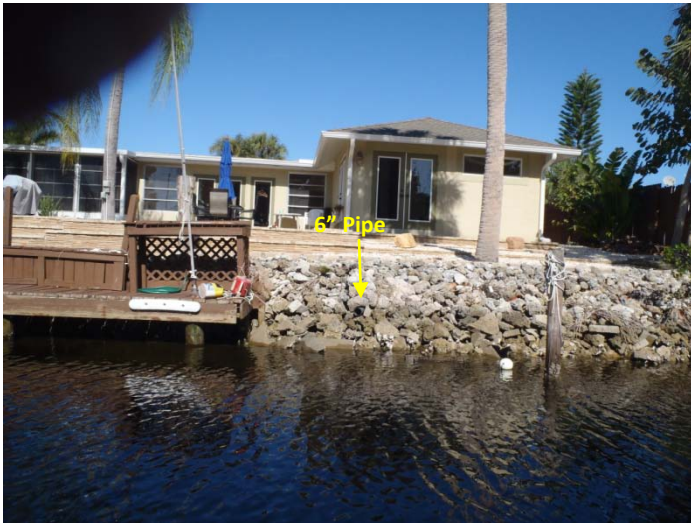
**Figure A.20.**

GC-19: 6" Black Plastic Pipe in RipRap  
26.95321/-82.34270

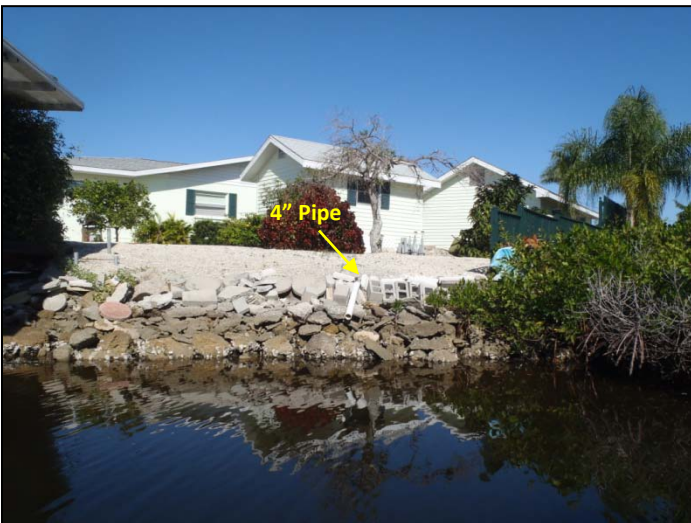
**Figure A.21.**

GC-20: 4" Metal Pipe with PVC Extension  
26.98323/-82.34335

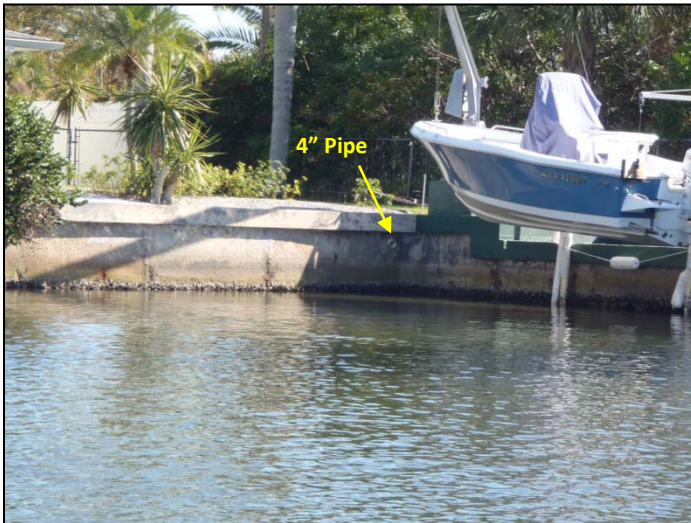
**Figure A.22.**

GC-21: 4" PVC Pipe in Bulkhead  
26.95273/-82.34412

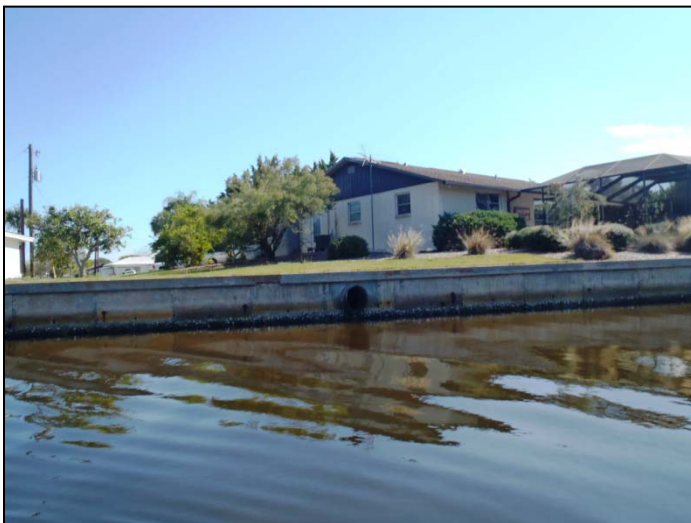
**Figure A.23.**

GC-22: 20" Concrete Stormwater Pipe  
26.95273/-82.34412

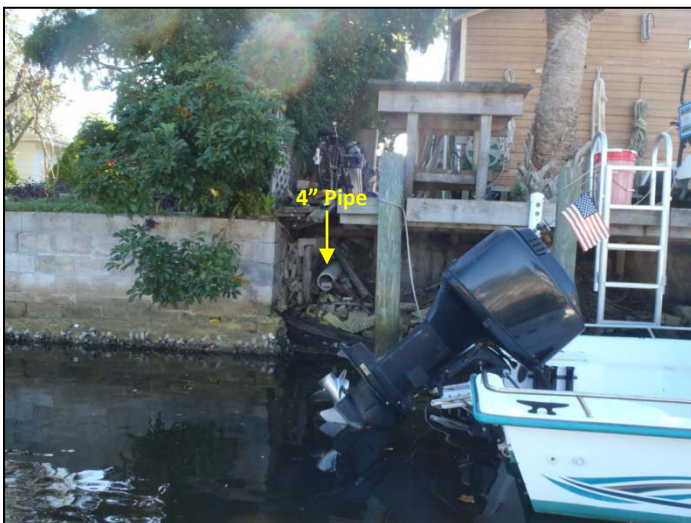
**Figure A.24.**

GC-23: 4" PVC Pipe under Dock  
26.94971/-82.34447

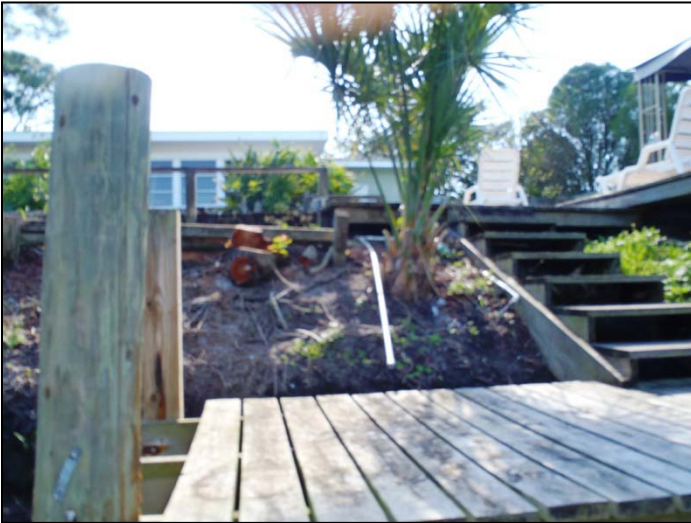
**Figure A.25.**

GC-24: 1" PVC Pipe. Swimming Pool on  
Property  
26.94966/-82.34418

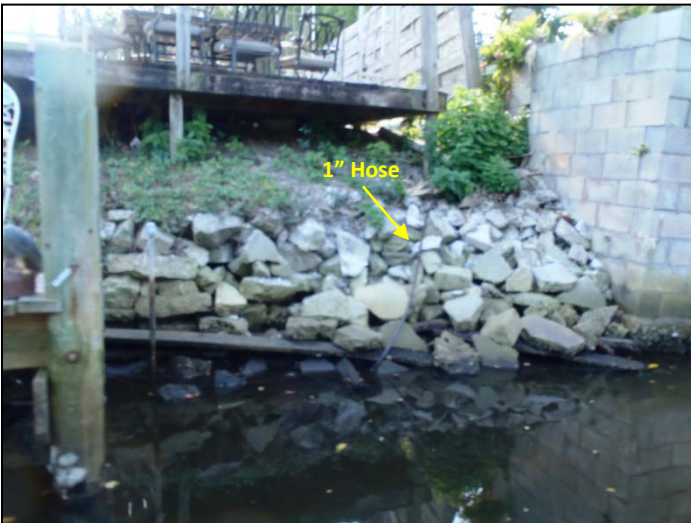
**Figure A.26.**

GC-24: 1" Garden Hose with Red Stripe  
26.94966/-82.34418

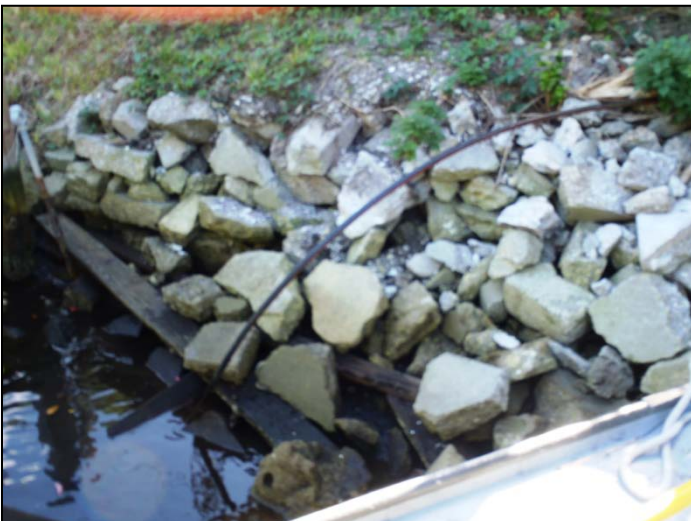
**Figure A.27.**

GC-24: 1" Garden Hose with Red Stripe  
26.94966/-82.34418

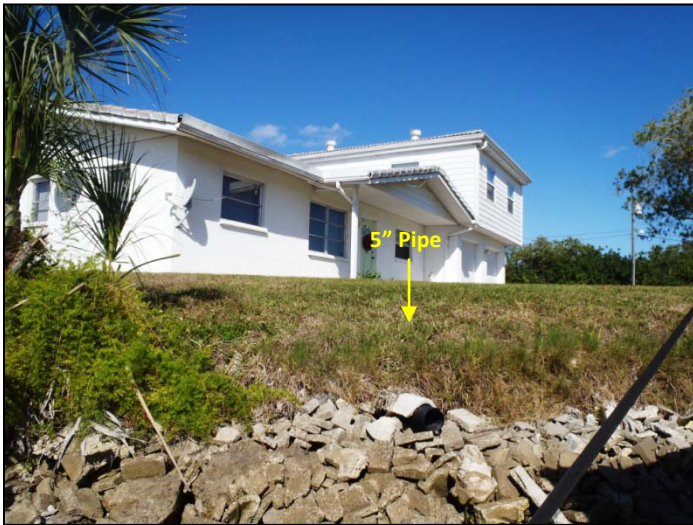
**Figure A.28.**

GC-25: 5" Black Plastic Pipe under  
Concrete Hood  
26.94970/-82.34465

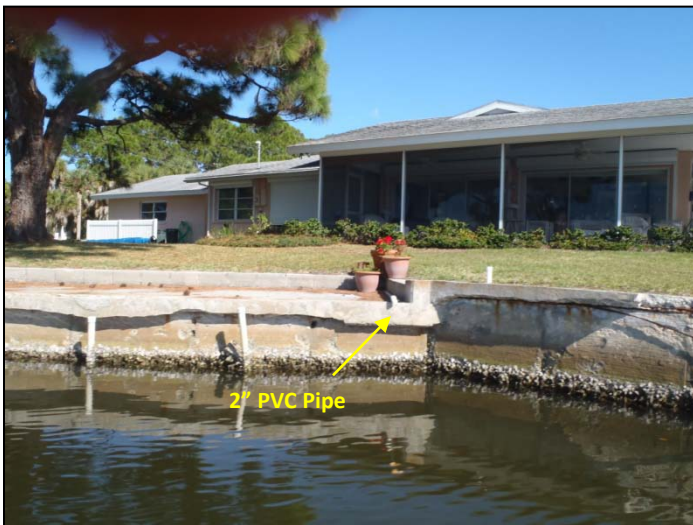
**Figure A.29.**

GC-26: 2" PVC Pipe with Gray Elbow  
26.94407/-82.34459

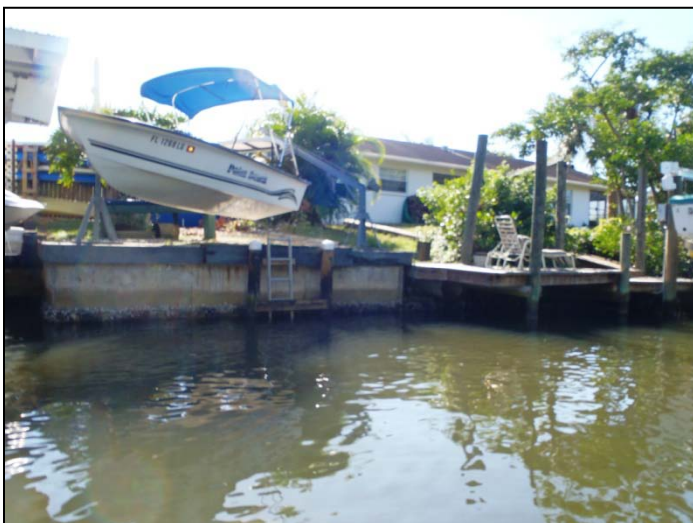
**Figure A.30.**

GC-27: 18" Metal Pipe Under Dock  
26.94375/-82.34364

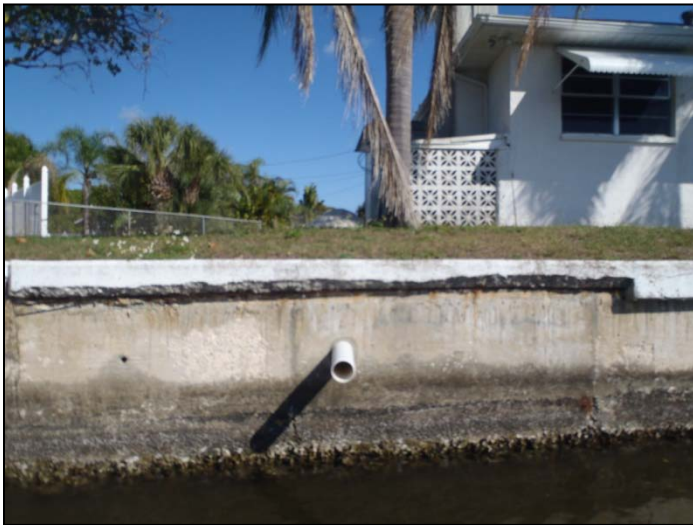
**Figure A.31.**

GC-28: 4" PVC Pipe in Bulkhead  
26.94320/-82.34423

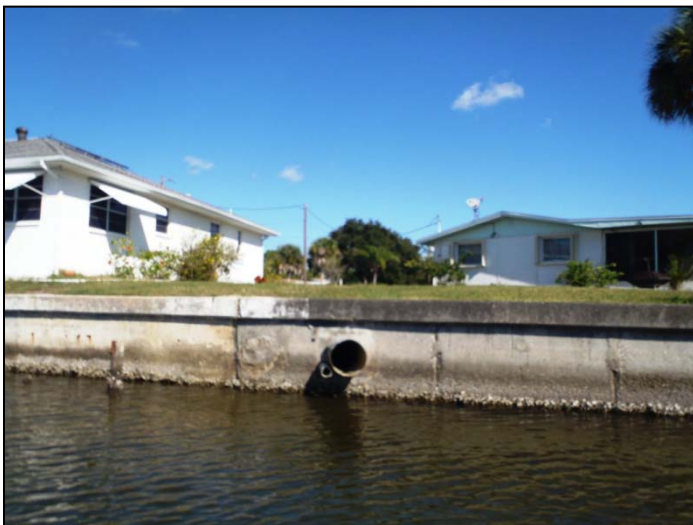
**Figure A.32.**

GC-29: 18" Metal Stormwater Pipe; 4" PVC  
Pipe in Bulkhead  
26.94297/-82.34415

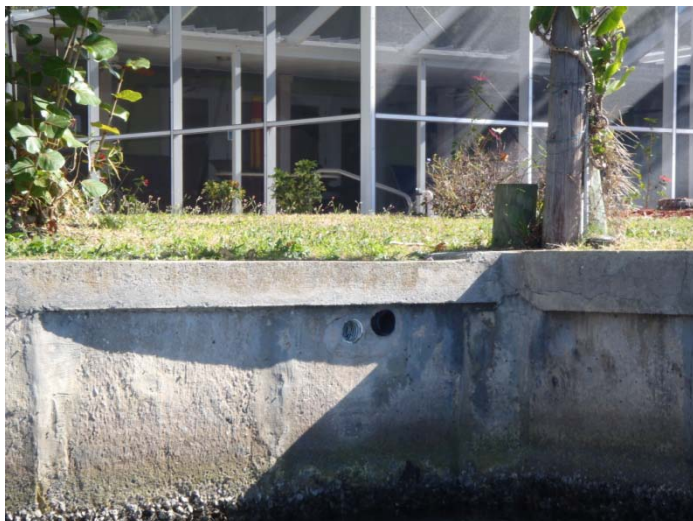
**Figure A.33.**

GC-30: 1-3" and 1-6" Pipes in Bulkhead  
26.94104-82.24448

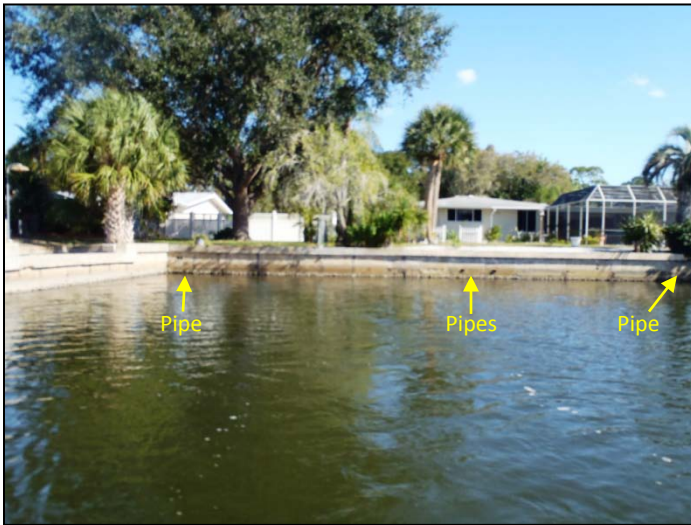
**Figure A.34.**

GC-31: 4 PVC and 2 Clay Pipes in Bulkhead  
26.94069/-82.34470  
Property owner advised that they were  
connected to roof drains, but they now have  
been disconnected.

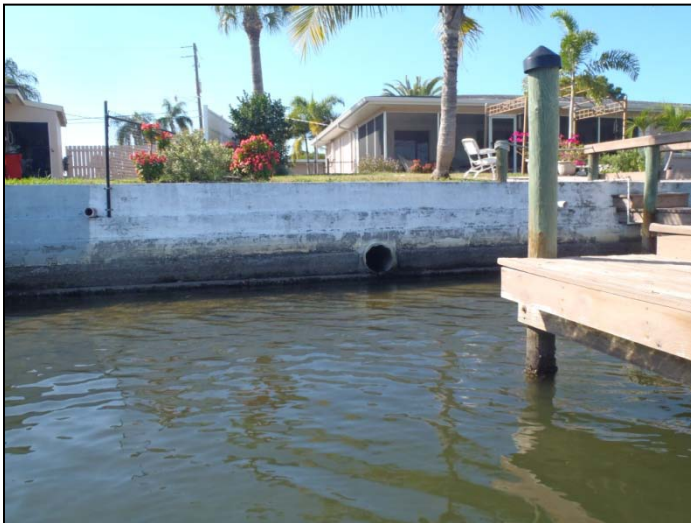
**Figure A.35.**

GC-32: 18" Concrete Stormwater Pipe  
26.93804/-82.34581

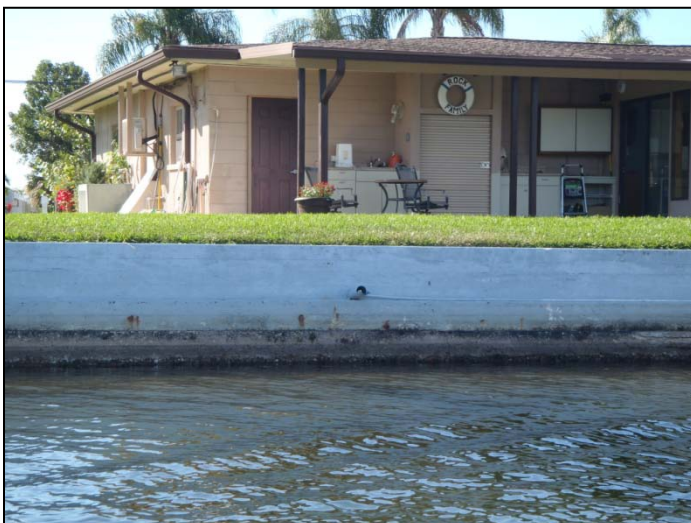
**Figure A.36.**

GC-33: 4" PVC Pipe in Bulkhead  
26.93778/-82.34574

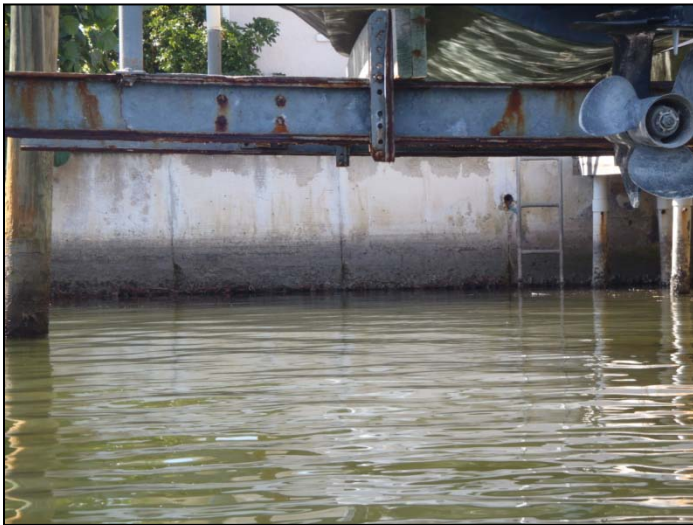
**Figure A.37.**

GC-34: 4" PVC Pipe in Bulkhead  
26.93730/-82.34557

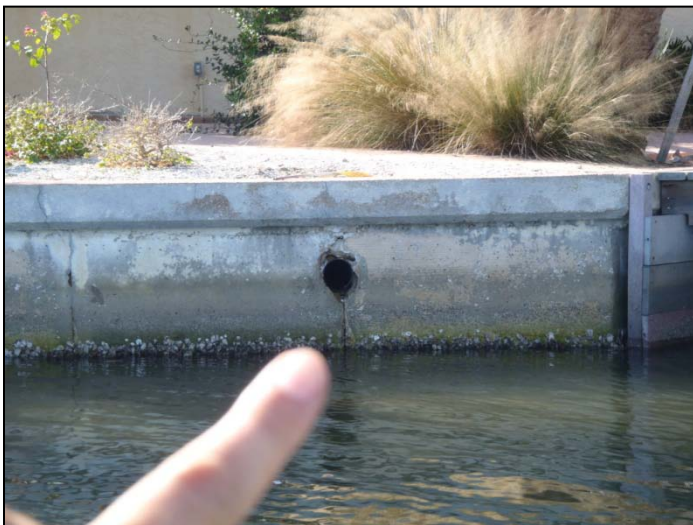
**Figure A.38.**

GC-35: 6" Plastic Pipe in Bulkhead  
26.93696/-82.34526

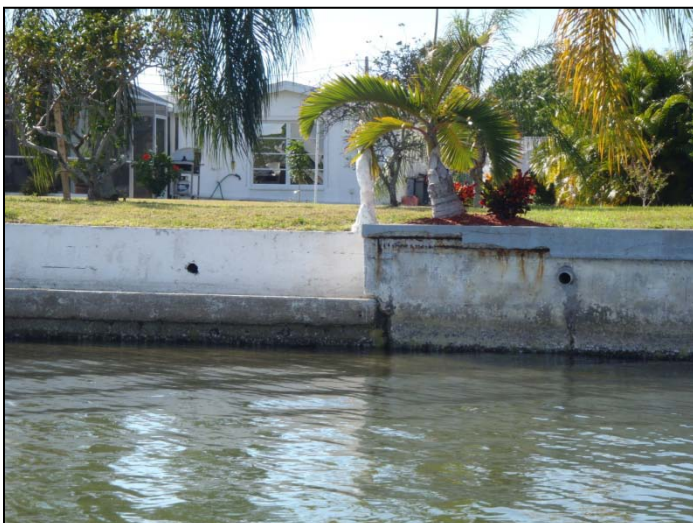
**Figure A.39.**

GC-36: 4" Pipes in Bulkhead  
26.93640/-82.34512

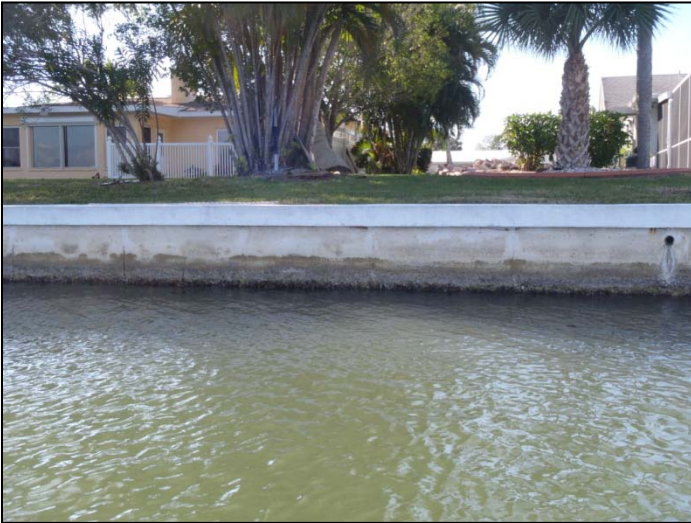
**Figure A.40.**

GC-37: 2-3" Pipes in Bulkhead  
26.93559/-82.34482

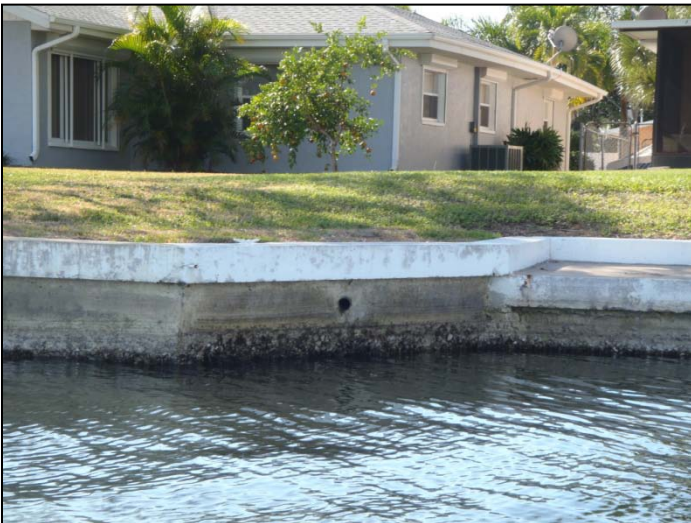
**Figure A.41.**

GC-38: 3" Metal Pipe in Bulkhead  
26.93532/-82.34482

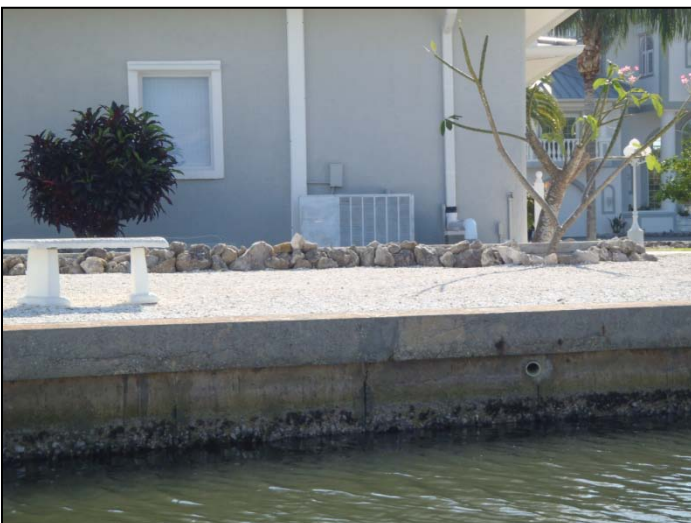
**Figure A.42.**

GC-39: 3" PVC Pipe in Bulkhead  
26.93466/-82.34489

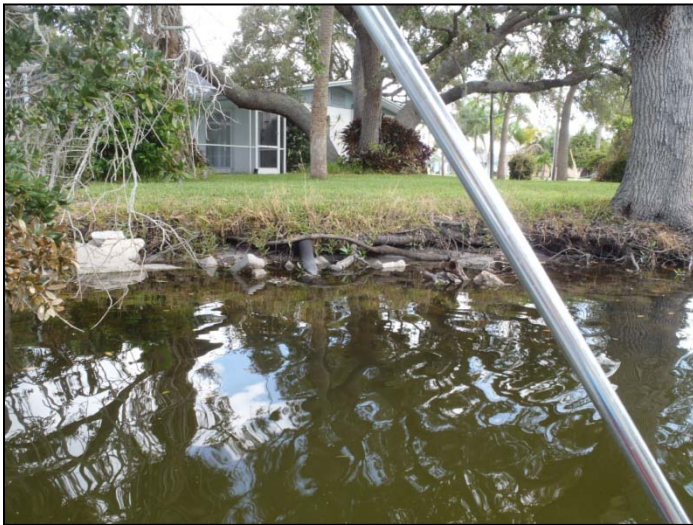
**Figure A.43.**

GC-40: 6" Black Plastic Pipe – Roof Drain  
26.93454/-82.34542

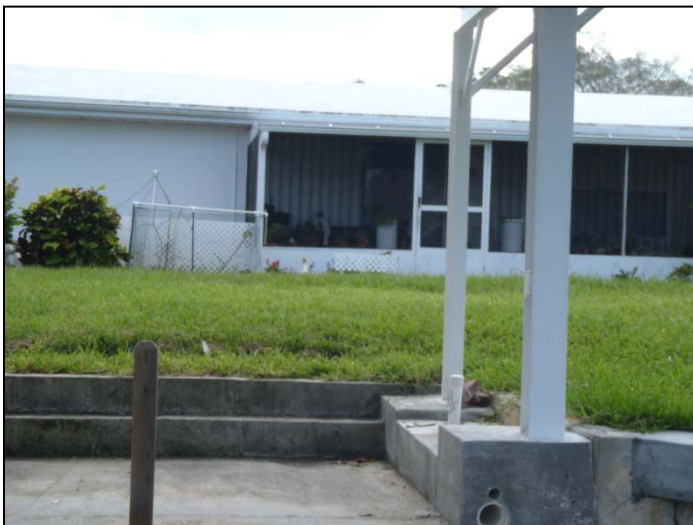
**Figure A.44.**

GC-41: 2" & 4" PVC Pipes; 4" could be roof drain  
26.93530/-82.34596

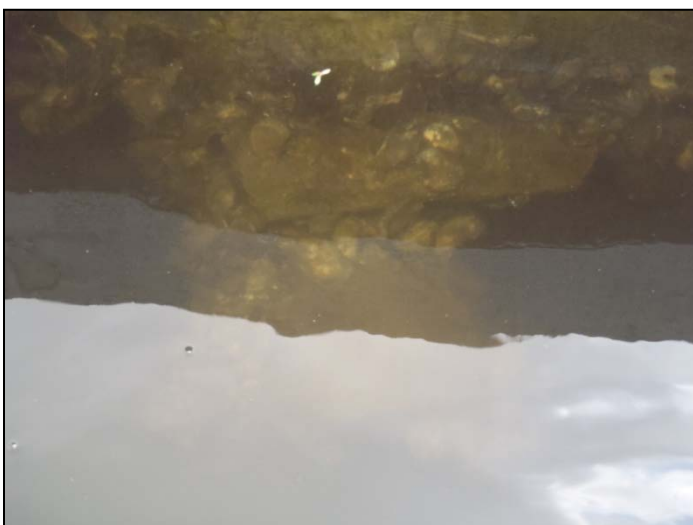
**Figure A.45.**

GC-42: Stormwater Outfall  
26.93626/-82.34625

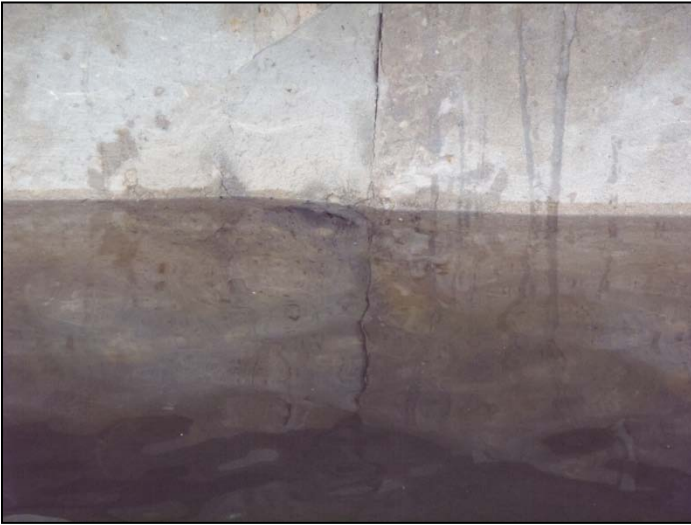
**Figure A.46.**

GC-43: 4" PVC Pipe – Angled Down; In line  
with roof drain  
26.93648/-82.34631

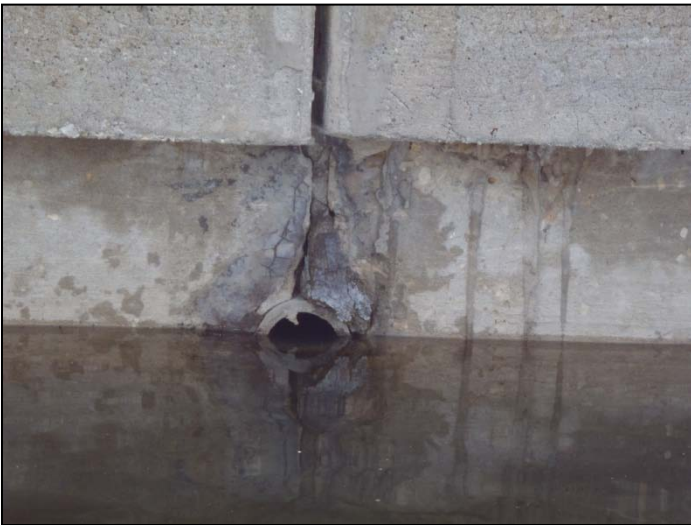
**Figure A.47.**

GC-44: 4" Metal Pipe  
26.93664/-82.34638

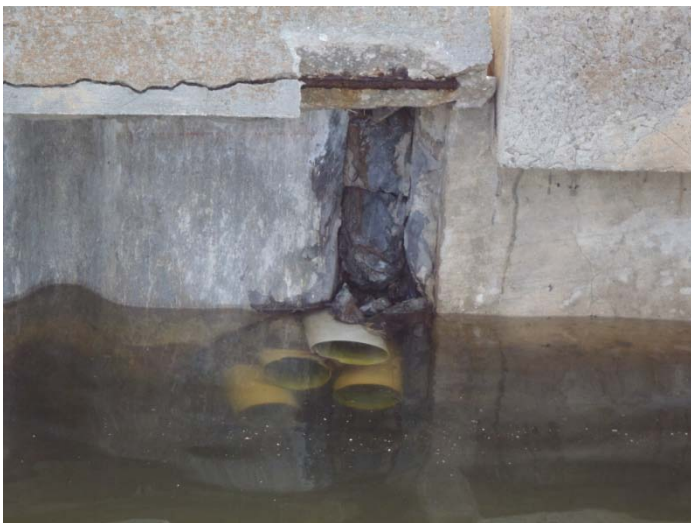
**Figure A.48.**

GC-45: 4 PVC Pipes  
26.93688/-82.34645

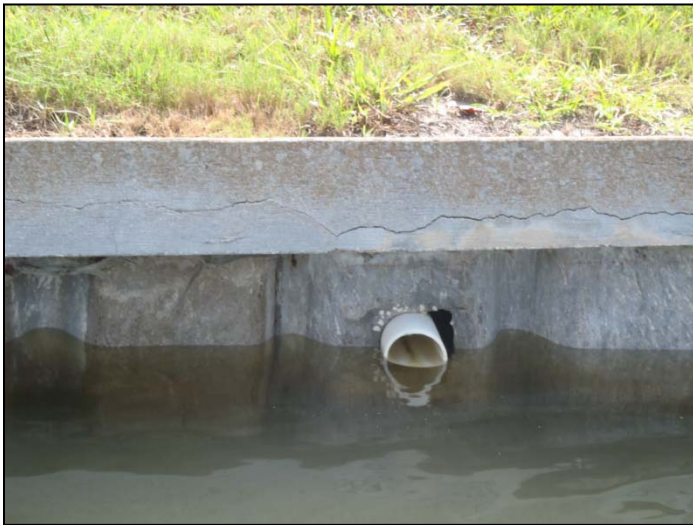
**Figure A.49.**

GC-46: 4" PVC Pipe  
26.93692/-82.34647

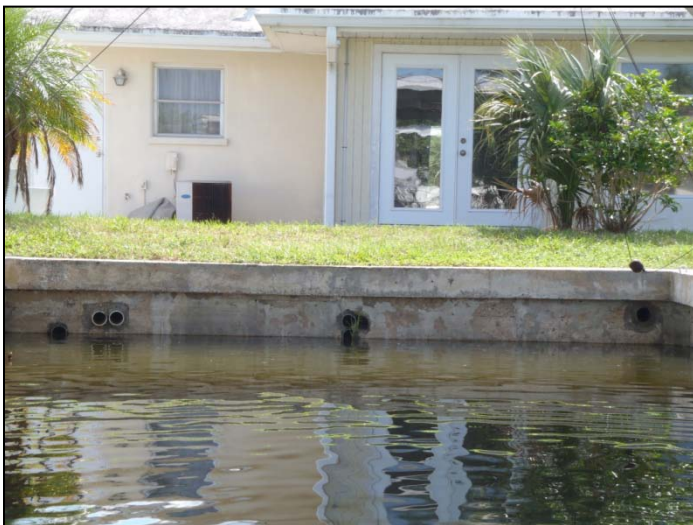
**Figure A.50.**

GC-47: Five 6" PVC Pipes in Bulkhead;  
Middle could be roof drain  
26.93702/-82.34657

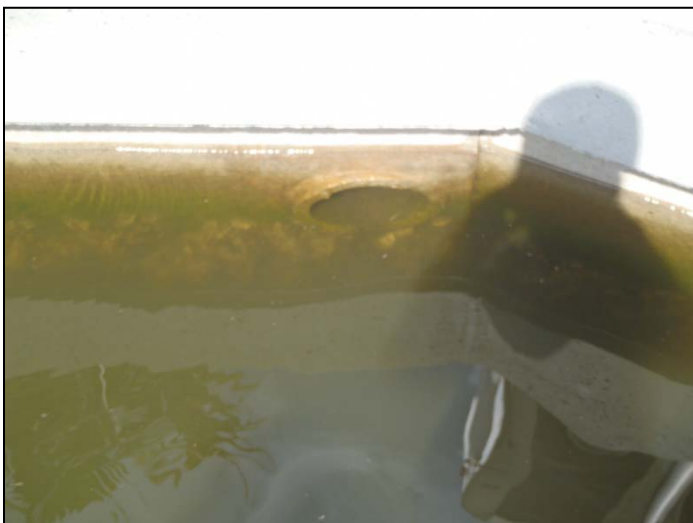
**Figure A.51.**

GC-48: 8" Concrete Stormwater Outfall  
26.93759/-82.34672

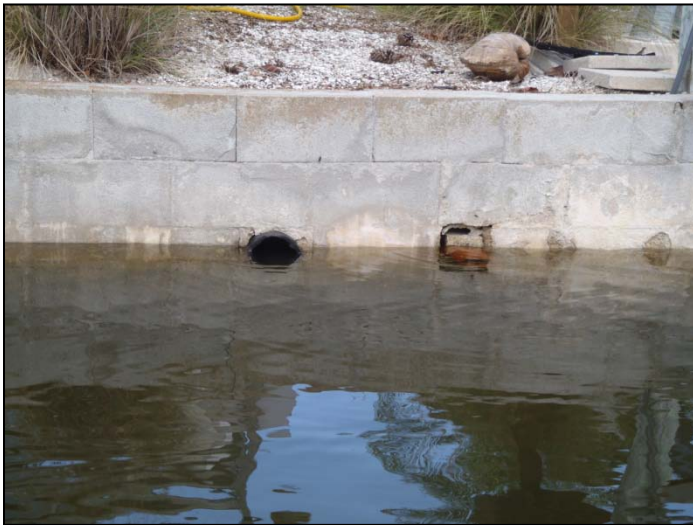
**Figure A.52.**

GC-49: 6" Plastic and 3" Clay Pipe  
26.93577/-82.34621

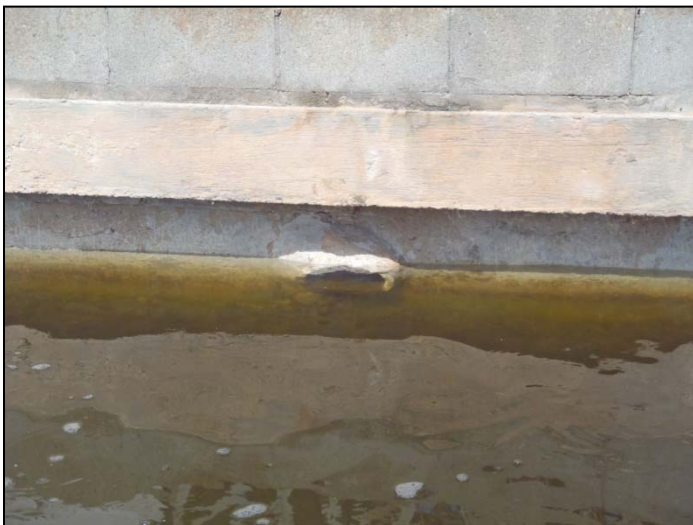
**Figure A.53.**

GC-50: 8" Concrete Stormwater Pipe  
26.93511/-82.34600

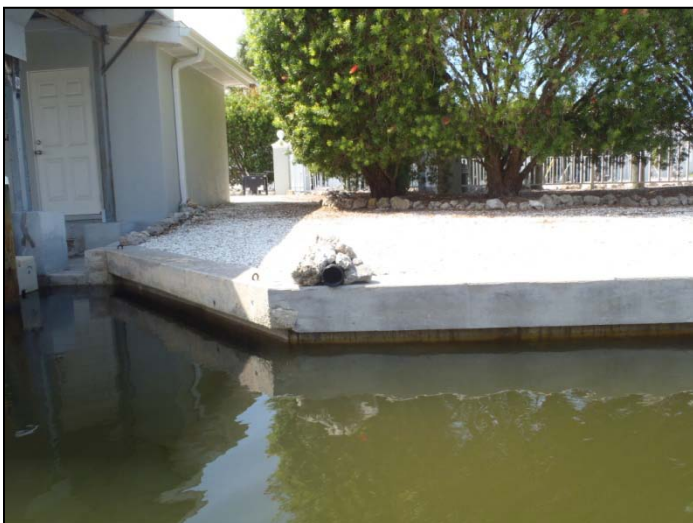
**Figure A.54.**

GC-51: 6" Black Pipe; Stormwater Runoff  
26.93511/-82.34600

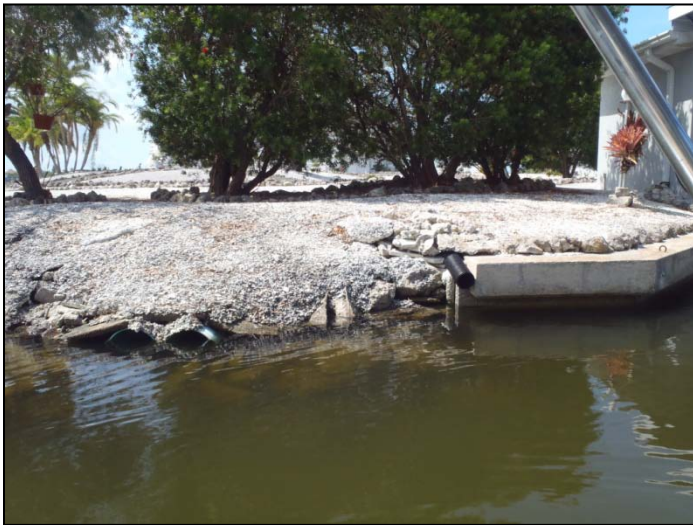
**Figure A.55.**

GC-52: 6" Black and 2-20" Green Pipes;  
Stormwater Runoff  
26.93541/-82.34534

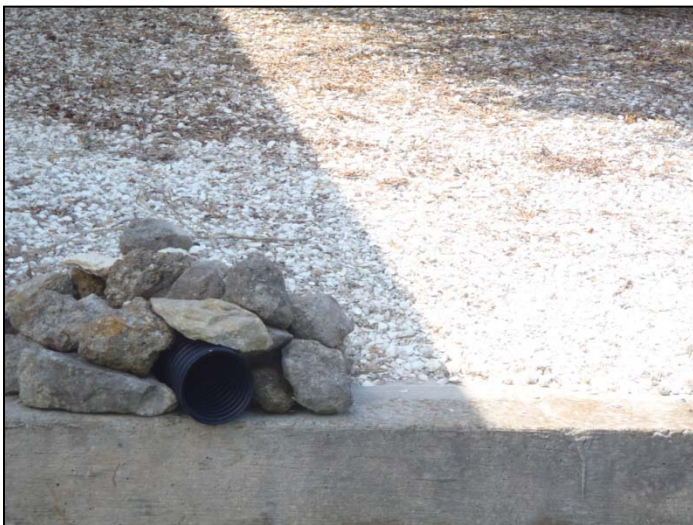
**Figure A.56.**

GC-53: 6" Black Pipe; Stormwater Runoff  
26.93543/-82.34521

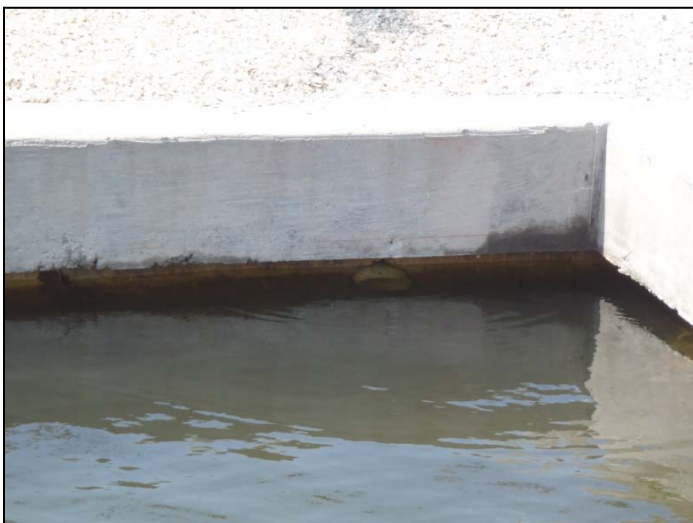
**Figure A.57.**

GC-54: 3" PVC Pipe in Bulkhead  
26.93455/-82.34508

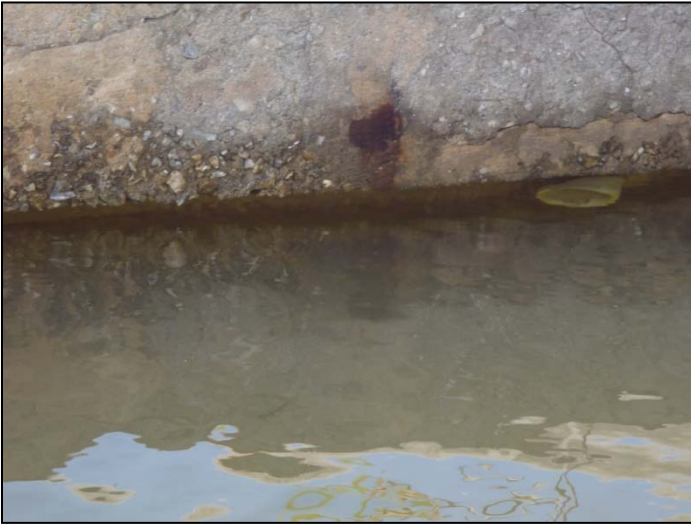
**Figure A.58.**

GC-55: 3" PVC Pipe; May be overflow  
from cistern  
26.93463/-82.34508

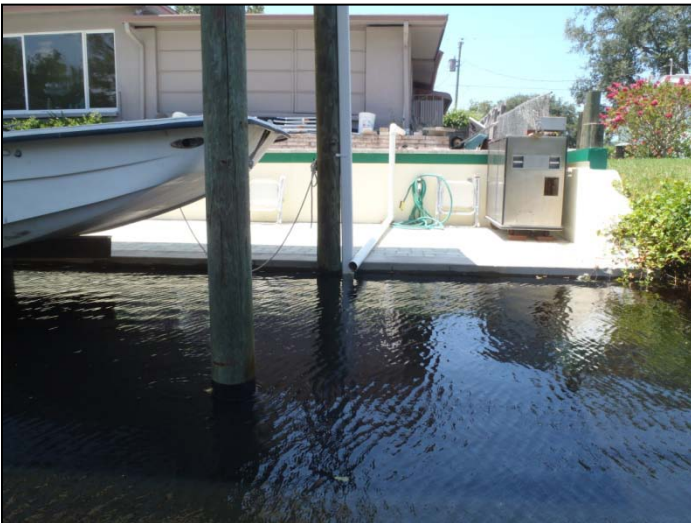
**Figure A. 59.**

GC-56: 3" PVC Pipe; Roof Drain  
26.96419/-82.34338

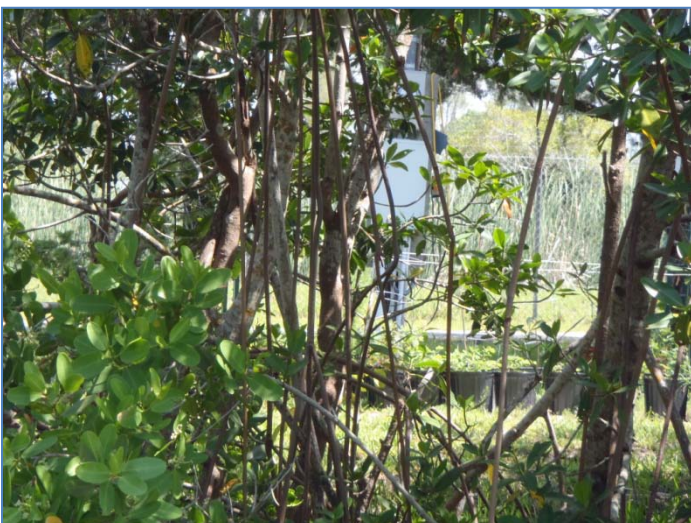
**Figure A. 60.**

GC-57. Private Lift Station.  
300 Bay Heights Ave., Englewood, FL  
26.94434/-82.34797
