# Summary of Results

## Walk the WBID Exercise for Wagner Creek (WBID 3288A)

September 2011

This report summarizes the results of the Walk the WBID exercise for the Wagner Creek watershed (WBID 3288A), located in the northwestern portion of the City of Miami, on November 18, 2010. (WBID is the abbreviation for **WaterBody ID**entification number, which is very similar to a watershed.) This field reconnaissance and source elimination effort was carried out to gain a better understanding of conditions within the watershed, including the hydrology of the creek and its contributing ditches and branches, flood-prone areas, the location of sewer and stormwater infrastructure, and potential sources that are contributing fecal coliform bacteria to the creek.

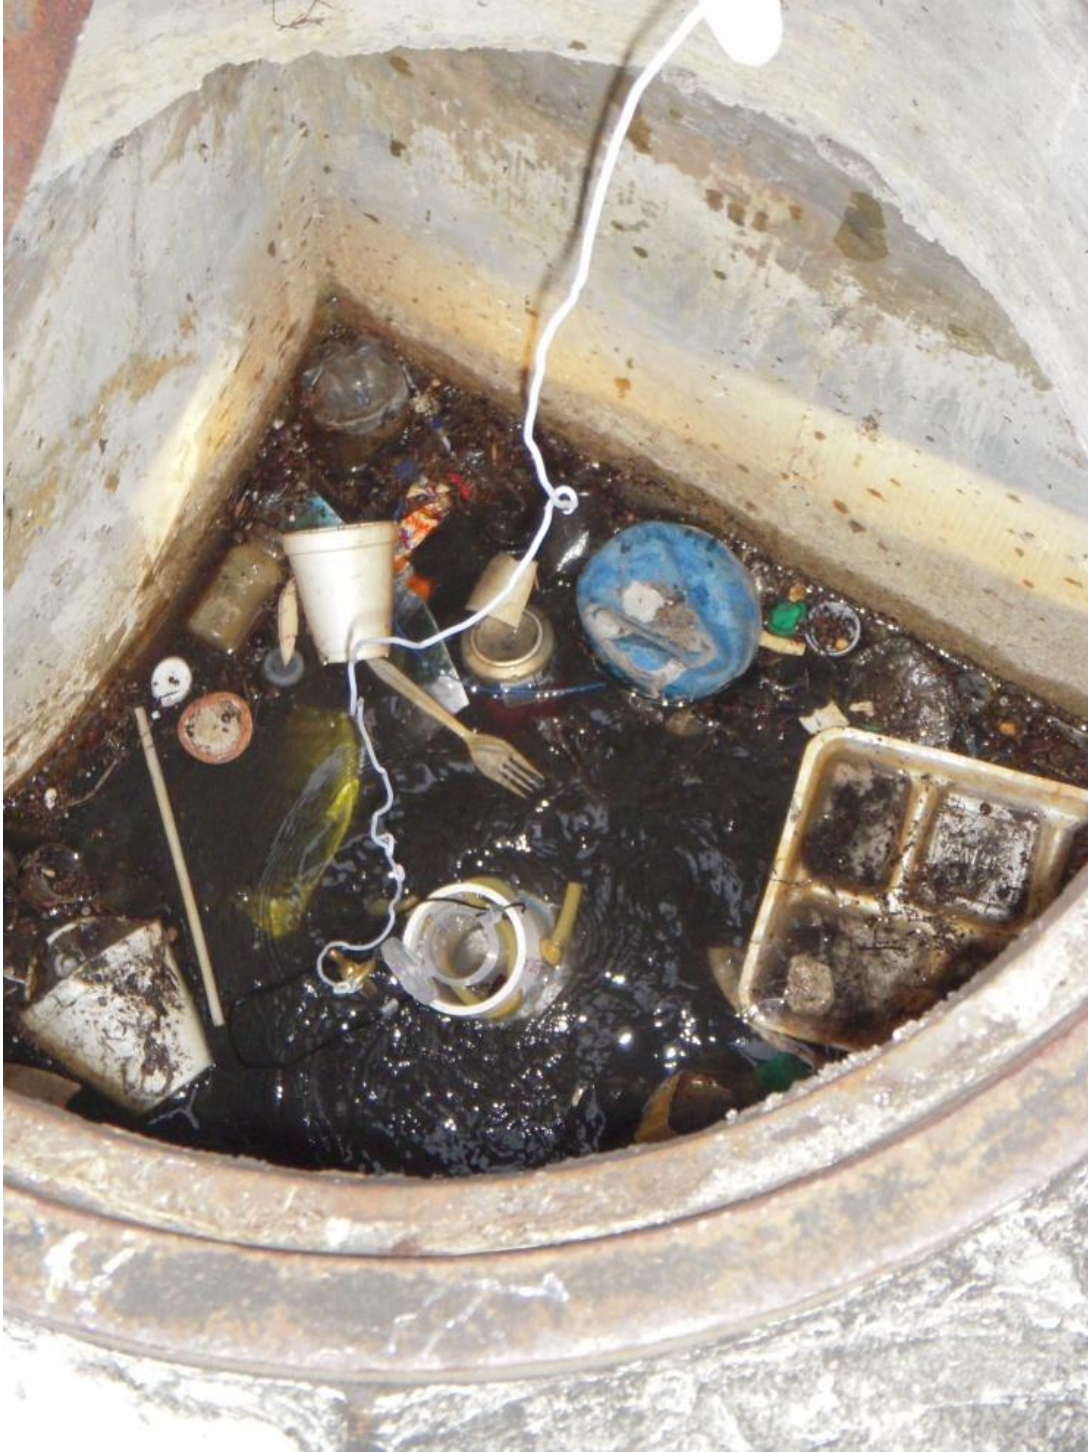
**Figure 3.** *Trash and debris in a stormwater manhole thought to be at the headwaters.*

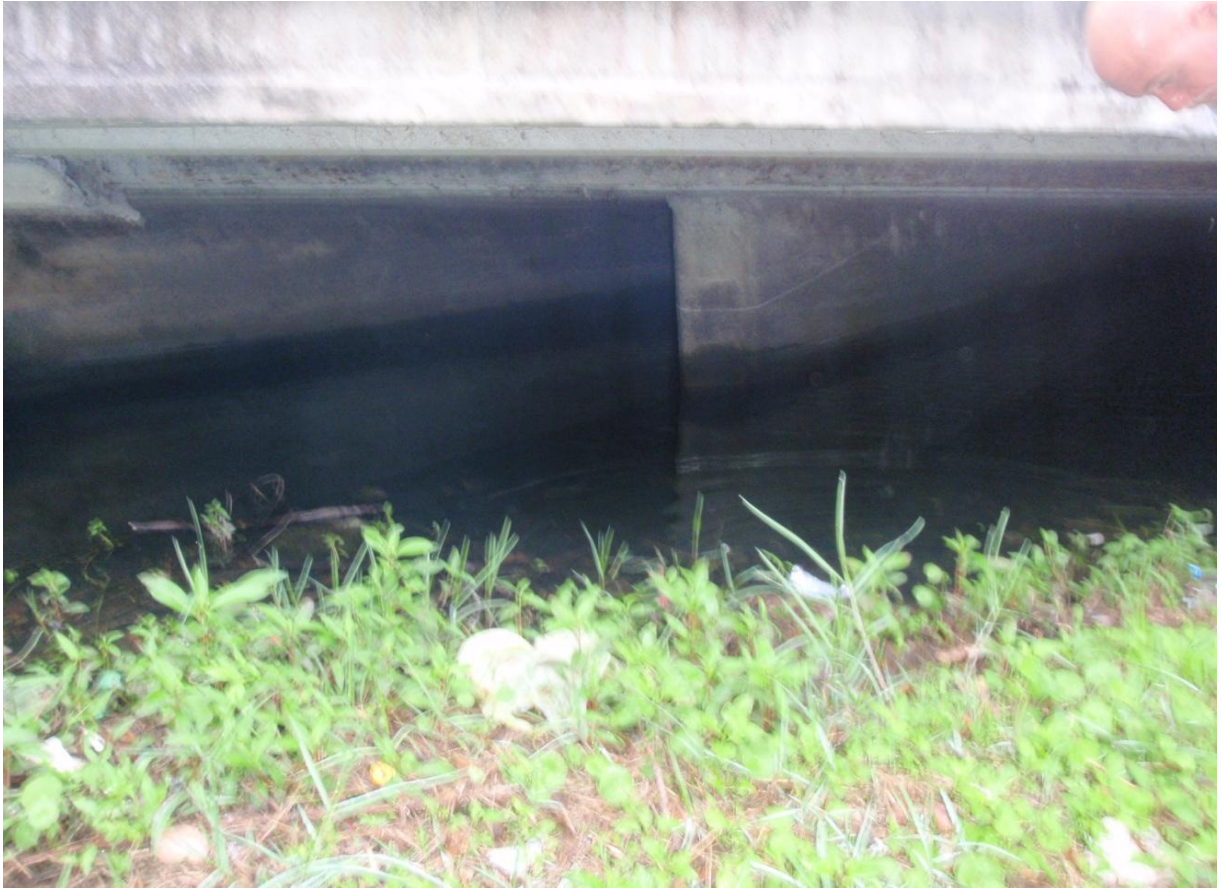
***Figure 5. View of stagnant water and trash buildup in the stormwater conveyance that flows underground to the 20<sup>th</sup> Street Bridge; the accumulation may be caused by a blockage and should be investigated. This may be where the perennial portion of Wagner Creek now begins.***

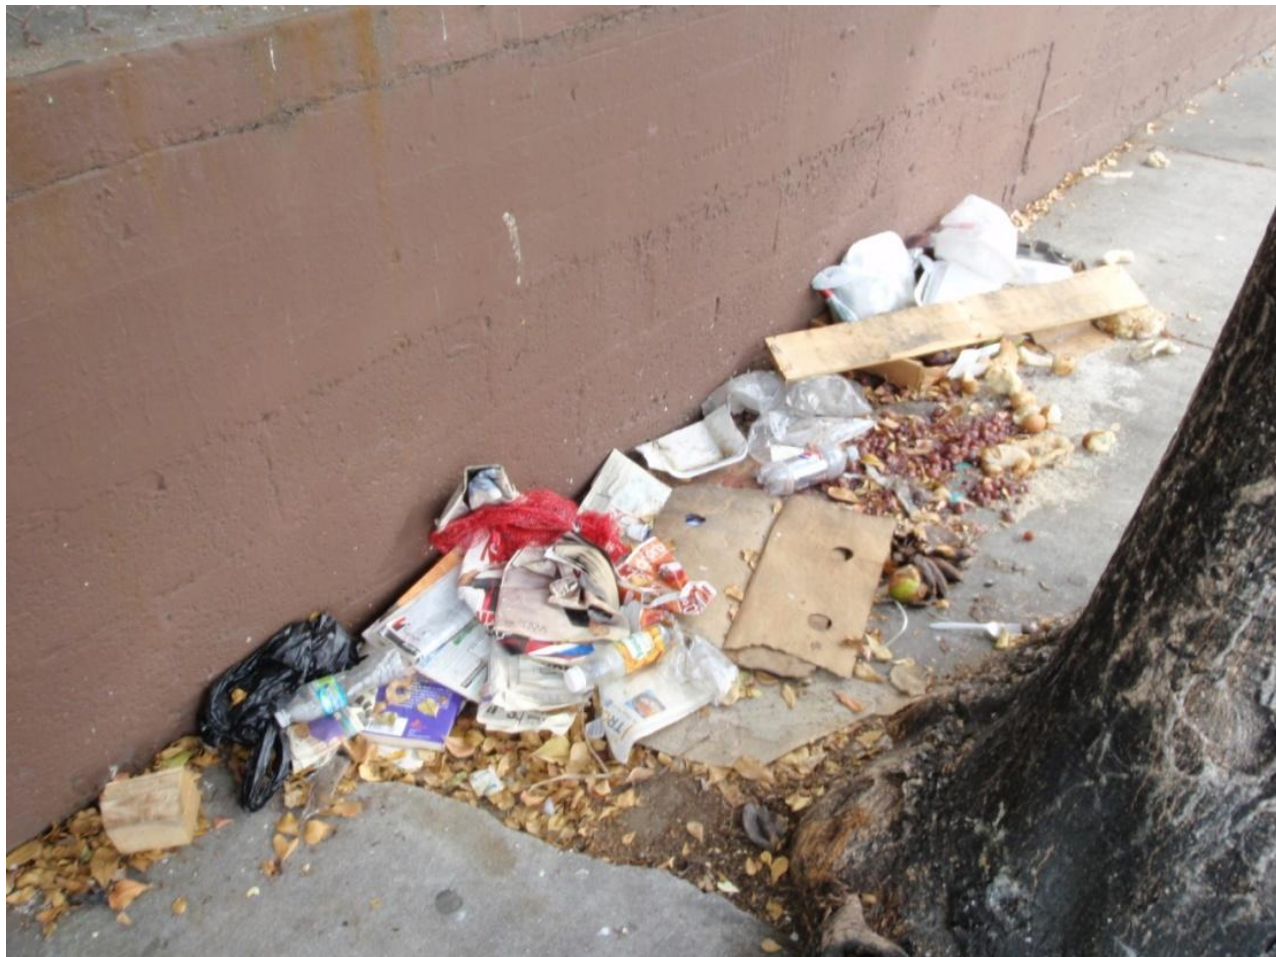
*Figure 9. Trash and debris along the street at the Allapattah Produce Market.*

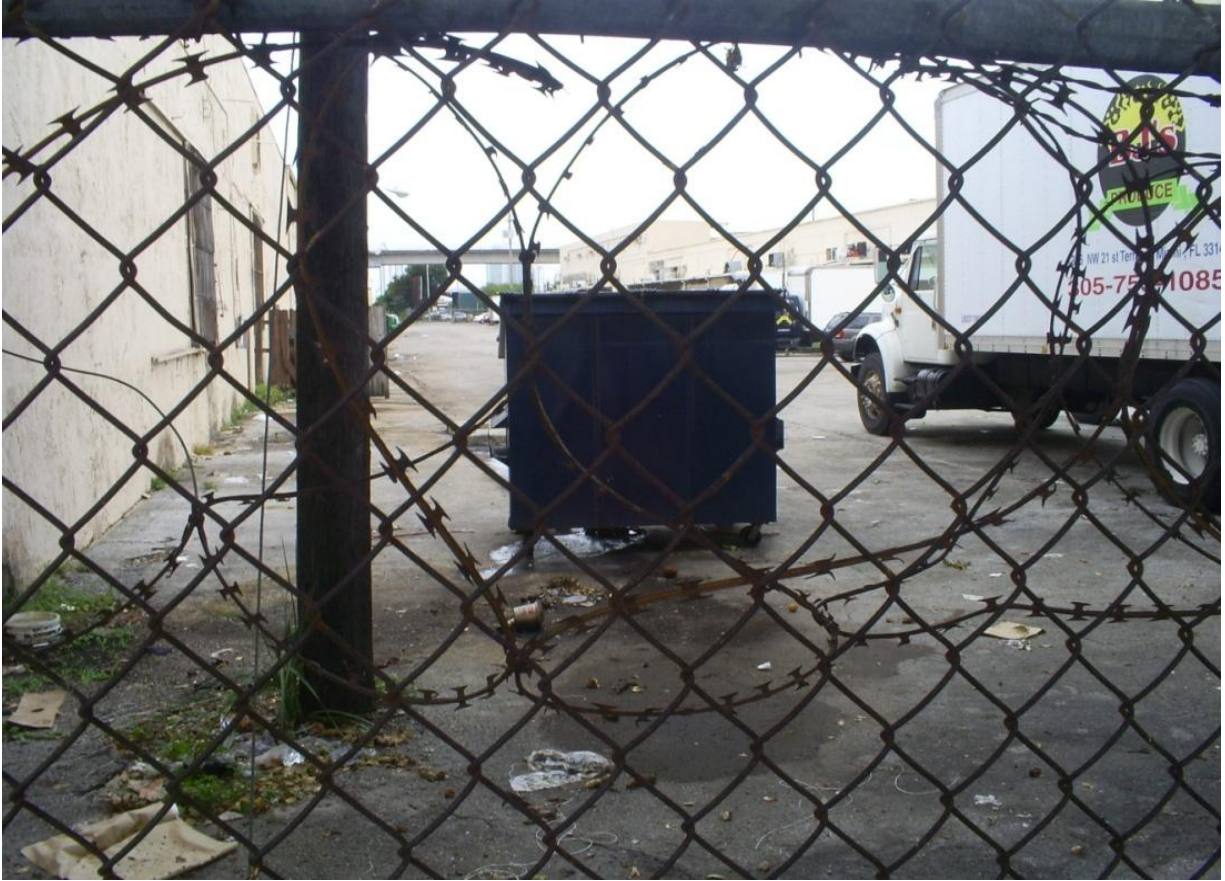
**Figure 12.** *Unsecured lids on a dumpster at the Allapattah Produce Market. The field team made observations at 1265 NW 21<sup>st</sup> Terrace.*

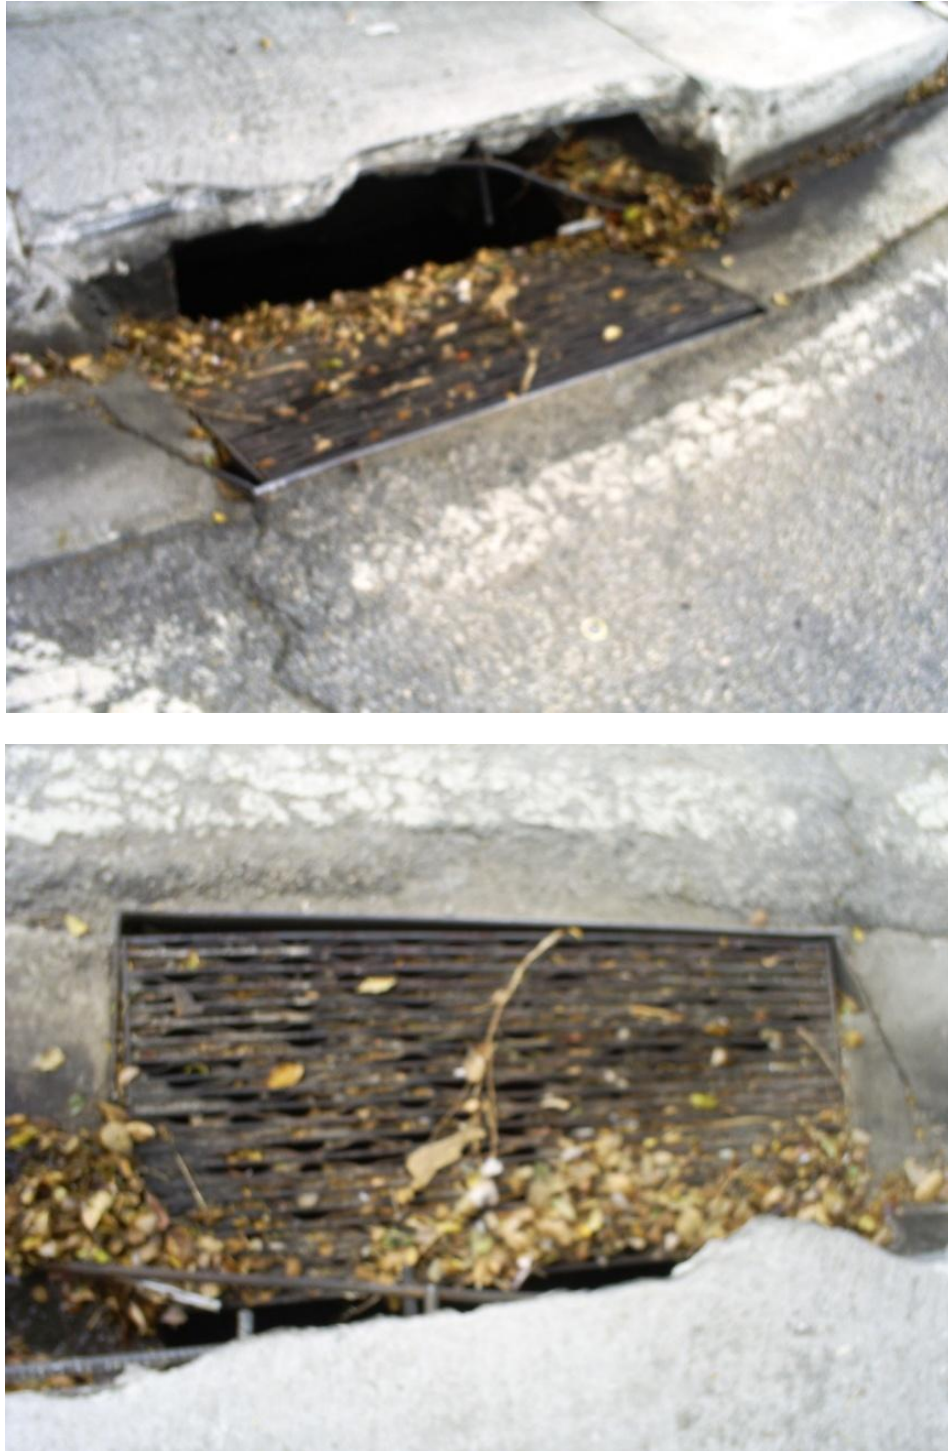
***Figure 19. Broken storm drain covers at NW 20<sup>th</sup> Street belonging to Miami-Dade County; the openings allow trash and other materials to enter the underground conveyance directly and provide a breeding ground for fecal coliform.***

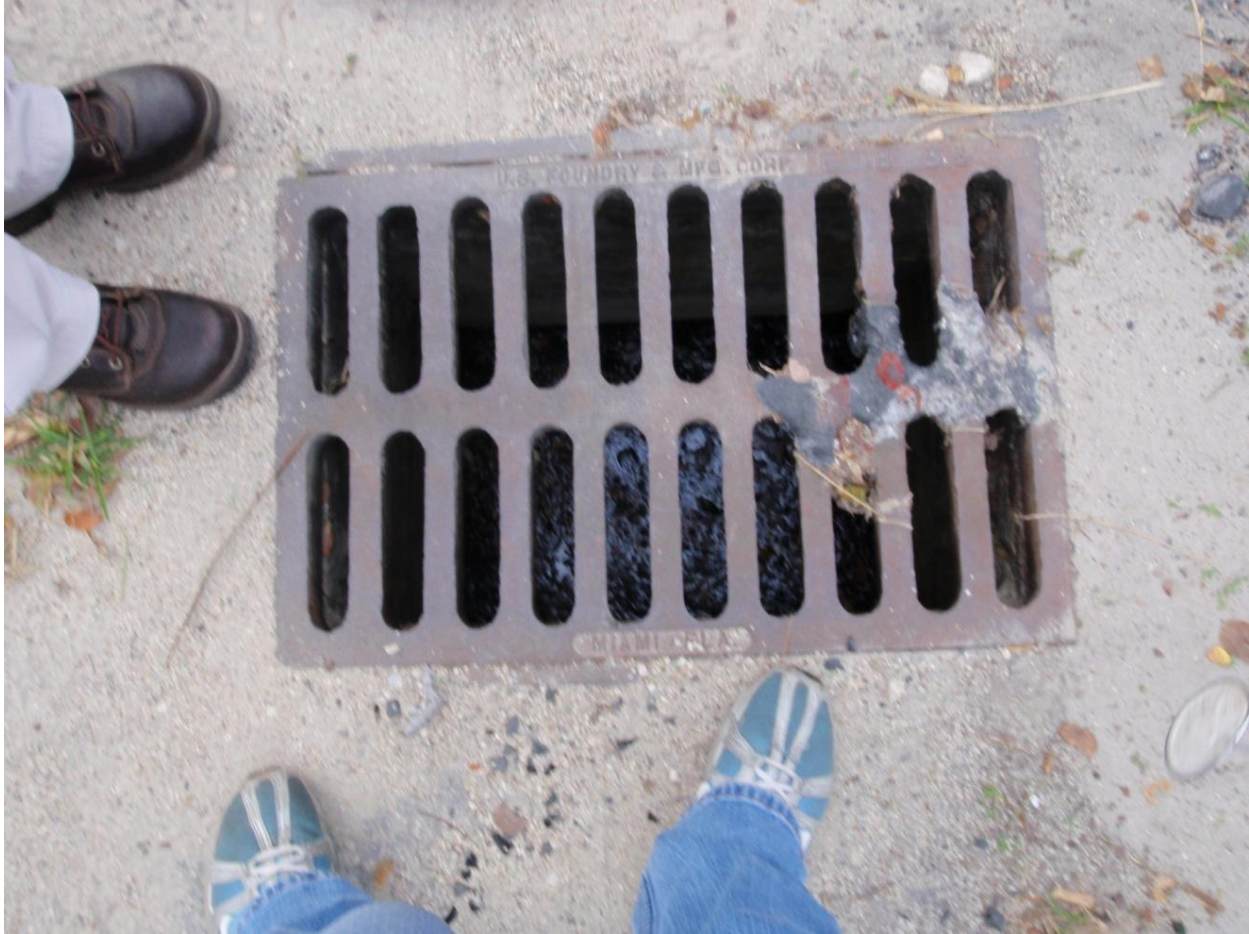
**Figure 20.** A storm drain on NW 15<sup>th</sup> Avenue south of NW 20<sup>th</sup> Street is filled with trash and not draining properly; any flooding that results could cause a failure of the wastewater system, and trash can provide a breeding ground for fecal coliform.

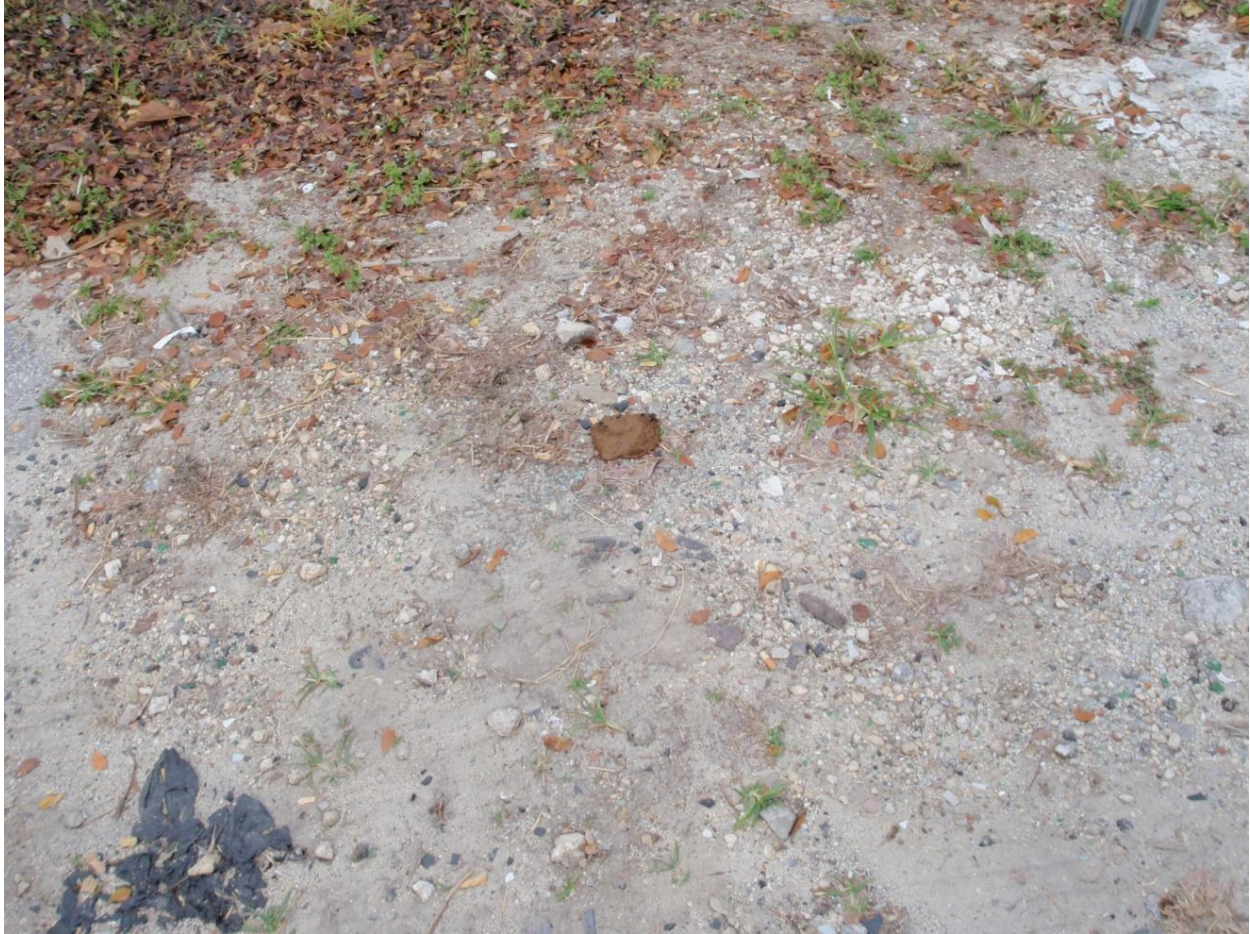
***Figure 21. Dog feces were observed near a stormwater drain at 20<sup>th</sup> Street; both sides of Wagner Creek near the 20<sup>th</sup> Street Bridge are popular areas for dog walking, and rainfall could wash fecal coliform from these areas into the creek.***

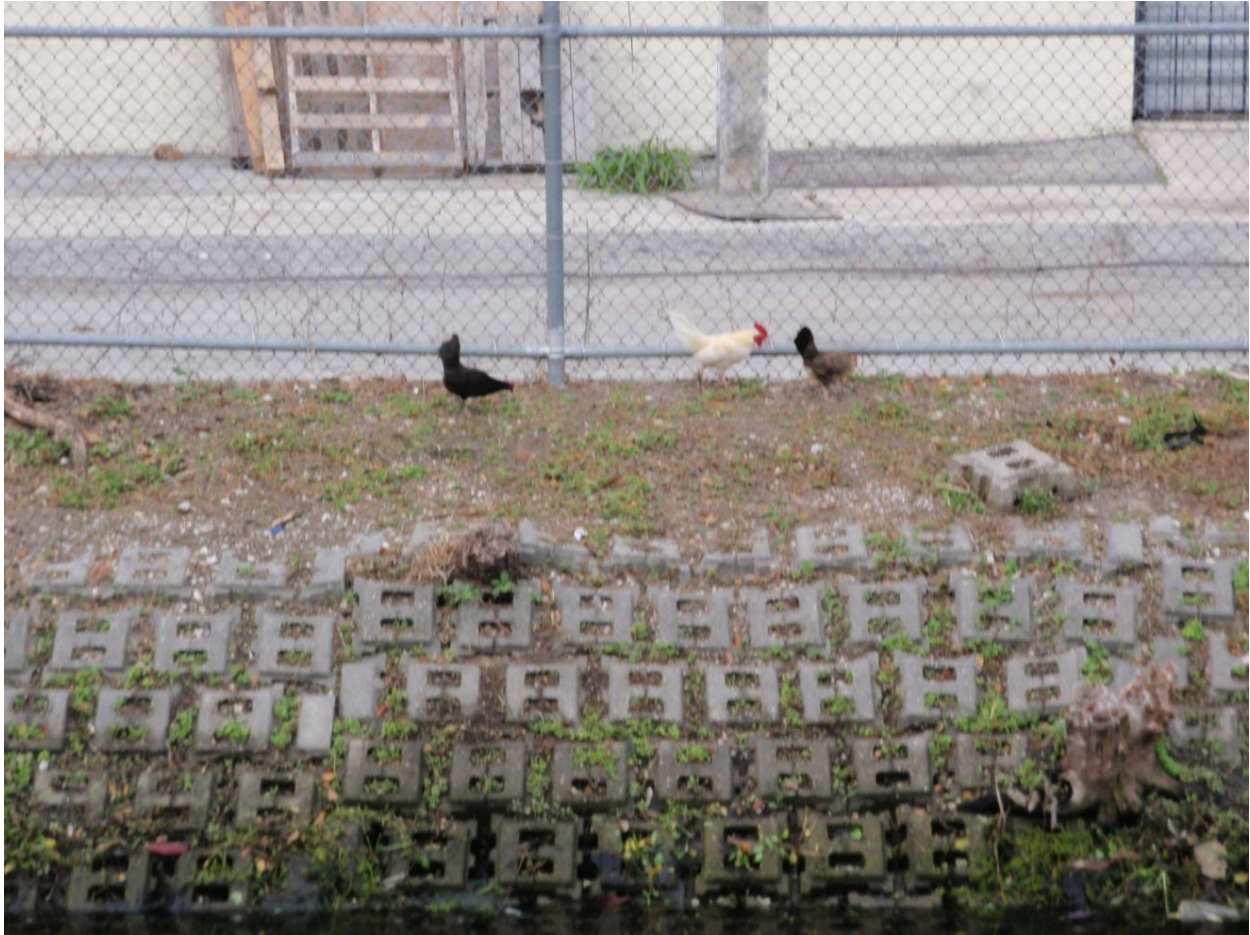
***Figure 22. Free-range chickens and a rooster were observed along the creek downstream of the 20<sup>th</sup> Street Bridge; their feces could wash into the creek, causing fecal coliform contamination.***

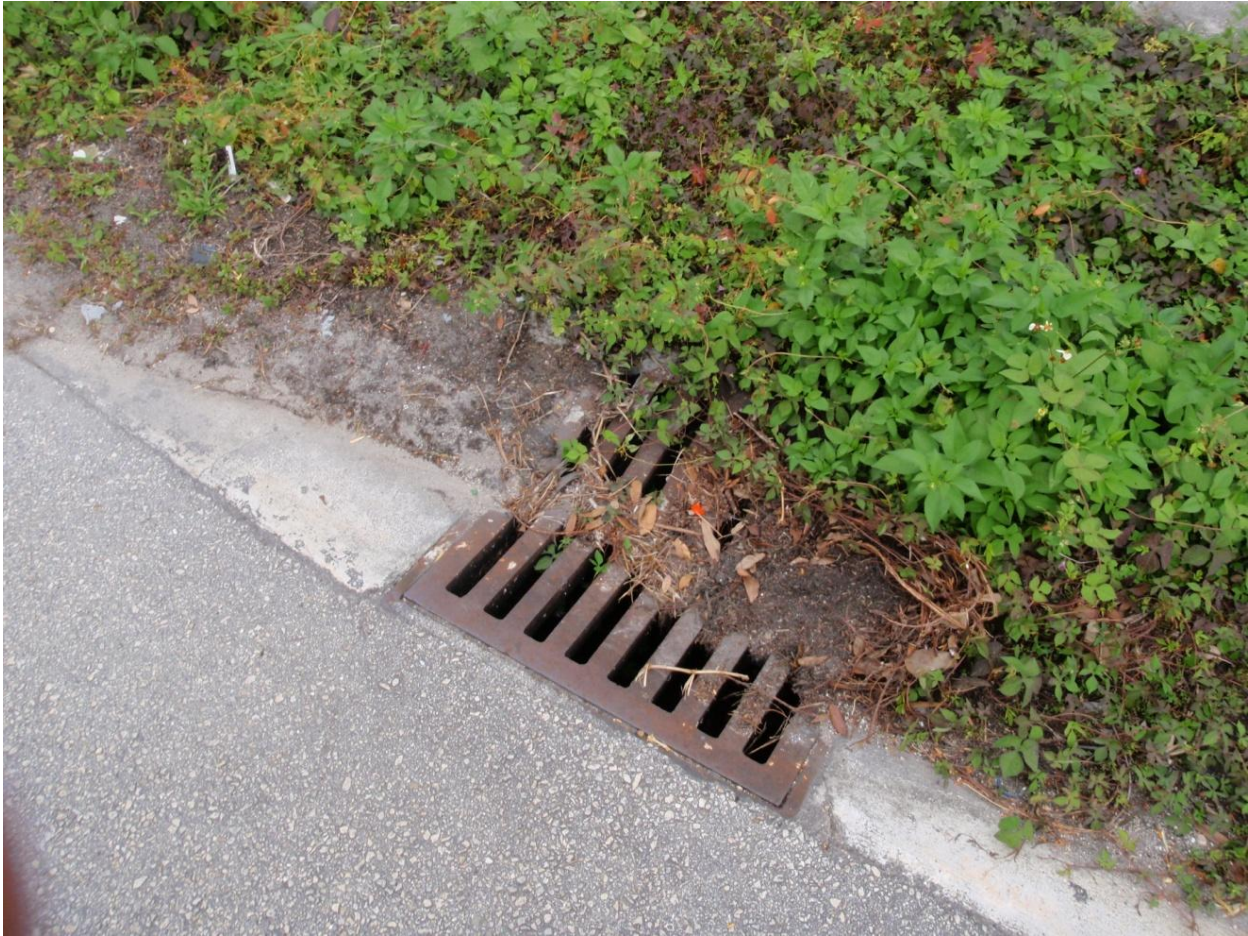
**Figure 25.** View of a partially blocked stormwater drain at 1501 to 1511 NW 13<sup>th</sup> Court; any flooding that results could lead to the failure of septic and wastewater infrastructure.

**POST-FIELD EVENT NOTE:** The City of Miami's records indicate that this inlet discharges via an outfall to Wagner Creek and that there have not been any flooding complaints at this location for the past two and a half years. Only two flooding complaints were found for NW 13<sup>th</sup> Court between NW 15<sup>th</sup> and NW 16<sup>th</sup> Streets from November 2006, to March 30<sup>th</sup>, 2011. This inlet is maintained by the City of Miami Public Works Department.

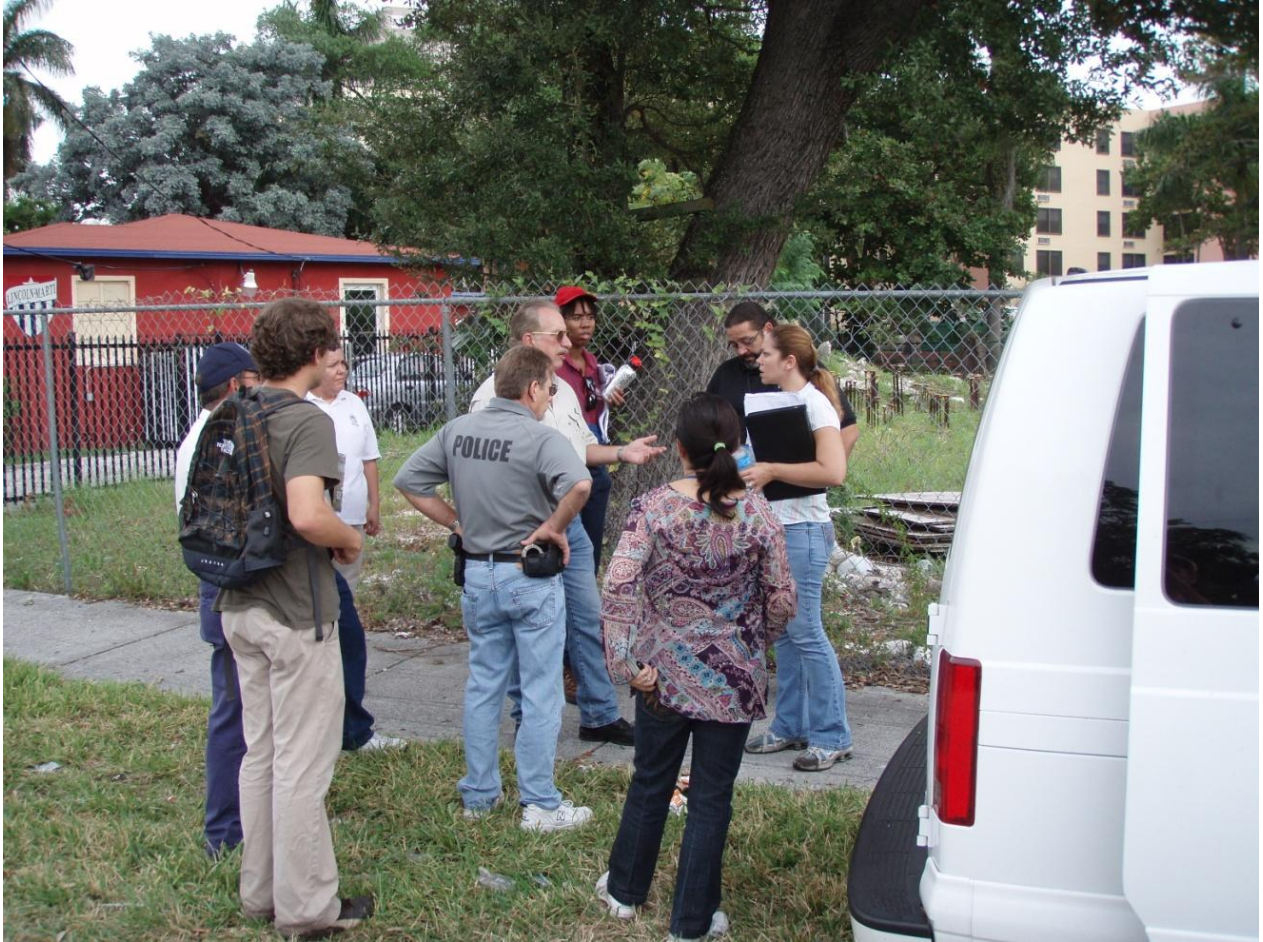
**Figure 26. Team members and law enforcement personnel investigating potential septic system failures and PICs at NW 13<sup>th</sup> Court.**

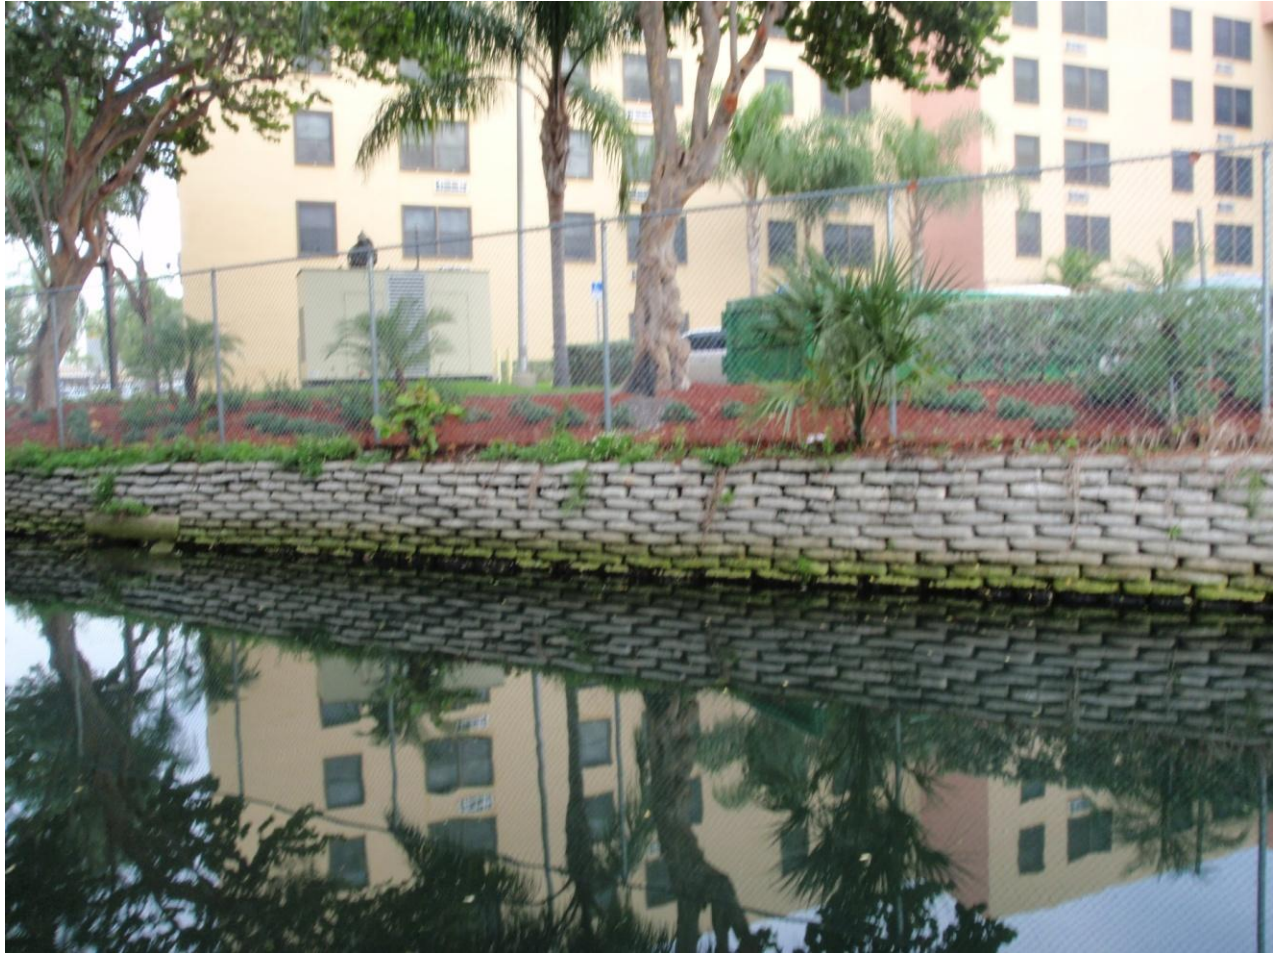
**Figure 28.** *Apartments along the creek at 1310 NW 16<sup>th</sup> Street, with private storm drain outlets that discharge directly to the creek; this is a gated community, with no access for an inspection.*

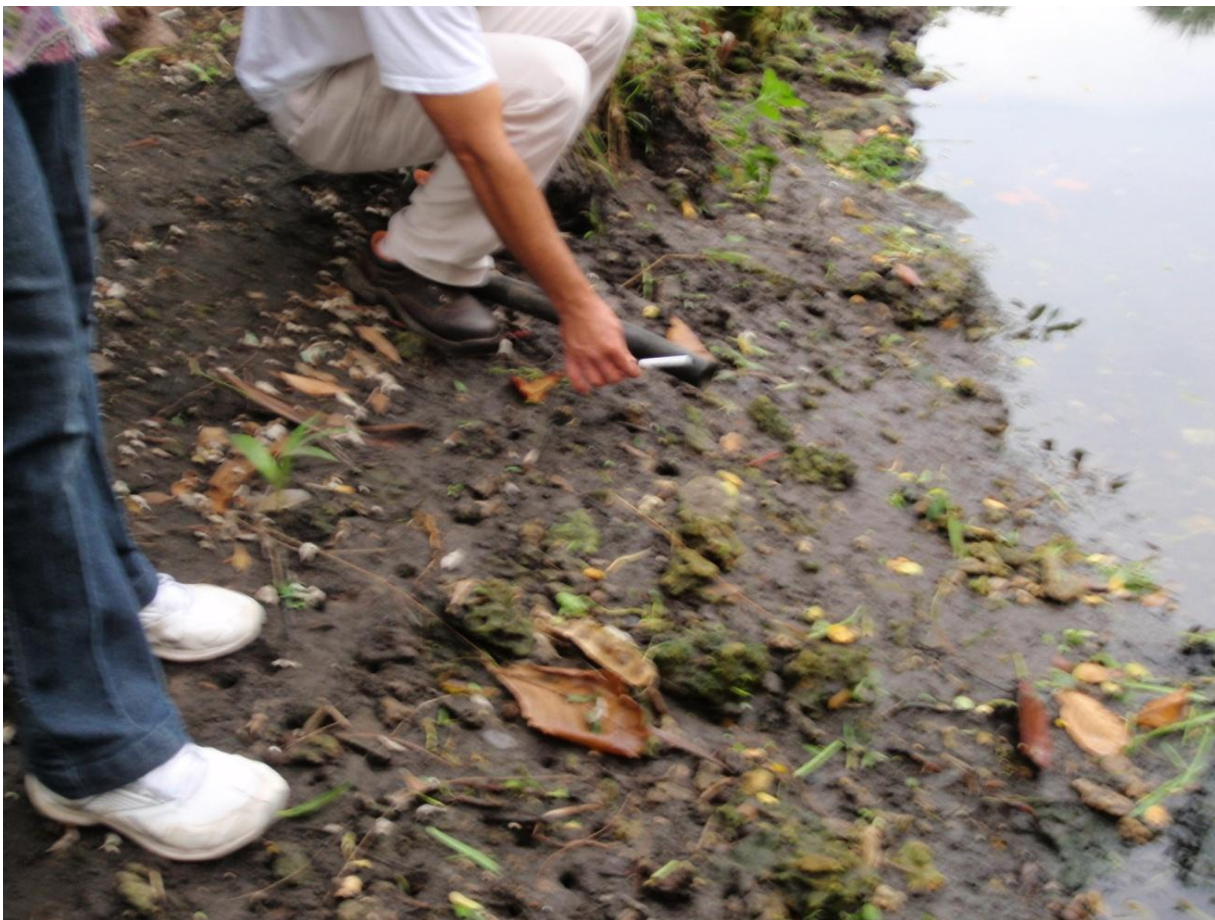
*Figure 29. PIC 1 at NW 13<sup>th</sup> Court consisted of a pipe sticking out of the ground.*

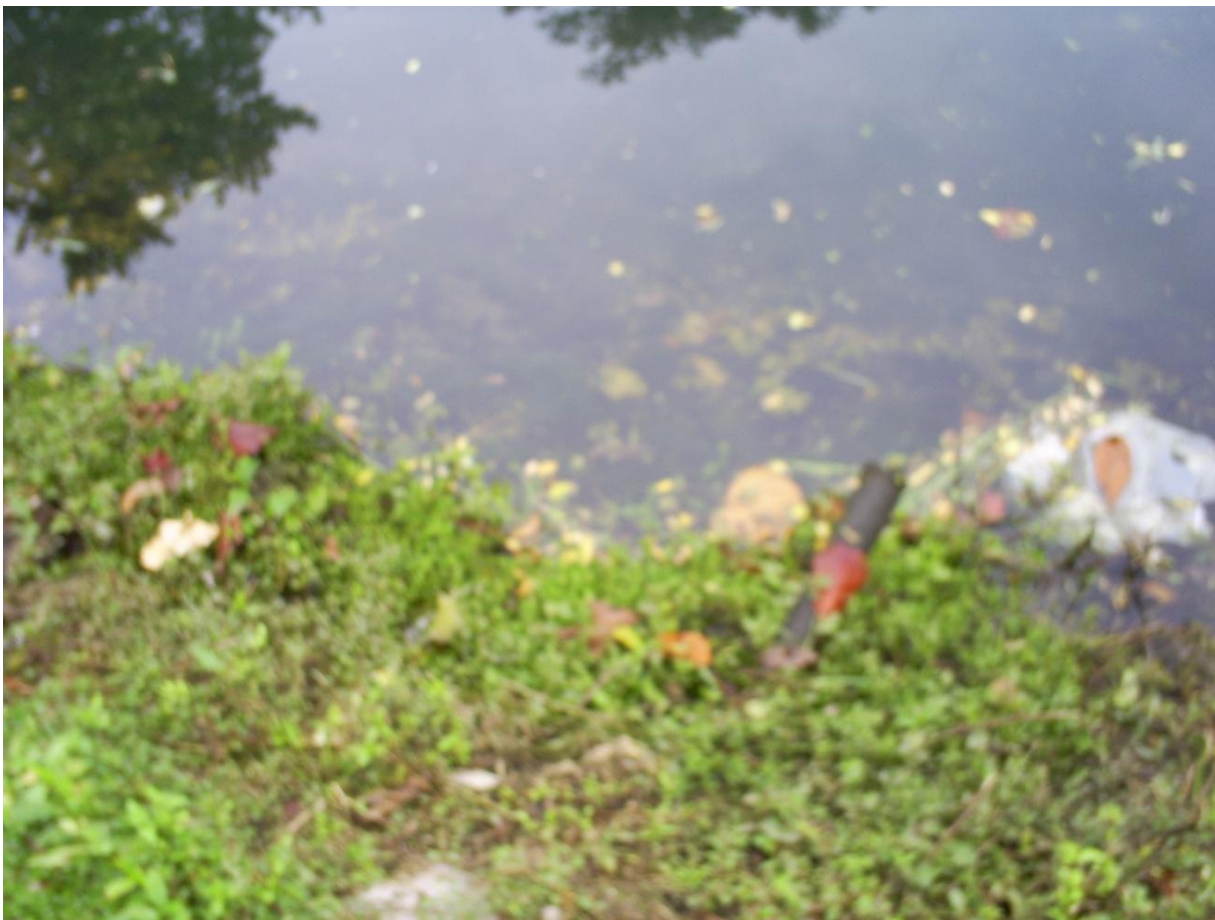
*Figure 30. PIC 3 consisted of an unknown pipe sticking out of the ground.*

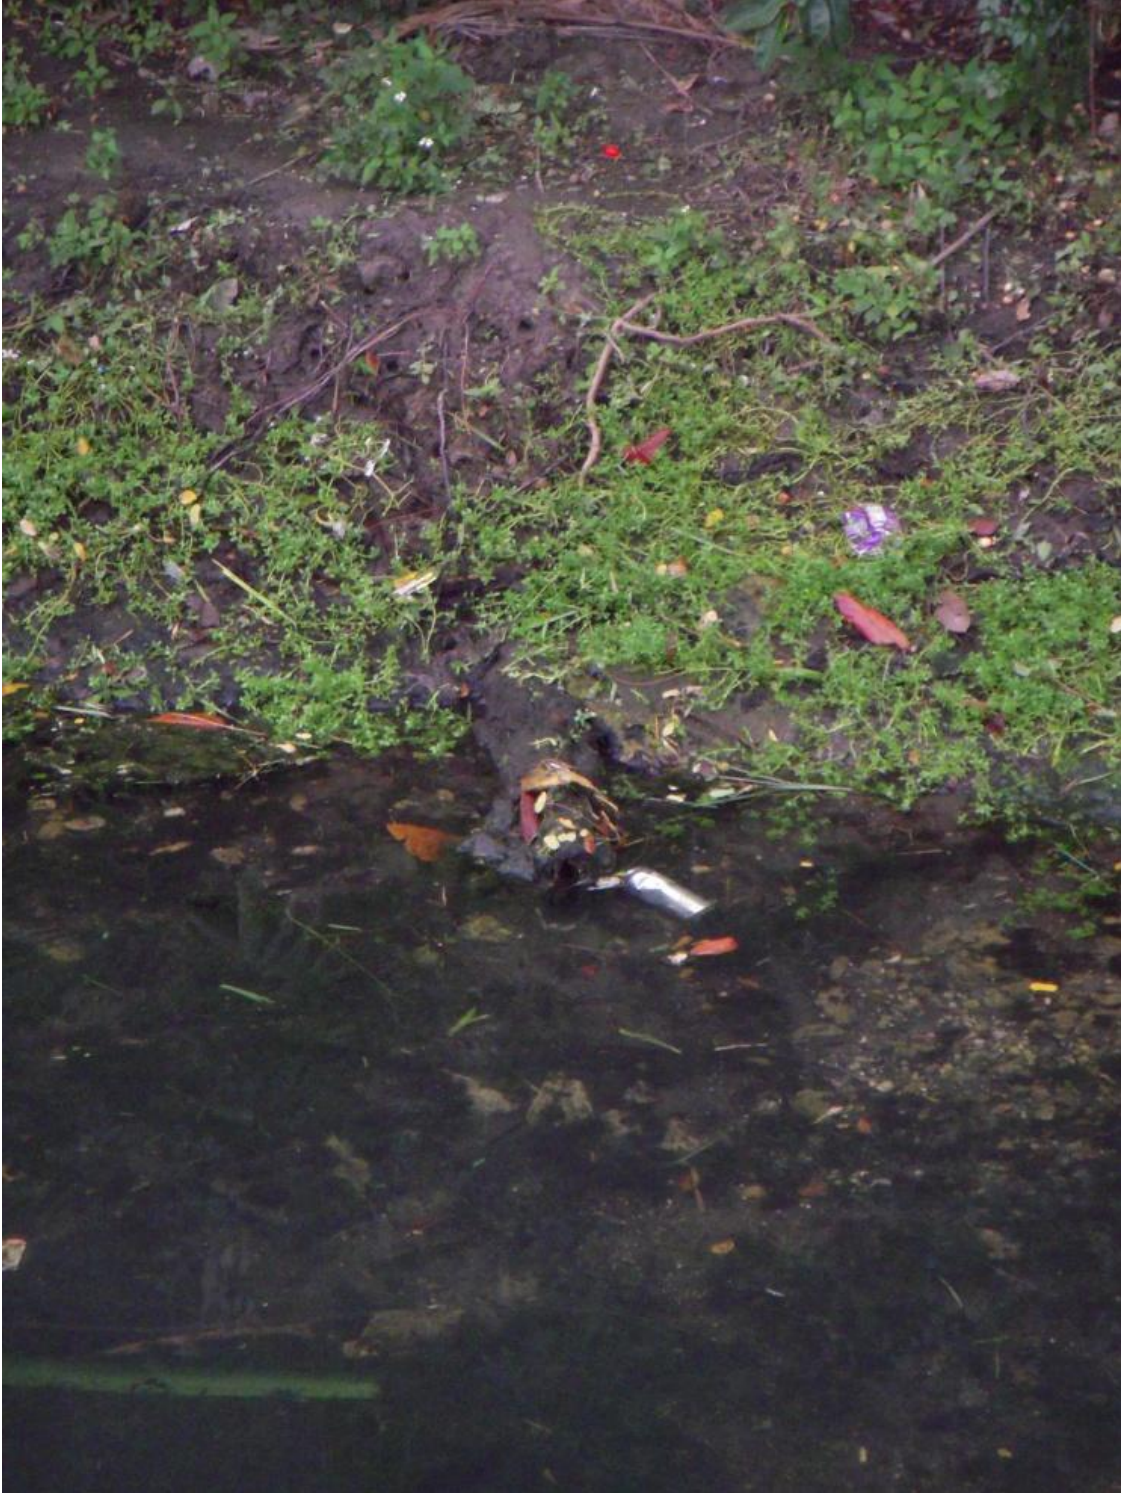
*Figure 31. PIC 4 was thought to be a pipe but was confirmed to be a log.*

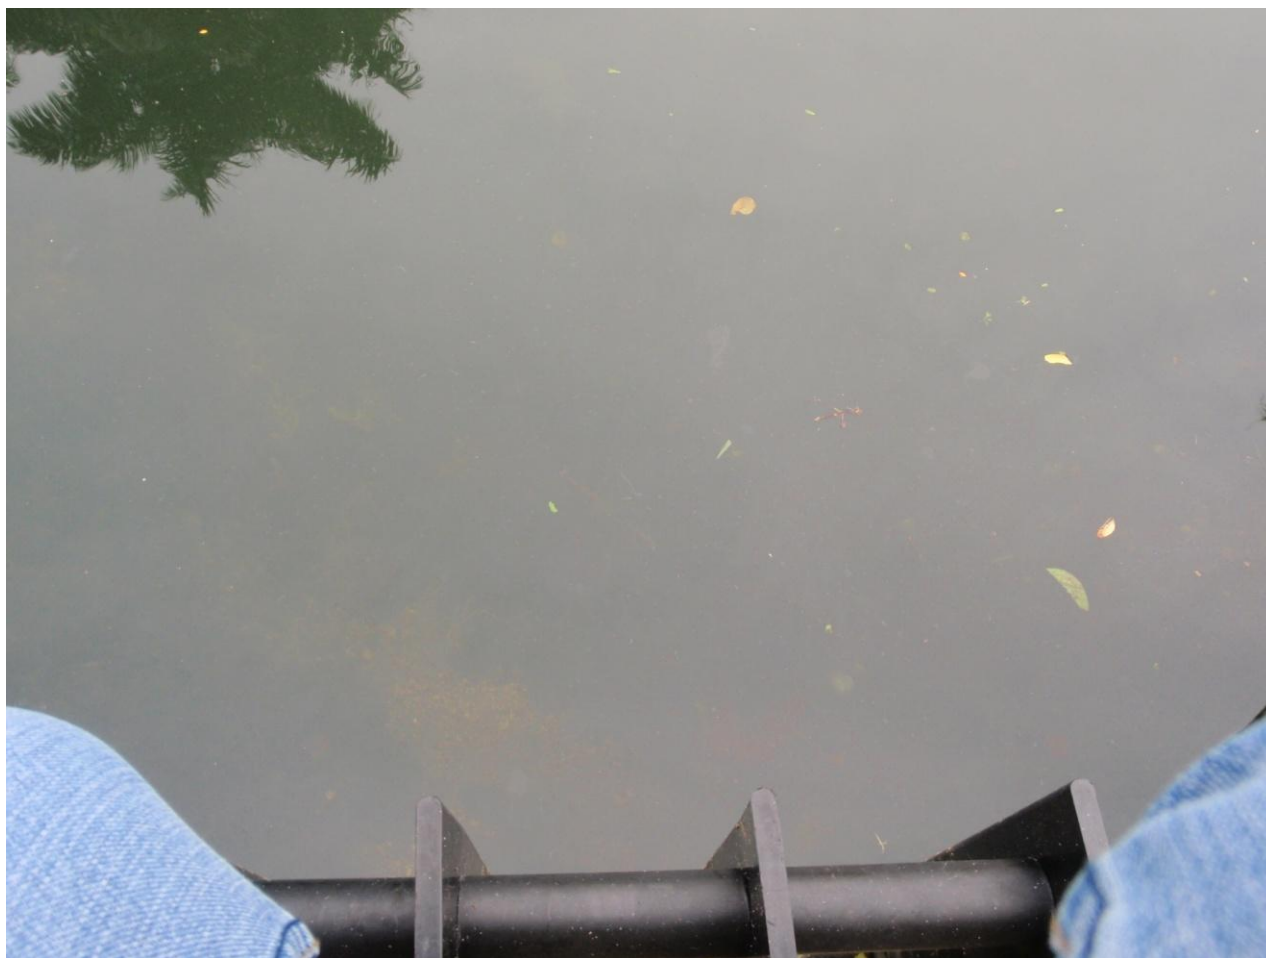
***Figure 32. Solids and oils floating on surface water at a stormwater outfall from the VA Hospital building.***

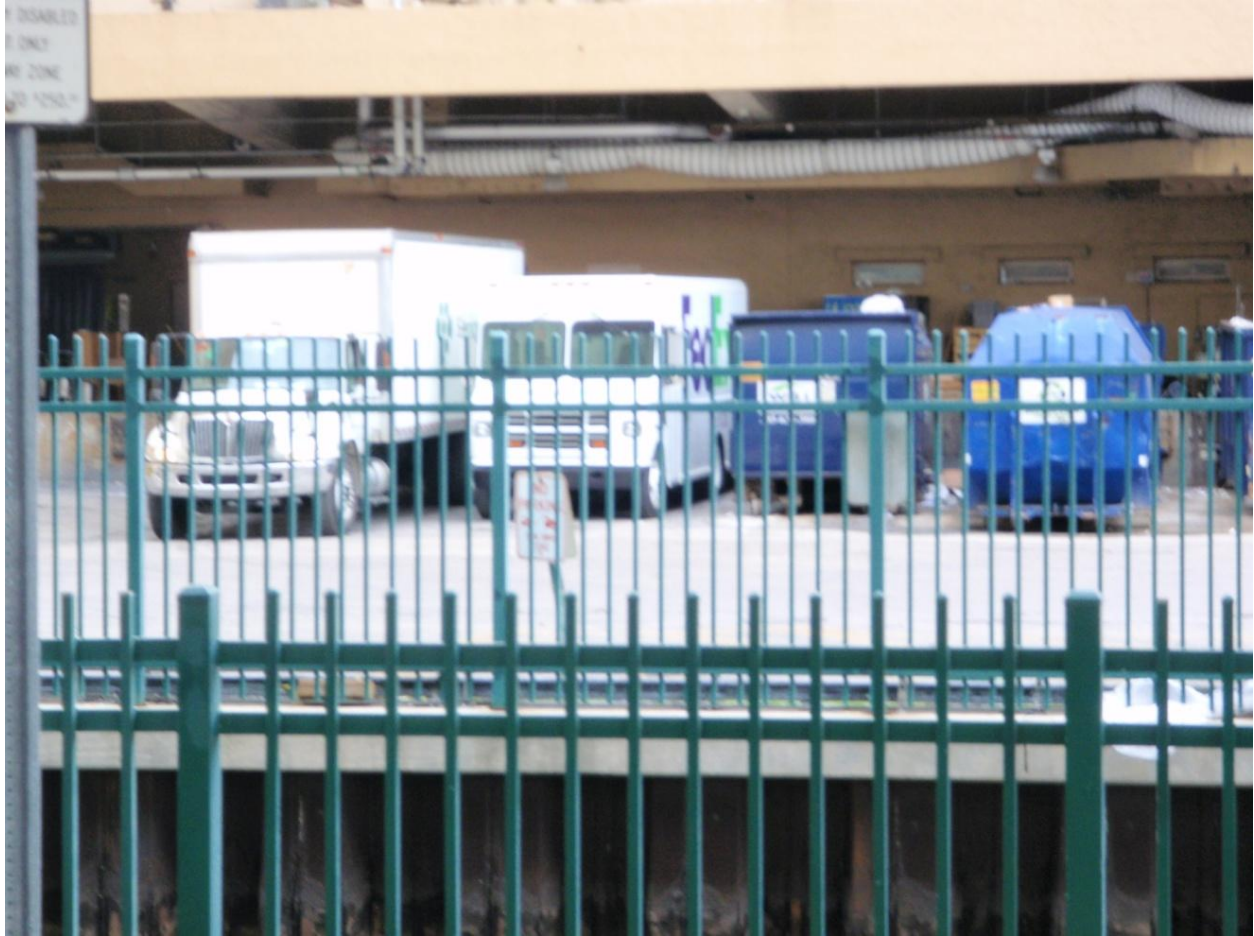
***Figure 35. A channelized Wagner Creek flowing past the University of Miami Medical Center, showing dumpsters and trucks right next to the creek, with no berm to prevent untreated stormwater runoff from entering the water.***

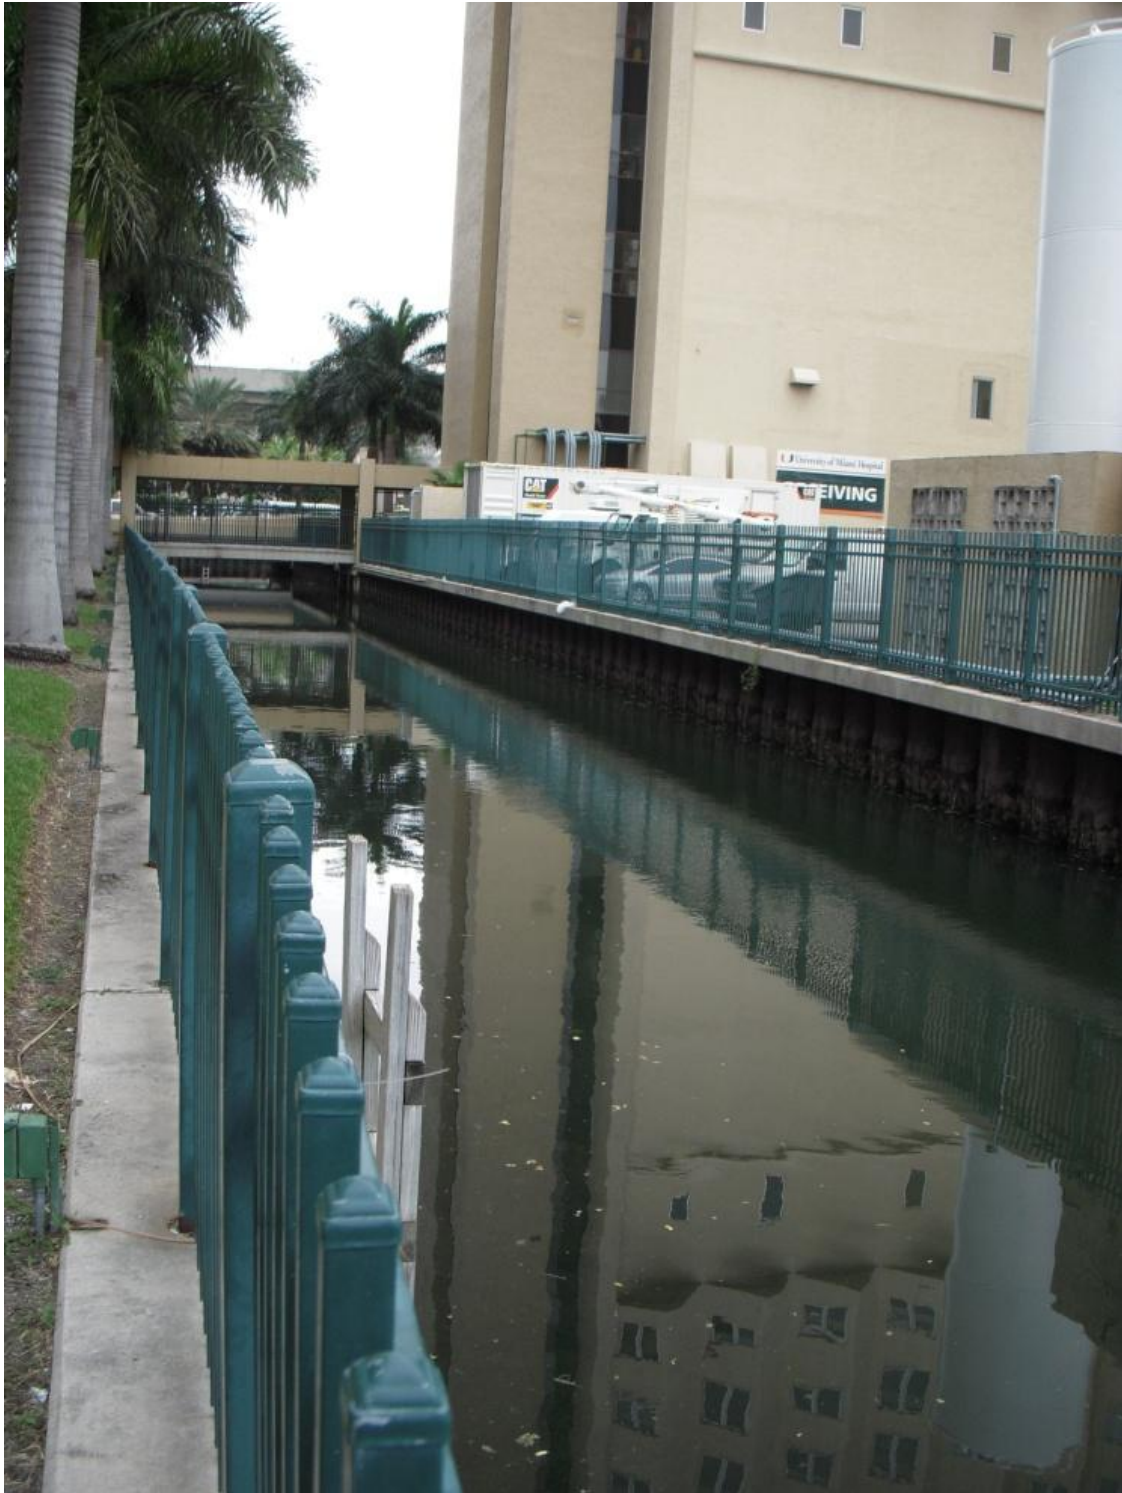
***Figure 38. Wagner Creek is channelized next to the University of Miami Medical Center. When the hospital was built, the creek was rerouted to make a 90-degree turn so that there would be enough space on the existing lot to place the hospital building.***
