# Summary of Results

## Walk the WBID Exercise for Wagner Creek (WBID 3288A)

September 2011

This report summarizes the results of the Walk the WBID exercise for the Wagner Creek watershed (WBID 3288A), located in the northwestern portion of the City of Miami, on November 18, 2010. (WBID is the abbreviation for **WaterBody ID**entification number, which is very similar to a watershed.) This field reconnaissance and source elimination effort was carried out to gain a better understanding of conditions within the watershed, including the hydrology of the creek and its contributing ditches and branches, flood-prone areas, the location of sewer and stormwater infrastructure, and potential sources that are contributing fecal coliform bacteria to the creek.

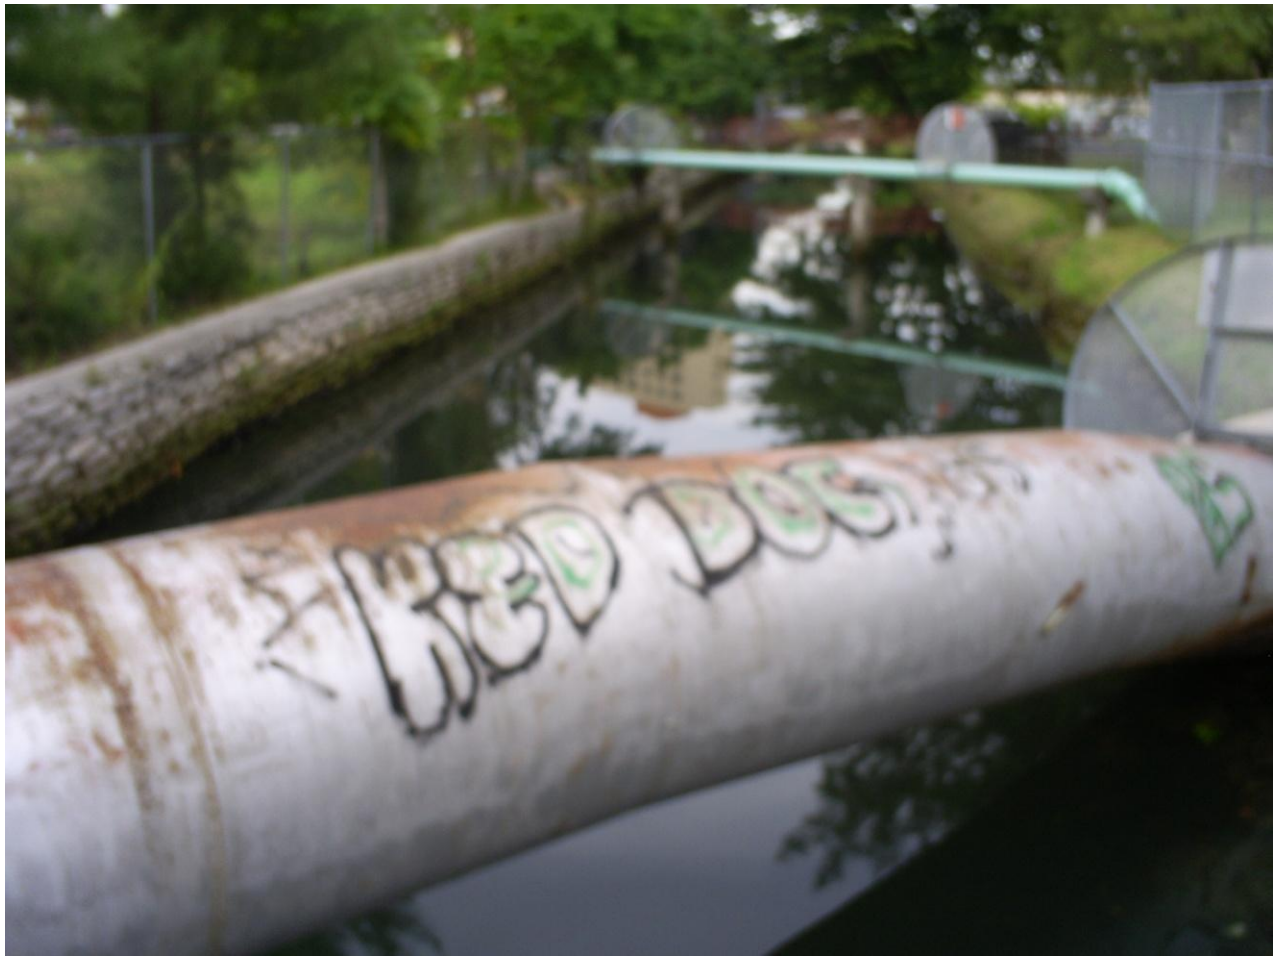
*Figure 39. Abandoned sewer line crossing the creek north of the NW 17<sup>th</sup> Street Bridge.*

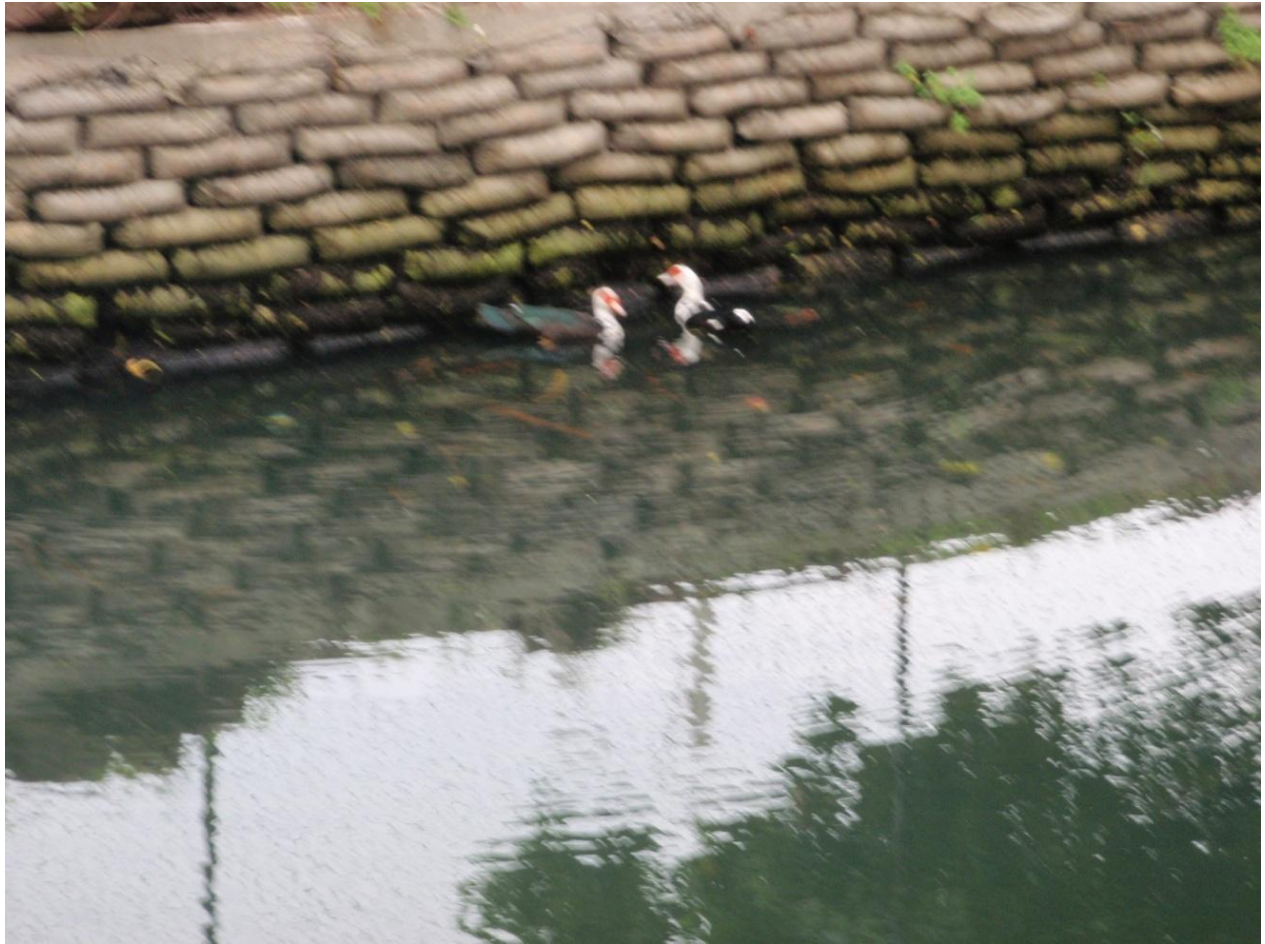
***Figure 40. Muscovy ducks in the creek at NW 14<sup>th</sup> Avenue; waterfowl can be a source of high fecal coliform bacteria in surface waters.***

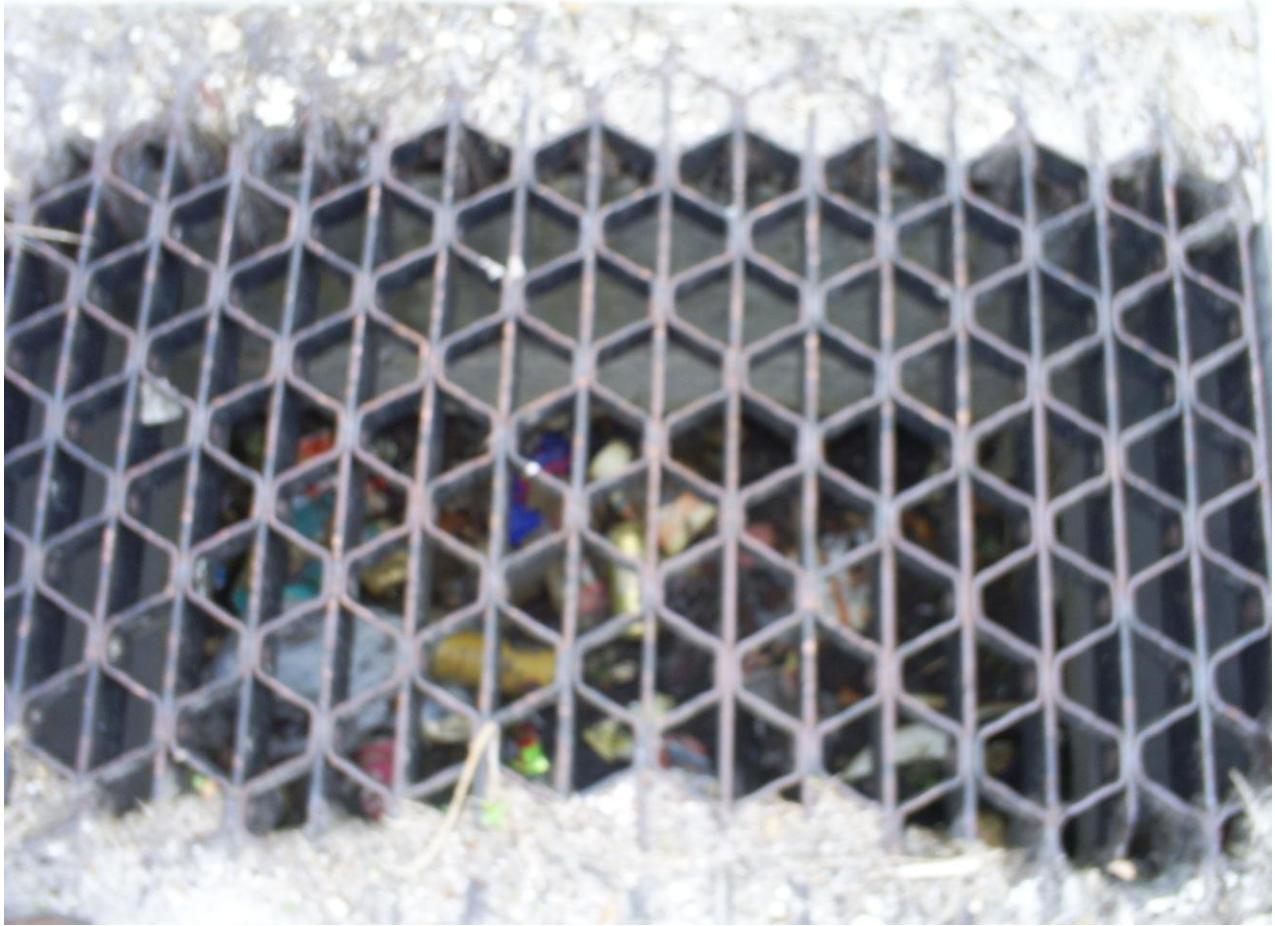
**Figure 42.** *Litter, debris, and trash in a stormwater drain inside the Miami–Dade Transit Culmer Metrorail Station in the Highland Park area.*

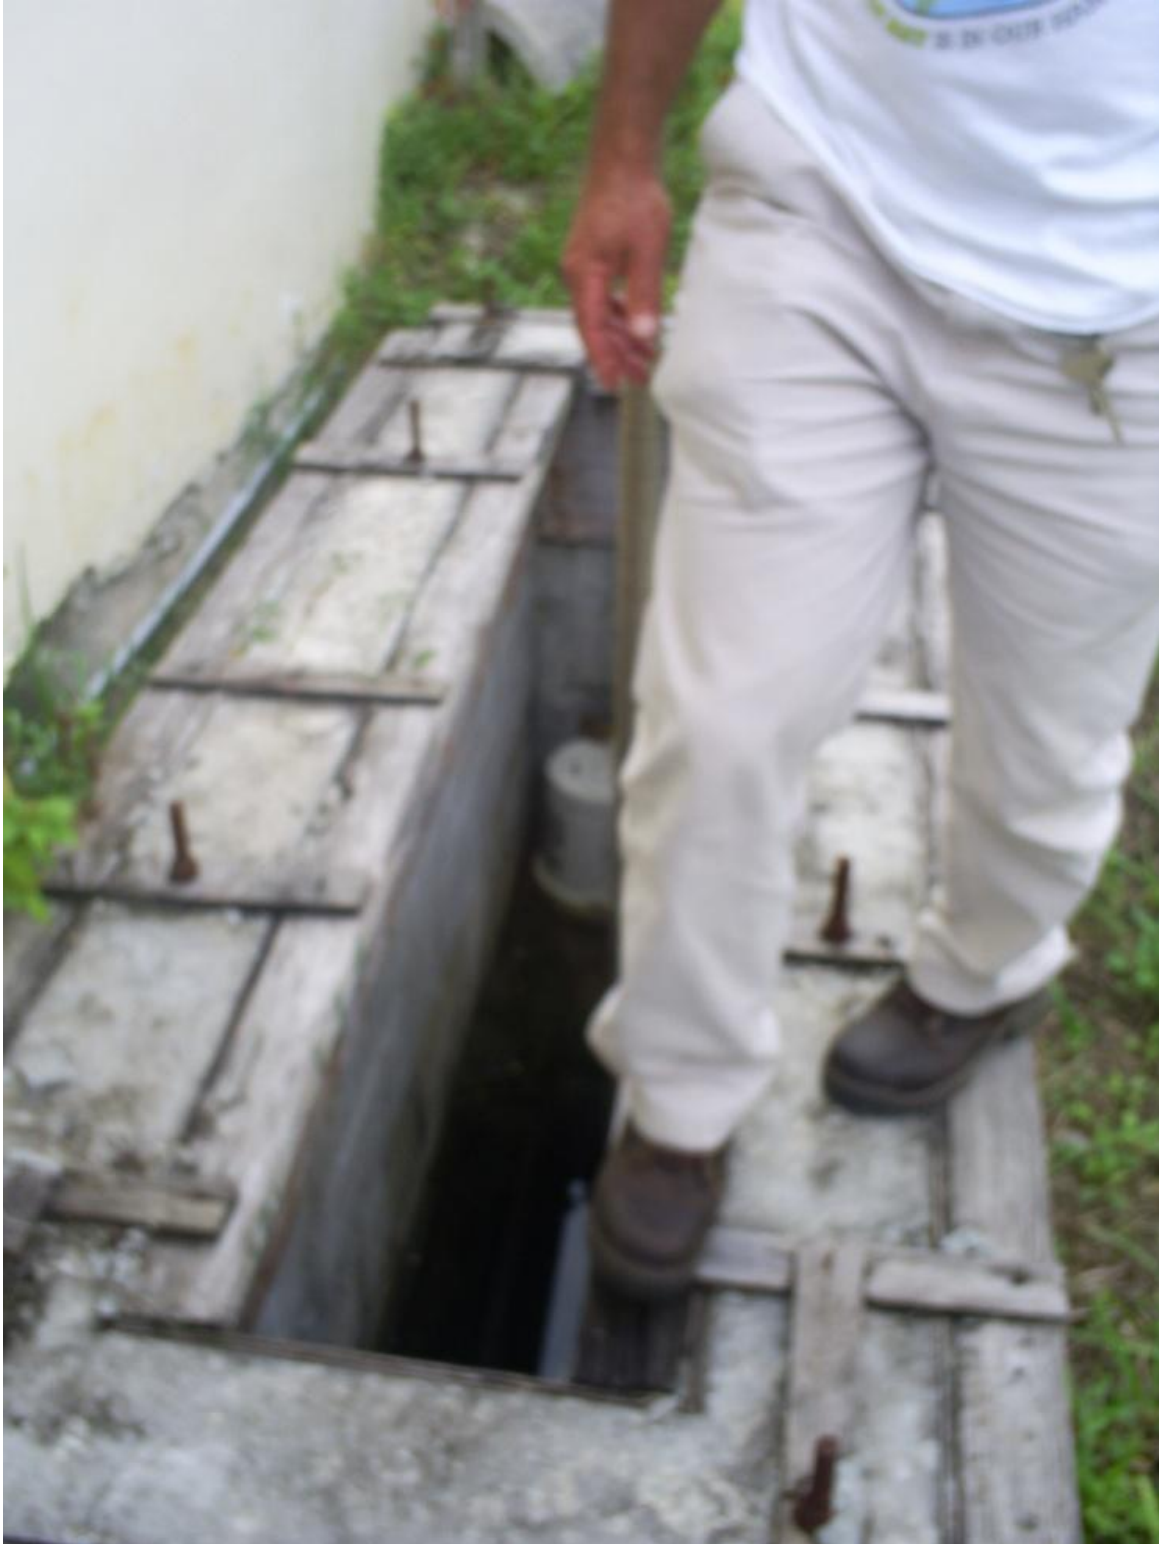
**Figure 46.** A PIC at the City of Miami Overtown stormwater pump station consists of those portions of the incomplete upgrades that allow foreign objects to enter the stormwater system.

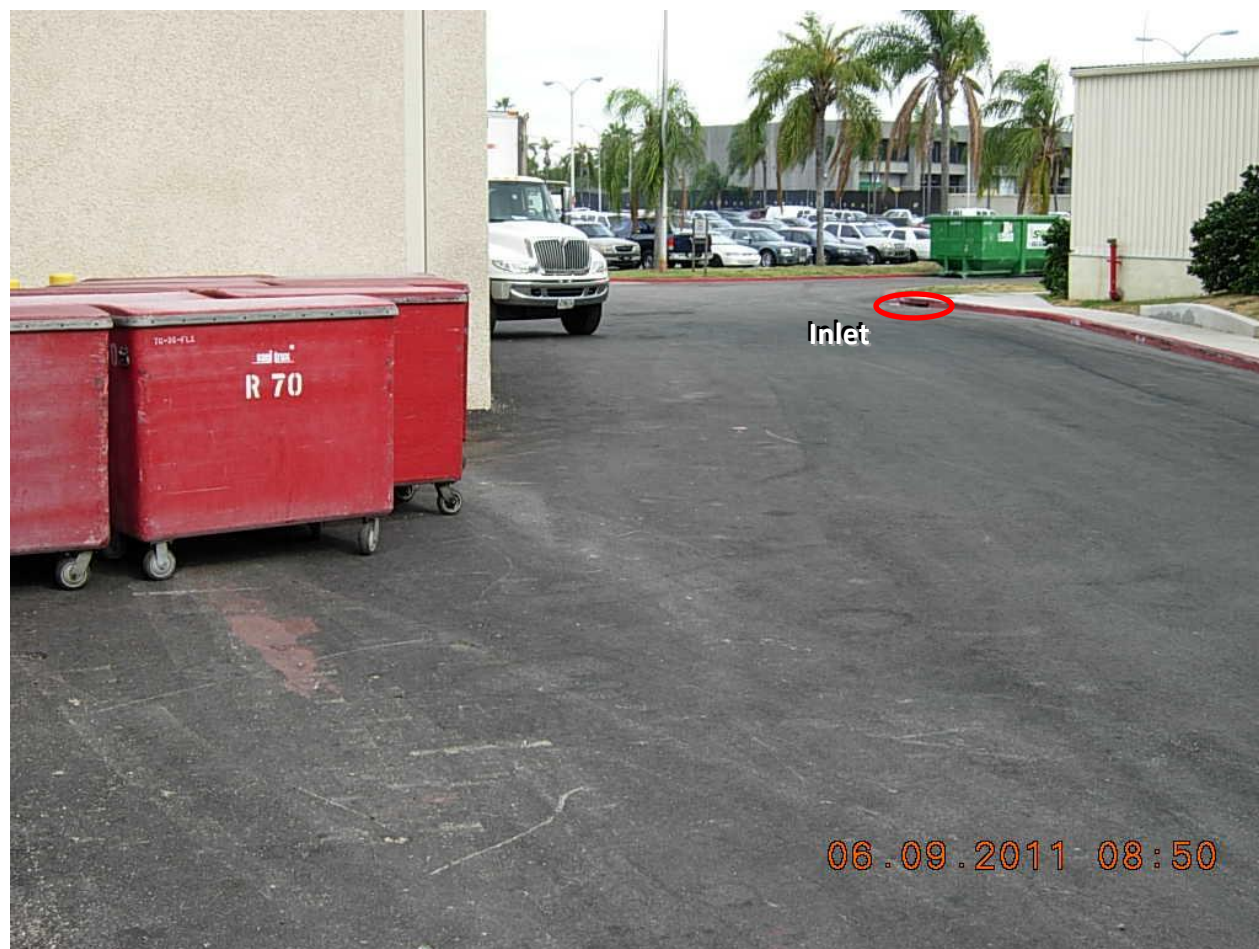
**Figure 53.** View of a portion of the VA Hospital site, near the western parking lot. On the way in to inspect the sanitary lift stations, the team observed closed biomedical waste bins upstream of the curb opening inlet (circled in red at top right). One of the team members observed some small holes in the bins. In the same area, a roll-off container was observed upslope of a drop inlet (at left).

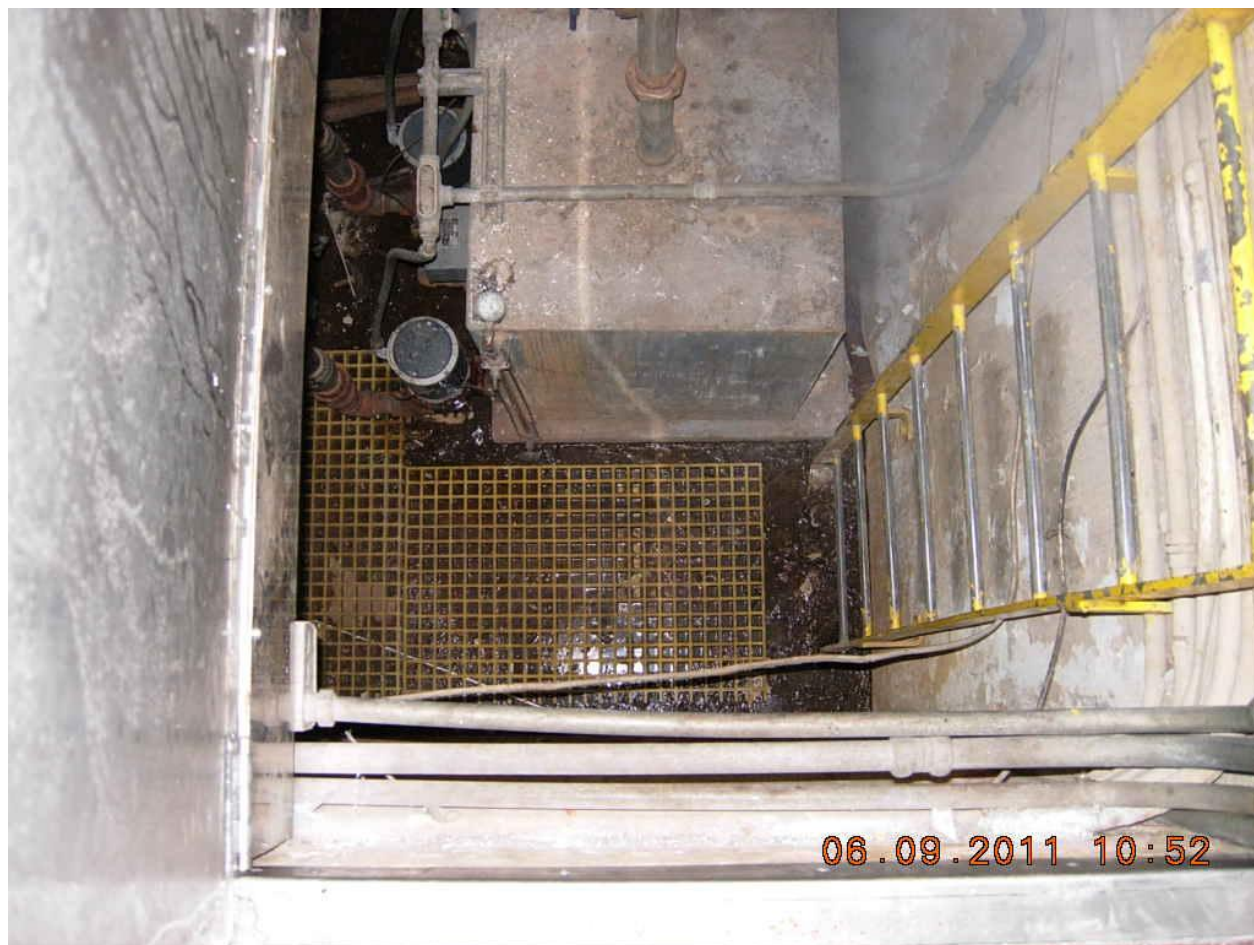
**Figure 54.** View of the first VA Hospital sanitary lift station, located inside one of the buildings. The VA staff stated that the pump station was “open” rather than “sealed” because it is located in an area where there is a continuous flow of air from outside. Harold Moesch from FDEP entered the pump station for a closer investigation. No unusual conditions were observed. There was a noticeable mercaptan odor at this location.

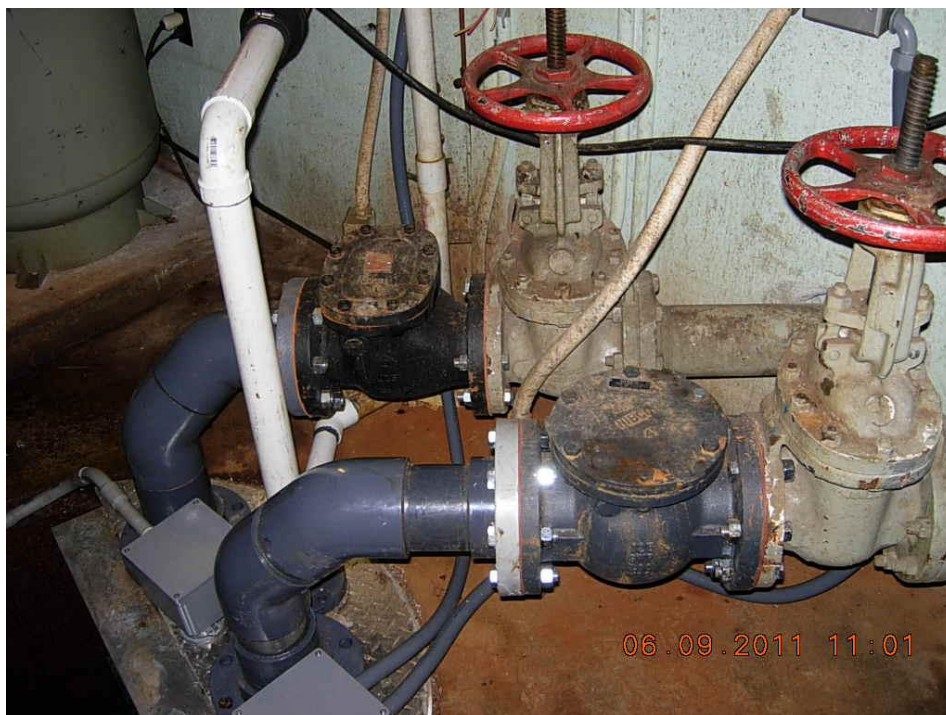
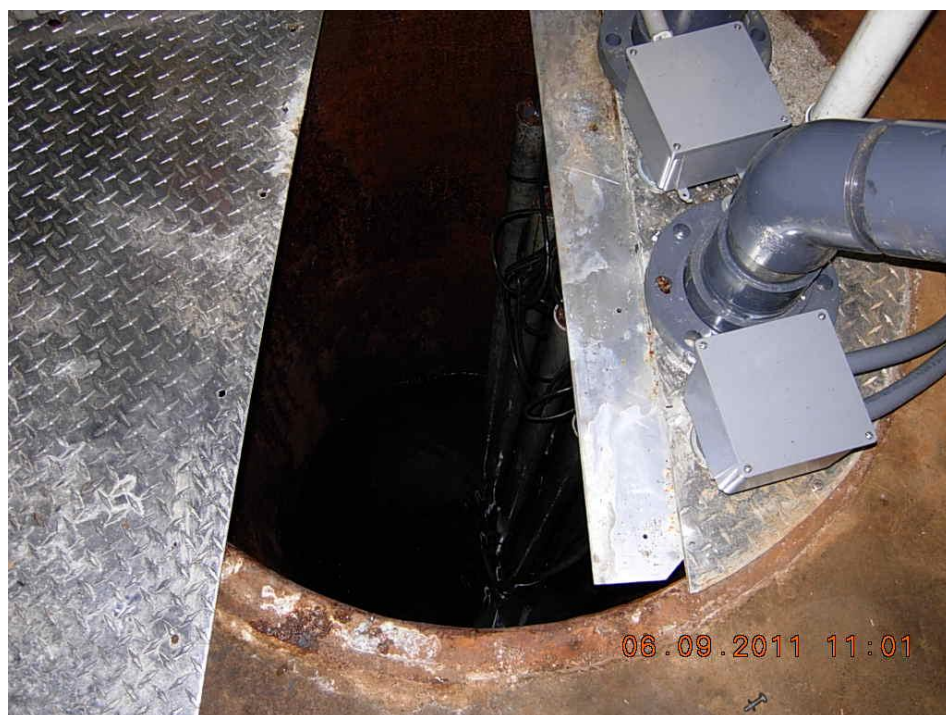
**Figure 55.** Views of the second VA Hospital sanitary lift station, also located inside one of the buildings. A noticeable sewage odor with ammonia prevailed. The pump station is sealed.

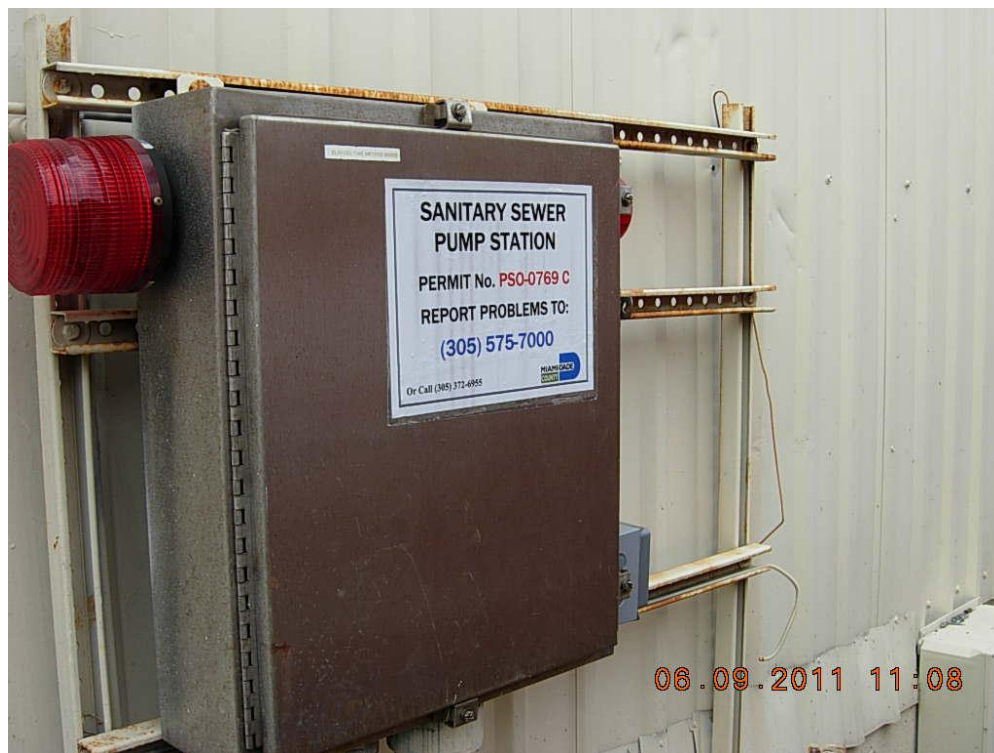
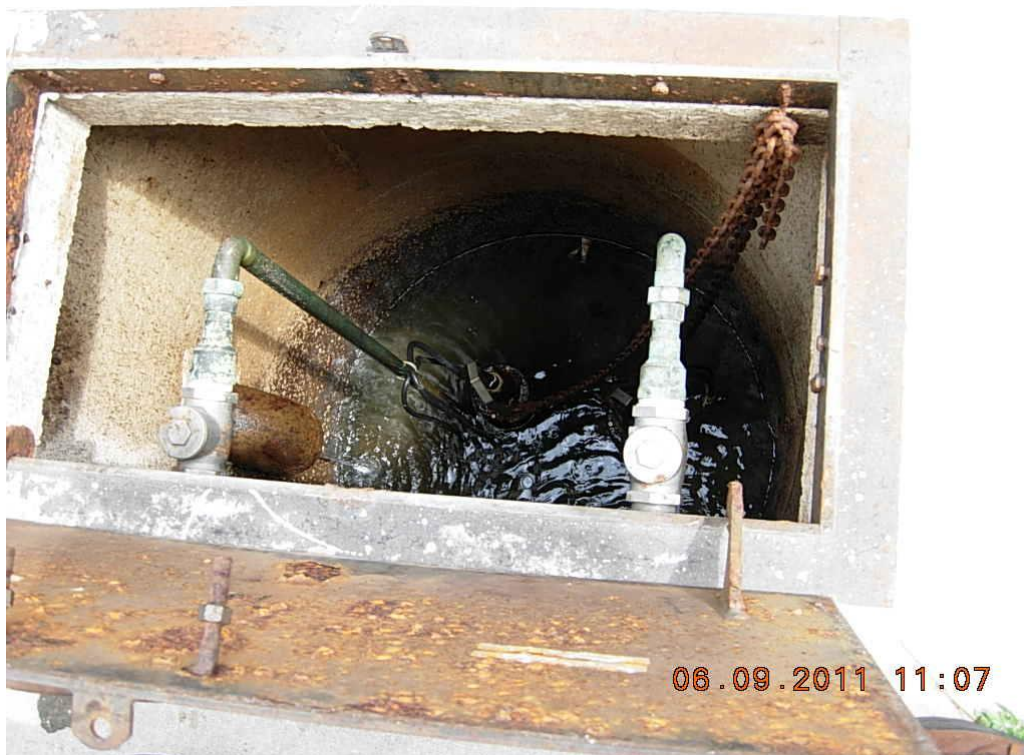
**Figure 56.** Views of the VA Hospital sanitary lift station located outside between Buildings 8 and 9. The pump station appeared relatively clean. No grease was observed.

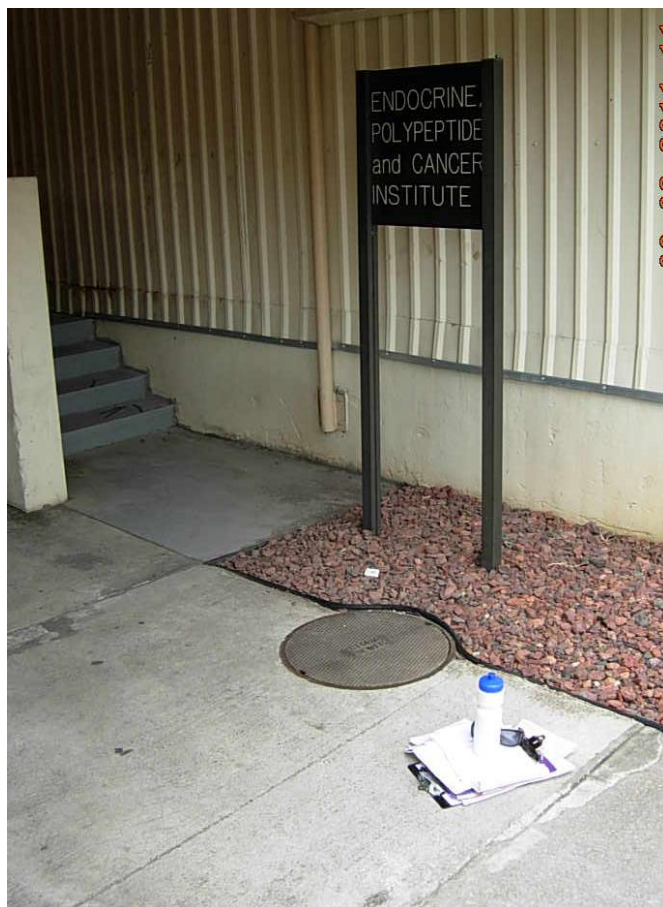
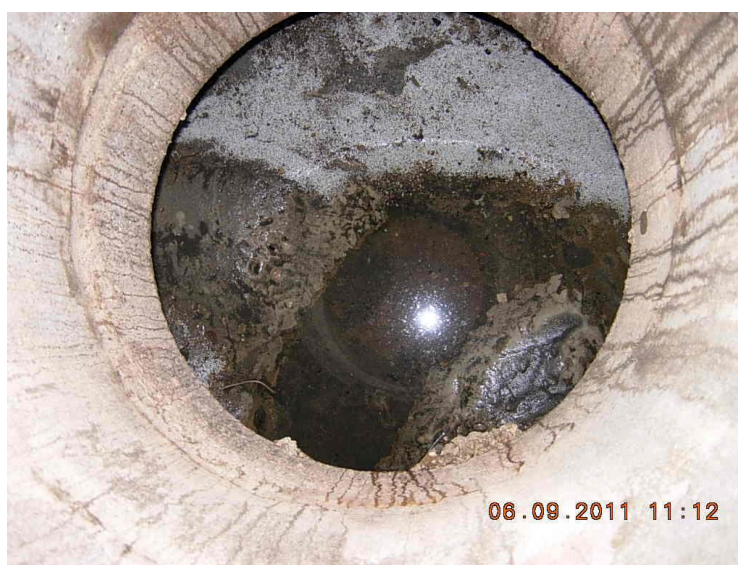
**Figure 57.** Views of the storm sewer manhole located around the corner from the VA Hospital's third pump station near the Endocrine, Polypeptide, and Cancer Institute. Upon inspection, no sanitary sewage impact was observed at this manhole.

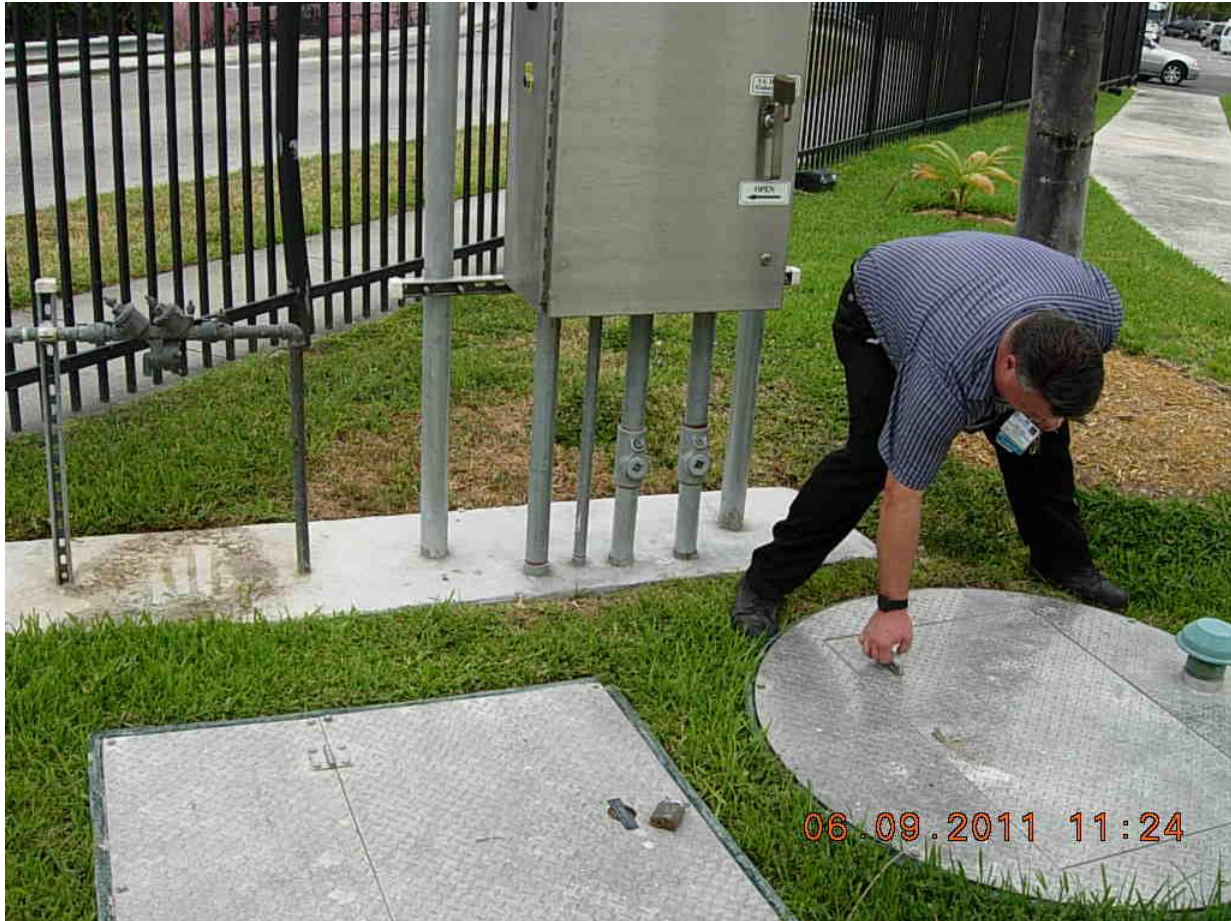
**Figure 58.** View of the fourth VA Hospital sanitary lift station near NW 17<sup>th</sup> Street, close to the newly completed Fisher House. The Wagner Creek guardrail is just visible in the upper left corner of the photo. This is a new lift station that had not yet completed the DERM permitting process at the time of inspection. Scott Olsen of the VA Hospital opened the pump station. Debris and some globules were observed. Allen Cox from DERM suggested pumping out the new station.

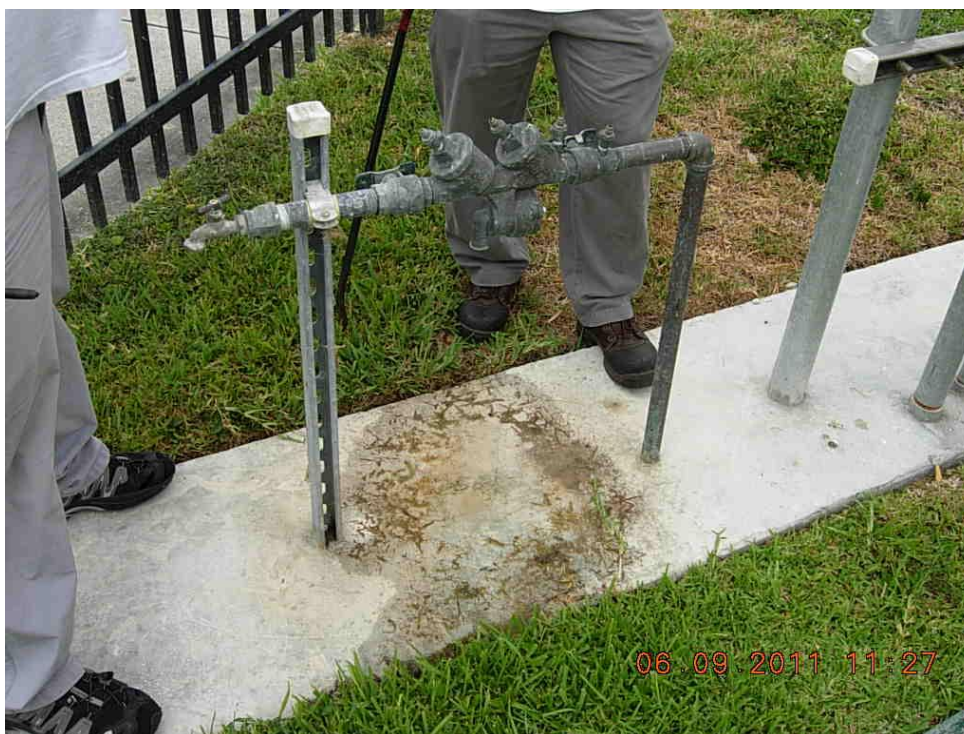
**Figure 60.** Close-up view of slowly leaking backflow preventer at the lift station.

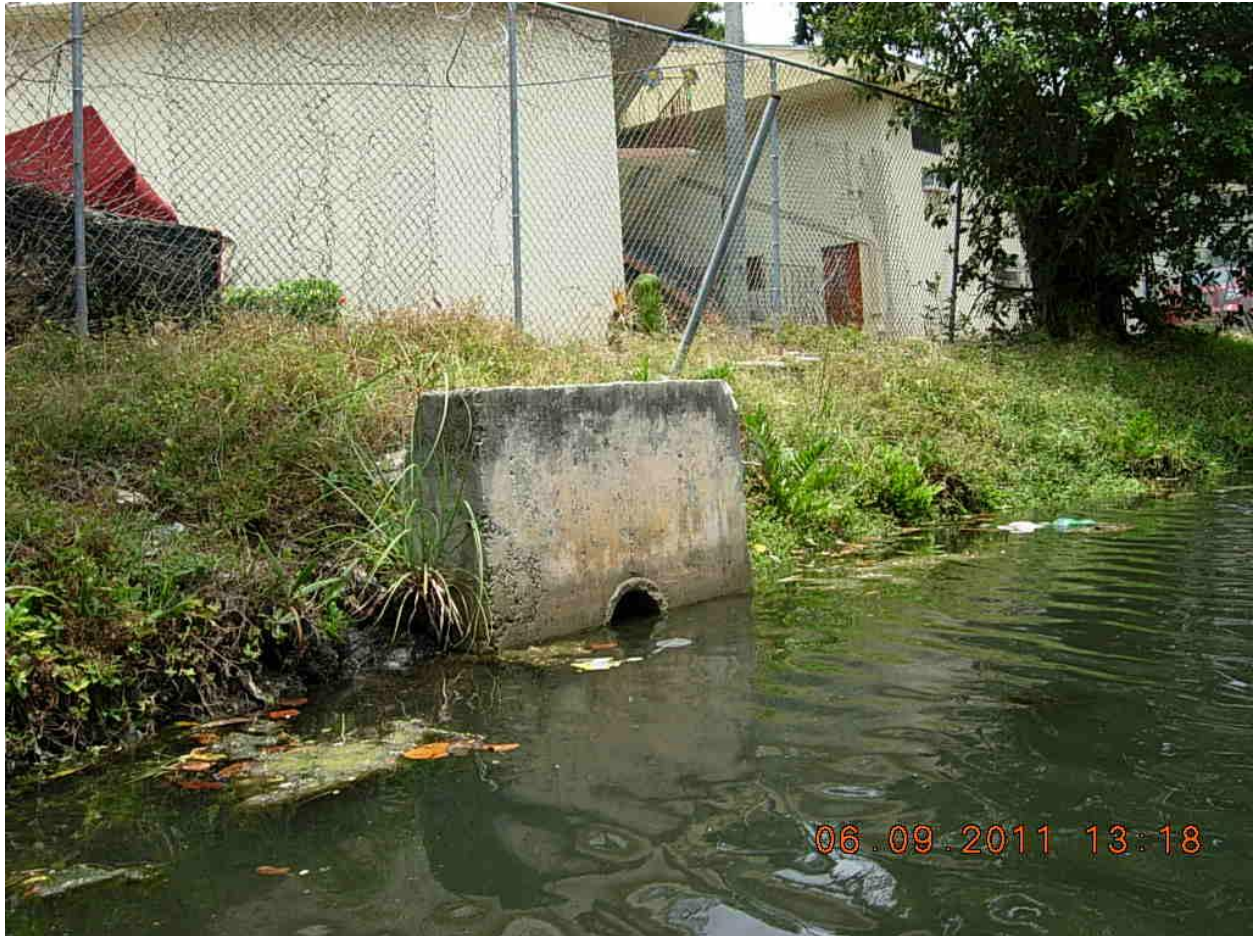
**Figure 63.** The first PIC was an 8-inch-diameter concrete pipe with a headwall. GPS coordinates are 25 47' 37.142" N, 80 13' 15.892" W.

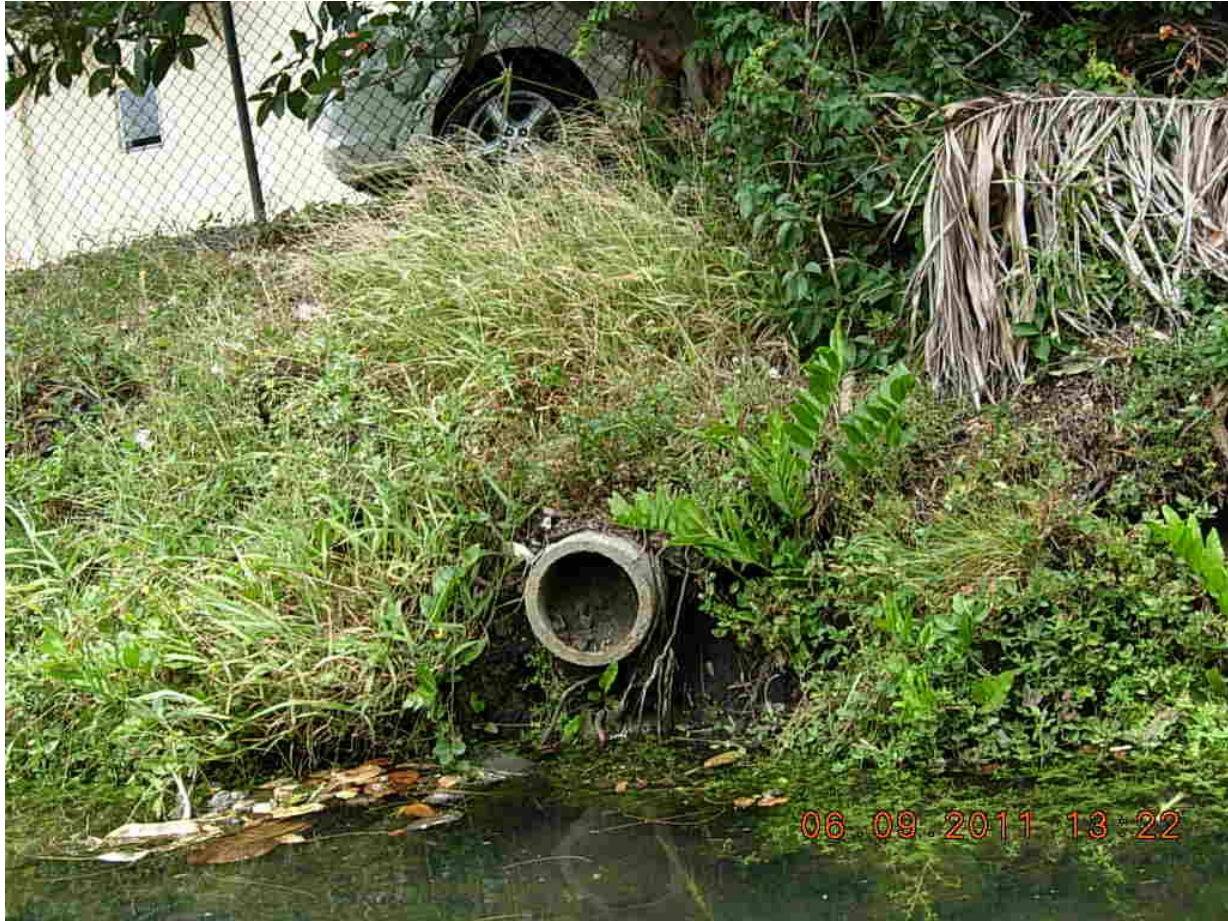
*Figure 65. Another 8-inch diameter concrete pipe, without a headwall, was located farther to the south and appeared to belong to the same apartment complex. The outfall was full of sediment. GPS coordinates are 25 47' 36.299" N, 80 13' 14.842" W.*

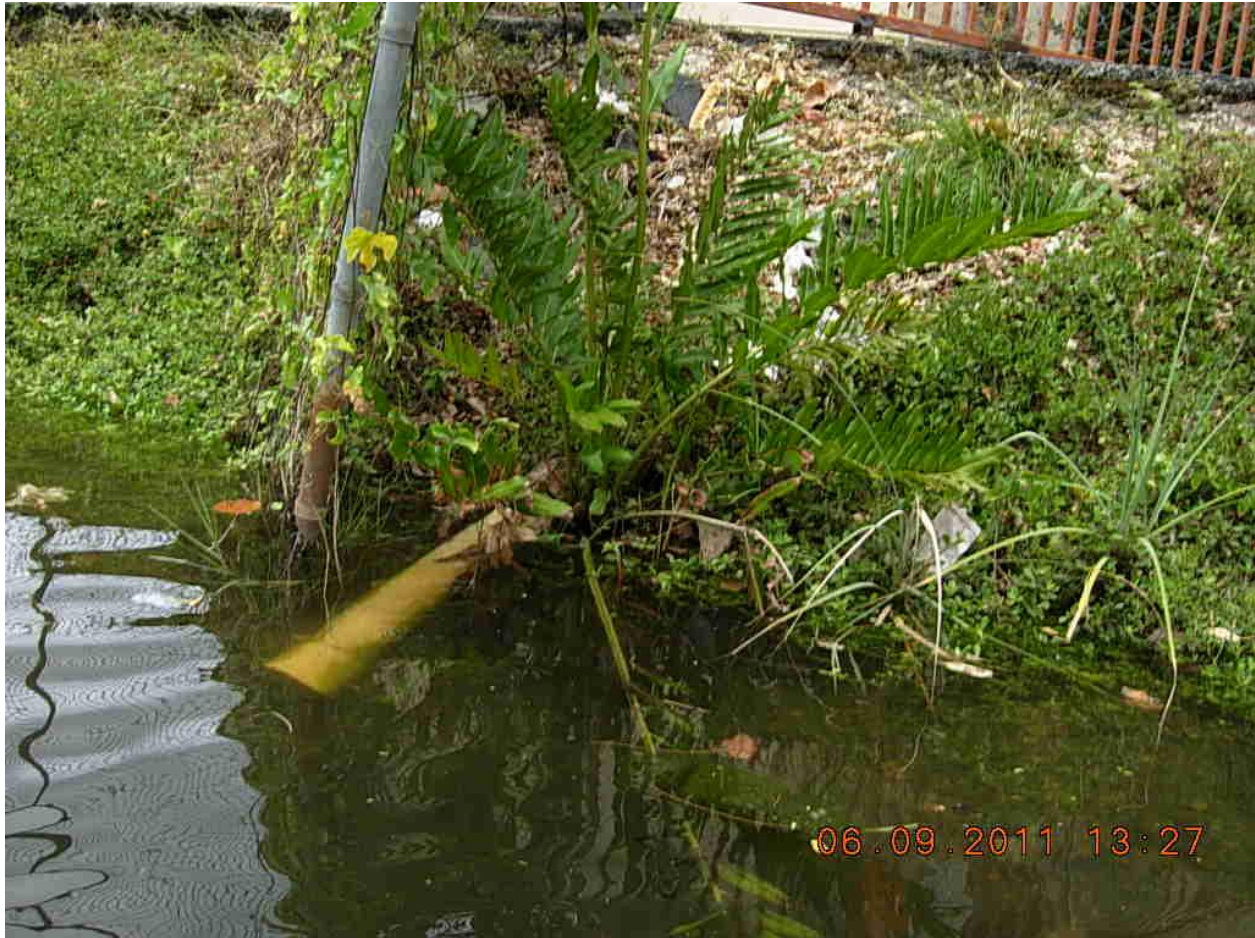
**Figure 67.** A polyvinyl chloride (PVC) pipe approximately 2 inches in diameter located near the southern boundary of the property could be a PIC or an irrigation line. GPS coordinates are 25 47' 35.028" N, 80 13' 13.741" W.

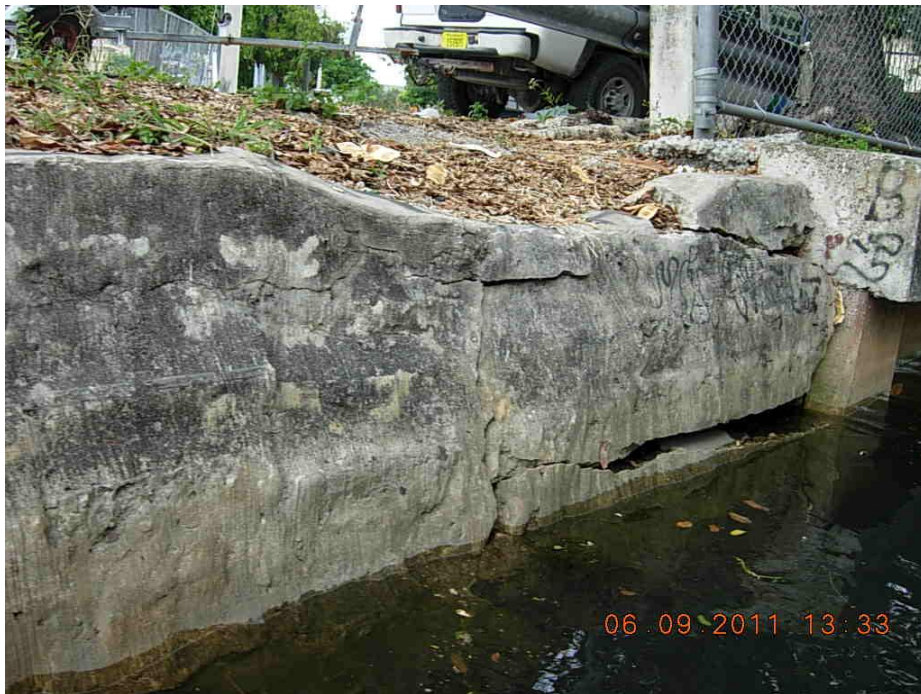
**Figure 69.** Due to the topography near the put-in point, surface runoff was also observed to be a potential source of fecal coliform bacteria.

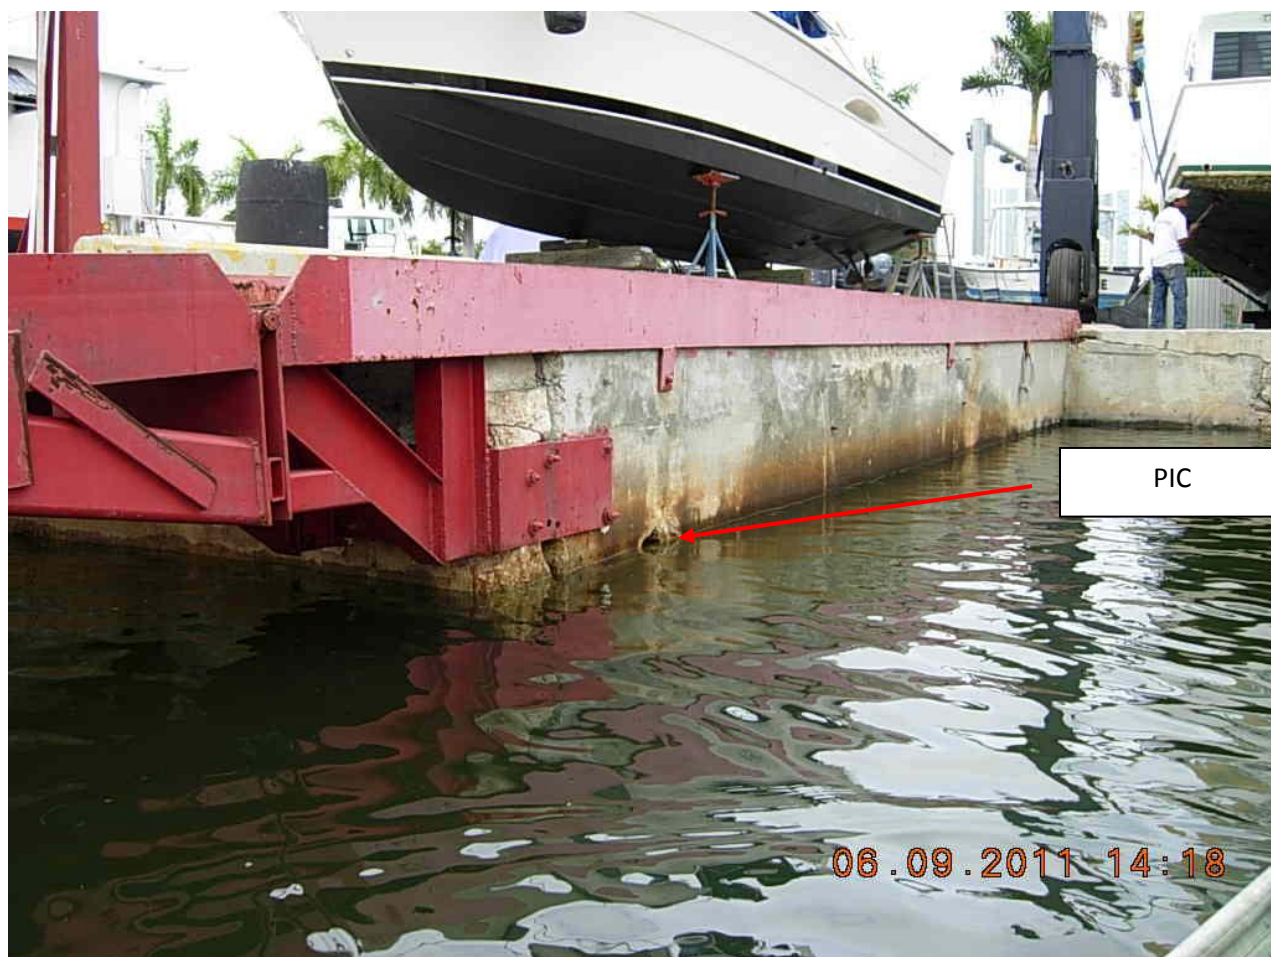
*Figure 71. PIC observed at Campeones Boatyard, 600 NW 7<sup>th</sup> Avenue. GPS coordinates are 25 46' 45.720" N, 80 12' 25.987" W.*

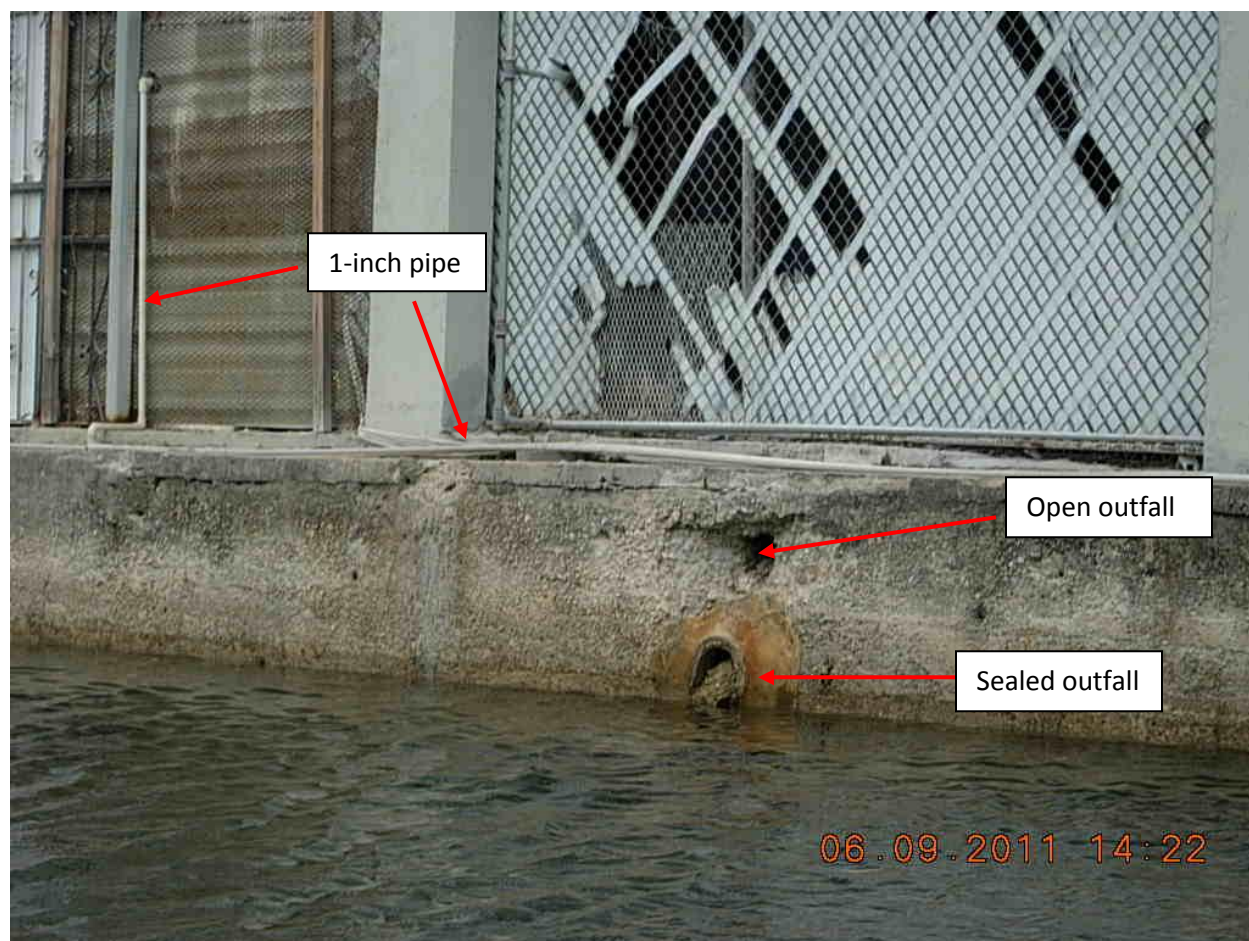
**Figure 72. Additional PICs observed at Campeones Boatyard. The lower outfall appears to be either full of sand or abandoned and filled with concrete. The upper outfall still appears active. Also note the small-diameter pipe that extends from the screen and then runs along the top of the seawall. The GPS coordinates of these outfalls and PICs are 25 46' 49.231" N, 80 12' 25.968" W.**

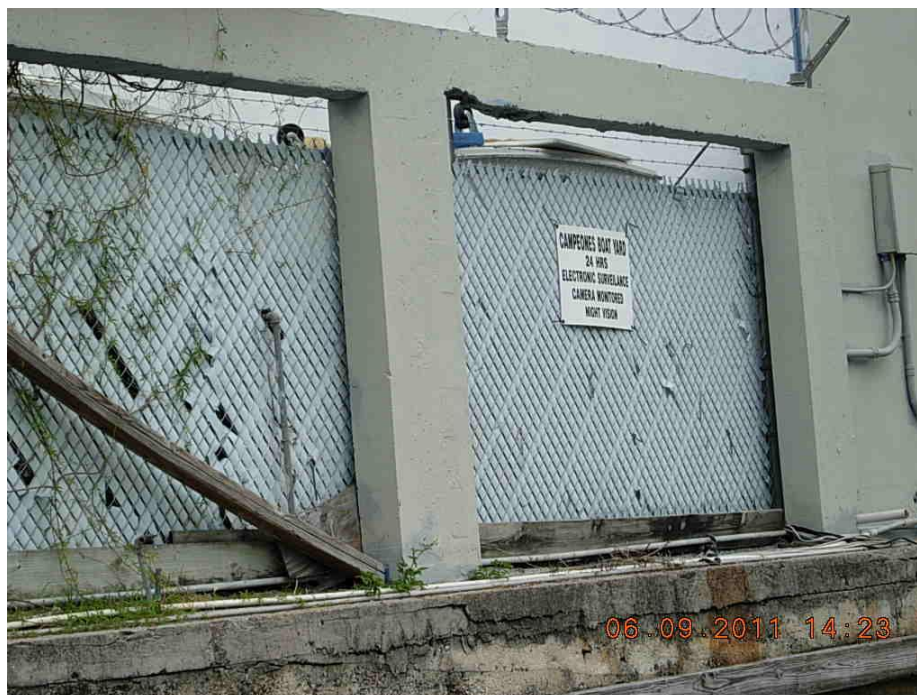
**Figure 73.** A PIC or electrical connection located a few feet north of the two Campeones Boatyard outfalls. GPS coordinates are still 25 46' 49.231" N, 80 12' 25.968" W.

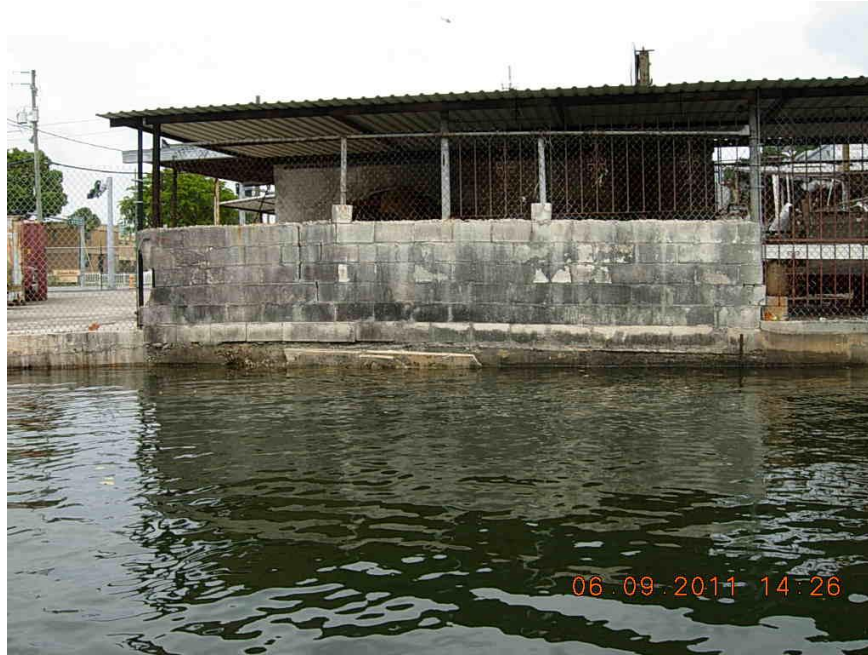
**Figure 75.** At 732 NW 7<sup>th</sup> Avenue, the team observed a concrete structure that may be a submerged outfall. The structure could not be observed in its entirety. GPS coordinates are 25 46' 50.661" N, 80 12' 26.025" W.

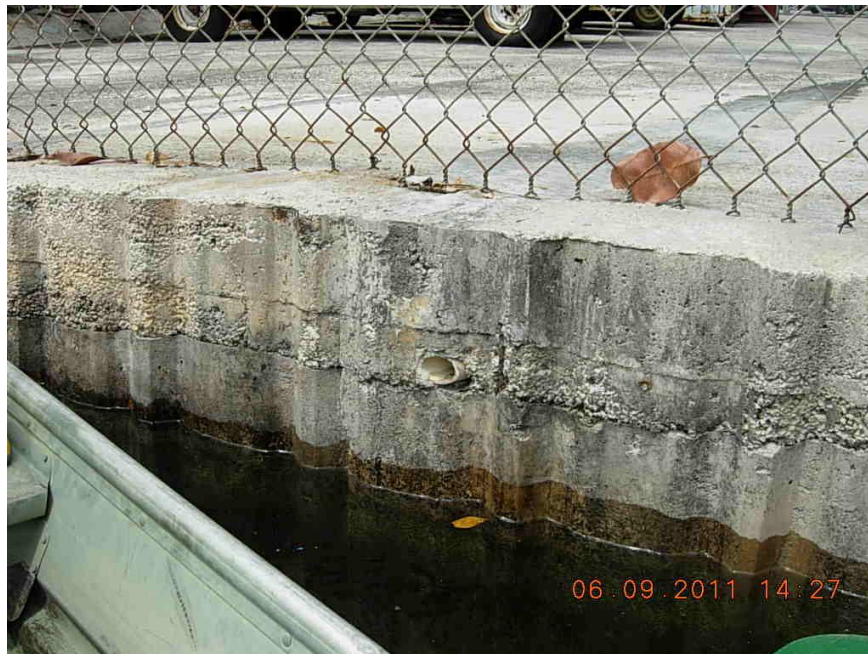
**Figure 76.** A 1.5-inch PVC pipe originating from Florida Precision at 800 NW 7<sup>th</sup> Avenue. GPS coordinates are 25 46' 52.232" N, 80 12' 25.917" W.
