# Summary of Results

## Walk the WBID Exercise for Wagner Creek (WBID 3288A)

September 2011

This report summarizes the results of the Walk the WBID exercise for the Wagner Creek watershed (WBID 3288A), located in the northwestern portion of the City of Miami, on November 18, 2010. (WBID is the abbreviation for **WaterBody ID**entification number, which is very similar to a watershed.) This field reconnaissance and source elimination effort was carried out to gain a better understanding of conditions within the watershed, including the hydrology of the creek and its contributing ditches and branches, flood-prone areas, the location of sewer and stormwater infrastructure, and potential sources that are contributing fecal coliform bacteria to the creek.

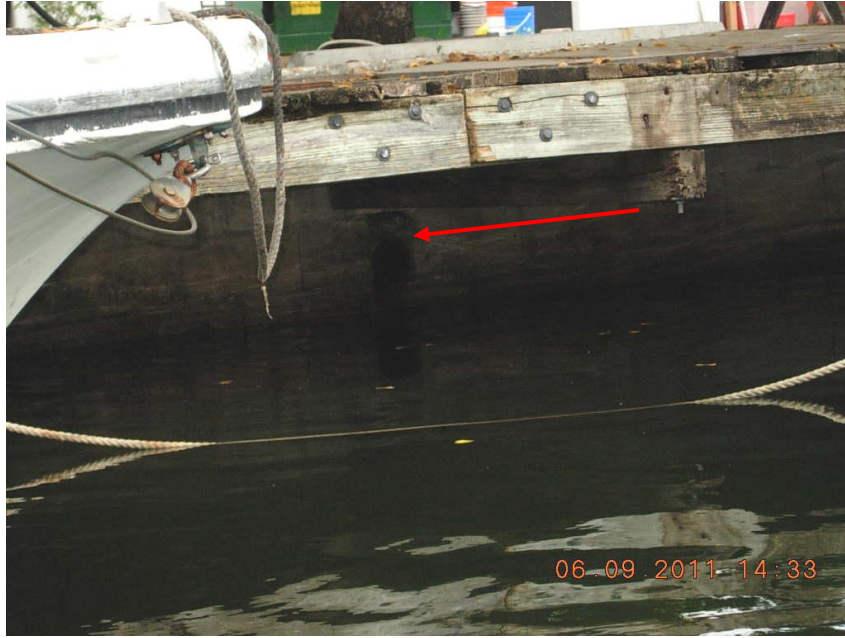
**Figure 77. Three 4-inch rusted pipes protruding from Popeye Marine at 810 NW 8<sup>th</sup> Street. GPS coordinates are 25 46' 52.232" N, 80 12' 26.621" W.**
