# Vessel Mooring Study - Boca Chica Harbor - Monroe County, Florida

## Final Project Report

May 17, 2011

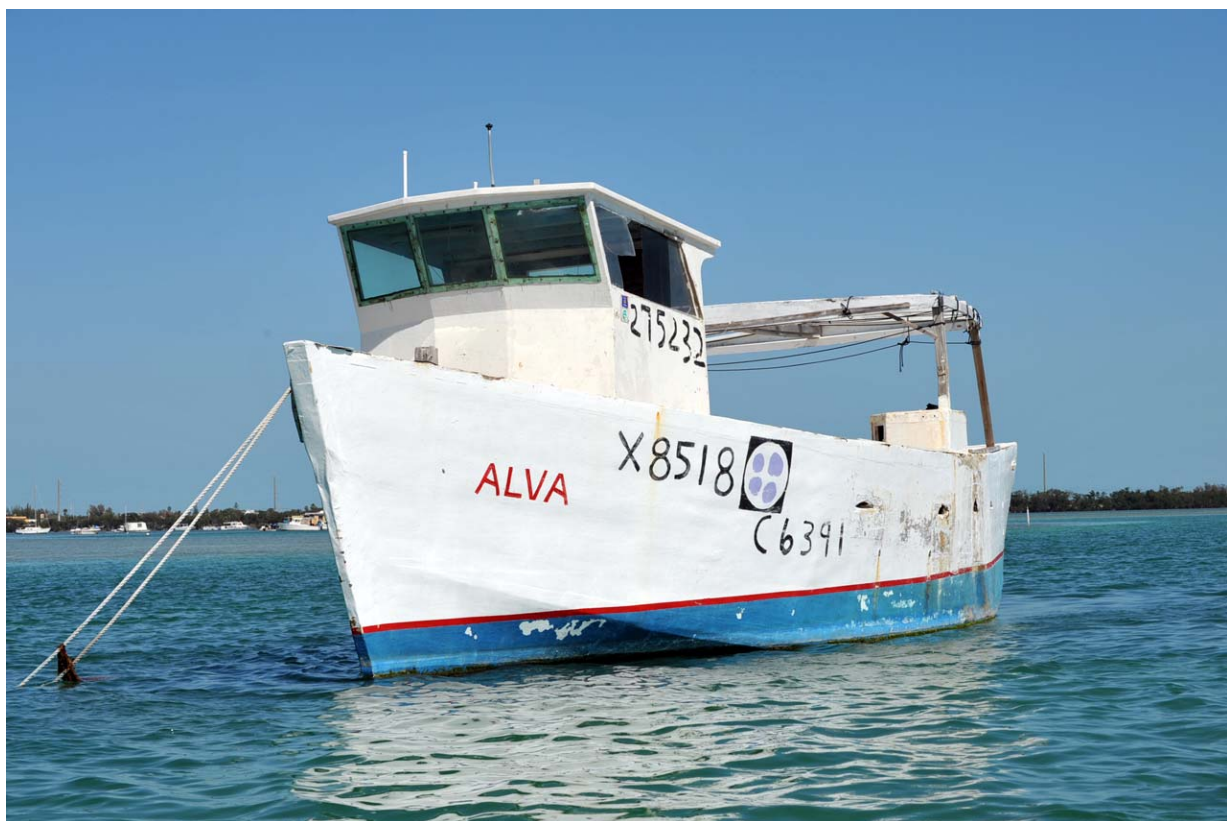
Photo of a stored powerboat. This vessel is not being used as a liveaboard or actively being used for fishing. The vessel is grounded on a shallow seagrass bed (note boot top well above waterline).

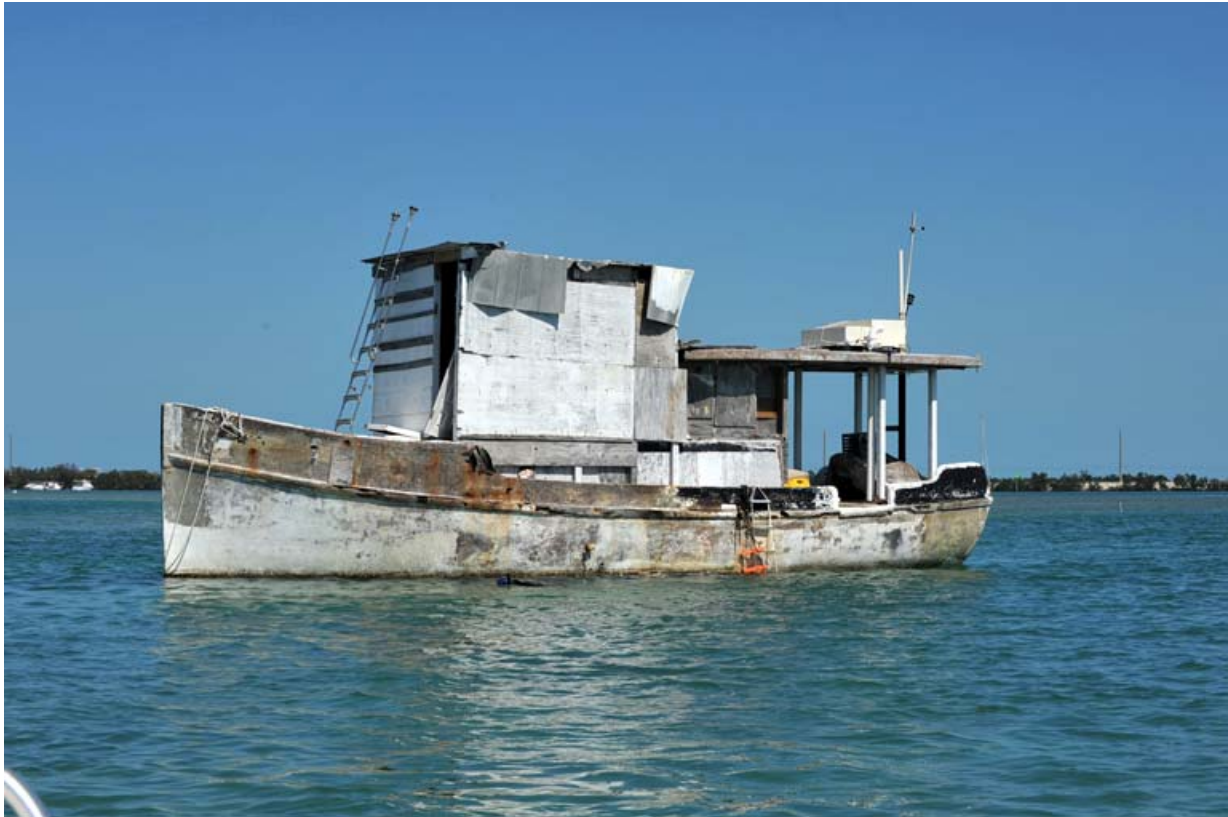
Photo of a poorly-maintained liveaboard powerboat. Vessels in poor condition typically lack operating propulsion and are at-risk for dereliction.

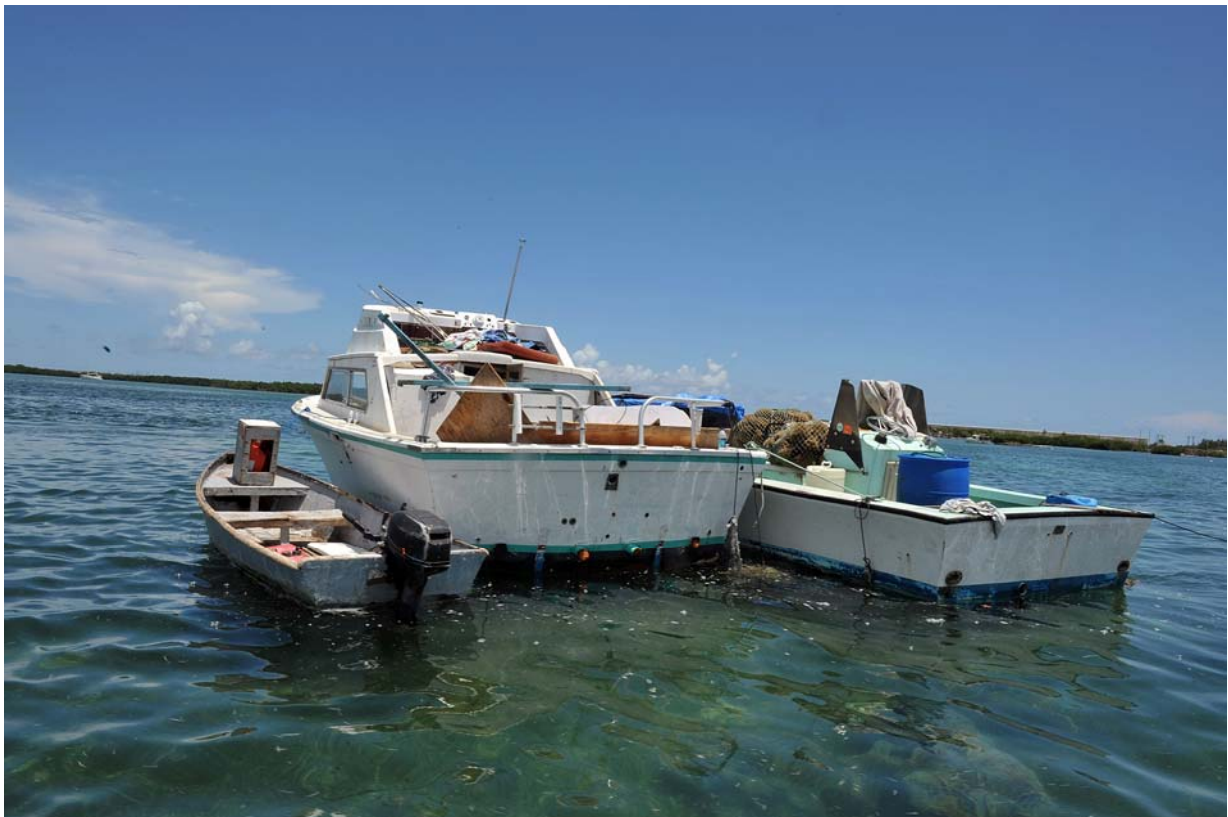
Photo of a poorly-maintained stored powerboat that is being used as a storage facility to support a commercial sponge fishing operation.

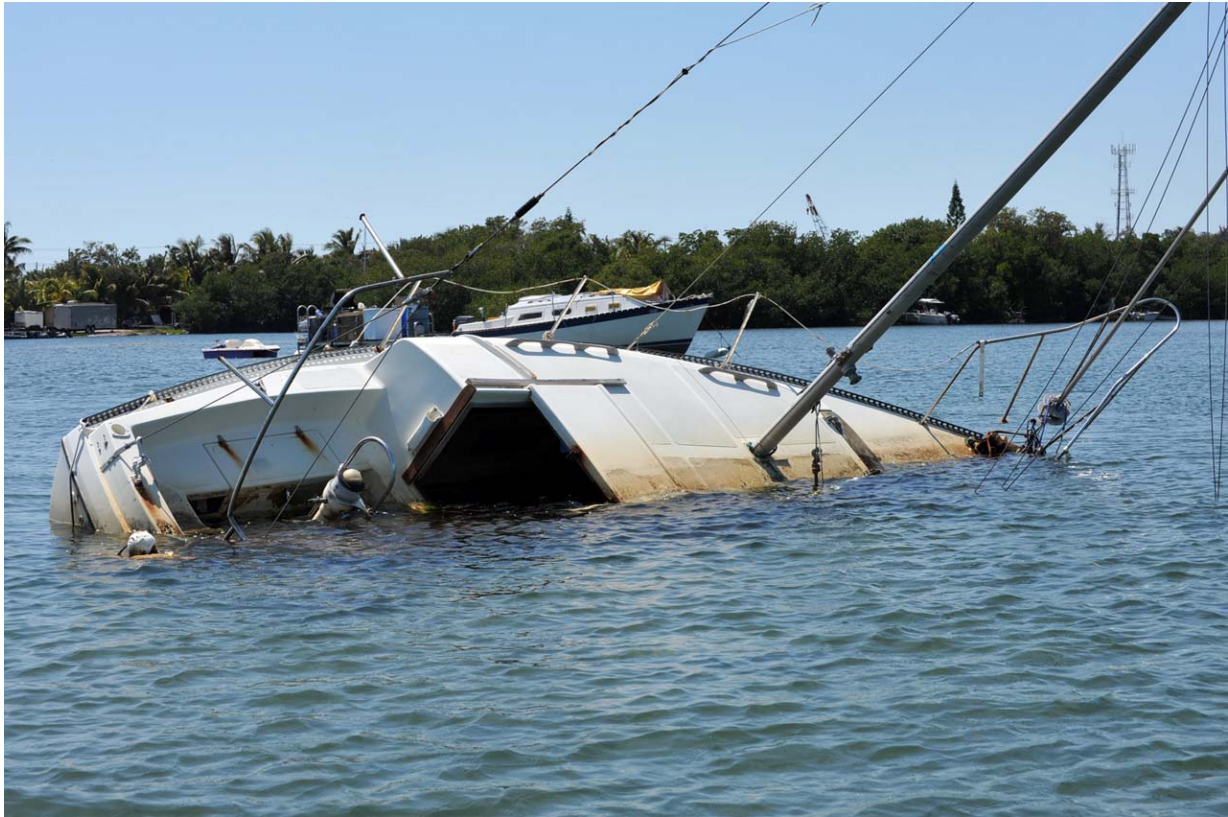
Photo of a derelict vessel sunk in a shallow seagrass flat. Vessels grounded or sunk in shallow seagrass beds cause a loss of seagrass habitat from shading and scour.

***Recommendation:*** Monroe County (and other marine resource management agencies) should develop a program to prevent derelict vessels from accumulating in anchoring areas throughout the Keys. A program that requires vessel owners to register vessels that are anchored over publicly-owned submerged lands would assist regulatory agencies in identifying owners of vessels and documenting the status of anchored vessels. Vessels that do not have proper documentation of ownership or vessels that are deemed prone to dereliction could be addressed before they become derelict. It should be noted that Monroe County and resource management partners (e.g. FWC, NOAA/FNKMS) are well aware of the problems associated with derelict vessels and are actively engaged in addressing the problem throughout the Keys.

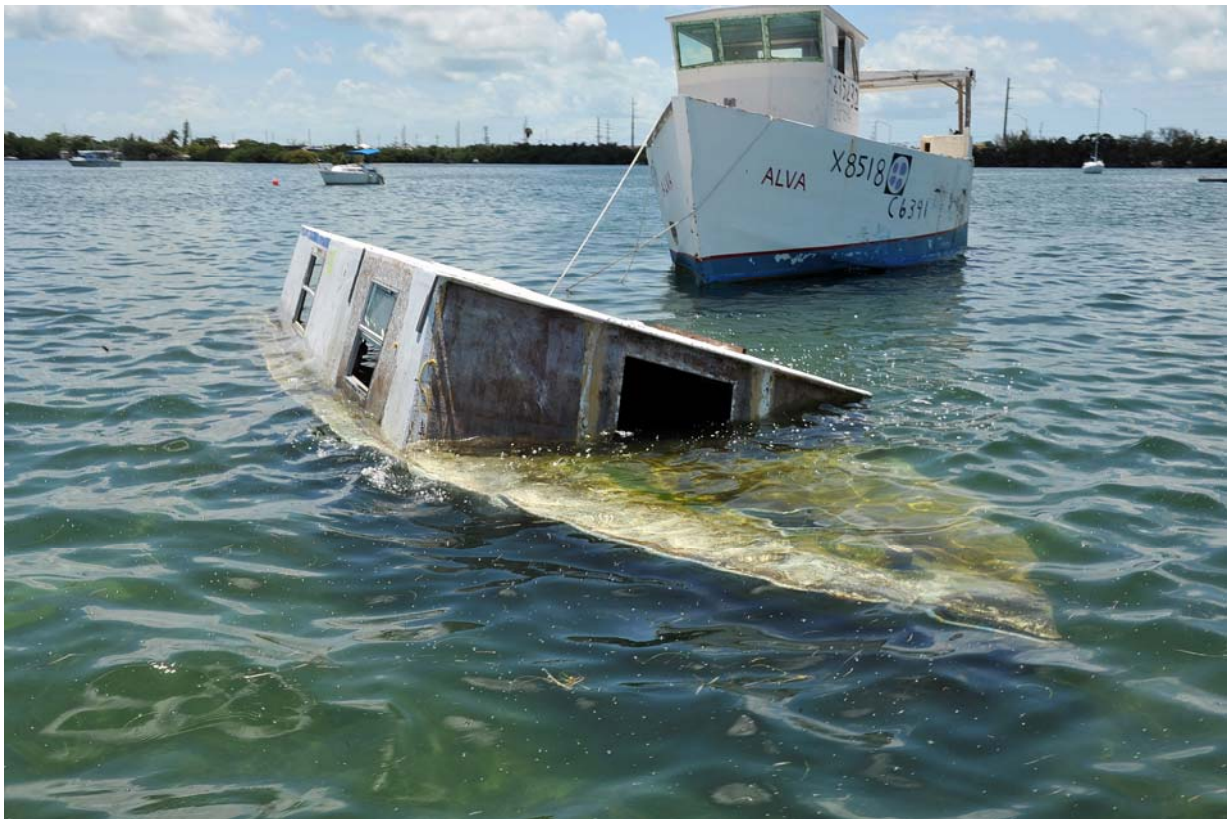
Photo of a derelict vessel sunk in a shallow seagrass flat with a grounded vessel moored to it. Vessels grounded or sunk in shallow seagrass beds cause a loss of seagrass habitat from shading and scour.
