**Survey Area: Escambia County segment FLES1-080 and FLES1-078 (dredge spoil on top of Sugar Island).**

**Survey Summary:**

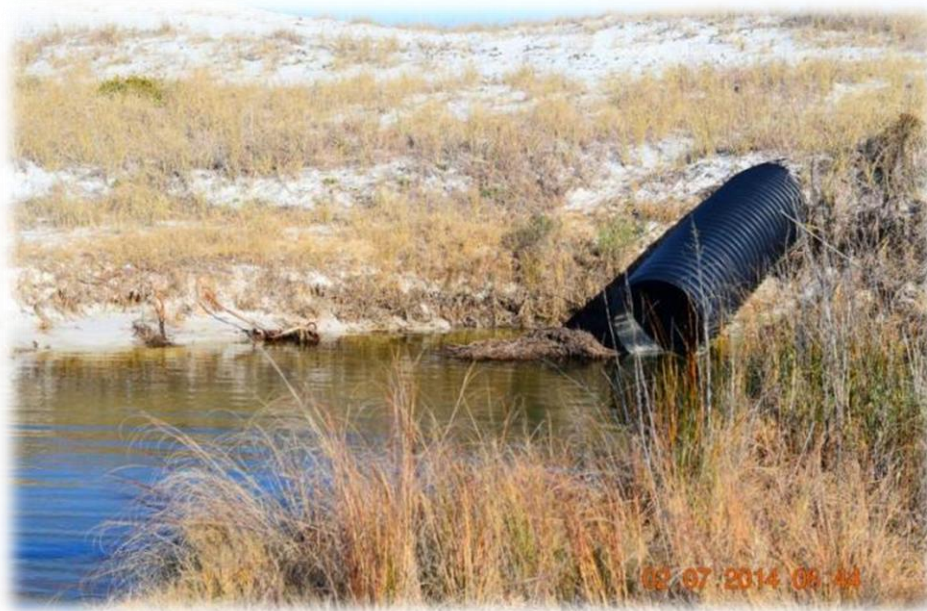
The team also investigated the drainage outflow in FLES1-080. While the dredge operation was in progress, a large volume of water was being discharged from the drainage outflow. The heavy flow caused a channel to be carved out of the shoreline in FLES1-080 (see map). Numerous SRBs were found in the channel and on the beach surrounding the outflow. The team mitigated as much as possible because the USCG will not be able to respond until tomorrow February 8, 2014.

Drainage outflow in FLES1-080

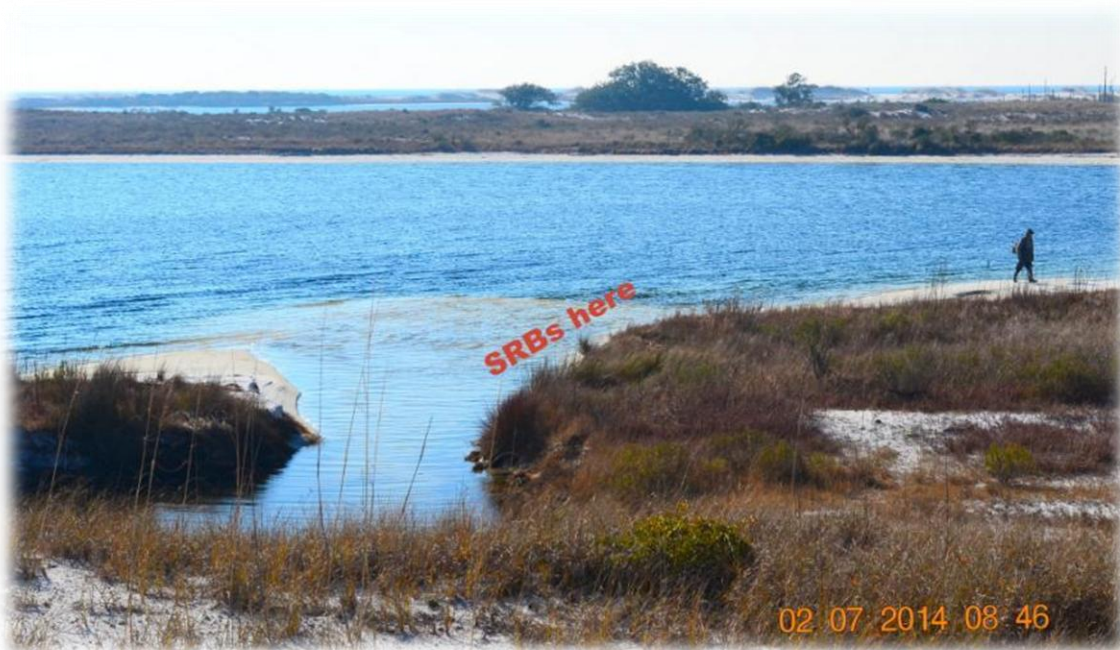
Drainage outflow in FLES1-080

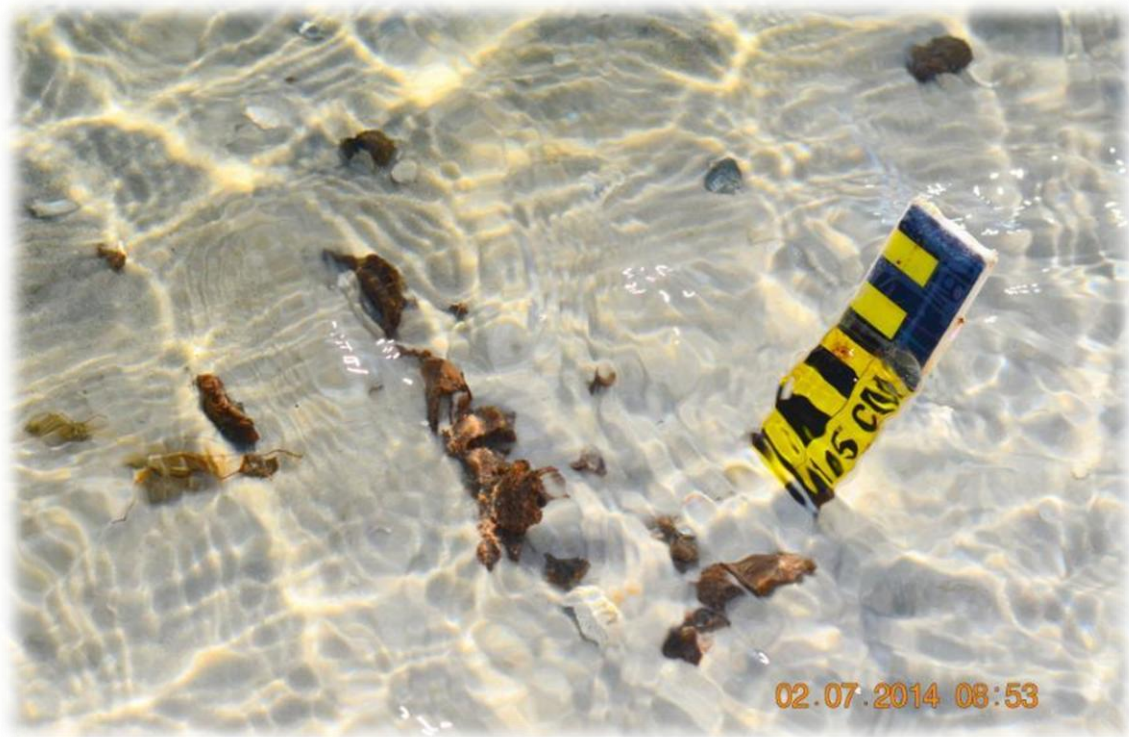
SRBs in drainage outflow of FLES1-080.

**FLES1-078 and FLES1-080:** Segments have been signed out of the response but continue to yield BP MC-252 material. Recommend further periodic monitoring when weather conditions are favorable for product recovery.

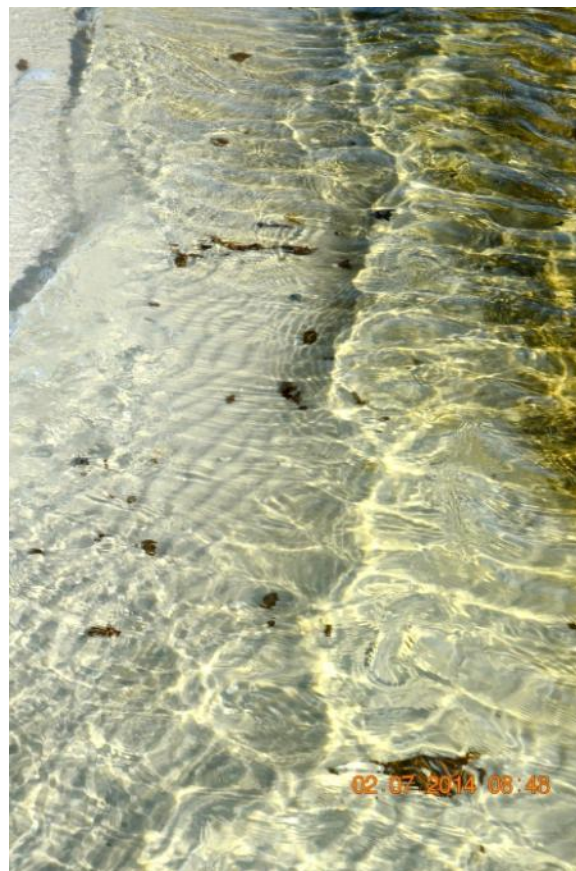
SRBs in swash of FLES1-080

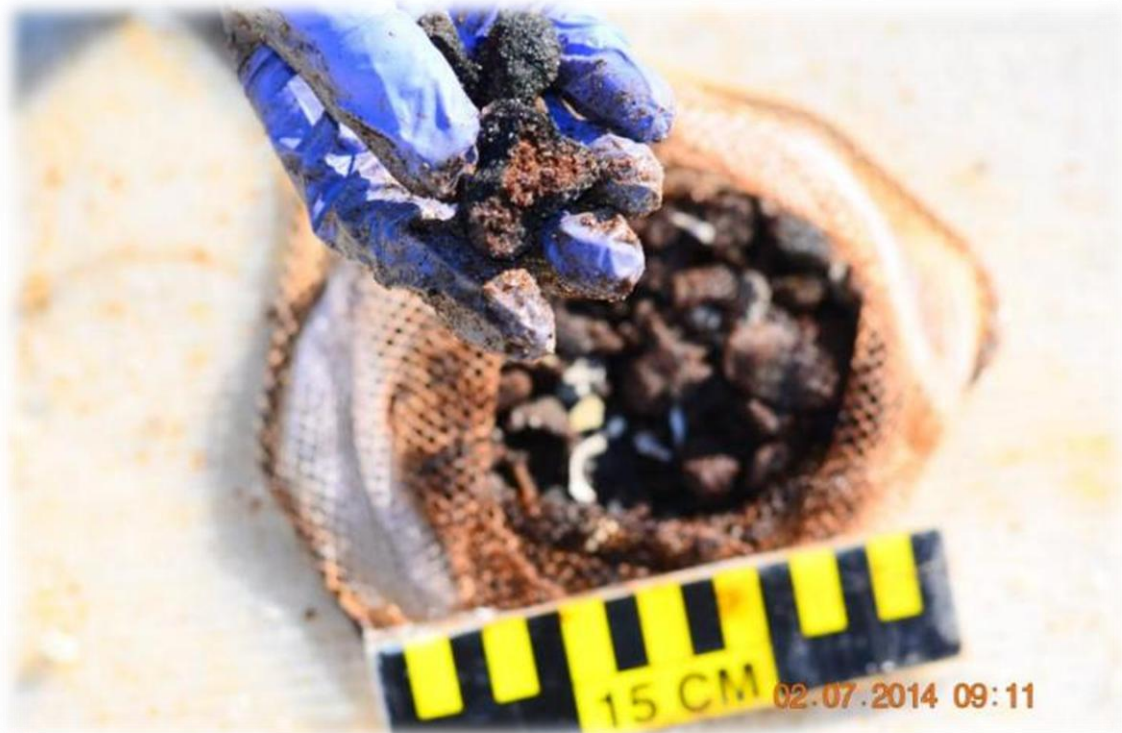
Cross section of SRB from FLES1-080

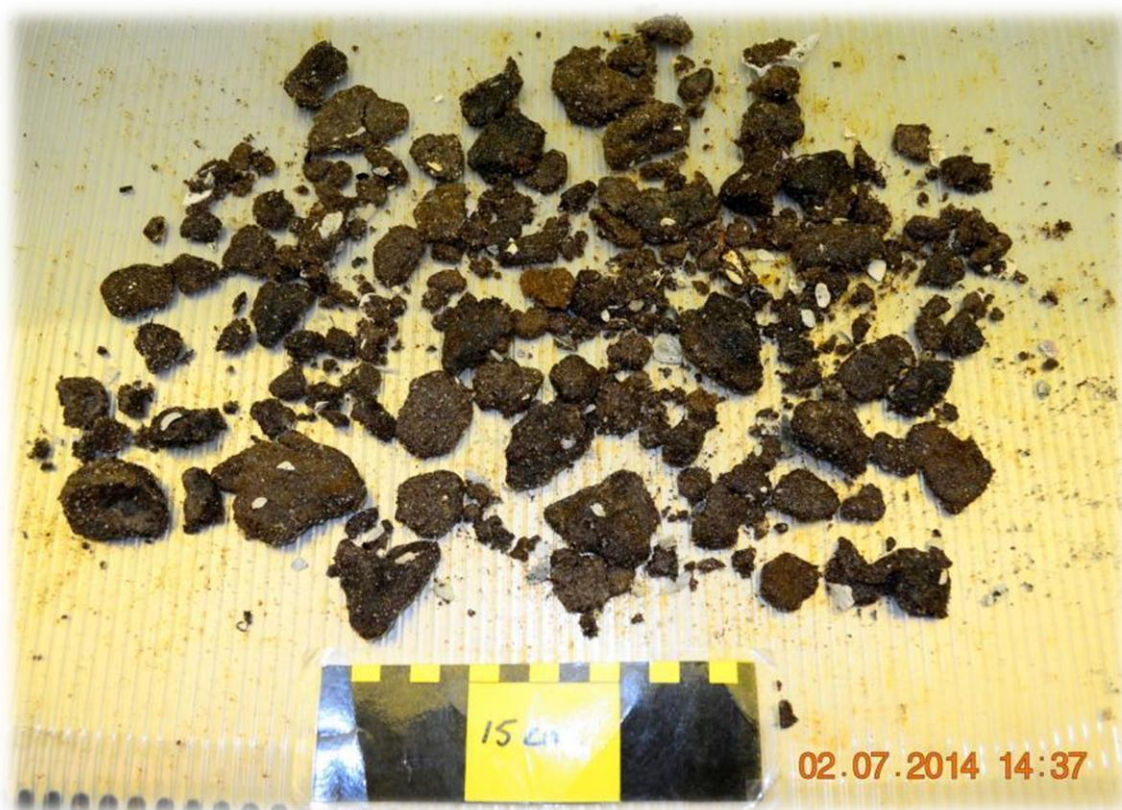
SRBs mitigated from FLES1-080 at the drainage outflow

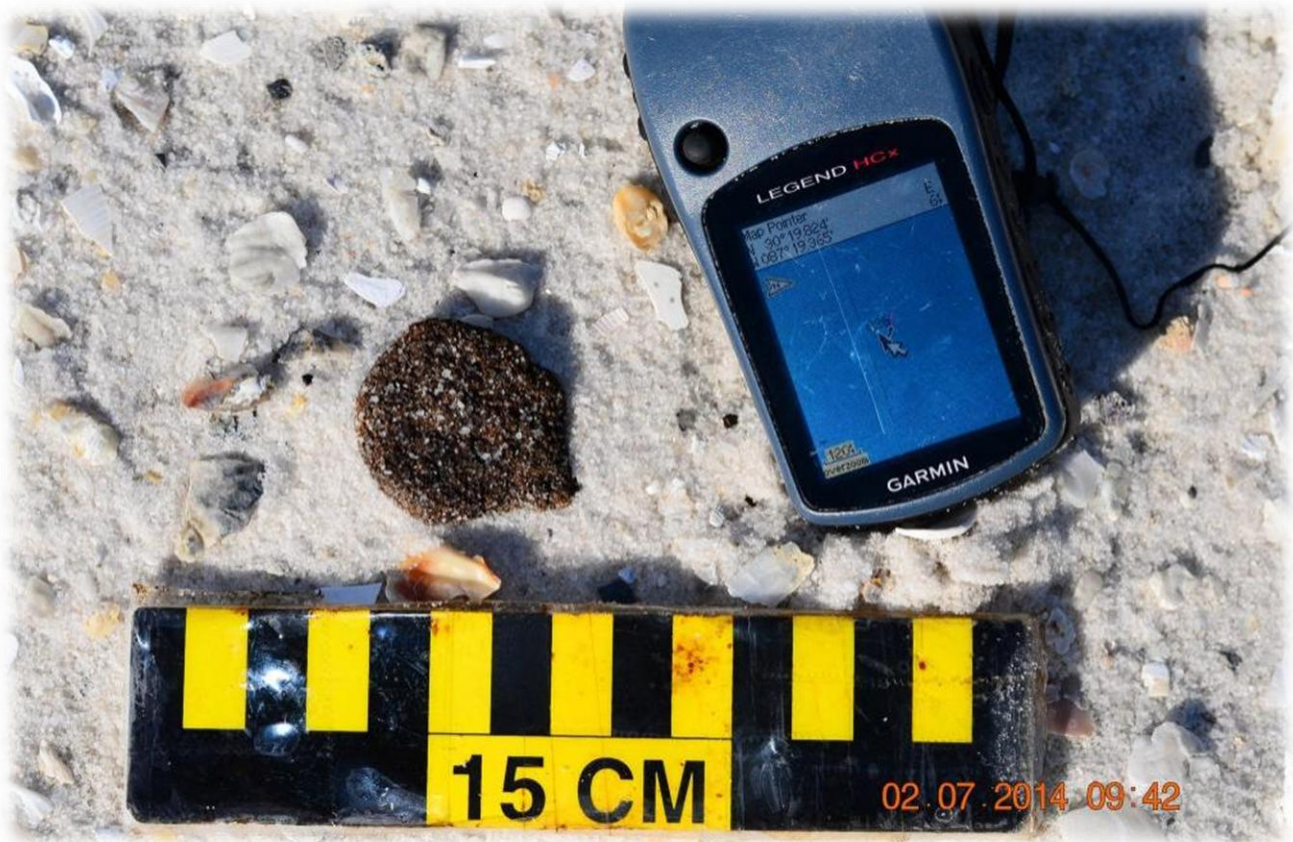
Today FDEP personnel conducted post-response monitoring surveys in Escambia County Division 1; segments FLES1-080 and in the middle of Sugar Island contiguous to FLES1-078. Today the FDEP beach monitoring team investigated the dredge spoil after a recent dredge operation on the north side of Sugar Island. The project has completed and in the area that dredge material was deposited there were numerous SRBs found. It appears that these SRBs are a result of the recent dredge operation pulling sand from FLES1-078 (see map). This is not historically a segment that would have much oiling. This area will be further investigated as the sand settles potentially exposing more SRBs.

SRB found in FLES1-078 on top of Sugar Island in dredge spoil

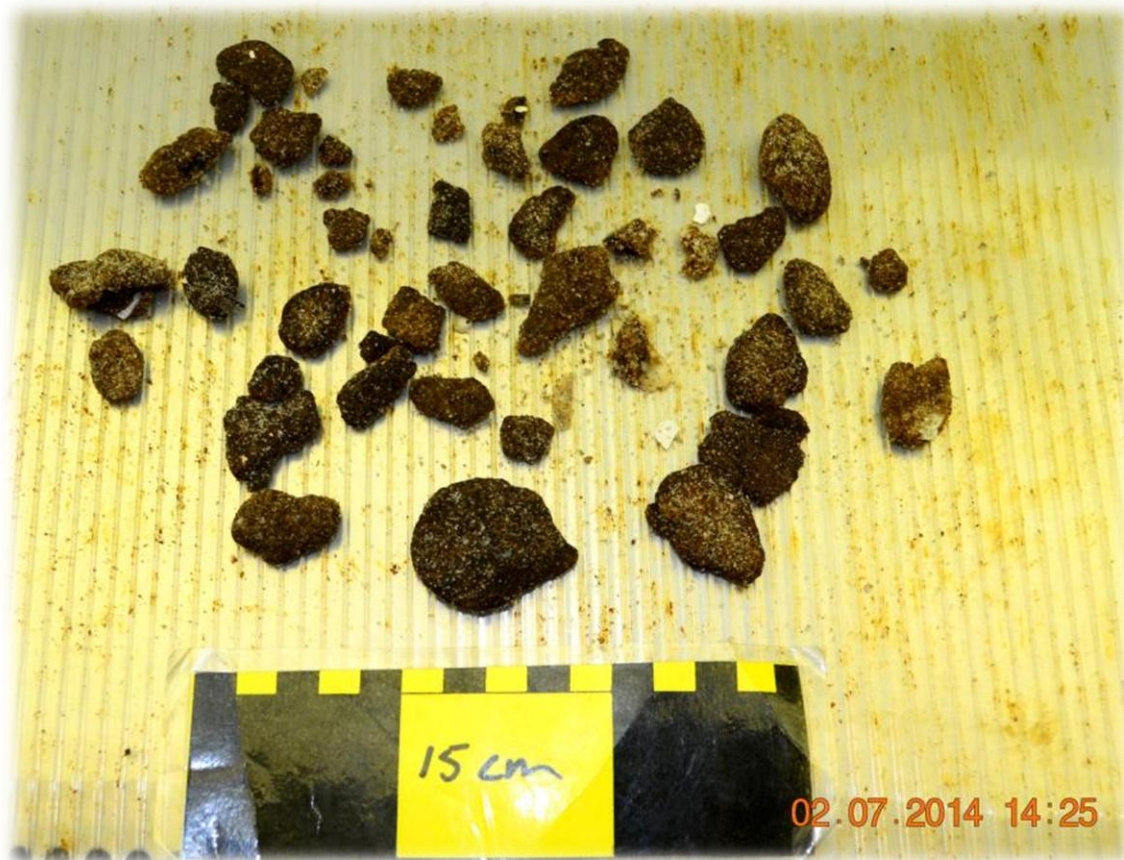
SRBs mitigated from FLES1-078 on top of Sugar Island in dredge spoil
