# **STRUCTURAL REPORT**

## **MEXICO BEACH PIER**

PROJECT # 001.088

DATE: March 15, 2016

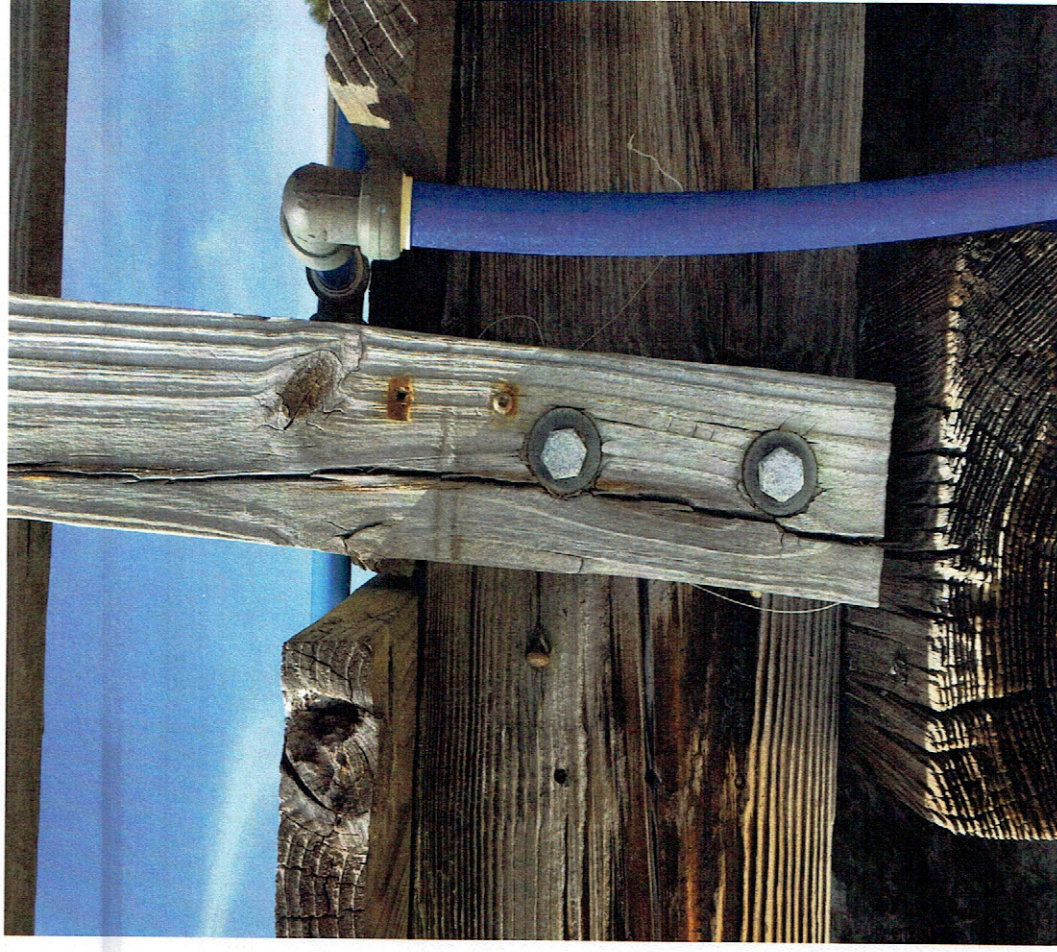
1. Many of the hand rails and their support posts are damaged or loose and need attention (reference Photograph D attached).
2. There is evidence of pile settlement and misalignment which has resulted in an un-even deck surface (reference Photograph E attached). This detracts from the overall appearance, however it does not concern us from a structural standpoint.

PHOTOGRAPH D – HAND RAILS & POSTS

- Replace damaged or rotted hand rails and posts, re-tighten and or replace loose nuts and bolts.
- Replace broken bracing members
- Recoat the fiberglass pilings (paint them).

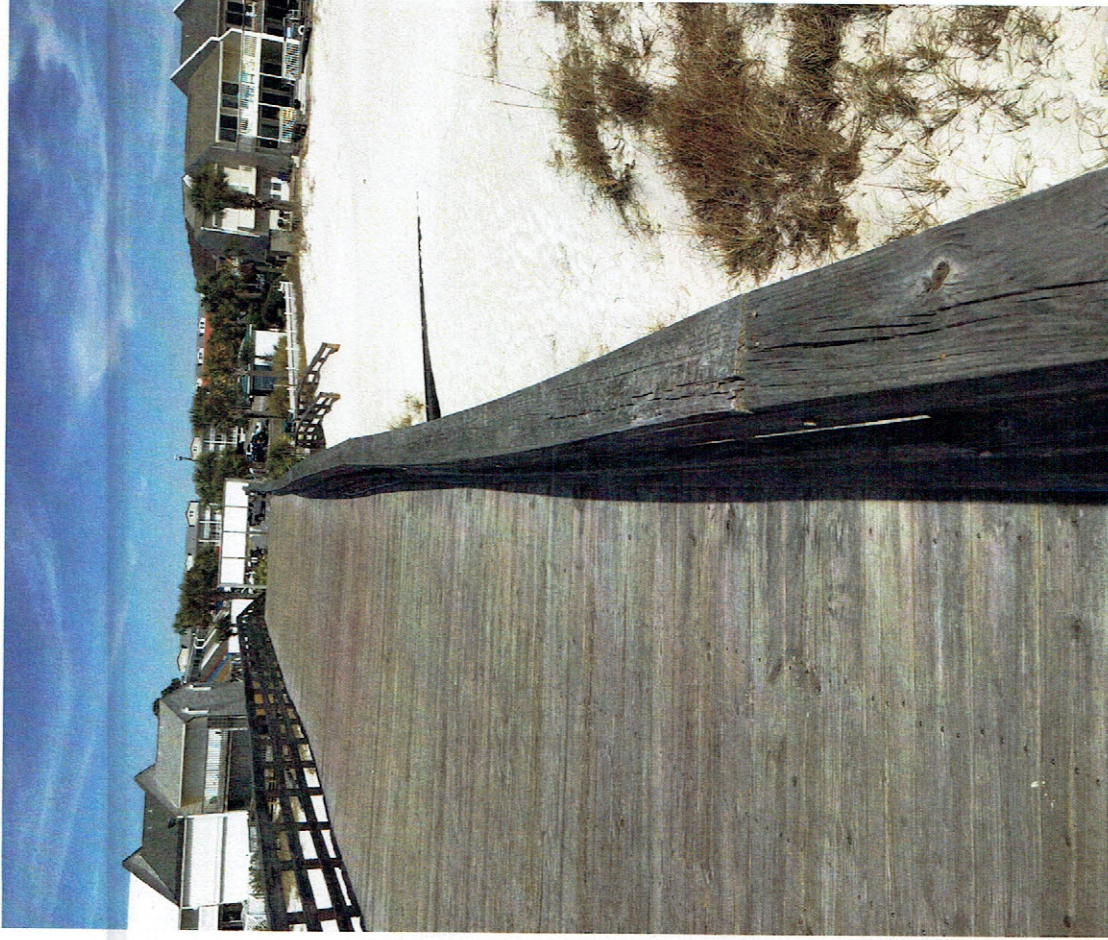
PHOTOGRAPH E – ALIGNMENT & ELEVATION ISSUES

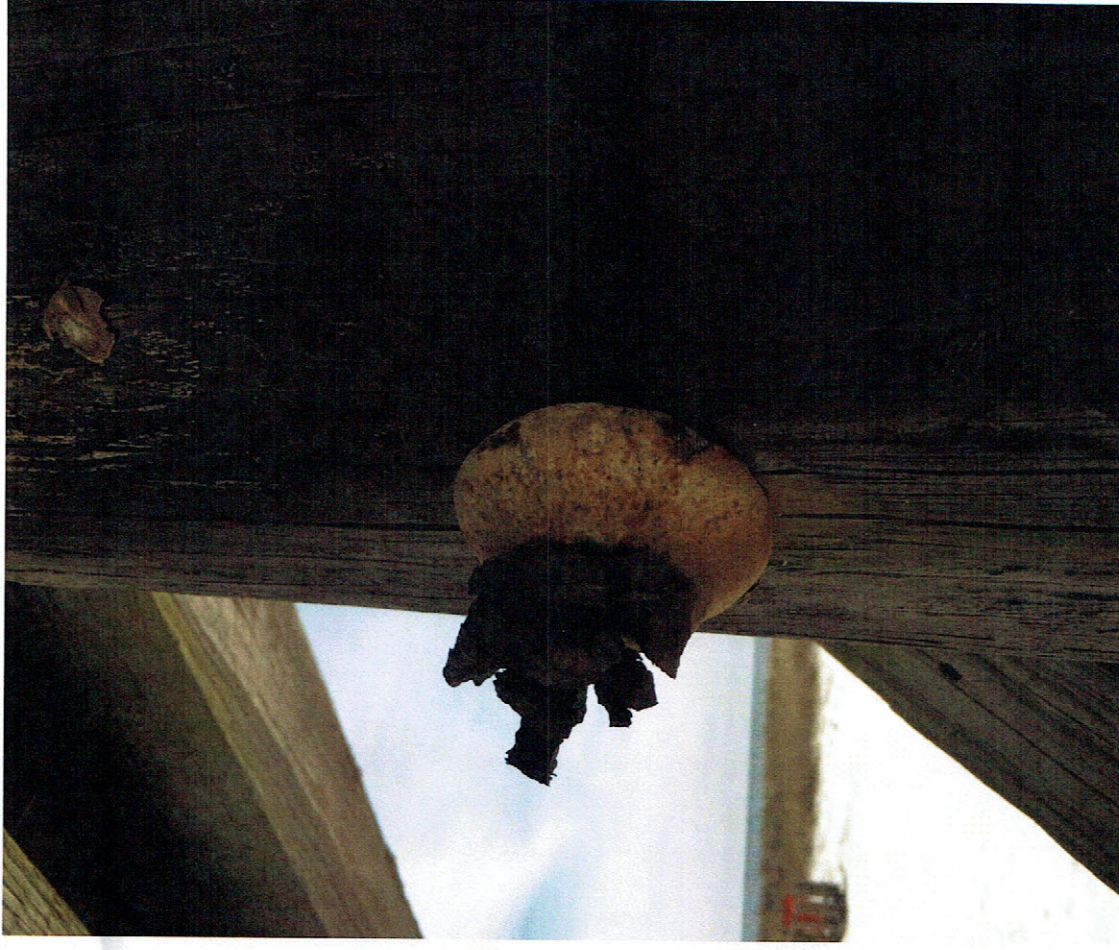
3. Many of the timber beams, bracing and connectors that comprise the original portion of the pier are, understandably, deteriorated due to their advanced age and the harsh environment to which they have been subjected. Some beams are warped, checked or cracked many of the connectors (bolts, brackets) are missing or badly corroded (reference Photograph F attached) and some of the bracing is broken. It is evident that quite a bit of repair work has taken place, especially on the pilings; crutch piles where they are rotten at the ground line and shim plates (reference Photograph G attached) either to compensate for settlement or to replace a rotted top section of pile. Luckily though, the original design/construction was so conservative that even in its deteriorated condition we believe it is structurally adequate for the time being. The timber beams, pilings and connectors that comprise the two pier extensions, except as noted below, are still in good shape.

PHOTOGRAPH F – RUSTY HARDWARE

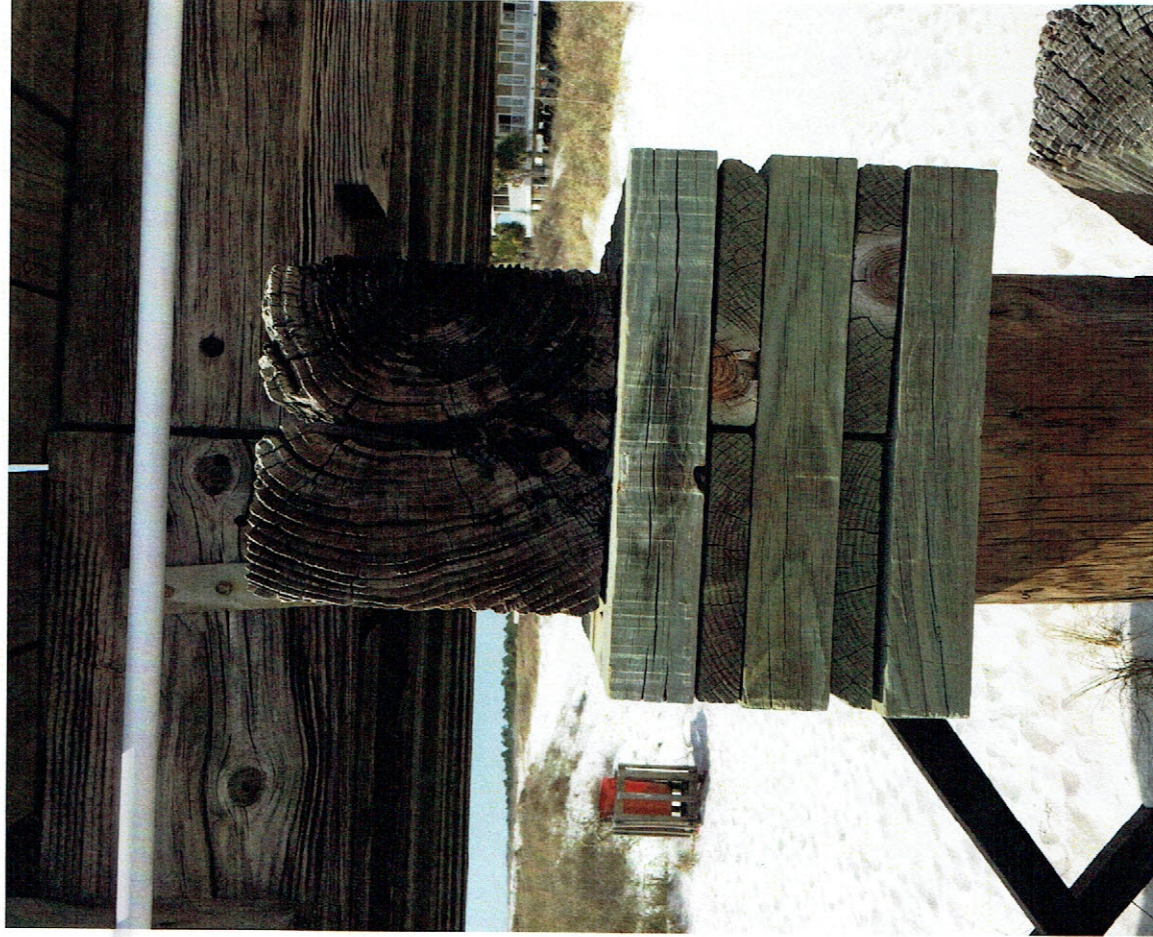
PHOTOGRAPH G – PILE SHIMS

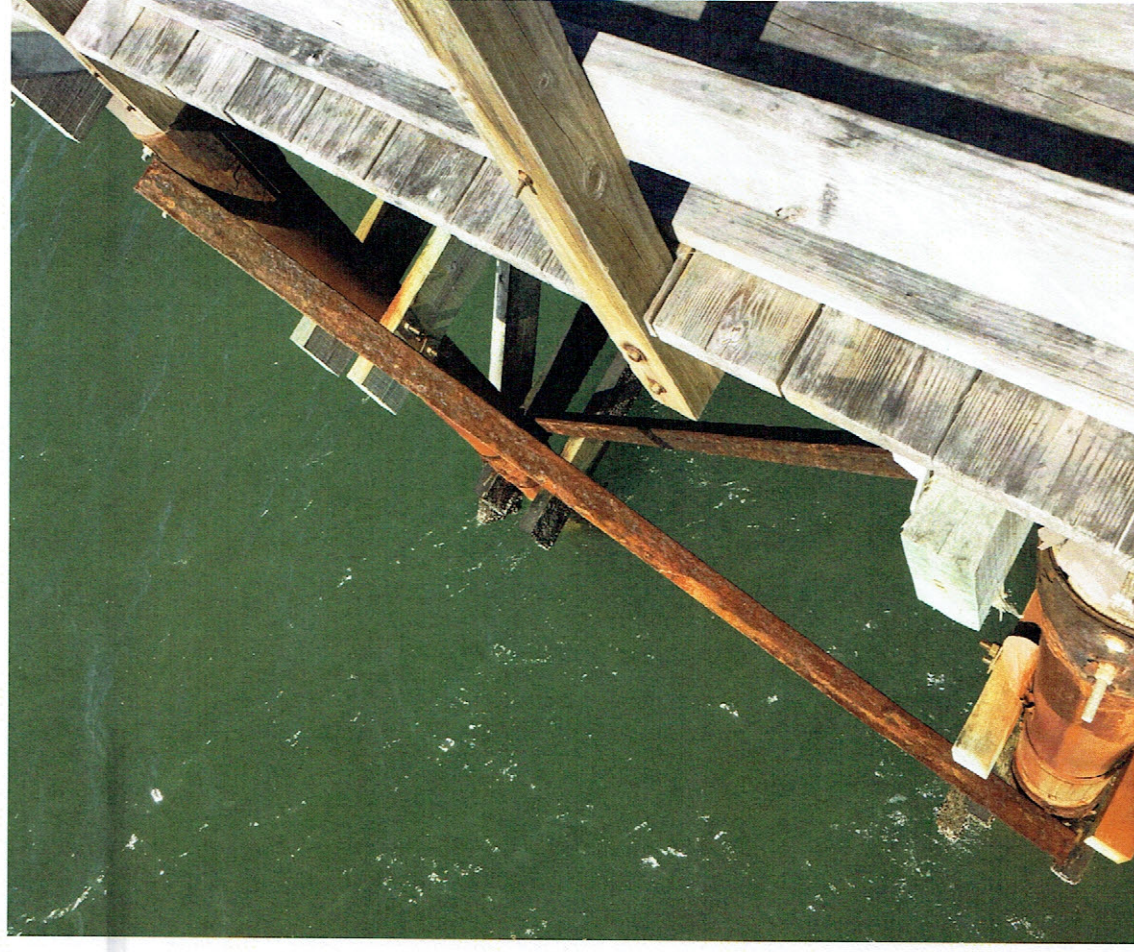
4. The fiberglass pilings that support the "T" section have a plastic coating that protects the fiberglass from ultra violet light (reference Photograph I attached). This coating has delaminated from the pilings and left the fiberglass exposed. Also, some of the steel bracing and connectors are rusted (reference Photograph H attached). These issues need attention, but are not urgent or critical at this time.

PHOTOGRAPH H – RUSTED BRACING AT "T" SECTION

In addition we recommend that you schedule periodic structural reviews to keep an eye on the hardware and connectors associated with the "T" Section bracing. Within a few years, you will need to replace them.

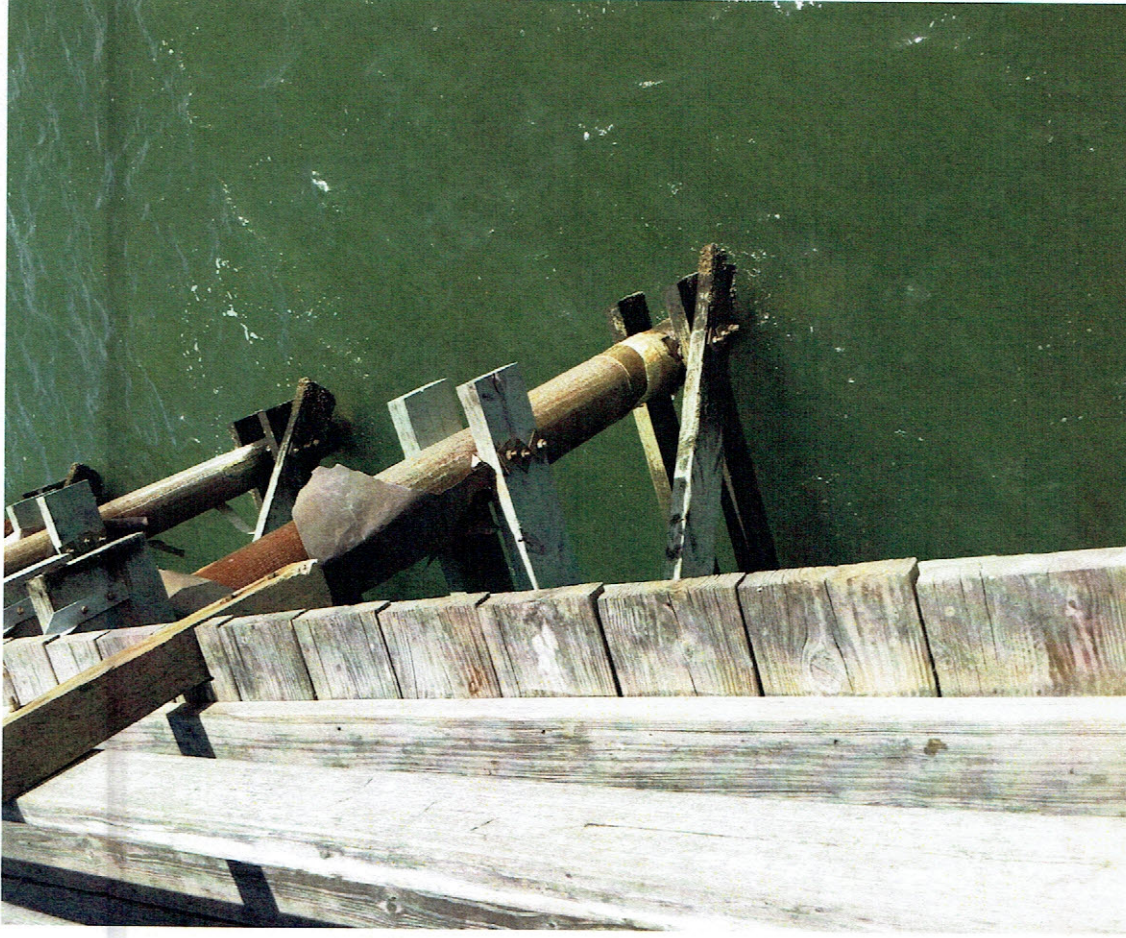
PHOTOGRAPH I – DELAMINATED UV COATING ON FIBERGLASS PILES

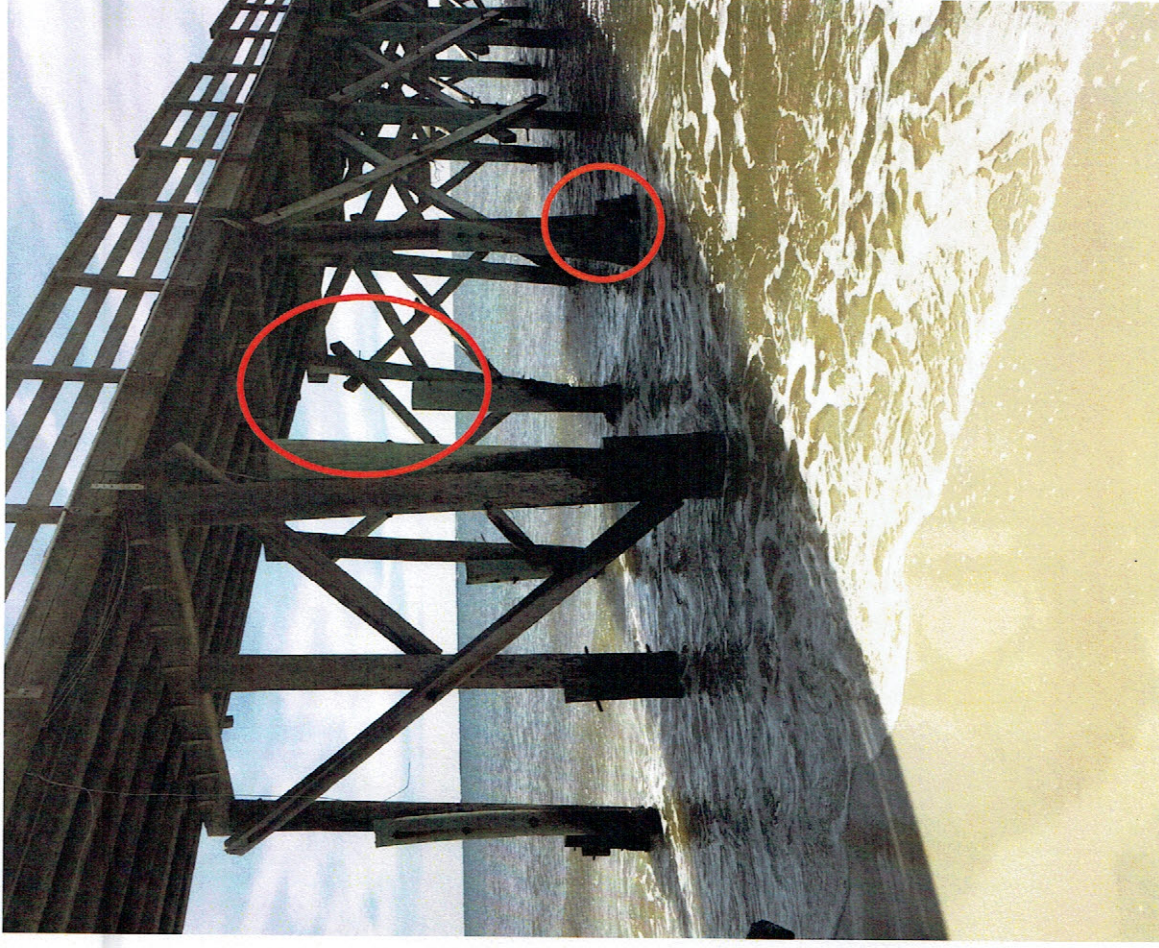
5. Several of the piling at the shoreline are completely rotted thru and were repaired in a shoddy manner, in one case, the middle support piling is missing (reference Photograph J attached). This is a cause for alarm and we recommend immediate repairs.

PHOTOGRAPH J – MISSING PILES & SHODDY PILE REPAIRS

Replace the missing pile and the ones that were poorly repaired. At least three section of the pier (45 ft.±) will have to be temporarily removed and set aside in order to conduct this work. These sections can be re-used if handled carefully.

We recommend that you limit the number of people allowed on the pier until the repairs can be completed. Do not host events or other activities that would attract large crowds. If this is unavoidable then at the minimum you should replace the missing pile and tighten up/repair the hand rails.
