FLORIDA DEPARTMENT OF ENVIRONMENTAL PROTECTION  
STRATEGIC MONITORING PROGRAM FIELD SHEET

WIN Station Name: McDavid Creek 100 m upstream SR99

Stream/River Habitat Sketch Sheet, Form FD 9000-4 (June 1, 2001)

# DEP Form FD 9000-5 Stream/River Habitat Assessment Field Sheet

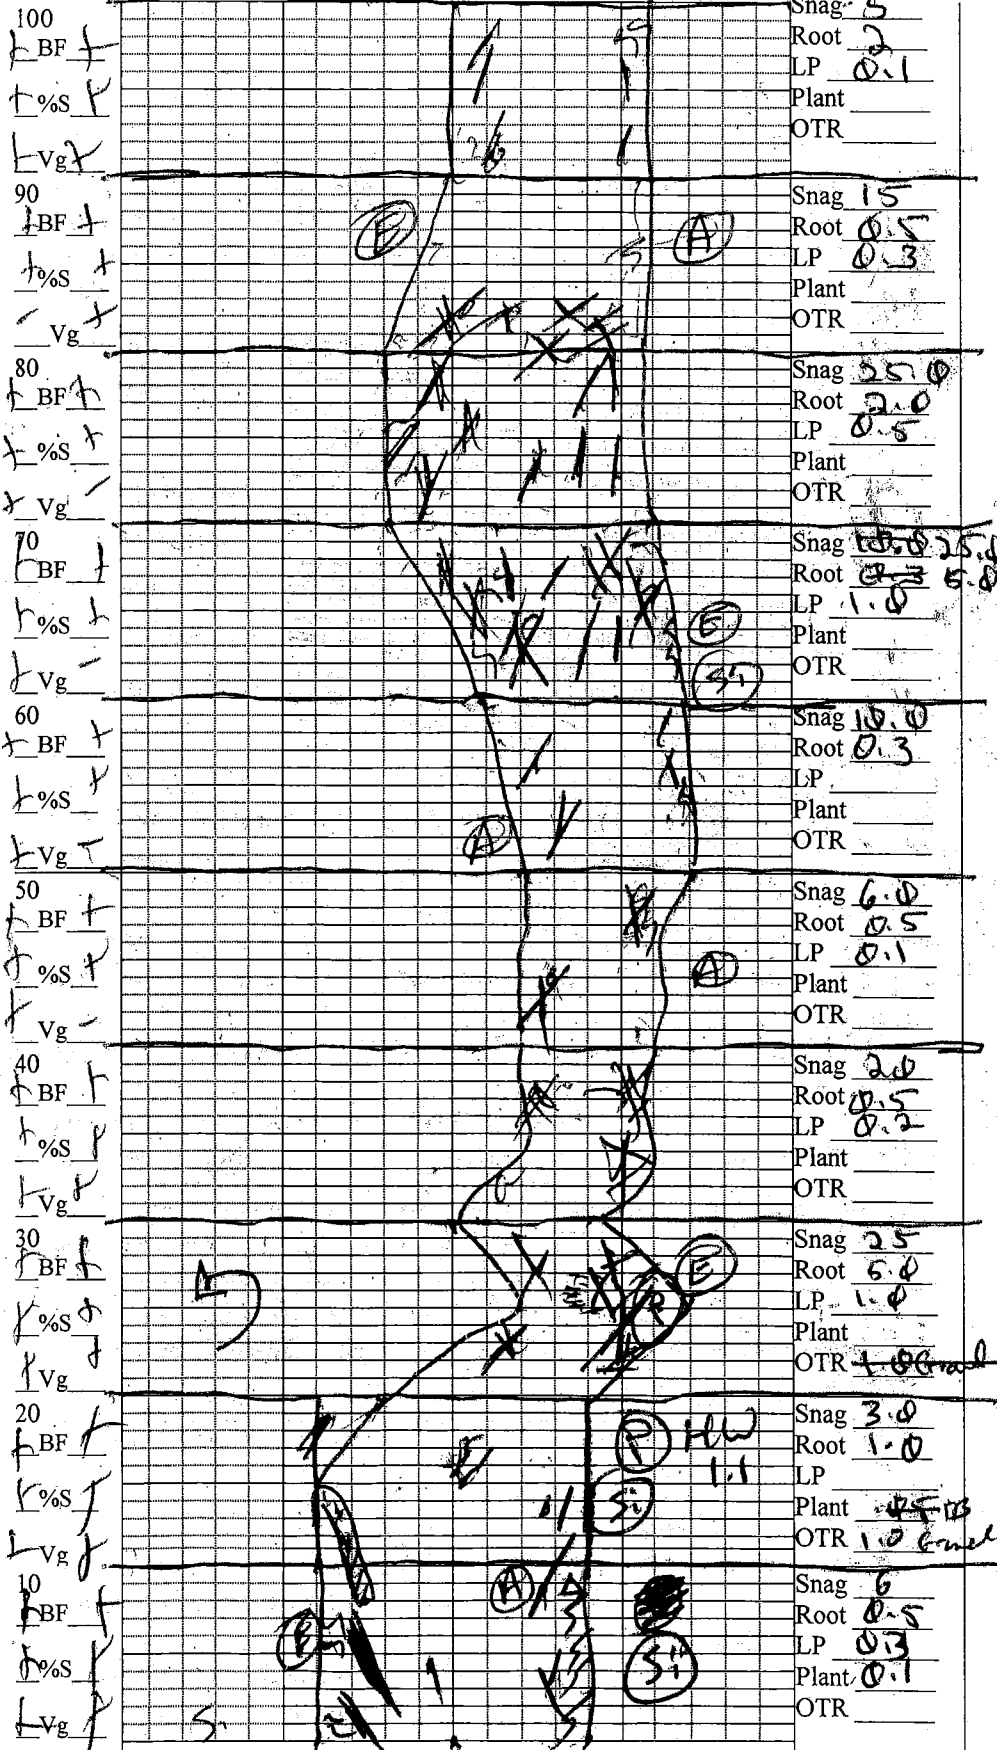
Silt smothering @

A, H

Algae Smothering @

A, E, F

Degraded Banks @

A, E, F, H, I
