DEP Form FD 9000-3 Physical/Chemical Characterization Field Sheet

SAMPLE ID 81630 ORG ID 21FLCEN LATITUDE \_\_\_\_\_  
 COUNTY Isle of Orleans STORET # 26010972 LONGITUDE \_\_\_\_\_  
 DATE 10/13/2020 TIME 1600 SAMPLING AGENCY FDEP  
 SITE NAME Davenport CR at SR 545 Bridge  
 FIELD ID/NAME 26010972 RECEIVING BODY OF WATER \_\_\_\_\_

DEP Form FD 9000-5 Stream/River Habitat Assessment Field Sheet

# DEP Form FD 9000-4 Stream/River Habitat Assessment Sketch Sheet

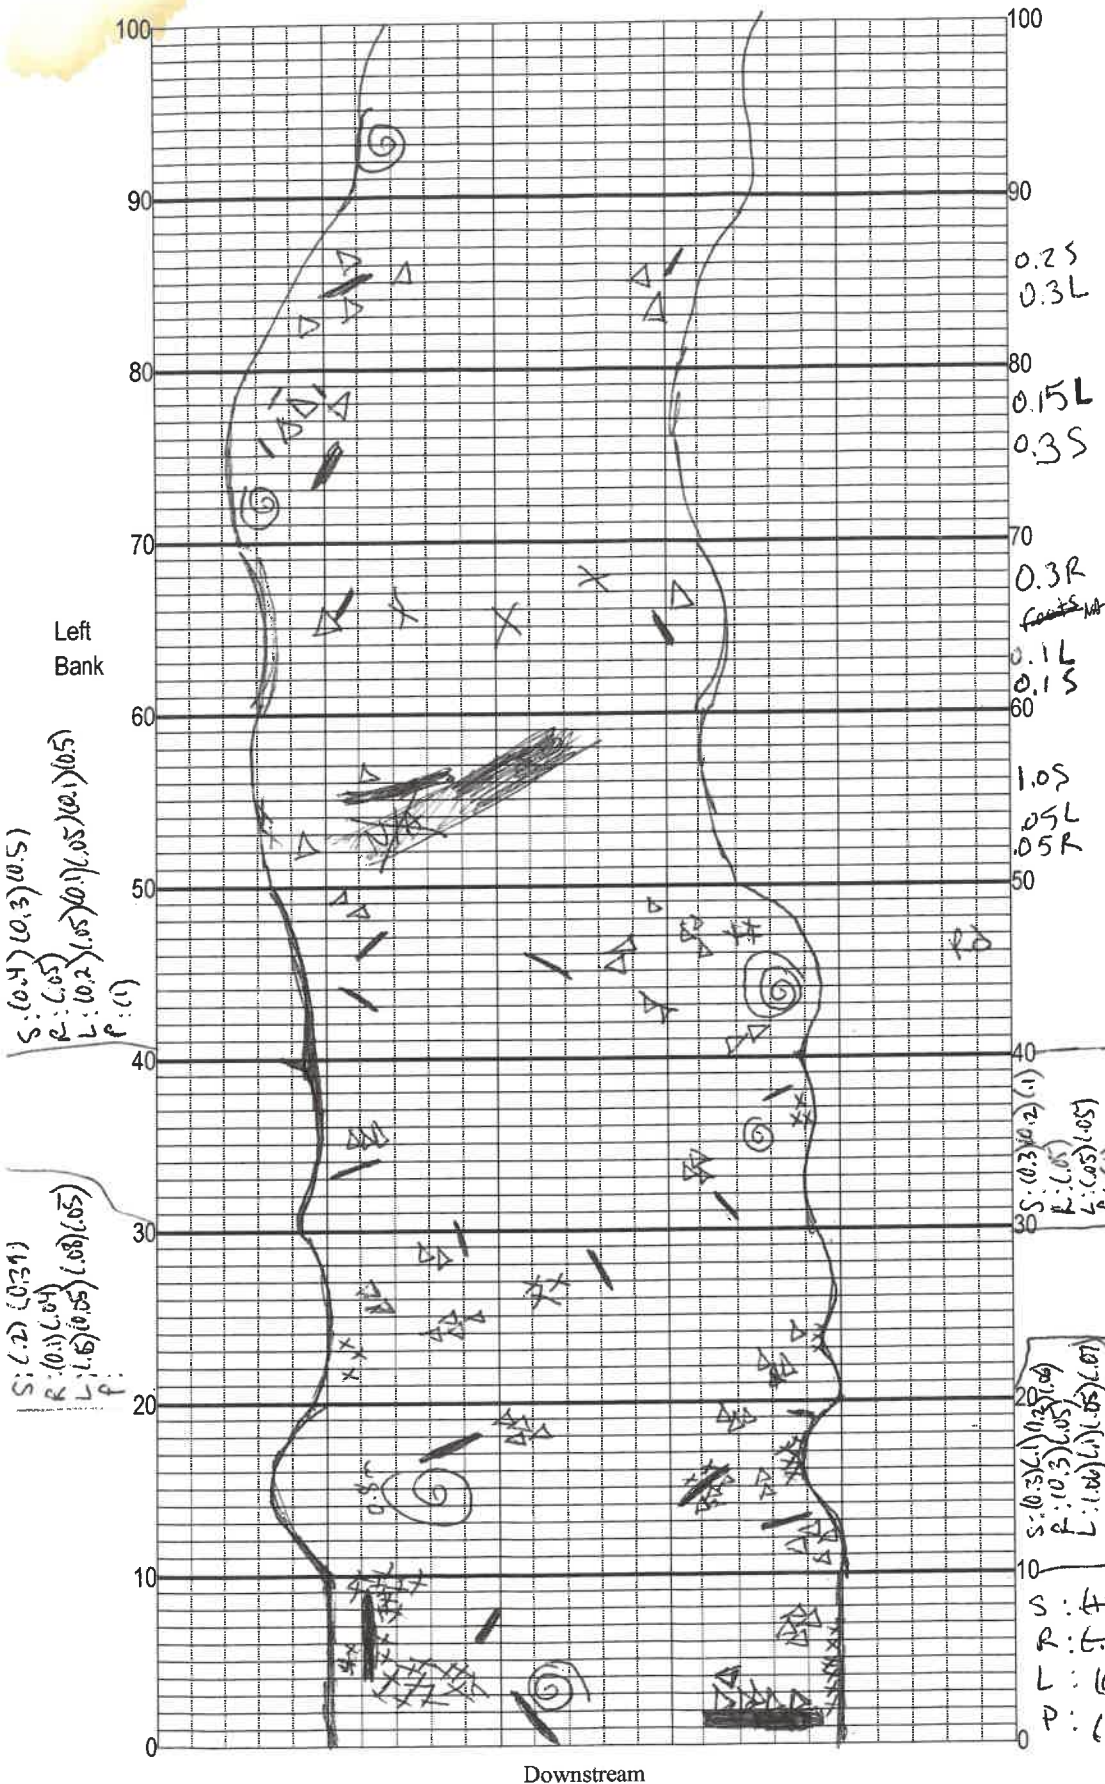
Location: Davenport at SR 545 Bridge  
 Date: 10/13/2020  
 Sampler: Natalie Ayala/Victoria S.

Substrates: Code key, draw proportionate habitat abundance. %

| | Snags | <u>3</u> |
| | Roots/undercut banks | <u>1</u> |
| | Leaf Packs (or mats) | <u>1</u> |

Average width 3 m  
 Average depth 0.4 m

Velocity measured at      meter mark.

WQ & chemistry taken at 60 meter mark.

S: (0.1) (0.3) (1.36) (0.2)  
 R: (0.85) (0.3) (0.5) (0.36) (2.1) (1)  
 L: (0.1) (0.2)  
 P: (1)
