# FLORIDA DEPARTMENT OF ENVIRONMENTAL PROTECTION

## REFERENCE STREAMS FIELD SHEET

WIN Station Name: McCostill Mill Creek Below Ebenezer Church

Stream/River Habitat Sketch Sheet, Form FD 9000-4 (June 1, 2001)

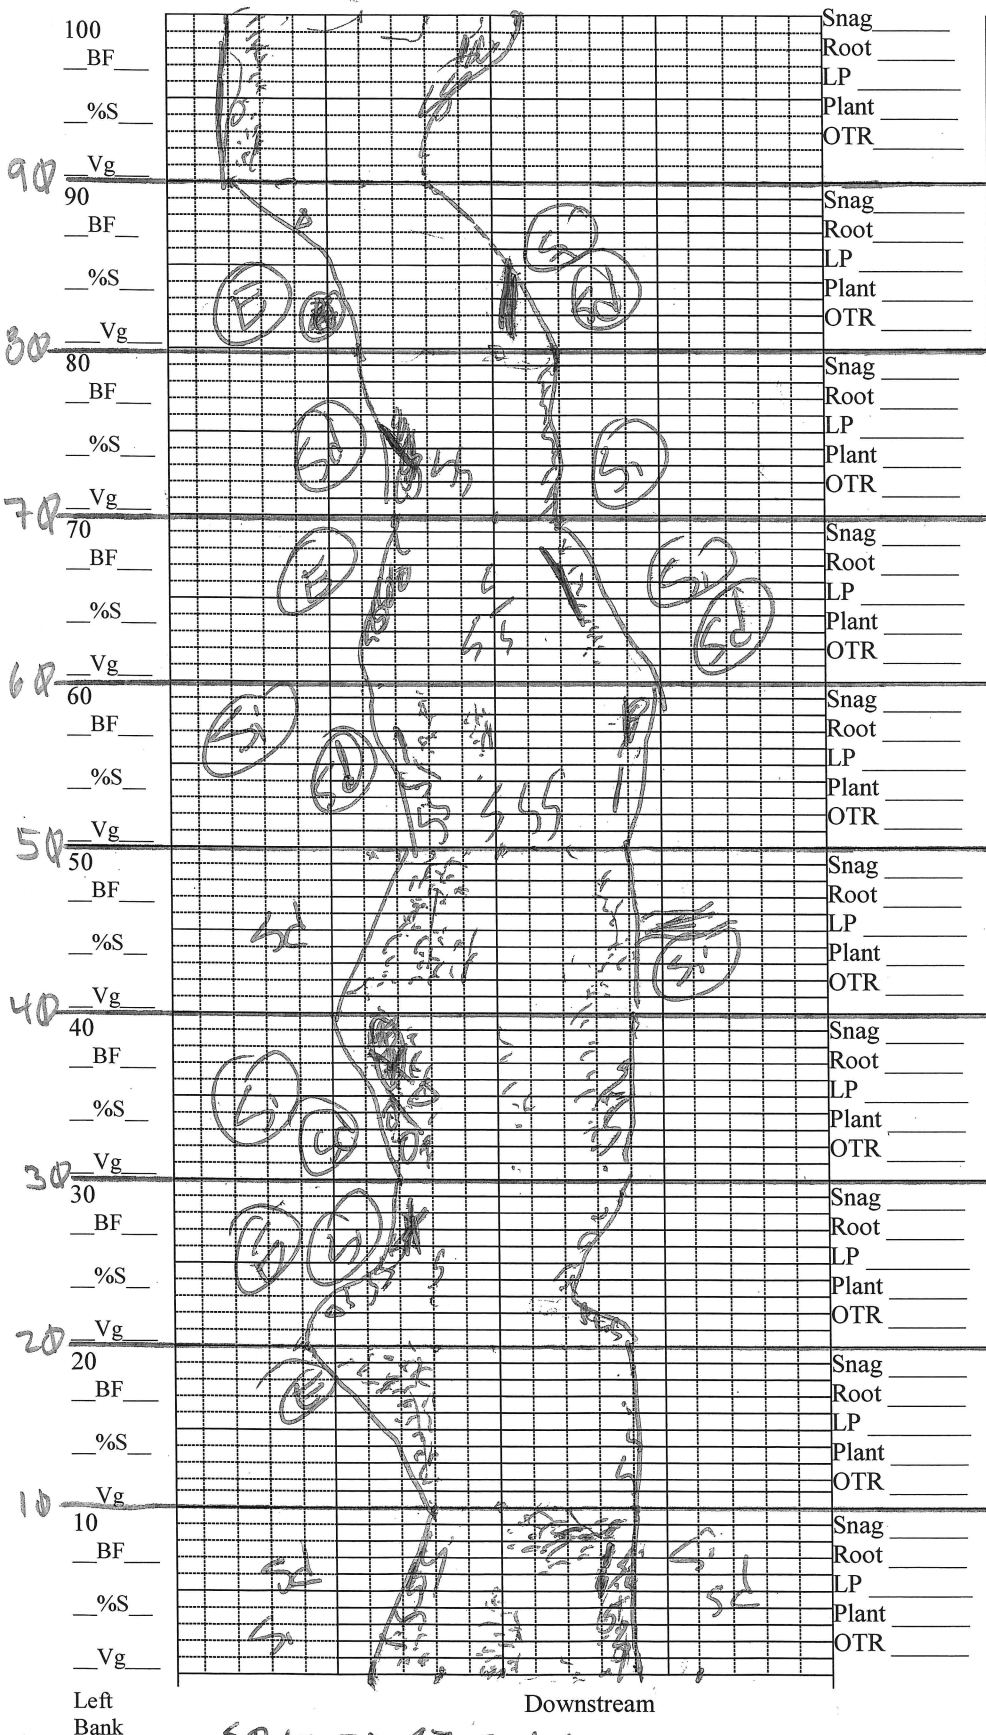
McCostill Mill Creek Below Ebenezer Church Rd.

- ☒ Snags  $\frac{75}{380} = 2.1\%$
- ☒ Roots/undercut banks  $\frac{25.9}{380} = 6.8\%$
- ☒ Leaf Packs (or mats)  $\frac{8.4}{380} = 2.2\%$
- ☒ Macrophytes
- ☒ Gravel  $\frac{37}{380} = 9.7\%$
- ☒ BAR
- ☒ Sand  $\frac{300}{380} = 79.1\%$

Note areas (on map) where  
sand or silt is something  
substrates, limiting  
habitability.

Average width 3.8 m

Average depth 0.2 m

WQ & chemistry taken @ 100 m
