FLORIDA DEPARTMENT OF ENVIRONMENTAL PROTECTION  
STRATEGIC MONITORING PROGRAM FIELD SHEET

Location/STORET Station Name: Elder Springs Run DS of Myrtle St - Sanford Date: 07/19/17  
(mm/dd/yyyy)

# DEP Form FD 9000-5 Stream/River Habitat Assessment Field Sheet

## DEP Form FD 9000-4 Stream/River Habitat Assessment Sketch Sheet

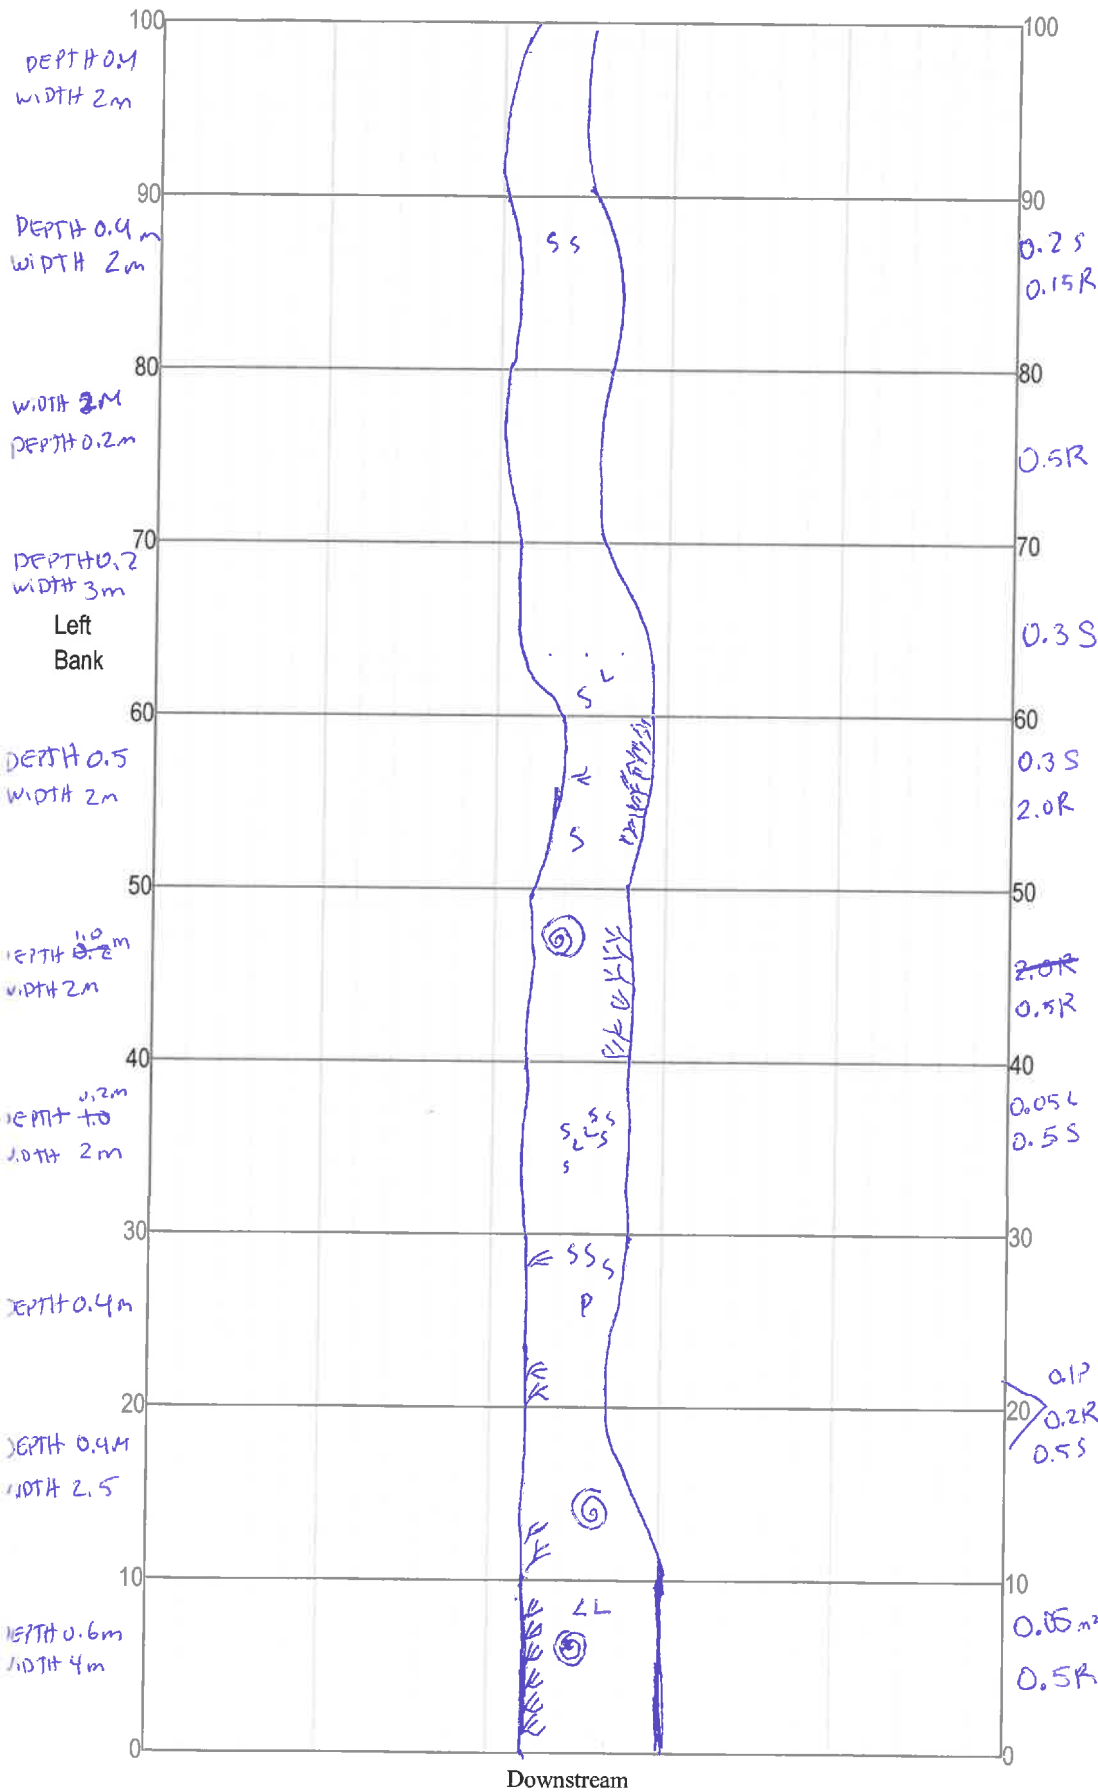
Pools      total # observed = 4  
# range expected = 3-6

Average width 2.3 m  
Average depth 0.4 m

Velocity measured at 30 meter mark.

WQ & chemistry taken at 100 meter mark.
