Site Name Sevenmile Creek upstream of Alder Brook Blvd

Date: 2/12/19

FLORIDA DEPARTMENT OF ENVIRONMENTAL PROTECTION  
STRATEGIC MONITORING PROGRAM FIELD SHEET

DEP Form FD 9000-4 Stream/River Habitat Assessment Sketch Sheet

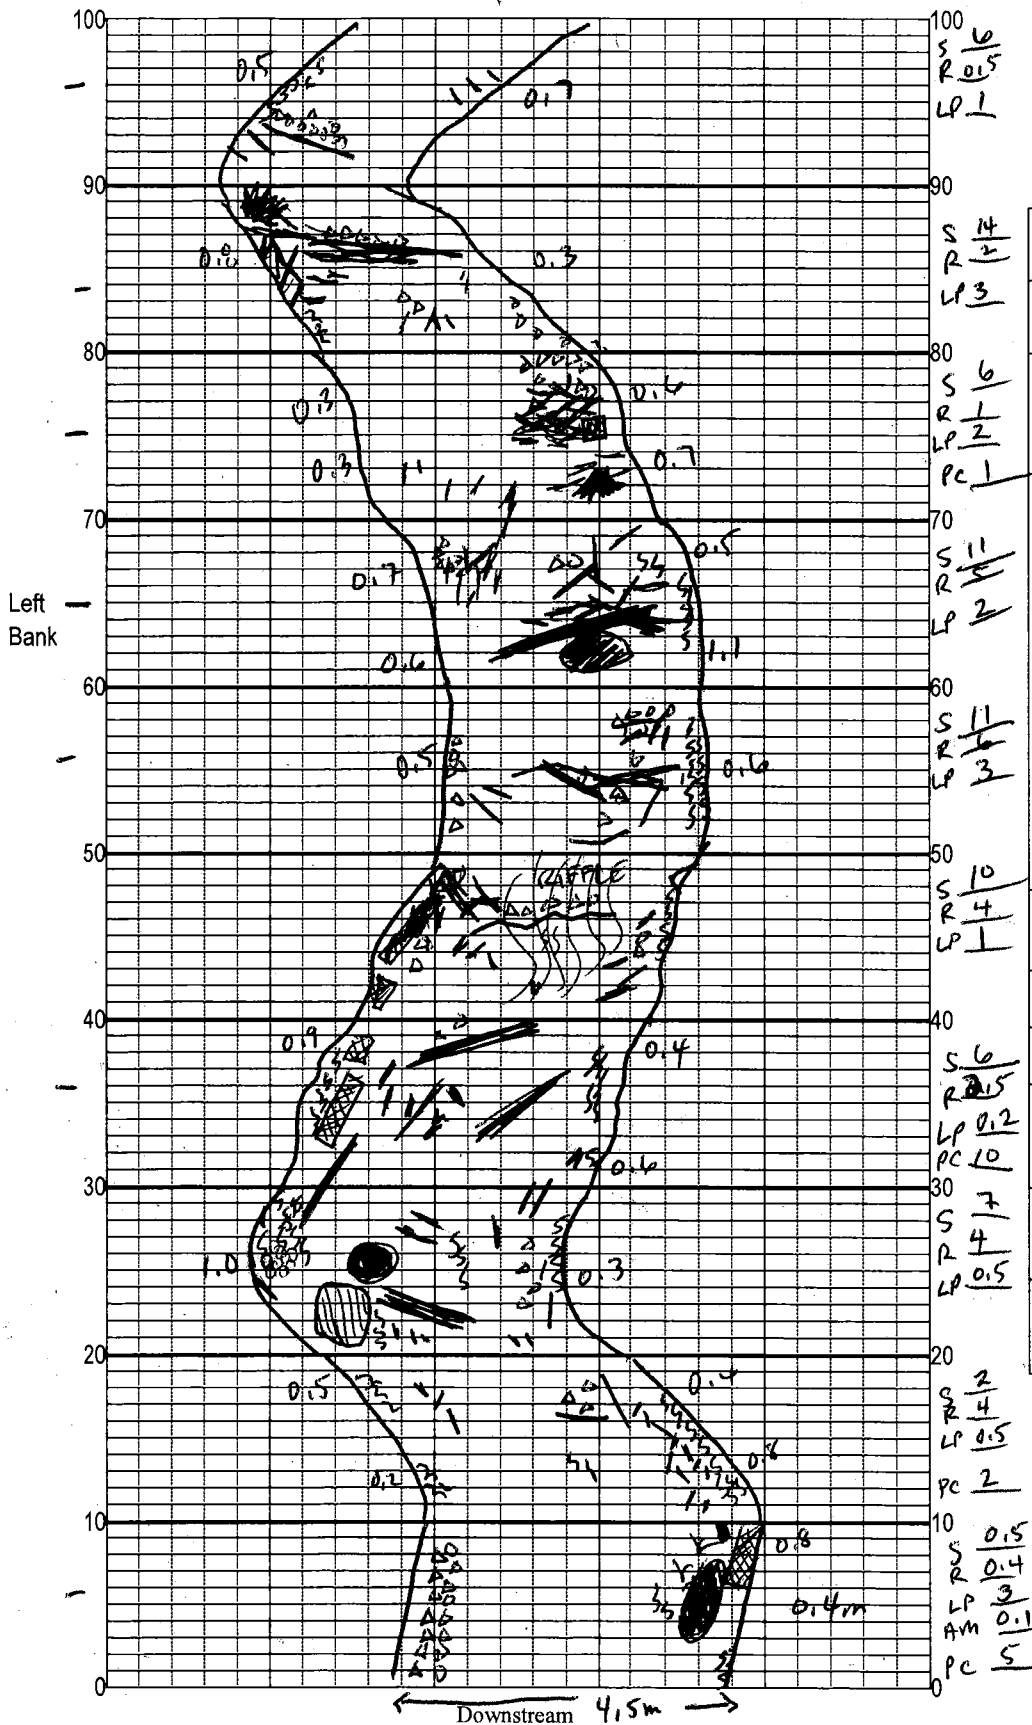
Habitat Smothering:  
 Note areas (on map) where sand or silt is smothering substrates, limiting habitability.

Bank Stability:  
 Note areas (on map) with unstable, eroding banks.

LOTS OF TREES FALLING INTO STREAM.  
SAND DEPOSITION WIDENING STREAM & ERODING BANKS
