## DEP Form FD 9000-5 Stream/River Habitat Assessment Sheet

Buffalo Creek Canal @ 115th Ave

Form FD 9000-4 Stream/River Habitat Assessment Sketch Sheet

## DEP FORM FD 9000-32: LINEAR VEGETATION SURVEY FIELD

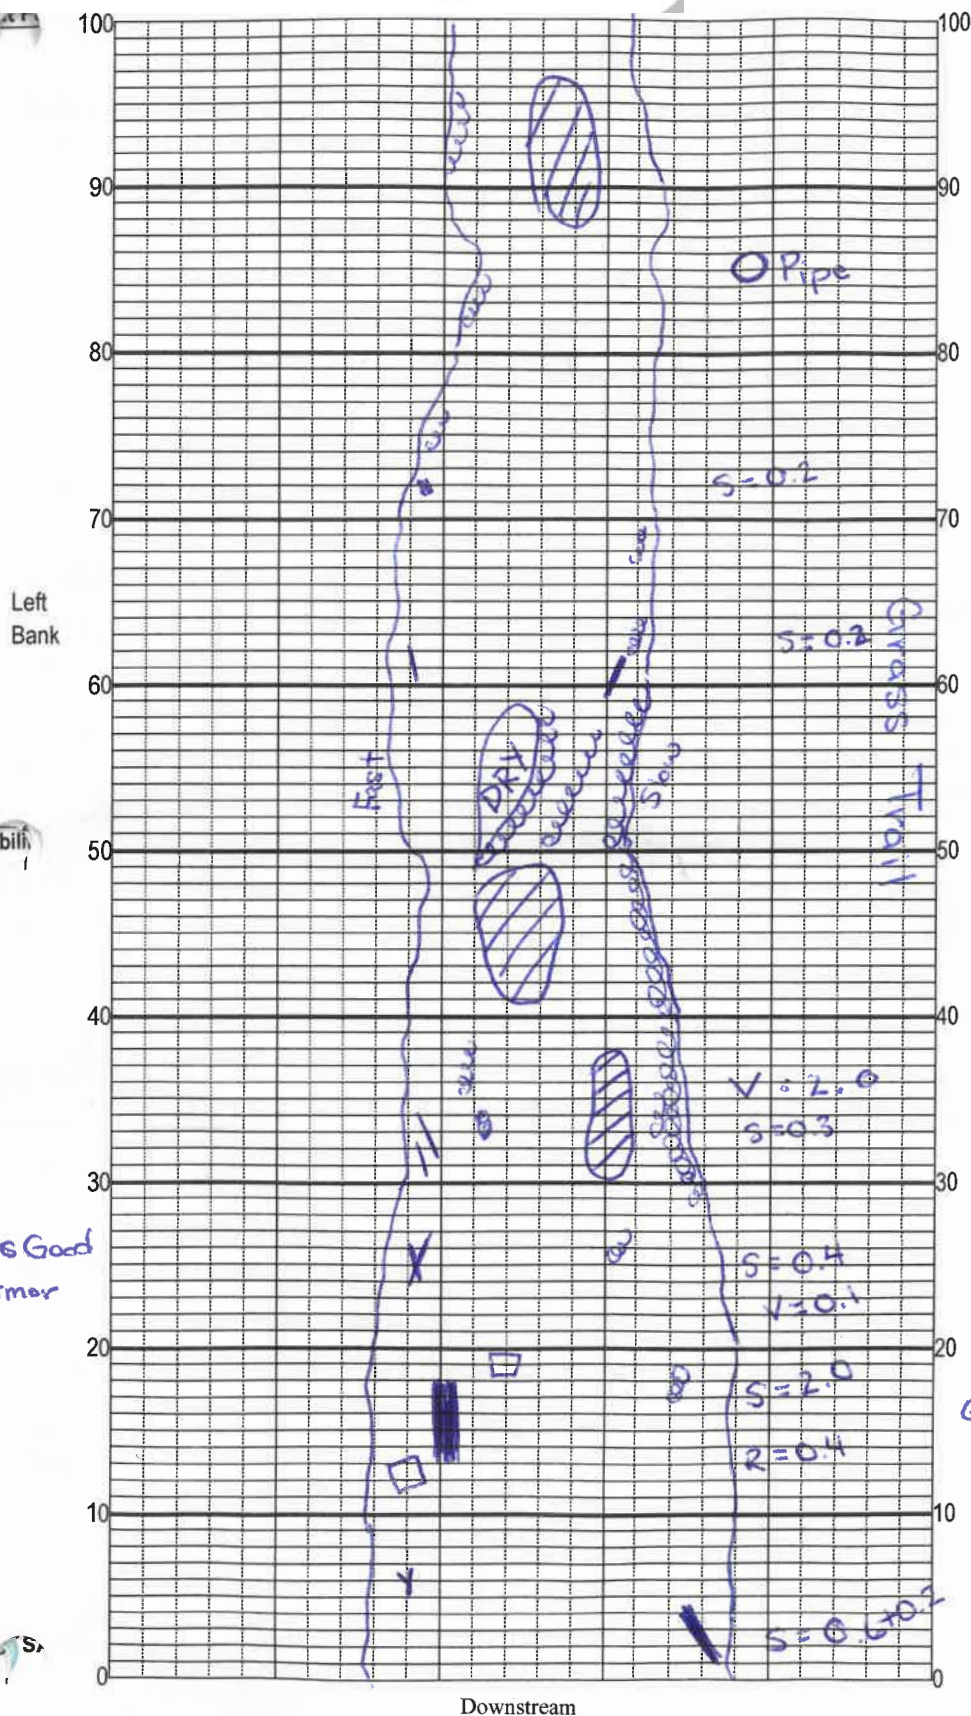
total # observed = 3  
# range expected = 4-8Average width 2 mAverage depth 0.2 mVelocity measured at 100 meter mark.WQ & chemistry taken at N/A meter mark.

| <b>AMBIENT FIELD CONDITIONS / NOTES:</b><br>High water mark not measured due to effects of Hurricane Ian. Homeowner noted canal flooded banks 5 days prior.<br><input checked="" type="checkbox"/> The antecedent hydrologic conditions have been met to my best knowledge. |
