# ECOSUMMARY

*A Report by the Surface Water  
Assessment and Monitoring  
Program (SWAMP)  
#96-004*

## Carlton Branch, Hillsborough County

*A BioRecon Assessment*

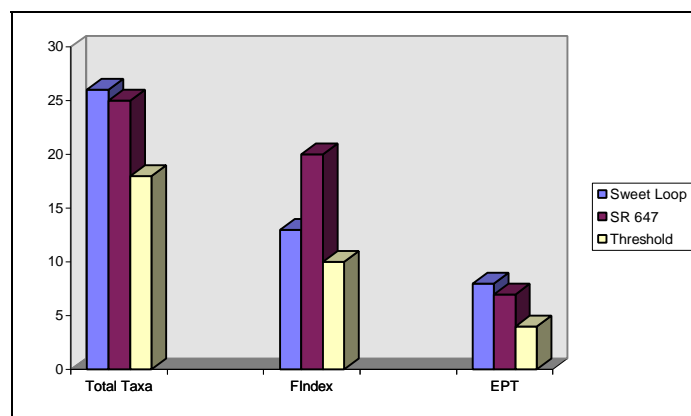
Fig. 2. BioRecon Scores

Both sites on Carlton Branch passed all three measurements of the BioRecon (Fig. 2). This indicated

a healthy stream macroinvertebrate community at the time of sampling. The two sites had similar numbers of Total Taxa and EPT species. The SR 674 site had more Florida Index species, probably due to greater recruitment potential downstream. The upper site may not be continually flowing, restricting the colonization of longer living aquatic organisms.
