Talking Points: OLD PLUGGING AND ABANDONMENT PROGRAM

## Old Well Plugging Program:

## **2004, OLD WELL REPLUGGING PROJECT REPORT**

## INADEQUATELY PLUGGED & ABANDONED OIL TEST WELLS IN FLORIDA

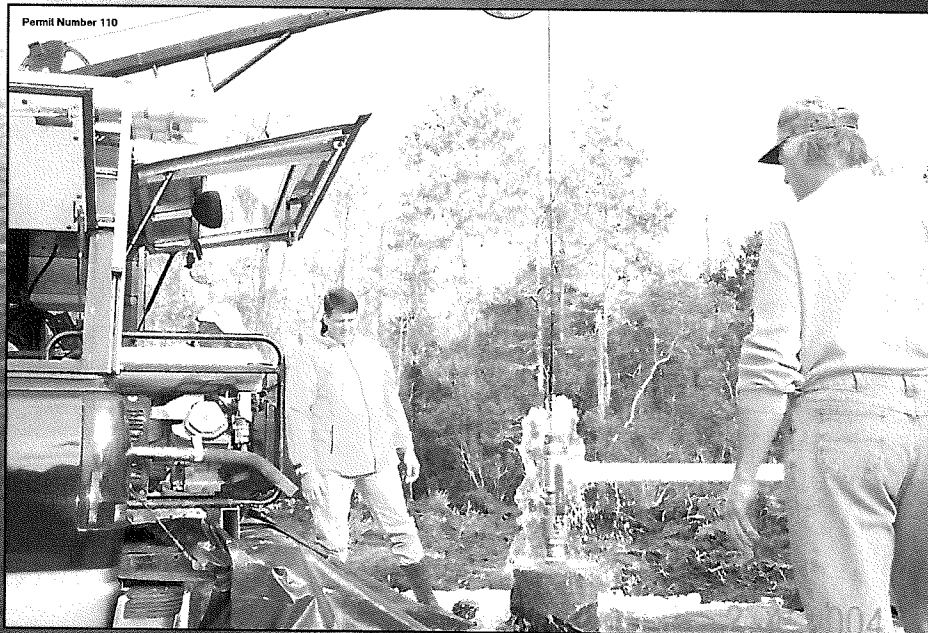
*February 2004, Permit 110  
Warren Zwanka (SRWMD), & Al Keaton  
(FDEP/O&G) attempting to run geophysical logs*

Permit Number 110, (see schematic) which is located in Levy County and was the last of six wells that had a high priority wells identified in the Woodward Clyde report and was prioritized by the Department to be replugged. Levy County is in the Suwannee River Water Management District, and we enjoyed 100% support of their field personal and management in this project. Permit Number 110 had the salt water/fresh water contact, USDW, and the depth of potable all exposed to one another and the wellbore was flowing at surface. The surface casing had deteriorated to a point the casing appeared to full of holes. Plugging the wellbore isolated all the aquifers from each other.

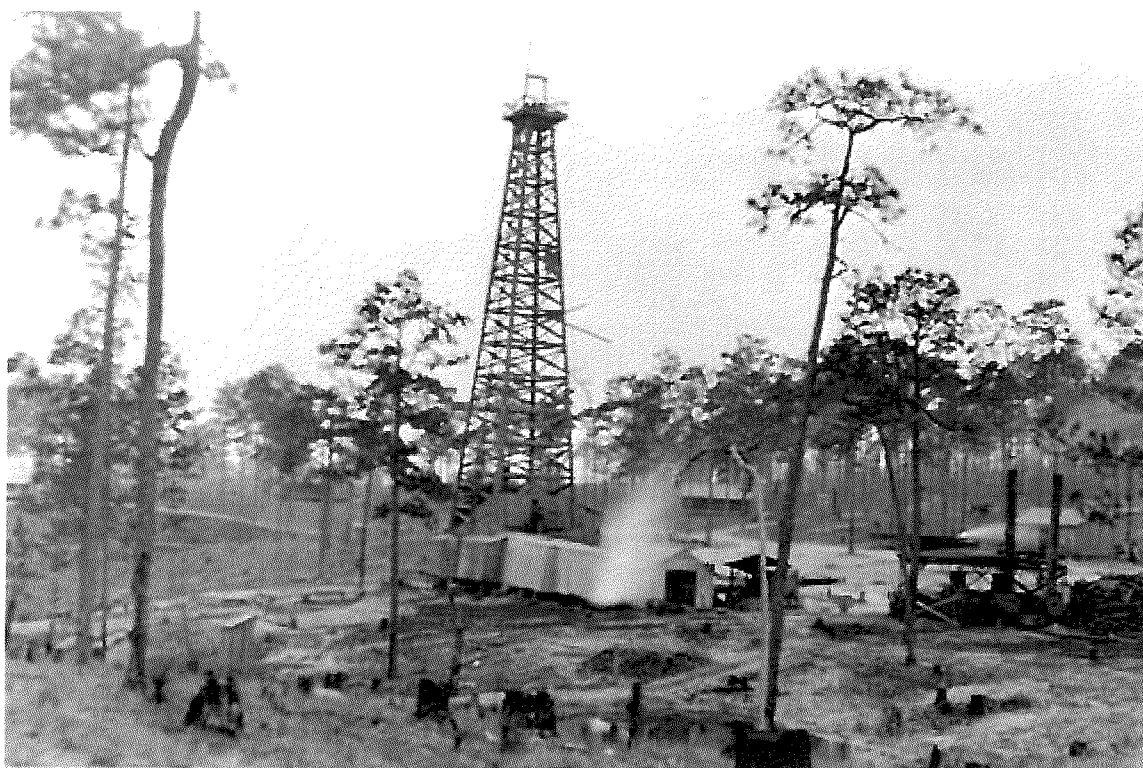
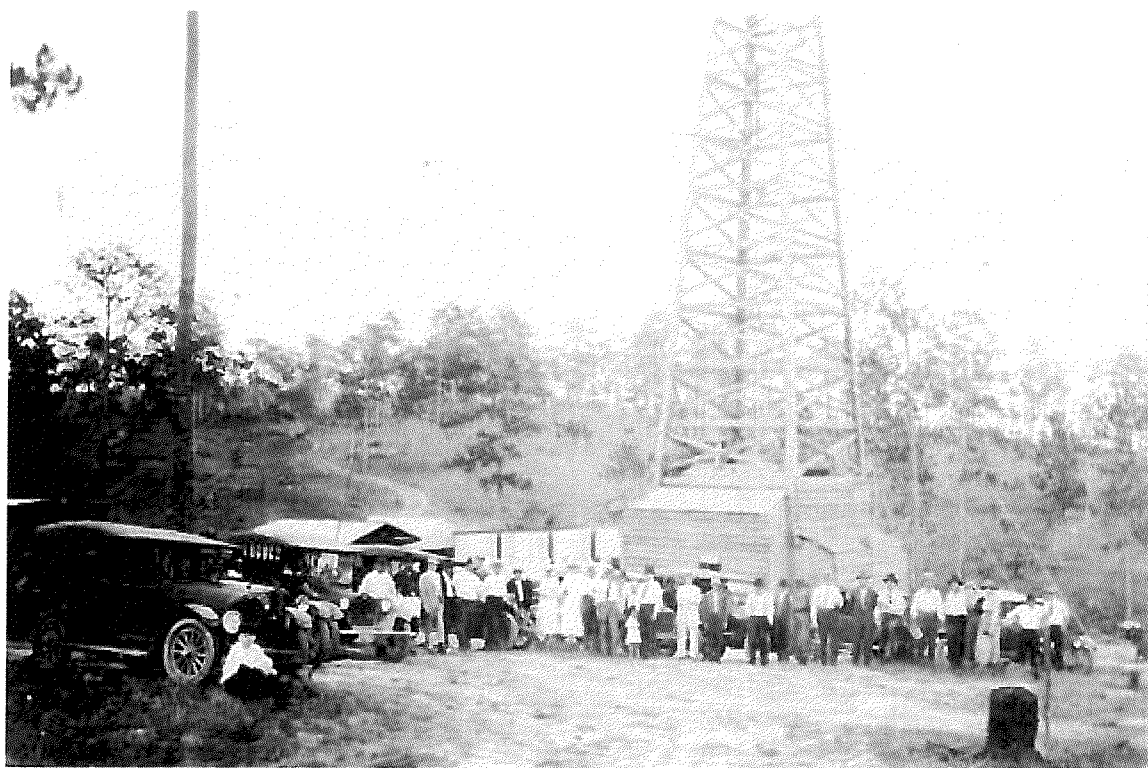
DEKLE NO. 1

~1920 Falling Waters St. PK.

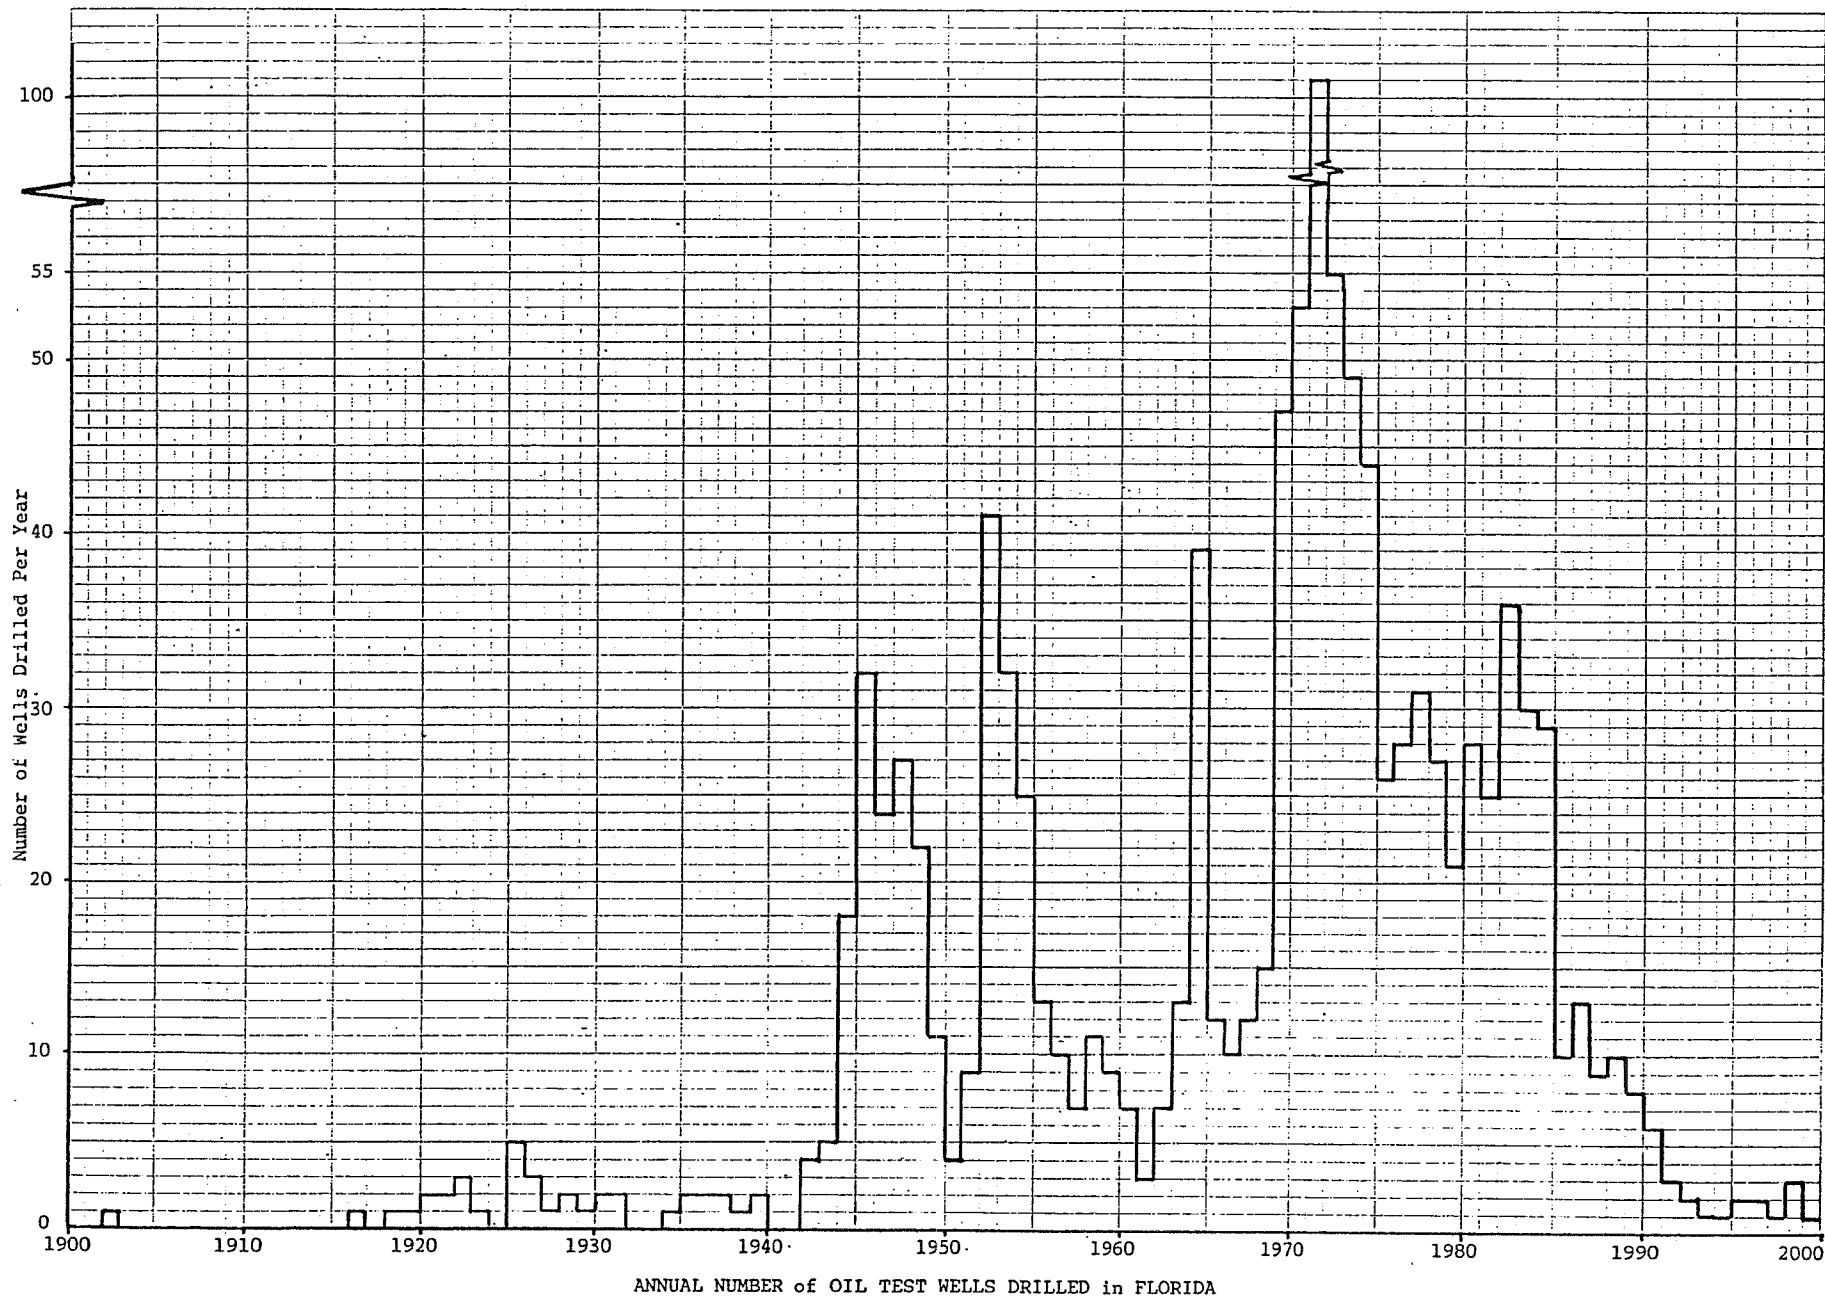
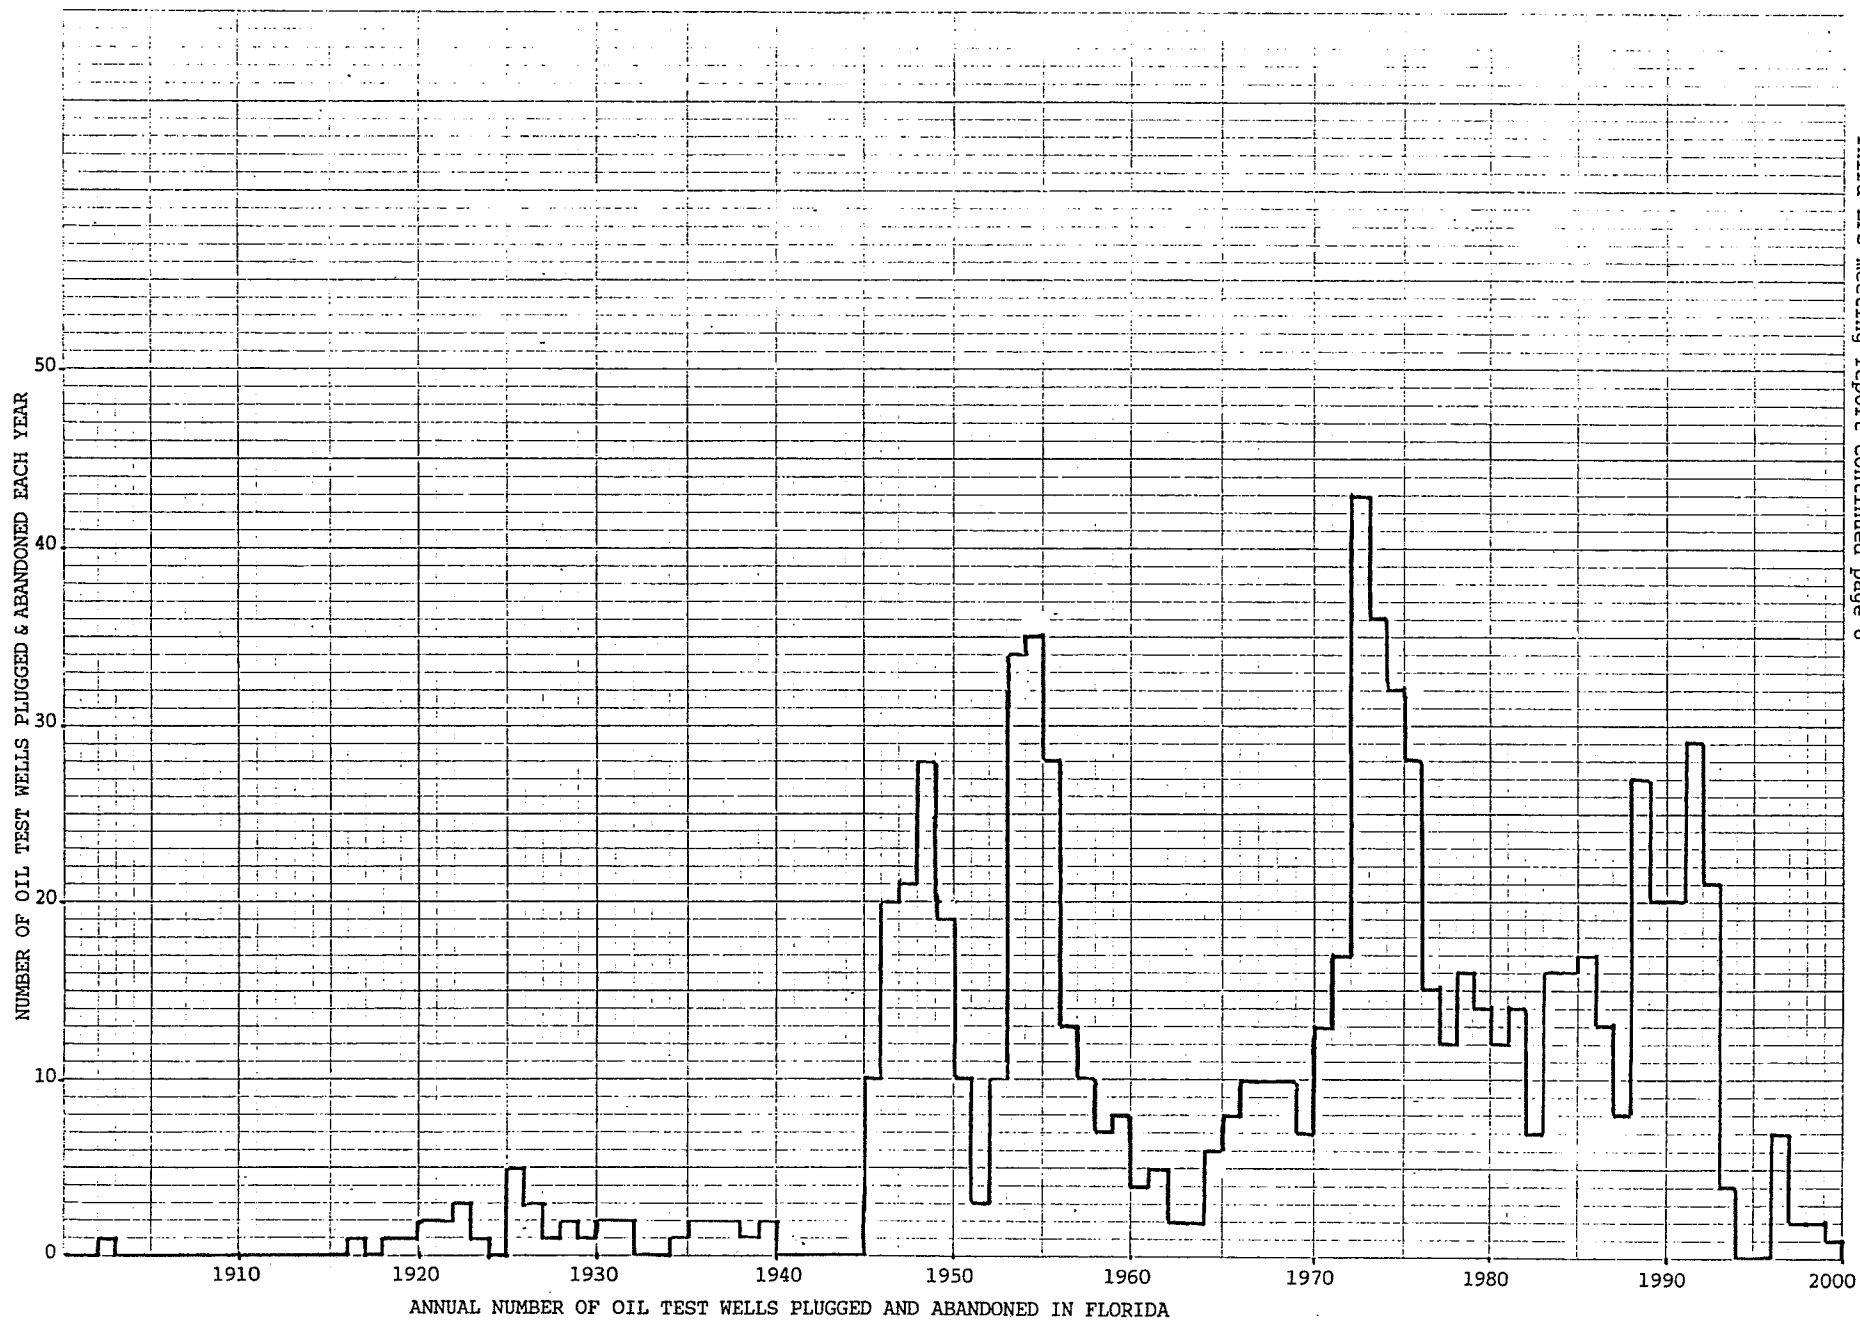
NUMBER PER YEAR OF INADEQUATELY PLUGGED & ABANDONED OIL TEST WELLS

Insufficient Data on Pre-permit oil test wells  
Prior to 1945 to Evaluate the Status of the  
Well Bore.
