DEP Form FD 9000-3 Physical/Chemical Characterization Field Sheet

DEP Form FD 9000-5 Stream/River Habitat Assessment Field Sheet

| REMARKS:<br><b>WB1D3641</b> | COUNTY:<br><b>Alachua</b> | LOCATION:<br><b>Rocky cr @ 156 Ave</b> | | FIELD ID/NAME: |

# DEP FORM FD 9000-25 Rapid Periphyton Survey Field Sheet

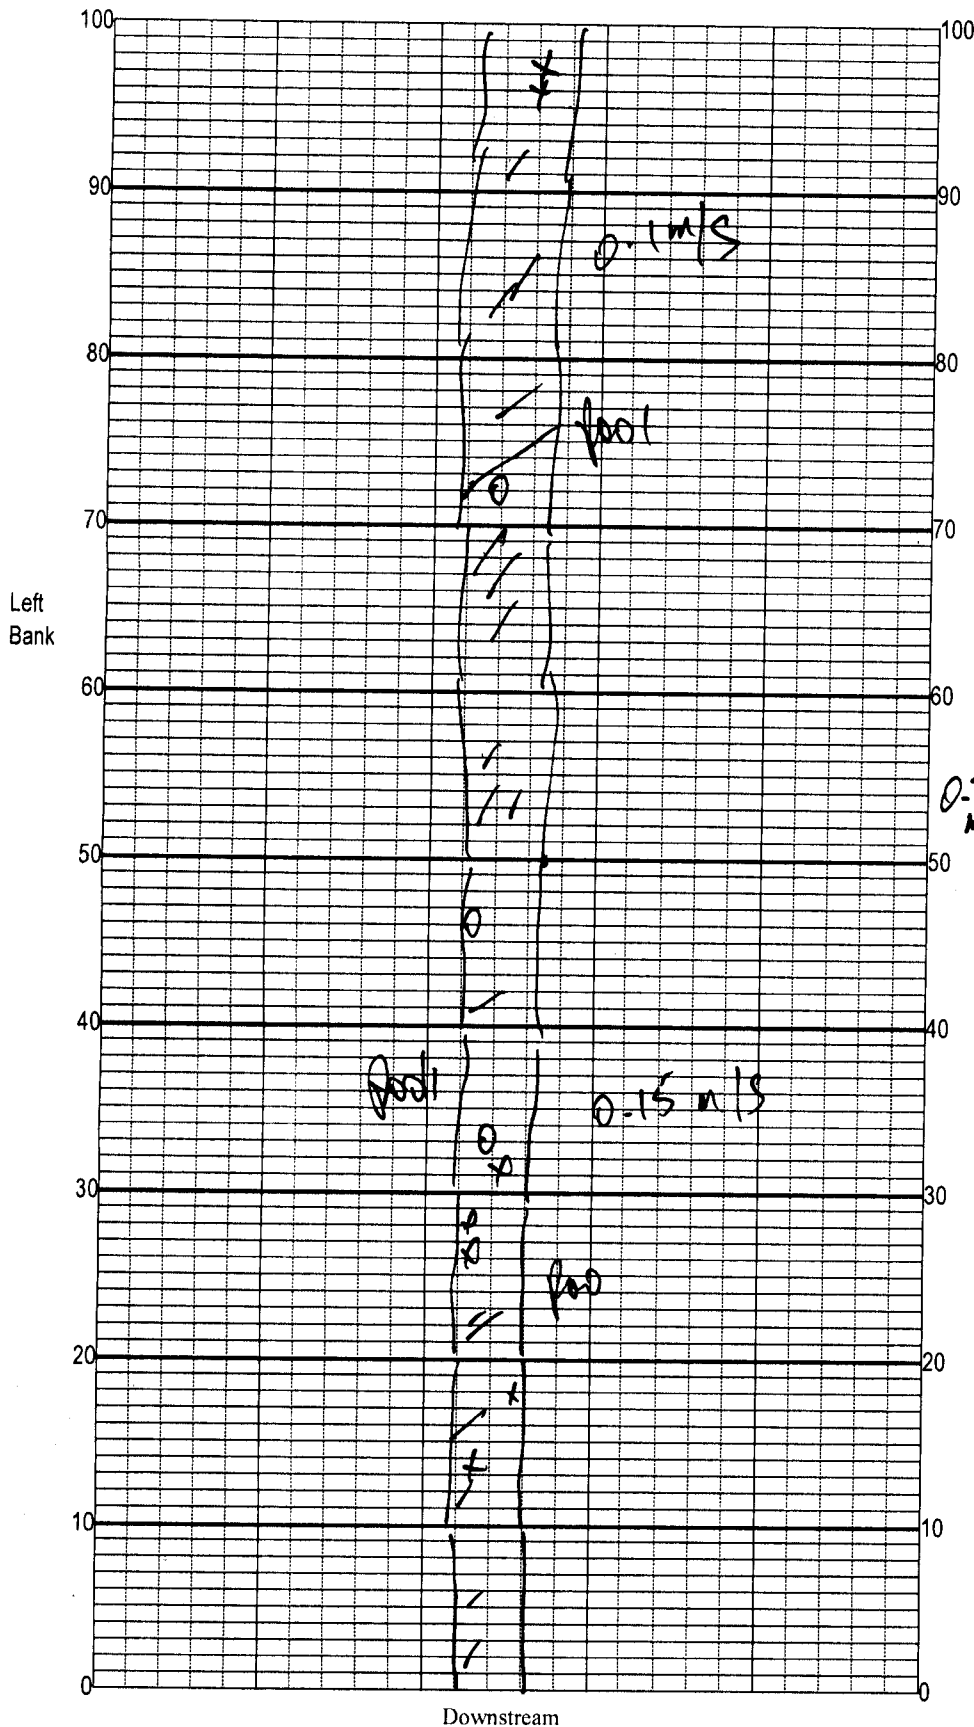
DEP Form FD 9000-4 Stream/River Habitat Assessment Sketch Sheet

2% leaf  
12% snag  
4% root  
0 m<sup>2</sup> AQUATIC plants
