Site Name Oak Creek below Tommy Steele Road

FLORIDA DEPARTMENT OF ENVIRONMENTAL PROTECTION  
STRATEGIC MONITORING PROGRAM FIELD SHEET

DEP Form FD 9000-3 Physical/Chemical Characterization Field Sheet

DEP Form FD 9000-4 Stream/River Habitat Assessment Sketch Sheet

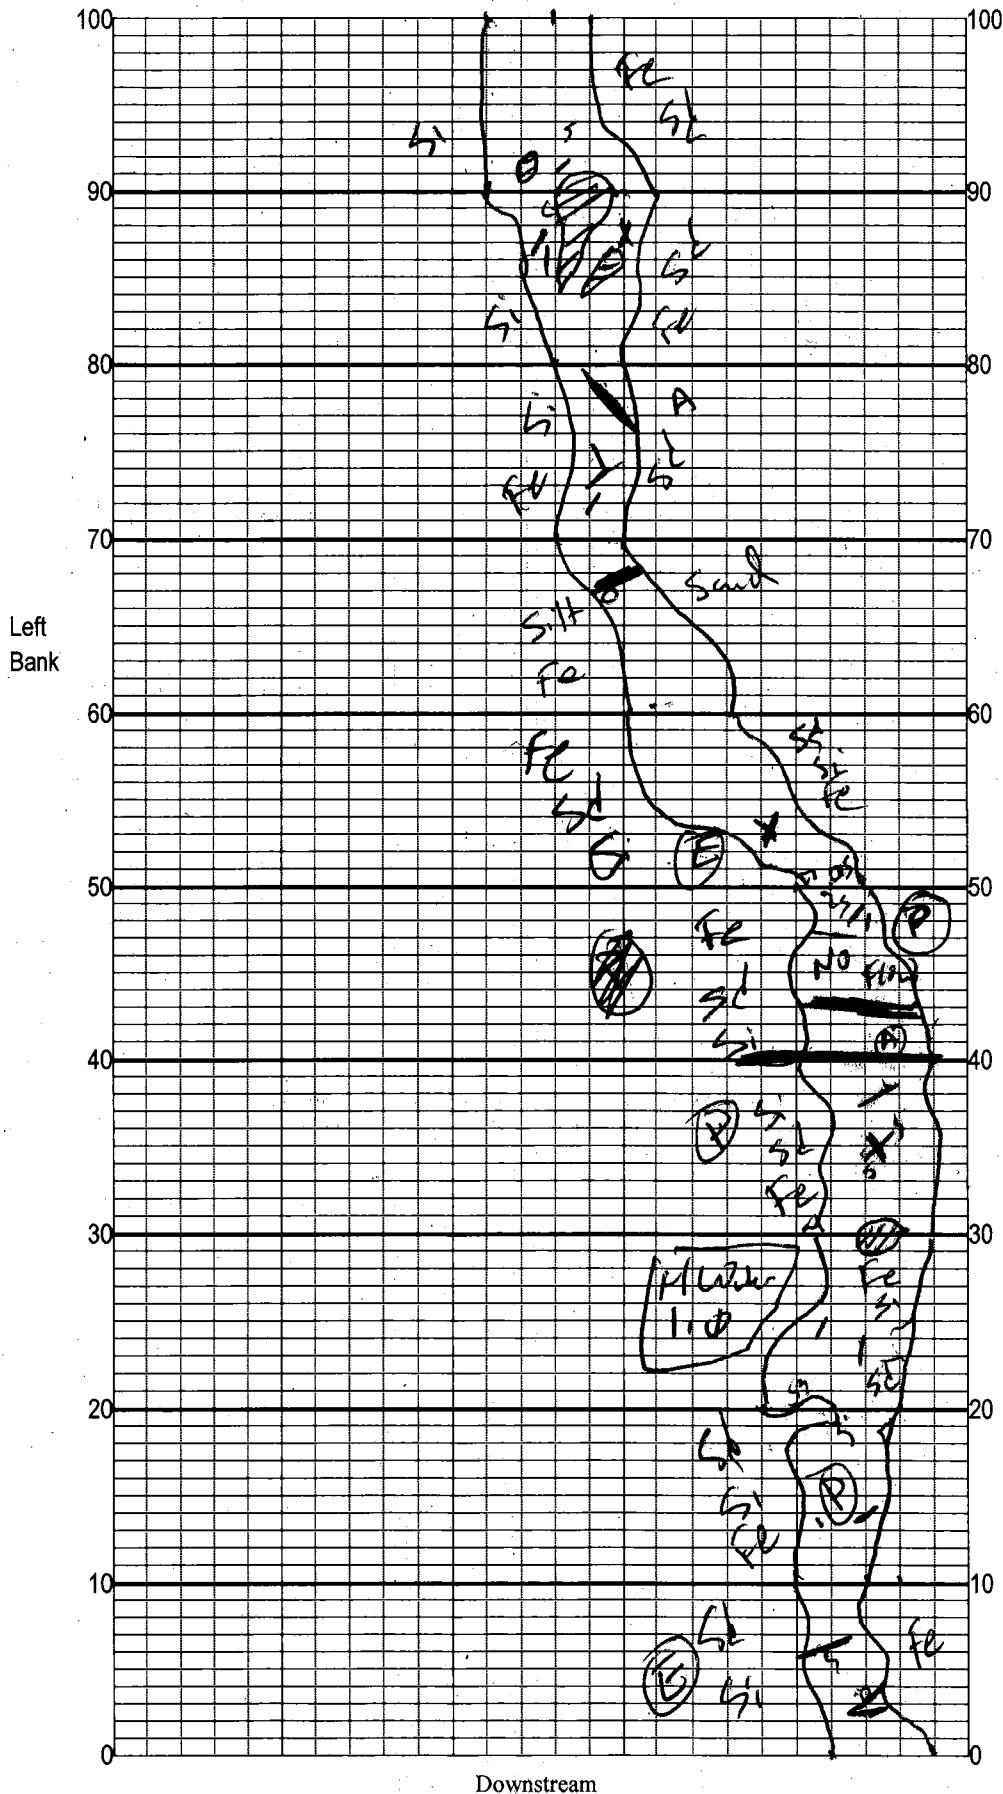
Oak Creek Below Tommy Steele Rd.

Habitat Smothering:  
Note areas (on map) where sand or silt is smothering substrates, limiting habitability.

Bank Stability:  
Note areas (on map) with unstable, eroding banks.

Riparian Buffer Width:  
Note areas (on map) where natural vegetation is altered or eliminated.

Silt smothering @

A-J

Sand Smothering @

Degraded Banks @

A, B, F

Fe/Sulfur Bact. @

Notes: Entire Stream Bottom Covered with thick "blanket" of Fe/Sulfur Bacteria.  
SB10 2A 79304
