## Mill Creek Eglin Golf Course below Trout Lake, Okaloosa County August 13, 1998

BioRecon: A rapid, cost-effective screening mechanism for identification of biological impairment

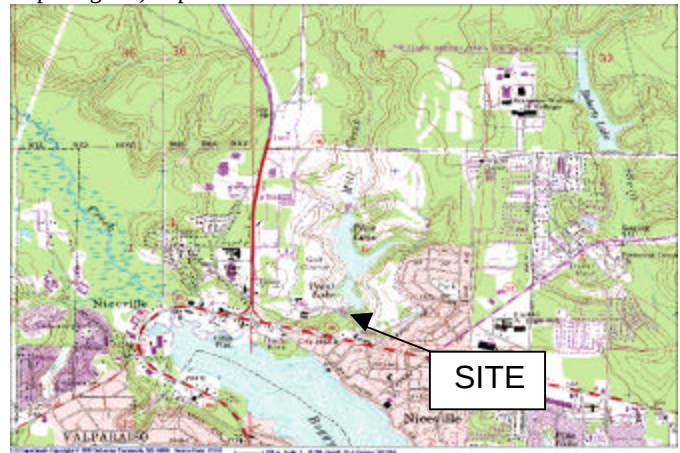
The aquatic wildlife community was dominated by pollution tolerant species. Canopy removal and dams in the lower Creek elevated water temperatures (27.5 °C) compared to upstream at hole #13 (23.5°C). The area's sand hill seepage slope features allow fertilizer applied to the golf course to rapidly percolate into the ground and surface waters. A severe drought in the Florida panhandle during the past 2 years has reduced leachate from applied nutrients. Higher concentrations of fertilizer could be expected to leach from the golf course during normal to high rainfall years. Water quality tests indicated an increase of total nitrogen in Mill Creek below the Trout Lake impoundment (0.59mg/l) compared to upstream above the golf course (0.03mg/l). Conductivity at this site increased to 45.5 umho/cm from 20.7 umho/cm above the golf course, which indicate leaching of dissolved salts. Trout Lake impoundment had a filamentous alga bloom and mowed greens for riparian zones. The nitrogen tied up in these plant materials decays to form the organic sediment deposits found below the golf course down to Highway 20. The natural stream channel in lower Mill Creek was eliminated and its former forested riparian zone

converted to a stagnant cattail swamp. Aquatic habitats (2% coverage) were limited by sediment smothering (98%). Sheet flow, 50 meters in width, replaced the natural stream channel. The riparian zone quality rated marginal, as disruption in the community was evident by the dominance of cattail and presence of invasive exotics (Chinese tallow, torpedo grass) in place of the natural forested buffer.

Restore Mill Creek to a single narrow sinuous channel from the existing shallow sheet flow. Add habitat such as large woody debris that would enhance the stream reach's biota diversity and productivity. Proper placement of large pine logs along the stream bank would restore depths creating additional root and aquatic vegetation habitats favored by Okaloosa darters. Maintain greater than 18 meters of riparian buffer zones. The buffer zones provide the necessary shade, food and habitat (woody debris/leaf fall) and filter fertilizers and pesticides to protect Mill Creek's fish and wildlife. Restore native emergent vegetation buffer zones along the golf course water boundaries to reduce nutrient loading. Buffer zones are important since the area's sand soils do not have the capacity for nutrient uptake. Restoring the stream by dam removal would benefit the watershed's endangered Okaloosa darter. **For more information, contact Donald Ray, FDEP Northwest District, 160 Governmental Center, Pensacola, FL 32501 (850) 595-8300 x1126 or SC 695-8300**
