# EcoSummary

BioRecon Report

## Open Branch above Eglin Road 214/374, Walton County July 18, 2000

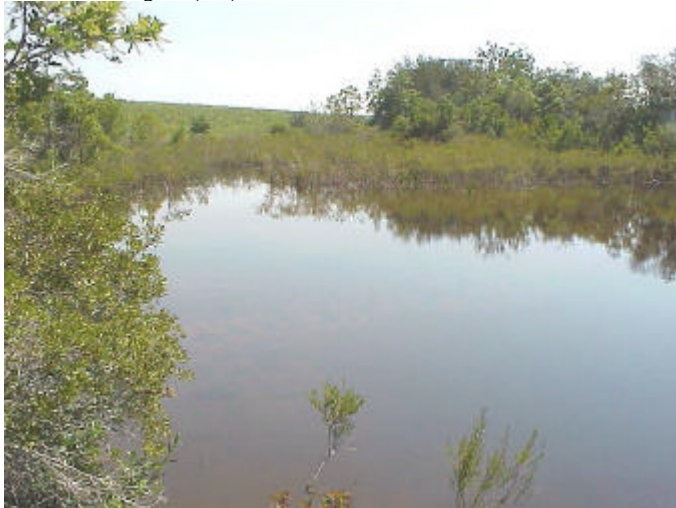
The BioRecon indicated an impaired biological community. All 3 biological indicators failed thresholds established for a healthy aquatic wildlife community:

The biota consisted of bloodworm midges and other pollution tolerant wildlife. Sediment loading, hydrological and buffer zone modifications negatively impacted fish and wildlife in this stream reach. Stream habitats were smothered by silt/sand (88%) from road sediments and weapons test range C-72 runoff. Iron/sulfur bacteria were abundant in the anaerobic sediments, which had a hydrogen sulfide odor. The Eglin Road 214/374 culverts and fill material used to span the stream and riparian zone acted as a dam (see photo). These conditions exacerbated smothering in addition to encouraging a beaver dam. Compared to other local streams, hydrological modifications to Open Branch had increased water temperature by 3.5° C, lowered the dissolved oxygen concentration by 2.4 mg/l, and widened the stream over 10 fold, which

reduced water velocity. Human disturbances reduced the riparian buffer zone to a width of 1 meter. The riparian zone's tree canopy originally consisted of an Atlantic white cedar type forest, which heavily shaded the stream. It converted to an open canopy of St. Johns wort and forbs after range personnel removed the streamside trees by mechanical/chemical methods.

Removing road fill and replacing with a bridge spanning Open Branch Creek and its floodplain would help restore the stream's natural morphological characteristics. Adding habitat such as large woody debris, along with stream bank protection and channel restoration during the stream rehabilitation program for the Okaloosa Darter should enhance fish and wildlife productivity and diversity. Proper placement of large pine logs along the stream bank would enhance riffle/pool habitat (velocity and depth) for the darters and other stream wildlife. Riparian buffer zones greater than 18 meters should be created and maintained. The buffer zones provide the shade, food, habitat (woody debris/leaf fall) and filter runoff necessary for the propagation of Open Branch's biota. Restoring the stream's natural hydrology (i.e. increase depth/width ratio) and riparian forests (replanting native Atlantic white cedars, allowing streamside tree growth) buffer zones would benefit the watershed's fish and wildlife including the endangered Okaloosa darter. **For more information, contact Donald Ray, FDEP Northwest District, 160 Governmental Center, Pensacola, FL 32501 (850) 595-8300 x1126 or SC 695-8300**

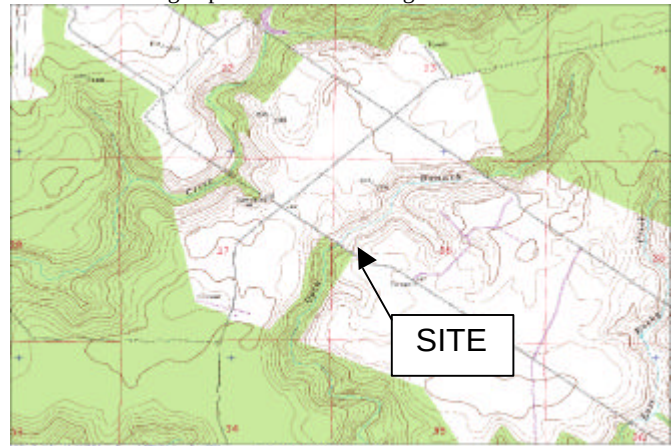
This Open Branch site did not meet Class III State Water Quality Standards 62-302 for recreation and the propagation and maintenance of a healthy, well-balanced population of fish and wildlife. Sediment loading from test range and dirt road erosion had affected fish and wildlife by eliminating habitat. This limited the stream's fish and wildlife nursery function, and impacted the federally listed endangered Okaloosa Darter found in Open Branch. The western panhandle of Florida experiences severe erosion. Soft sandy soil, intense rainfall, and steep topographical relief make this area highly susceptible to erosion after range operations remove vegetative cover.
