# **WETLAND MITIGATION EVALUATION REPORT FLORIDA KEYS BRIDGE REPLACEMENT**

**WETLAND MITIGATION EVALUATION REPORT**  
**FLORIDA KEYS BRIDGE REPLACEMENT**  
WPI No. 6116901; SP No. 90000-1560

March 30, 1994

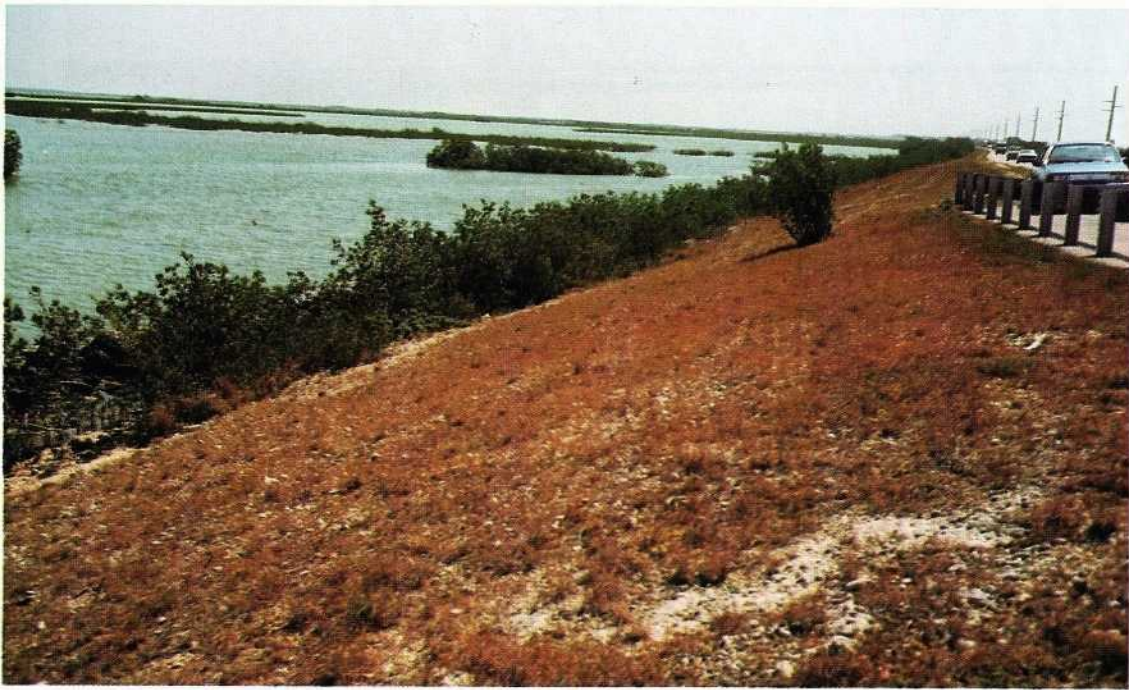
Figure 7. Shark Channel, natural toe of slope mangrove revegetation, Miami Gulf side, view east, 5/93.

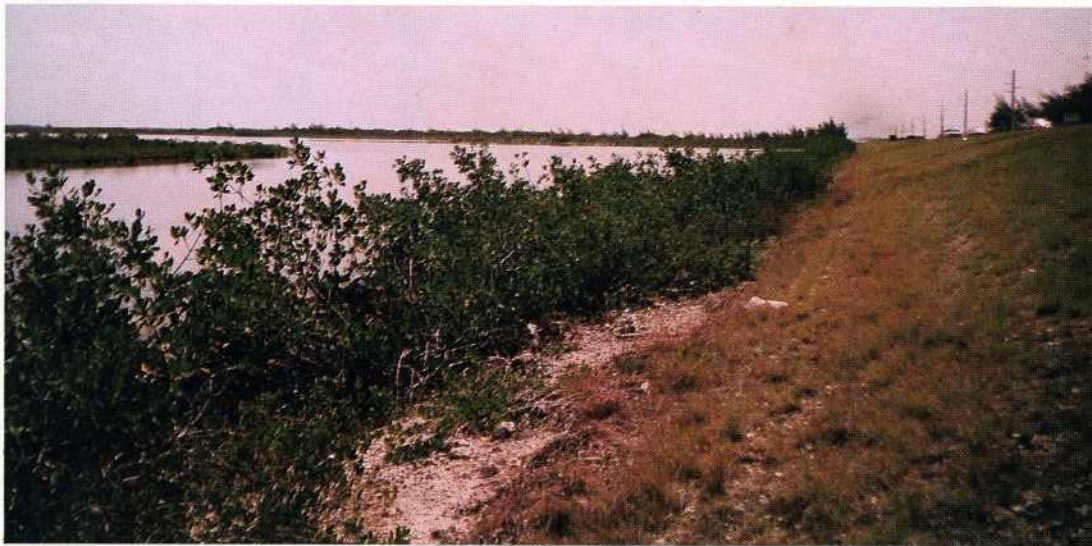
Figure 11. Saddlebunch #2, natural toe of slope mangrove revegetation, Miami Gulf side, view east, 6/93.

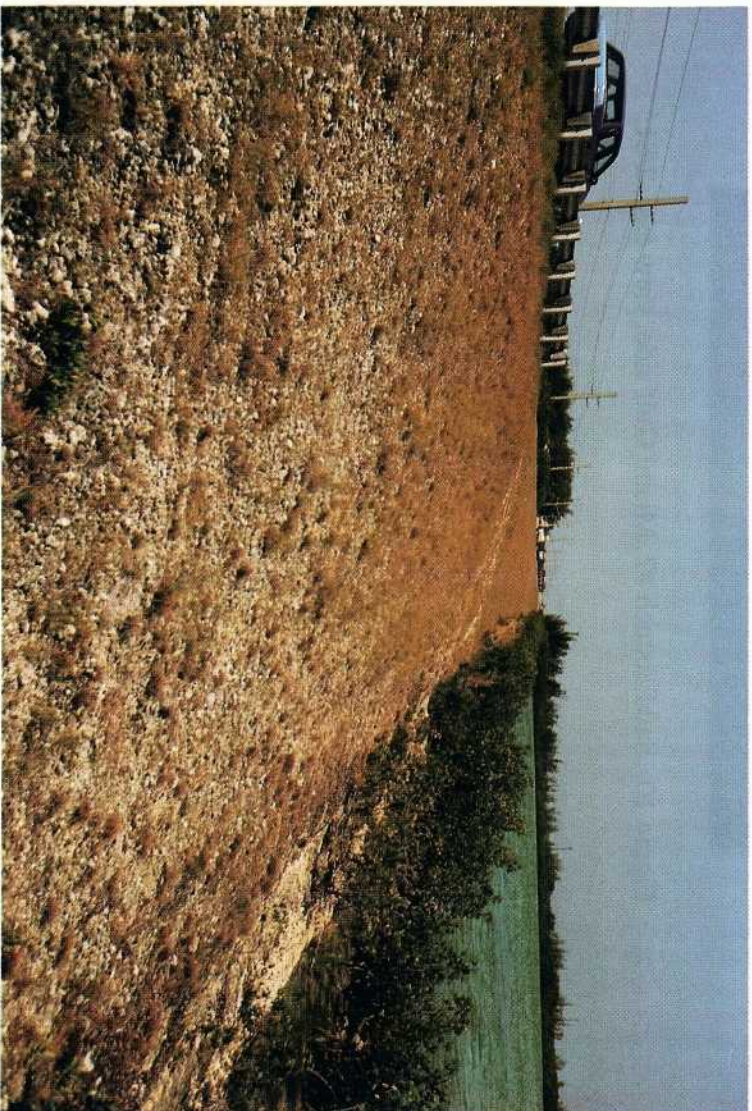
Figure 13. Lower Sugarloaf Channel, natural toe of slope mangrove revegetation, Key West Gulf side, 5/93.

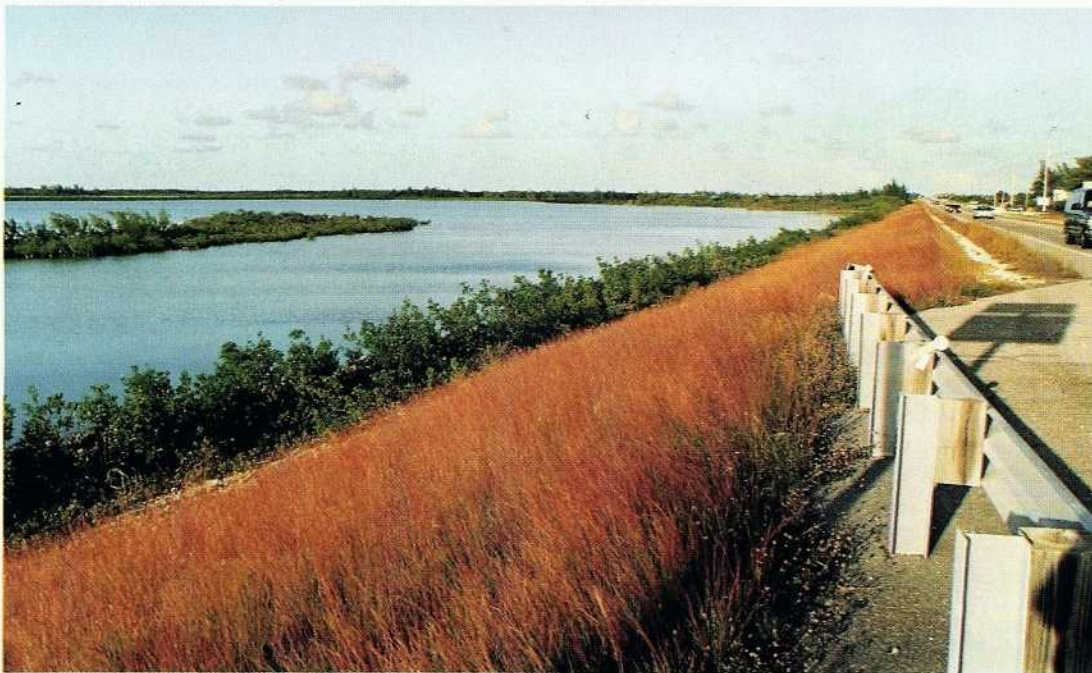
Figure 15. Lower Sugarloaf Channel, grassed slope, Miami Gulf side, view east, 11/92.

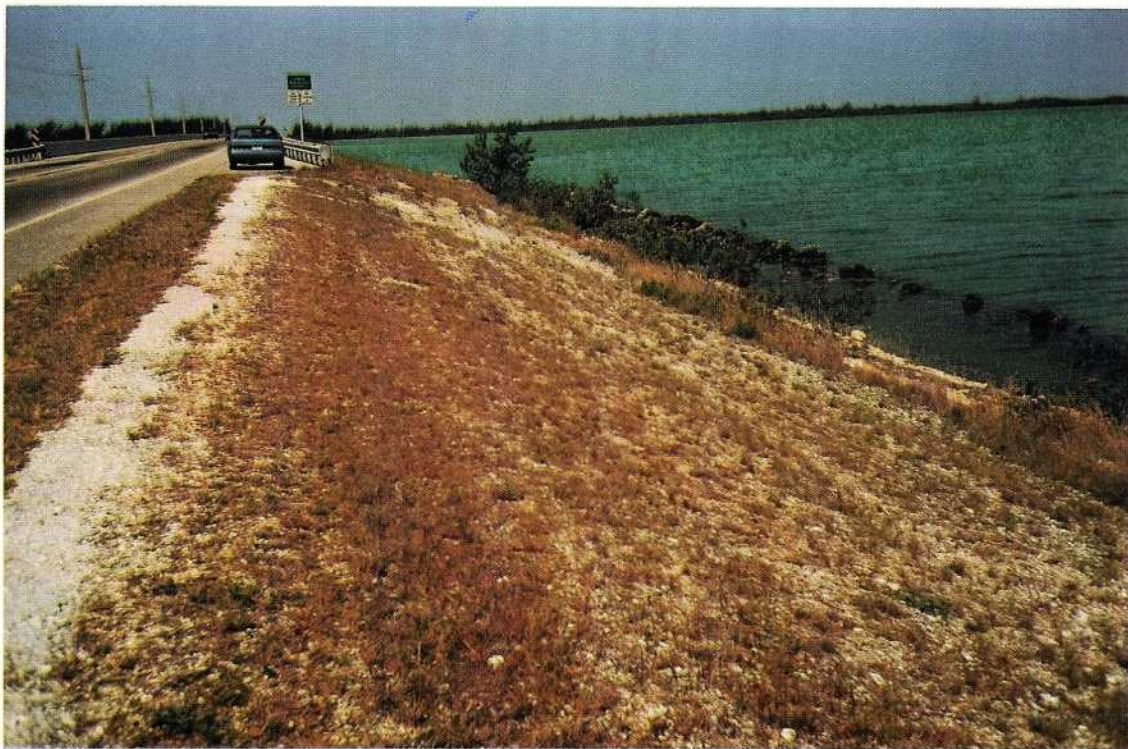
Figure 17. Lower Sugarloaf Channel, erosion limiting revegetation, Miami Gulf side, view west, 5/93.

Some settlement of riprap barriers since placement has occurred, especially in exposed settings or where placed on soft marl substrates. These changes made determination of effectiveness of various riprap heights difficult. Current conditions include a wide range of riprap types, from eroded, redistributed boulders (e.g. Boca Chica/Key West end, Spanish Harbor/Miami Gulf end) to solid, wide riprap at Saddlebunch No. 4 (Key West end) and Saddlebunch No. 3 (Miami end) that may limit mangrove recolonization. Exposed sites (or parts of sites) with little riprap were prone to failure. It appeared that height was an important factor especially as related to exposure and slope behind the riprap (width of mangrove zone). Where rock boulders were placed to the elevation of extreme high tides or above it seemed that better conditions for regrowth occur, but if riprap is too high the overwash of seeds and organic matter cannot occur. Where riprap was too easily overwashed, erosion and unstable conditions resulted, especially where slopes were steep.

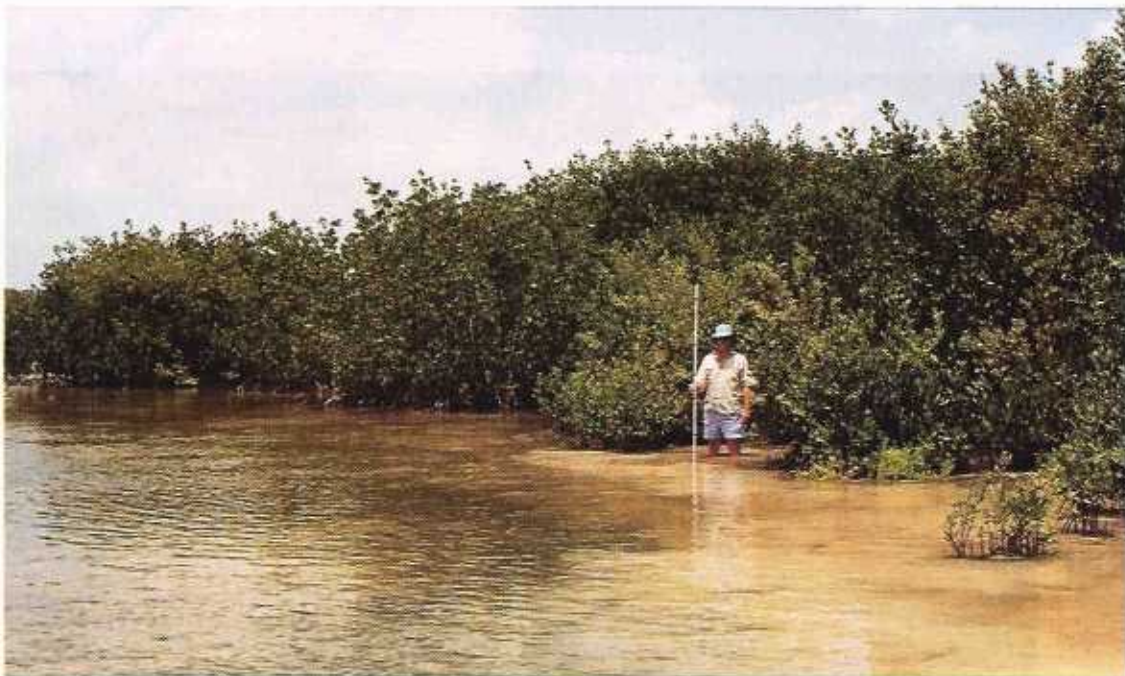
Figure 22. Typical volunteer and planted red mangroves at culvert C-4, Boca Chica Lagoon, 1993. Staff is 2 m tall.

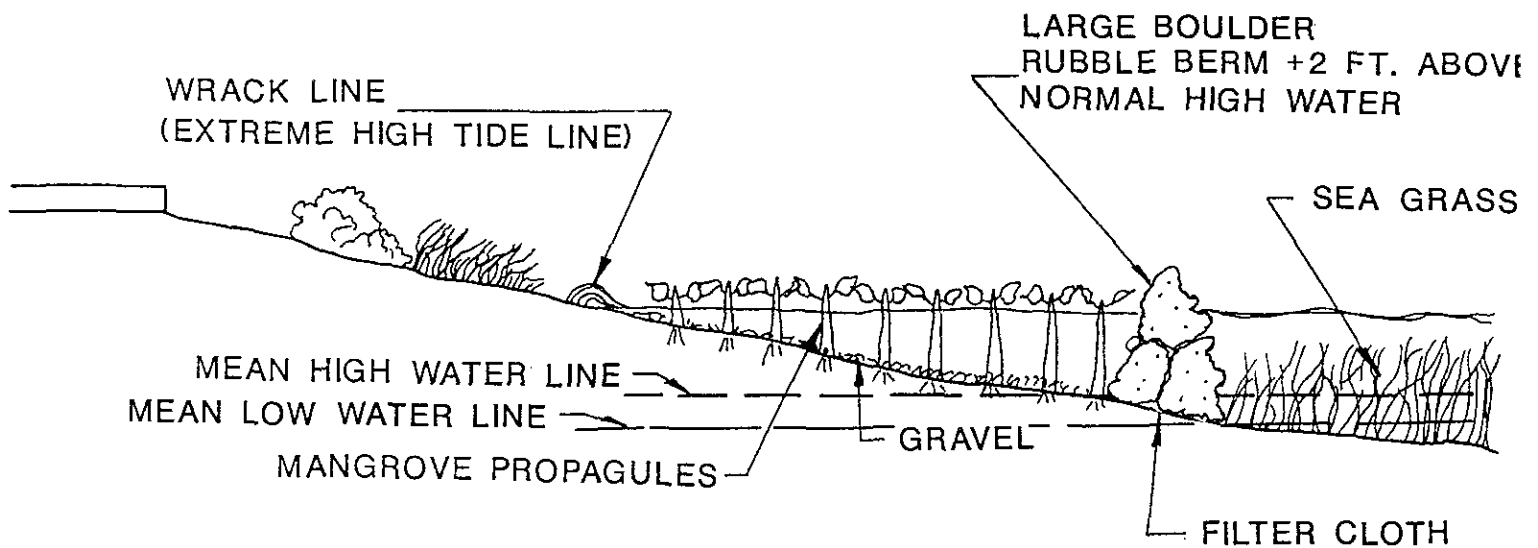
Figure 23. Idealized version of Figure 4 illustrating the best location of toe of slope features and the need to ensure that the rubble berm is large and high enough to reduce wave action during windstorms and periods of high water.

2. Design riprap barrier size and placement to projected an intertidal zone where recovery of a mangrove fringe is desired (Figure 23). If possible, encroachment into offshore seagrasses should be minimized while still allowing establishment of a stable intertidal zone capable of sustaining a mangrove fringe. The width of this intertidal zone is a function of the design slope which usually reflects the degree of encroachment permitted into roadside wetlands or open waters. A gently sloping, protected intertidal zone about 2-3 meters wide is recommended.

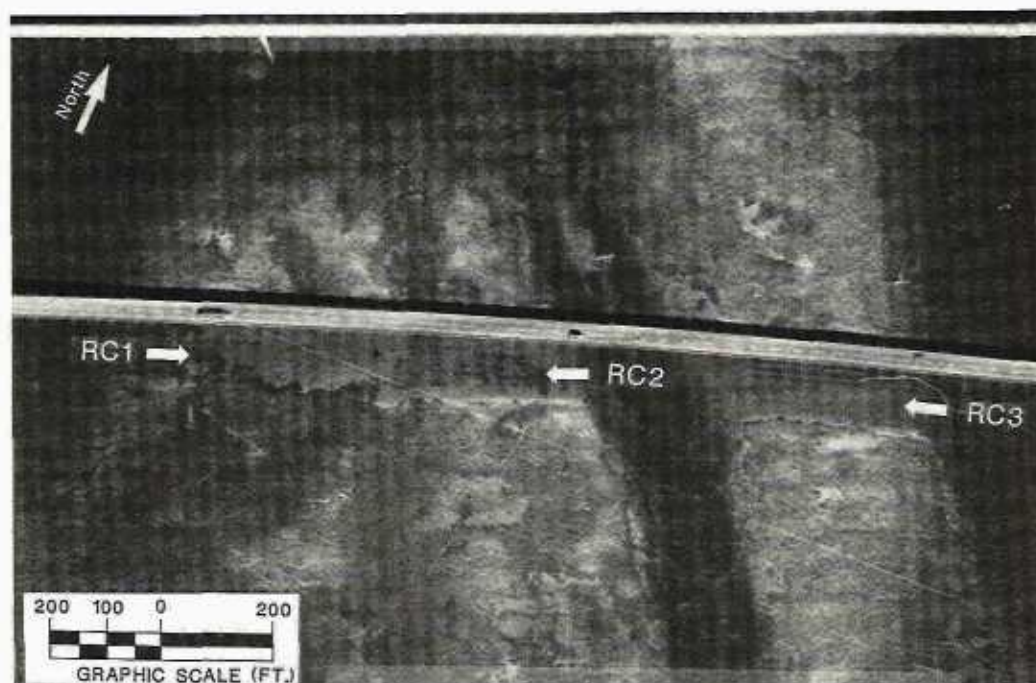
Figure 44. Vertical aerial photograph taken February 12, 1991, showing same area as above. The only significant reclamation of the barge access channel is shown at RC1 and RC2, which were confirmed in the field to be a mixture of *Halodule* and *Thalassia*, and RC3 which was all *Halodule*.

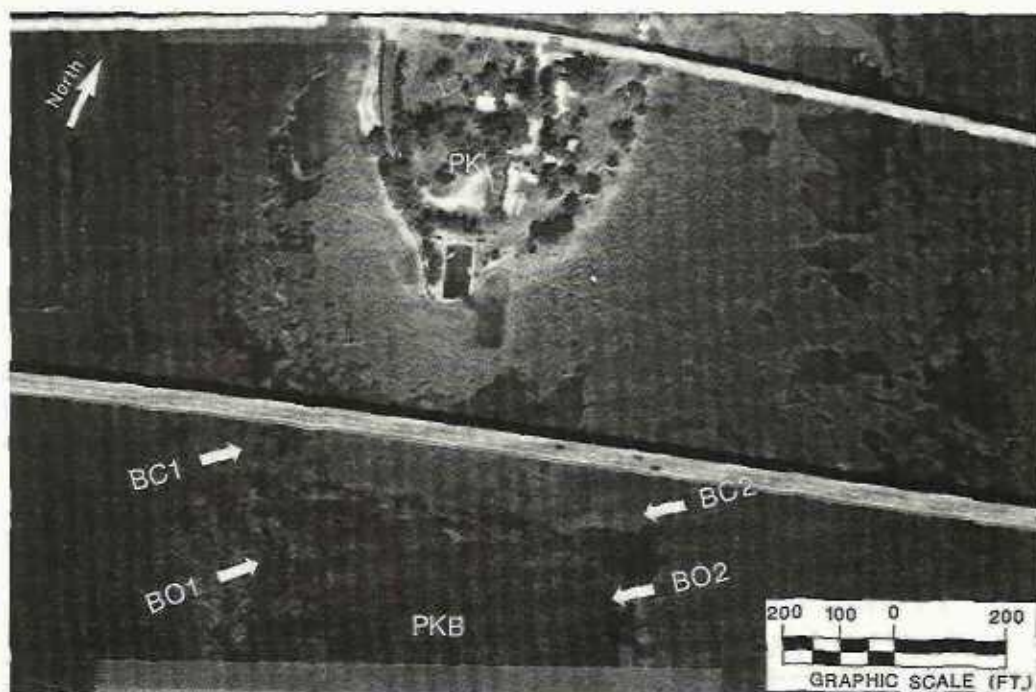
Figure 46. Vertical aerial photograph taken February 12, 1991, of the same area shown above. The new 7-Mile Bridge can be seen in its completed form. The excavated barge access channel is still very evident (BC1-BC2). The two sand blowouts are completely revegetated (BO1 and BO2).

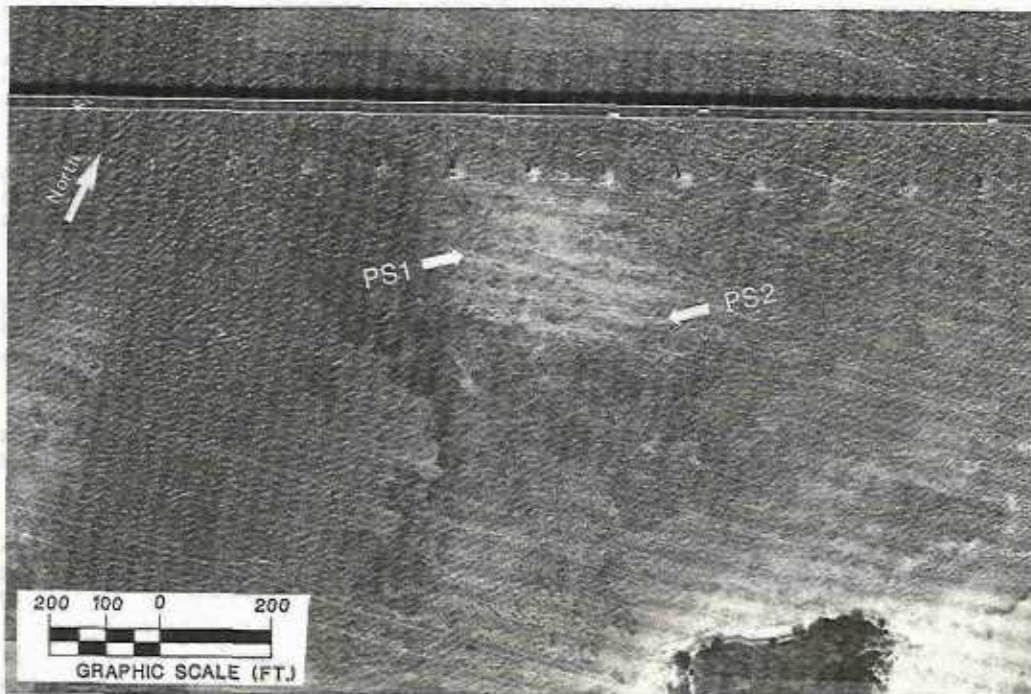
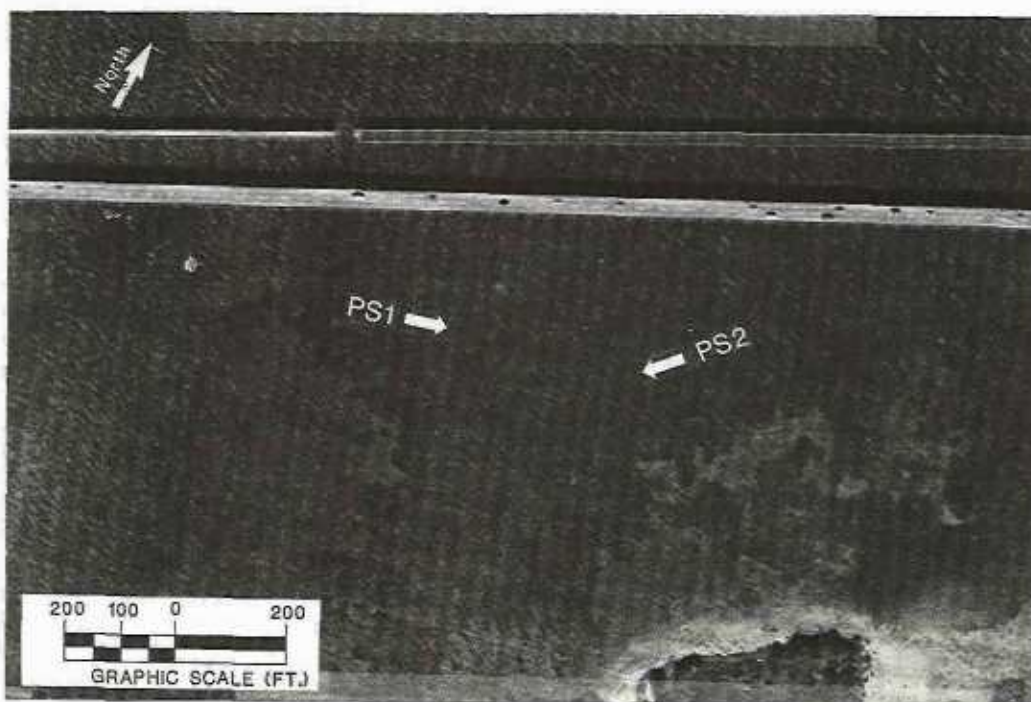
Figure 47. Vertical aerial photograph of the 7-Mile Bridge taken February 25, 1981. A 2.21-acre prop scar area is shown within the arrows (PS1-PS2). This is site B (Figure 42).

Figure 48. Vertical aerial photograph of the same site as above, taken February 12, 1991. The location of the previous prop scar is indicated by PS1-PS2 as above.

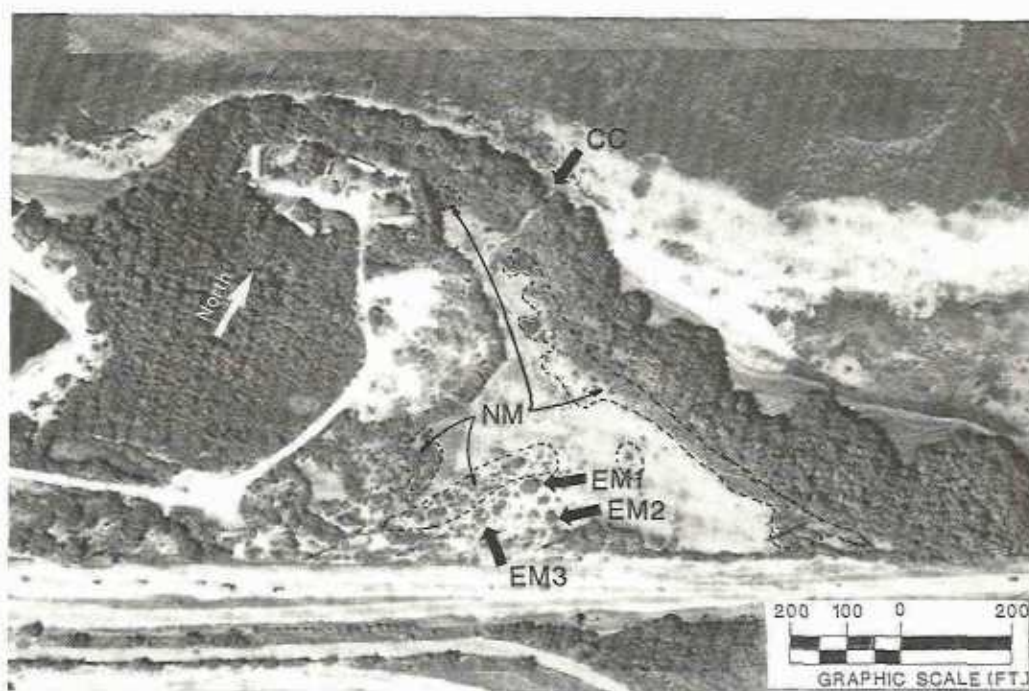
Figure 52. Vertical aerial photograph of Bahia Honda Lagoon taken February 12, 1991. CC indicates the location of the circulation cut made in March 1981. NM and dotted lines indicate the location of areas of natural mangrove recolonization, 1.35 acres (compare with above).

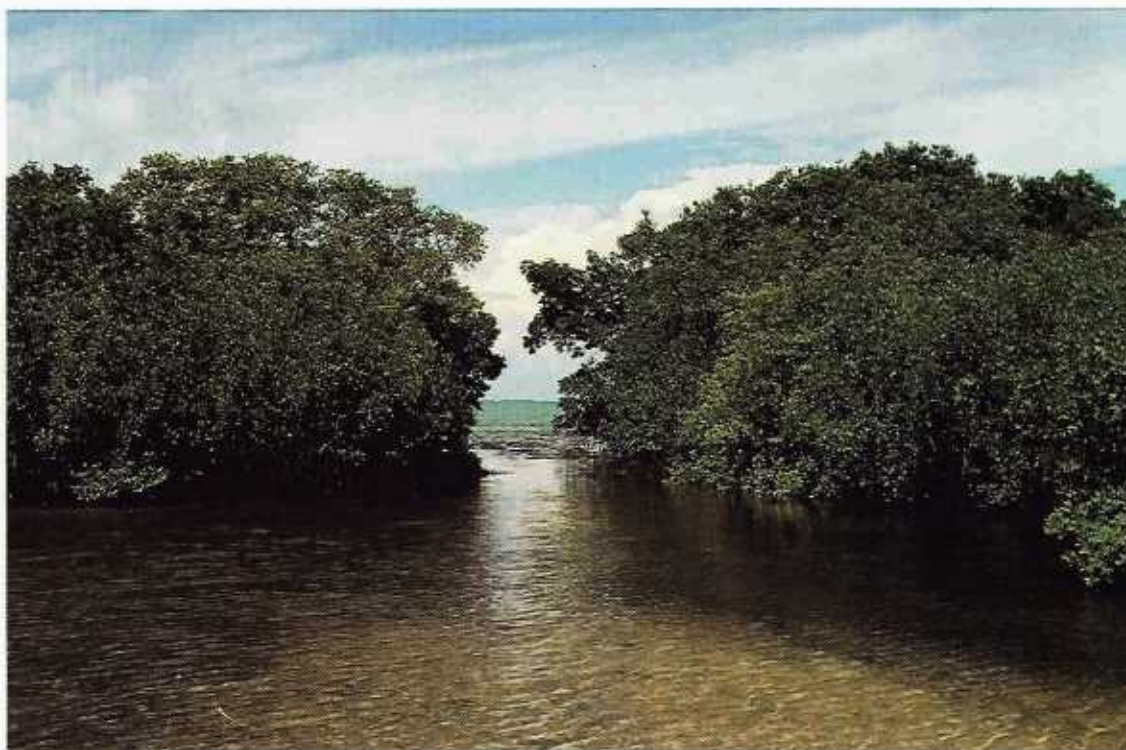
For this study, several site visits were made, including one in July 1993. Figures 56 and 57 show the excavated opening in 1981 and twelve years later. Field measurements compared to Figure 53 indicate that the opening has remained remarkable stable, losing less than 20% of its area in twelve years. Figures 58 and 59 show the significant colonization by and rapid growth (to 3 m tall) of volunteer red mangroves which did not occur inside the lagoon prior to opening (see also Figures 60-61). Numerous fish and wildlife species were observed within the lagoon including reddish egrets, roseate

Figure 57. Bahia Honda Lagoon, circulation cut, 7/93.

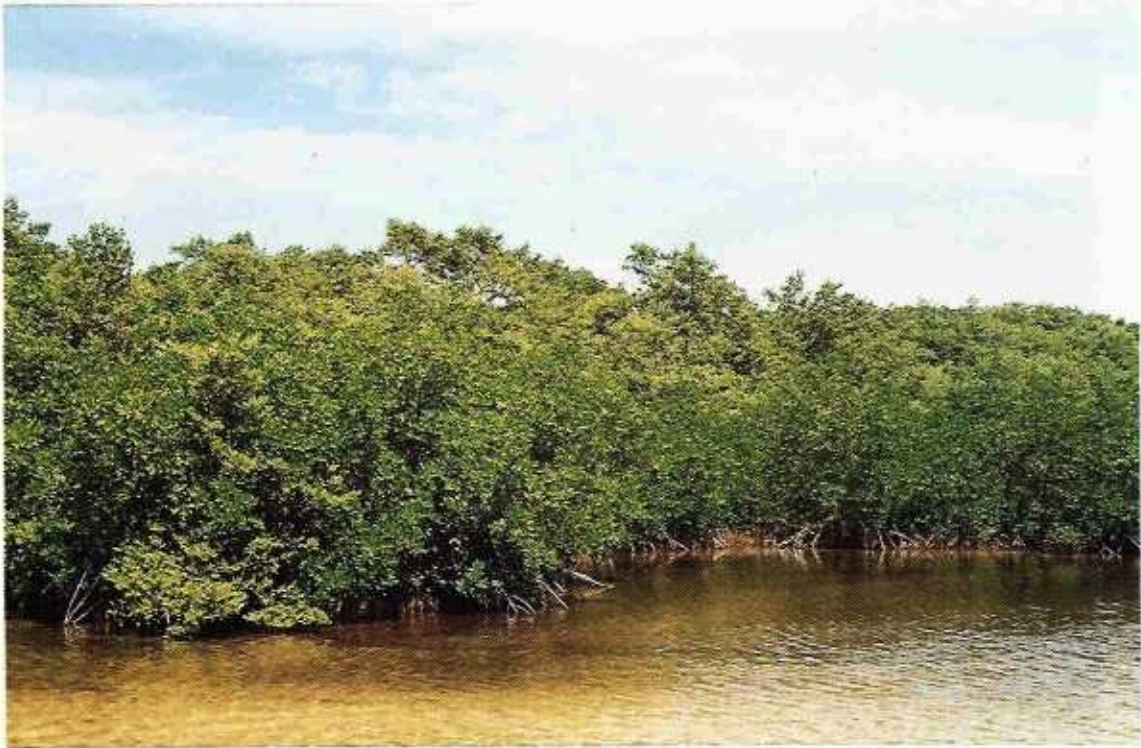
Figure 59. Bahia Honda Lagoon, red mangroves now on inside, 7/93.

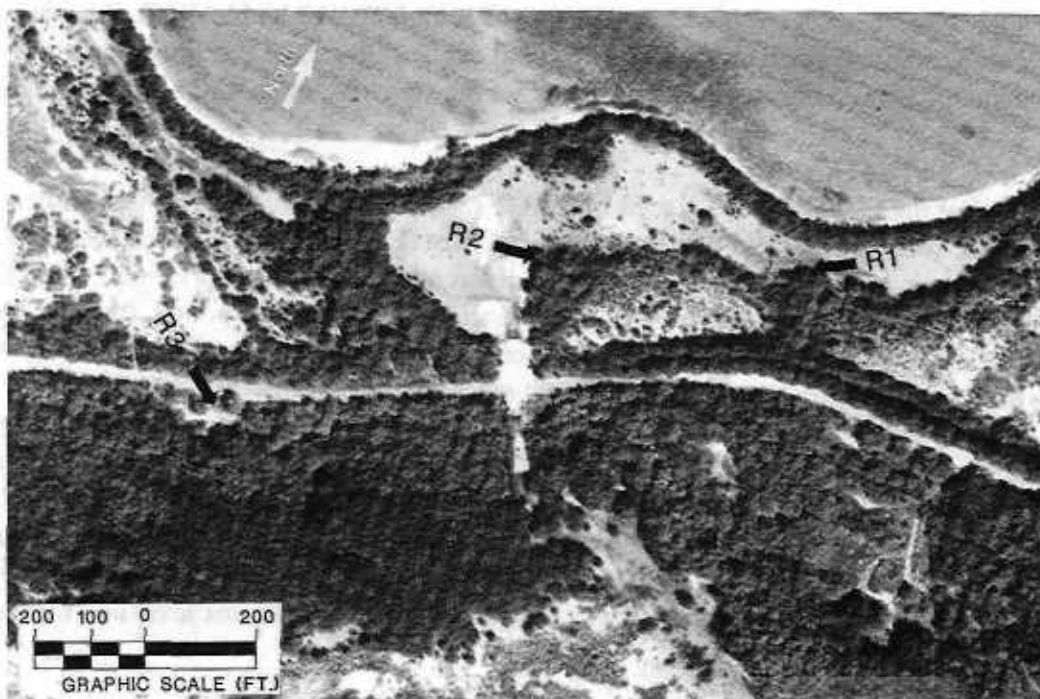
Figure 65. Vertical aerial photograph of the location of culvert C2 (in center) with the same three reference points marked as above. Photographed February 17, 1991.

culvert C-2 where the extent of red mangroves has expanded considerably and now threatens to block the shallow, mostly intertidal, flow-ways to the culvert.
