**Attachment III – Site Photos**  
**Cape Canaveral Energy Center PA 08-53**  
**Storm Surge Mitigation**

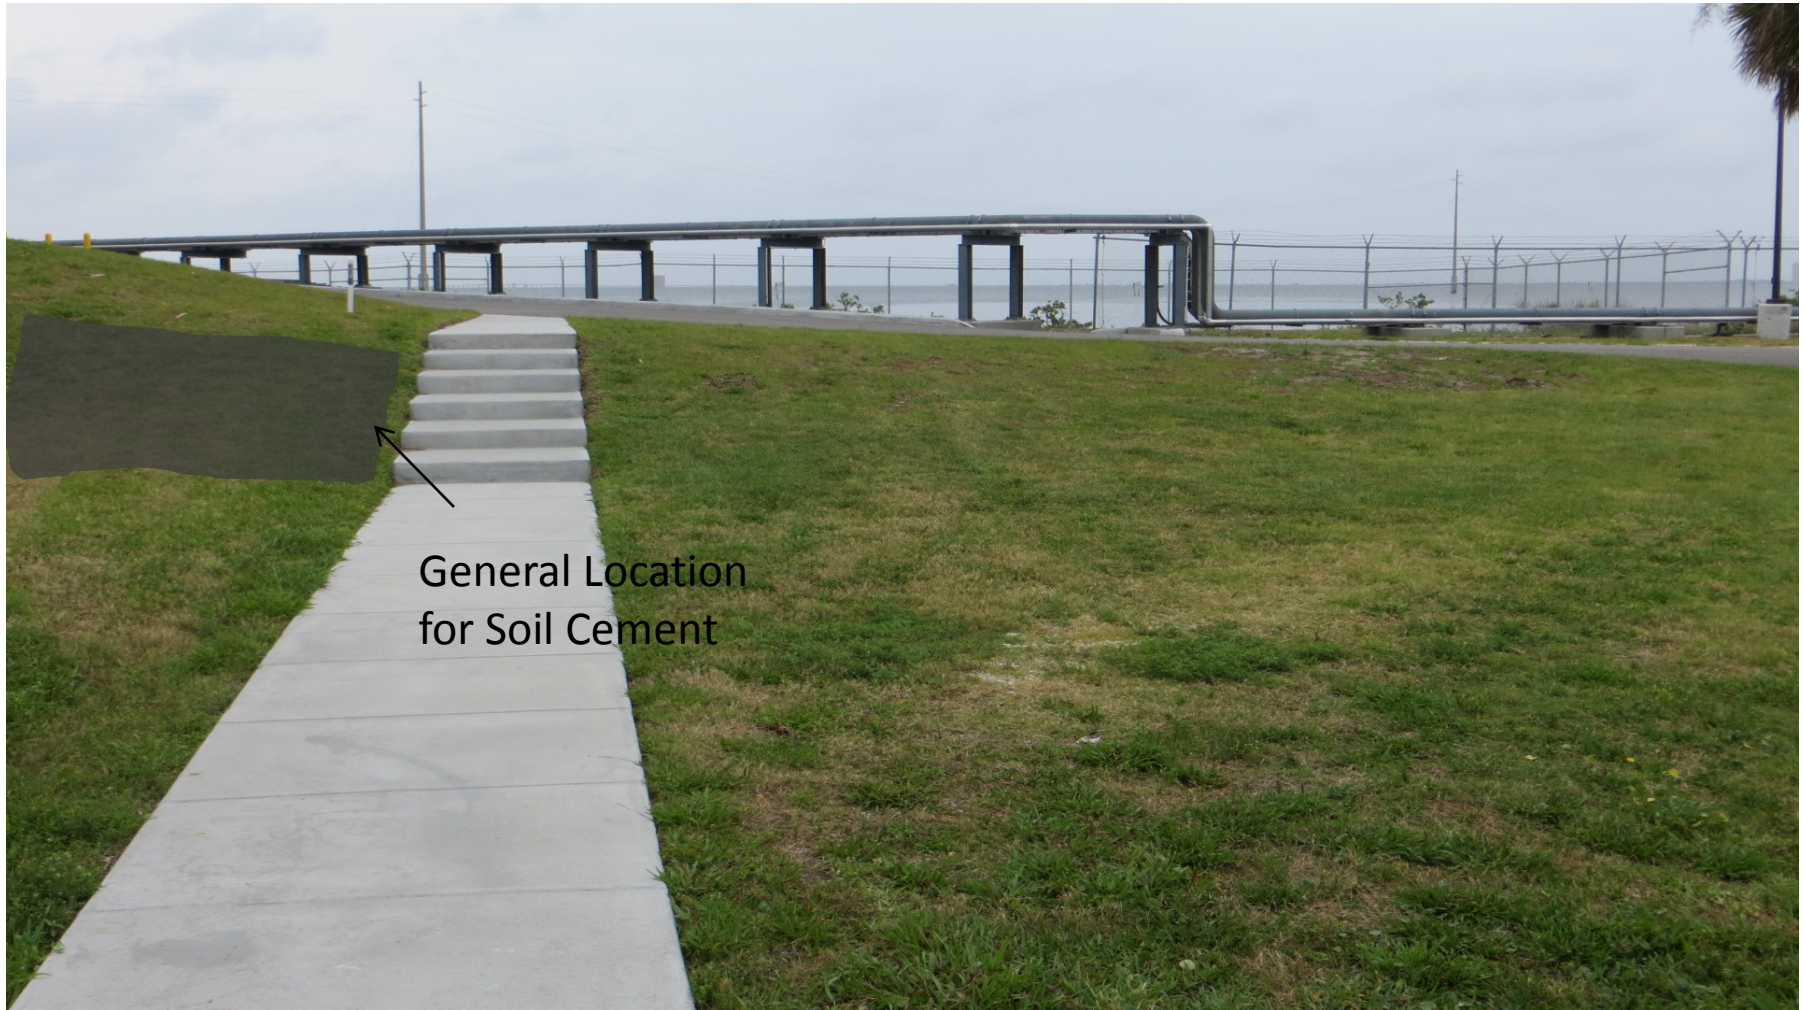
# Photo 4 - Area for Soil Cement Installation (Looking North - East of Pond A )

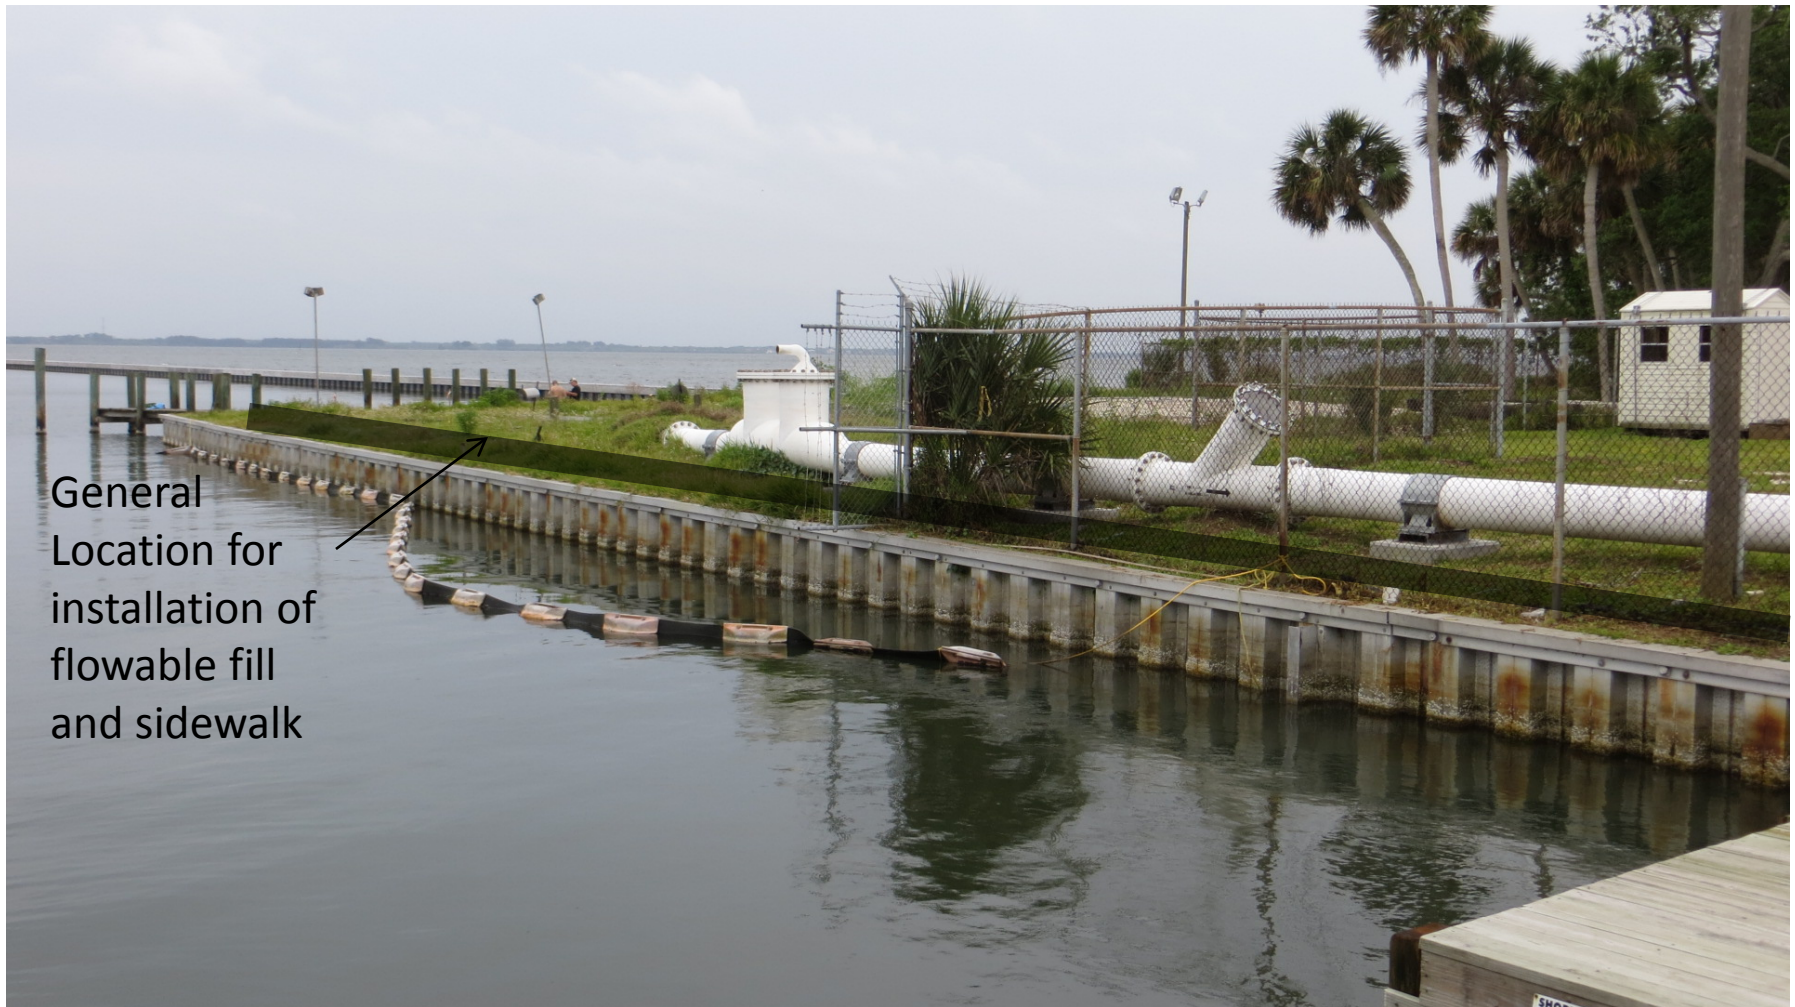
Photo 5 - Flowable Fill Sea Wall Seal with Concrete Sidewalk Area  
(Looking Southeast)
