# Lake Gibson

## LAKE VEGETATION INDEX ASSESSMENT

David Eilers | USF Water Institute | June 17, 2021

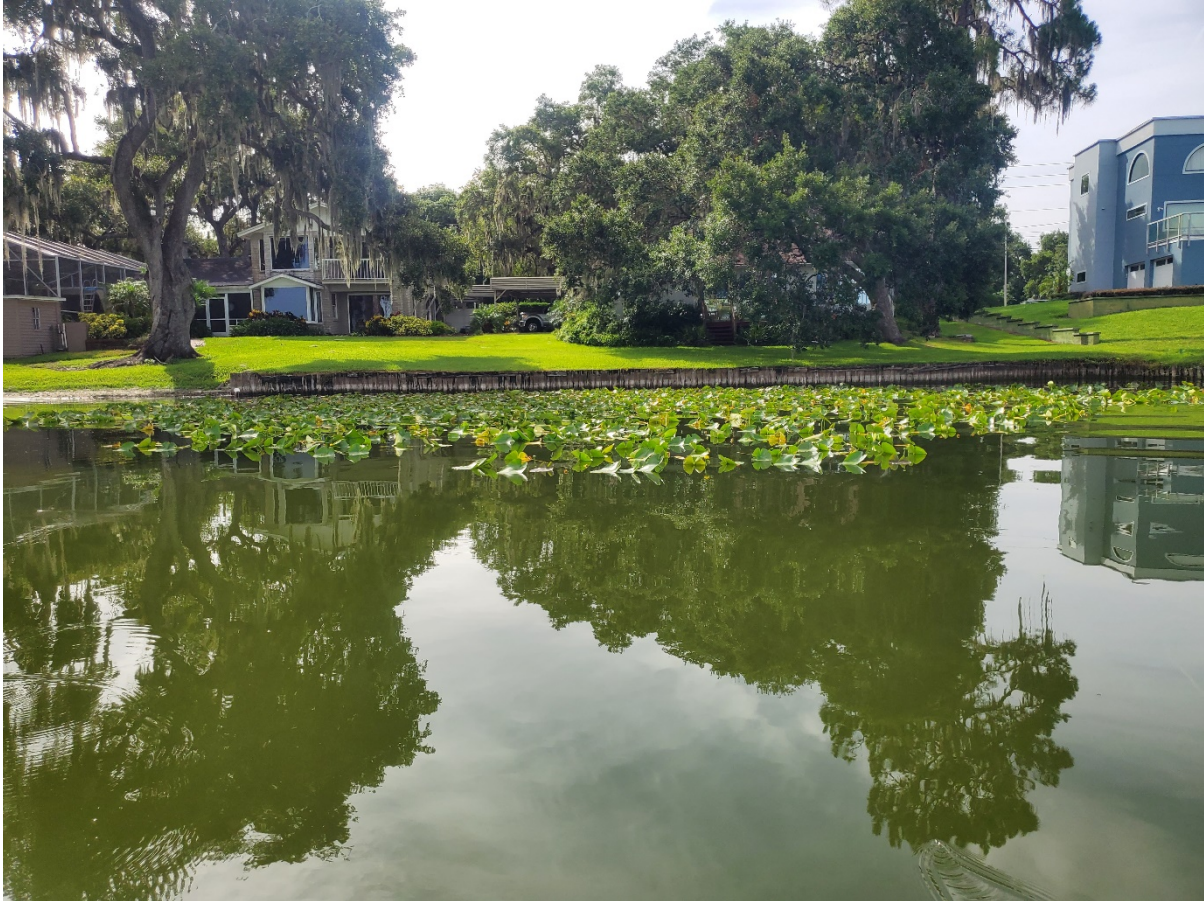
*Figure 2 Overview photograph of the Lake Gibson showing typical shoreline vegetation.*

The lake assessment for the Lake Gibson was conducted on June 17, 2021. The water in Lake Gibson was characterized as turbid and green. The secchi disk depth was 0.46 meters (1.5 feet). The vegetation quality of the plants in Lake Gibson are predominantly native species (69.4%) with moderate growths of non-native nuisance species such as *Urochloa mutica* and *Panicum repens*. Some direct inputs of stormwater were noted through pipes to the lake but the majority of stormwater reaches the lake through sheet flow off residential lawns. The bottom substrate quality was dominated by sand with some accumulation of muck and coarse particulate organic matter.

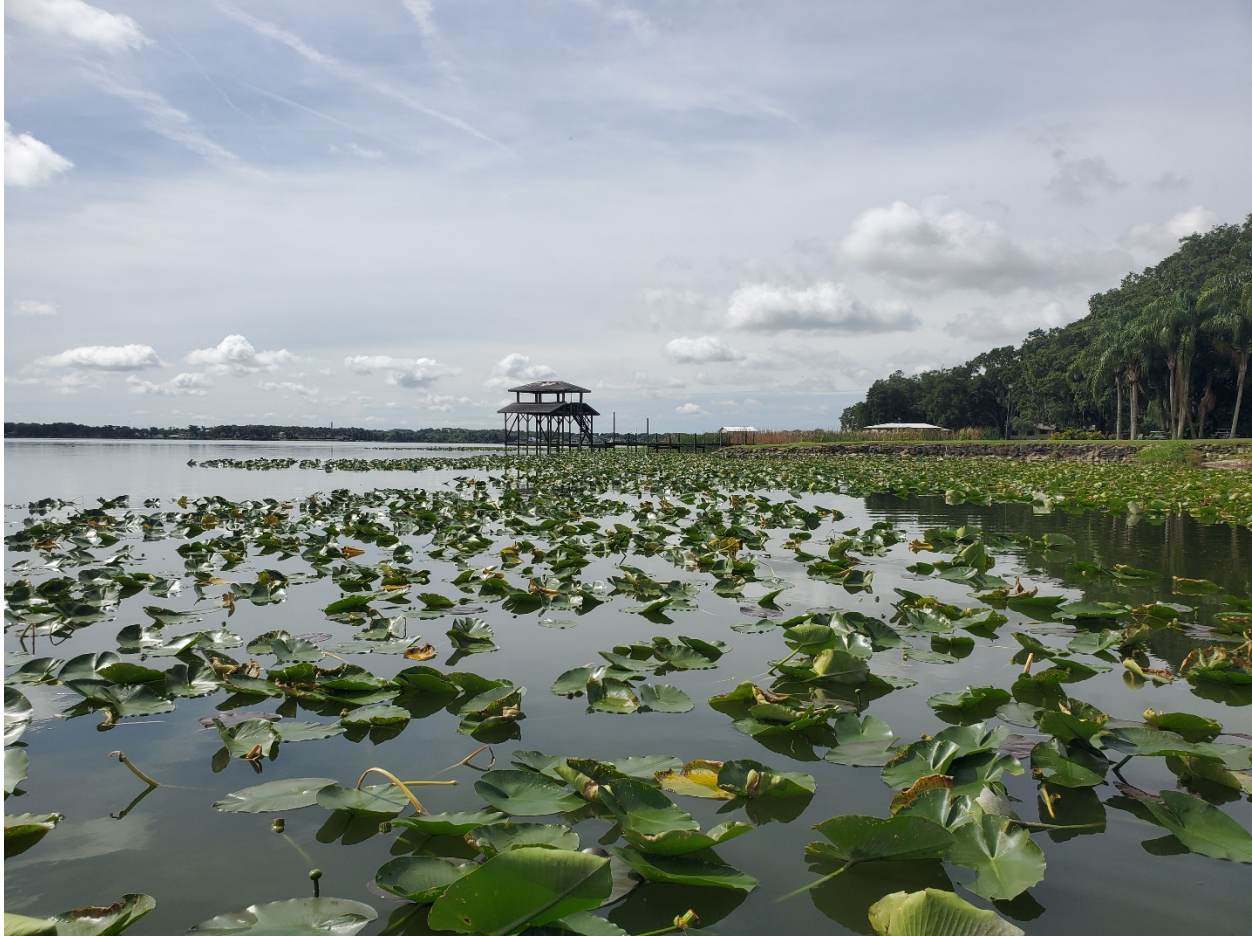
Figure 3 *Nuphar* was a dominant species along the shorelines of Lake Gibson.

The Lake Vegetation Index identified 36 species of wetland vegetation growing in the four selected sections along Lake Gibson. The majority of these species (27) are native species. The remaining 9 species (*Panicum repens*, *Alternanthera philoxeroides*, *Urochloa mutica*, *Colocasia esculenta*, *Sphagneticola trilobata*, *Schinus terebinthifolius*, *Eichhornia crassipes*, *Sapium sebiferum* and *Ludwigia peruviana*) are non-native and invasive to this region. The emergent vegetation community along Lake Gibson is limited by the large amount of seawall along the shoreline. *Panicum repens*, *Urochloa mutica* and *Typha* were common in areas where seawalls were absent. The floating leaved vegetation community in Lake Gibson was dominated by *Nuphar*. *Nuphar* was dominant or co-dominant in all four sections of the LVI. Submerged aquatic vegetation was present in Lake Gibson, but growth was limited by the low light penetration in the water column. The only species of submerged vegetation was *Vallisneria spiralis*.
