# CITY OF LAKELAND WATER QUALITY MANAGEMENT PLAN

Prepared for:

City of Lakeland  
407 Fairway Avenue  
Lakeland, FL 33801

October 2019

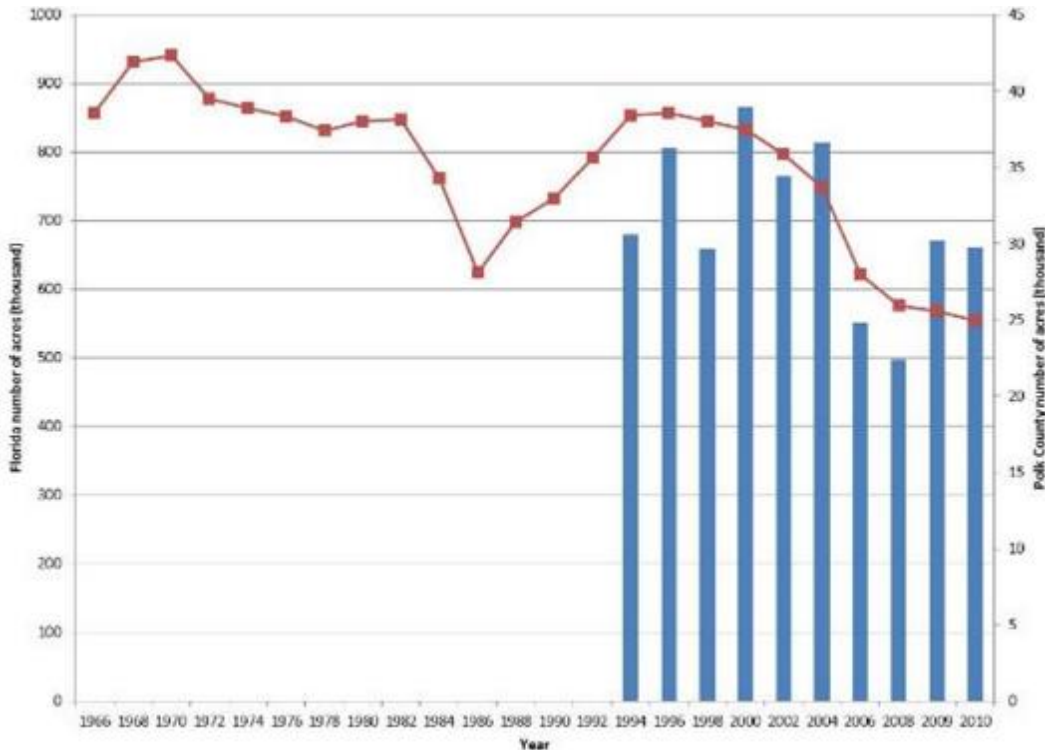
**Figure 3-2. Florida (red line) and Polk County (blue bars) citrus acreage decline from 1966 to 2010 (data taken from Florida Department of Citrus 2011 and NASS 2015)**

A reduction in citrus-related agriculture is widespread throughout Florida. Due to a combination of land development (commercial or residential), citrus canker and citrus-greening, citrus acreage has declined since the 1960’s (Figure 3-2). State-wide, citrus was at the peak of production in the late 1960’s, followed by declines in the 1980s perhaps precipitated by hard freezes in 1983 and 1985, followed by slight increases during the 1990s, and then a more recent reduction perhaps associated with citrus greening. The Florida citrus production is estimated to remain constant or decline over the next ten years (Florida Department of Citrus 2011).

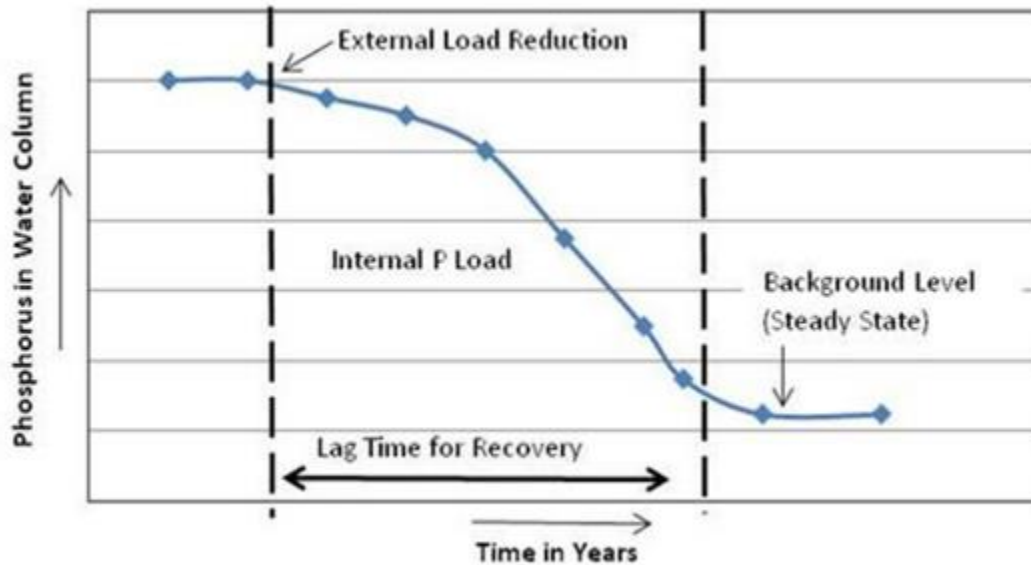
**Figure 3-3. Influence of reduced external phosphorus reductions on phosphorus in water column (after Reddy et al. 1999)**

Phosphorus inputs into lakes include external sources from the watershed and internal sources from the lake sediments. Phosphorus flux from sediments is sometimes sufficient to maintain anthropogenic eutrophication of a lake even when external phosphorus loads have been reduced or eliminated (Larsen et al. 1979, Ryding 1981). Consequently, after watershed management strategies reduce external phosphorus flux (e.g. stormwater treatment), recovery to a steady state (no net efflux of phosphorus from sediments into the water column) can be delayed many years if

mechanisms controlling internal phosphorus flux due to sediments are not included in restoration plans (Haggard et al. 2005, van Hullebusch et al. 2005) (Figure 3-3).

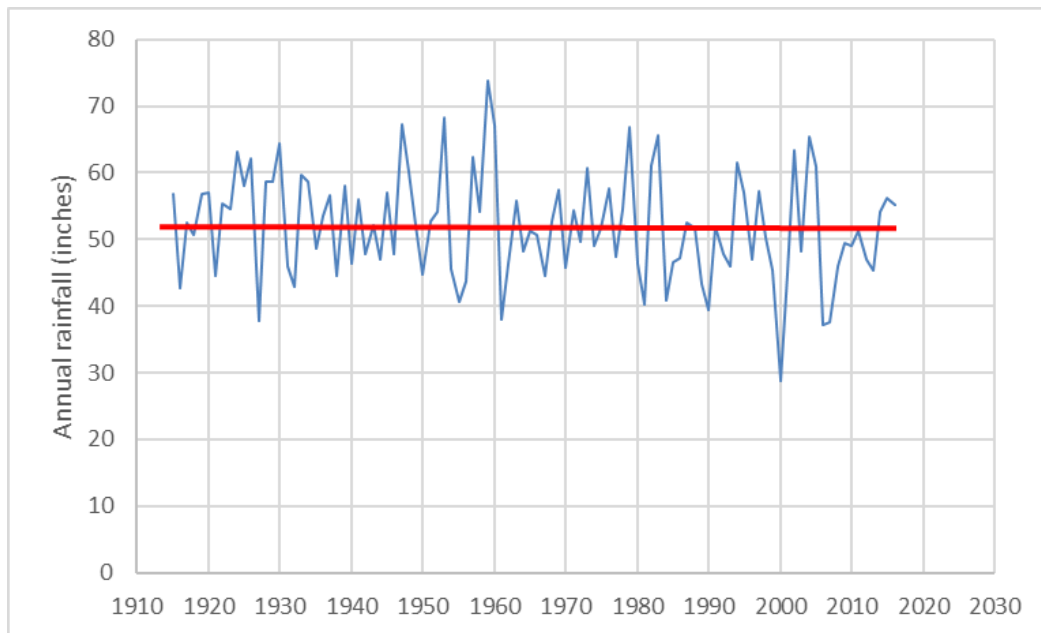
**Figure 3-4. Mean annual rainfall for Polk County for 1915 to 2016 (data from SWFWMD). Red line equals average value of 52.01 inches.**

The POR trend in annual rainfall is shown in Figure 3-4. In addition, the shorter timeline of 1980 to 2015 was examined for annual, total wet season, and total dry season rainfall, as shown in Figures 3-5, 3-6 and 3-7, respectively.

Comparing the period of record (1915 to 2016) to the more recent period of 1980 to 2016, it appears that there has been slightly less rainfall over the past 36 years than the long-term average. Over the period of record, annual rainfall averaged 52.01 inches, while the average from 1980 to 2016 is 50.07, a value 3.7 percent lower.

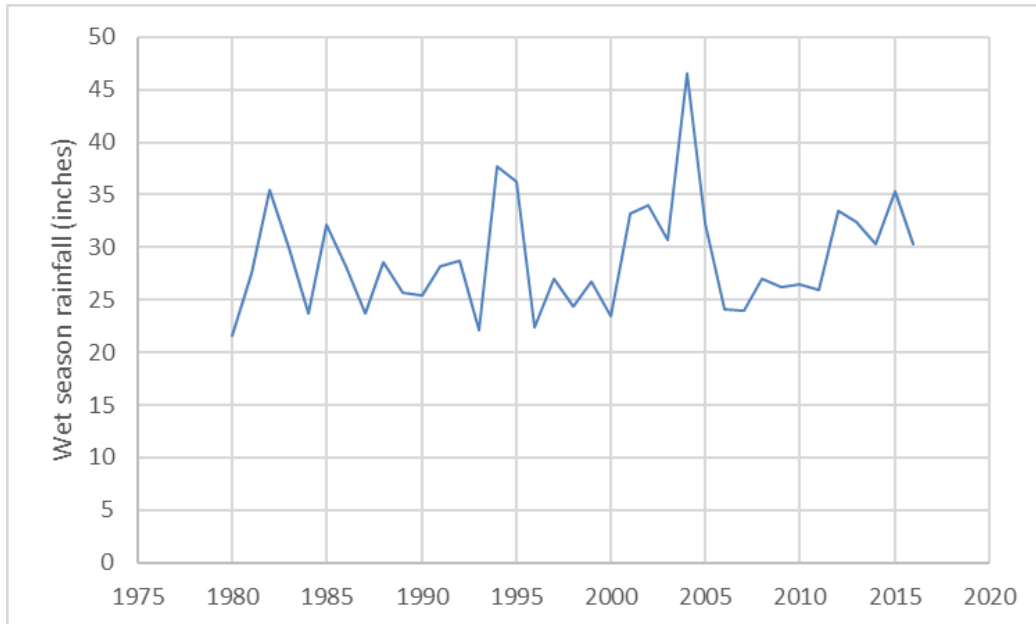
**Figure 3-6. Mean wet season rainfall for Polk County for 1980 to 2015 (data from SWFWMD)**

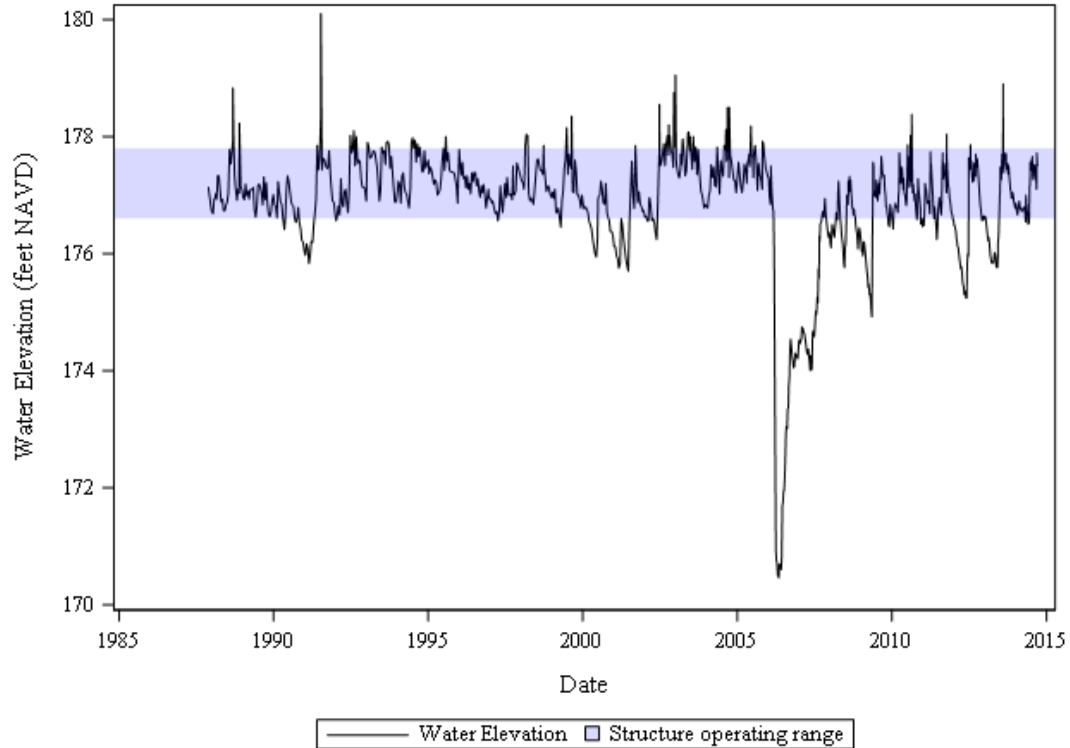
**Figure 3-12. Period of Record water elevation for Lake Morton (data from SWFWMD)**

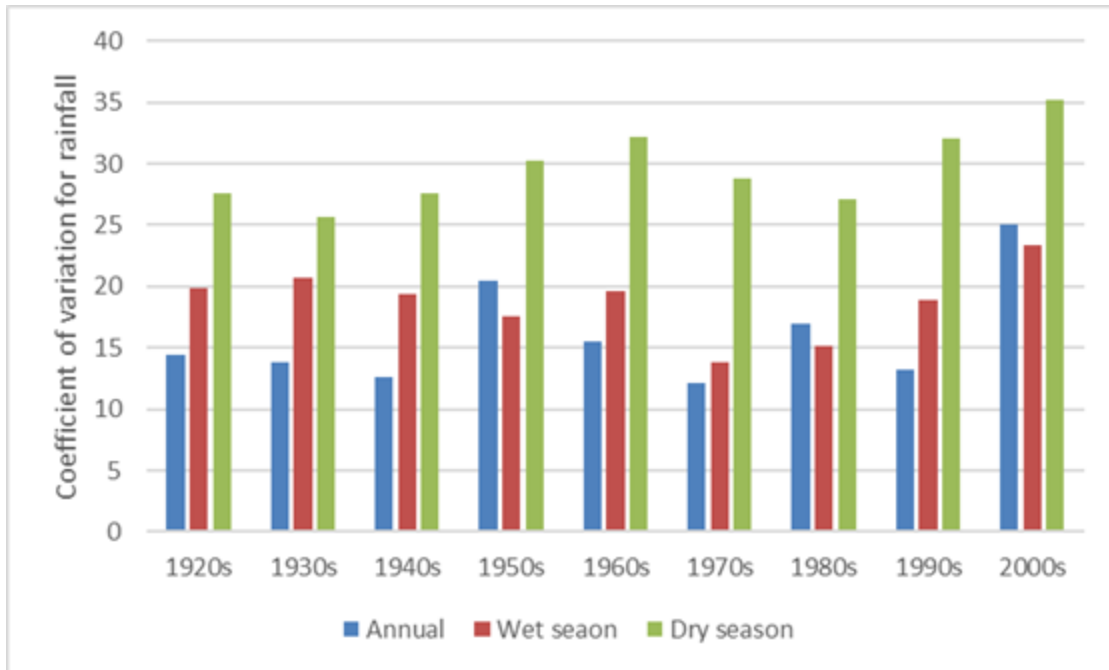
**Figure 3-13. Coefficient of variation for rainfall by decade for Polk County**

Across all decades, the variability in rainfall is always greater in the dry season than in both the wet season or annual rainfall. This might reflect the fact that the main cause of rainfall in the dry season, the passage of cold fronts, might be less predictable than the main cause of wet season rainfall, the typical convective storms associated with differential heating of Florida’s landmass vs surrounding coastal waters. Across all groupings – annual, wet season and dry season - the decade of the 2000s exhibits the greatest variability in rainfall of any the nine decades examined. It would seem that for the City, situated as it is in Polk County, there isn’t a trend of more or less rainfall over time (for annual, wet or dry seasons). But, rainfall appears to be more variable now than at any time over the last 90 years. This poses particular challenges for both water managers and lake managers.

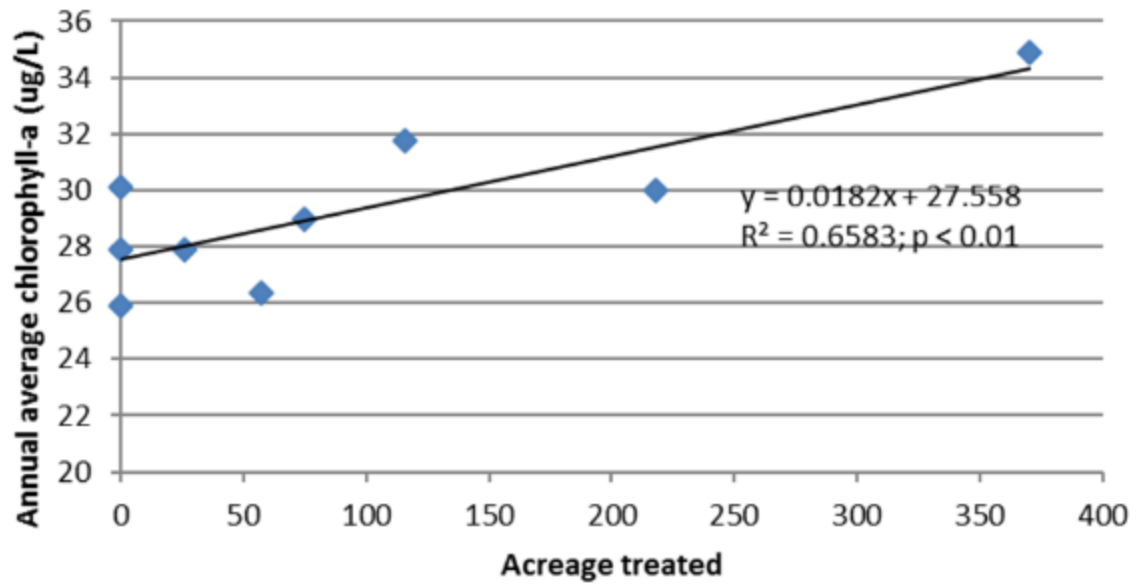
**Figure 3-14. Annual Average chlorophyll-a Concentrations vs. Acreage of Hydrilla Treated in the Same Year. Data from Lake Tarpon from 1993 to 2014**

Should PVI be similarly important for Lakes Beulah, Mirror, Morton and Wire as was found by Moreno (2010) then target values for SAV could be developed based on empirically-derived relationships between PVI and water quality parameters. This could give rise to guidance related to the establishment of native SAV populations. If sufficient data exist from applicable aquatic vegetation control efforts, it may be possible to find out if there is an inverse relationship within a given lake between Hydrilla eradication via chemical treatment and subsequent levels of chlorophyll-a, as was found in Lake Tarpon (Figure 3-14). If a positive correlation between Hydrilla eradication efforts and levels of chlorophyll-a occur in Lakeland’s lakes as well, then guidance criteria could be developed in terms of maximum acreages to be treated via herbicide application efforts.

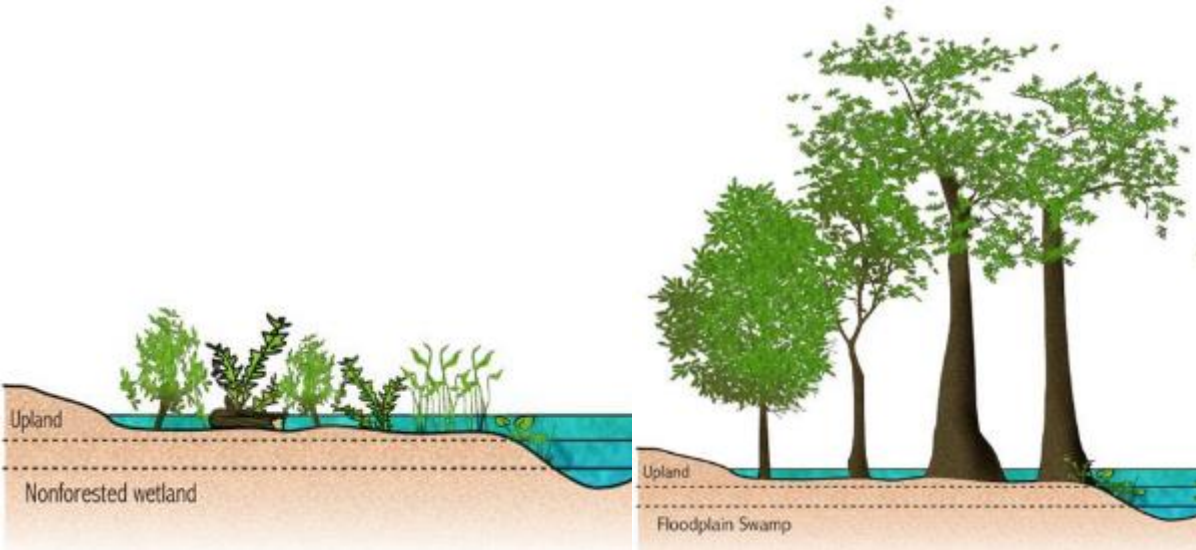
**Figure 4-2. Conceptual diagram of EAV and SAV (left) and forested (right) wetlands lake restoration projects**

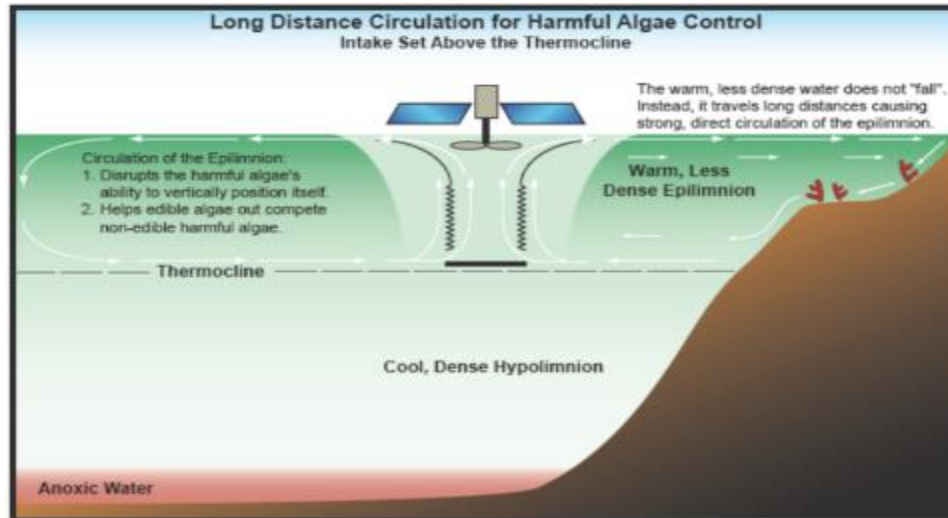
**Figure 4-4. Schematic of proposed artificial circulation system using SolarBee system**

evaluate the efficacy of incorporating bacteria inoculation (e.g., bio-block) in concert with artificial circulation to reduce sediment nutrient loading.

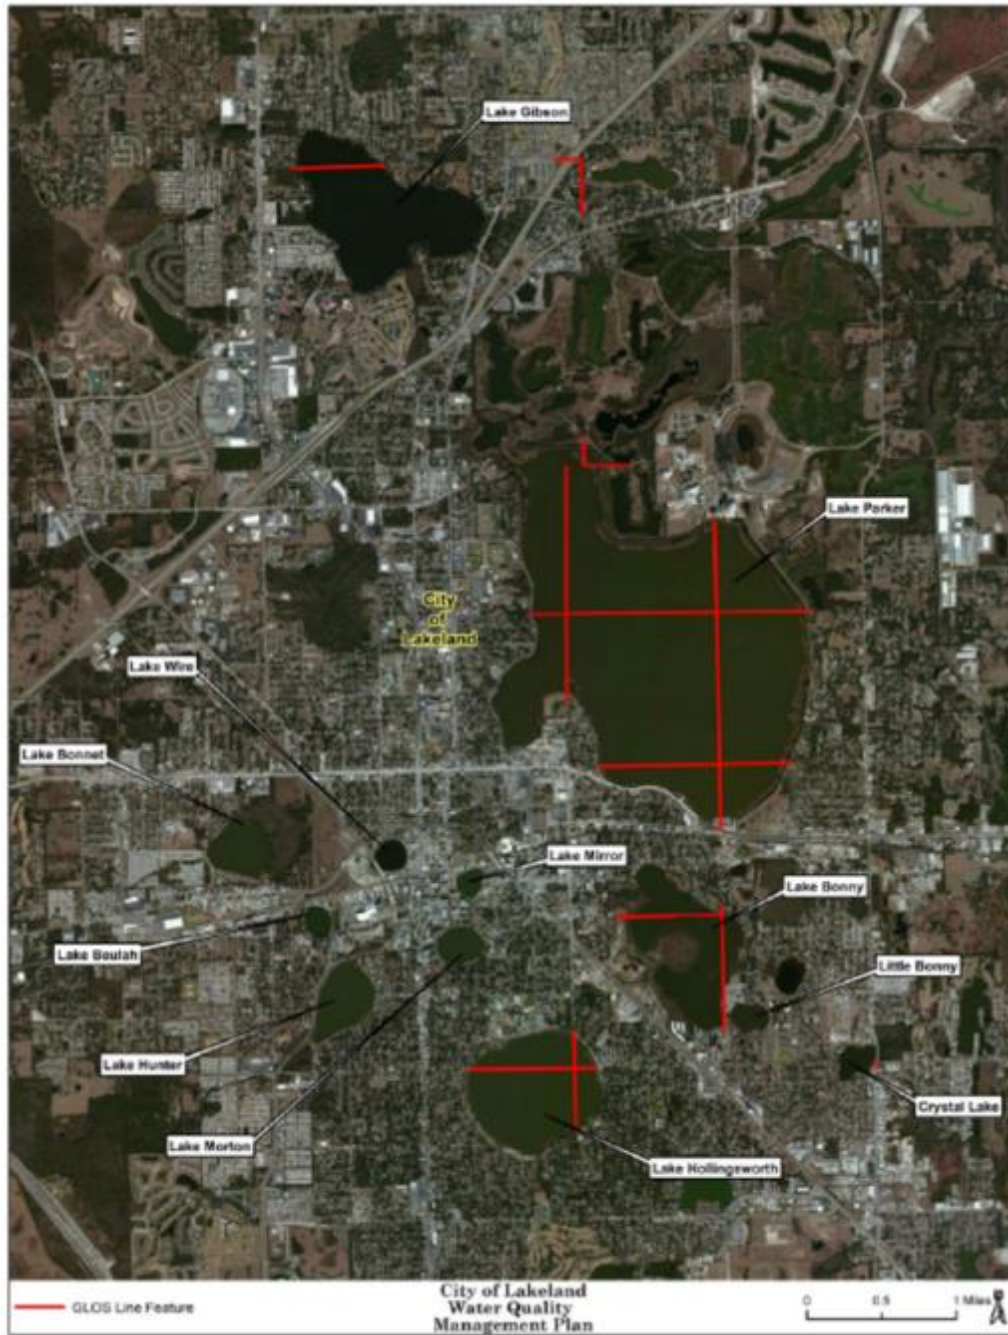
Figure 5-4. GLOS Data Points Used in Analysis of the City's Priority Lakes

Existing lake edges were established by referencing SWFWMD 2011 land use data and 2014 aerial photographs. Figure 5-4 shows the GLOS line features used on a current aerial photograph. Table 5-1 lists the historical and current elevation from the GLOS line features.

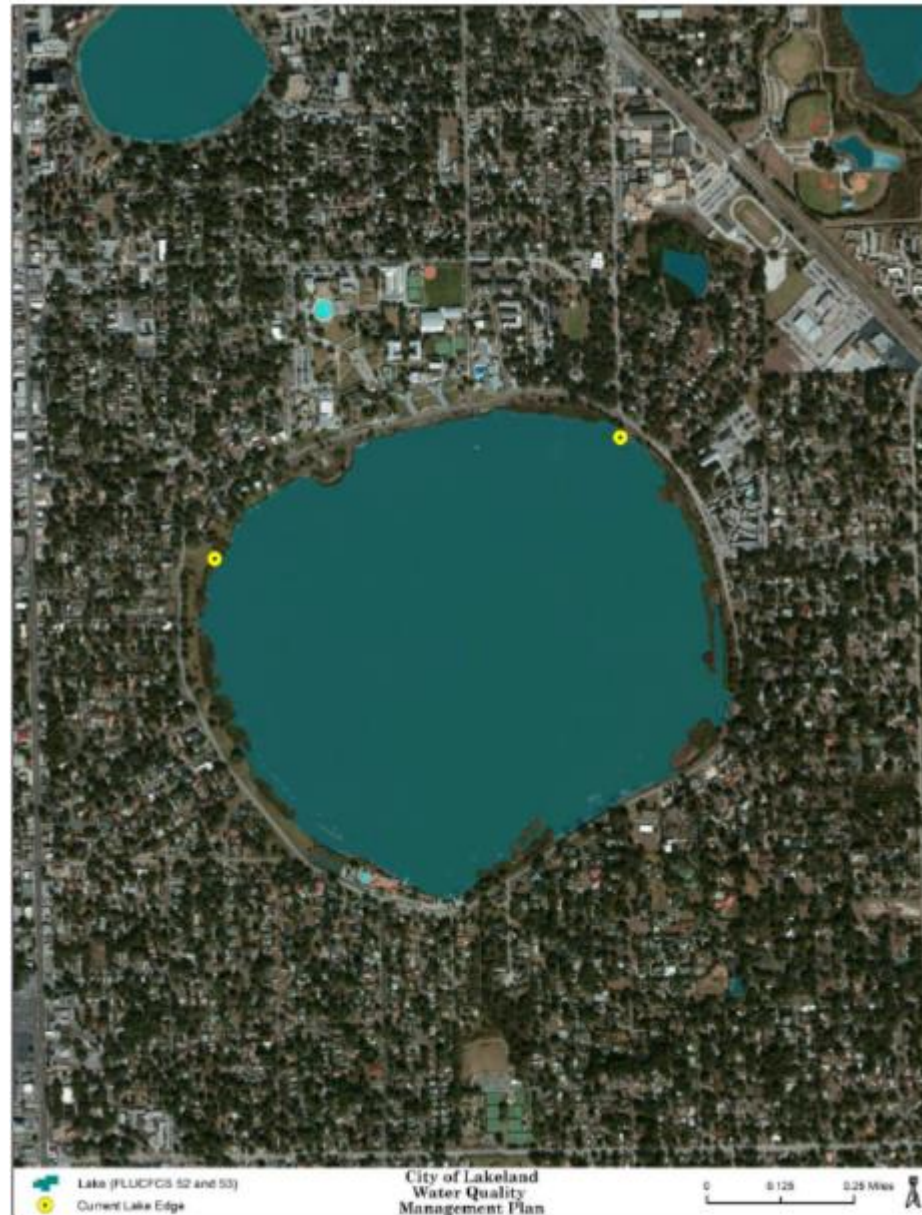
**Figure 5-6. Lake Hollingsworth Current Lake Edge**

GLOS line features were found around five of the lakes. In addition, elevation information for one lake not in the City but in the general area was included. Figures 5-5 and 5-6 display the data points indicating the historical and current lake edge around Lake Hollingsworth, respectively.

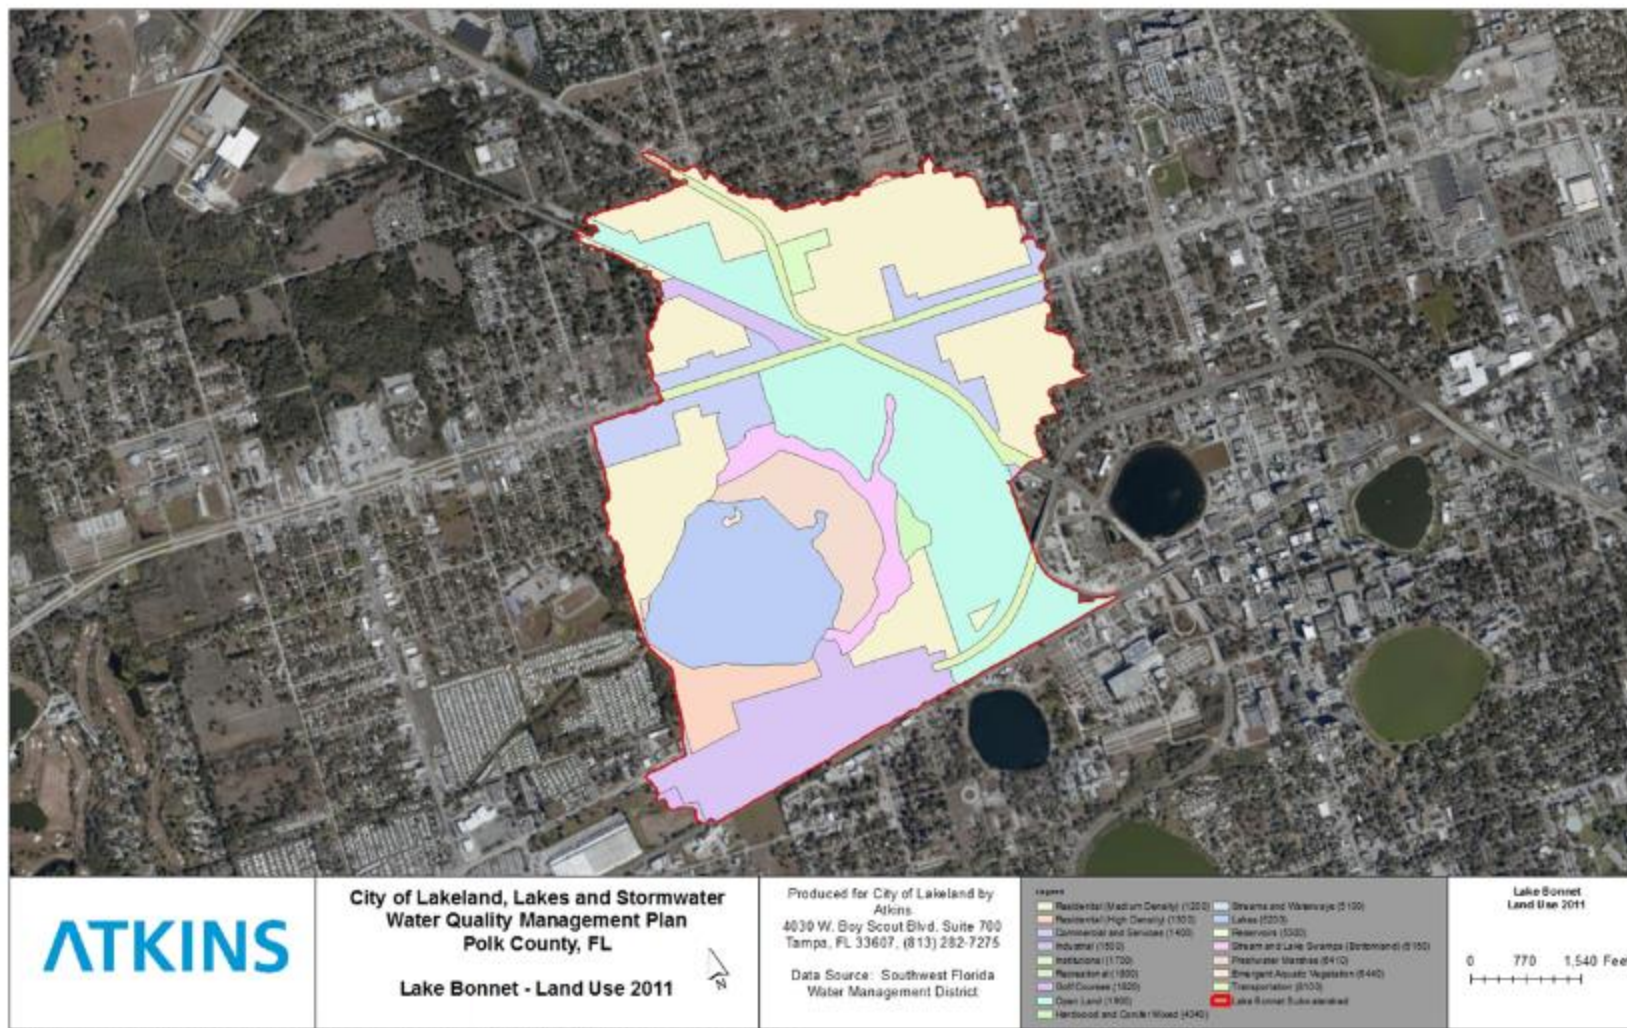
**Figure 6-18. Lake Bonnet 2011 land use map**

A review of historical aerial photography (from 1941) indicates the open water portion of the lake expanded substantially compared to recent photography (2016). In 1941, citrus agriculture is apparent along the northeastern wetland portion of Lake Bonnet and areas to the south were cleared for development. By 1958, a majority of the land south of Lake Bonnet was improved and the construction of the Brunnell Parkway created a dam effect resulting in increased water storage within the lake itself (Figure 6-17). In 1968, residential development was present along the northwest border of the lake and citrus agriculture continued to the northeast (Figure 6-17). The extensive development within the watershed is reflected in the land use/land cover data provided by both USGS and SWFWMD (Table 6-6). Specifically, the SWFWMD land use data from 2011 classifies 451 acres (58%) as developed lands compared to 327 acres (42%) of undeveloped land (Figure 6-18).

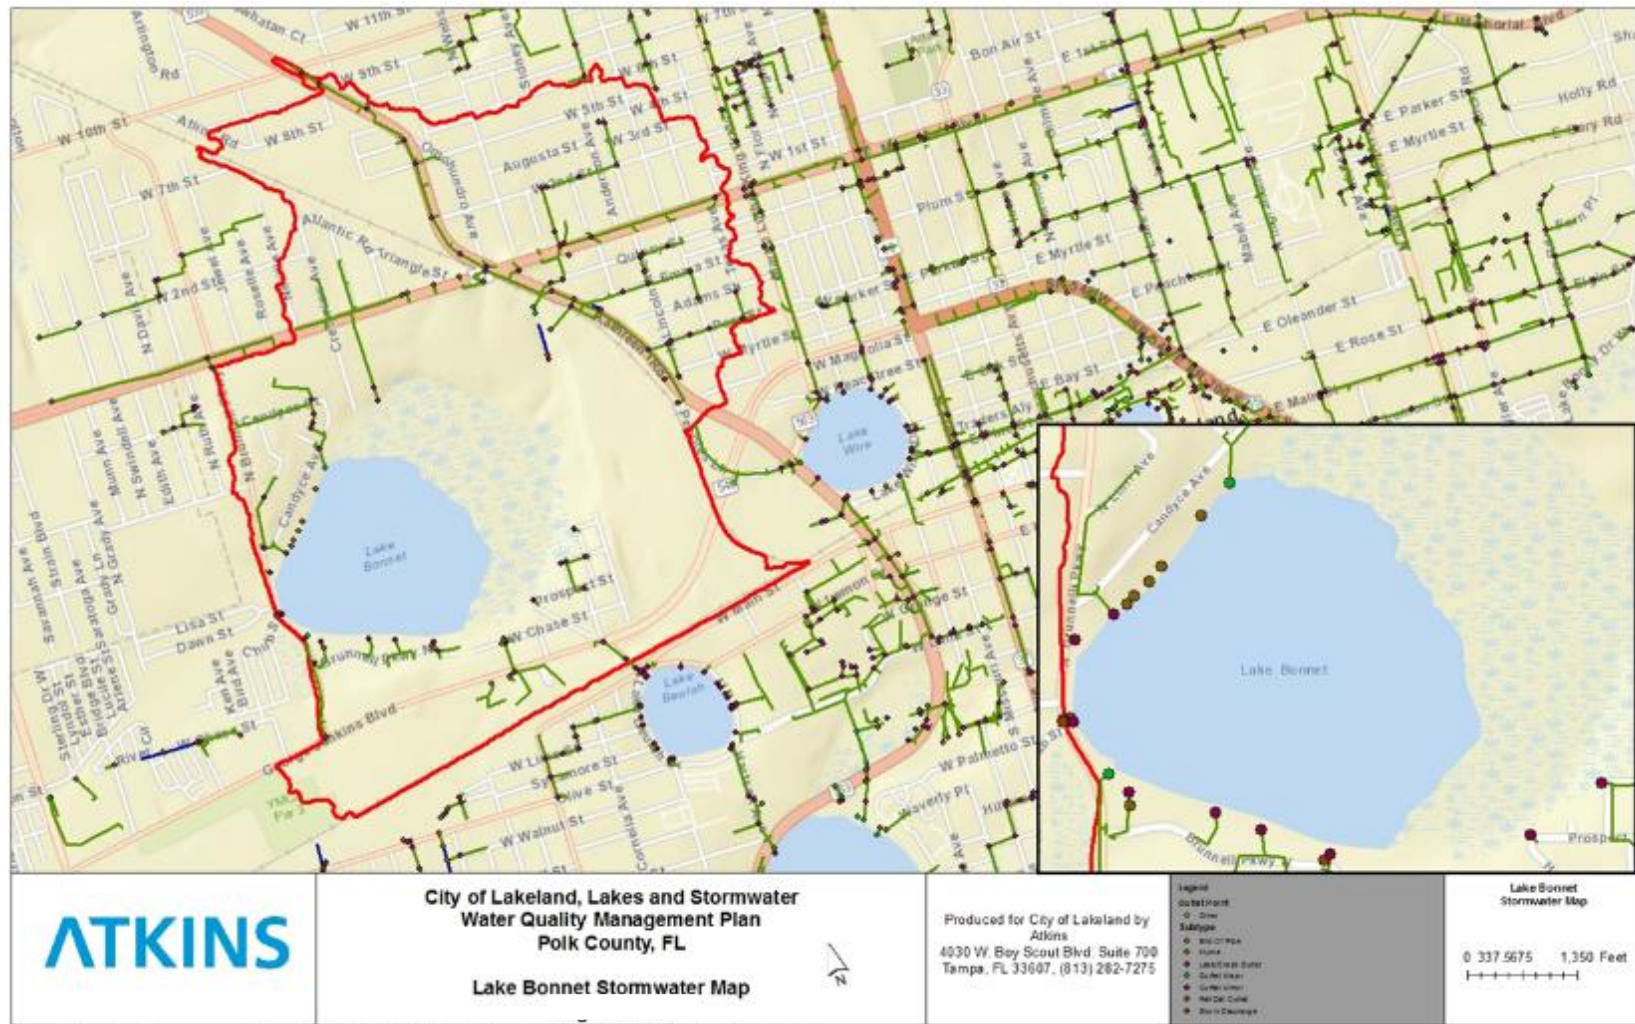
Figure 6-19. Lake Bonnet stormwater map

There are 44 stormwater inputs that discharge to Lake Bonnet watershed, including 12 minor outfalls, four retention/detention outfalls, six stormwater discharges, 17 end of pipe inputs, and five major outfalls (Figure 6-19). In regards to infrastructure, the majority of the existing residential developments within the watershed utilize sanitary sewer for wastewater treatment provided by the City (City of Lakeland 2010). Ten OSTDS construction permits were identified within the Lake Bonnet watershed (Figure 6-20). Based on a review of SWFWMD soil survey geographic data, soils within the watershed have a low runoff potential with high, moderate, and low infiltration rates and are classified either as hydrologic soil group A (39 acres), B (115 acres), B/D (84 acres) or C (400 acres), respectively (Figure 6-21).

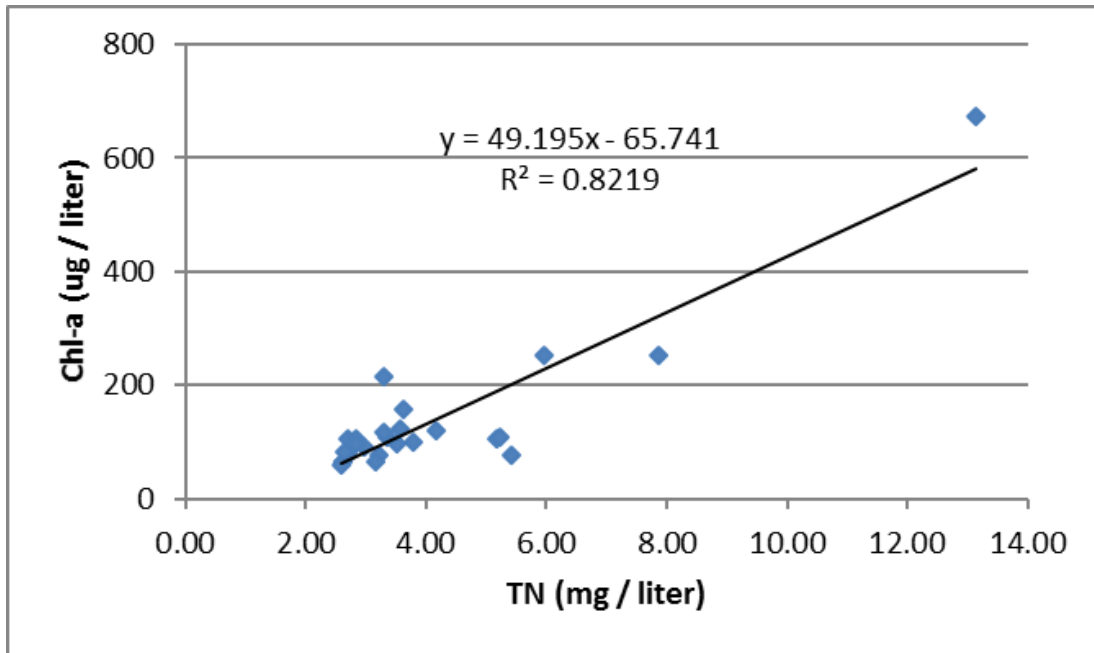
**Figure 6-22. Relationship between TN and chlorophyll-a. Line is best fit equation of statistically significant ( $p < 0.05$ ) relationship**

Positive relationships were found between both TN and chlorophyll-a (Figure 6-22) and TP and chlorophyll-a (Figure 6-23).

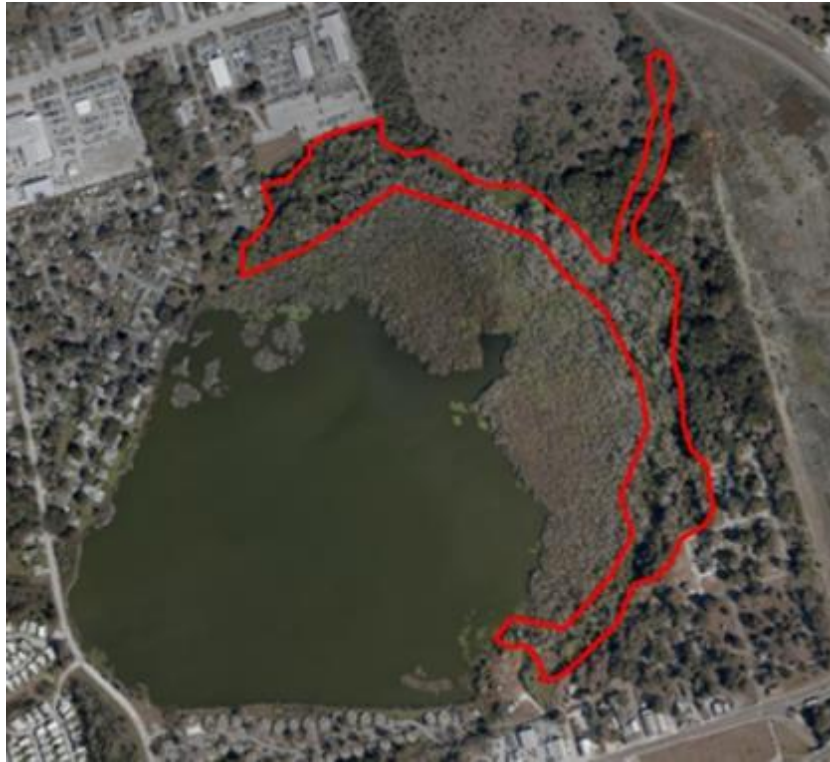
**Figure 6-24. Proposed forested wetland rehydration project area (in red) for Lake Bonnet**

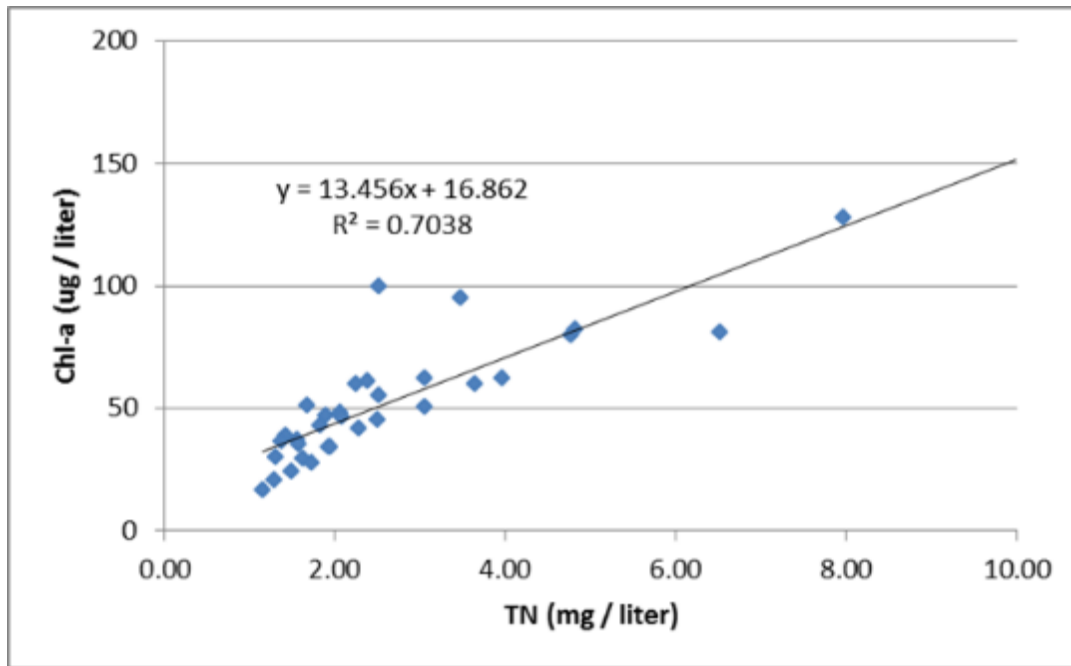
**Figure 6-34. Relationship between TN and chlorophyll-a. Line is best-fit equation of statistically significant ( $p < 0.05$ ) relationship**

Positive relationships were found between both TN and chlorophyll-a (Figure 6-34) and TP and chlorophyll-a (Figure 6-35). However, the very high TN values in Lake Bonny are indicative of nitrogen-fixing cyanobacteria, and thus the TN vs. chlorophyll-a likely reflects TN “made” by phytoplankton in the lake, rather than stimulation of phytoplankton by external TN loads.

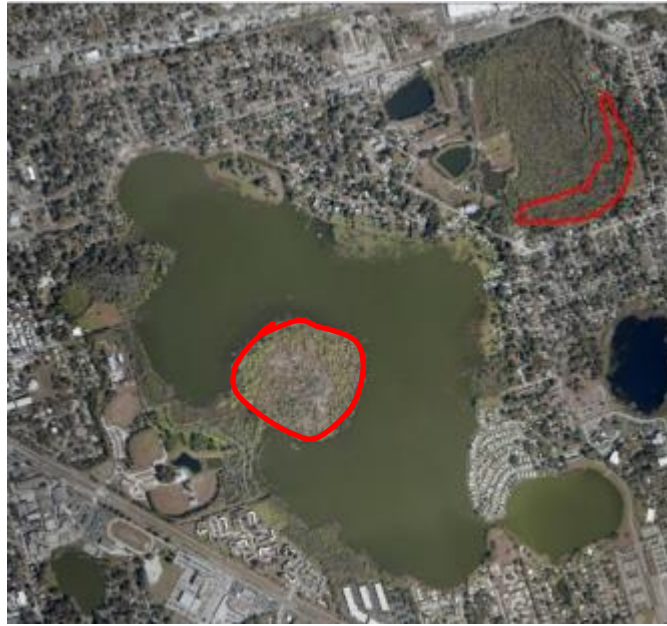
There are two wetland areas adjacent to Lake Bonny identified for potential rehydration within the 500-foot buffer surrounding Lake Bonny which are classified as forested wetland mixed or freshwater wetlands using the 2011 FLUCCS data (Figure 6-36). The first area is approximately 14 acres located northeast of the lake while the second area is an approximately 35-acre lobe of wetland which protrudes into the lake from the west. Depending on findings from site investigations, these may offer an opportunity to increase tannin levels in the lake, if sufficient amount of impacted (i.e., drained) forested wetlands could be rehydrated so that the percentage of the lake's shoreline could exceed 10 to 20 percent of the adjacent watershed, which may allow for color levels above 50 PCU. While FLUCCS classifies the land cover as identifies the smaller parcel as forested wetland, the hydrologic connection between the lake and adjacent land might be partly severed. In regards to the second larger parcel, a more comprehensive evaluation of current land cover would be necessary to determine if rehydration or management of the area to enhance wetland treatment is a more viable option. A feasibility study is recommended in order to evaluate the proposed project areas for inundation or wetland treatment enhancement.

**Figure 6-36. Proposed forested wetland rehydration project areas for Lake Bonny**

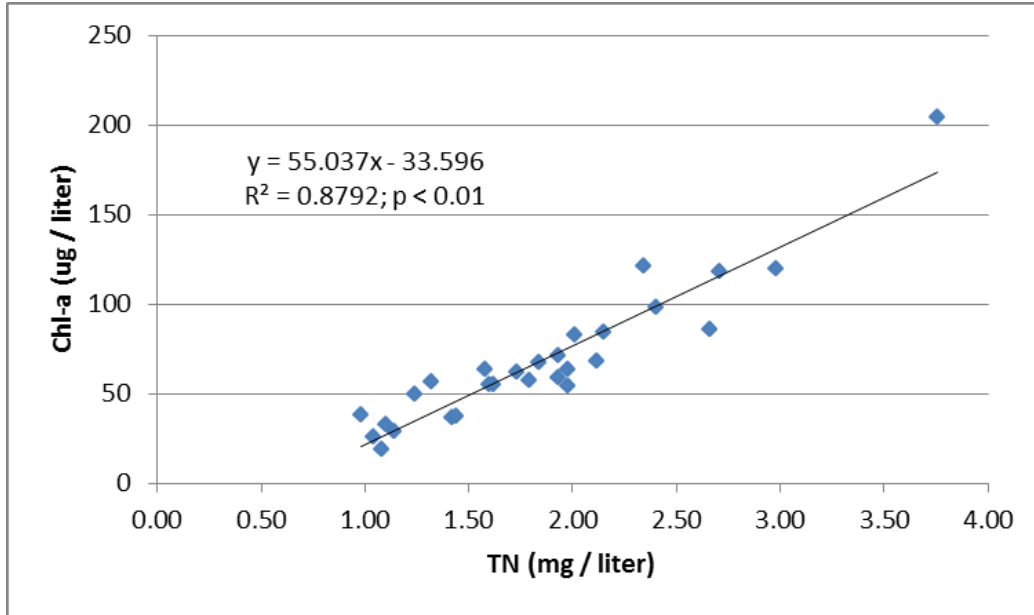
**Figure 6-46. Relationship between TN and chlorophyll-a. Line is best fit equation of statistically significant ( $p < 0.05$ ) relationship**

Positive relationships were found between both TN and chlorophyll-a and TP and chlorophyll-a (Figures 6-46 and 6-47, respectively). The very high levels of TN shown in Figure 6-46 suggest the presence of nitrogen-fixing cyanobacteria, rather than external nitrogen loads with such high concentrations.

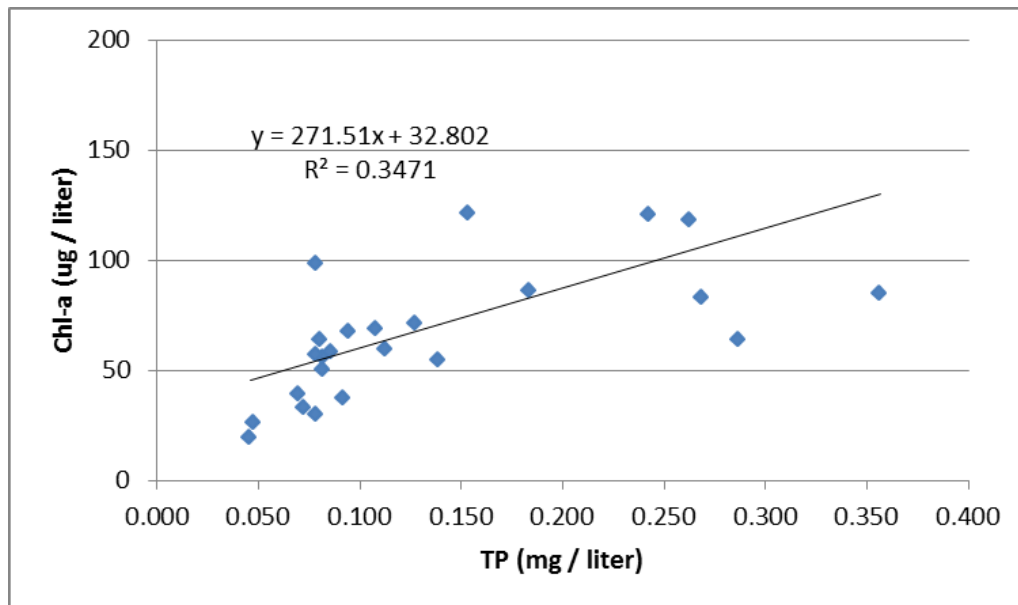
**Figure 6-47. Relationship between TP and chlorophyll-a. Line is best fit equation of statistically significant ( $p < 0.05$ ) relationship**

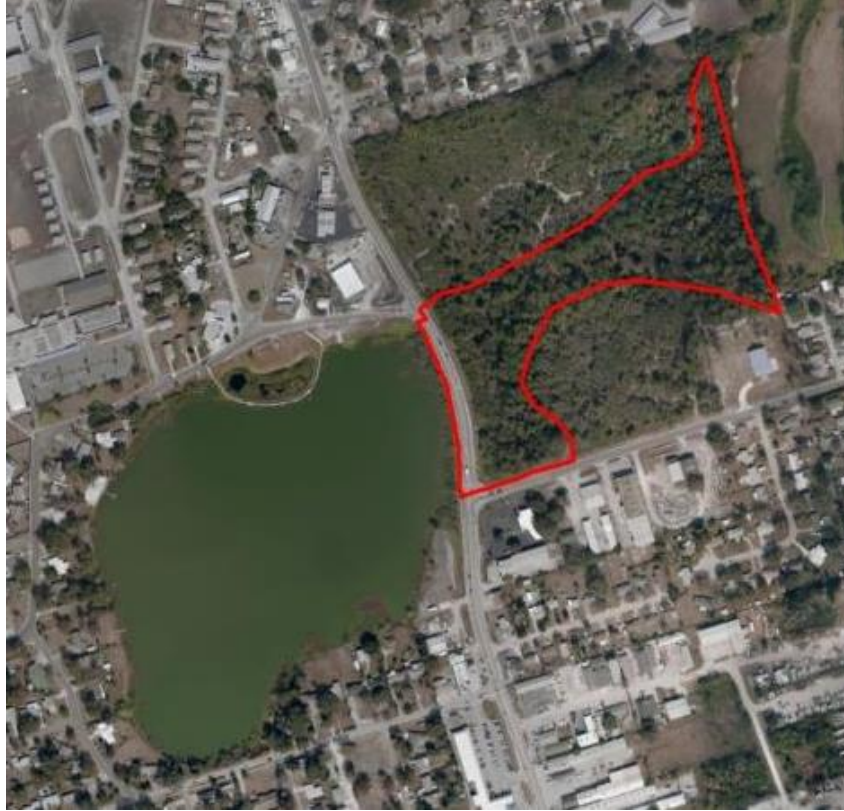
**Figure 6-48. Proposed forested wetland rehydration project area for Crystal Lake**

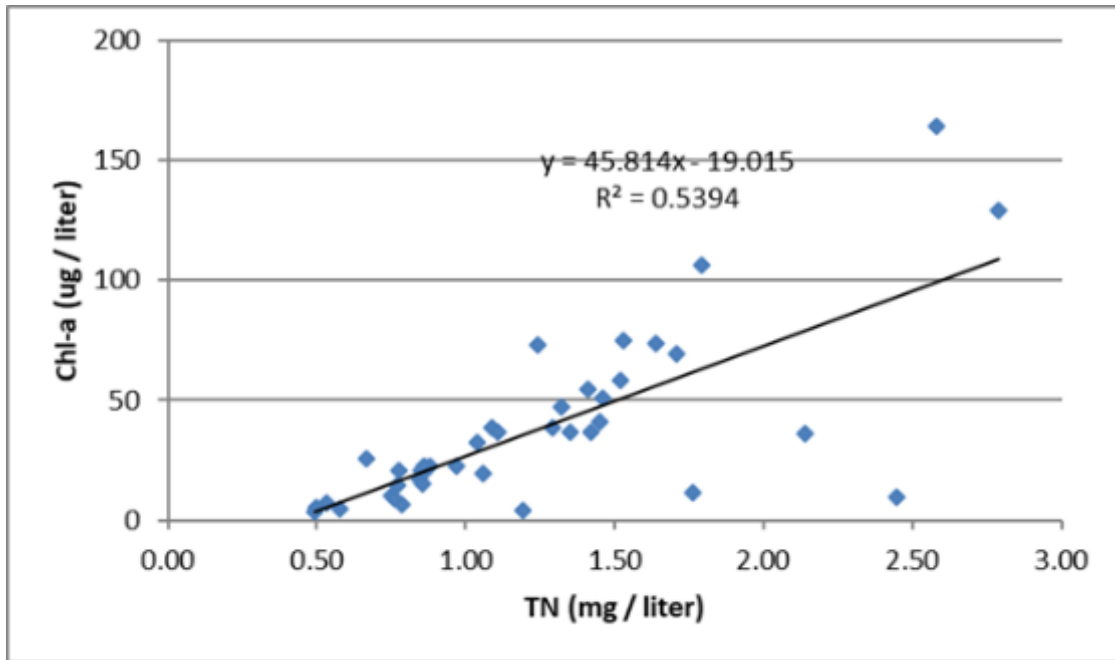
**Figure 6-58. Relationship between TN and chlorophyll-a. Line is best fit equation of statistically significant ( $p < 0.05$ ) relationship**

Positive relationships were found between both TN and chlorophyll-a and TP and chlorophyll-a (Figures 6-58 and 6-59, respectively).

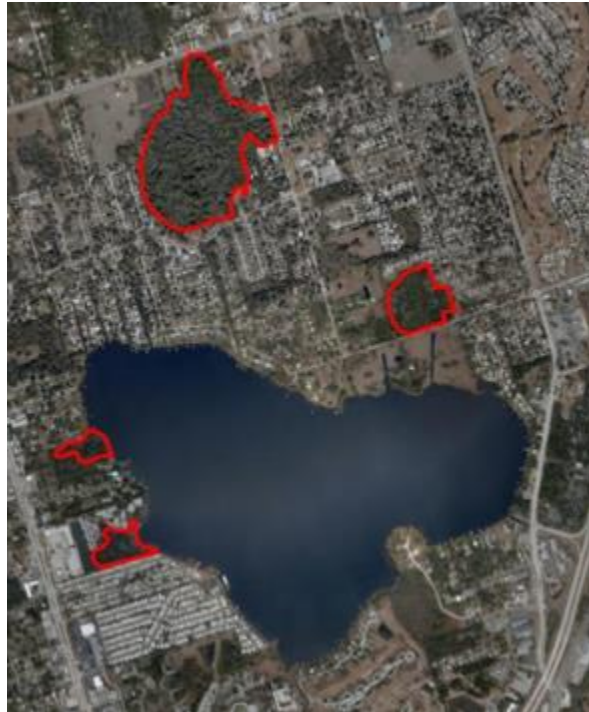
**Figure 6-60. Proposed forested wetland rehydration project area for Lake Gibson**

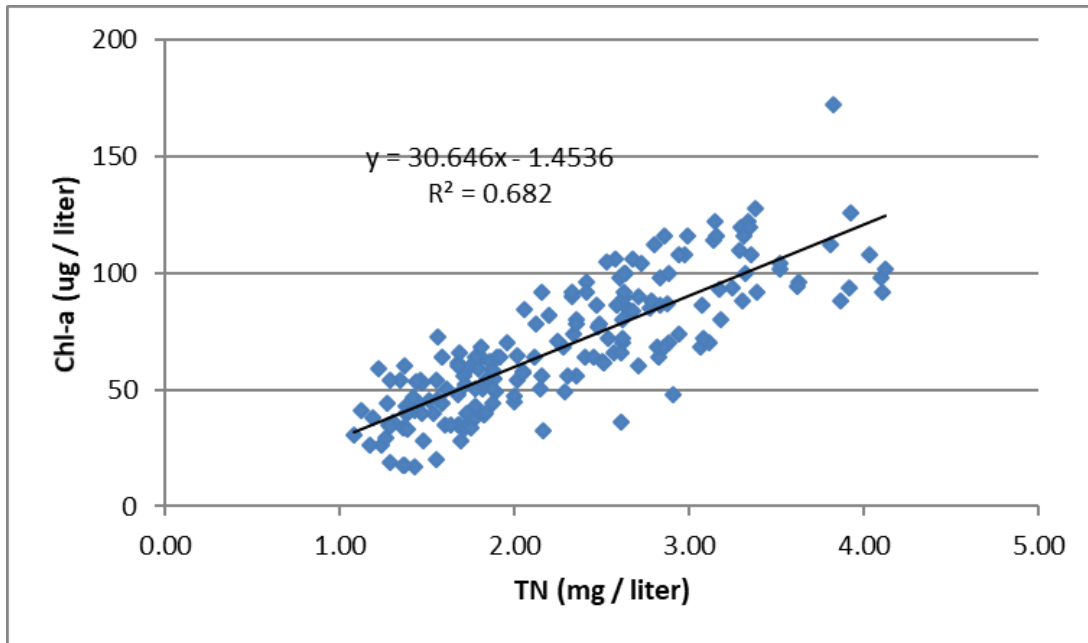
**Figure 6-72. Relationship between TN and chlorophyll-a. Line is best fit equation of statistically significant ( $p < 0.05$ ) relationship**

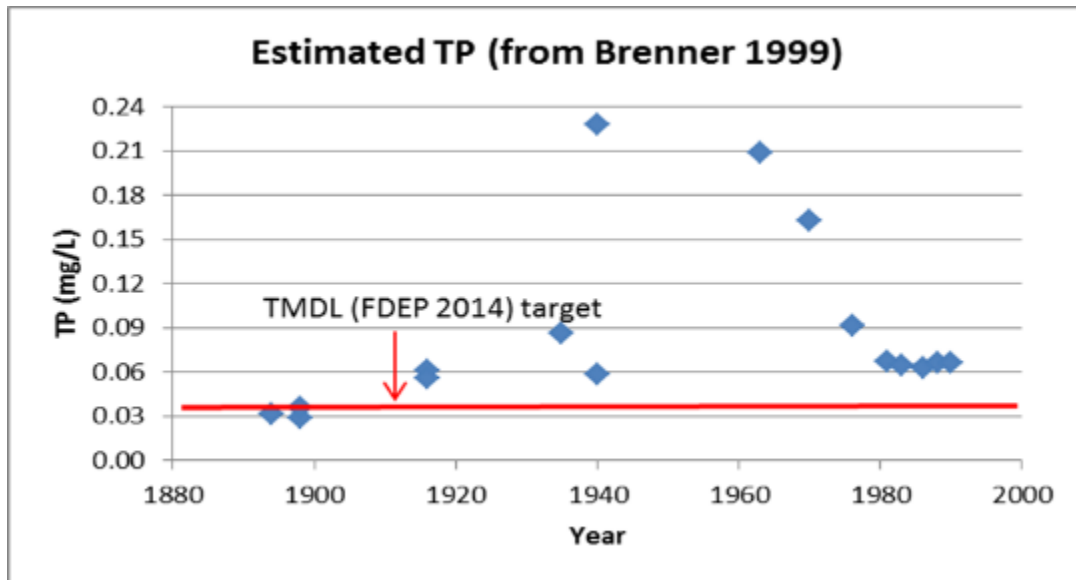
**Figure 6-74. Display of TP Concentrations over Time (Results Derived from Brenner et al. 1999)**

While the TMDL is to be applauded for its inclusion of the applicable paleo study, the "average" target of 0.036 mg/L TP corresponds to the year 1898 based on an analysis of data supplied by Dr. Mark Brenner. When the TP values from the paleo study are plotted out over time, it can be seen that not only are current TP concentrations in Lake Hollingsworth lower than they were in the 1940s and 1950s, but that the target FDEP TP concentration is lower than TP concentrations as far back as 1918 (Figure 6-74).

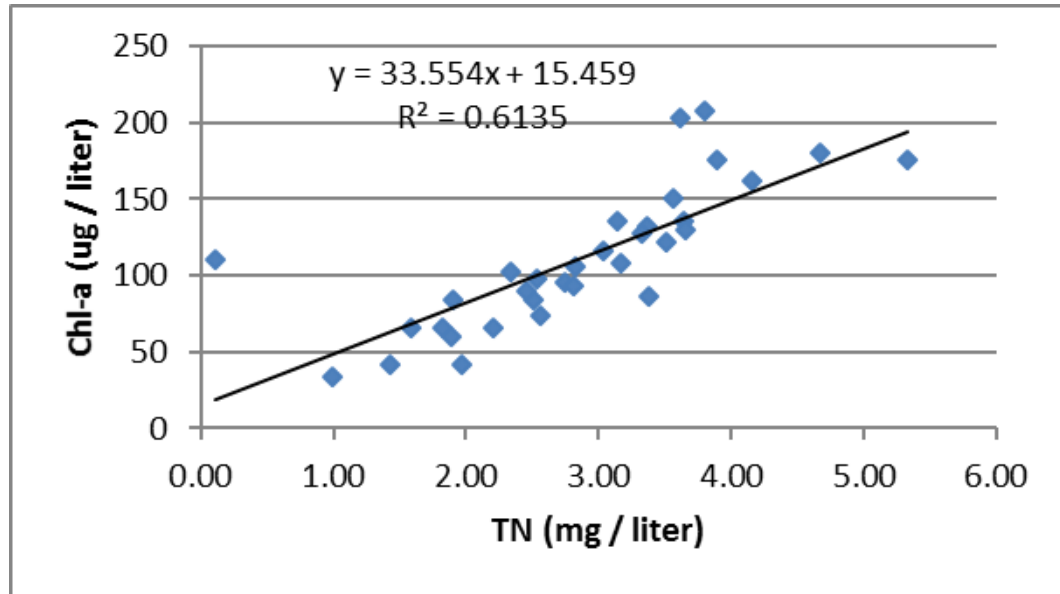
**Figure 6-84. Relationship between TN and chlorophyll-a. Line is best fit equation of statistically significant ( $p < 0.05$ ) relationship**

Positive relationships were found between both TN and chlorophyll-a and TP and chlorophyll-a (Figures 6-84 and 6-85, respectively). The very high levels of TN shown in Figure 6-84 suggest the presence of nitrogen-fixing cyanobacteria, rather than external nitrogen loads with such high concentrations.
