# CITY OF LAKELAND WATER QUALITY MANAGEMENT PLAN

Prepared for:

City of Lakeland  
407 Fairway Avenue  
Lakeland, FL 33801

October 2019

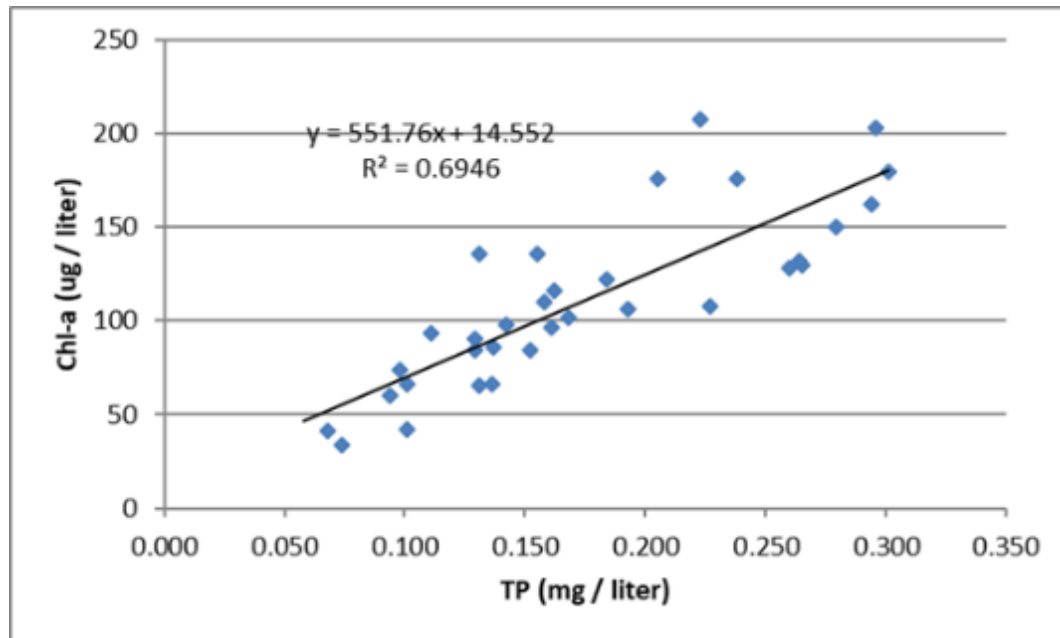
**Figure 6-85. Relationship between TP and chlorophyll-a. Line is best fit equation of statistically significant ( $p < 0.05$ ) relationship.**

An evaluation of the TN data indicates that concentrations exceed 3.0 mg/L; therefore, nitrogen-fixing cyanobacteria are likely playing a role in nutrient cycling within the lake (Figure 6-84). As such, reductions in external loads of TN are not likely to significantly reduce TN concentrations within the lake. Therefore, TP was identified as the NOC and reducing TP concentrations are the focus of proposed lake management activities.

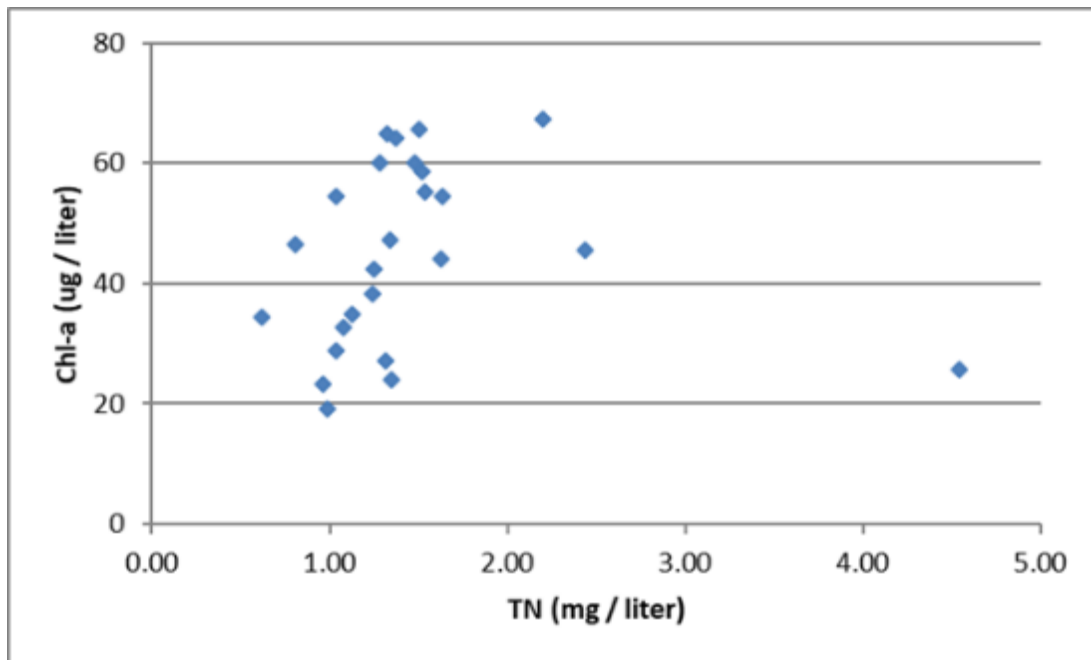
Figure 6-97. Relationship between TN and chlorophyll-a.

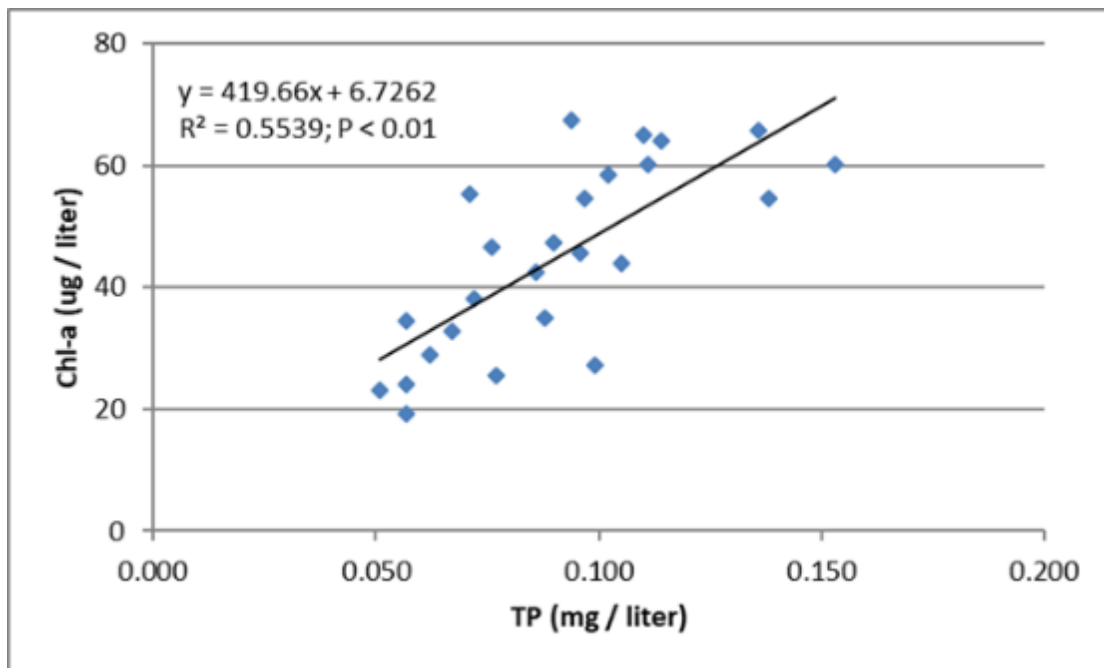
Figure 6-98. Relationship between TP and chlorophyll-a. Line is best fit equation of statistically significant ( $p < 0.05$ ) relationship

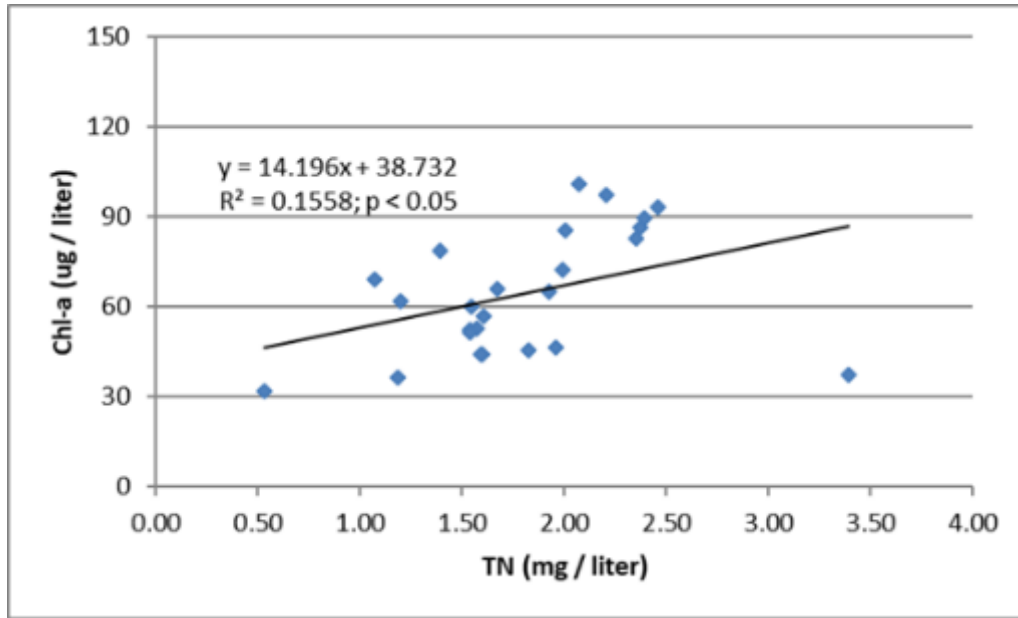
**Figure 6-110. Relationship between TN and chlorophyll-a. Line is best fit equation of statistically significant ( $p < 0.05$ ) relationship**

Statistically significant relationships were found between TN and chlorophyll-a and also between TP and chlorophyll-a (Figures 6-110 and 6-111, respectively).

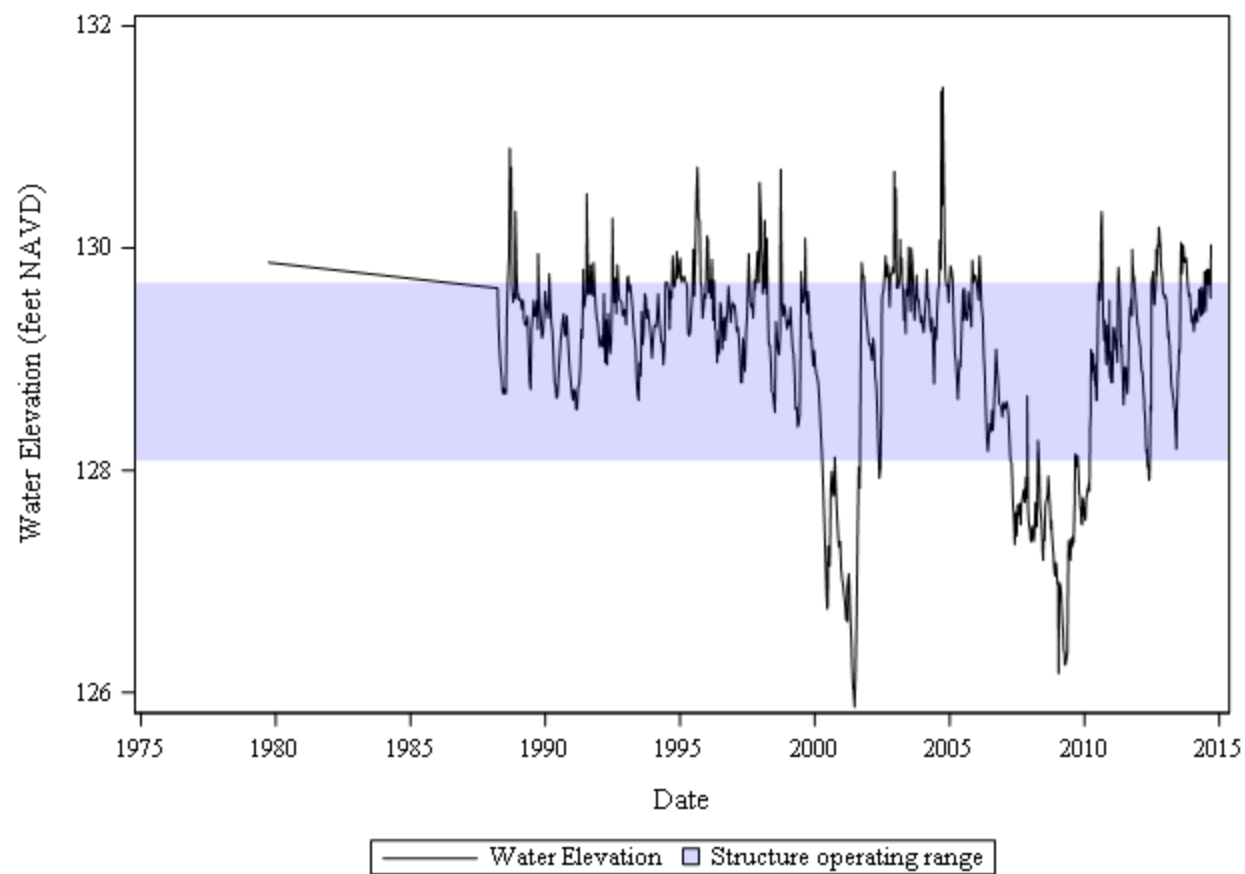
**Figure 6-113. Period of record water elevation for Lake Parker**

Lake Parker is influenced by inflows from Lake Gibson (through Lake Crago), Lake Mirror, and Lake Bonny (City of Lakeland 2010). Lake Parker discharges into North Saddle Creek, which then flows into Lake Hancock. Over the past 20 years, the lake level appears to have mostly fluctuated within or above its structure operating range, with the exception of an extensive period of low flows in 2000 to 2002, and then again during 2007 to 2010 (Figure 6-113). The operational water elevation range for Lake Parker is 128.09 to 129.69 feet NAVD. Within the Lake Parker watershed, there is an elevation gradient ranging from 119 to 220 feet NAVD (Figure 6-114). Lake Parker is located between 80 and 120-foot potentiometric surface elevations for the Florida aquifer and southwest of the potentiometric peak, as of September 2011 (Figure 6-115). Additionally, the northern boundary of the intermediate aquifer system crosses Lake Parker (Spelcher and Kroening 2007). Therefore, it is unlikely that there is direct connectivity between Lake Parker and the Floridan aquifer.

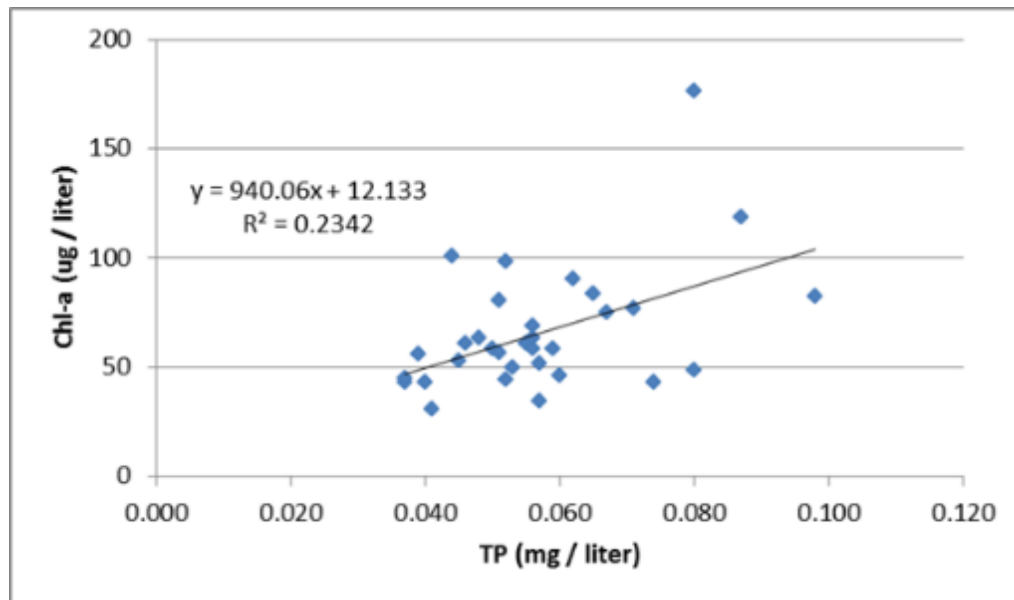
**Figure 6-124. Relationship between TP and chlorophyll-a. Line is best fit equation of statistically significant ( $p < 0.05$ ) relationship**

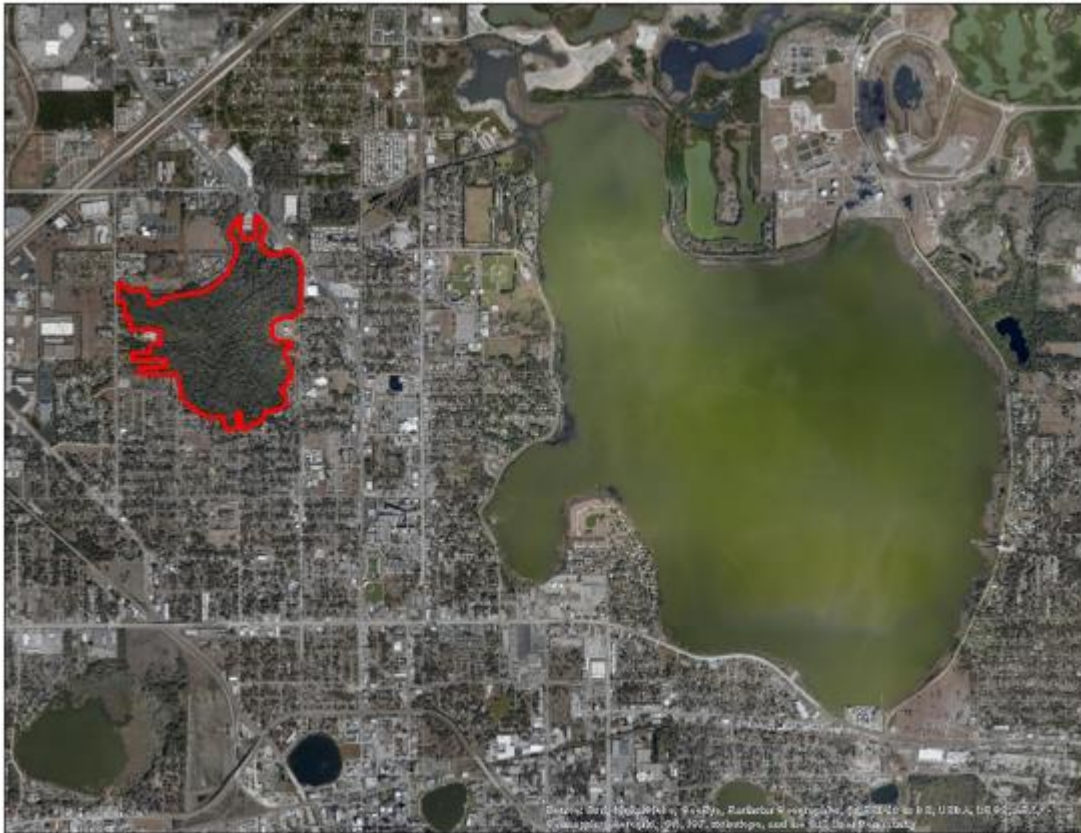
**Figure 6-125. Proposed forested wetland rehydration project area for Lake Parker**

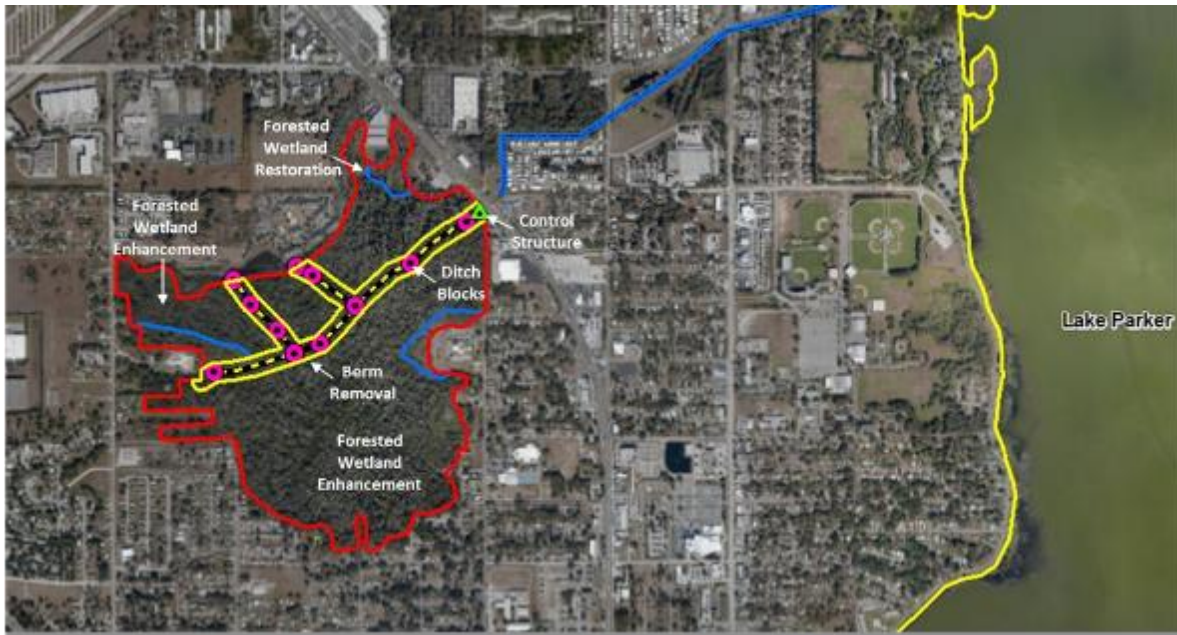
**Figure 6-126. Lake Parker Conceptual Wetland Restoration map**

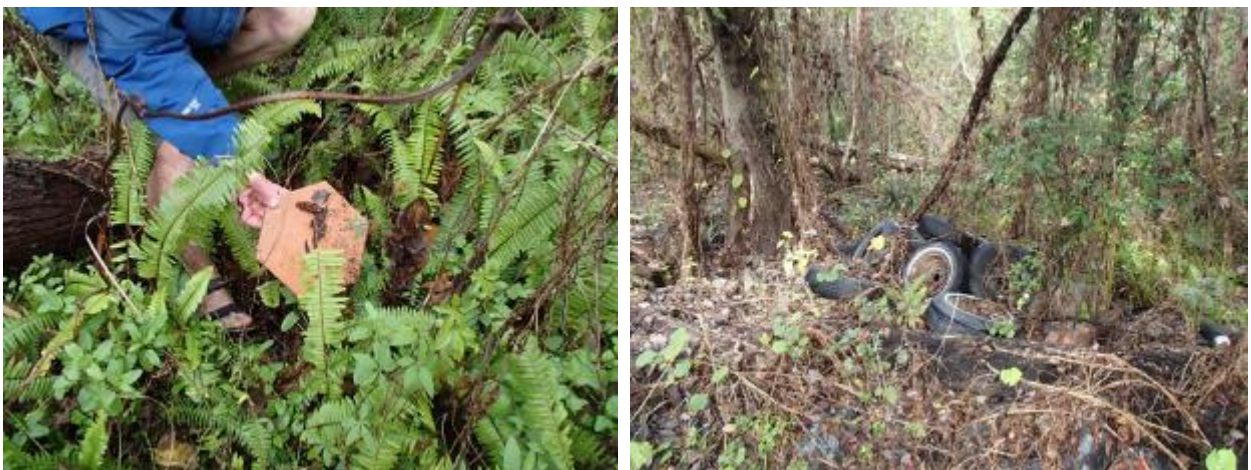
**Figure 6-127. Area of potential contamination within the forested wetland west of Lake Parker. Left Photo: Tile Remnants. Right Photo: Tire disposal**

During preliminary field assessments conducted within the forested wetland west of Lake Parker, an area with the potential for contamination was identified - primarily due to the evidence of unregulated dumping of waste materials (debris) into the former wetland site, such as ceramic tiles, tires, and other miscellaneous commercial and household wastes (Figure 6-127). Based on knowledge of contamination impacts identified at sites with disposal of similar tiles, tires, and other materials, there is the potential for contamination to be present; therefore, an environmental assessment of the property would be warranted prior to initiation of any restoration projects.

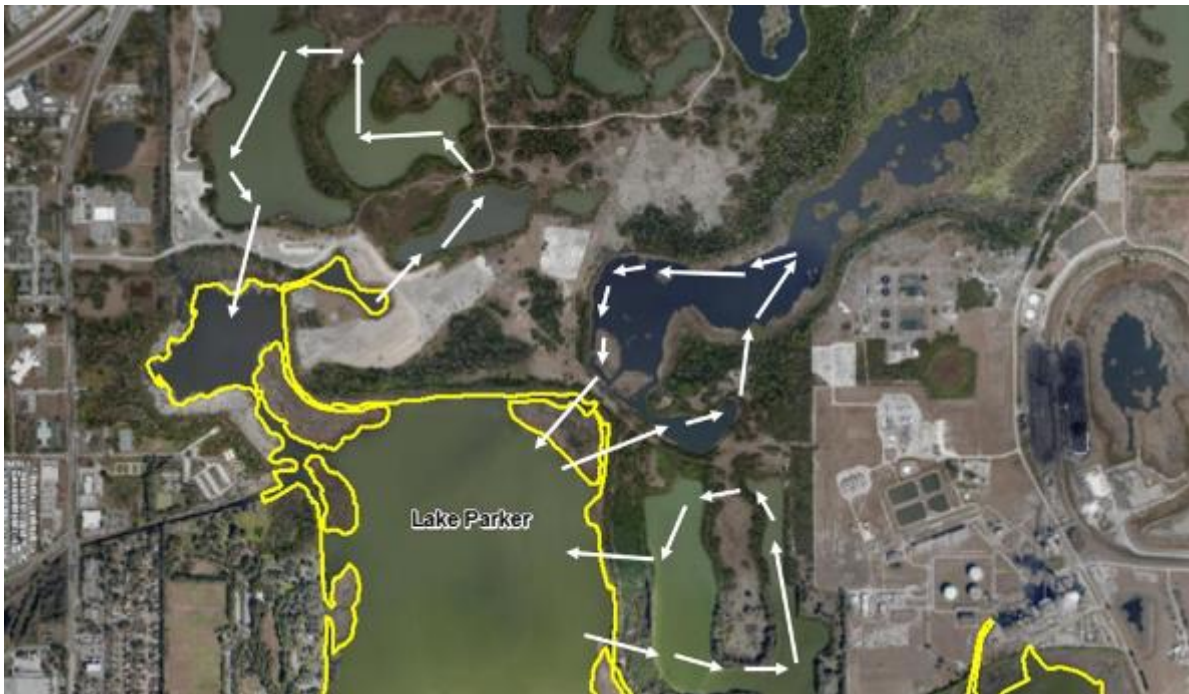
**Figure 6-128. Proposed conceptual restoration plan for Lake Parker utilizing Lake Teneroc**

Figure 6-128 gives a general overview of the potential restoration project for the Teneroc System and Lake Parker.

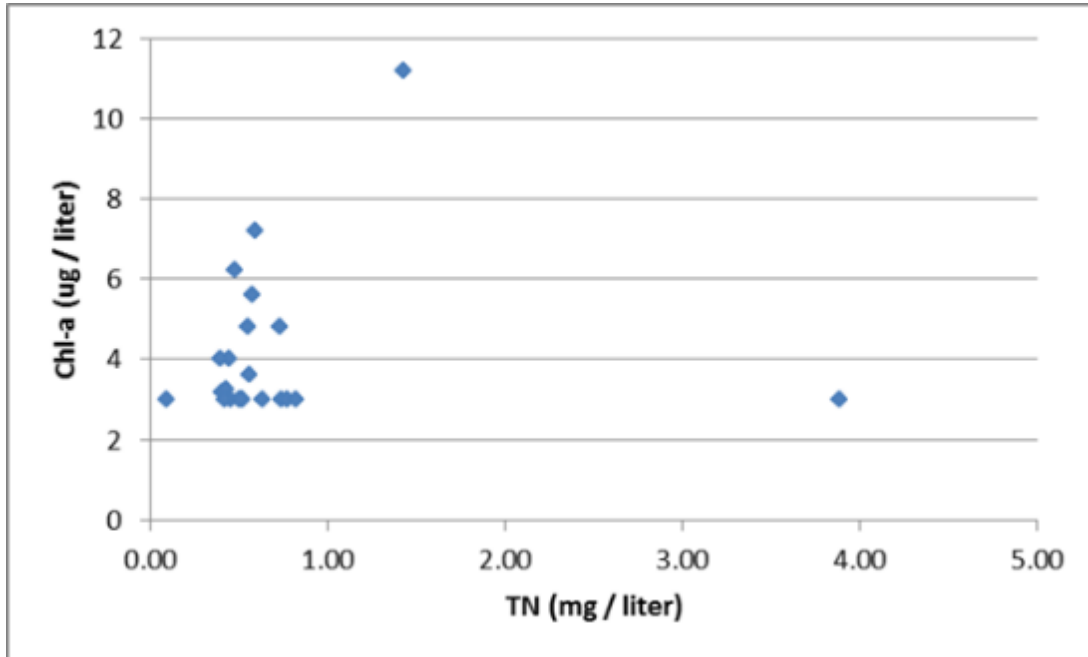
Figure 6-140. Relationship between TN and chlorophyll-a. Line is best fit equation of statistically significant ( $p < 0.05$ ) relationship

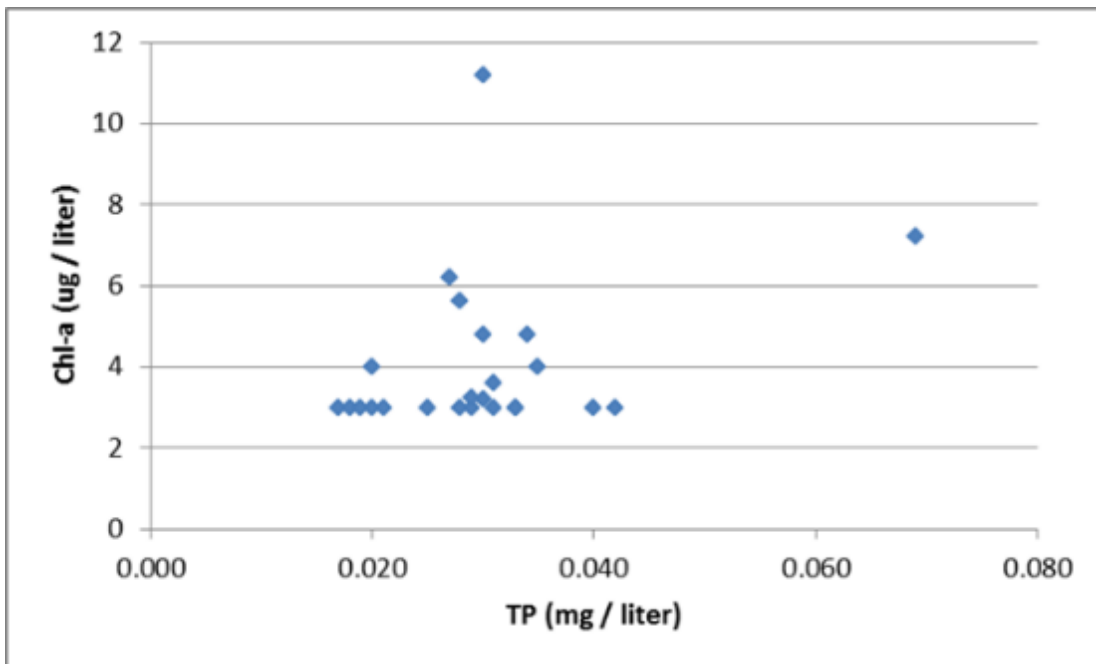
Figure 6-141. Relationship between TP and chlorophyll-a. Line is best fit equation of statistically significant ( $p < 0.05$ ) relationship

Additionally, there are no statistically significant relationships between either TN and chlorophyll-a or TP and chlorophyll-a (Figures 6-140 and 6-141, respectively).

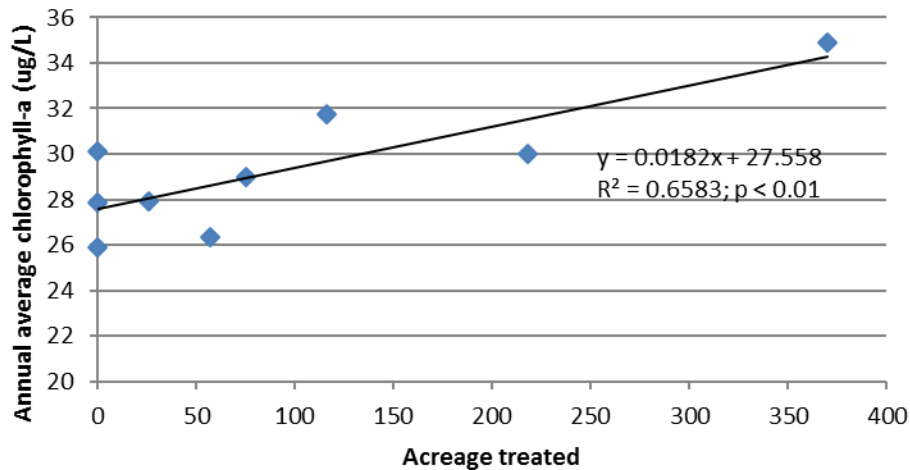
**Figure 7-1. Annual Average chlorophyll-a Concentrations VS Acreage of Hydrilla Treated in the Same Year (Data from Lake Tarpon from 1993 to 2014).**
