# Lake Gem Mary

## Hydrologic & Nutrient Budget and Water Quality Management Plan

Final Report

Orange County, Florida

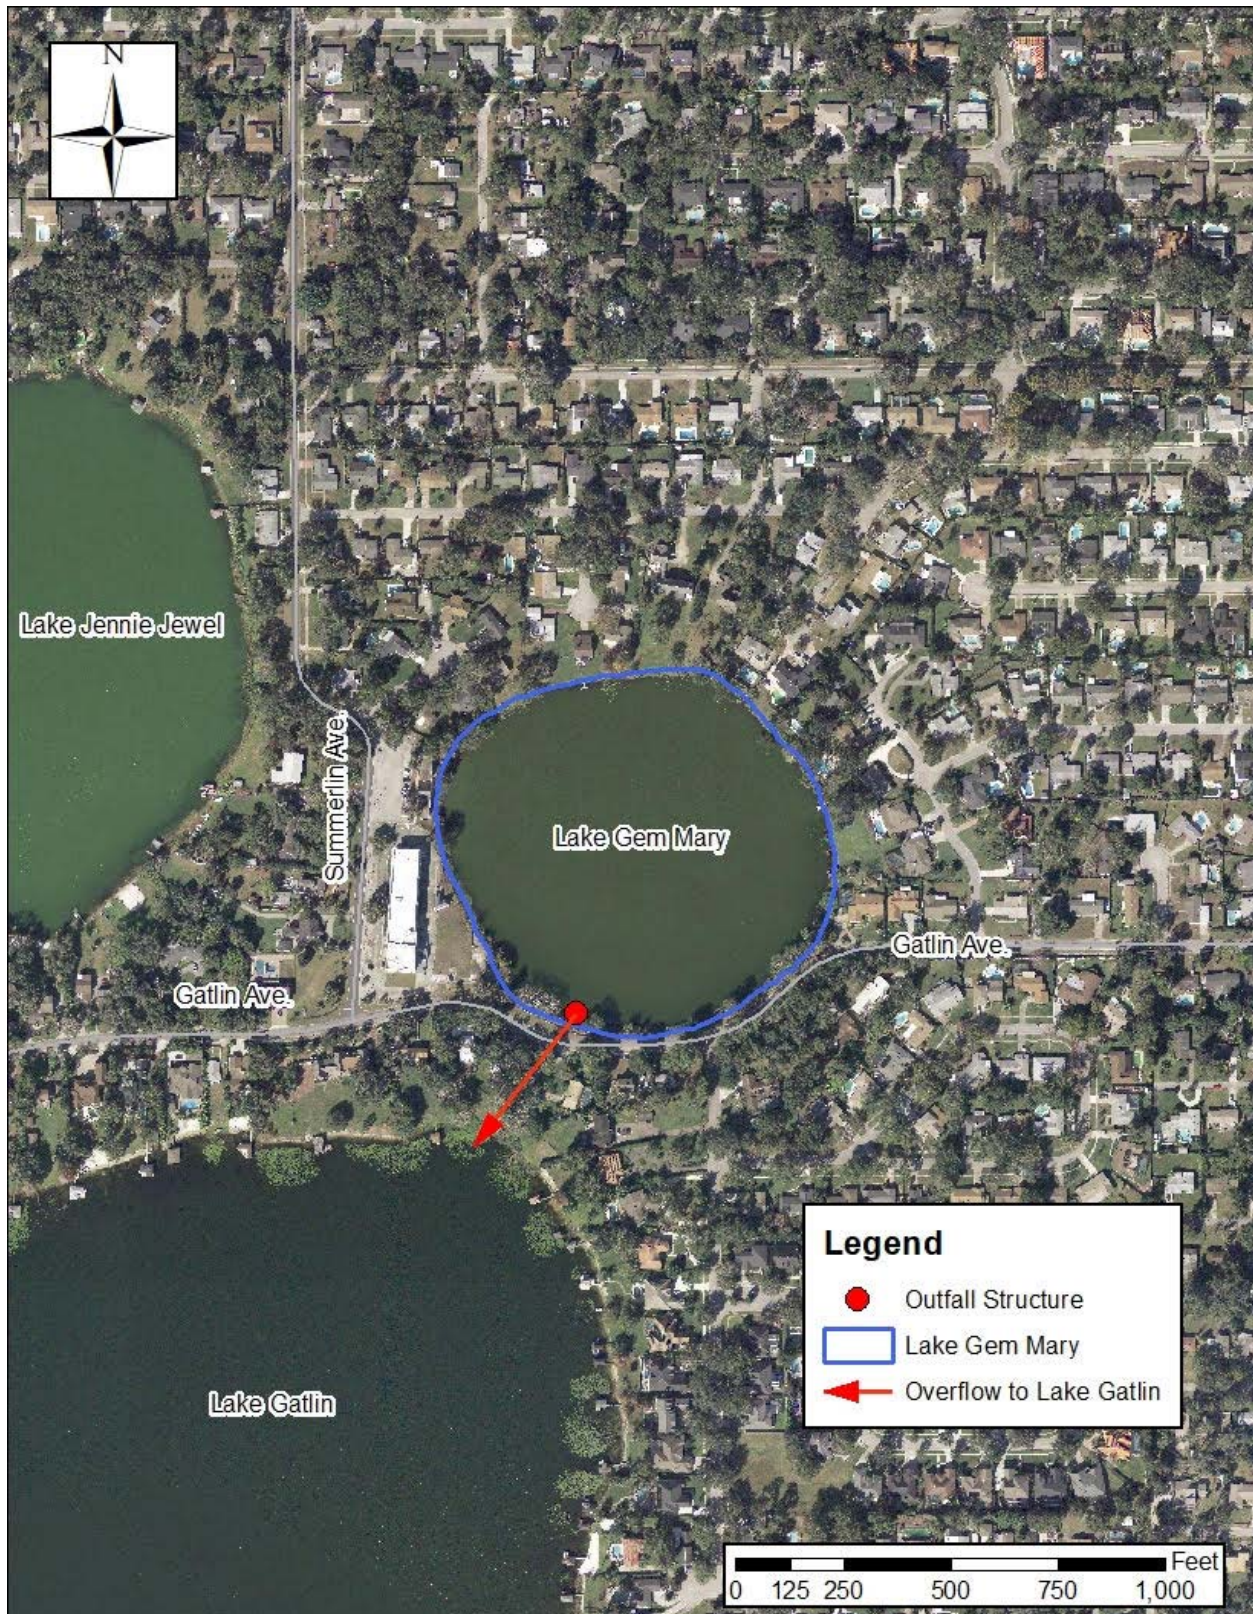
*Figure 2-1: View of Lake Gem Mary and Surrounding Areas*

The Lake Gem Mary surface area is approximately 14 acres. An aerial view of Lake Gem Mary and the surrounding area is shown in Figure 2-1. Residential homes with yards directly connected to the lake are located along the north and east shore. Gatlin Avenue runs along the south shore separated from the lake by a vegetated strip. Commercial buildings with paved parking are located along the west shore. These buildings were initially owned by the US Navy and sold to Orange County through quitclaim deed in 2010.

Discharge from Lake Gem Mary is regulated by a concrete weir located on the outfall structure to Lake Gatlin at an elevation of 90.0 feet, NAVD 88 (see Figure 2-1 for outfall structure location). Historical water elevations were recorded in Lake Gem Mary from 1960 to 2018, with a 5-year gap between 1975 and 1980. A graphical summary of recorded surface water elevations available from Orange County is presented in Figure 2-53. Water Elevations in Lake Gem Mary fluctuated between 83.7 and 95.5 feet, NAVD 88, with the highest recorded elevation in 2000 and the lowest elevation recorded in 2001.

During October 2015 through September 2016, water elevation data was collected based on a disk set into a concrete flume structure on the south side of the lake and surveyed by Orange County. Water elevation data collected during the study for Lake Gem Mary is presented in Table 2-12. The monthly water elevations during the year-long study are graphically represented in Figure 2-54. Discharge from Lake Gem Mary to Lake Gatlin is controlled by a weir within an outfall structure at an elevation of 90.0 feet, NAVD 1988 (see Figure 2-1).

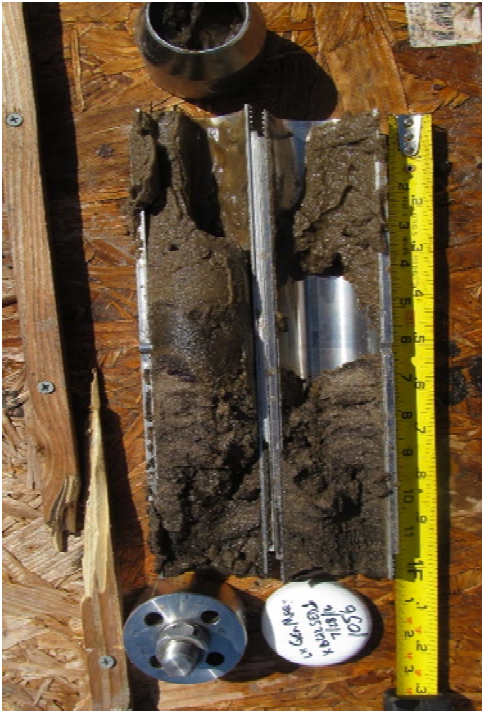
**Figure 2-8: Photographs of Lake Gem Mary Sediment Samples**

Sandy Sediments w/Some Mottling  
XBC12SED1

Visual characteristics of sediment core samples were recorded for each of the 6 sediment samples collected during July 2016. A summary of visual characteristics of the sediment core samples is presented in Table 2-4. In general, four sediment samples were collected near the perimeter of the lake in the shallow portion near existing stormwater outfalls. Two sediment samples were collected in the deeper portion of the lake. A surficial layer of sand with undecomposed organic matter was observed in three of the four shallow sites and muck in the surficial layer of the fourth shallow site. Muck was observed in two deeper sites. Loose to watery muck was observed in the surficial layer of the deeper sites with more consolidated muck beneath the surface layer, almost with a consistency similar to pudding. These layers, which reflect older organic deposits that are resistant to further degradation, are referred to as consolidated organic muck and typically do not re-suspend into the water column except during relatively vigorous wind or boating activity on the lake. Shallow shoreline areas of the lake are characterized by various types of brown fine to medium-coarse sand which appears to be the parent soil layer forming the original lake bottom. Photographs of some of the sediment characteristics are presented in Figure 2-8.

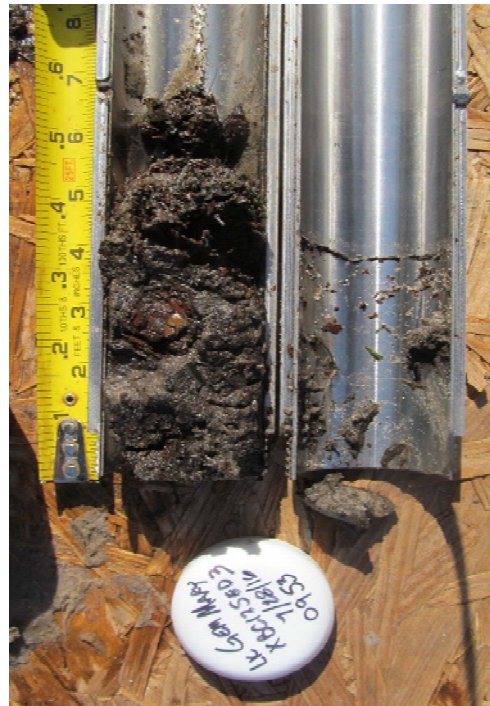
Sandy Sediments w/Organic Matter  
SBC12SED3

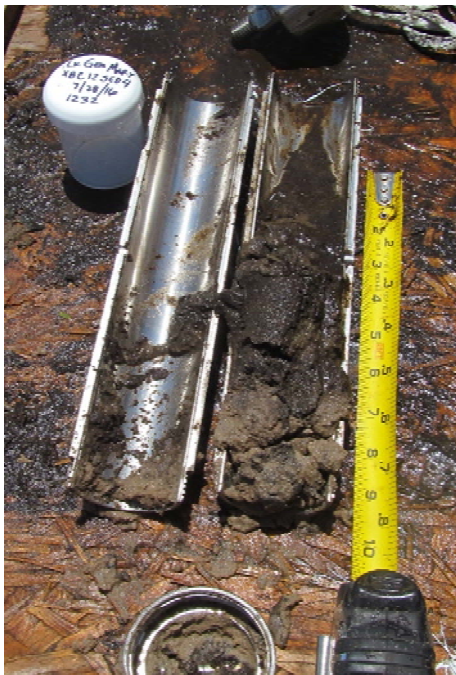
Brown Sandy Muck  
XBC12SED4

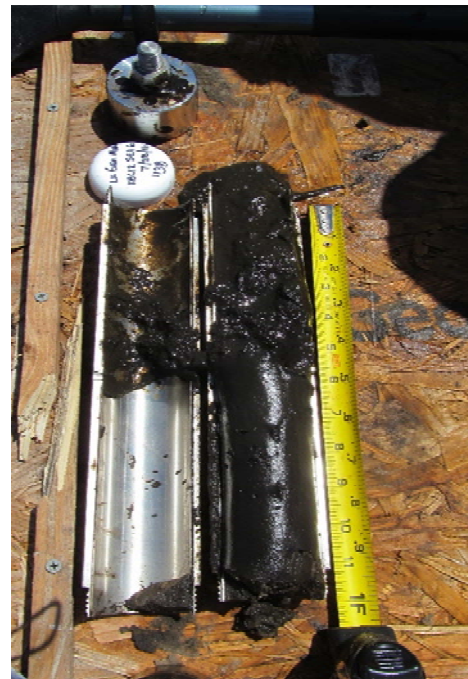
Muck – Loose & Consolidated  
XBC12SED6

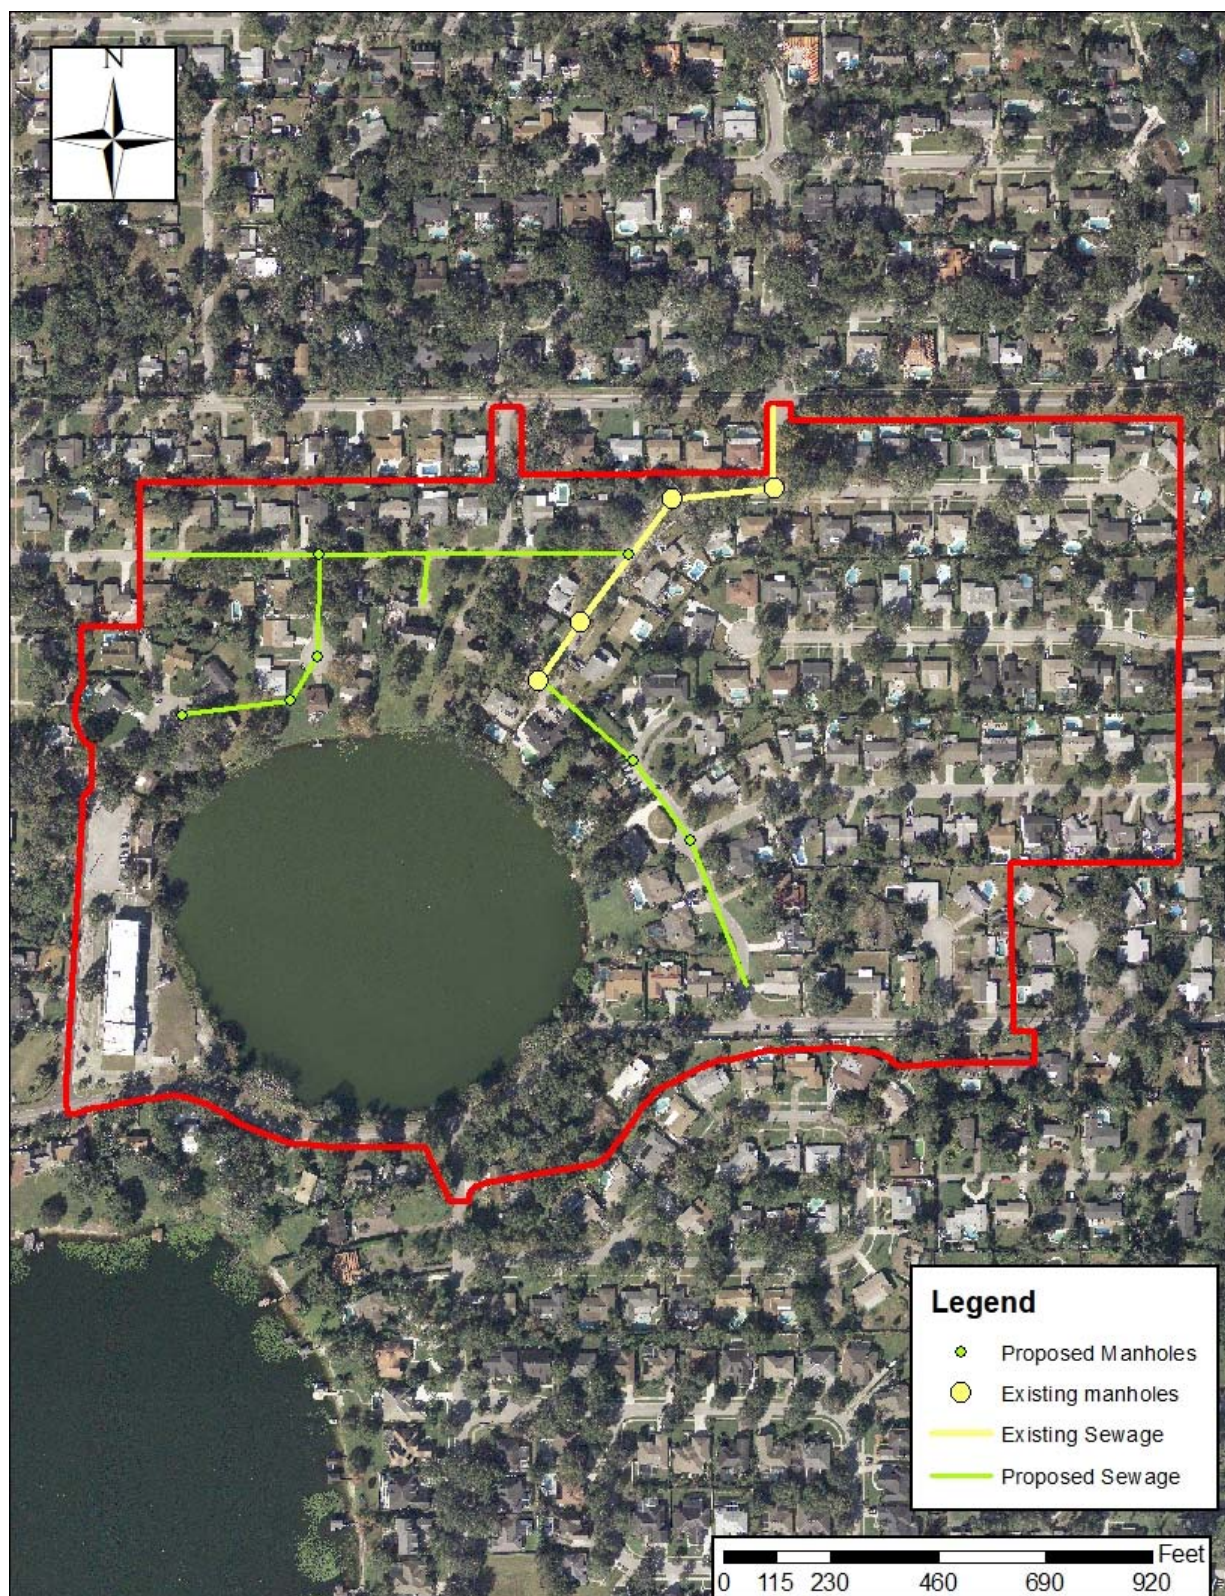
**Figure 6-1: Sanitary Sewer Alternative**

If the County chooses to install a sanitary system in the Lake Gem Mary watershed, the nearest sanitary sewer connection is owned and operated by the City of Orlando. The closest manhole is located at the intersection of Northglenn Drive and Appleton Avenue. The manhole location and potential sewer lines necessary to connect to the sanitary system are presented in Figure 6-1. The estimated construction costs to install sanitary sewer and a lift station as shown in Table 6-6. The estimated pollutant removal cost is presented in Table 6-7.

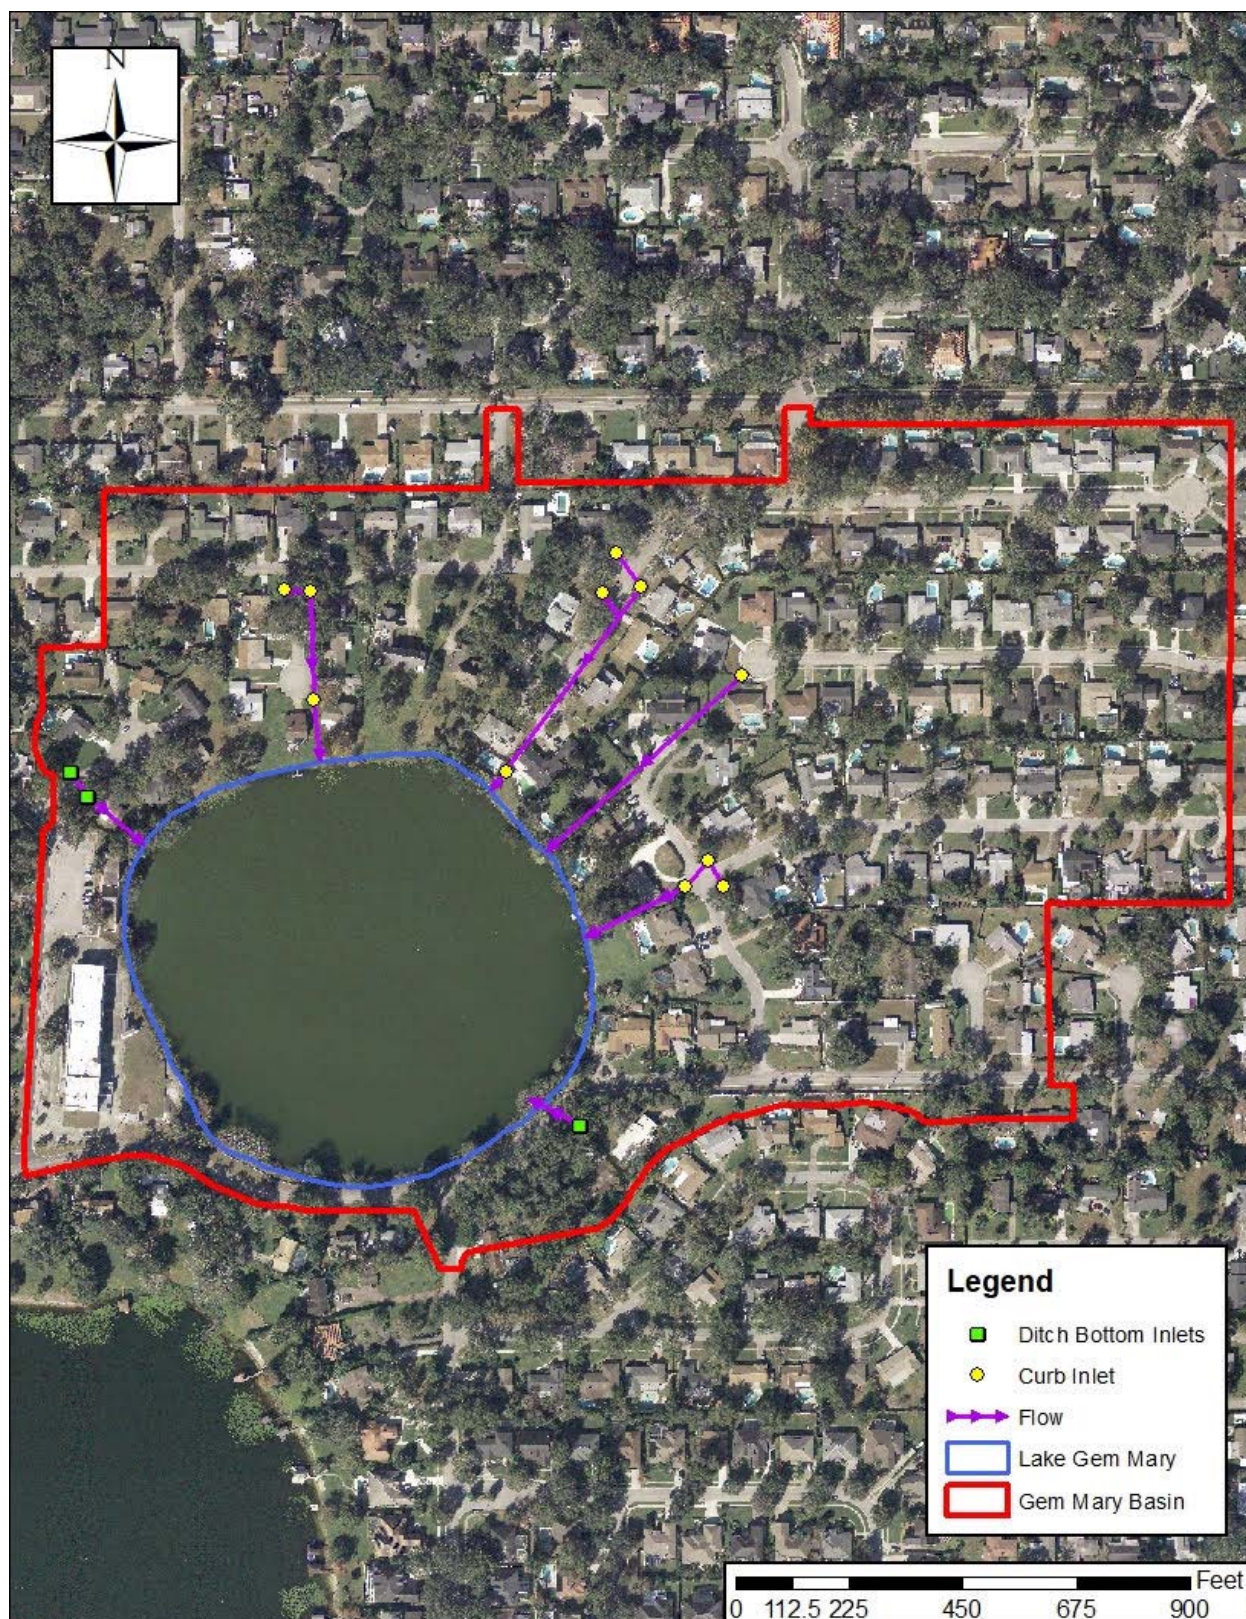
Figure 6-5: Inlet Basket Locations

Locations of proposed curb and grate inlet baskets in the Lake Gem Mary watershed are illustrated in Figure 6-5. Literature values indicated a TP removal rate of 4.4/kg/curb mile/year and TN removal rate of 12.0/kg/curb mile/year. Biological Activated Media (BAM) can be added to inlet baskets to increase their pollutant removal efficiencies. Pollutant removal efficiencies for inlet baskets retrofitted with BAM are reported to be between 71% to 96% for TP and 65% to 96% for TN. Estimated nutrient removal and costs that can be expected with inlet basket installation without BAM usage are presented in Table 6-8.
