**Appendix A. Sample Site Descriptions for Gaineville Urban Creek Fecal Coliform, Fluorescent Whitening Agents and Microbial Source Tracking Monitoring, 2001 through 2007**

## **Appendix H**

**Figure H-1. Aerial photographs of the GRU Kanapaha Water Reclamation Facility and Main Street Water Reclamation Facility**

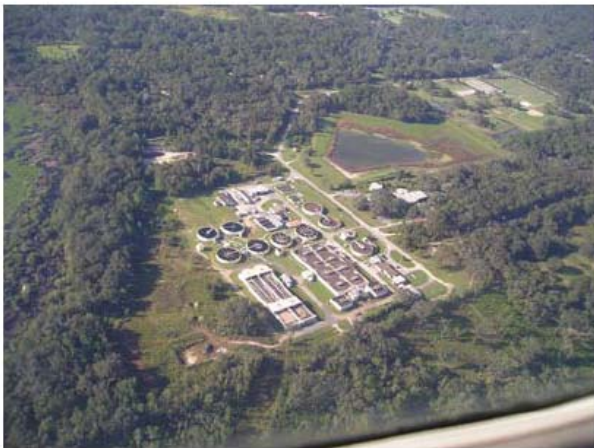
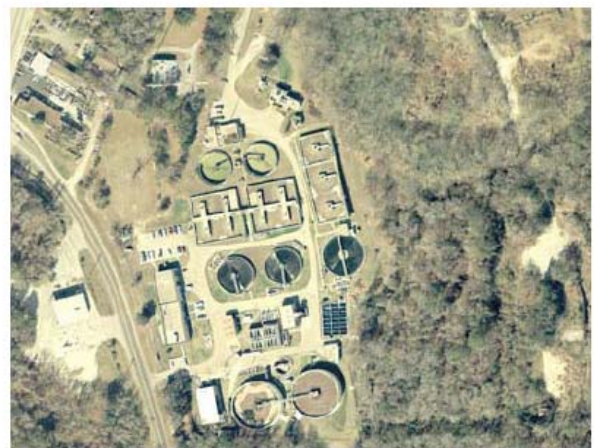
**KWRF**

**MSWRF**

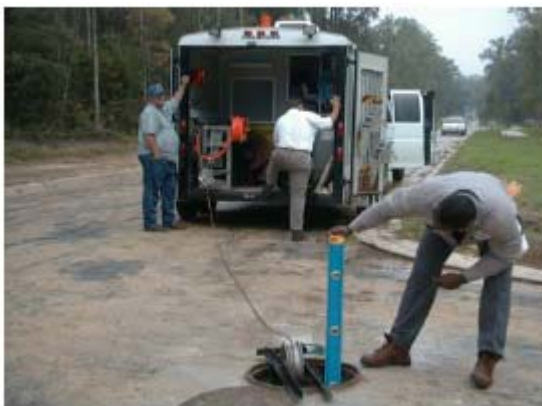
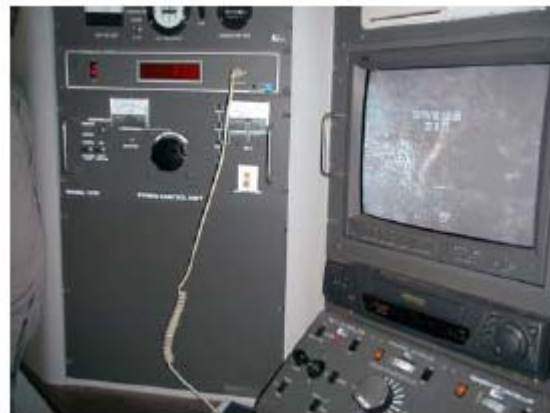
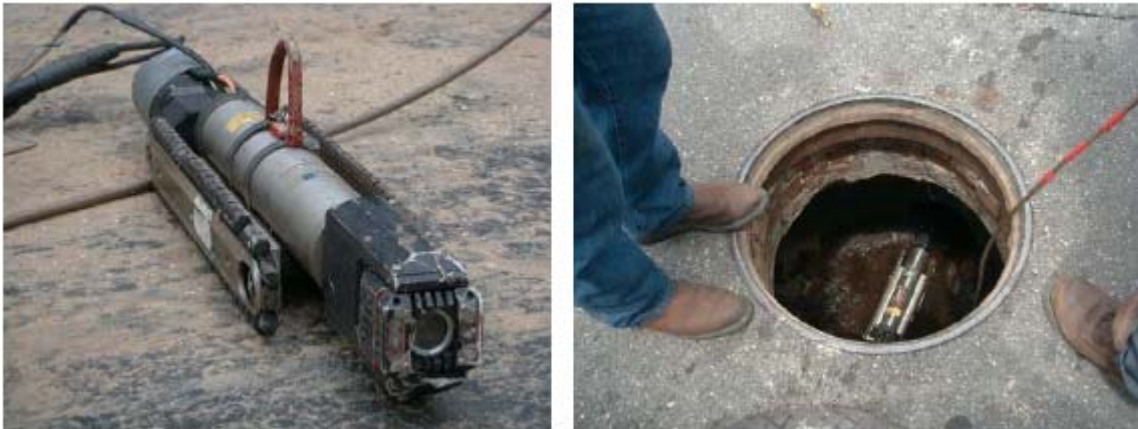
**Figure H-5. Closed-circuit TV unit components**

GRU has an ongoing closed-circuit TV inspection/repair and cleaning program, and added a new closed-circuit TV unit (truck and crew) in FY 2006. Crews clean gravity mains with high-pressure water jets prior to closed-circuit TV inspection. As the crews inspect the lines, they log any deficiencies that may inhibit the pipe's performance. A closed-circuit TV/sealing (grout) unit (truck and crew) follows the inspection to make repairs to damaged pipelines as needed. If necessary, additional crews are dispatched to repair the pipe by sliplining techniques or by utilizing some other appropriate repair method to restore the pipeline to optimum condition. GRU has the ability to make joint repairs and sliplining repairs for the pipe diameters up to 12 inches immediately. This eliminates the time and expense of procuring outside contractors to perform the work. **Figure H-5** shows the components of the closed-circuit TV unit.

### ***Closed-Circuit TV Inspection Crew and Equipment***

### Closed-Circuit TV Inspection Camera

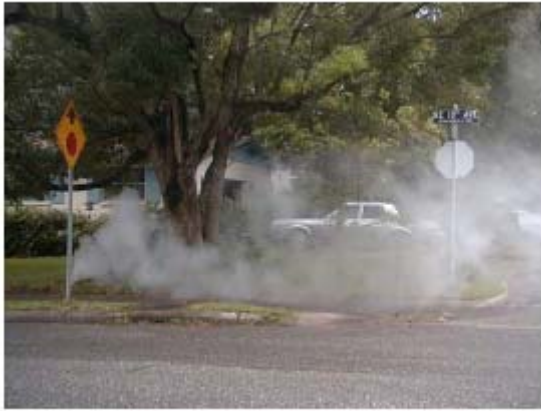
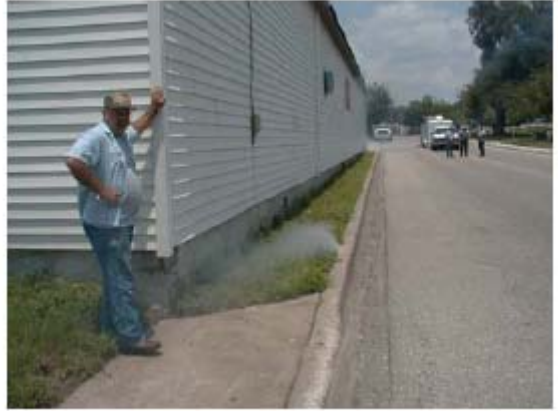
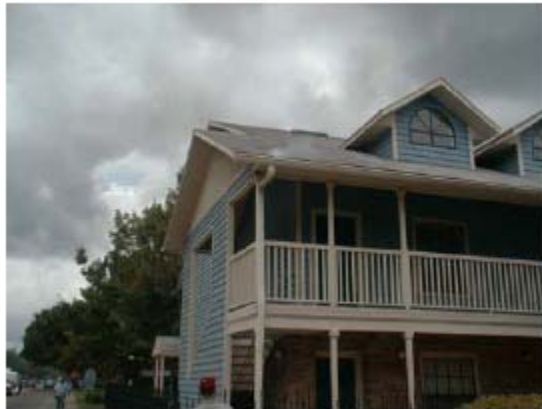
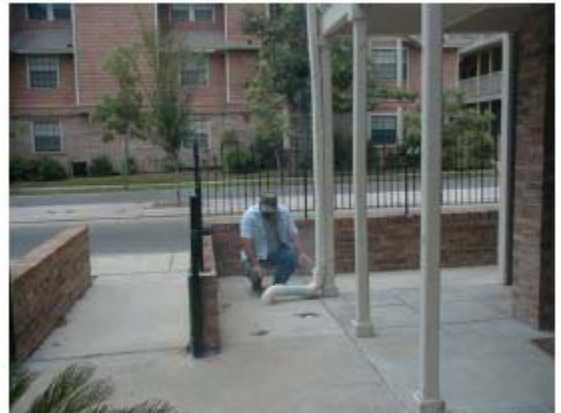
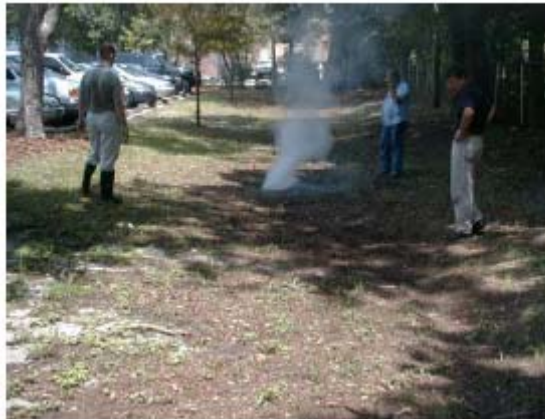
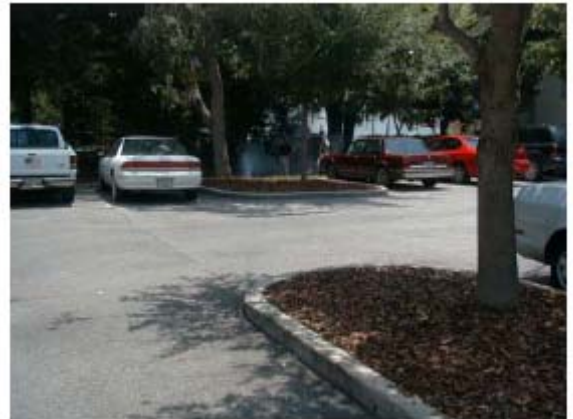
**Figure H-8. Smoke testing used to find I&I**

***Broken Cleanout***

***Broken Service Lateral***

***Illegal Connections to GRU Wastewater Collection System: Apartment Rain Gutter***

***Illegal Connections to GRU Wastewater Collection System: Stormwater Retention Pond***

If collection system defects are found, crews immediately repair each defect in the collection system area before moving on the next designated test area. **Figure H-8** shows the use of smoke testing to find sources of I&I, some of the illicit connections that exist. GRU has tested over 71% of its wastewater collection system since January 2001, with the urban creek areas covered in Phase 3 of the project during 2003, 2004, and 2005. GRU has spent \$2.8 million since 2001 on I&I and has budgeted \$1.36 million to continue this effort for the 2007 to 2012 budget period.

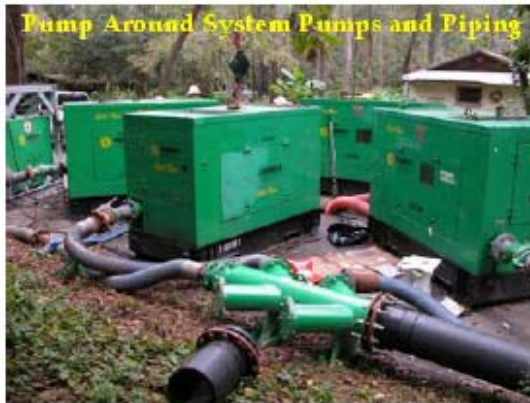
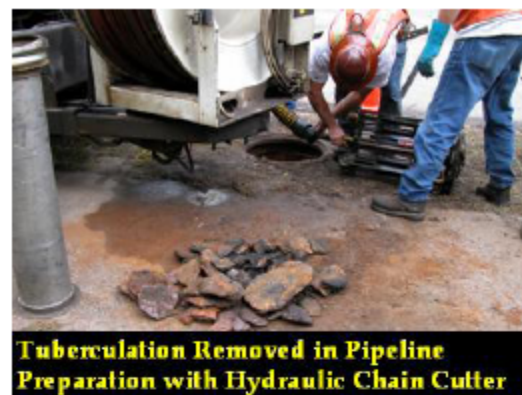
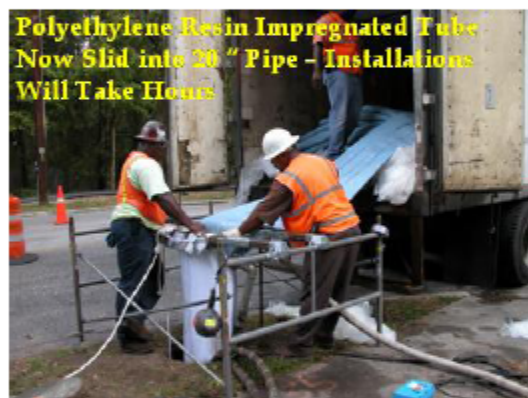
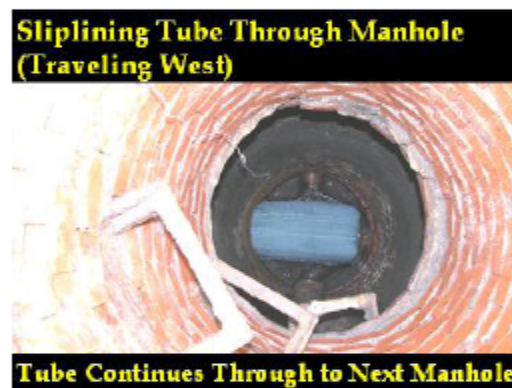
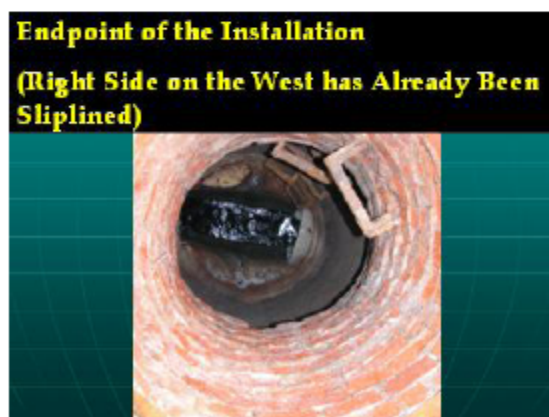
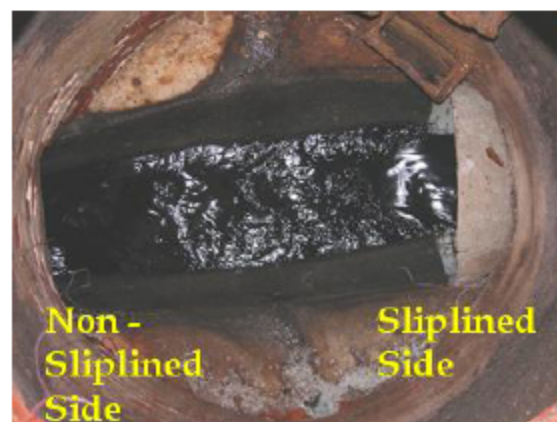
**Figure H-9. Installation sequence of a Hogtown Creek sliplining project**  
***Pump Around (Hogtown Creek Basin)***

**Sliplining Pipe Installation**

**Sliplined Pipe in Manhole**

**Finished Pipe in Manhole**

**Figure H-9** shows the installation sequence for a Hogtown Creek sliplining project. The sliplining process typically restores the hydraulic and structural integrity of the older pipe to that of a new pipe. While sliplining is an expensive technology, it is less invasive than open trench construction along the urban creek corridors.

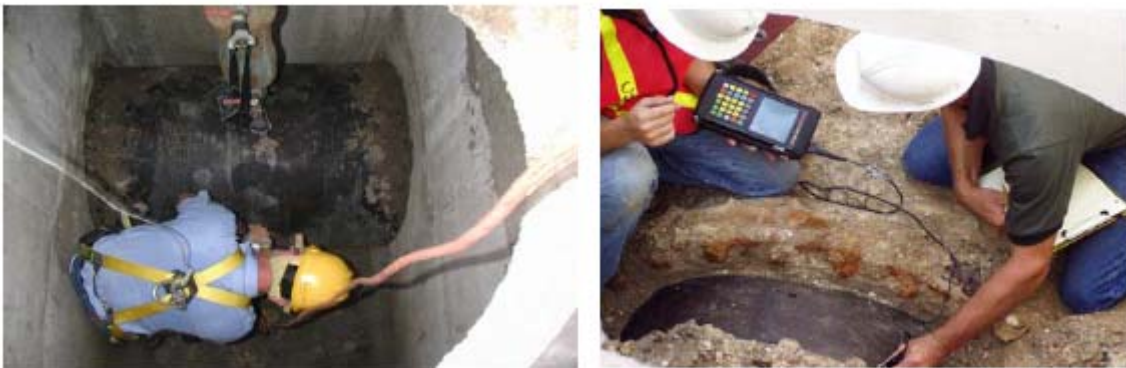
**Figure H-11. GRU engineers and crews performing pipe wall thickness testing**

**Figure H-11** shows engineers and crews performing pipe wall thickness testing after accessing the pipeline.

Nearly 1,700 pipe wall thickness test measurements have been collected to assess the overall condition of GRU's major force mains. The following conclusions can be made from this effort:

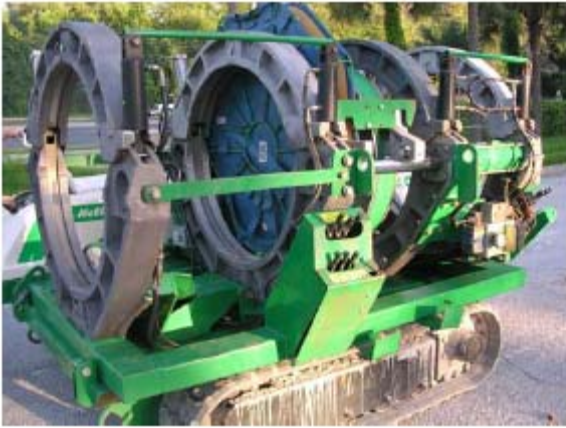
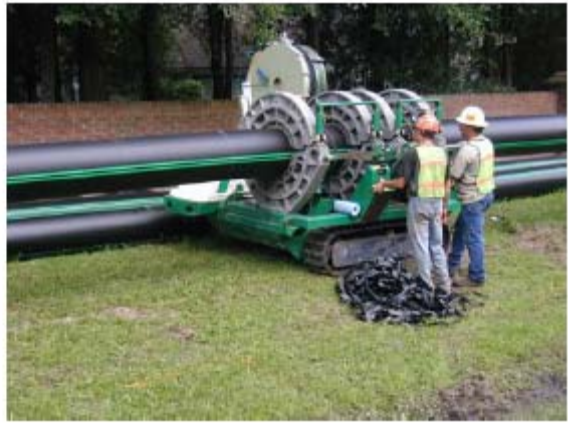
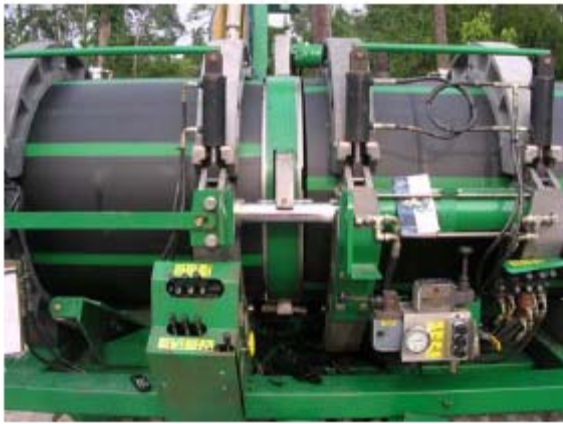
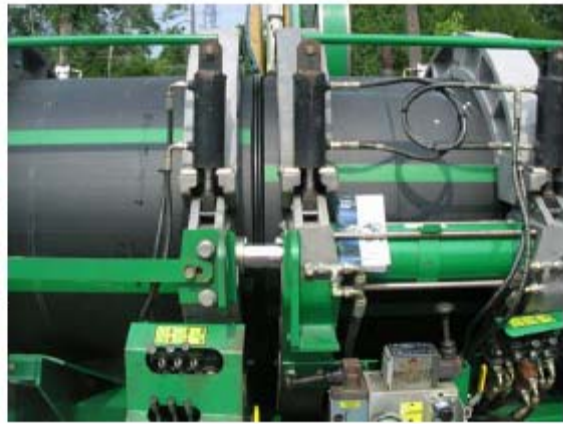
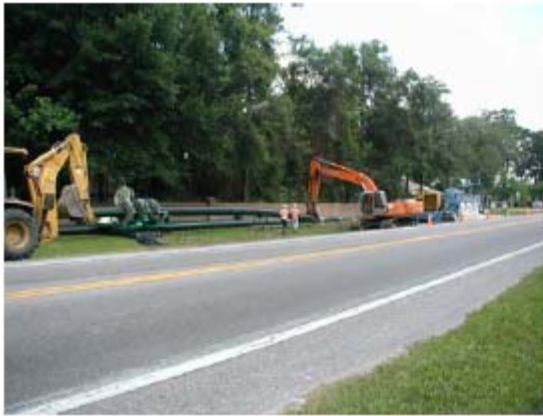
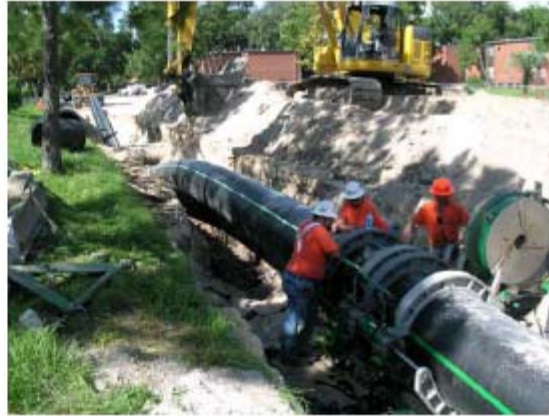
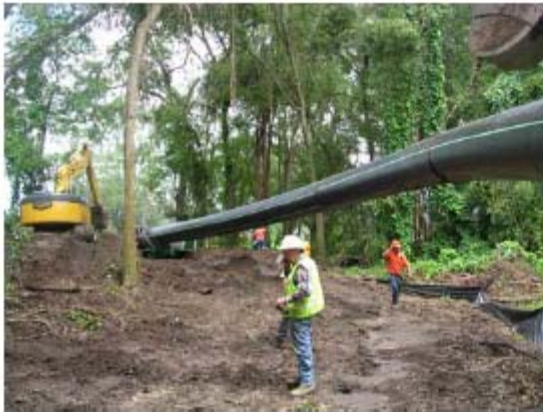
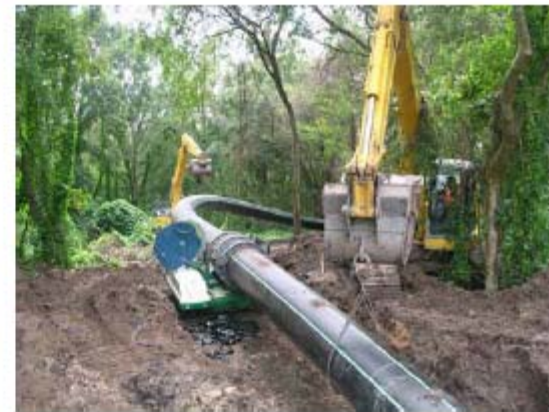
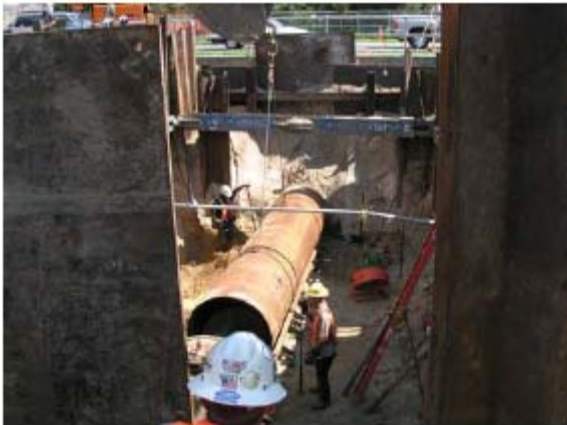
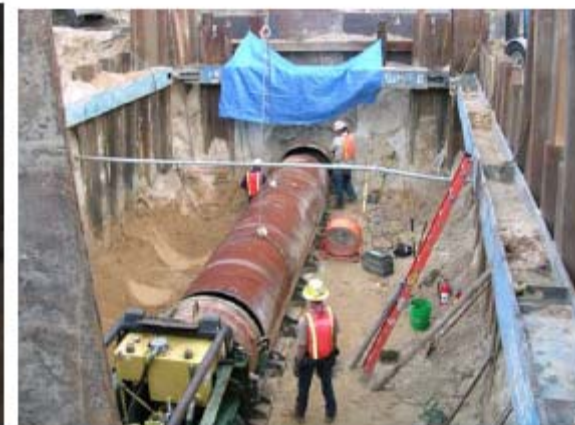
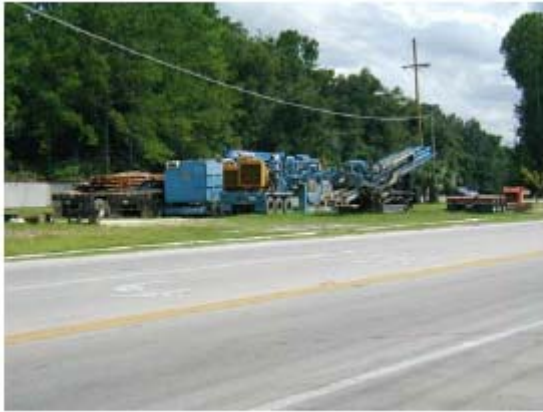
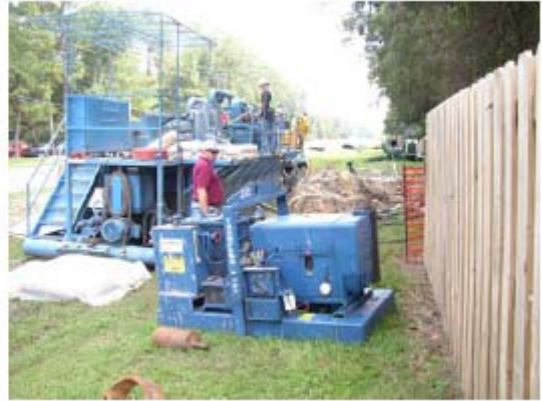
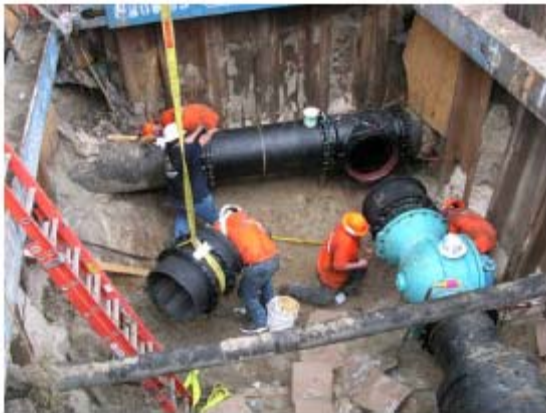
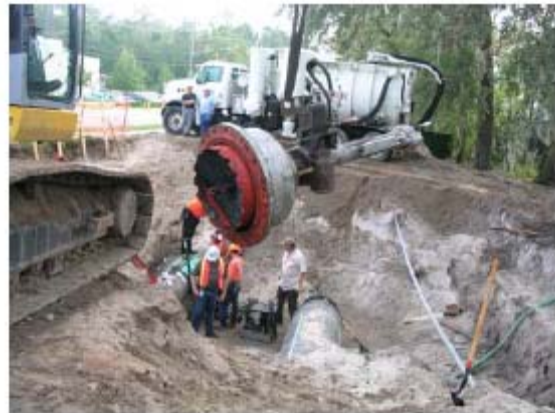
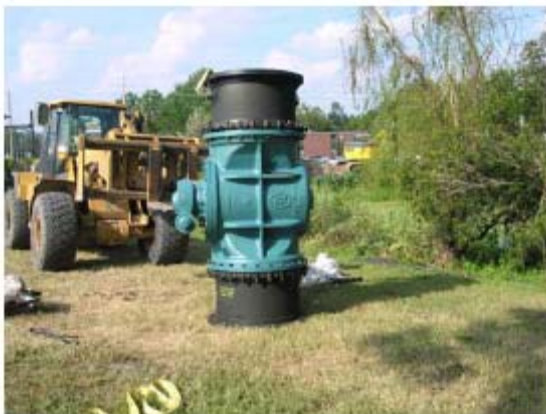
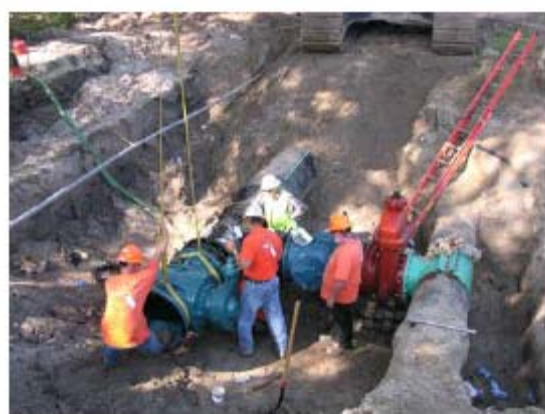
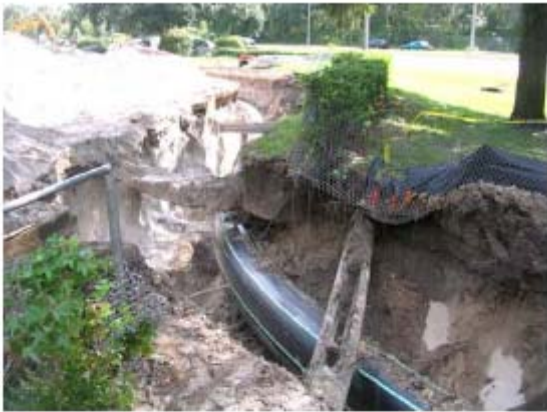
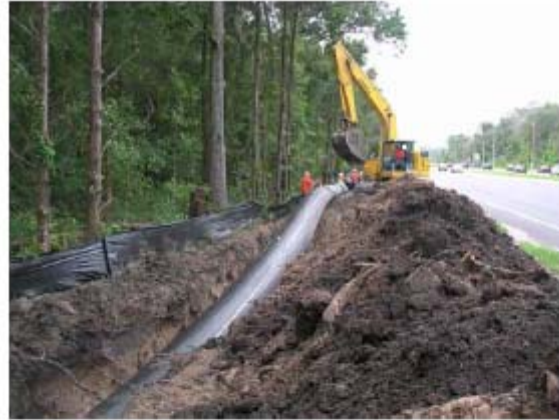
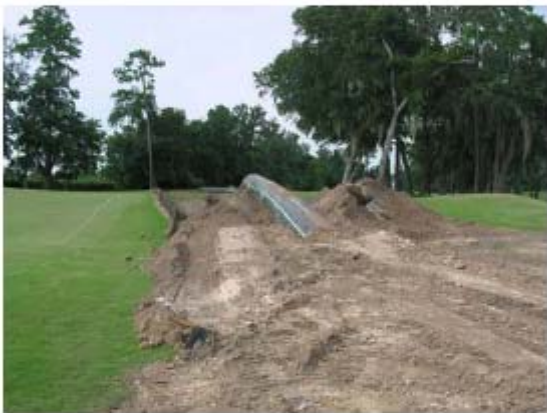
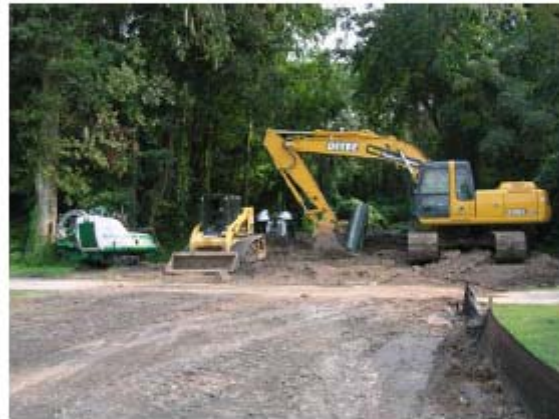
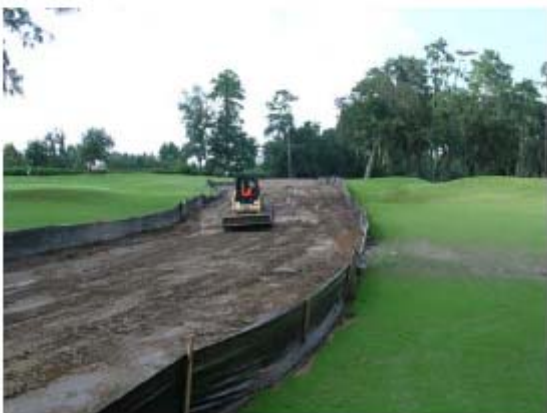
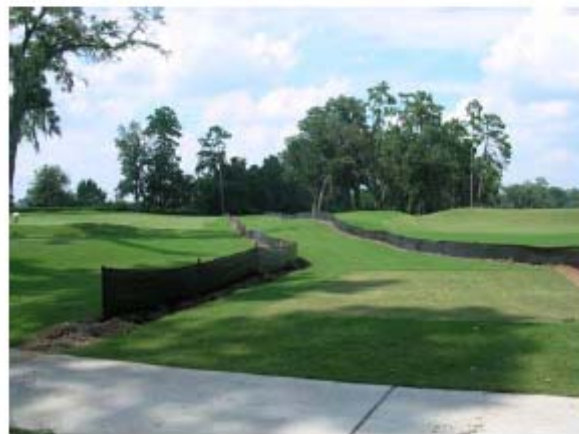
**Figure H-12. Force main replacement on NW 34<sup>th</sup> Street**

**Figure H-12** shows the force main replacement on NW 34<sup>th</sup> Street; this provides an example of a major capital project and the equipment methods utilized to complete a project of this scale. Approximately \$4.2 million was spent to replace 10,730 feet of force main piping.

***HDPE Butt Welder Creates Contiguous Force Main Pipe Onsite***

***Pipe Assembly and Installation near 34<sup>th</sup> Street***

***Trench Boxes Installed and Jack and Bore Method Utilized to Install Pipe Casing under Utility Conflicts such as Roads, Gas Lines, and the Stormwater Sewer System***

***Directional Boring Method Utilized to Install Piping Casing under  
Utility Conflicts such as NW 34<sup>th</sup> Street***

***Tie In of New Pipe to Existing Pipe Utilizing Trench Box, Tapping  
Tool, Valve Assemblies and Excavation***

### ***Final Steps in Pipeline Installation***

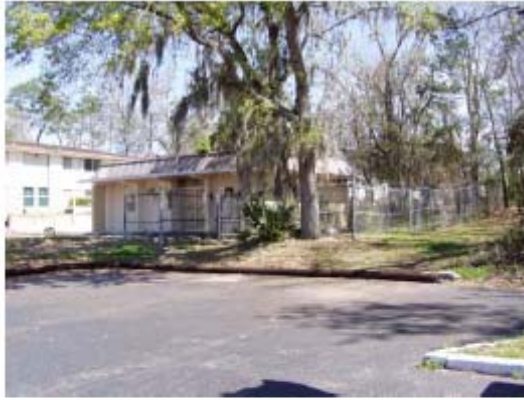
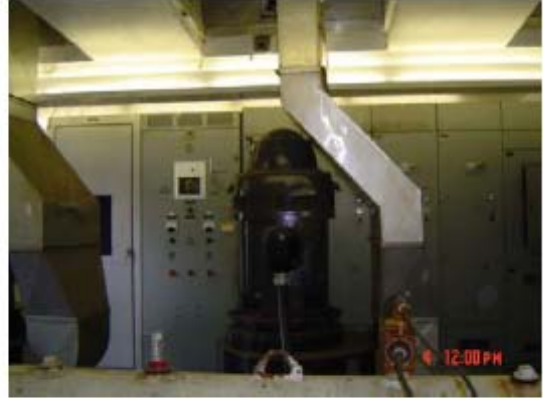
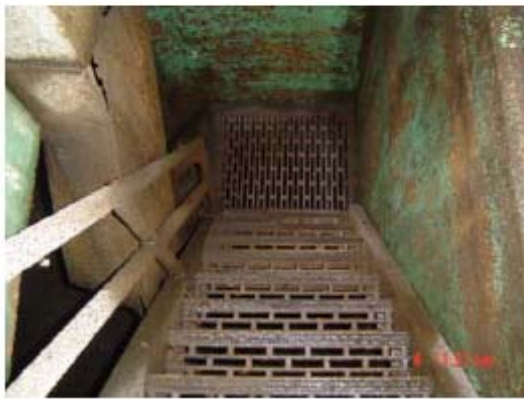
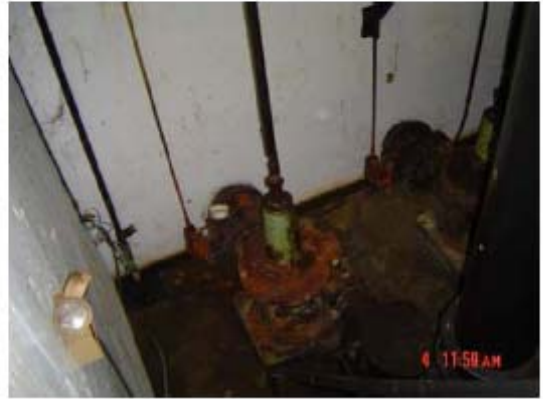
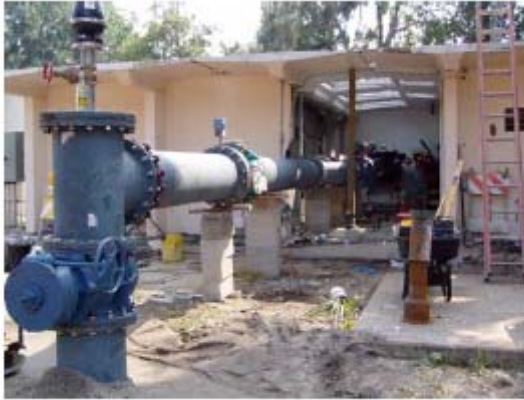
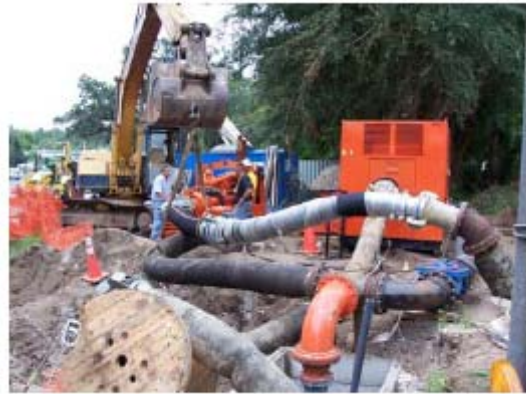
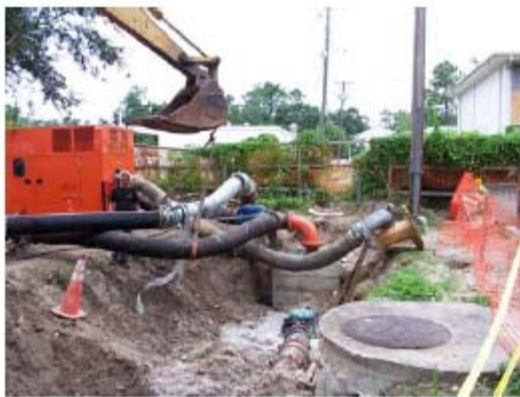
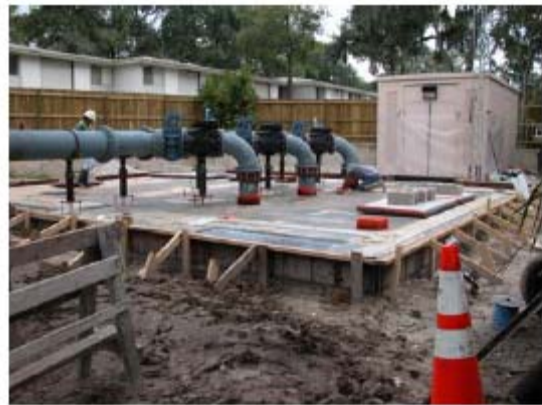
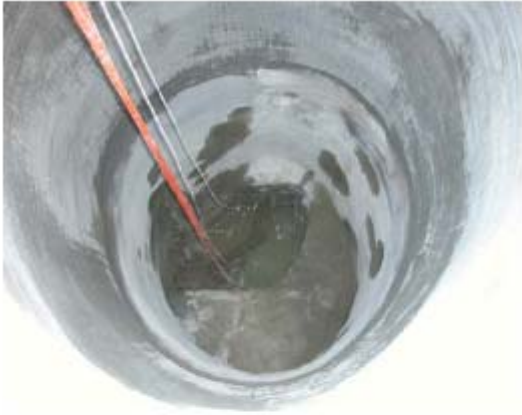
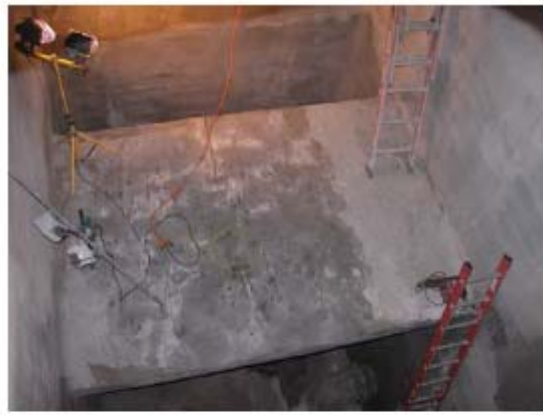
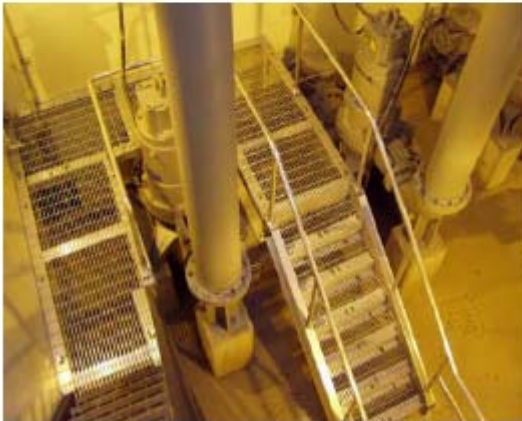
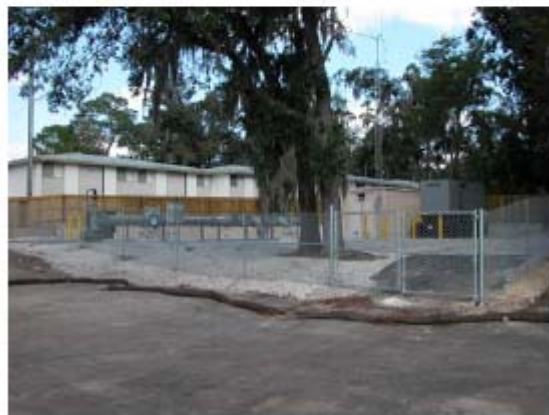
Figure H-13. LS 10 renovation

This capital project replaced the existing pumps, controls, and mechanical equipment. The antiquated station was converted from a Yeomans wetwell/drywell station to a more efficient Flygt submersible station with upgraded controls, variable frequency drives, and mechanical appurtenances.

*Lift Station before Renovation*

***Lift Station during Renovation with Demolition and External Pumping***

***Renovated Receiving Manhole, Wetwell, Drywell, and Completed Lift Station***
