# **Orange Creek Basin Management Action Plan:**

## **Gainesville Urban Creek Watersheds Hot Spots Project Overview and Implementation**

Orange Creek Basin Working Group  
September 11, 2009

# **Evaluation of Fecal Coliform Bacteria “Hot Spots” in Gainesville Urban Creeks (Orange Creek Basin)**

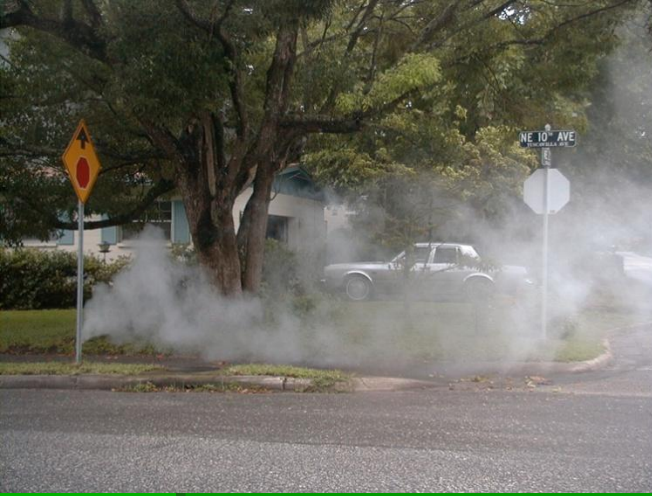
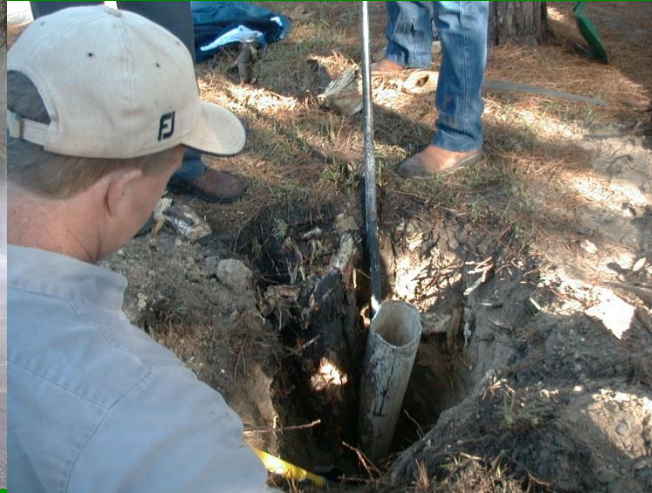
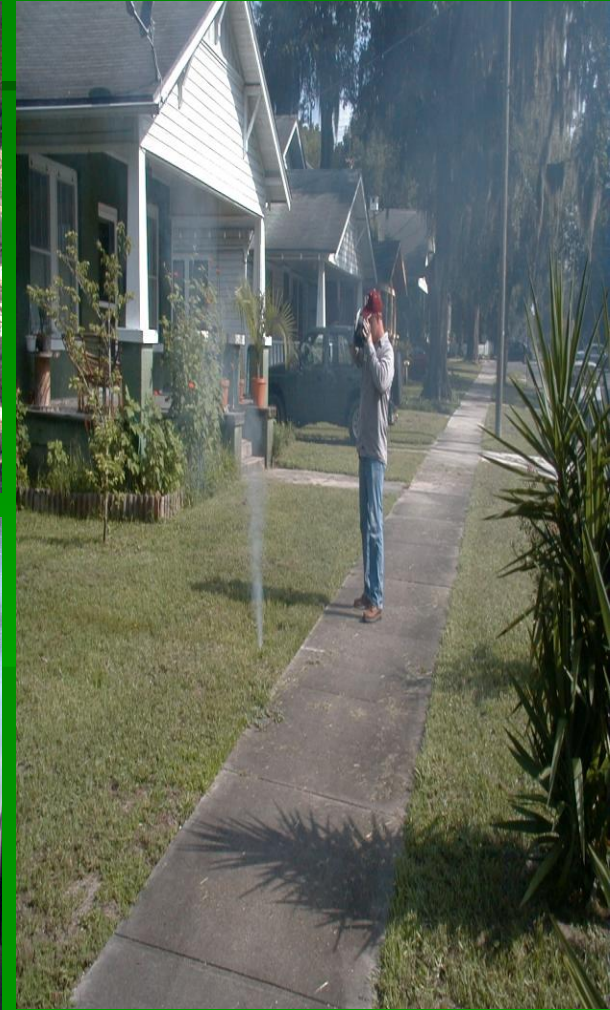
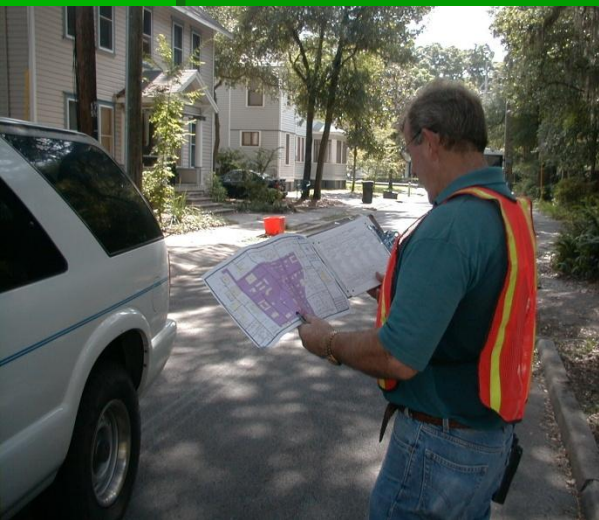
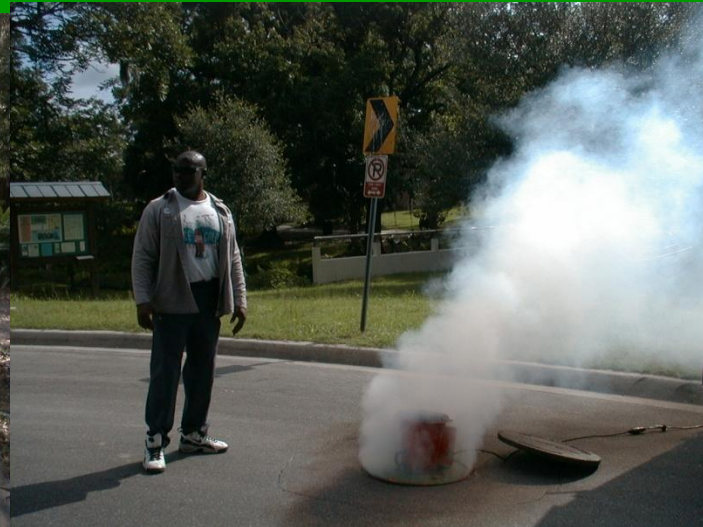
# I & I Inspection – Smoke Testing

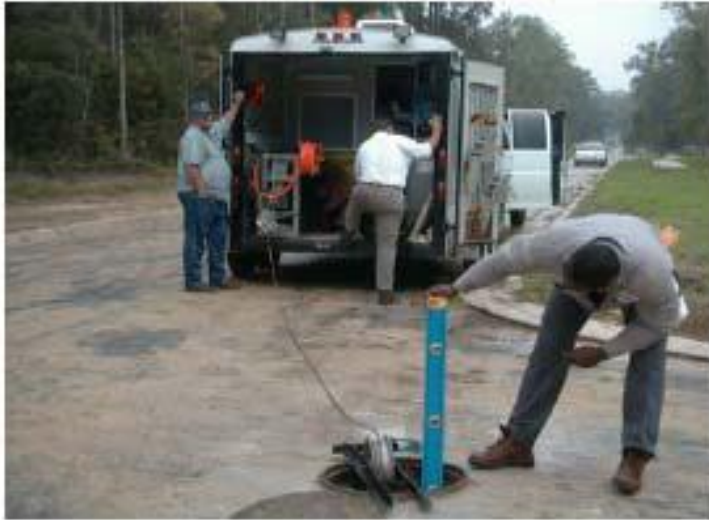
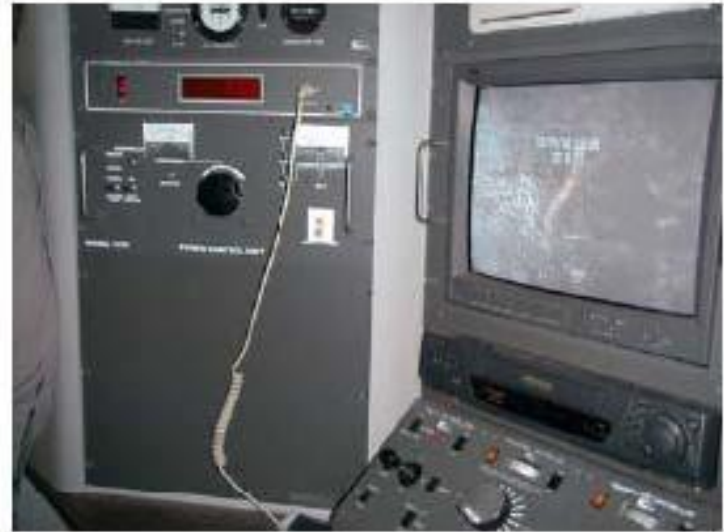
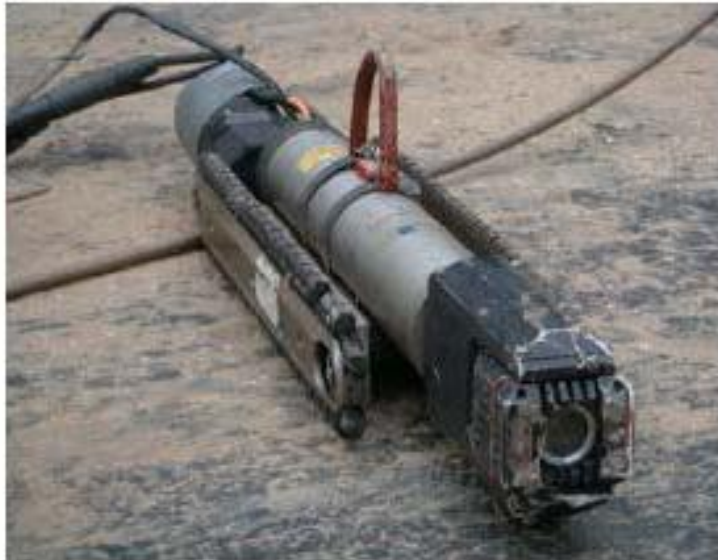
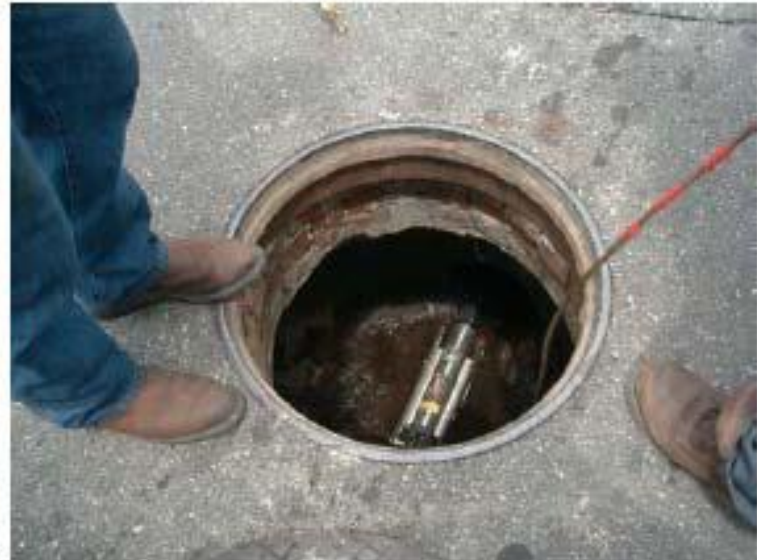
# ***Closed-Circuit TV Inspection Crew and Equipment – Used in recent implementation work with ACEPD Stormwater Recon***

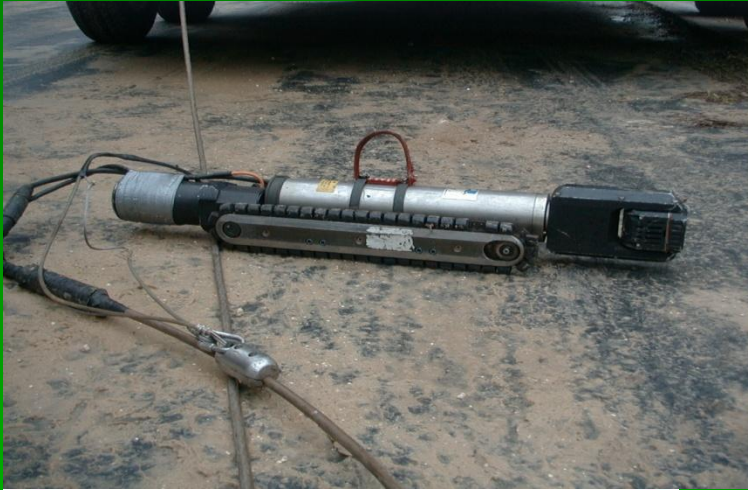
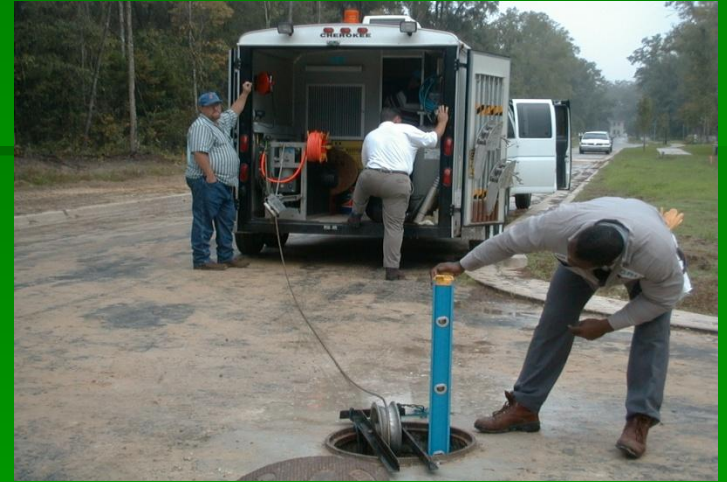
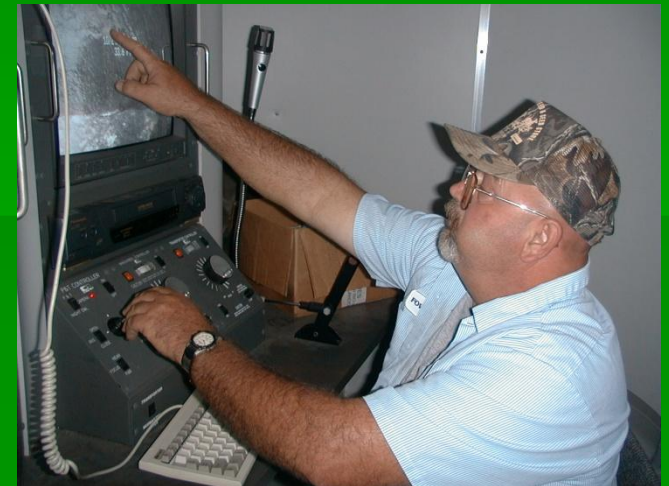
# TV Inspection

CCTV Camera

- Approximately 220,000 LF of pipe inspected per year
- Average Annual O & M Cost \$130,000

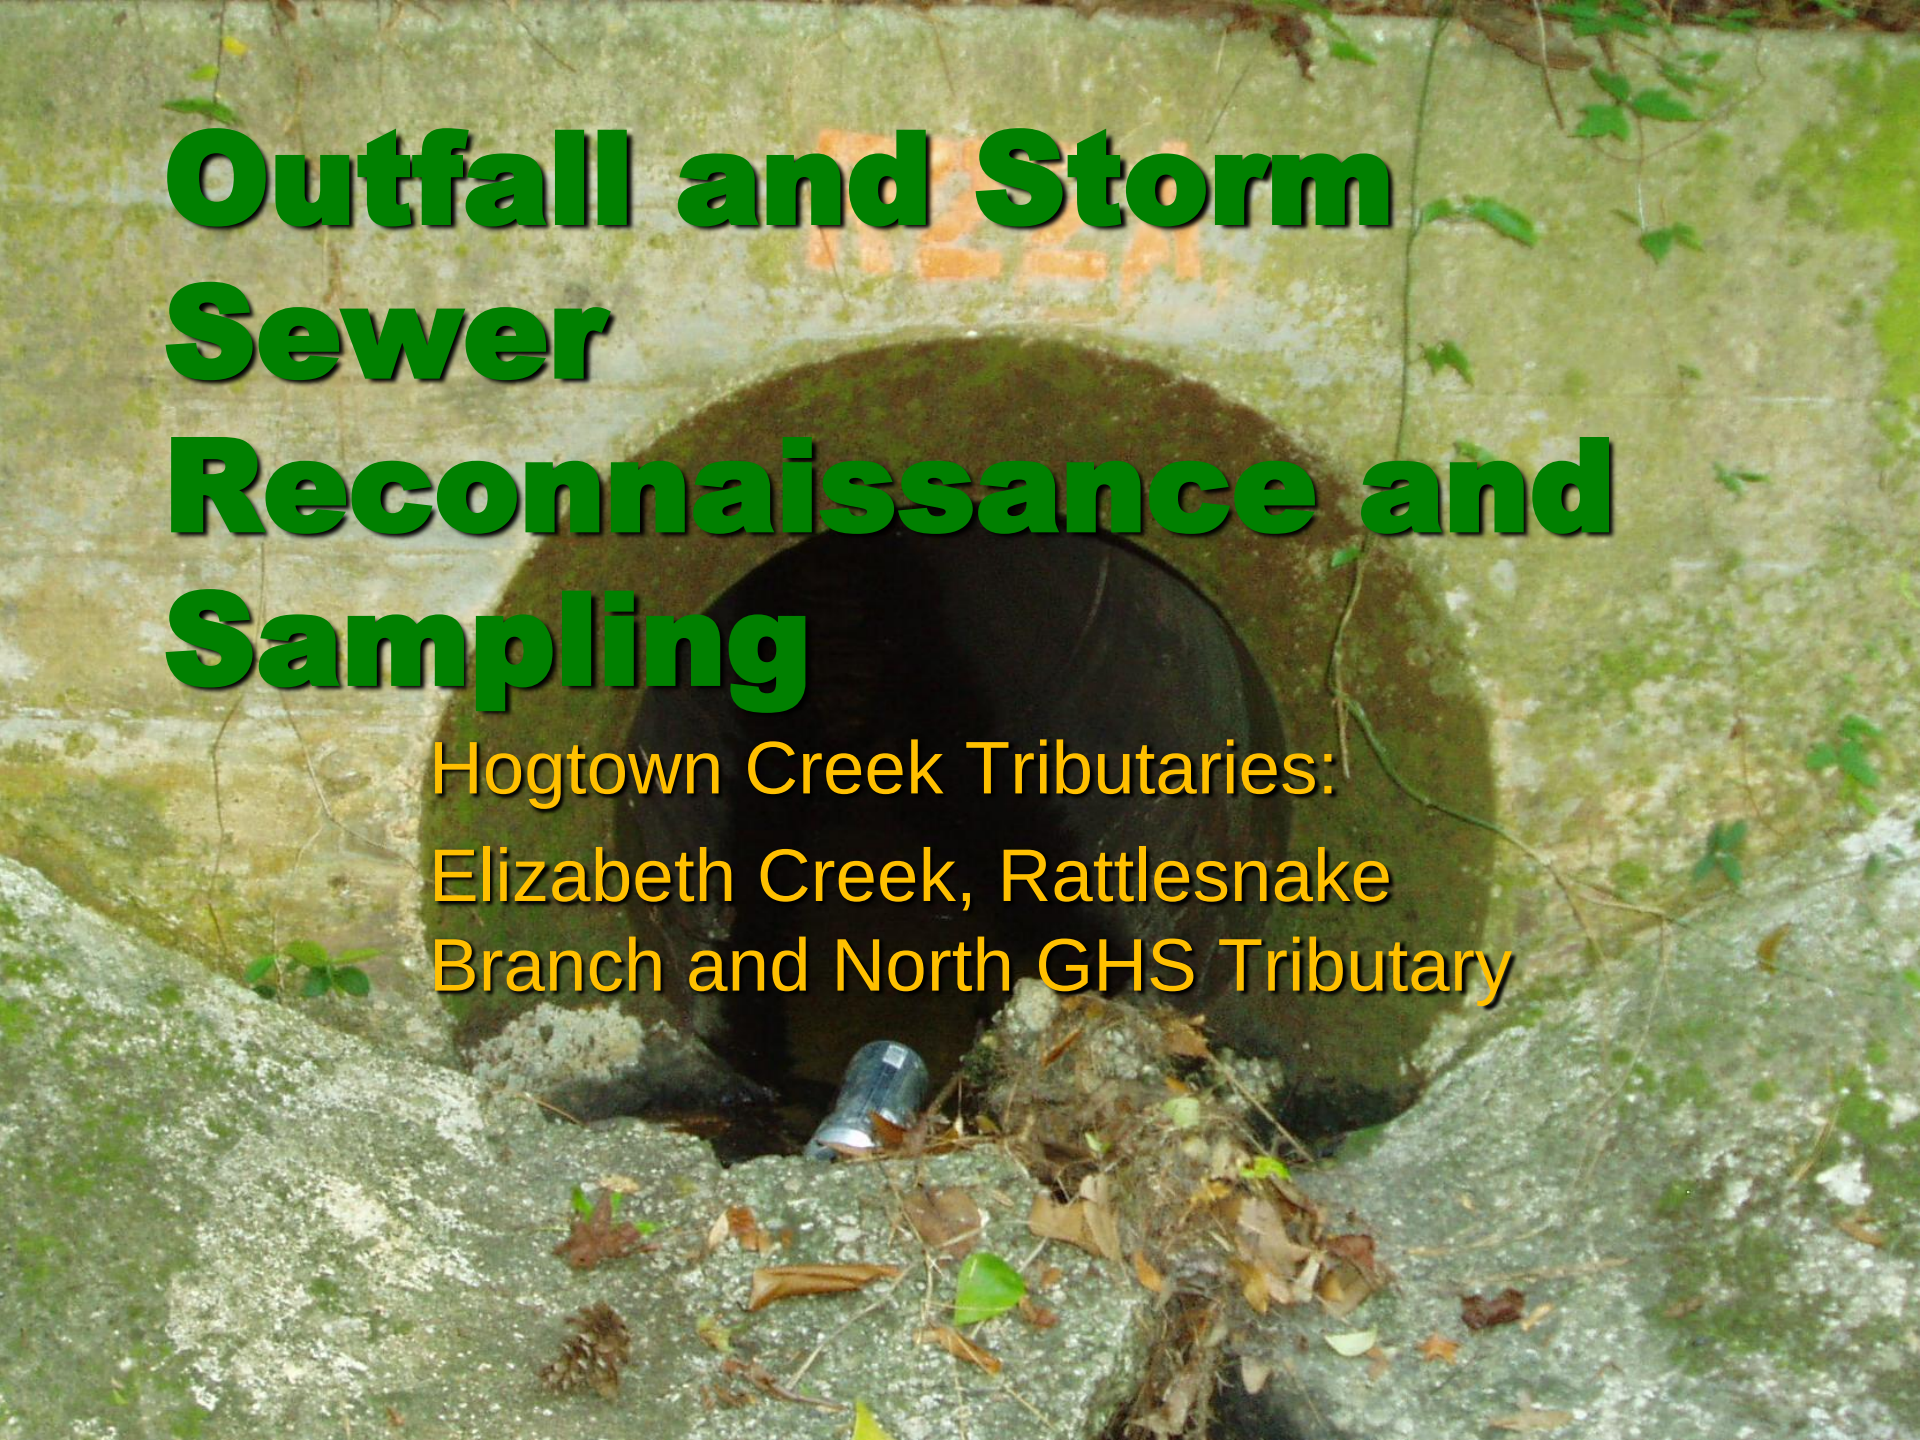
The background image is a photograph of a concrete storm sewer outlet. A dark, circular opening is visible in the center, with a metal pipe protruding from the bottom. The concrete is covered in green moss and algae. There are some brown leaves and debris scattered around the base of the pipe.

# **Outfall and Storm Sewer Reconnaissance and Sampling**
