**Analysis of Fecal Loadings  
Into Bayous Grande, Chico, and Texar  
Pensacola Bay System, FL**

12 September 2006

Prepared for:  
Florida Department of Health  
Escambia County Health Department

Richard A. Snyder, Ph.D.  
Center for Environmental Diagnostics and Bioremediation  
University of West Florida  
11000 University Parkway  
Pensacola, Florida 32514

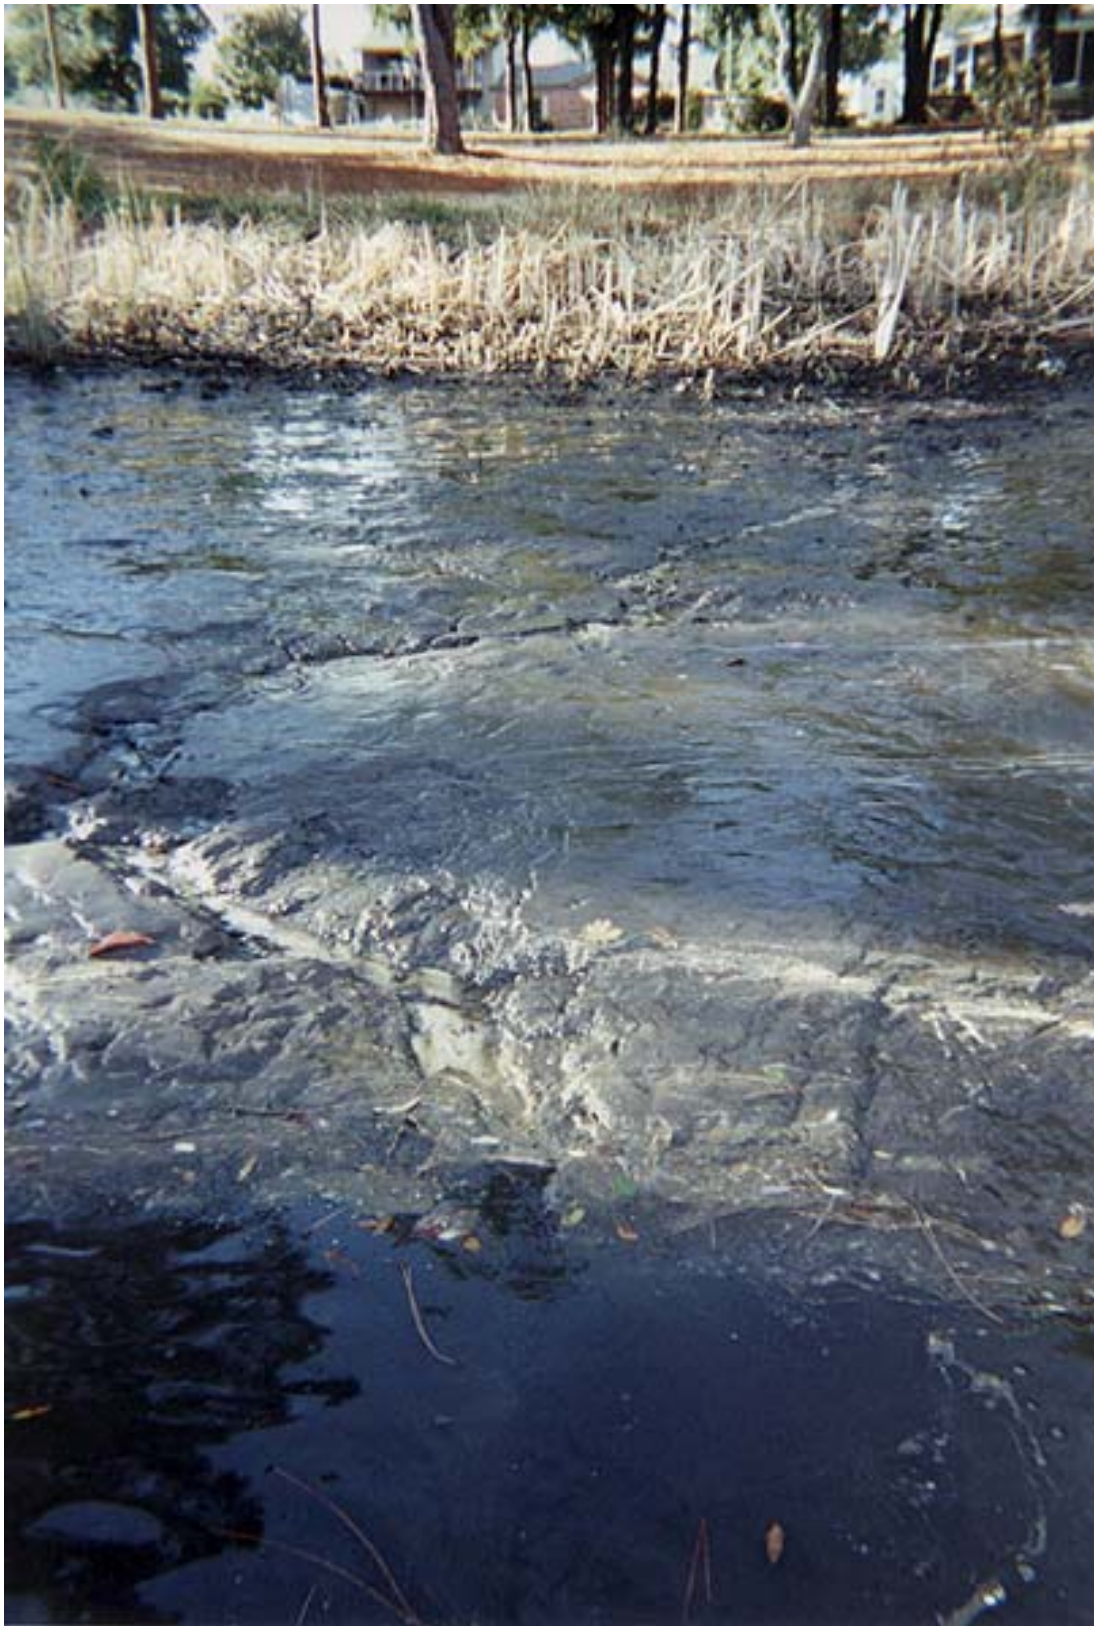
Figure 38. In the north arm of Bayou Grande, a ground water stream is pictured leaving the shoreline below the wetland vegetation under the high tide mark and traversing the intertidal zone.

In Bayou Grande, extreme low tides in the winter of 2001 were targeted for sampling exposed groundwater flows across the intertidal areas into Bayou Grande. These groundwater discharges were visible as streams flowing out of the shoreline across the intertidal zone (Figure 38), plumes of water emerging from invertebrate burrows under hydrostatic pressure, and as less well defined broad seepage areas emerging from the sands and muds of the intertidal zone. For Bayou Grande, sample locations were identified by eye, and by gauging the rate of fill (if any) in shallow (6-8") holes dug in the upper intertidal zone.
