# Palm Springs

## Sampled 2013-2014

### Site Information

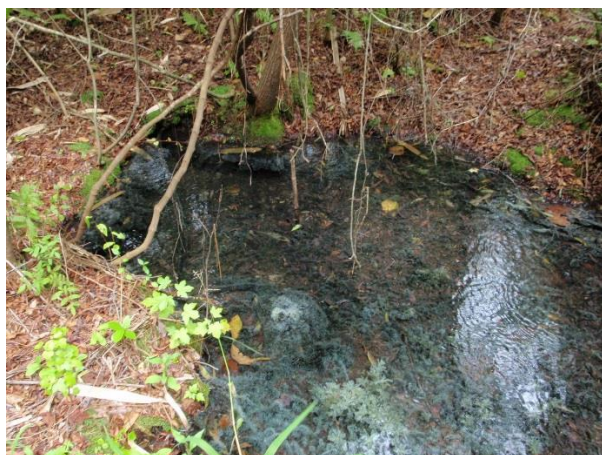
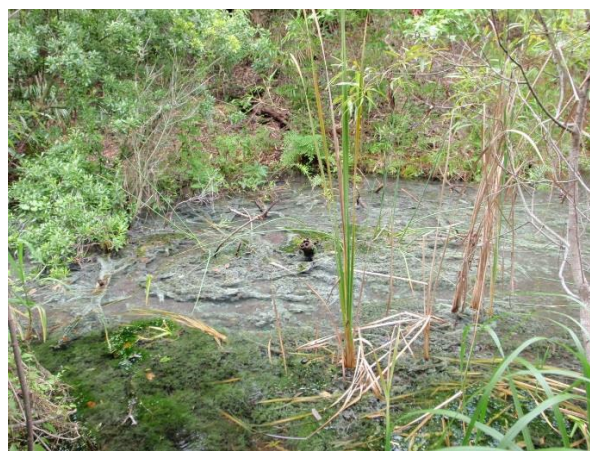
**Figure 2-PA. Palm Springs Vent (A) and Spring Run (B)**

(A)

(B)

A full habitat assessment was performed on October 9, 2013. Two major macroinvertebrate habitats were noted: aquatic macrophytes and snags, though both were heavily smothered by sulphur-reducing bacteria and periphyton in most of the run. Smothering lessened the further away from the springs the habitats were located. All secondary parameters reflected optimal conditions, with just one point deducted for bank stability as the bank slope was steep due to the springs being at the bottom of a ravine. The spring run was shallow and mostly sandy, but soft.
