**PHOTOGRAPHS**  
**New River**

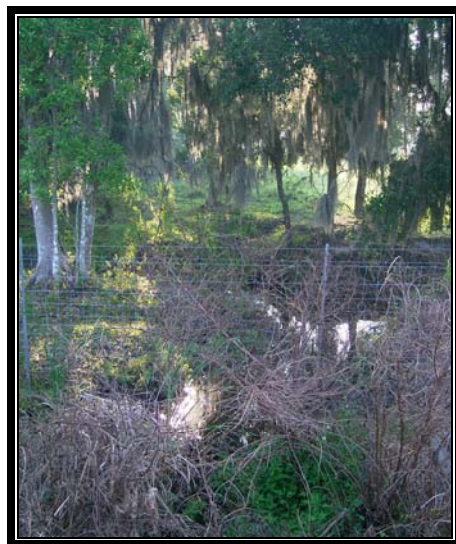
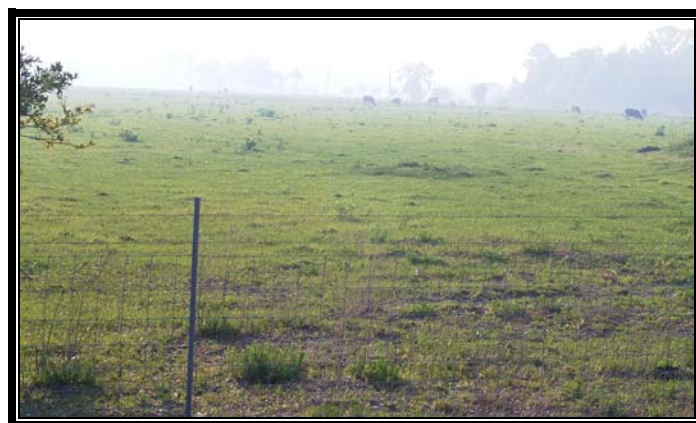
**Photographs 2 and 3.** Pasturelands characterize the headwaters of the eastern branch of the New River north of SR-54.

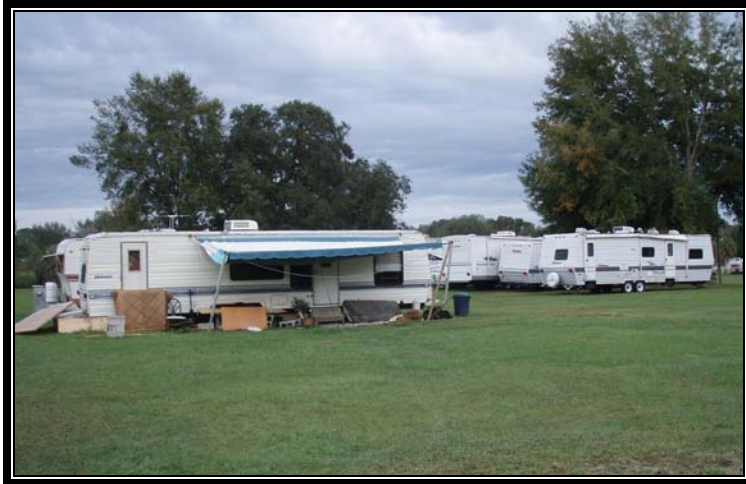
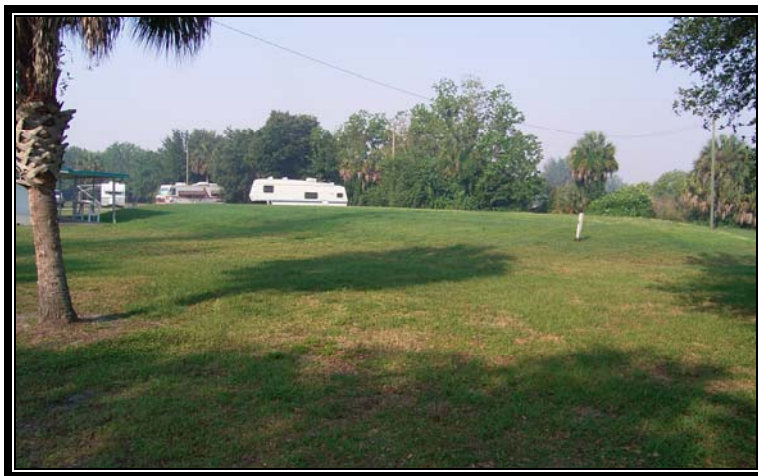
**Photographs 4 and 5.** The New Beginning RV Park, located immediately south of SR-54, utilizes a septic drainfield located within 20 m of the New River.

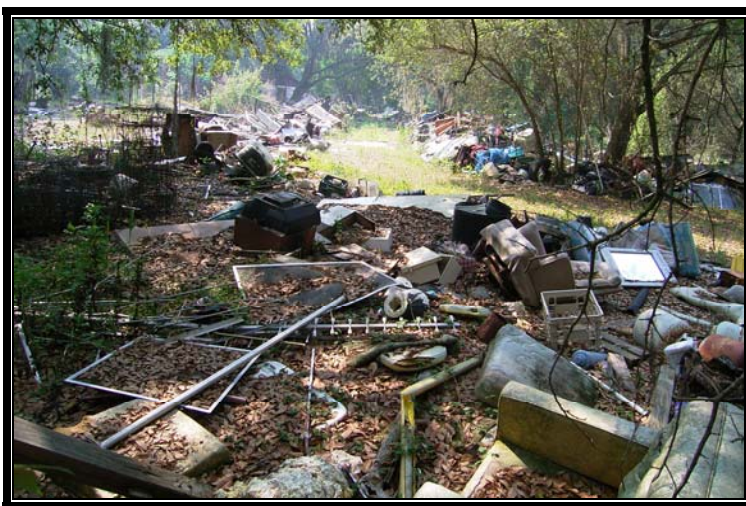
**Photograph 6.** Trash was commonly observed in the main channel of the New River during the May 8, 2007 field effort. This property is directly adjacent to the channel.

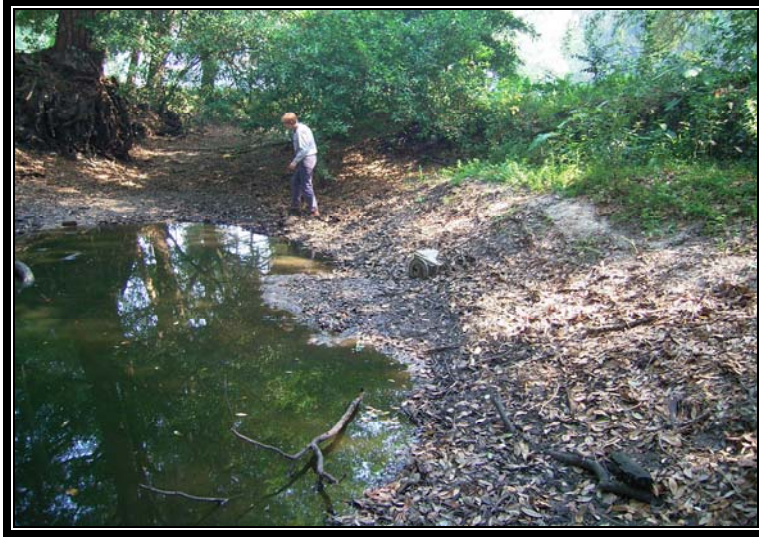
**Photograph 7.** A slight sewage odor was detected in this area during the "Walk the WBIDs" effort on May 8, 2007.

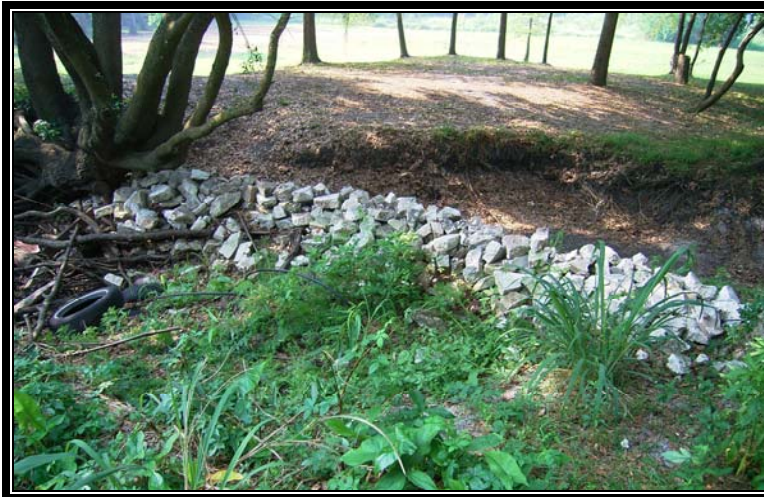
**Photograph 8.** A manmade dam located between Brisk Drive and Chancey Road just upstream of a wetland that may help to mediate impacts from potential upstream sources of fecal pollution.

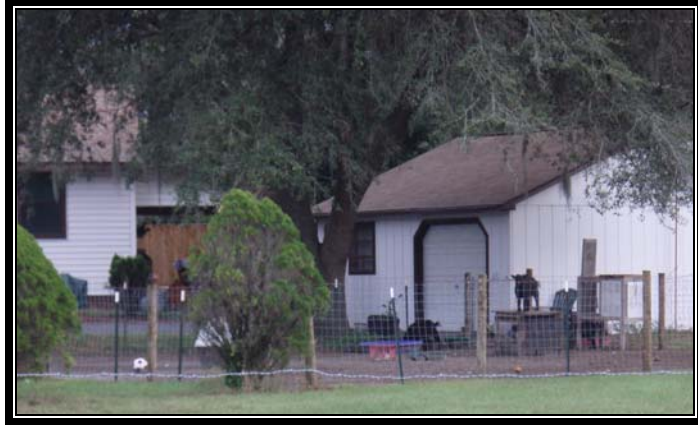
**Photograph 9.** Secondary sources of fecal pollution just south of SR-54 include wildlife and domesticated animals.

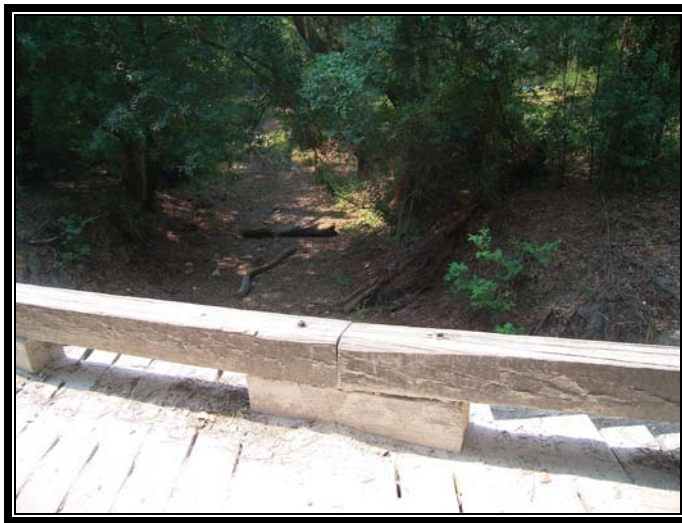
**Photograph 10.** Field observations indicated that there was no flow in the New River on May 7, 2007.

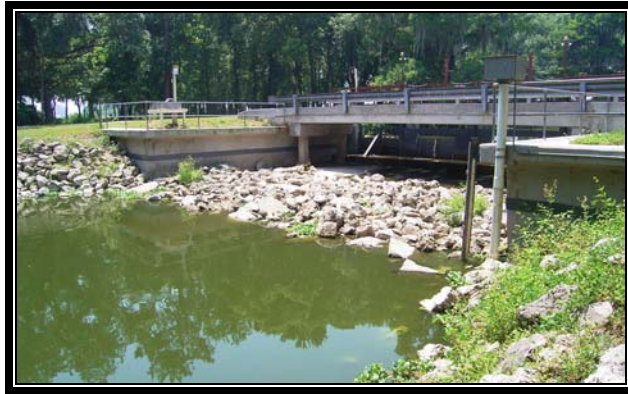
**Photograph 11.** Lake Thonotosassa control structure at the headwater of Flint Creek.

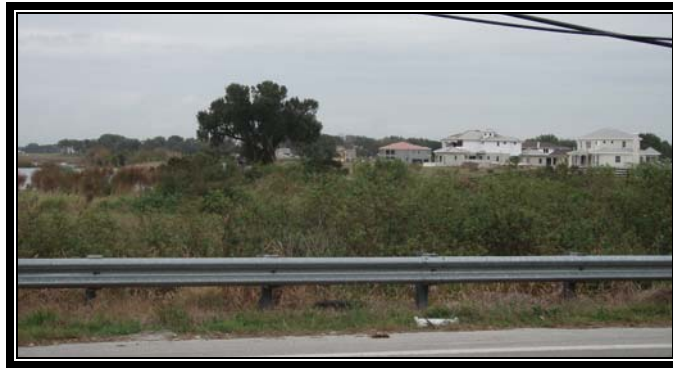
**Photograph 12.** New housing developments are common along the shoreline of Lake Thonotosassa.

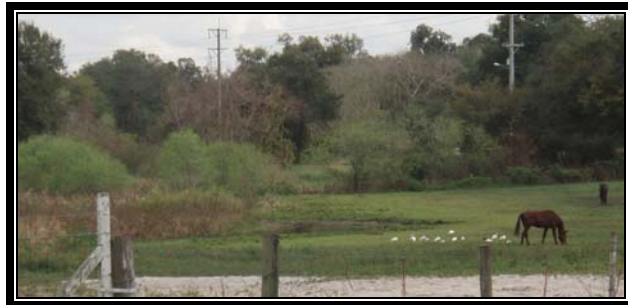
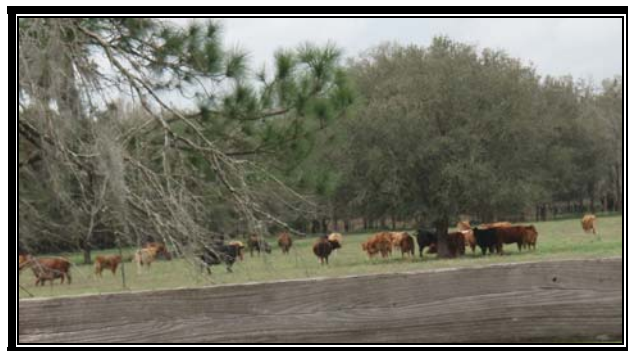
**Photographs 13 and 14.** Livestock were observed standing alongside creek beds and associated wetlands during both preliminary field reconnaissance efforts (February and May 2007).

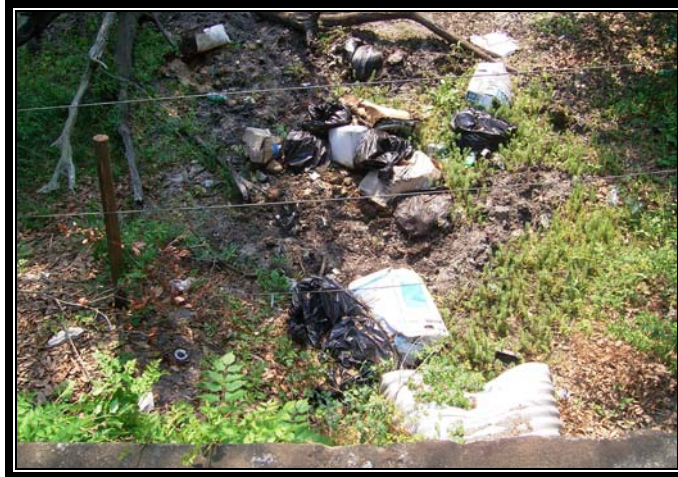
**Photograph 15.** Trash was observed, apparently dumped from the road, in the dry bed of Baker Creek along Kingsway Road during the May 8, 2007 field visit.

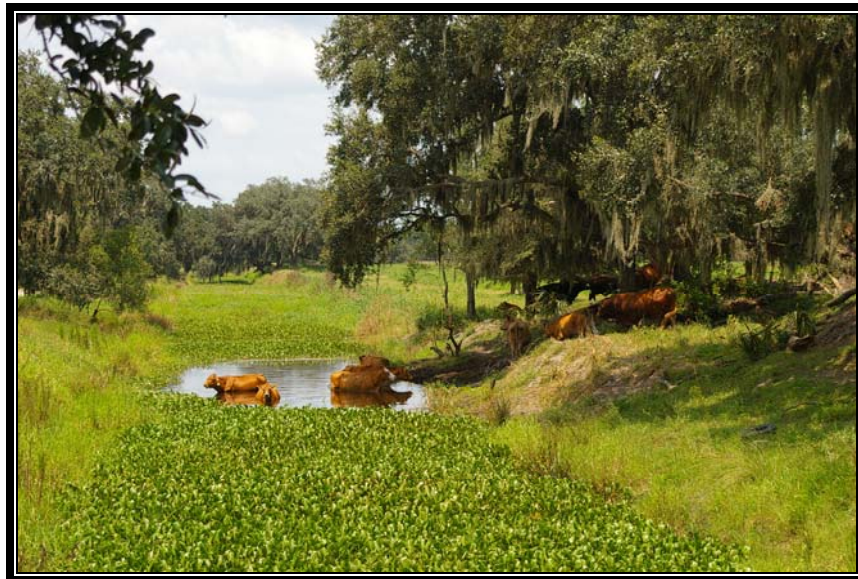
**Photograph 16.** Station DBK1 was characterized by highly vegetated water resulting in a greater potential for persistence and growth of bacteria.

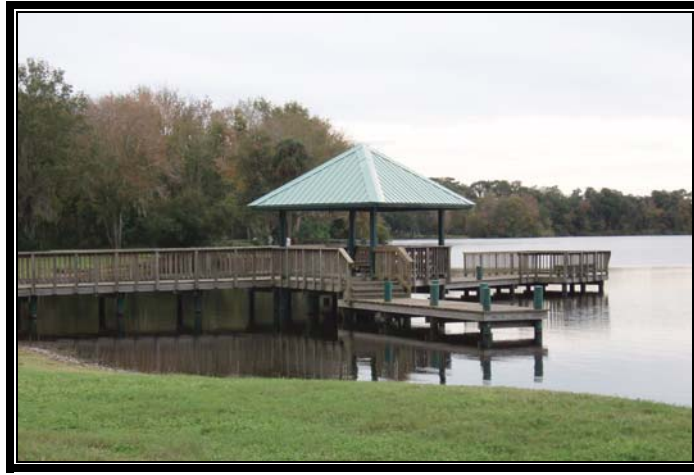
**Photograph 17.** The headwater of Spartman Branch is Walden Lake, located in a large residential golf community.

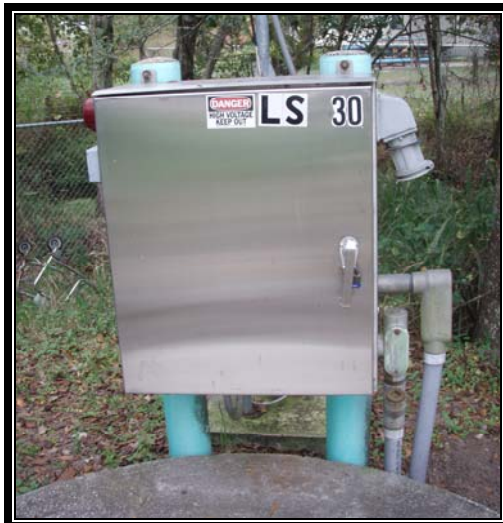
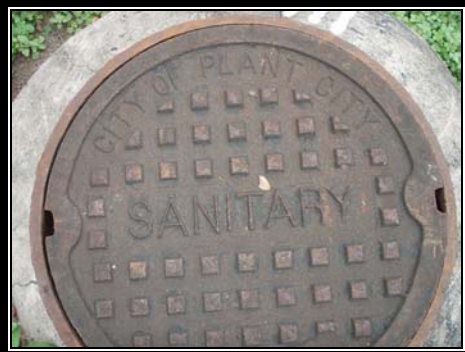
**Photographs 18 and 19.** City of Plant City lift station and manhole located on Airport Road in the industrial area of Spartman Branch.

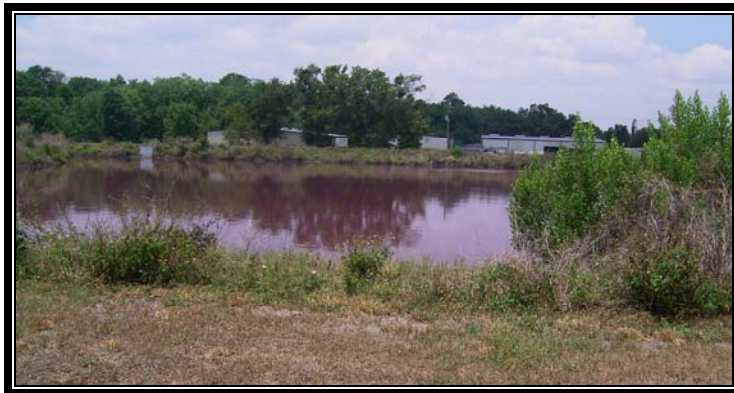
**Photograph 20.** A discolored stormwater pond was identified at the junction of Sammonds Road and Woodrow Wilson Street during the May 10, 2007 site visit.

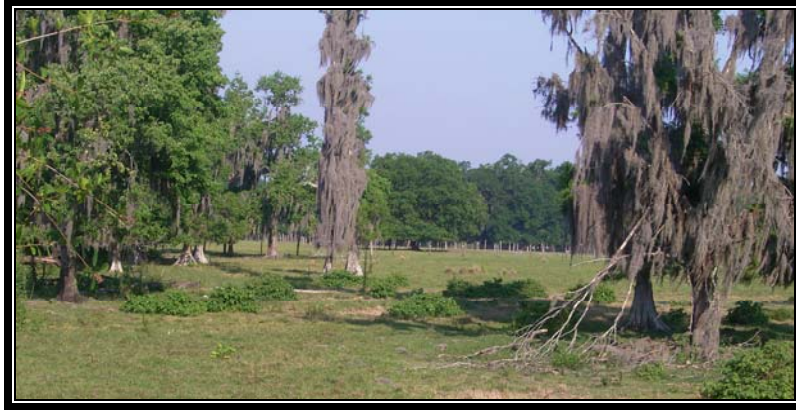
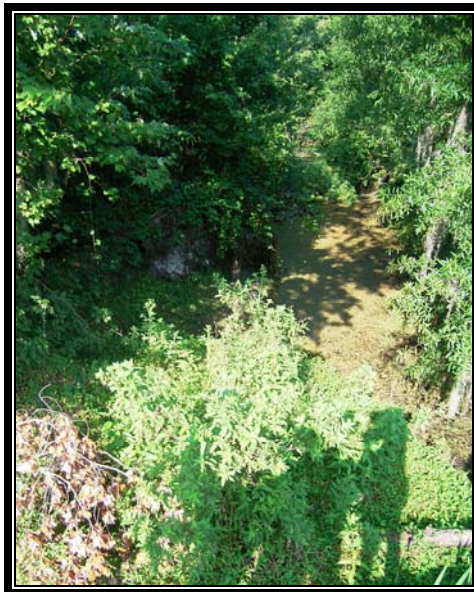
**Photographs 21 and 22.** Pasturelands and natural landscapes are characteristic of areas in Spartman Branch, especially in transition areas such as around Turkey Creek Road.

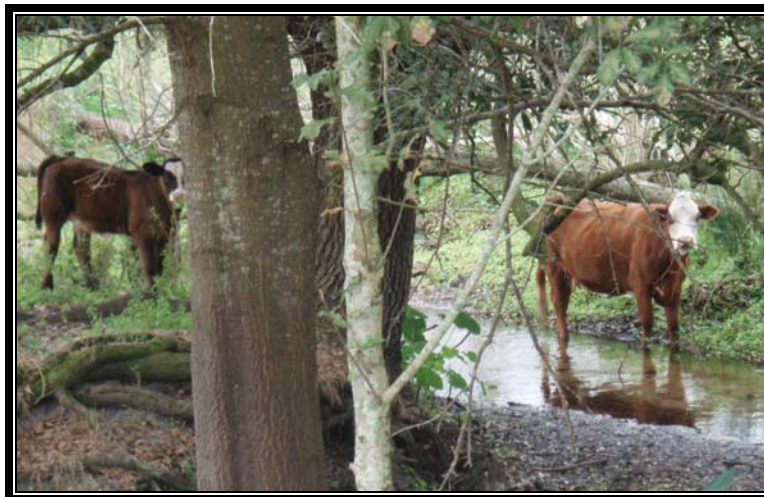
**Photograph 23.** Livestock are a potential source of fecal pollution in Spartman Branch, especially in the northern reaches of the WBID.

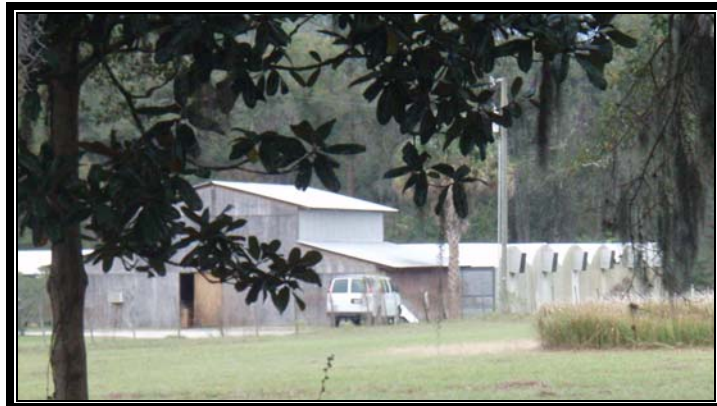
**Photograph 25.** Chicken houses, such as this one on Rushing Road, are located in the upstream section of Blackwater Creek.

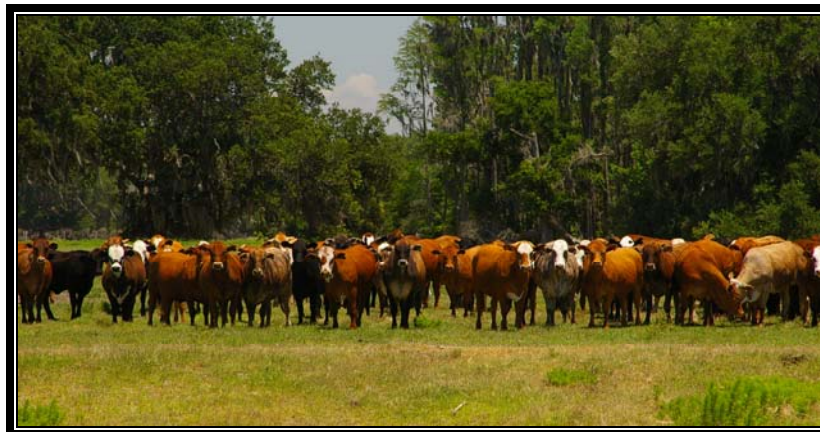
**Photograph 26.** Cone Ranch, an active cattle ranch, is the primary land use in the middle section of Blackwater Creek.

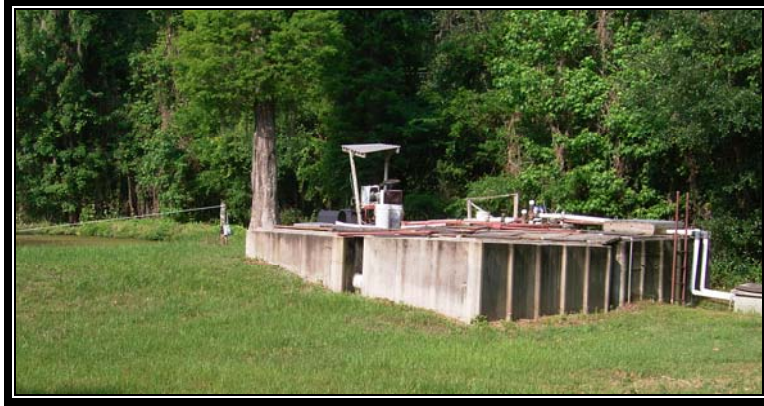
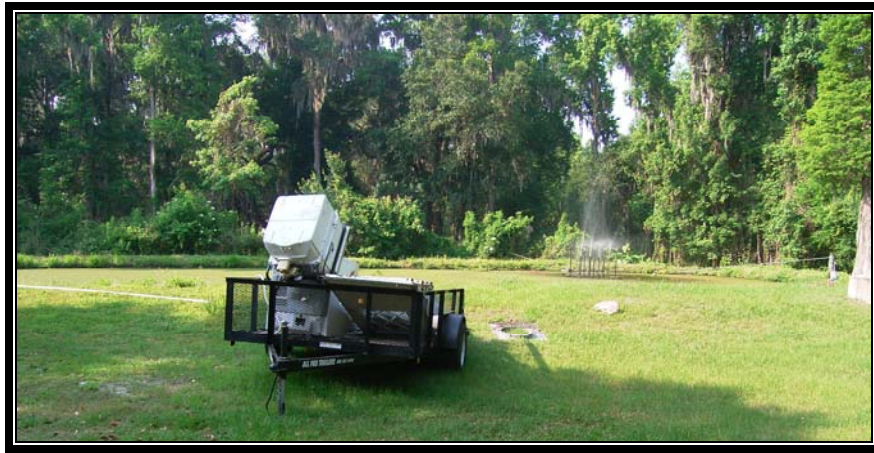
**Photographs 27 and 28.** Briarwood Estates is a mobile home park located in the upstream portion of Blackwater Creek and has its own wastewater treatment plant and pond system.

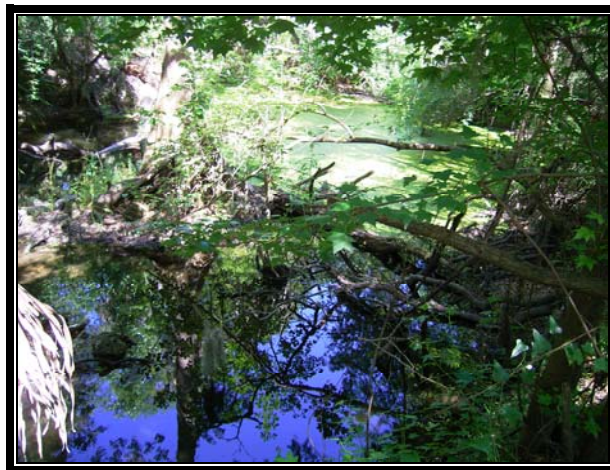
**Photograph 29.** The downstream section of Blackwater Creek includes large areas of native range, including Two Rivers Ranch.

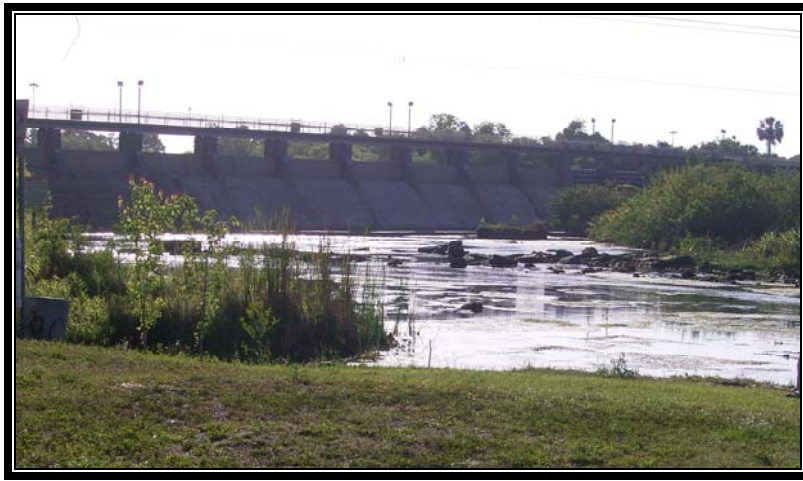
**Photograph 30.** Rowlett Park and associated dam structure are located just upstream of the Lower Hillsborough River northern WBID boundary.

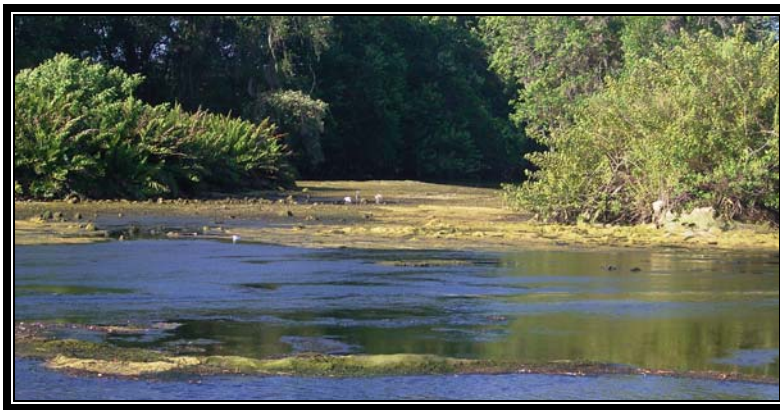
**Photograph 31.** Thick algal mats are common in the Lower Hillsborough River in the Rowlett Park area.

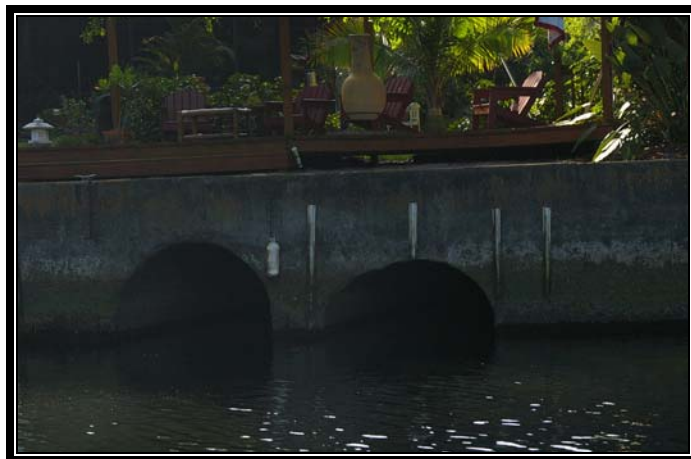
**Photograph 32.** There are several significant stormwater outfalls, such as this double culvert, that line the main channel of the Lower Hillsborough River. These conveyance systems are potential sources of fecal pollution to the tributary.

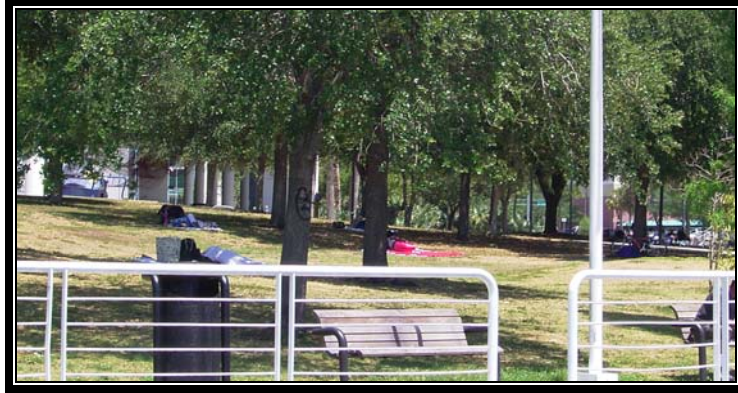
**Photograph 33.** Homeless populations, such as this one in Riverfront Park, are common along the Lower Hillsborough River. Although these communities are probable contributors of fecal contamination, their overall impact is likely to be relatively minor and insignificant.

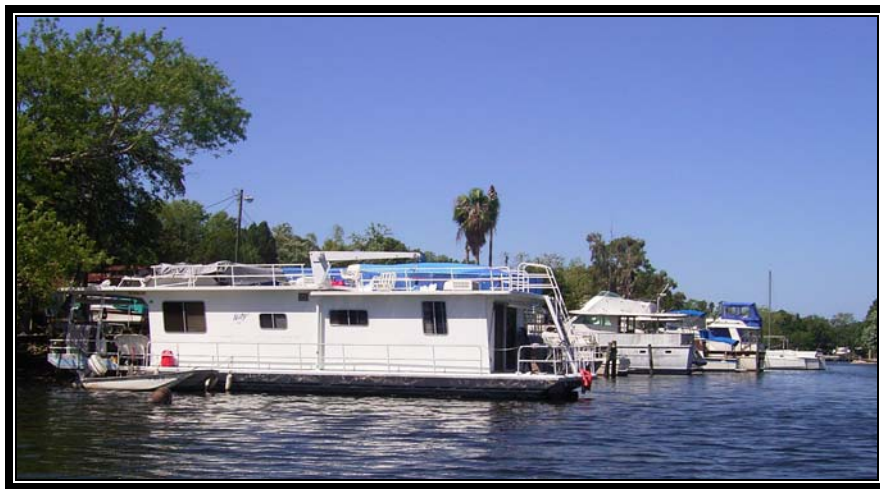
**Photograph 34.** Live-aboard vessels docked at marinas scattered throughout the Lower Hillsborough River possibly contribute relatively minor levels of fecal pollution to the tributary.

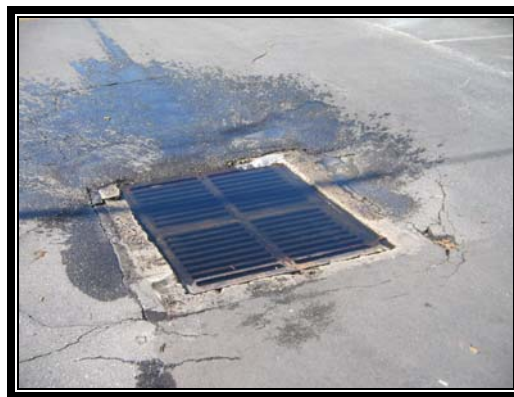
**Photograph 35.** This stormwater grate in the Fountain Bridge Apartment complex parking lot was consistently surcharged. Elevated bacteria concentrations and the human *Bacteroides* marker were detected in the water when sampled in December 2007 (station DHR10).
