# Rattlesnake Slough WBID #1923

*A SUMMARY OF THE*  
***WALK-THE-WBID***  
*EXERCISE*

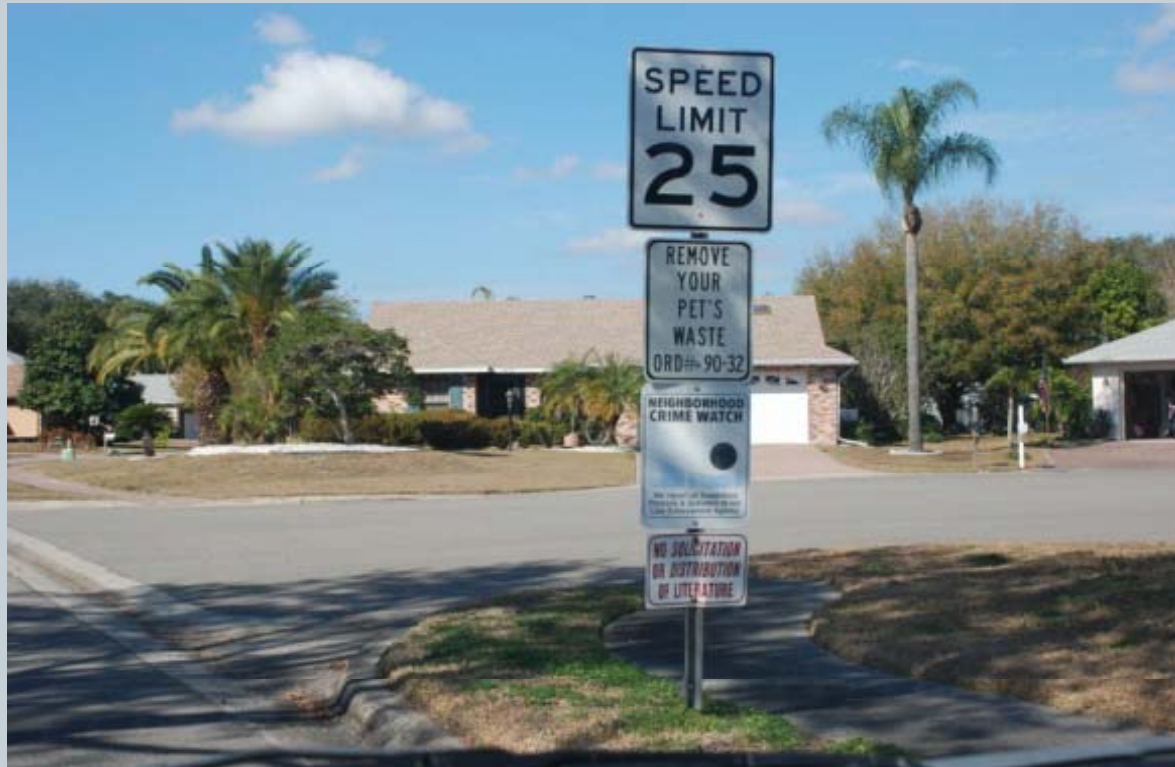
Sign on the right-of-way at the entrance to the Quail Run Subdivision east of Lockwood Ridge Road south of the Whitfield Avenue intersection encouraging removal of pest waste.

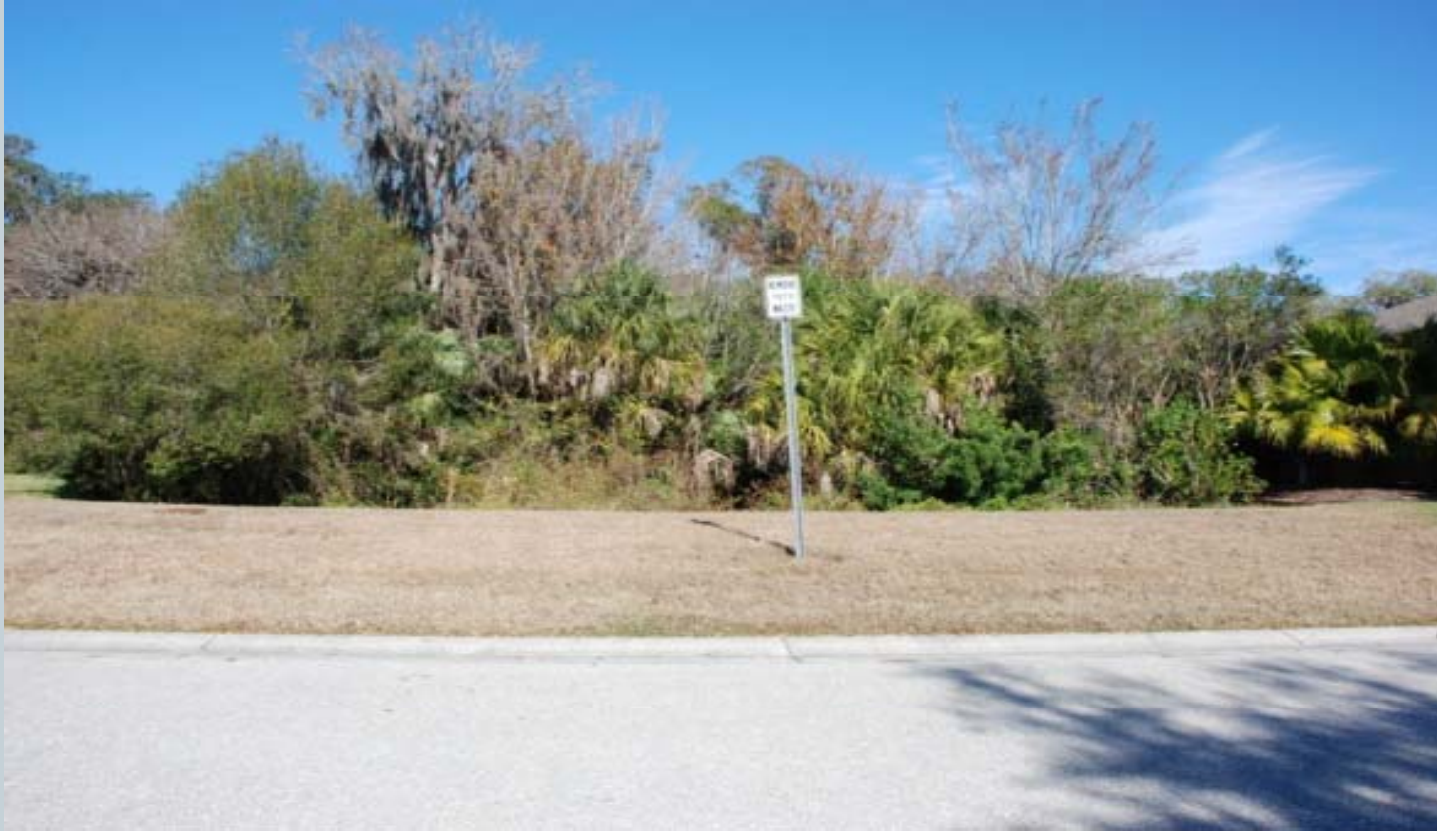
Sign on the right-of-way in the Villages of Palm Aire Subdivision at Creekside Trail near Carlyle Lane encouraging removal of pest waste. The Rattlesnake Slough riparian buffer is behind the sign. Other signs are located along Creekside Trail.

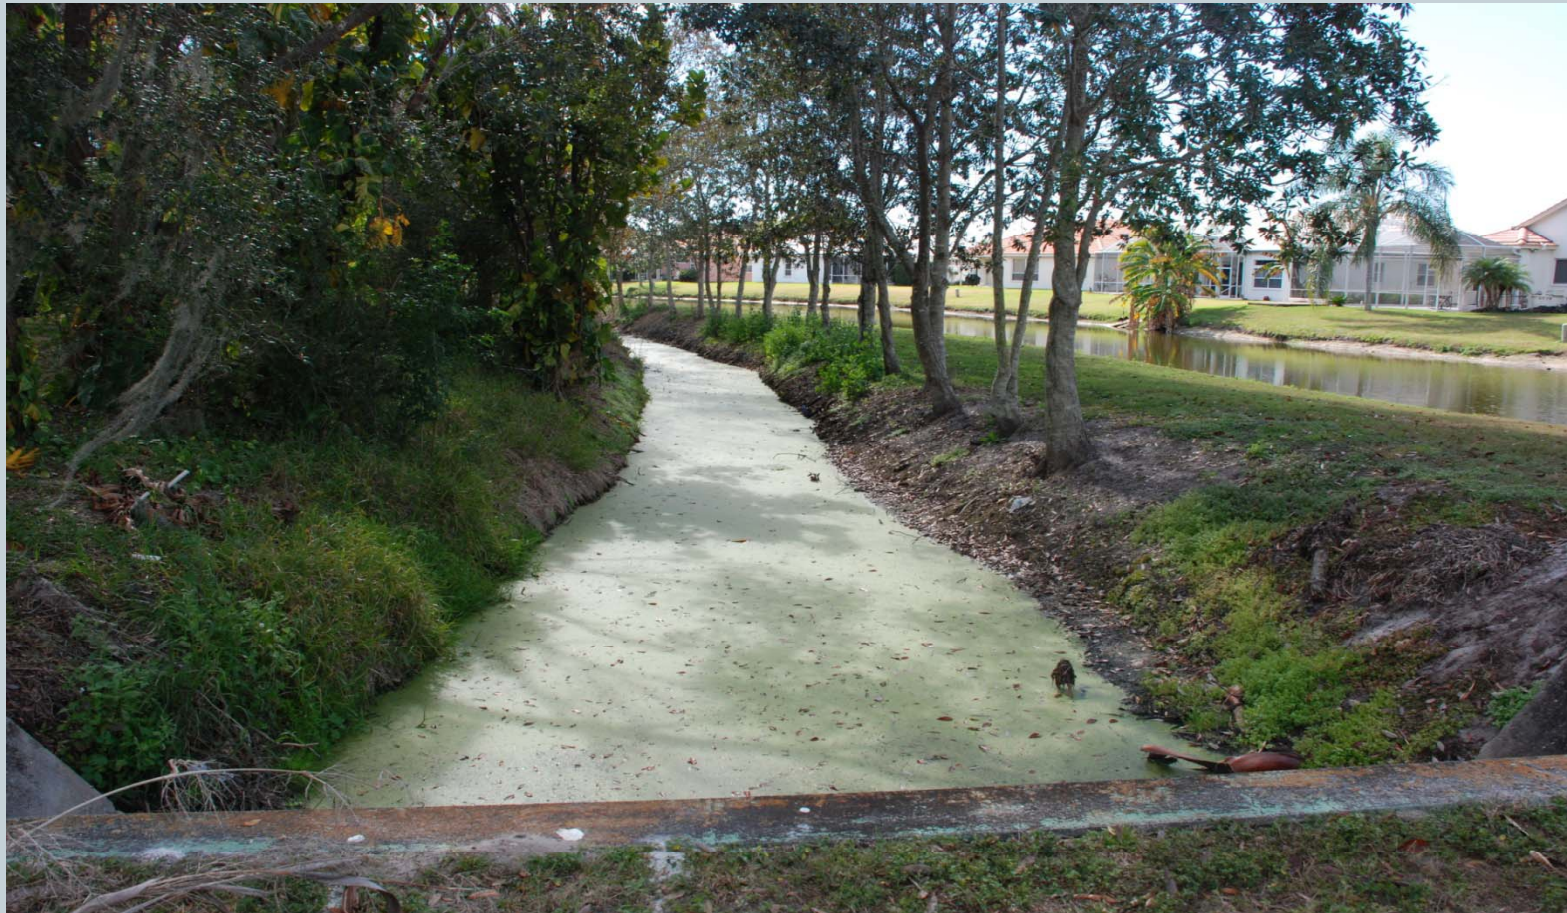
Rattlesnake Slough @ crossing with 72<sup>nd</sup> Ave

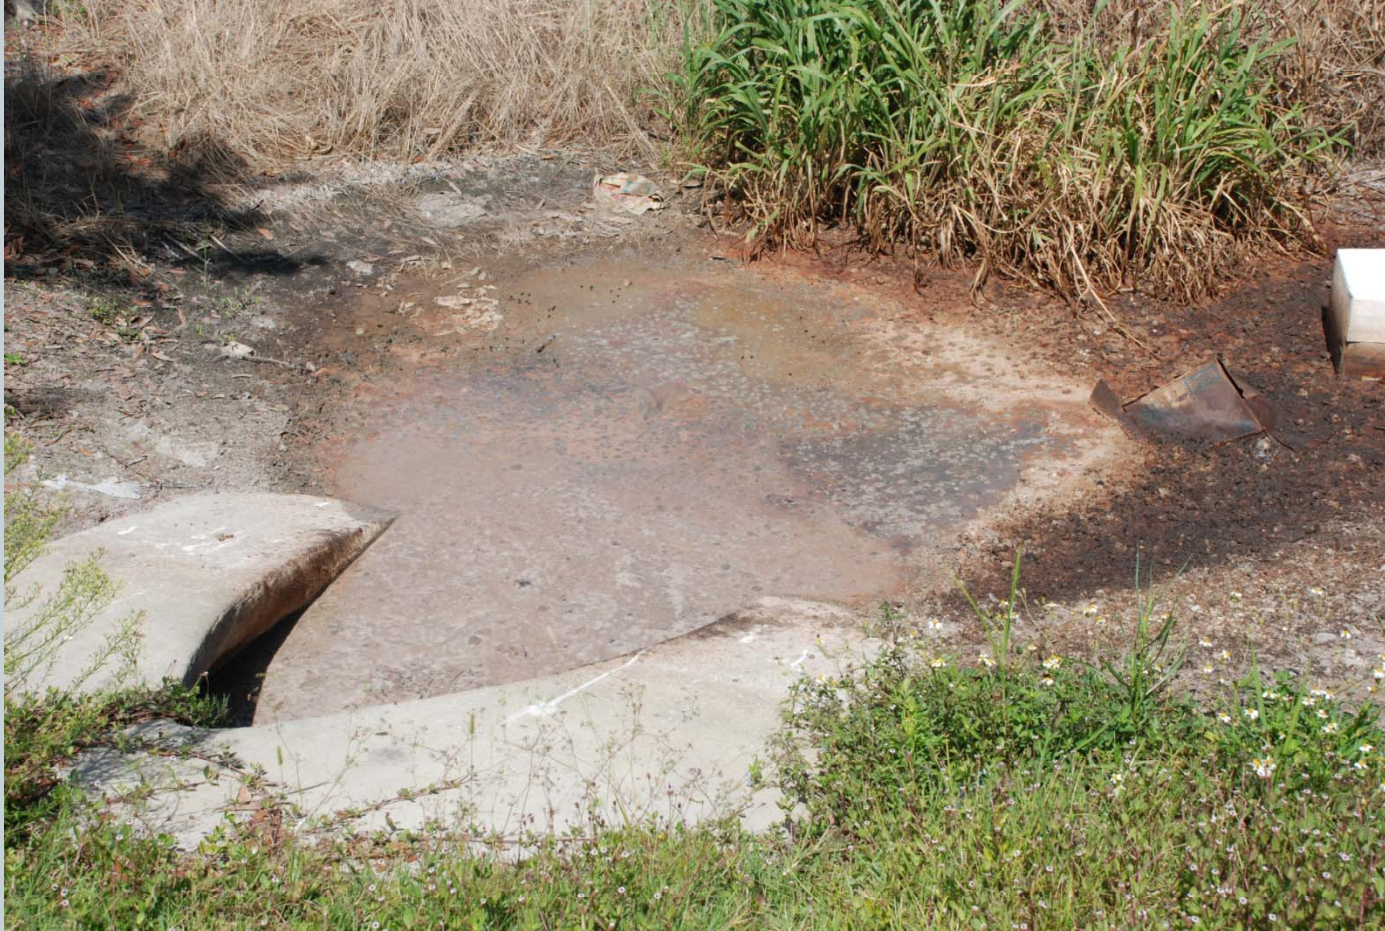
Grease trap waste dumped into a stormdrain  
leading to a detention pond (near Univ Pkwy)

- Significant portions of Rattlesnake Slough are surrounded by a natural riparian buffer limiting human access
- Specific issues identified during WTW addressed through MCNRD's NPDES complaint investigation & resolution program
