# LAKE ROBERTS HYDROLOGICAL AND NUTRIENT SOURCE ASSESSMENT

Mitchell Katz, Ph.D.

Water Sciences, Orange County EPD

# Lake Roberts – WBID 2872A

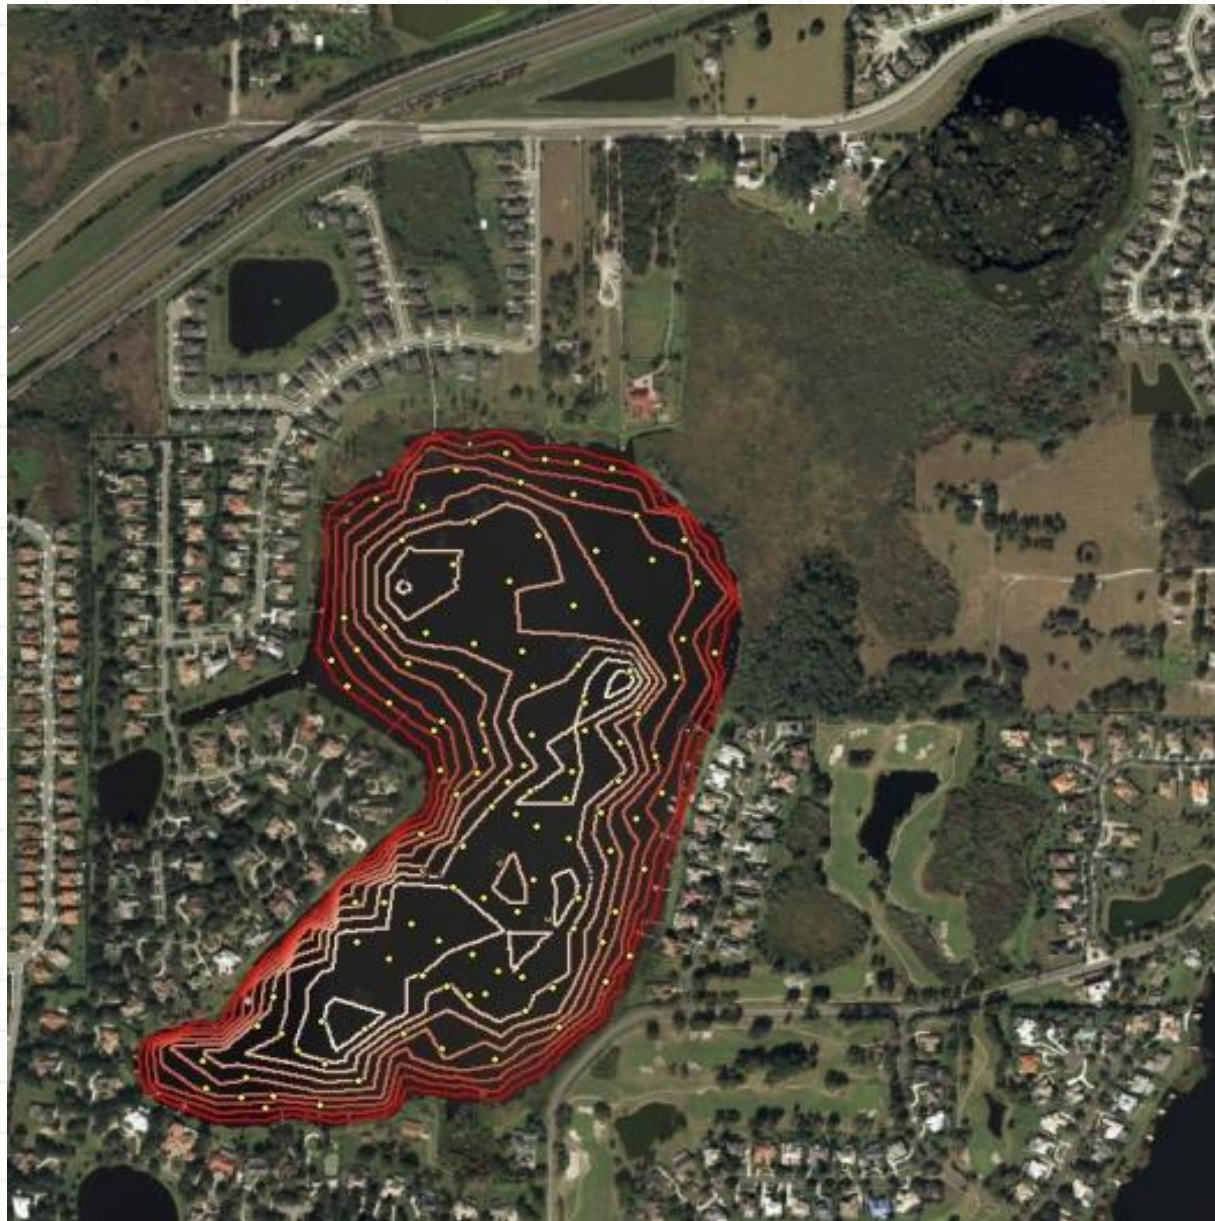
# Bathymetry and Muck Depths

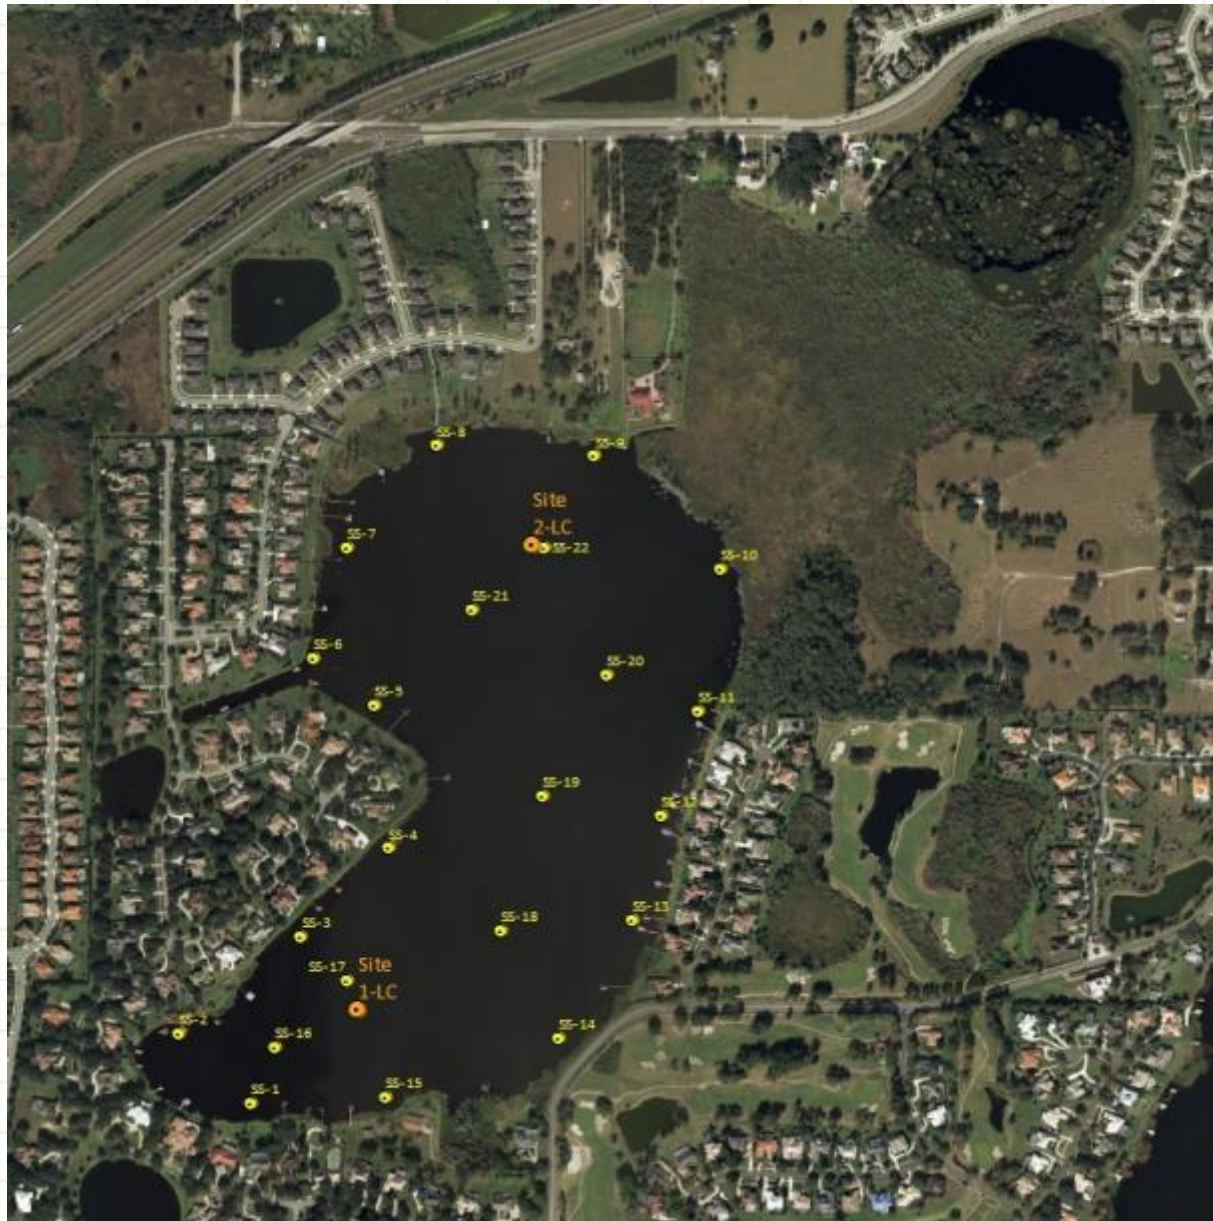
# Sediment Mapping and Collection
