# **Water Quality Update for BMAP Focus Lakes**

**St. Johns River Water Management District**

**April 7, 2021**

## **External Nutrient Loading and Water Quality Trends in the Upper Ocklawaha Basin Lakes, 1980s Through 2019-2020**

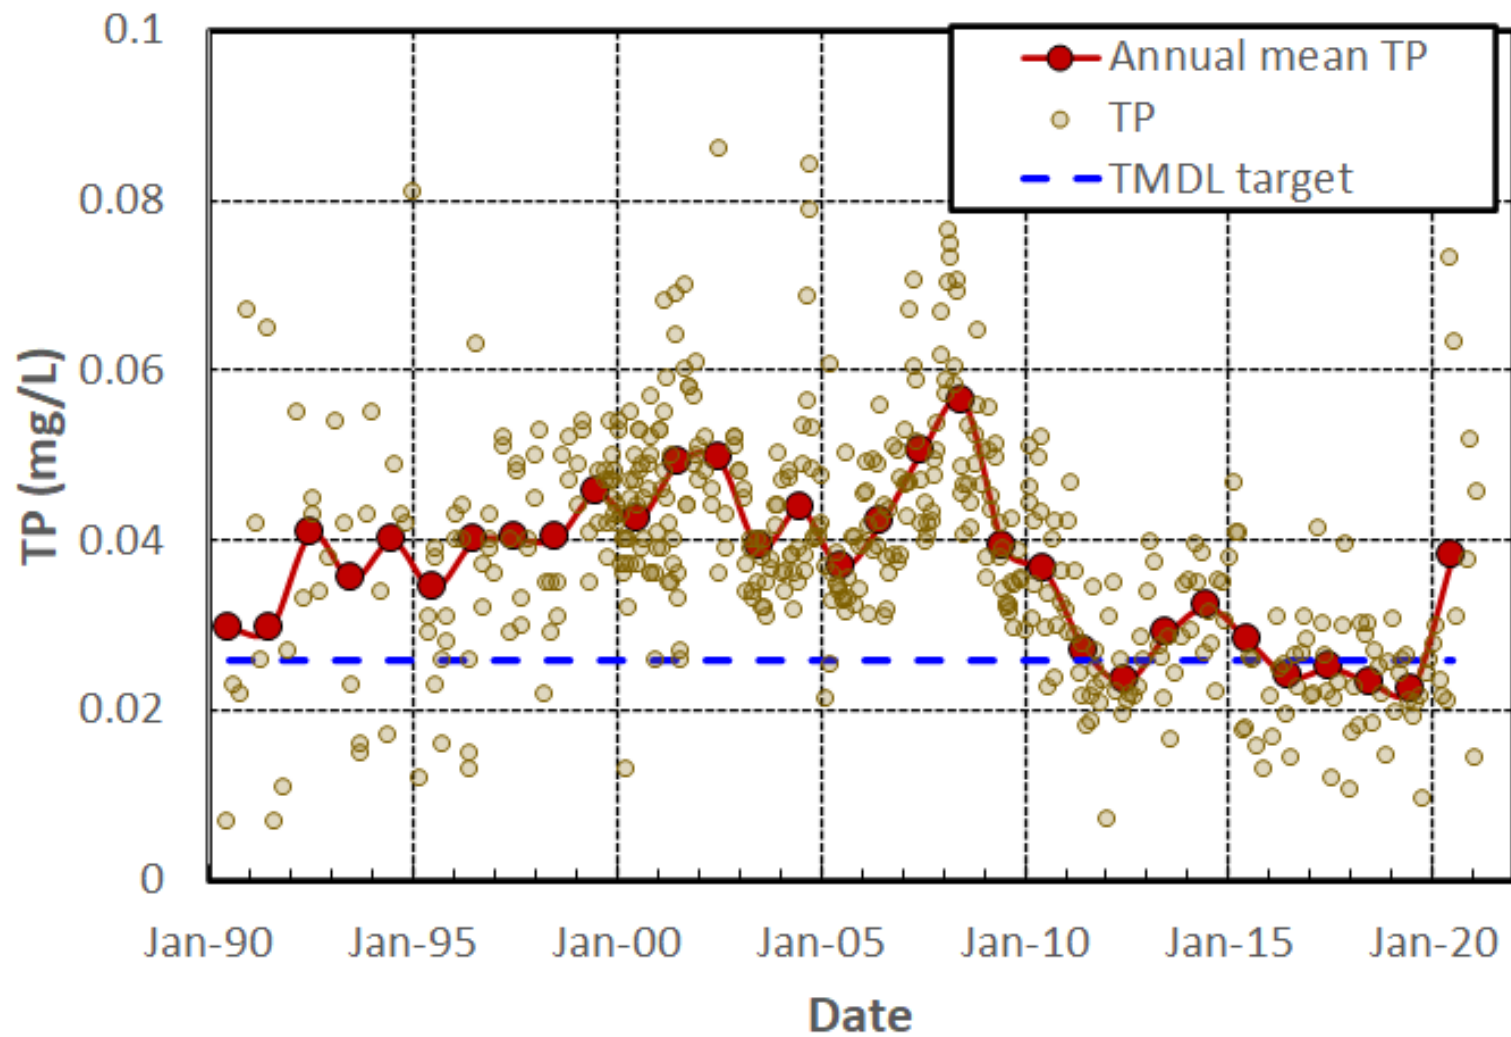
## Lake Harris total phosphorus concentrations

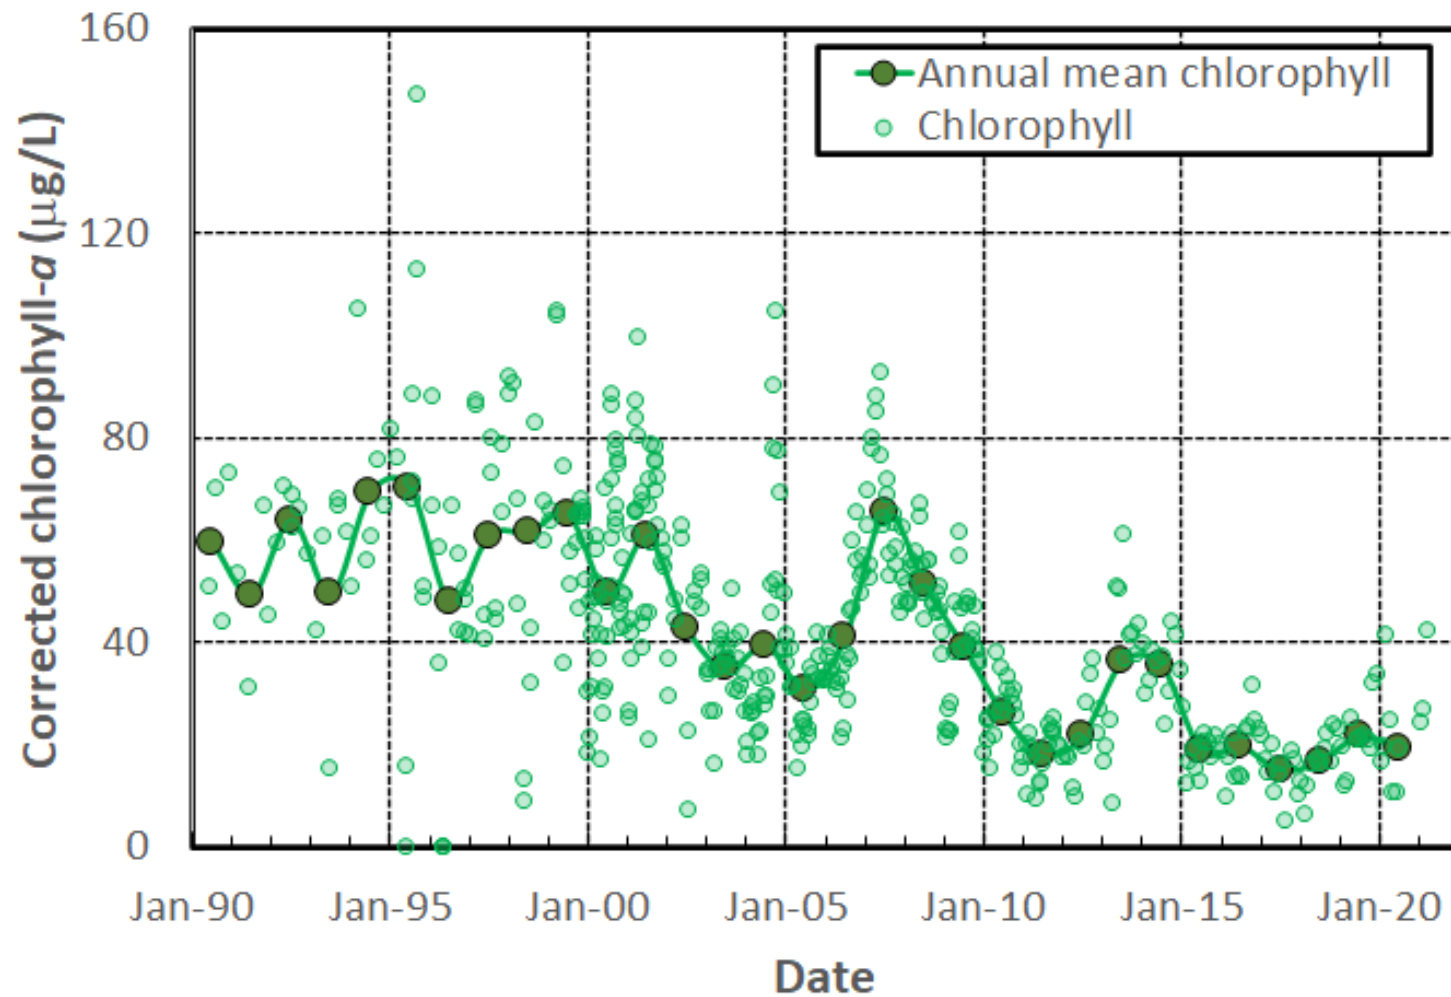
## Lake Harris corrected chlorophyll-*a* concentrations

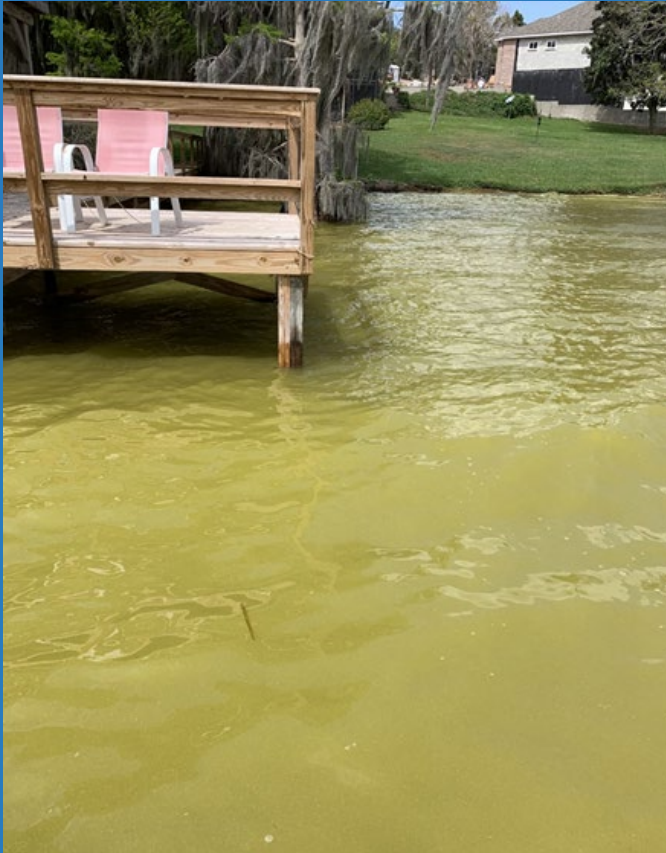
Lake Harris, March 11, 2020

Photo: SJRWMD. Co-dominant taxa

*Microcystis* and *Cylindrospermopsis*

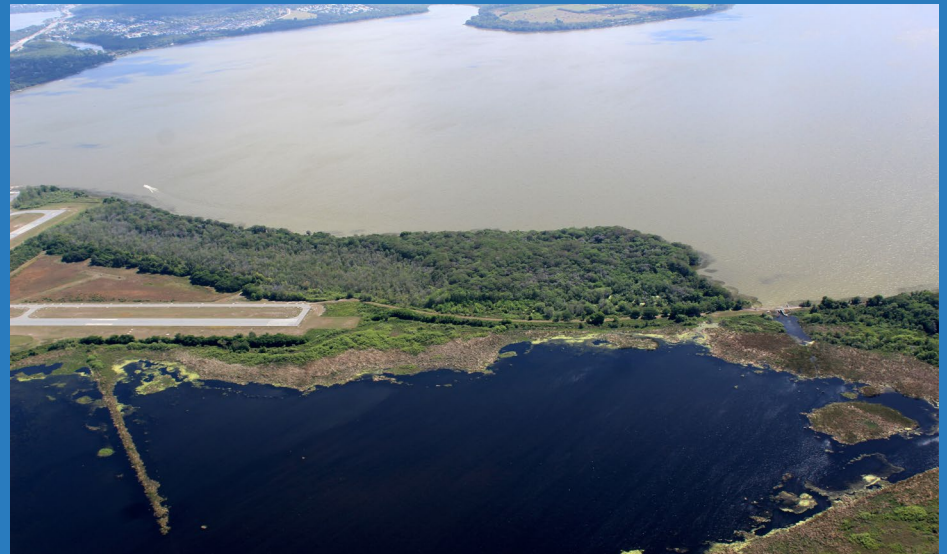
Aerial photo of Lake Harris (top)  
and Harris Bayou Restoration  
Area (bottom)

March 19, 2020 Photo: SJRWMD

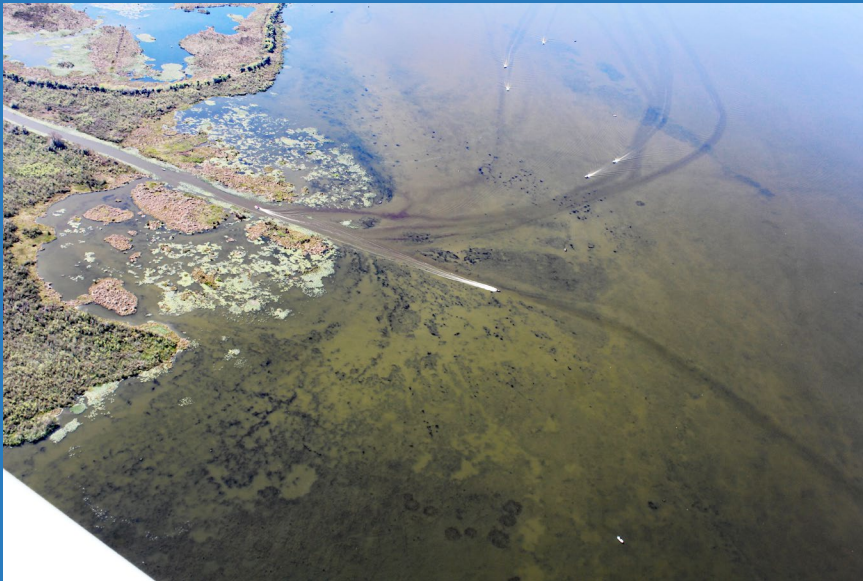
Lake Eustis-Haynes Creek,  
Feb. 25, 2021  
Photo: SJRWMD

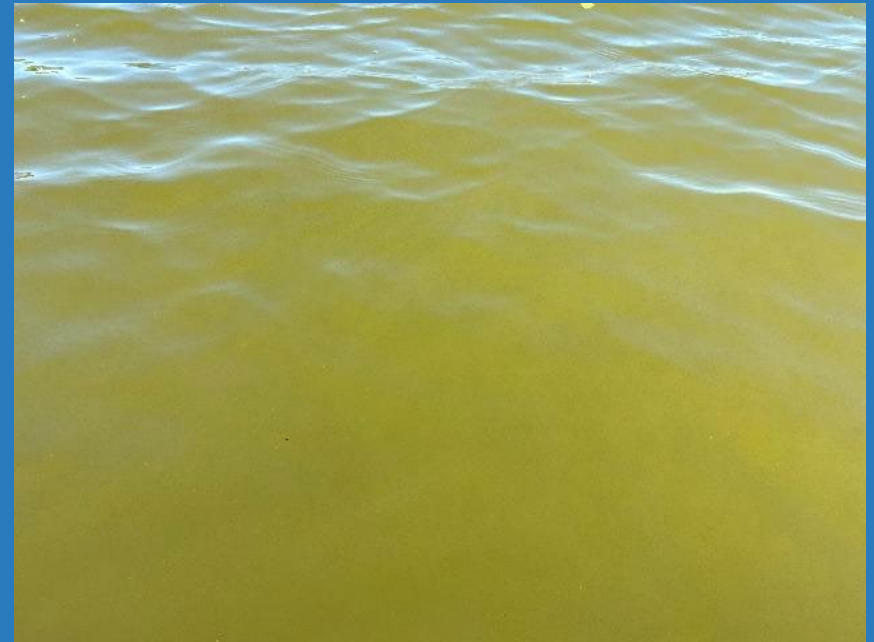
Lake Eustis, NW corner,  
March 4, 2021  
Photo: FDEP  
Dominant taxon *Cylindrospermopsis*

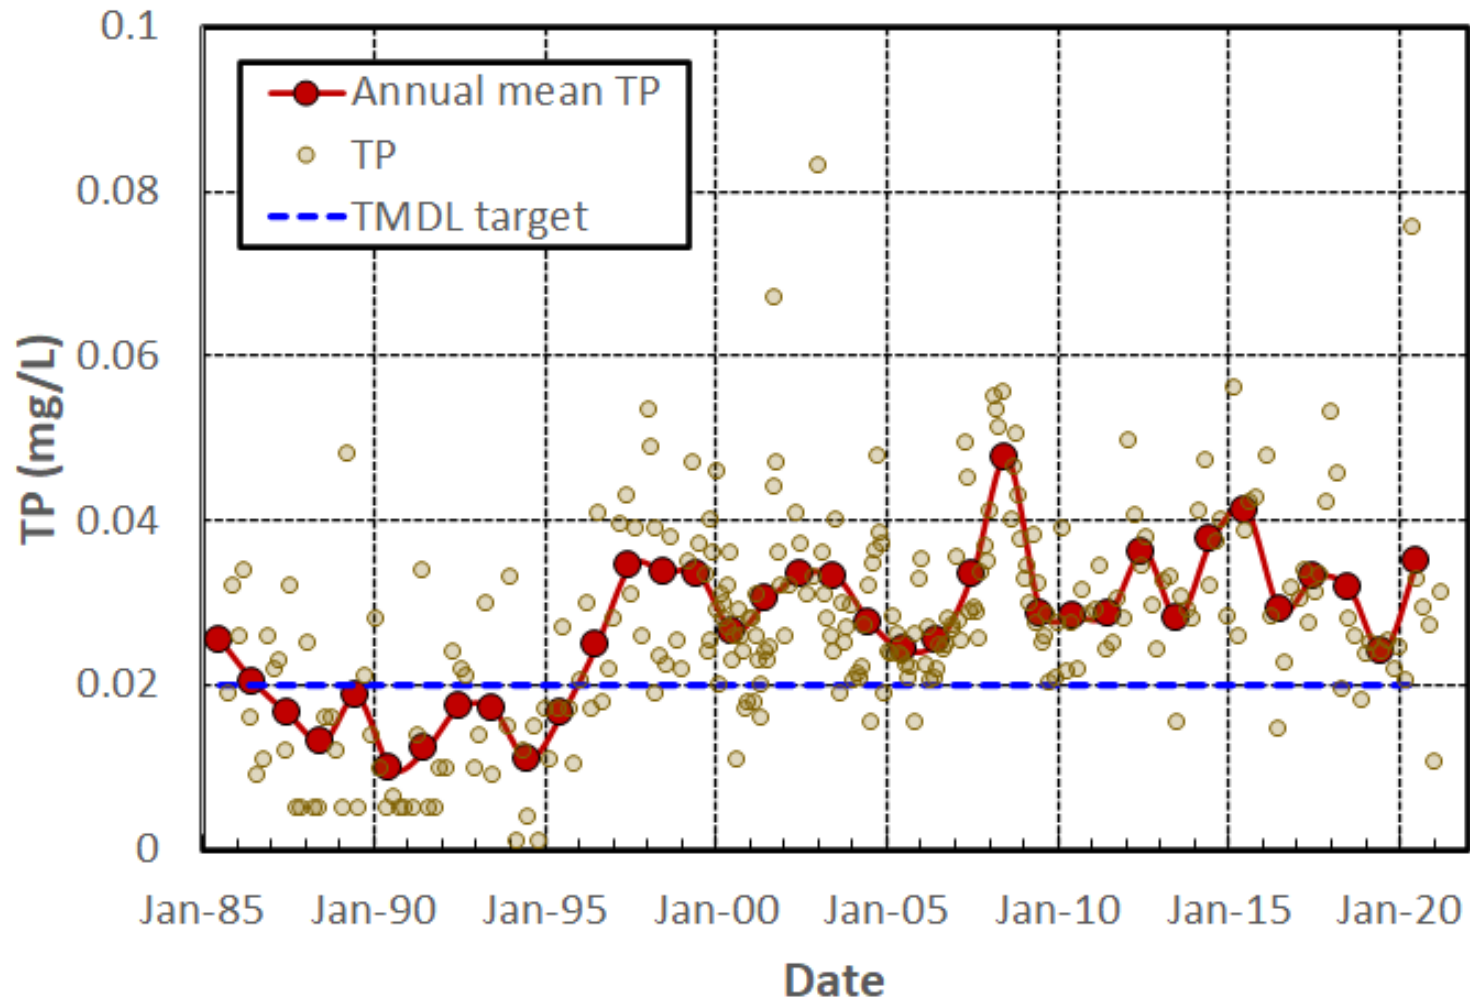
## Lake Yale total phosphorus concentrations

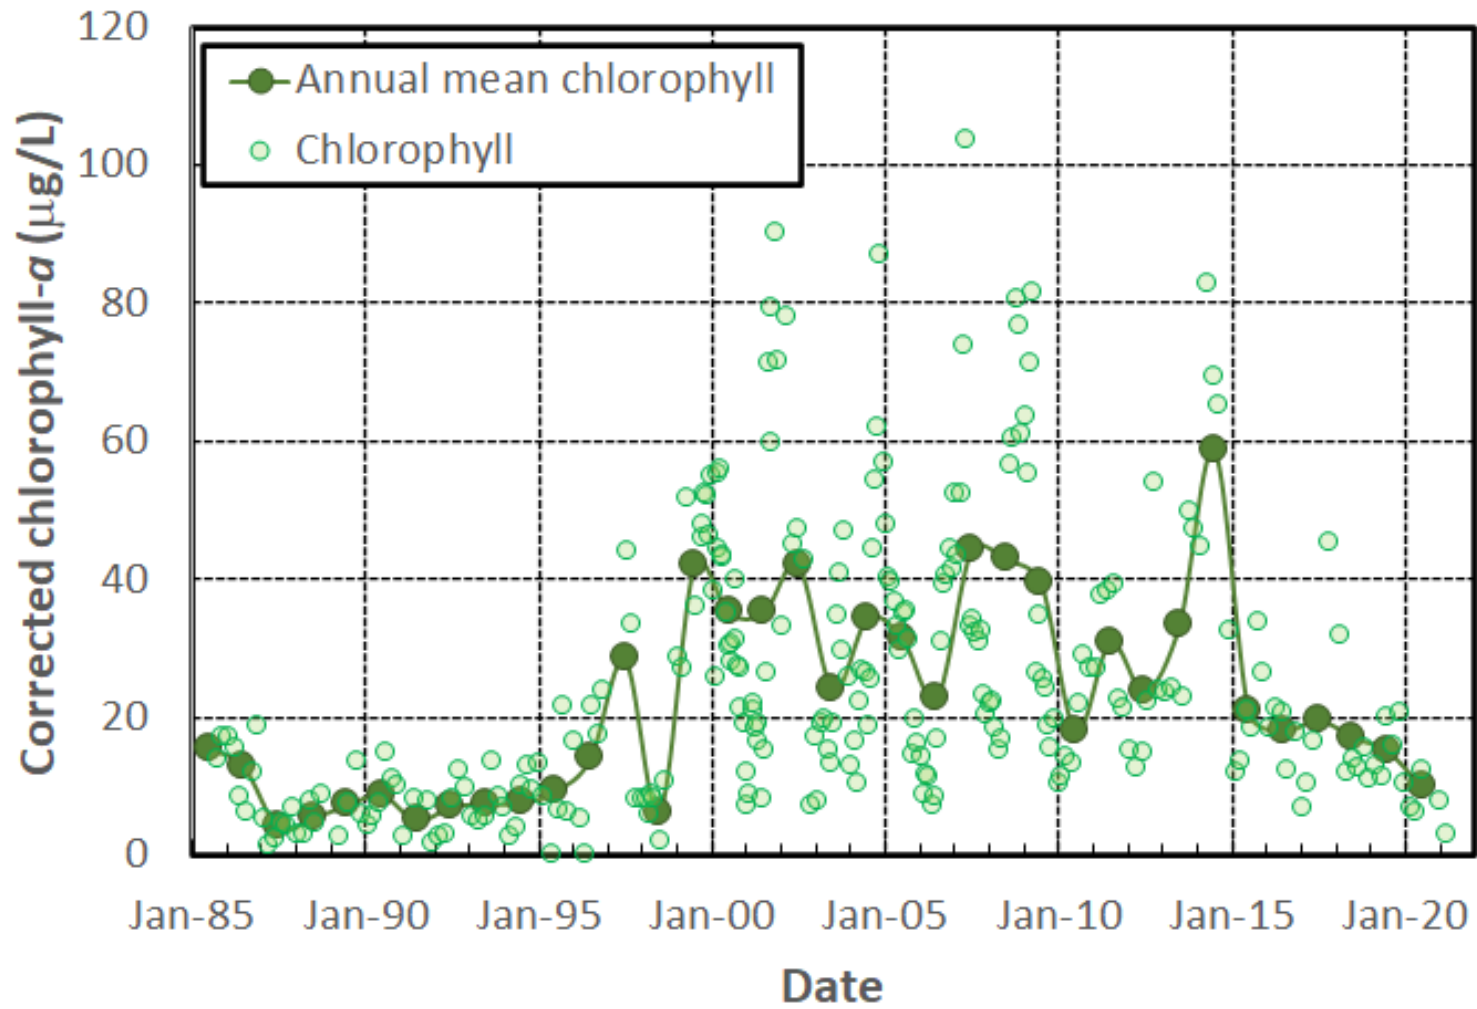
## Lake Yale corrected chlorophyll-*a* concentrations

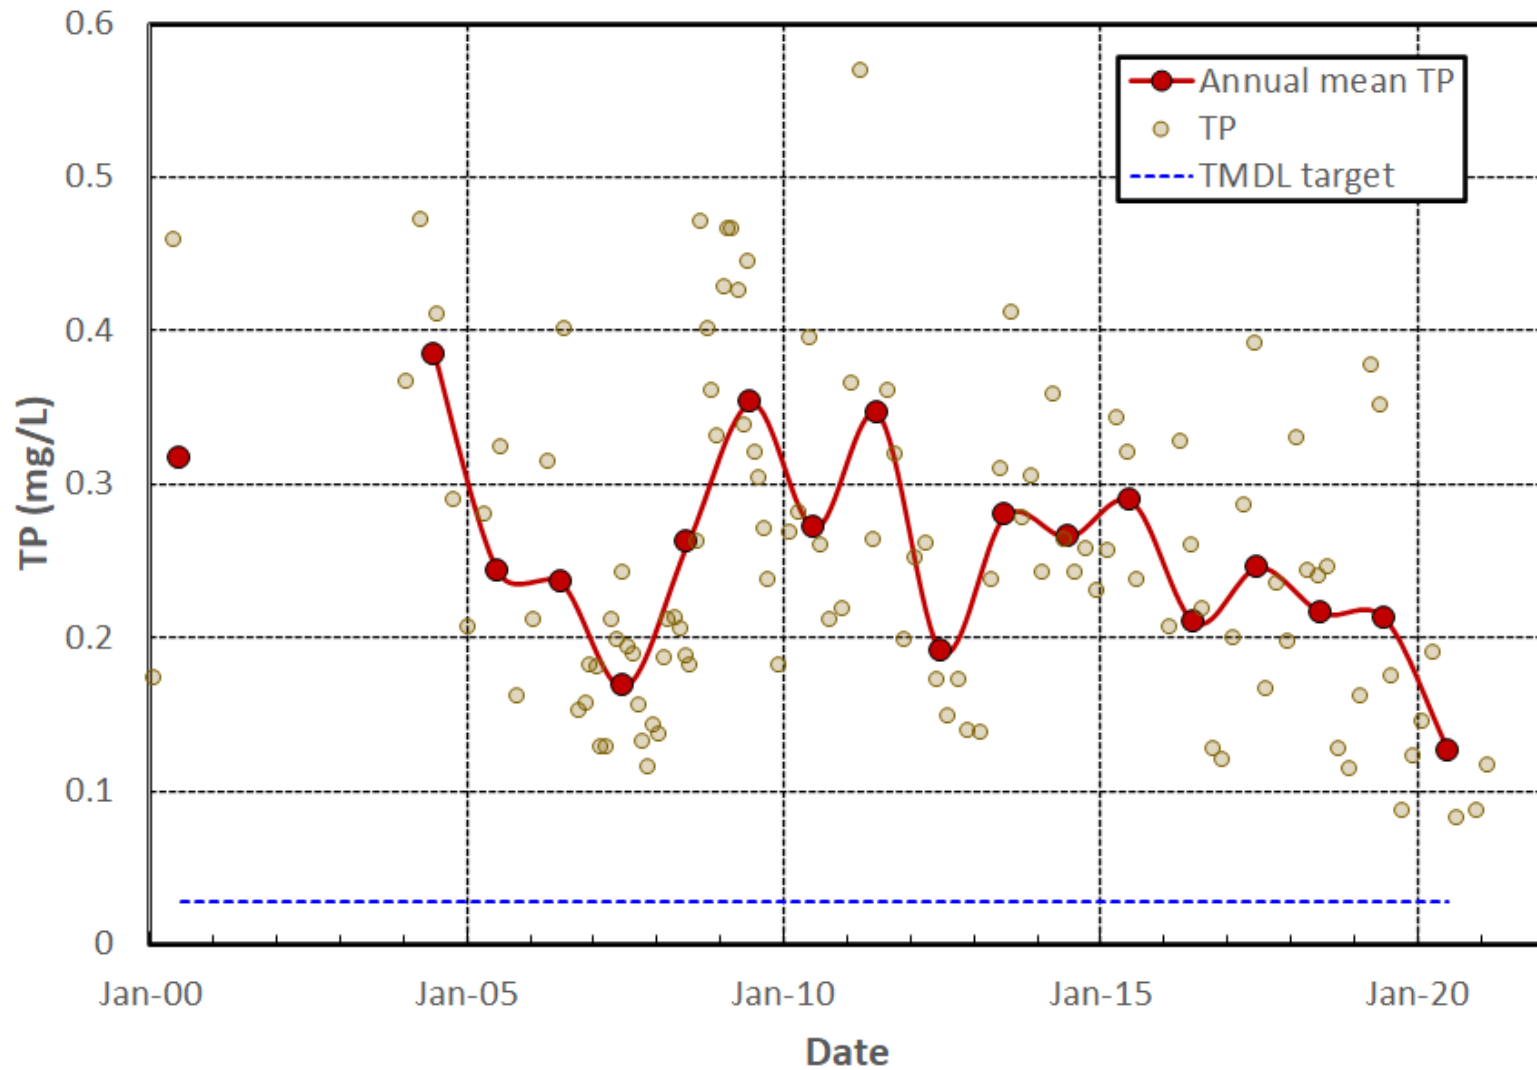
## Trout Lake total phosphorus concentrations

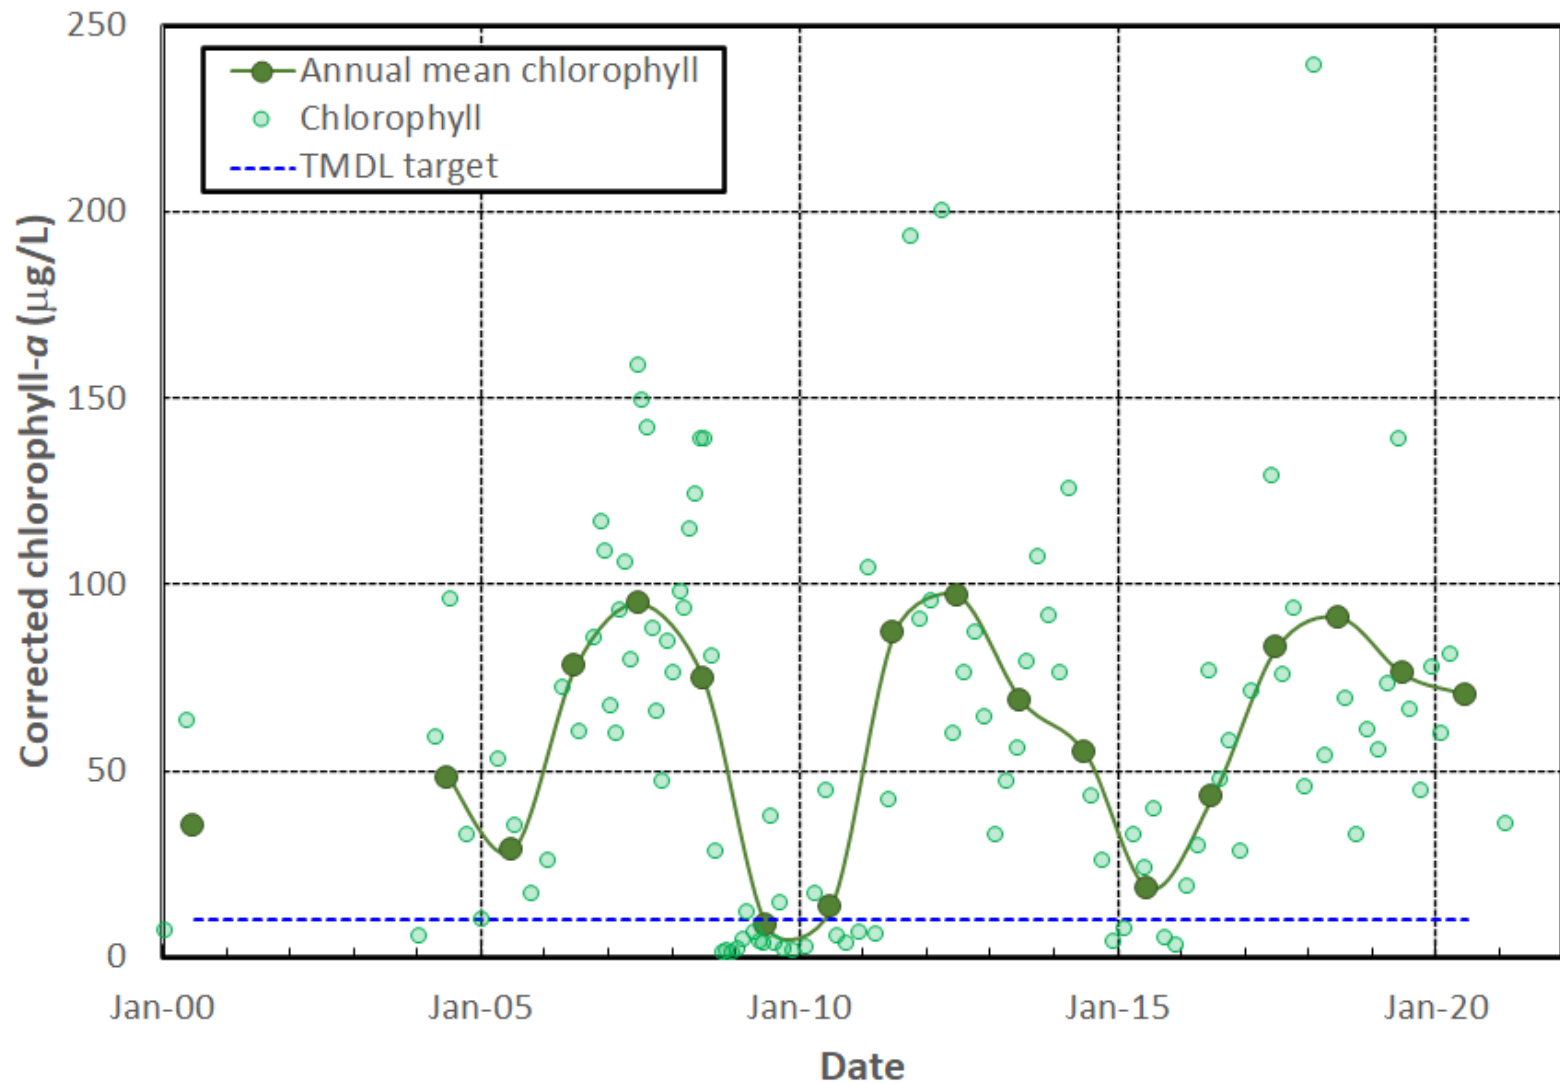
## Trout Lake corrected chlorophyll-*a* concentrations

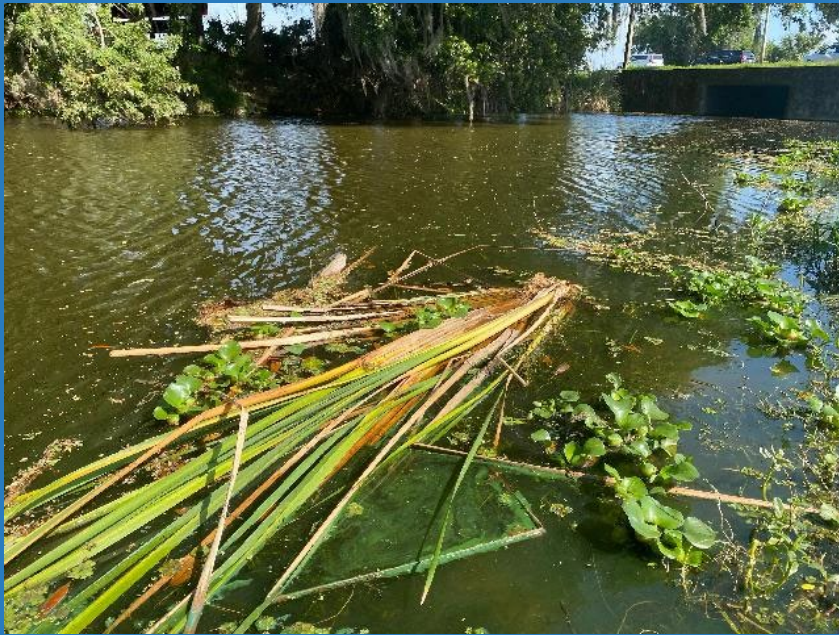
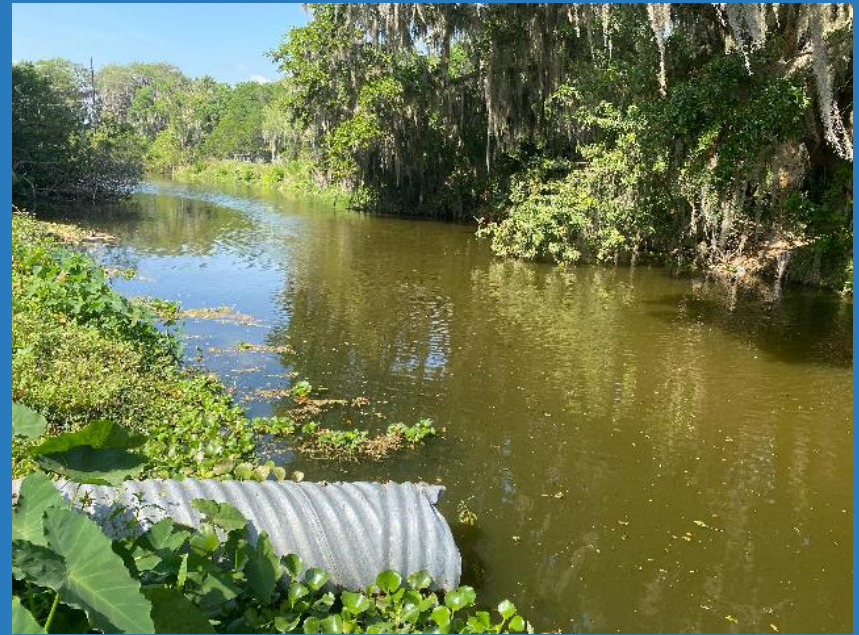
Trout Lake canal, March 18, 2021

Photos: FDEP

Co-dominant taxa: *Microcystis* and *Dolichospermum*

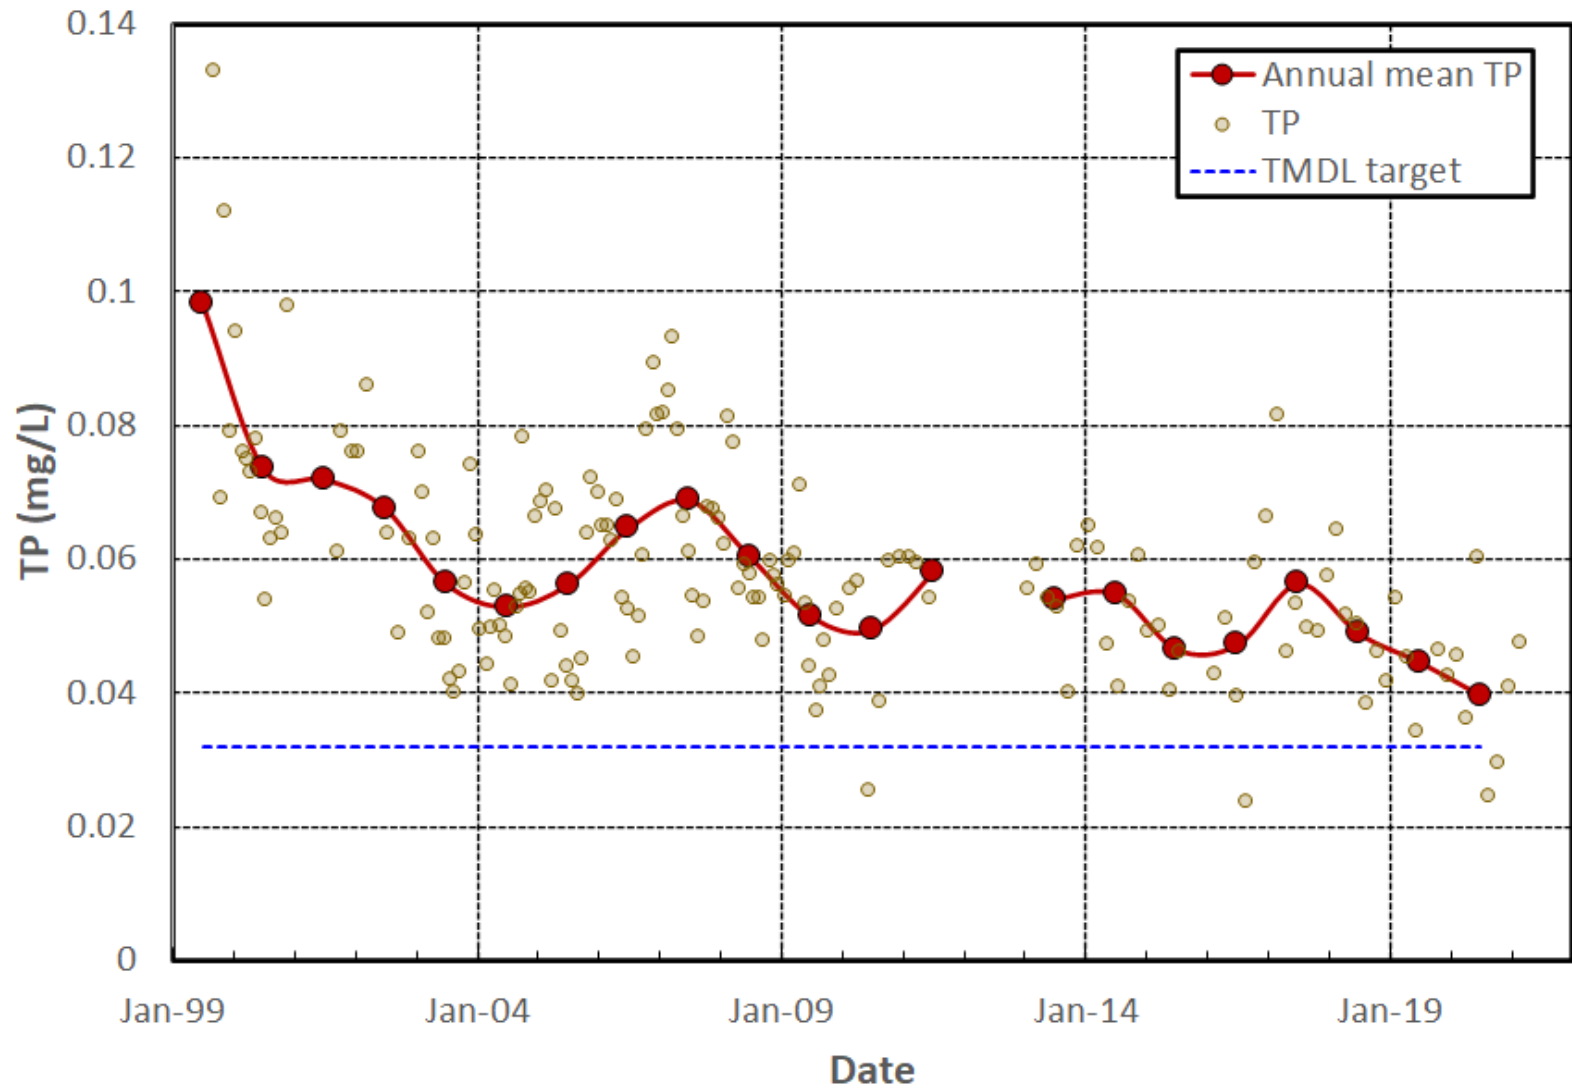
## Lake Carlton total phosphorus concentrations

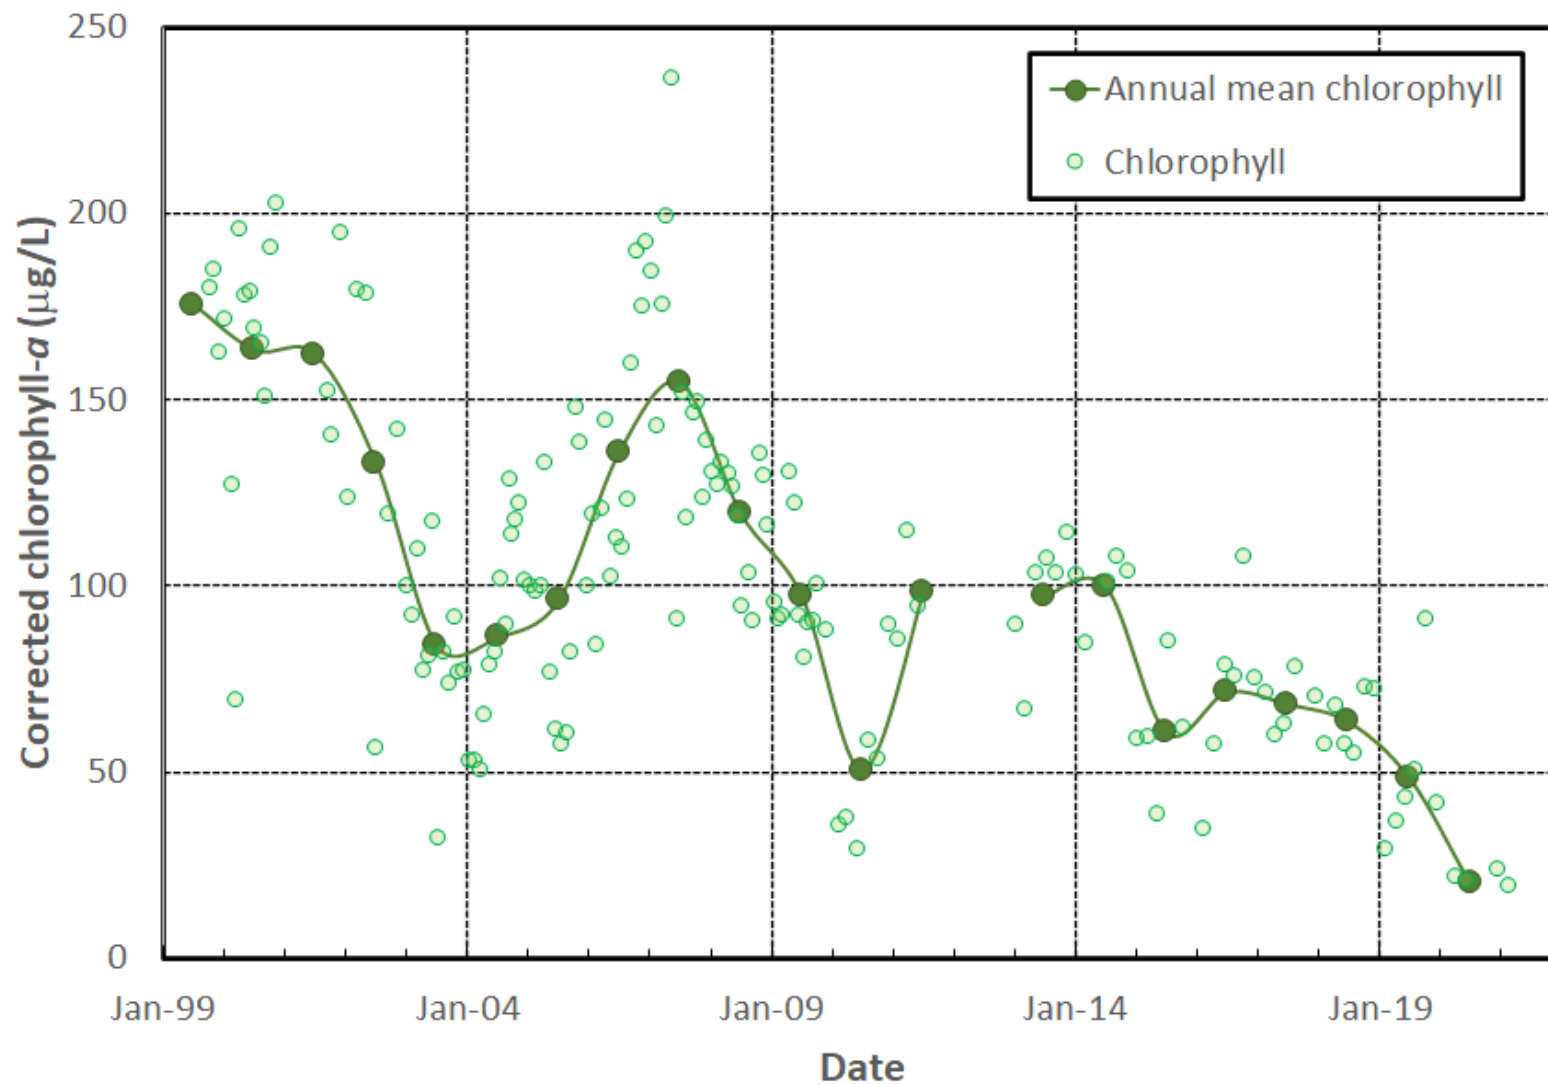
## Lake Carlton corrected chlorophyll-*a* concentrations

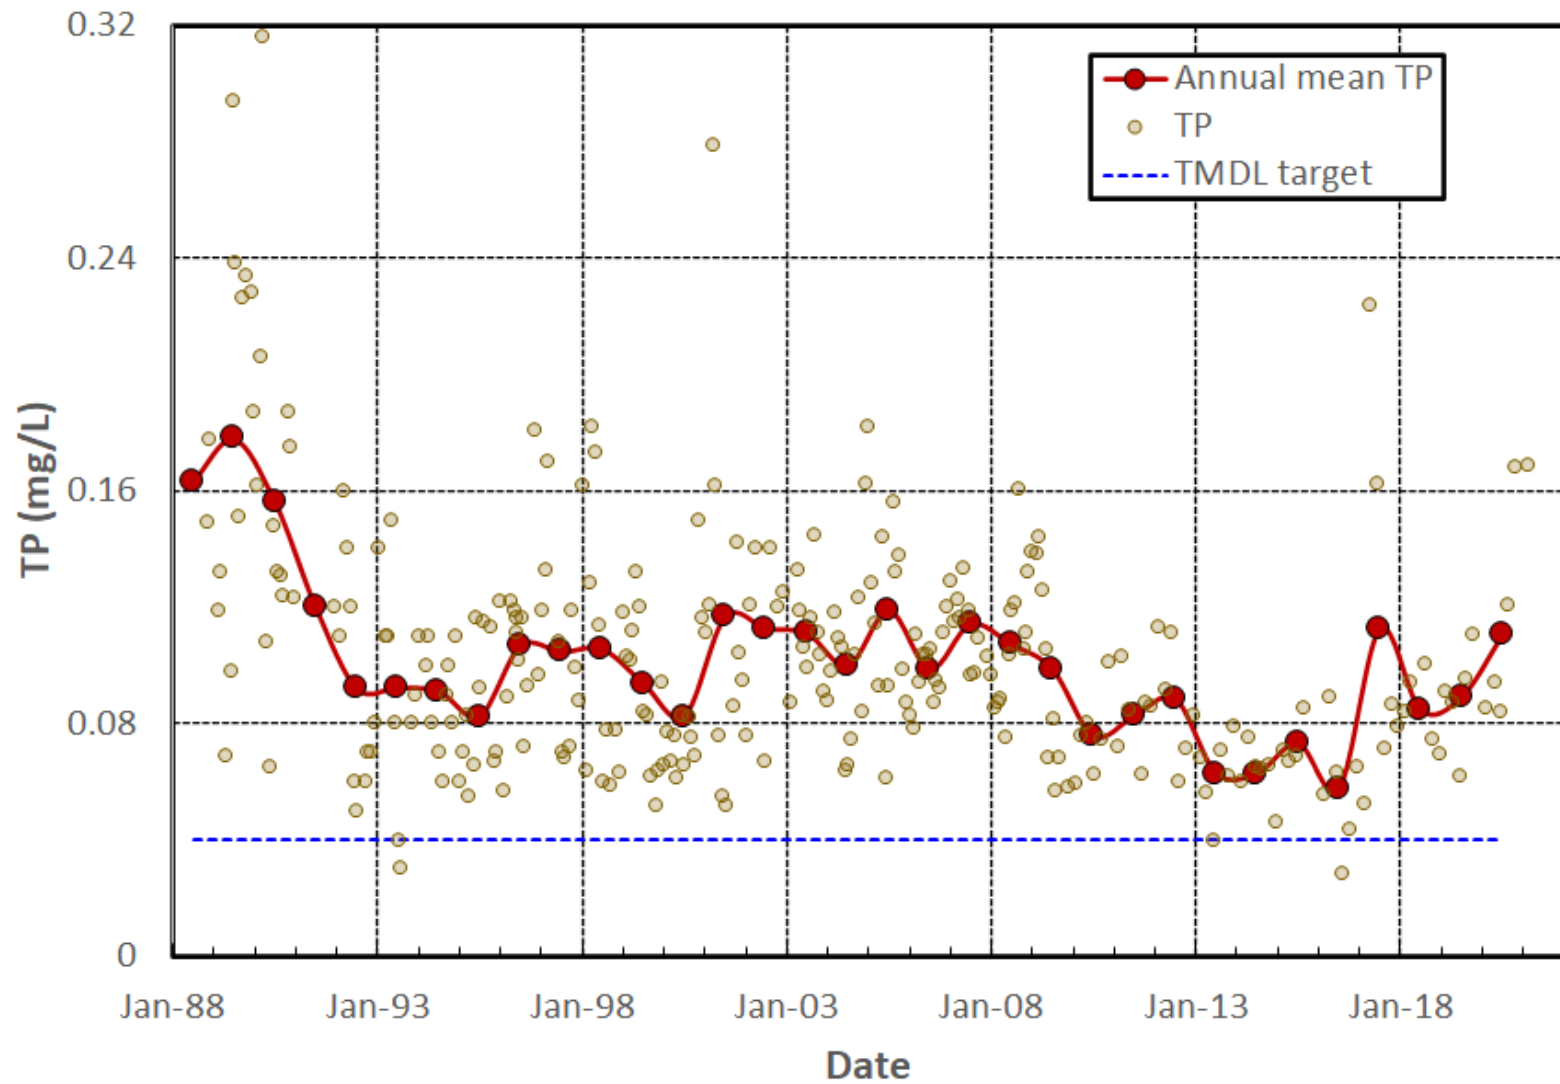
## Lake Denham total phosphorus concentrations

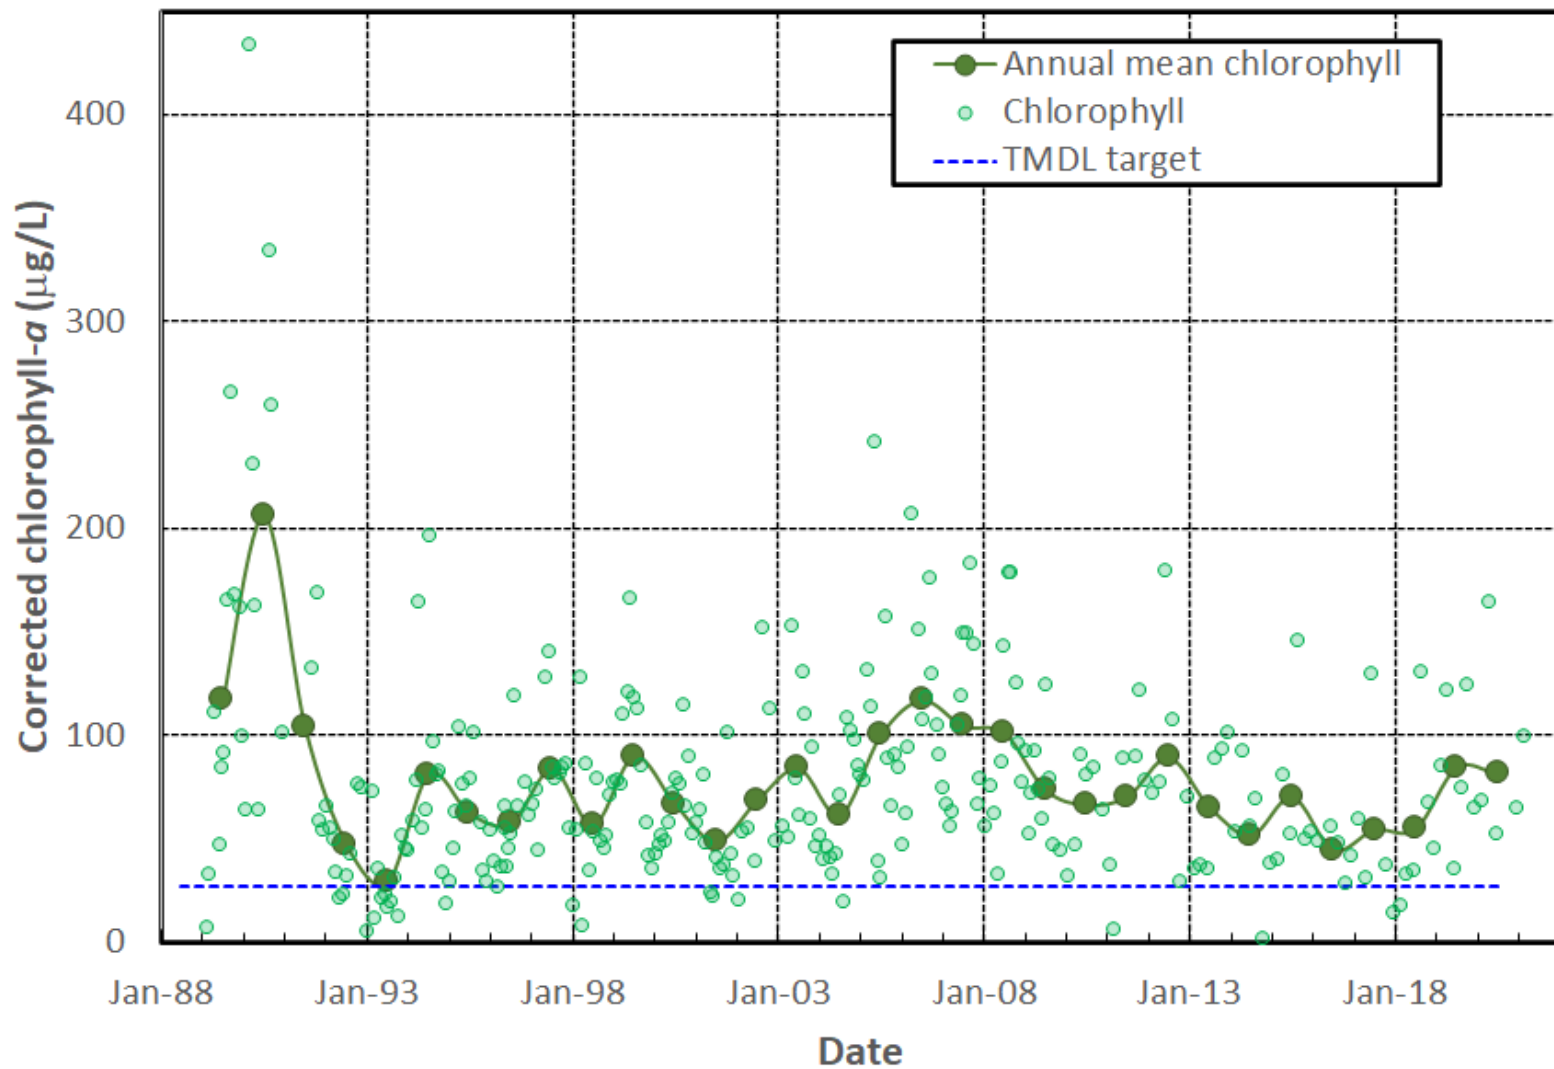
## Lake Denham corrected chlorophyll-*a* concentrations
