**TO:** All Potential Respondents  
RFP 018-10 Three Sisters Treatment Wetland

**SUBJECT:** Response to Questions

**ANSWER:** The Phase I Environmental Site Assessment of the Three Sisters Springs parcel that HSA Engineers & Scientists prepared in July 2010 under contract with The Conservation Fund is attached to this question and answer document.

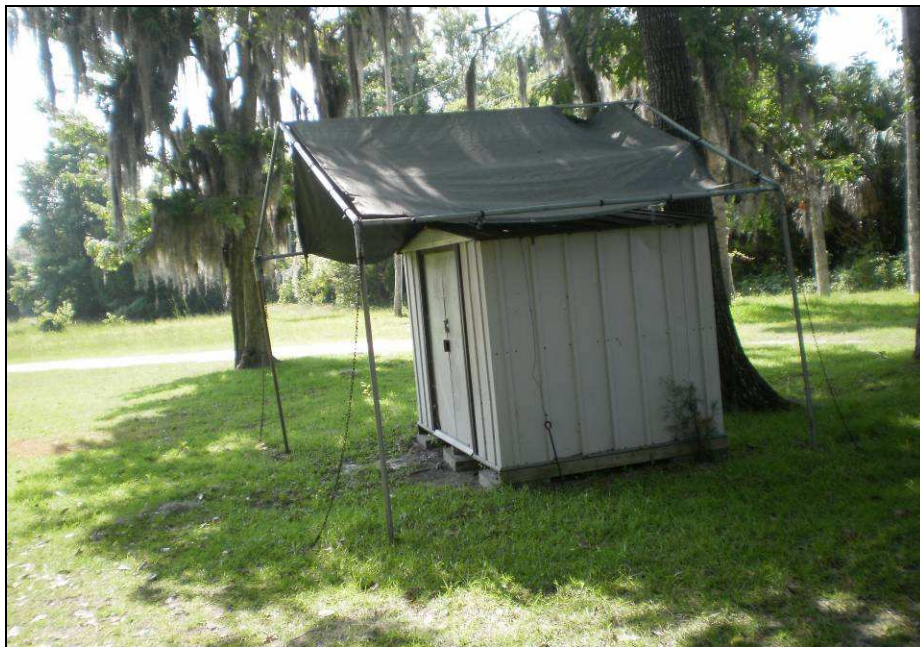
**Photograph 2 – View of storage shed on southern portion of Property.**

The subject Property received a combination driving tour and walk-through examination. A metal storage shed, picnic area, and burn pit were observed on the southern portion of the Property, adjacent to Three Sisters Springs area (**Appendix E, Photographs 1, 2 and 3**). According to Mr. Willson, swimming materials (kayaks, fins, etc.) were stored within the shed. A man-made lake was observed along the central portion of the site (**Appendix E, Photograph 4**). No stressed vegetation was noted in or around the water bodies. Mr. Willson stated that soils excavated from the pond were spread throughout the Property. Rows of planted pines were observed throughout the Property (**Appendix E, Photograph 5**). A stormwater ditch surrounded the perimeter of the subject Property and was densely vegetated with various trees, shrubs and grasses (**Appendix E, Photograph 6**).

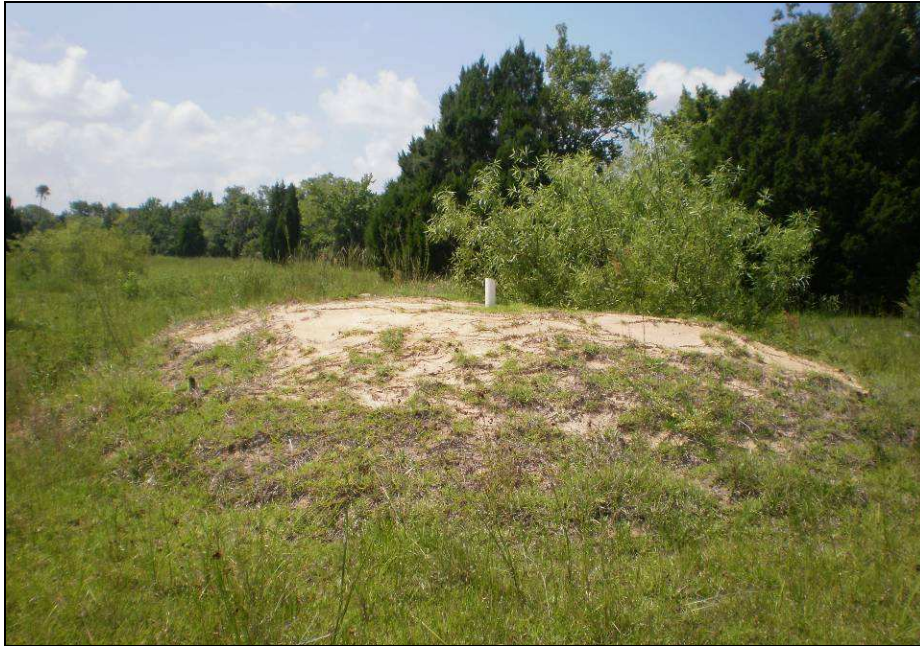
**Photograph 7 – View of stockpiles located on subject Property.**

Three soil stockpiles ranging from 3 to 5 feet high were observed on the subject Property, two on the western portion of the Property and one on the southeastern portion of the Property (**Appendix E, Photograph 7**). A 2- to 3- inch PVC riser was observed in the center of each of the stockpiles. According to Mr. Hal Flowers, a representative of the owner of the subject Property, the stockpiles were installed to measure compression on the site.

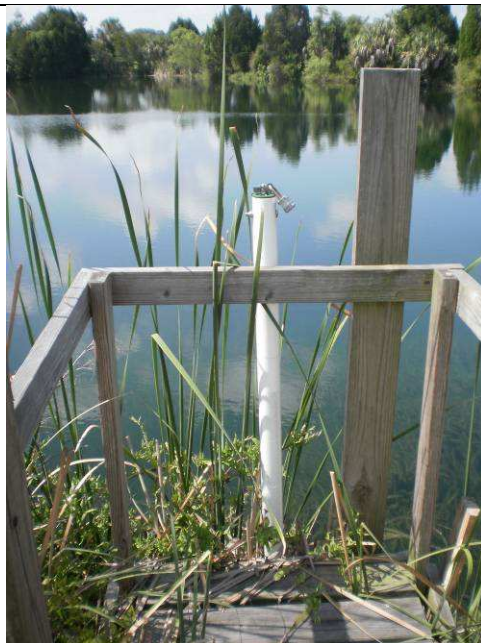
**Photograph 8 – View of monitor well located on subject Property.**

Monitor wells were observed on the northern and southern sides of the centrally located lake (**Appendix E, Photograph 8**). According to Mr. Willson, the wells were used to measure water levels and temperature at the lake.

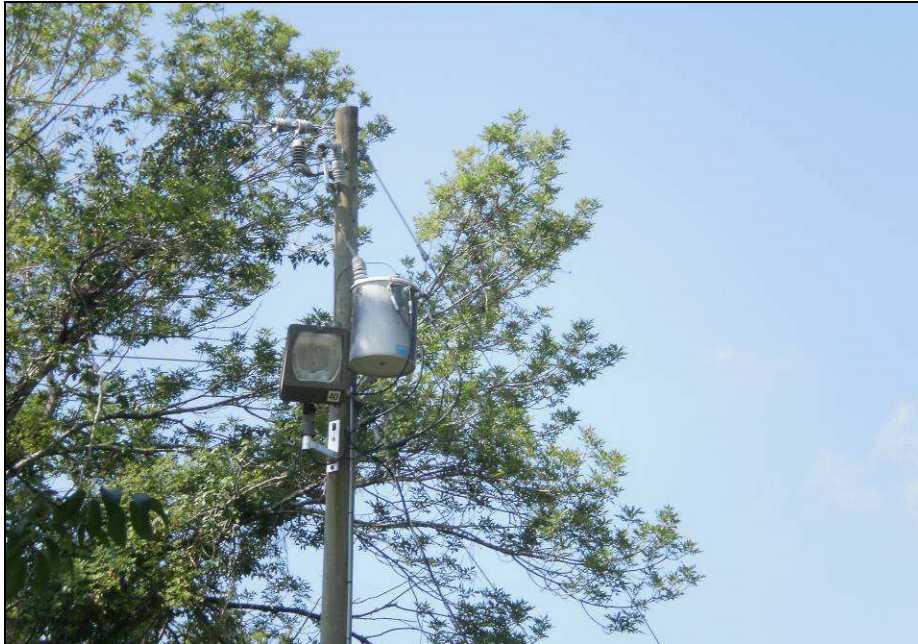
**Photograph 9 – View of pole-mounted transformer located on the southern portion of the Property.**

A pole-mounted transformer was observed on the southern portion of the site. The transformer was labeled “PCB Free” and appeared to be in “good” condition (**Appendix E, Photograph 9**). The transformer appeared to be free of corrosion and no leaks appeared to be emanating from it.
