## 5.1: Lake Lafayette

### 5.1.1: Upper Lake Lafayette

### 5.1.2: Lake Piney Z

### 5.1.3: Lower Lake Lafayette (Including Alford Arm)

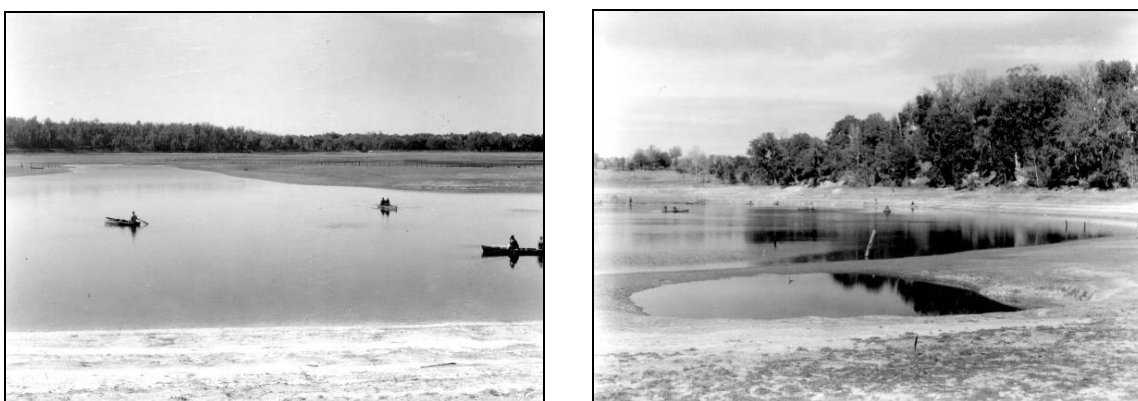
**Figure 5.1.5:** Photographs of Lafayette Sinkhole by Herman Gunter, Dec. 18, 1931. There have always been a lot of fish here!

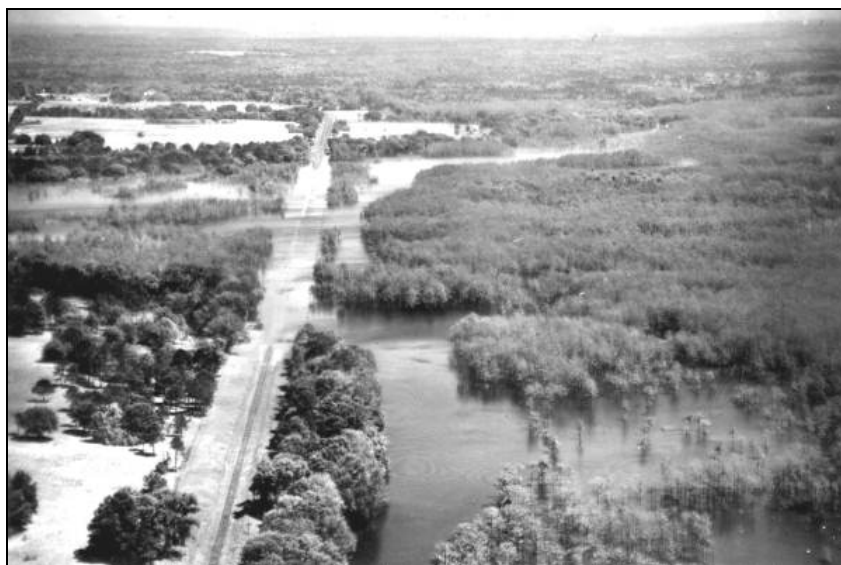
The most significant feature impairing the hydrological flow of Lake Lafayette is the Seaboard Lines railroad bed that separates Alford Arm from Lower Lake Lafayette. There is a distinct vegetative wetland boundary at 45.5 feet elevation throughout the lake basin, indicating that Lake Lafayette was once whole.

**Figure 5.1.6:** Flood damage on the track of the Seaboard Line that divides Alford Arm from Lower Lake Lafayette (April 2, 1948)

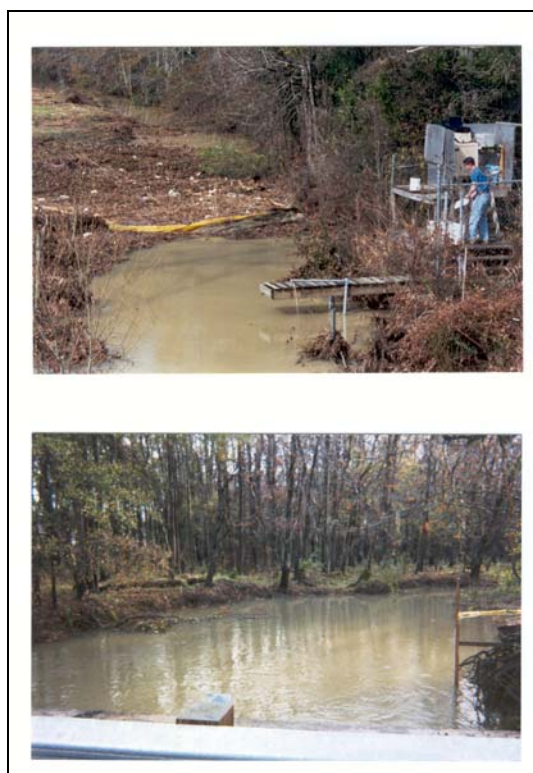
**Figure 5.1.1:** Weems Pond inflow (upper picture). Weems Pond Outfall (lower picture).

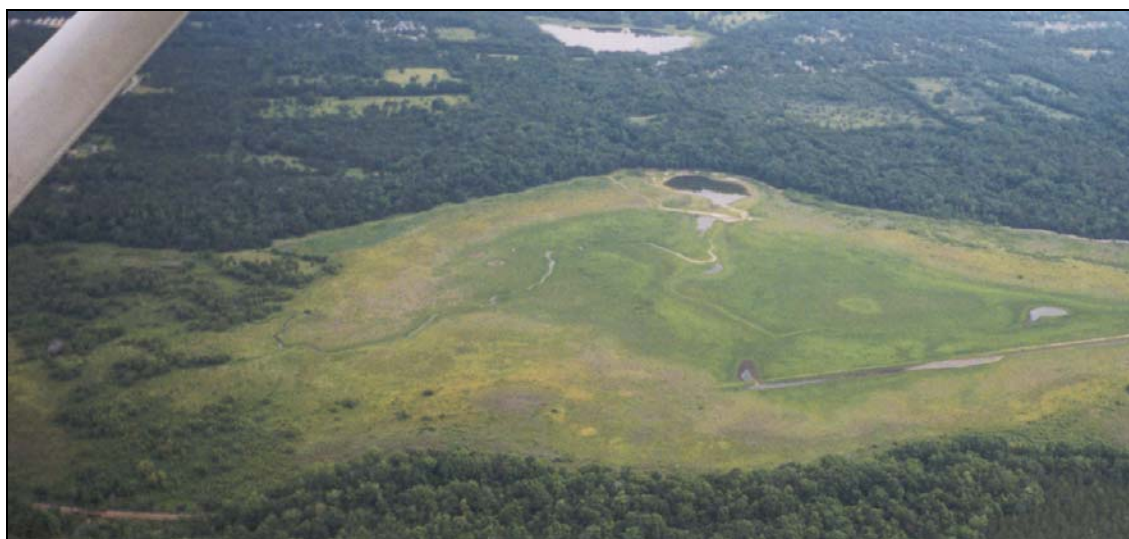
**Figure 5.1.2:** The dry lakebed of Upper Lake Lafayette with the sinkhole in the upper portion of the picture.

During periods of normal rainfall, the area around the Lafayette Sink becomes a 300-acre lake, while in dry periods, the waters in Upper Lake Lafayette drains through fissures, cracks and caverns into the aquifer leaving a one acre pond, 50 feet deep over the sink. This is a permanent waterbody is at the piezometric surface of the aquifer. There are two caverns in the north wall of the sink. They are at 35 ft depth and are large enough to park

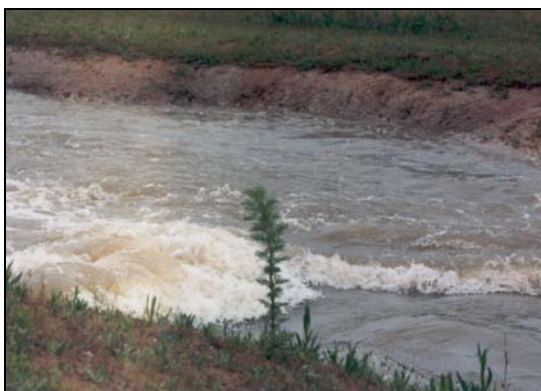
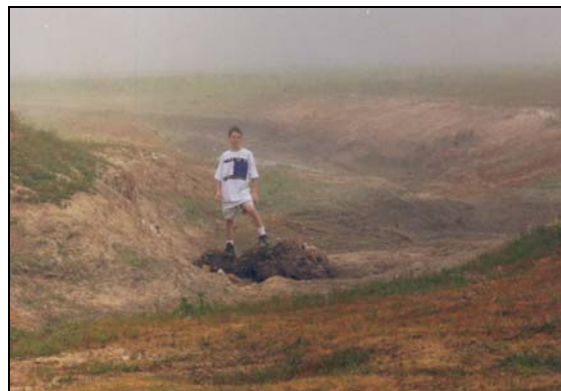
**Figure 5.1.3:** Station L02A, the inflow to Lafayette Sinkhole. Stormwater surges into the Sinkhole after a 2" rain (left). A view of the dry channel in the lakebed between storms.

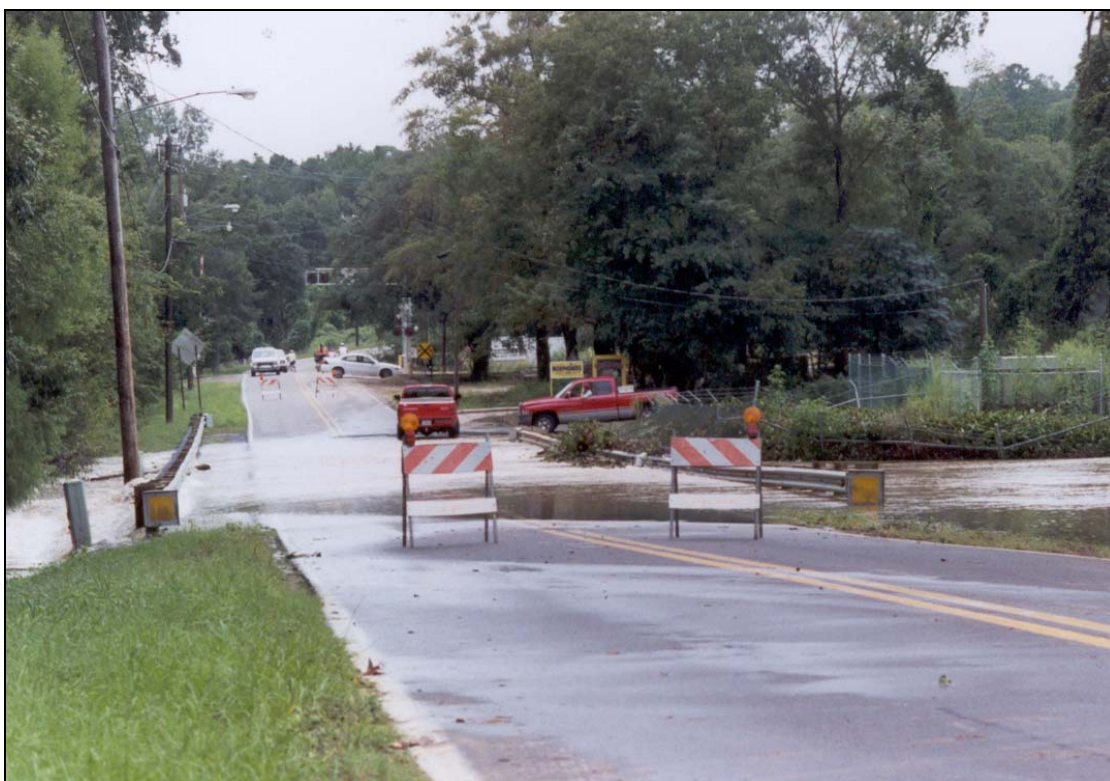
**Figure 5.1.4:** Weems Pond flooding into Upper Lake Lafayette, summer 2002. This flooding is from Tropical Storm Helene. The storm water is not getting much treatment here.

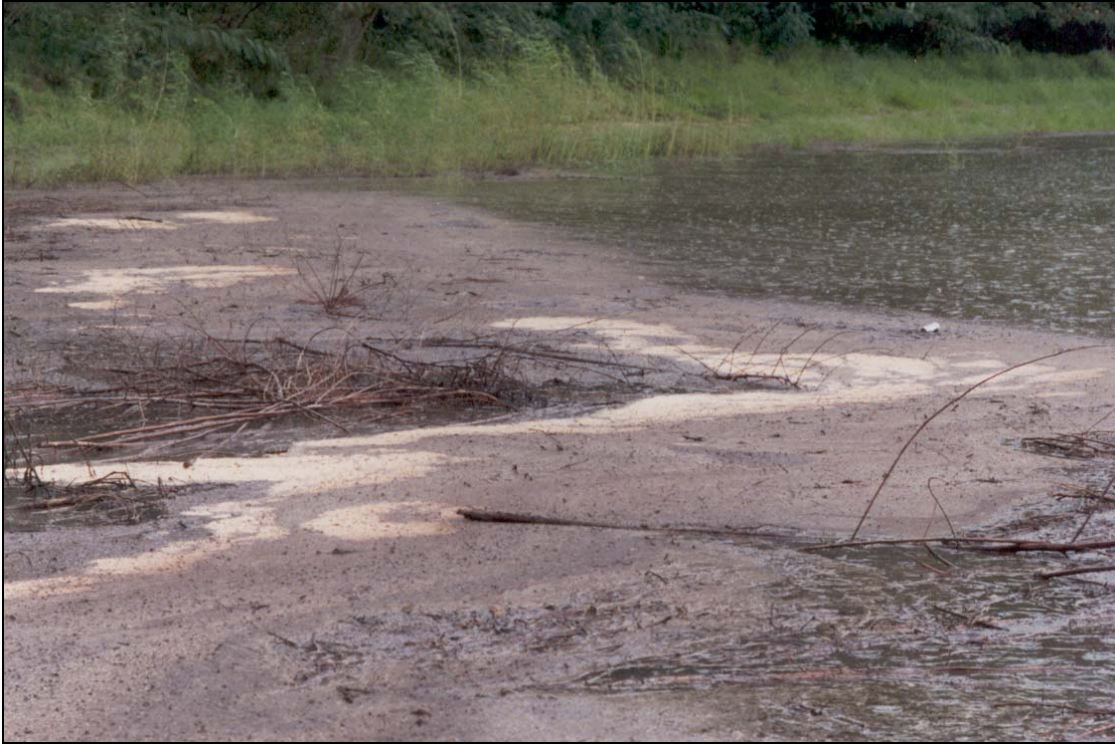
**Figure 5.1.5:** A view of the sink the day after Tropical Storm Helene. This water is going into the Aquifer.

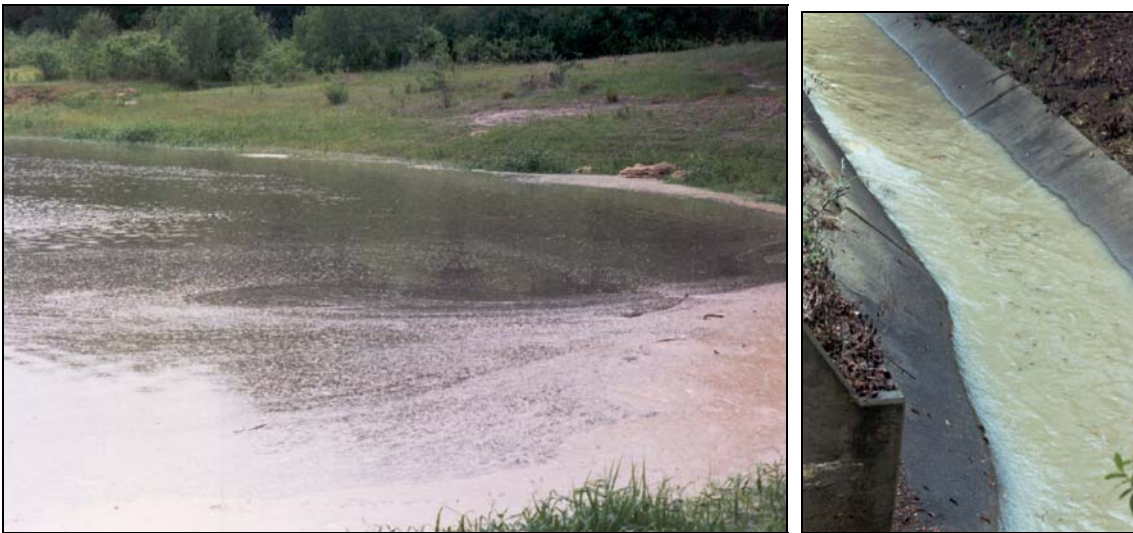
**Figure 5.1.6:** Foam and swirling stormwater in Lafayette Sink (left). Urban stormwater flowing out of Trescott Pond to Lake Lafayette (right).

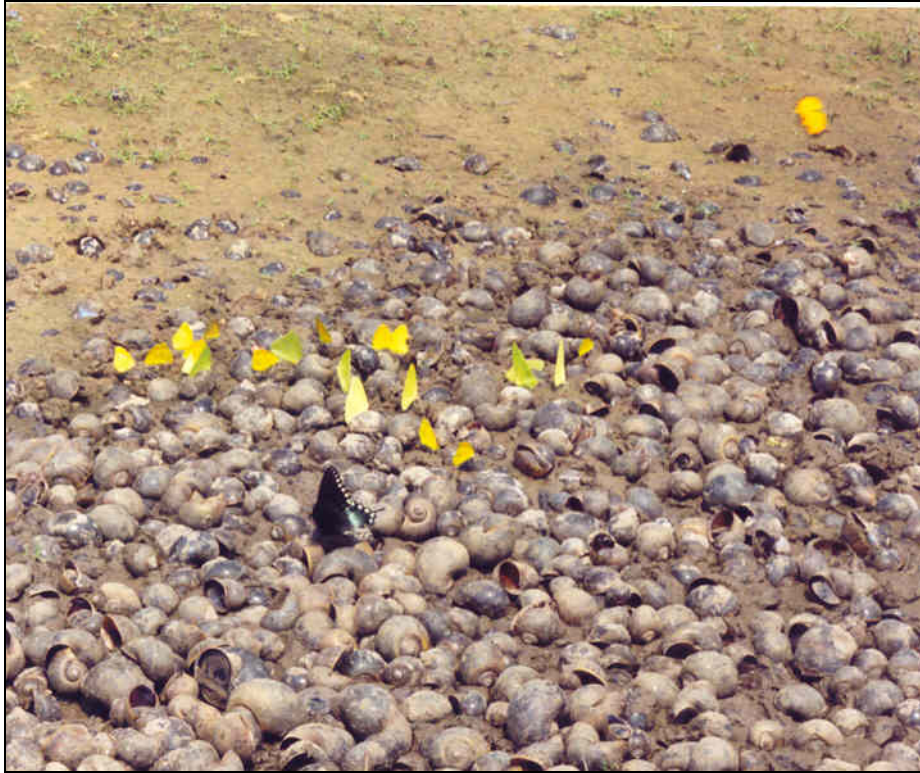
Lake Lafayette has been infested with invasive exotic Channeled Apple Snails. These snails are in both Upper Lake Lafayette and Alford Arm. From Alford Arm they can spread into Lake McBride and Lower Lake Lafayette and eventually the St. Marks River and Wakulla. These snails are voracious herbivores devouring almost all the vegetation. An average female lays 3000 eggs a week. They carry parasites that cause Rat Lung Disease, which can kill humans. USF&G did not find the parasitic nematodes in Lake Lafayette.

**Figure 5.1.7:** An invasive exotic species of snail, *Pomacea canaliculata* has turned up in Upper Lake Lafayette. This species is thriving. This species can host a nematode that can be parasitic to humans.

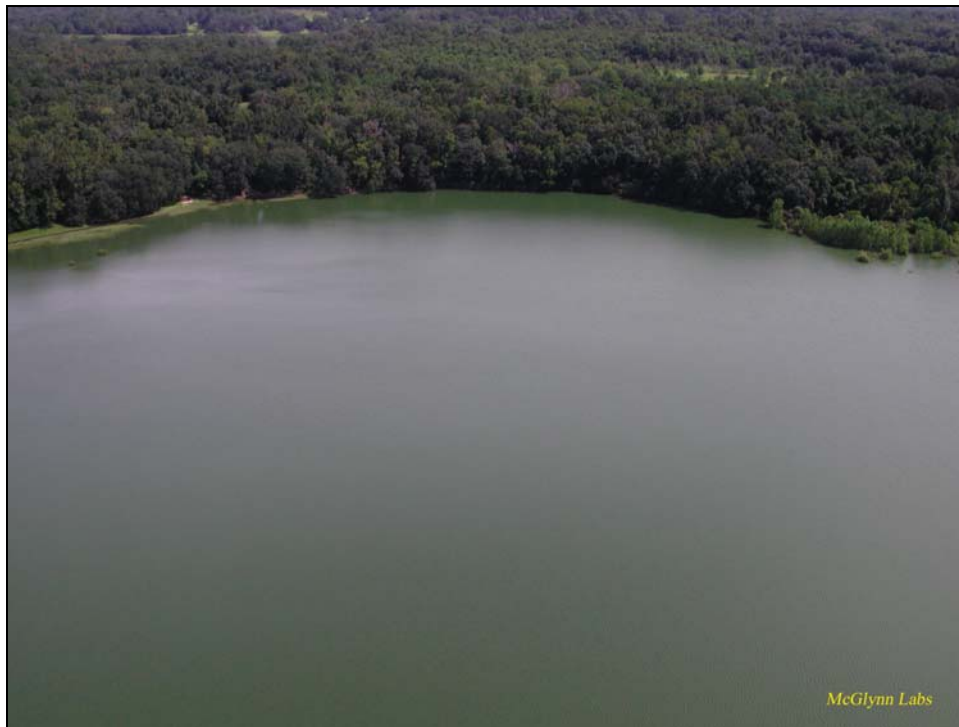
**Figure 5.1.8:** Lafayette Sink with the lake full of water 2001 (photo by Michael Hill, GFC)

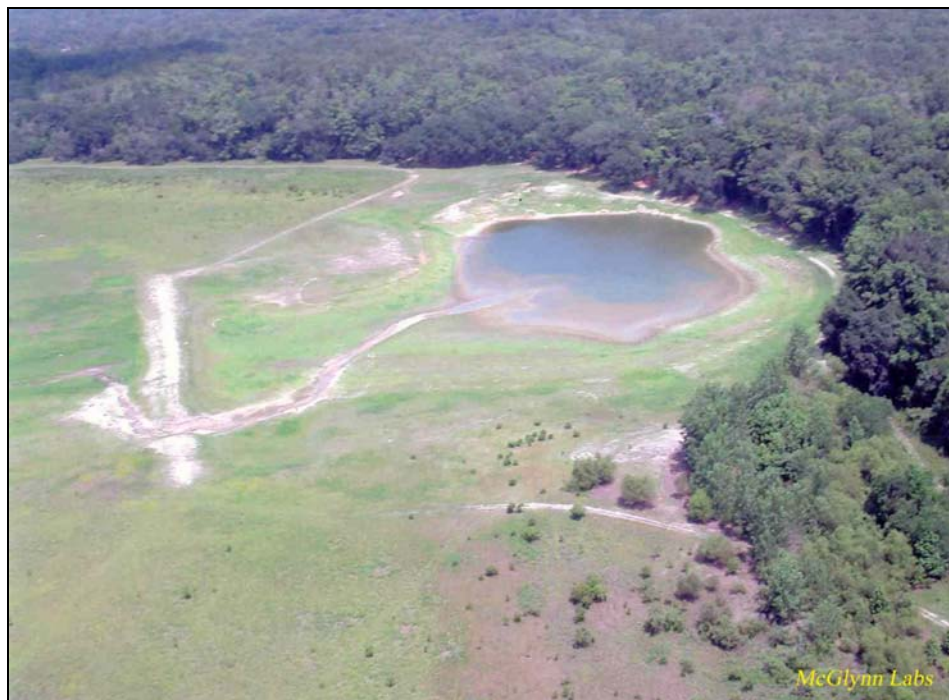
**Figure 5.1.9:** Lafayette Sink, a similar view to the one above, with the lake empty, 2004 (photo by Michael Hill, GFC)

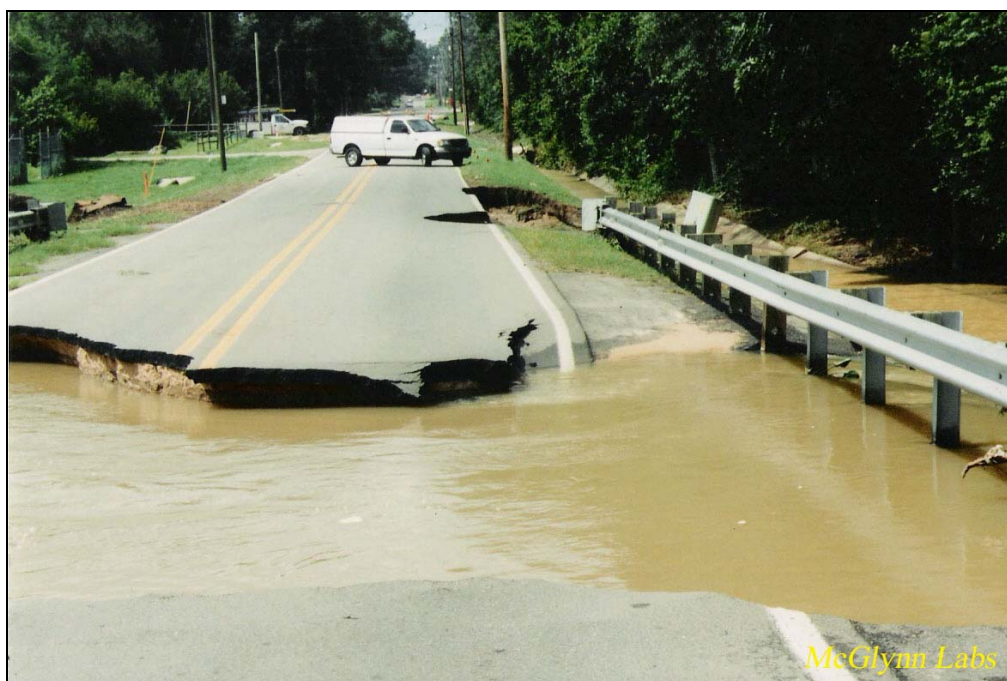
**Figure 5.1.10:** Stormwater laden with pollutants washes out Weems Road as Weems Pond, a stormwater treatment facility is overwhelmed, June 2001

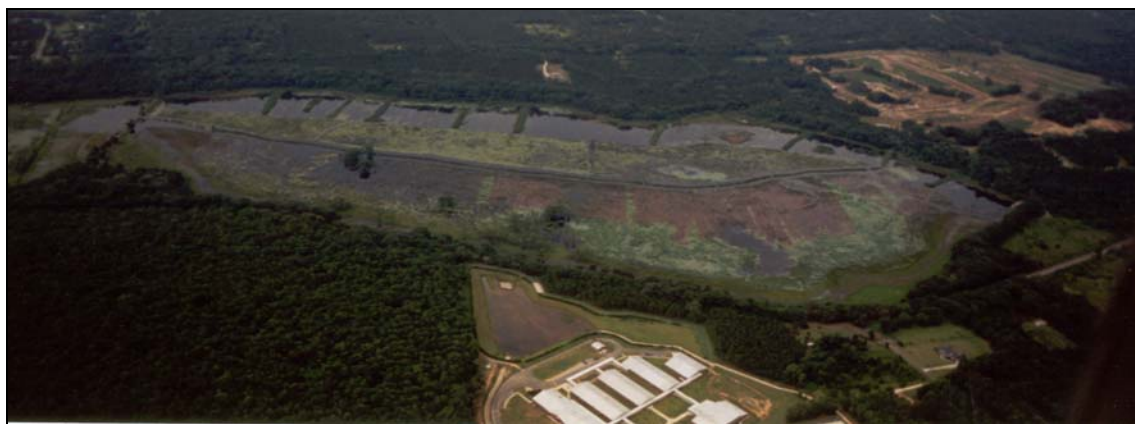
**Figure 5.1.2.1:** Lake Piney Z looking south. Note the development (Piney Z Plantation). Swift Creek Middle School is below the Lake. The Lake is overgrown with vegetation. Clear areas are the result of mechanical harvesting, grass carp and herbicide application.

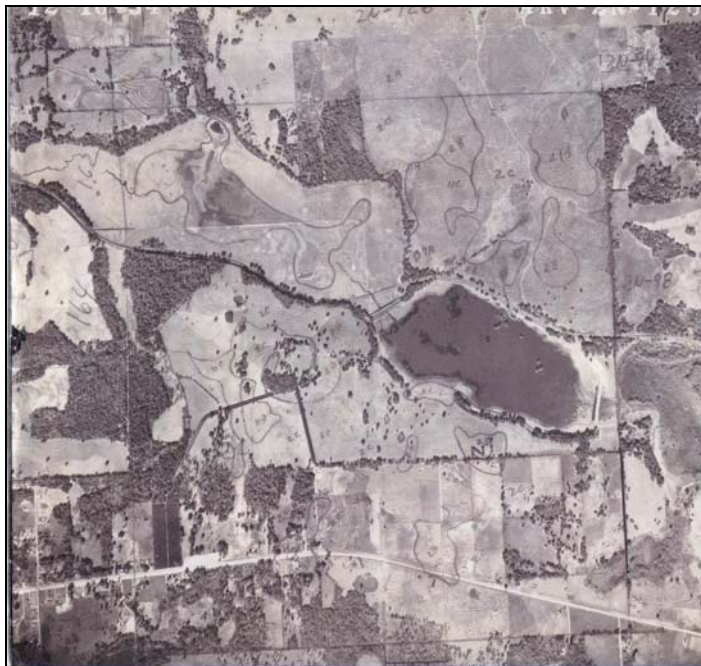
**Figure 5.1.2.2:** 1957 aerial photograph; note the absence of vegetation in the open water of Lake Piney Z (center). At this time the lake basin was rural and Upper Lake Lafayette was dry. Compare with the photo above taken in 2000.

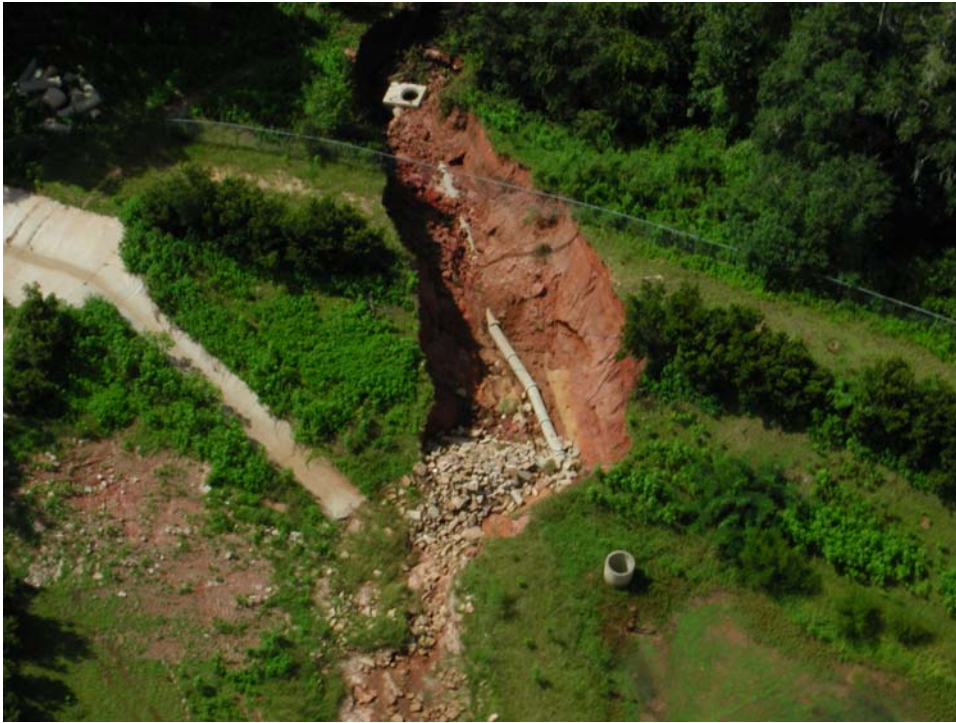
**Figure 5.1.2.3:** 2002 aerial photograph; The berm on the holding pond north of Lake Piney Z failed after Tropical Storm Berl.

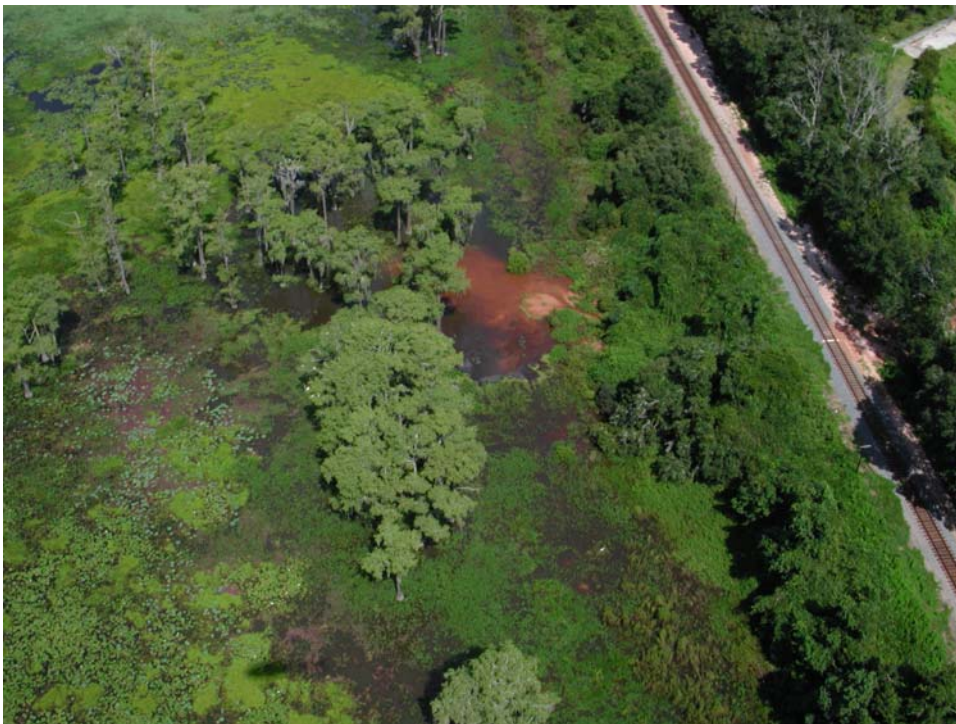
**Figure 5.1.2.4:** 2002 aerial photograph; Plume in Lake Piney Z from the failed berm.

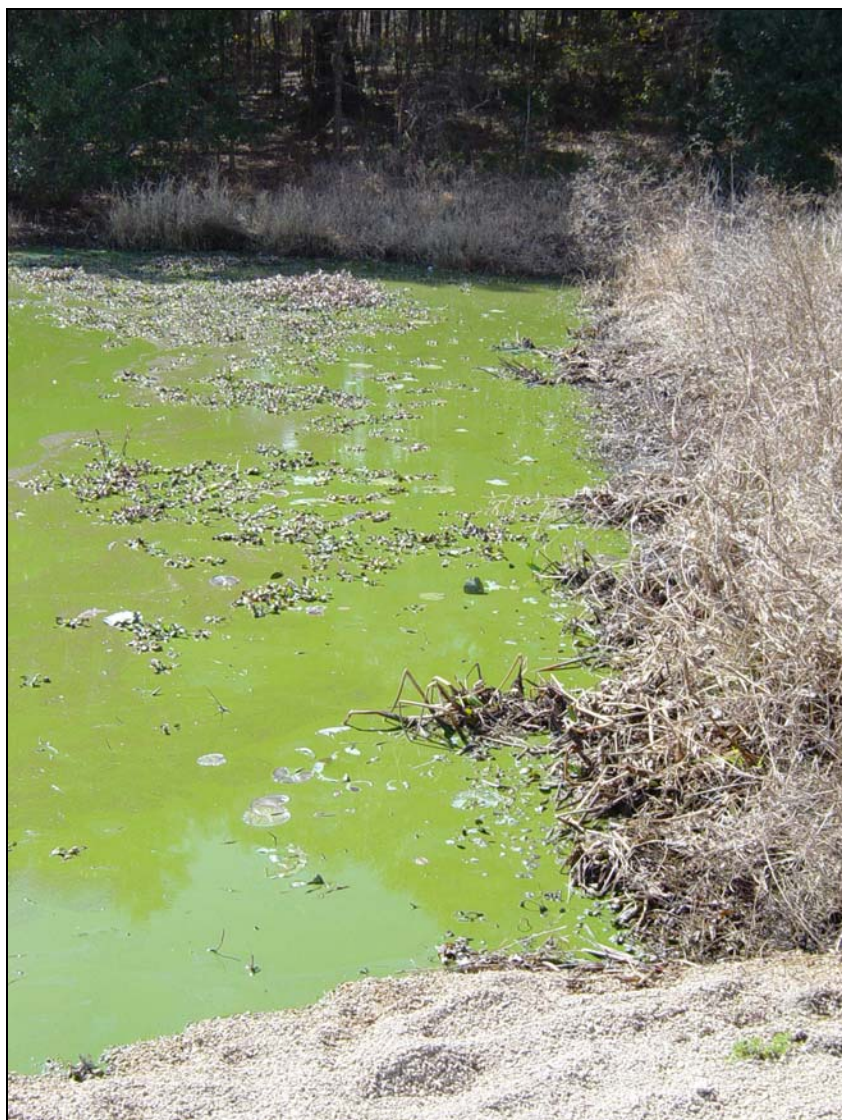
**Algal toxin analysis (Lake Piney Z)**– The drinking water threshold the cyanobacterial toxin microcystin, as defined by the World Health Organization (WHO), is 1.0 µg/L MCLR. No other Algal toxin standard exists. The blooms sampled in the Lake Piney Z on 5/1/06 exceed that standard. The algal bloom contained harmful algae and exceeded the WHO standard. *Anabaena* algae was found which produces an algal toxin called microcystin that was assayed at 10.0 ug/L on 9/23/05. There have been problems associated with incidental contact with water containing algal toxins and these blooms are properly termed Harmful Algal Blooms (HAB). The algal toxin analytical results from Green Water Labs and a poster from the Florida Department of Health are included (see the Lake Munson discussion, suggested for use in affected waters).

**Figure 5.1.2.5:** In February 2005 there was a severe algal bloom on Lake Piney Z. It was *Anabaena* sp., a potentially harmful cyanobacteria.

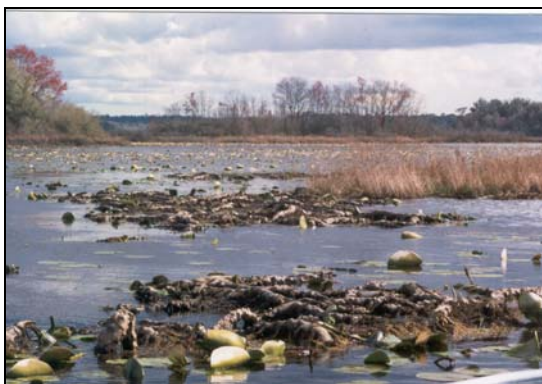
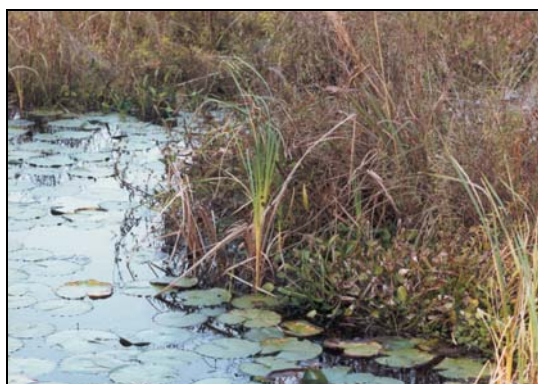
**Figure 5.1.3.1:** Tussocks in their early stage (left) and mature tussock in 6 ft of water (right), these pictures are from station L15 that has good water quality. It is obvious that there is another problem here, water level stabilization. This is what happens when the natural hydrocycle is disrupted.

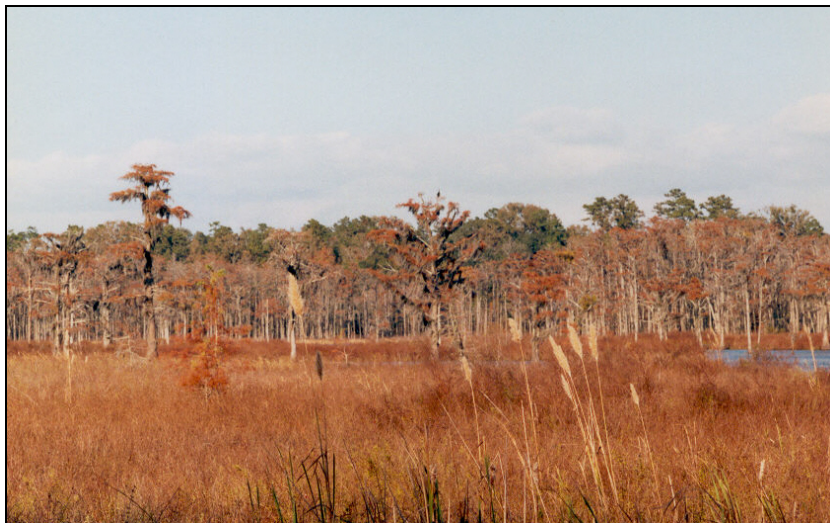
On Lower Lake Lafayette it seems that there is no water. The surface of the lake is almost completely covered with vegetation, floating islands called Tussocks. Decaying roots floating up from the lake bottom, usually fragrant water lilies, forms them. Aquatic grasses, sedges and even small trees eventually colonize them. This causes problems within a lake. Shifting winds can trap boats and crush them. Tussocks can drift to shore and children playing on them have been blown to the center of the Lake. The neighborhood association at Windham Hills recently spent \$30,000 dollars in 2003 to remove their Tussocks. Soon after removal was accomplished a storm blew in new ones from across the Lake.

**Figure 5.1.3.2:** Tussocks, or floating islands of vegetation covering the water surface in Lower Lake Lafayette.

The Florida Wildlife Conservation Commission and Bureau of Aquatic Plant Control (FDEP) could launch a massive Tussock removal program in Lower Lake Lafayette if a few obstacles were removed. 'A waterbody must have access to the boating public by way of an established, improved boat ramp or a direct navigable connection to an eligible water body' to be eligible for government funding (Rule 62C-54.0035(b)). This does not seem like much of a problem but there are no established or improved boat ramps on many of the impounded subsections of Lower Lake Lafayette. There are at least 5 berms across Alford Arm. These agencies eventually pulled their funding and moved their efforts to Washington County (2006).

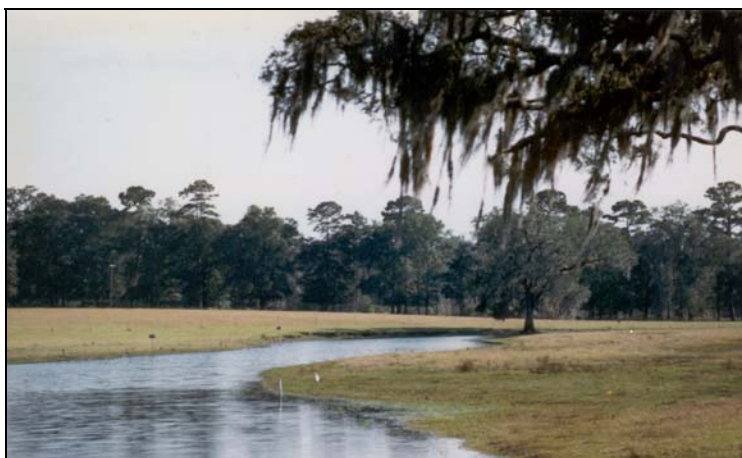
**Figure 5.1.3.3:** Station L28 is located at the inflow to Alford Arm off Buck Lake Road. Water from northern Tallahassee, from Bradfordville and the Killearn Chain of Lakes drains into Lake Lafayette here.

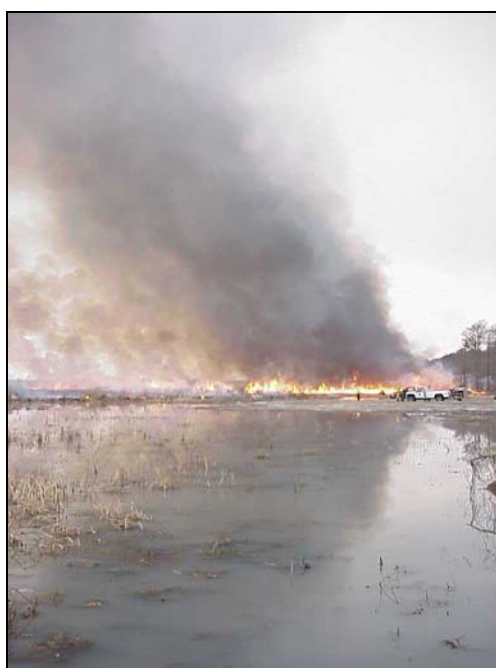
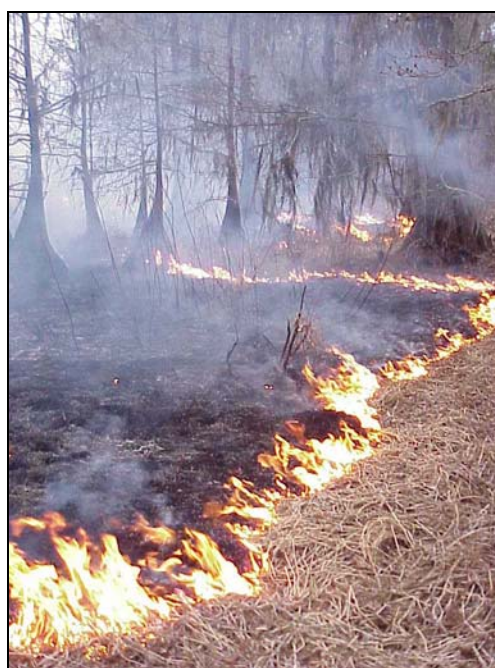
**Figure 5.1.3.5:** These pictures are from recent controlled burns on Lake Miccosukee. No burning occurred on Lake Lafayette during the drought because the numerous impoundments prevented a drawdown. Lakes Iamonia and Jackson were burned. Lake Lafayette is missing out on these beneficial management strategies that would really help with the aquatic plant problem.

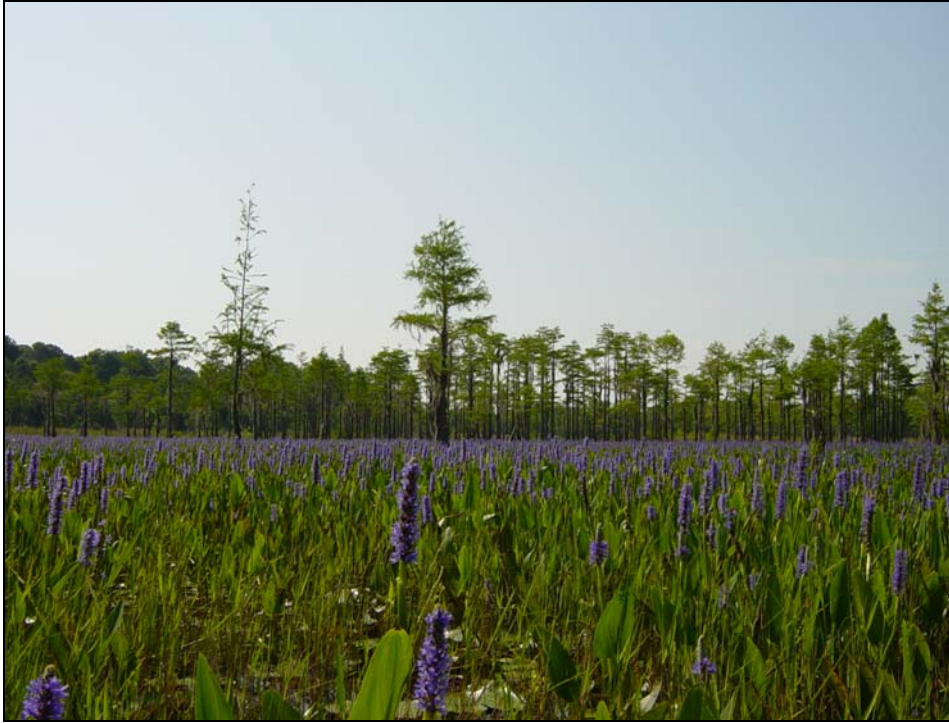
**Figure 5.1.3.7:** Central Alford Arm, there is four feet of water here, this is what Lake Piney Z looked like before the recent restoration by the Florida Wildlife Commission.
