# **An Evaluation of the Biological Health of Lake Powell, Walton/Bay Counties, Florida**

**Florida Department of Environmental Protection  
Northwest District  
160 Governmental Center  
Pensacola, Florida 32502**

**ABSTRACT:** Biological and Physiochemical assessments were performed on Lake Powell, (Walton, Bay Counties, FL) in the summer of 2003 and spring of 2004. The biological condition of Lake Powell, was determined by evaluating the habitat conditions of the lakeshore, surveying the littoral plant and macrobenthic invertebrate assemblages, analyzing a suite of chemical parameters which measure the levels of nutrients and pollutants in the water, and measuring characteristics of the bottom sediment of the lake. These results were compared to FL DEP study conducted in 2000 (Payne and Butts, 2001). Overall water quality in Lake Powell was similar to levels measured in 2000. However, a decrease in habitat quality, a significant shift in sediment grain size and organic content, and a near complete collapse in the macrobenthic community show that biological impairment in Lake Powell has occurred since 2000.

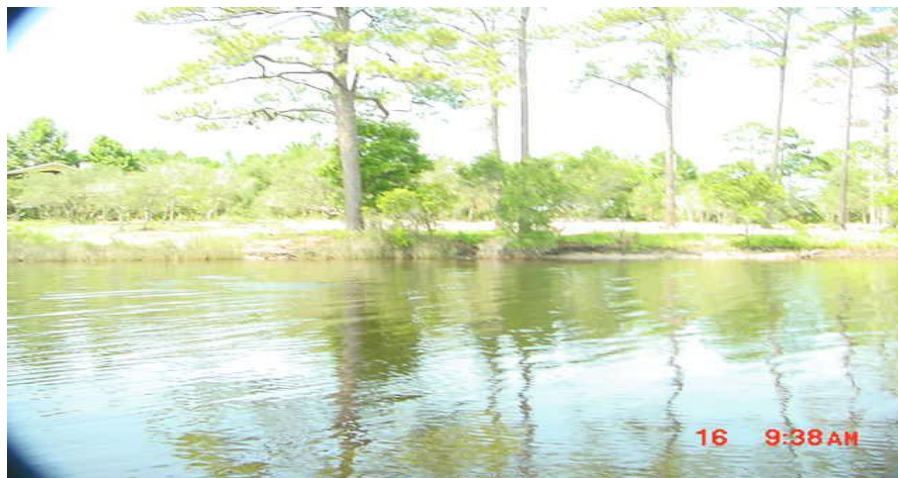
Riparian buffer zones were not adequately vegetated along the entire margin of Lake Powell, most notably on the western side of the golf course (Figure 5). The western edge of the golf course has the most poorly protected riparian zones of the facility. As an example, a description of the lakefront from the western side of the golf course follows. In some areas, the buffer strip starts at the edge of the golf course, of which the first 8-10' is cleared with exposed soil. Adjacent to the bare strip is a sparsely vegetated steep slope to the waters edge, approximately 20'. This slope was vegetated by small palm trees, Yaupon Holly, and other shrubs and crisscrossed with gaps of bare soil and paths from people or animals walking down to the waters edge. This riparian buffer zone is inadequate, and does not provide sufficient protection of erosion of soils, chemicals, and nutrients from the surrounding land into the water.

Figure 5. Inadequate Riparian Buffer Zone along Lake Powell.  
Photo is east side of Section 12, July 16, 2003 by F. Butera

Overall, habitat conditions at Lake Powell have degraded since surveyed in 2000 by Randall Payne. Research by ecologists has shown that a 30-foot non-sloped buffer provides minimal service for sediment removal. To be effective in protecting water and habitat quality Riparian Buffer Zones should be at least 100 feet across and to enhance Riparian wildlife, buffer zones should be greater than 300 feet across (Wegner 1999).

To restore the biological integrity of Lake Powell actions need to be taken which will reduce and eliminate both sediment and nutrient sources into the system, along with a reconsideration of water level management practices currently being utilized by local governments. Sediment and nutrient sources include fertilizers from new construction projects, lawn and golf course maintenance must be practiced in such a way that fertilizer run off is minimized or eliminated when possible. This is especially important while establishing new lawn areas in construction zones, when the seepage of nutrients through the sand into the lake is most prevalent. Although costly, septic tanks should also be replaced with a sewer system. The reduction of sediment into the watershed requires an added emphasis on maintaining and enforcing strong erosion control programs in construction sites within the entire watershed. Several streams feed Lake Powell, all of which carry sediment into the water body. Therefore it is as important to eliminate sedimentation into the feeder streams as it is to prevent sedimentation from occurring at the lake front. Additionally, the establishment of an effective riparian buffer zone and

strong storm water controls around the entire lake must be vigorously pursued. Well-vegetated buffers around the lake act as a sediment, nutrient, and chemical filter, trapping and utilizing these products before they enter the water body. Lastly, the return to more natural hydrologic conditions at Lake Powell should be implemented and the strict maintenance of the current hydrological regime for Lake Powell must be reconsidered. Allowing the water level in Lake Powell to rise higher than current practices, would allow for a less frequent, but more natural and vigorous exchange between Lake Powell and the Gulf of Mexico. This may also have an added benefit for the recruitment of fishes into the system as well.
