These images show the erosion along Scott Bridge Road.

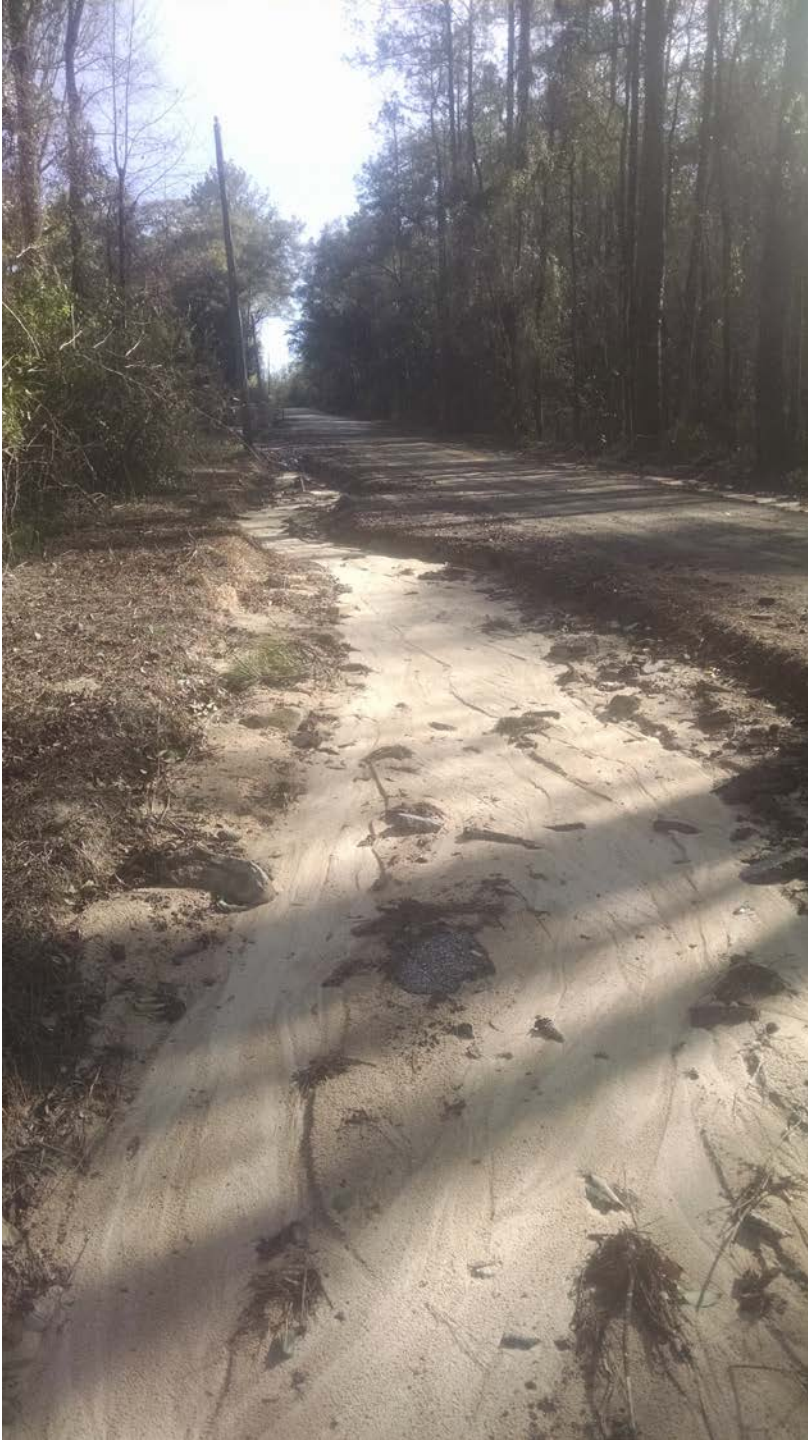
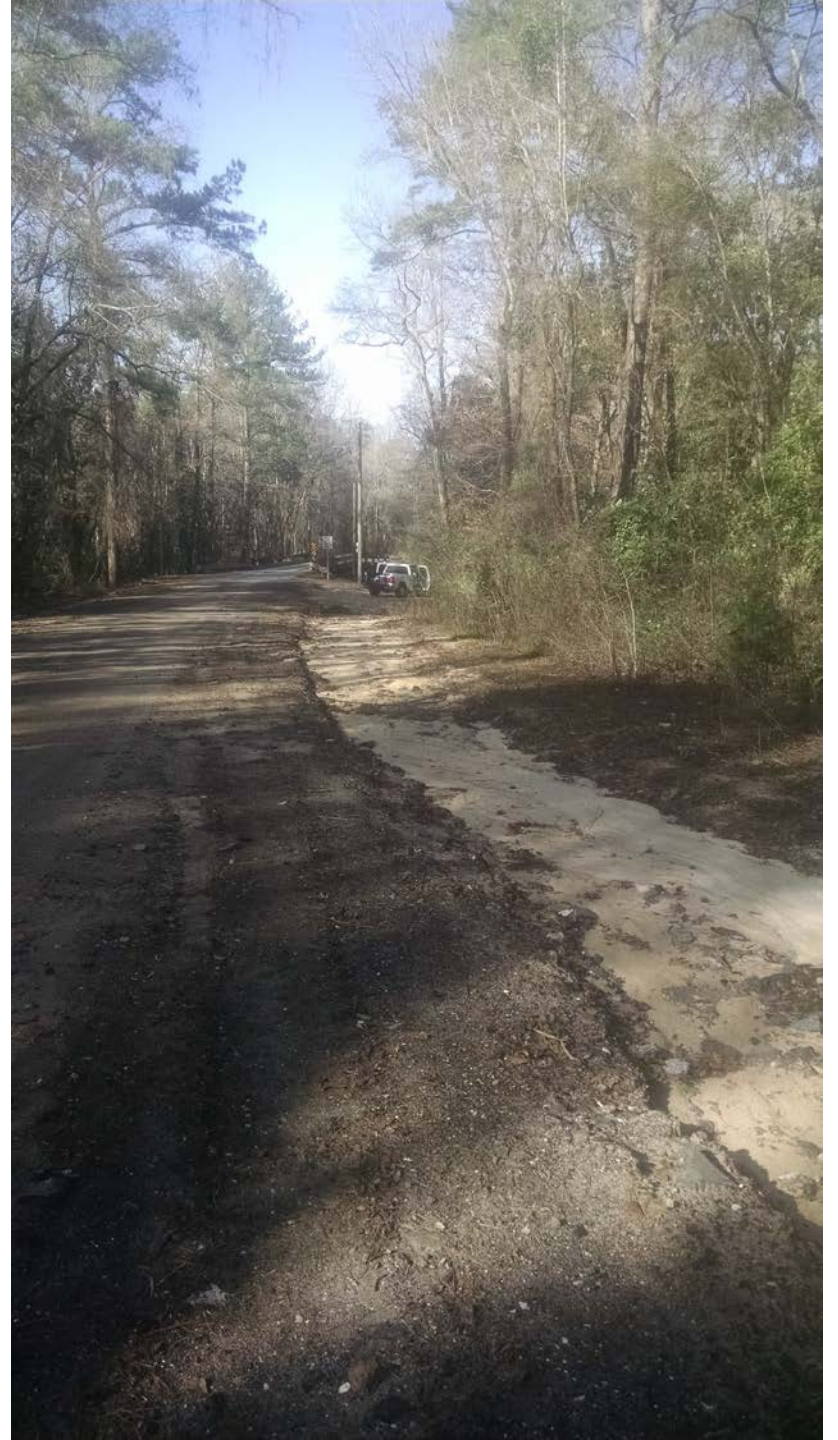
The image on the left is looking from our vehicle back towards the east.

The image on the right is looking towards our vehicle which is parked on the right shoulder near the bridge and creek.

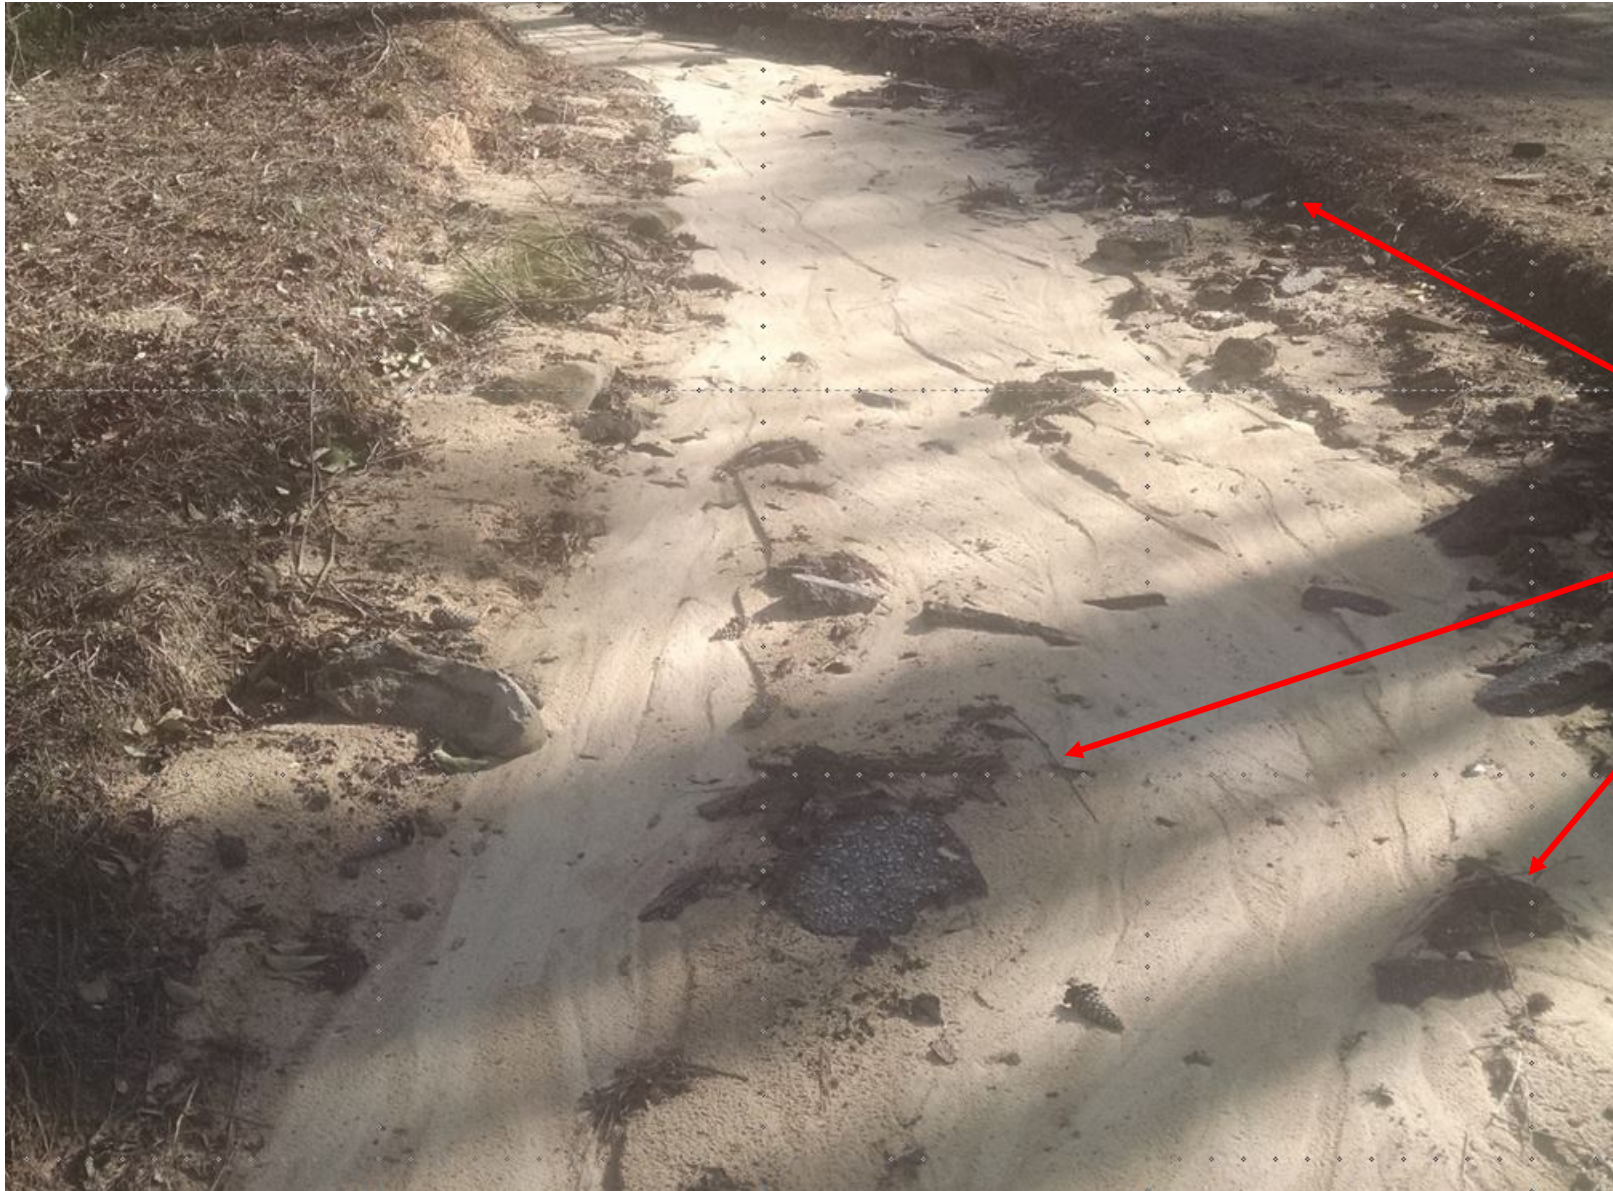
This is the previous image zoomed in to show the road debris that is being washed downstream.

Pieces of asphalt that have been undercut and are making their way downstream towards the creek.

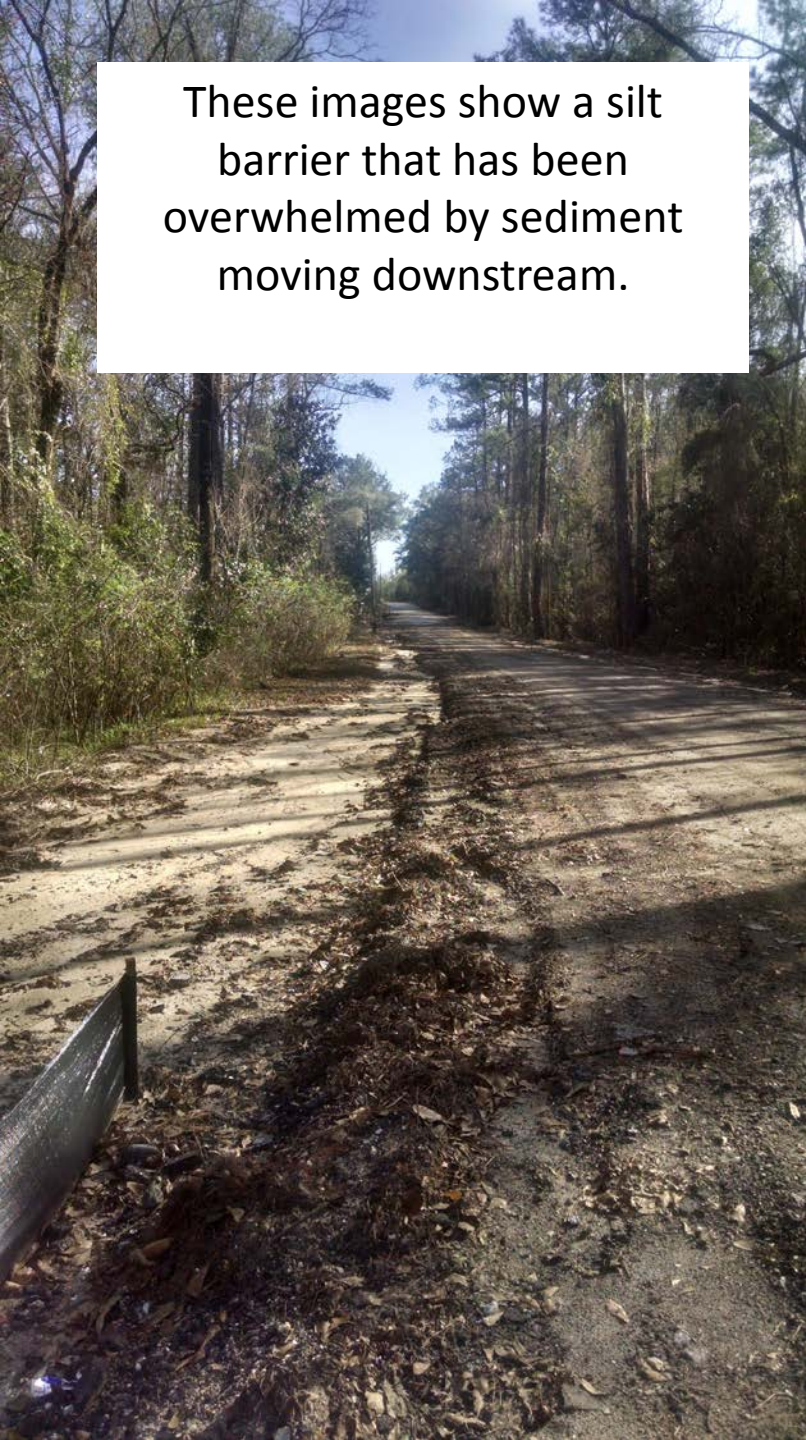
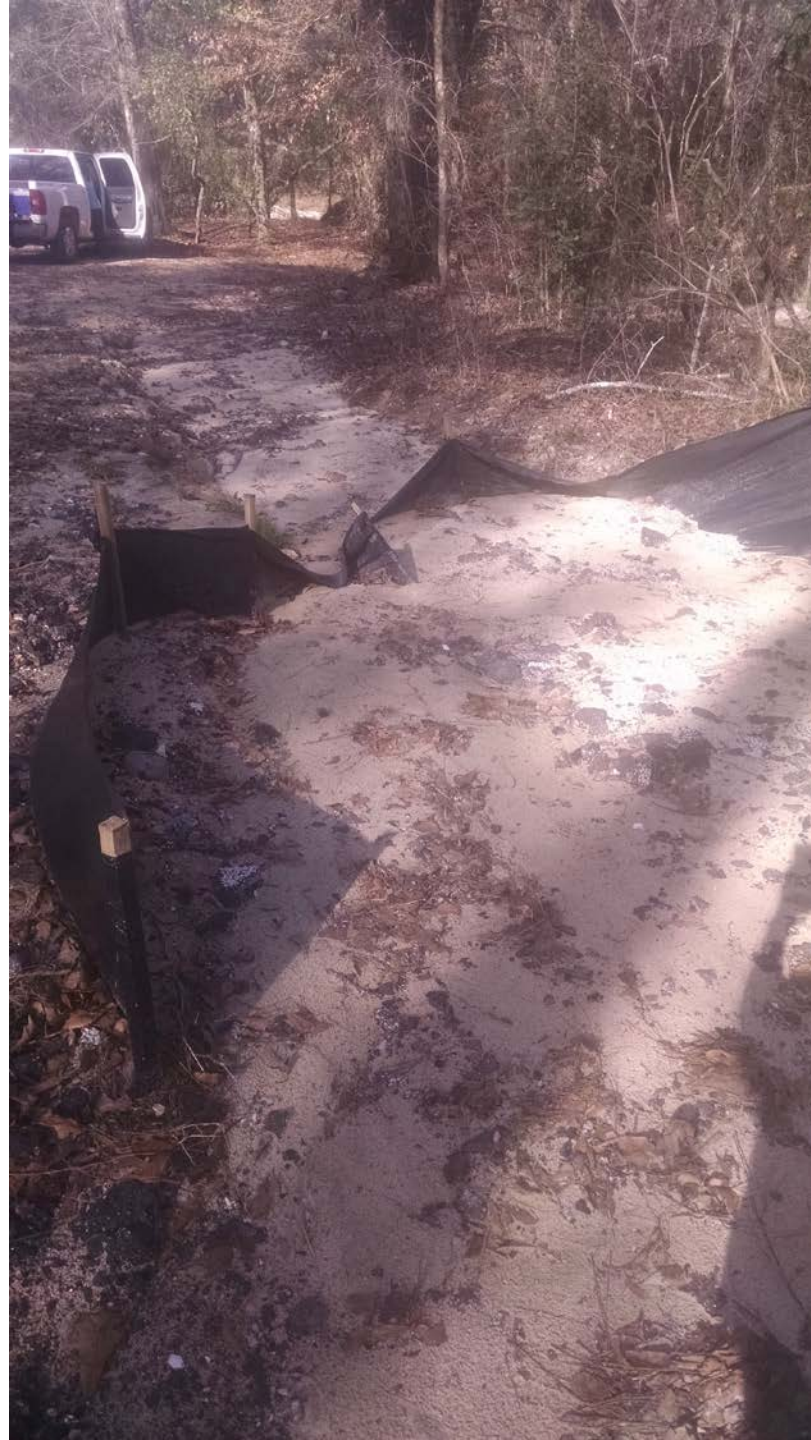
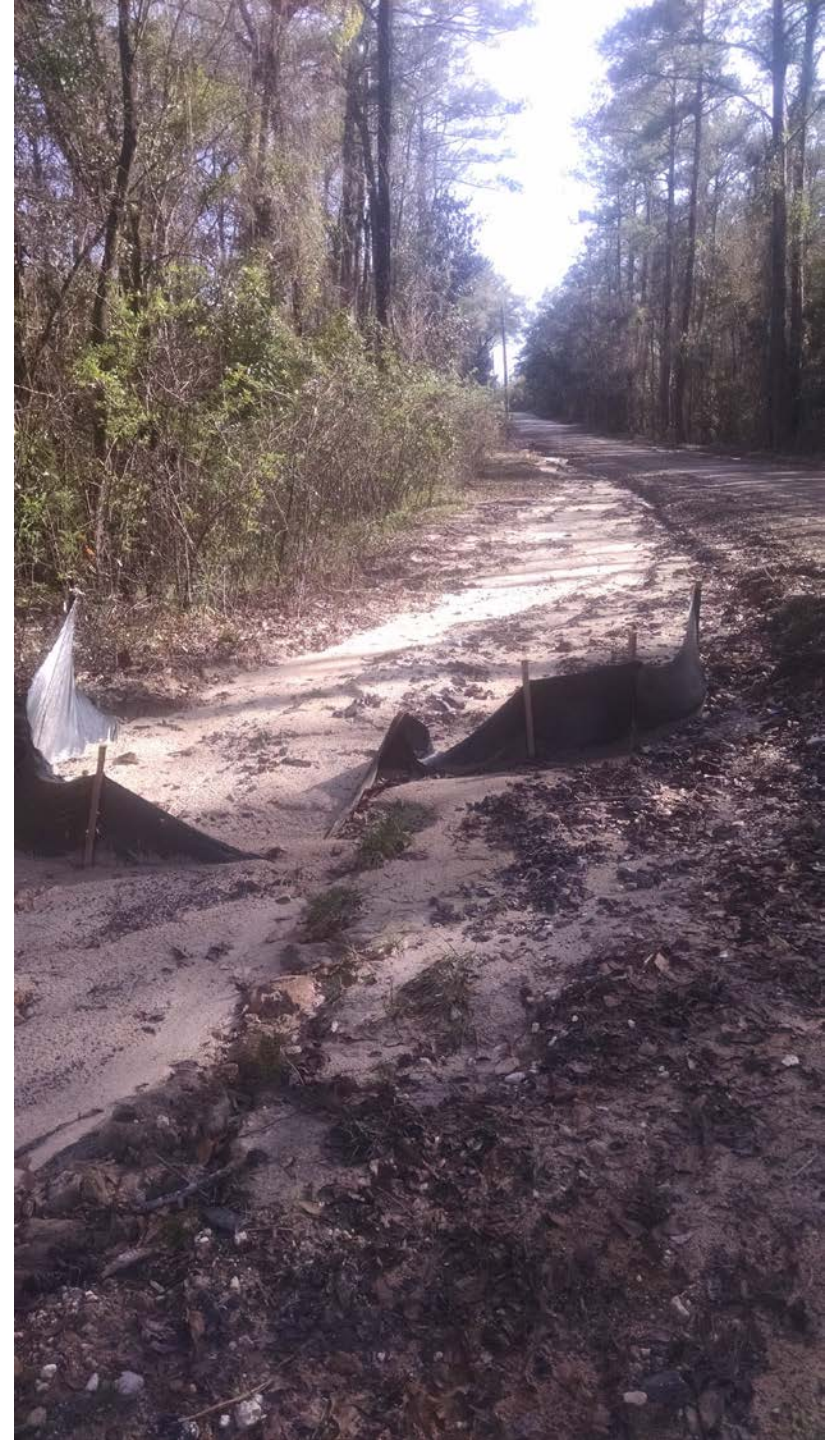
These images show a silt barrier that has been overwhelmed by sediment moving downstream.

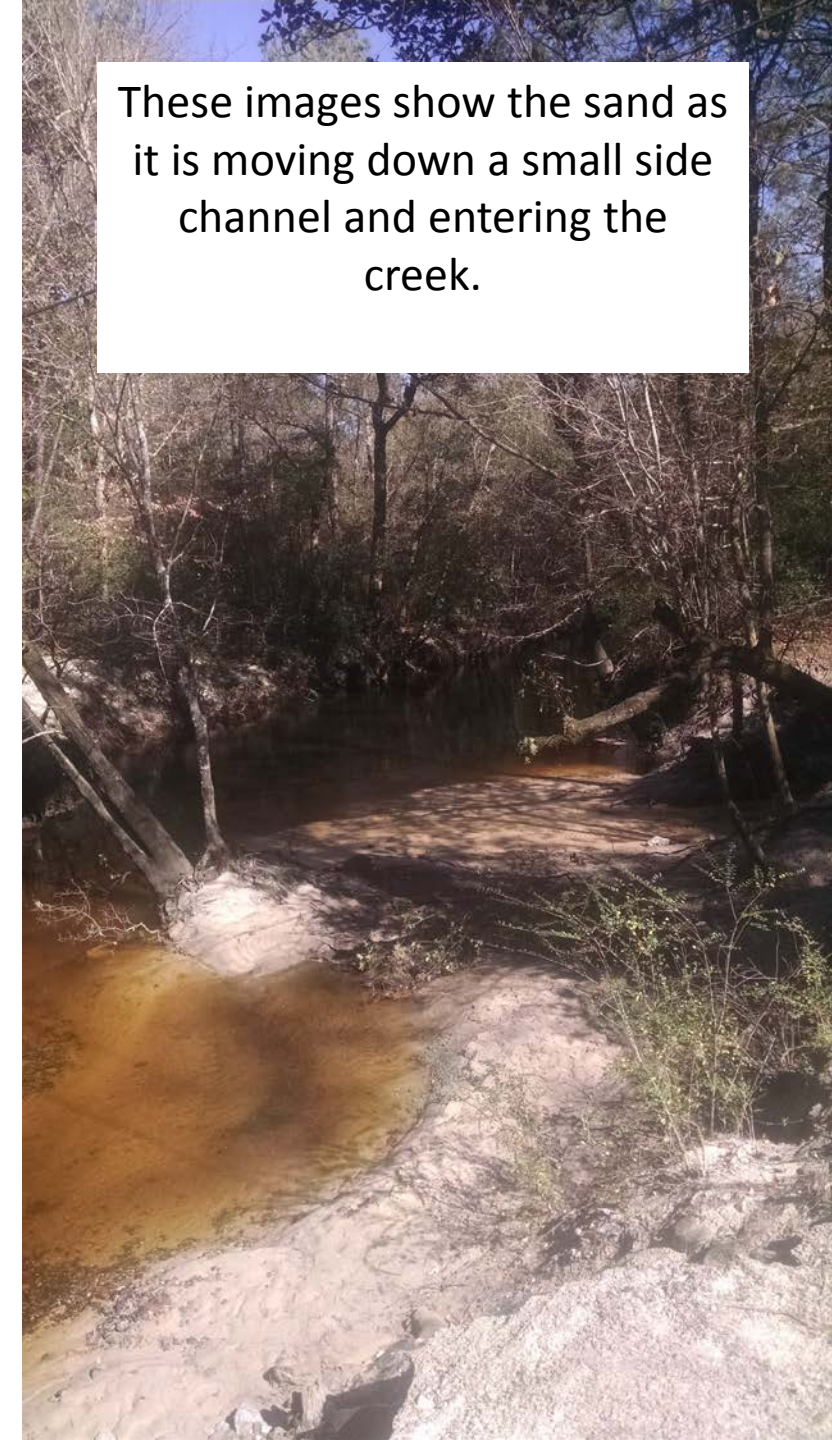
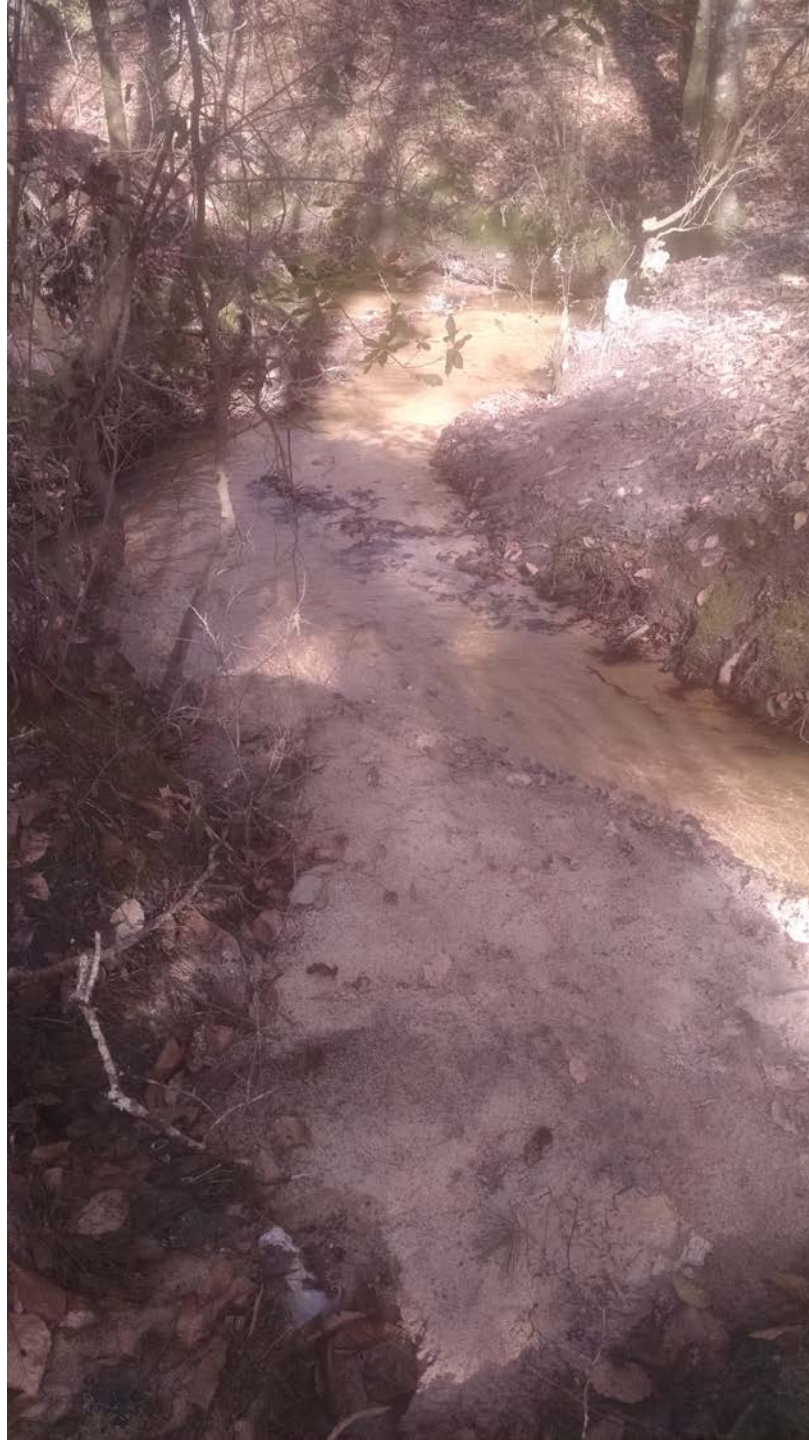
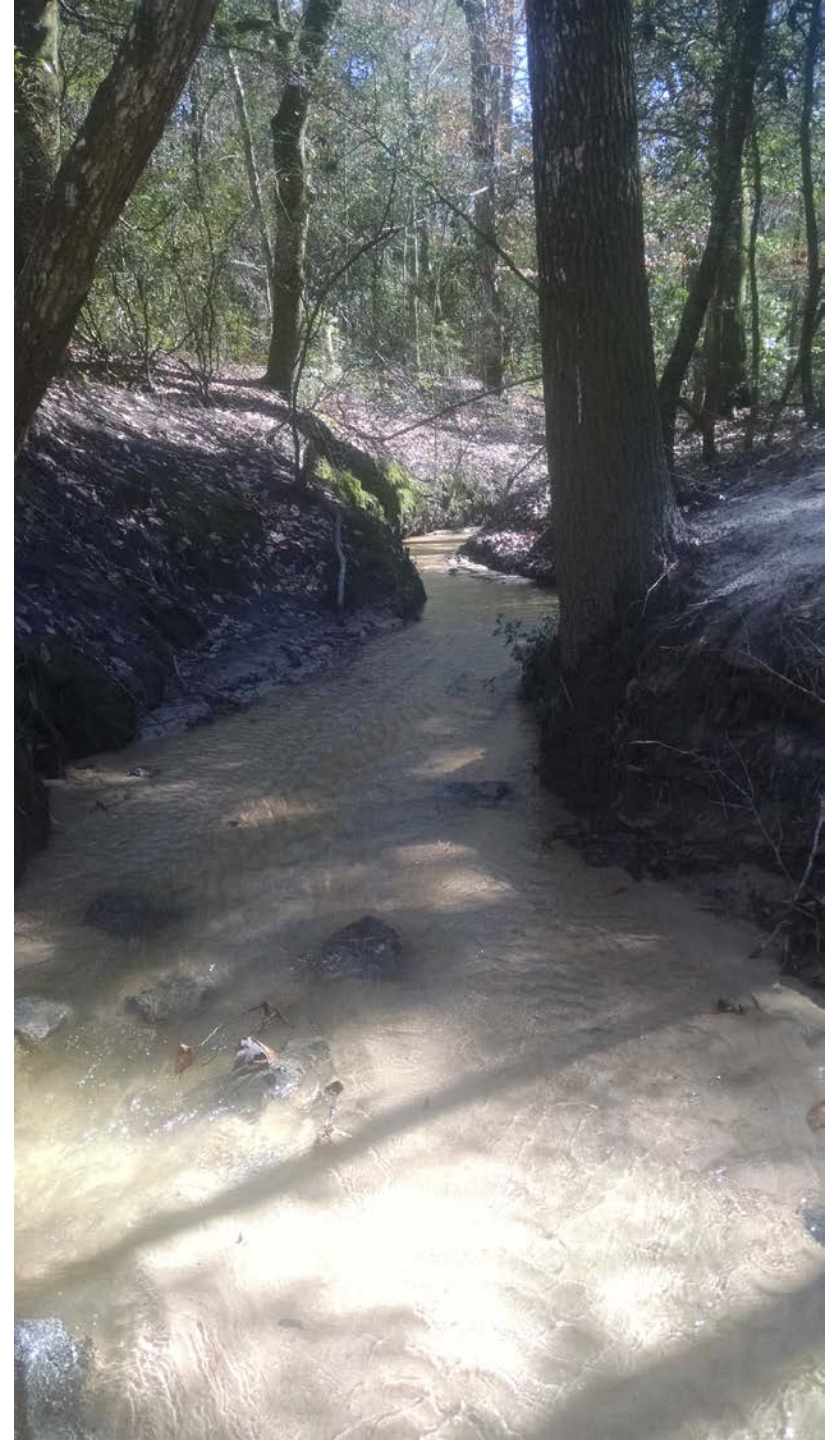
These images show the sand as it is moving down a small side channel and entering the creek.

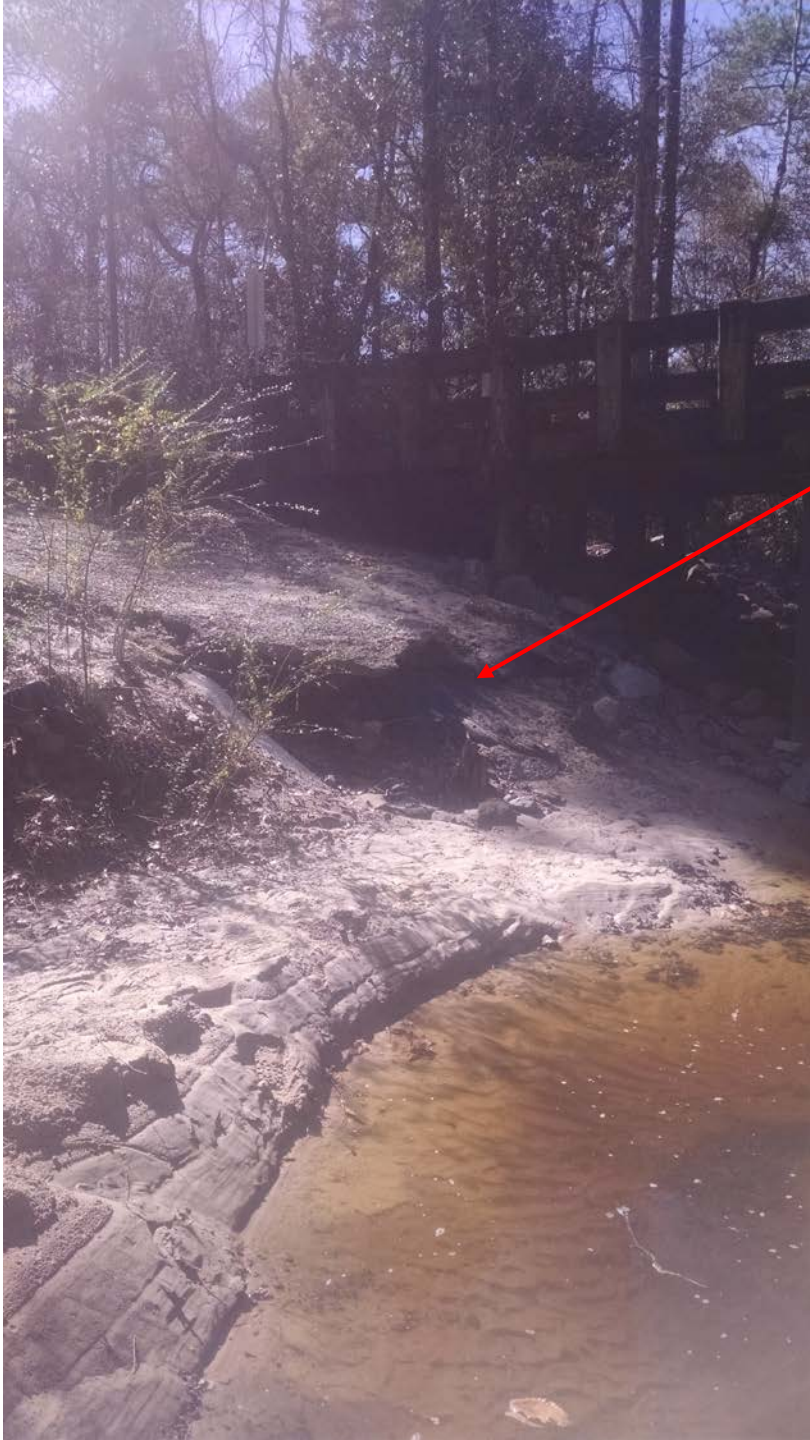
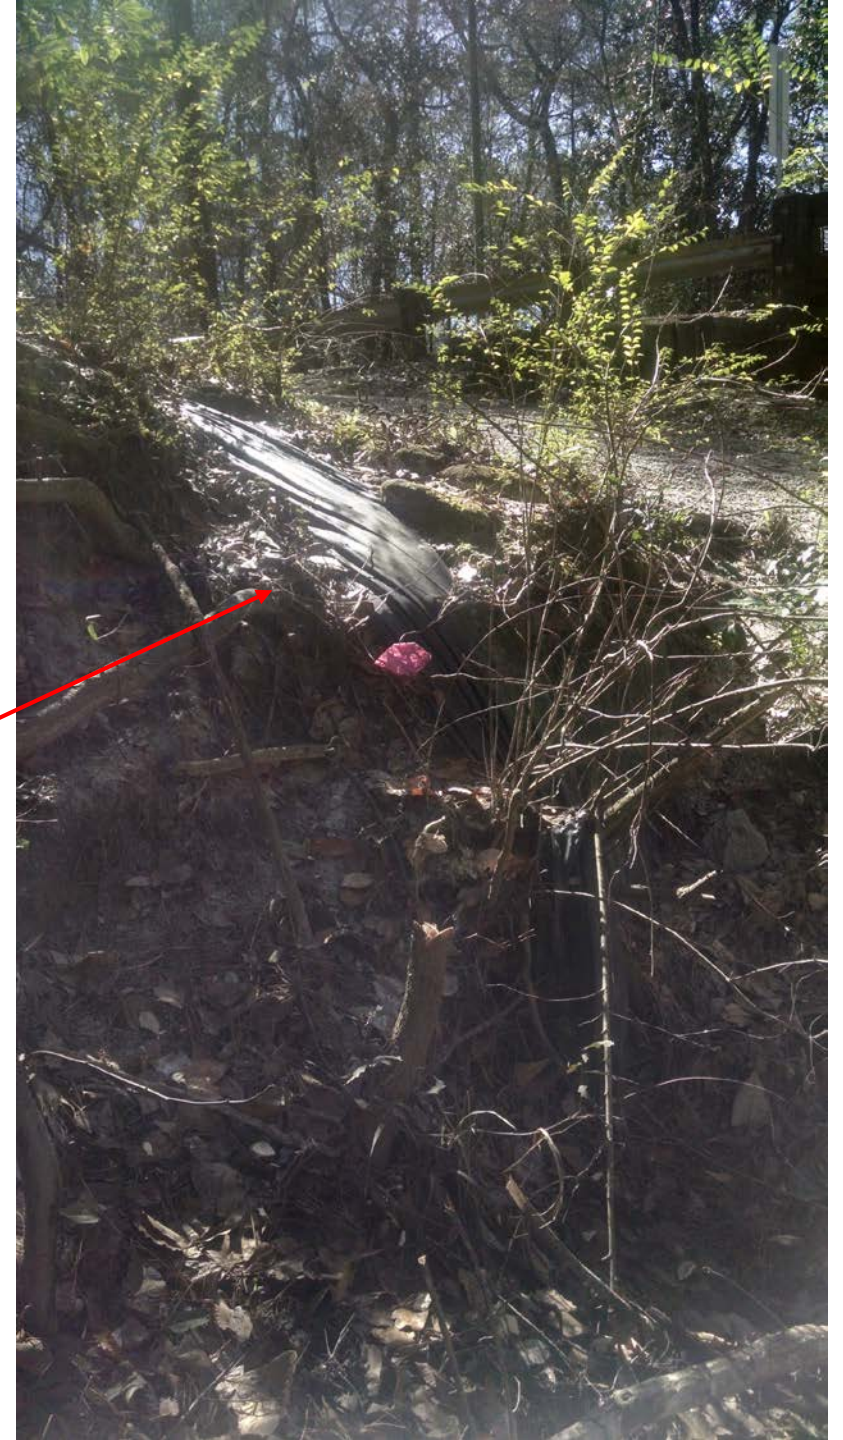
These images show the erosion that is occurring along the banks of the creek at the bridge crossing.

The image on the left shows the undercutting that is occurring.

The image on the right shows a silt barrier that has been completely overwhelmed by the erosion.

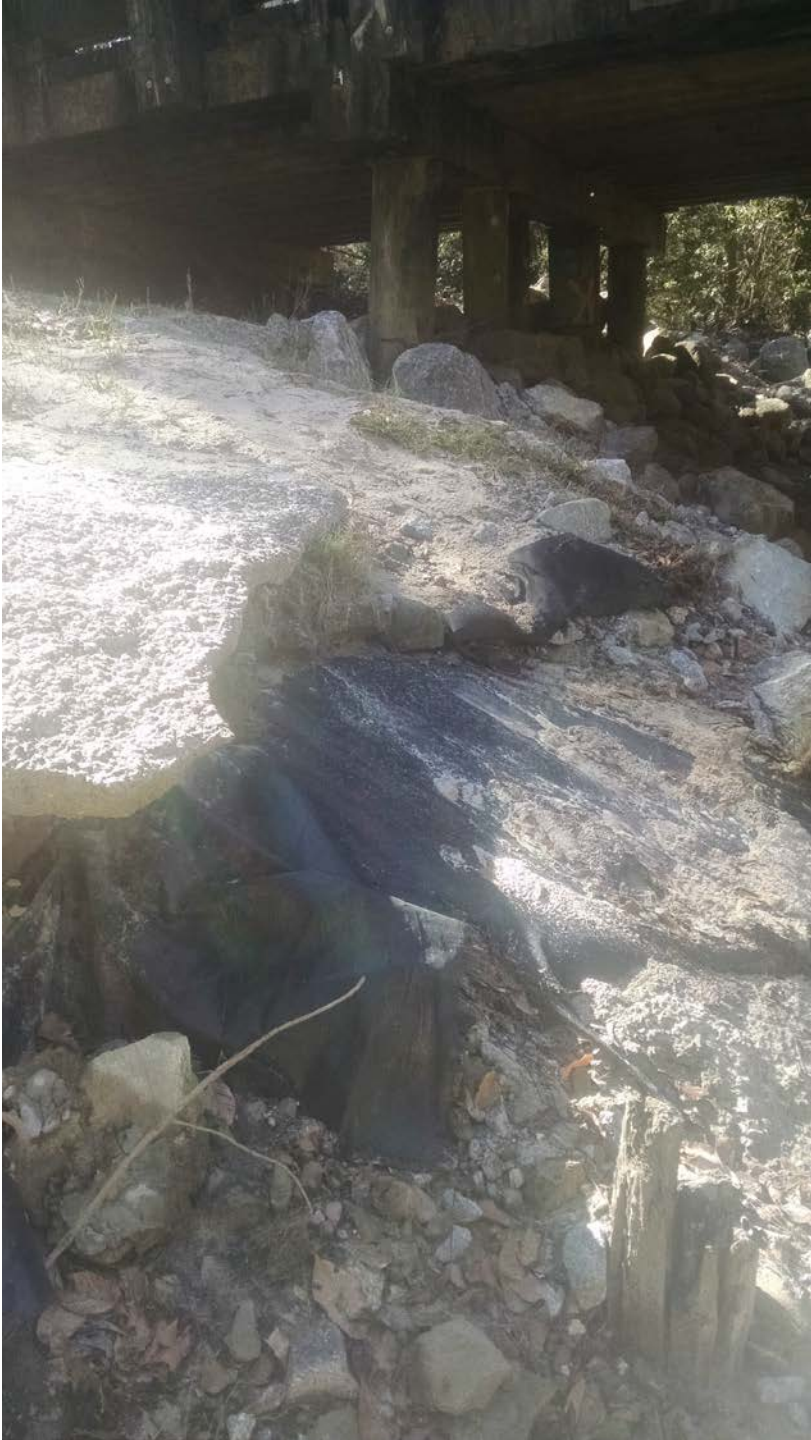
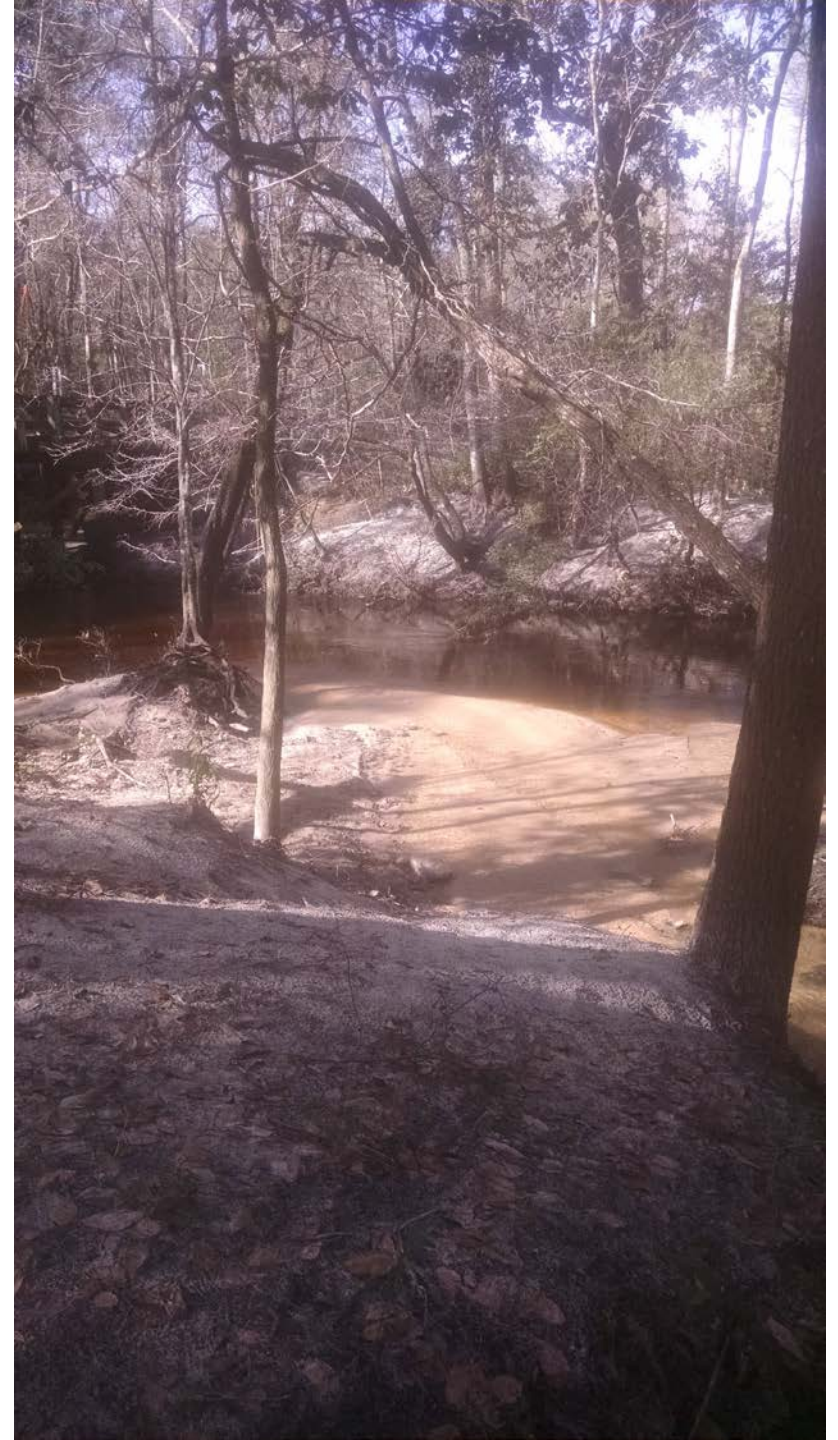
These images show the erosion that is occurring along the east bank of the creek at the bridge crossing.

The image on the left shows the undercutting and destabilization of the sand and rock.

The image on the right shows the sand creating a delta out into the creek burying aquatic habitats.

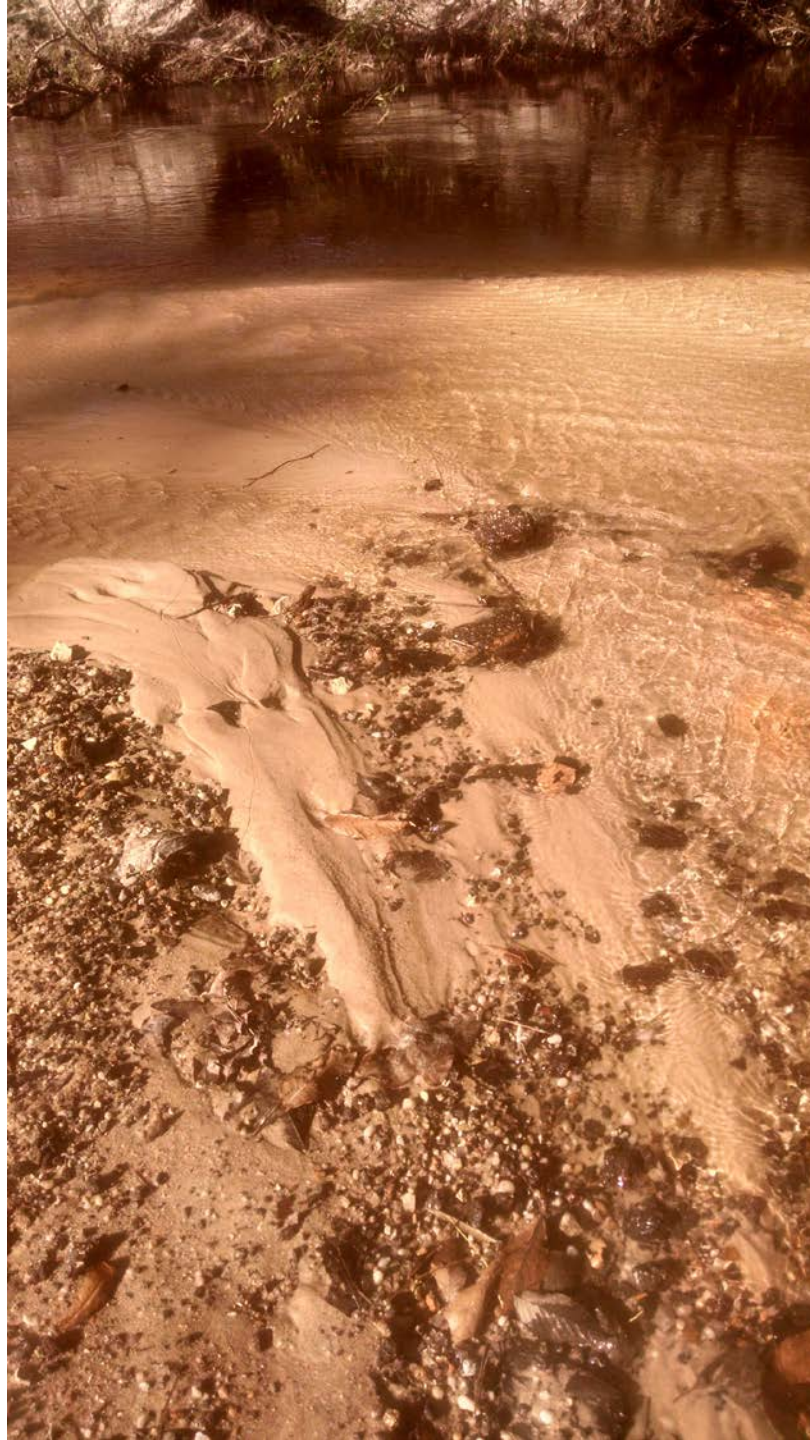
This image is a close up of the sand delta with pieces of asphalt that is being deposited into the creek.

Asphalt is a potential source of PAHs.
